### The Case Study of St. Andrew's Church in Ceto, Brescia, Italy

International Journal of Architectural Heritage

# Combining Architectural Conservation and Seismic Strengthening in the Wood-Based Retrofitting of a Monumental Timber Roof: The Case Study of St. Andrew's Church in Ceto, Brescia, Italy

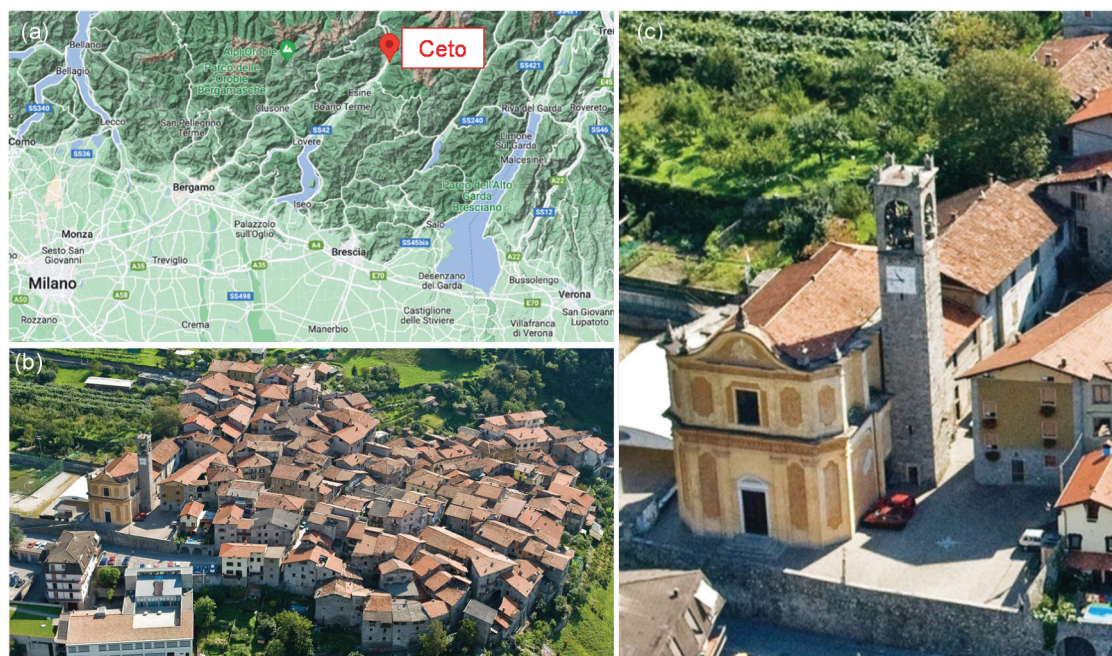
**Figure 1.** (a) Location of the analysed church in the province of Brescia; (b) position of the church in the town of Ceto; (c) case-study building.

This work presents the application of the aforementioned concepts to a case-study building, namely St. Andrew's Church (Figure 1) in Ceto (Province of Brescia, Italy). This existing stone masonry construction features a monumental timber roof, which has been retrofitted by means of wood-based seismic strengthening techniques. The main objective of this work is to highlight, aided by a specific case study, the advantages of timber-based solutions for both seismic improvement and architectural conservation. These benefits are not only presented from an academic perspective, but also from the point of view of professional engineering, in order to contribute to the framework supporting both further research on wood-based seismic retrofitting techniques, and their actual, practical application on monumental buildings. Hence, the present article starts from a frequent scenario in engineering practice, where both the allocated budget and the execution time are limited. This led to conservative design and modelling assumptions, since only visual inspections on the existing structure were conducted, and a more in-depth structural assessment was not possible. Yet, even in such situation, the adopted wood-based techniques allowed to meet the requirements in terms of realization time and cost, and to provide the church with additional energy dissipation sources, as will be presented in the following.

The Church of St. Andrew (Figure 1) in Ceto (Province of Brescia, Italy) was built between 1708 and 1732 on the location of a pre-existing 11<sup>th</sup> century chapel, and consecrated on 1<sup>st</sup> September 1743. According to the detailed information available in the local parish archives, the construction of the masonry structure was realized with local stones, and was completed in 1713, including the timber roof. From 1713 to 1726, mainly finishing works took place, enriching the church with altars, statues, frescos and some valuable paintings, realized by, among others, two very active and respected North-Italian masters of the time, Giacomo Ceruti and
