**Development of Condition Monitoring System for Railway Crossings  
Condition Assessment and Degradation Detection for Guided Maintenance**

Condition Assessment & Degradation Detection  
for Guided Maintenance

Keywords: railway crossing, condition monitoring, degradation detection, maintenance guidance

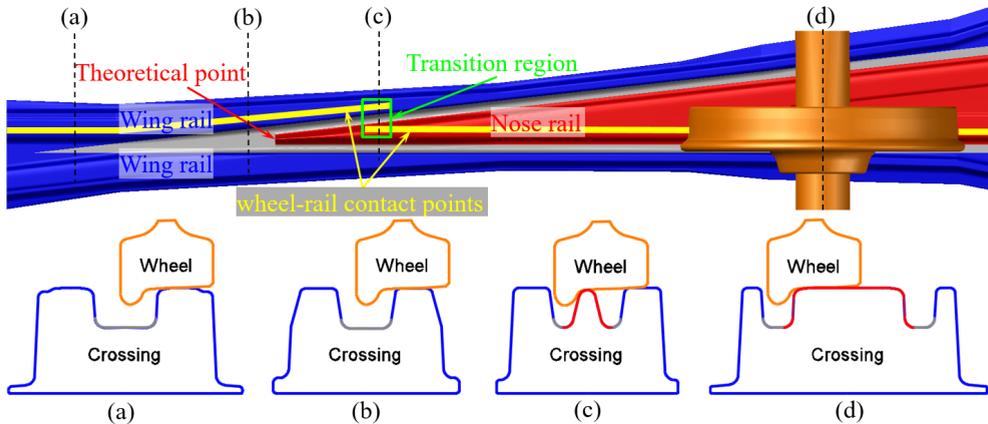
Figure 1.2. Main stages of wheel passing through a turnout crossing: approaching crossing (a)-(b), the transition from wing rail to crossing nose (c), continue moving on the crossing and through rail (d).

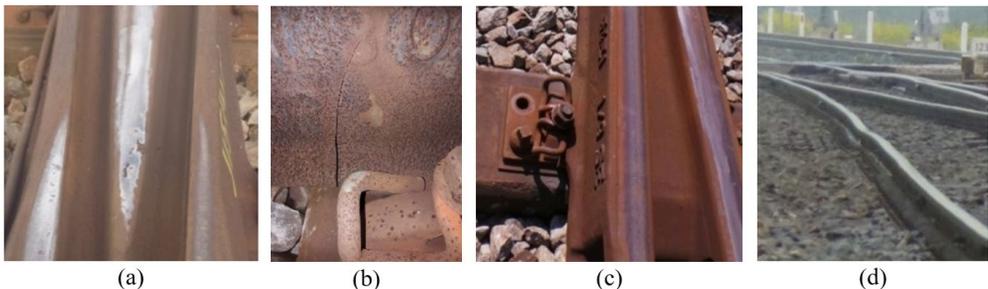
The high wheel-rail impacts in the railway crossings make them vulnerable elements in the railway infrastructure. Such high impacts result in not only substantial damages on the crossing rail (e.g., cracks and spalling on the railhead (Figure 1.3 (a)), broken rail foot (Figure 1.3 (b)), etc.), but also failures in the related track components (e.g., broken clips (Figure 1.3 (c)) and uneven ballast settlement (Figure 1.3 (d)), etc.).

Figure 1.3. Crossing damages in the Dutch railway. (a): spalling on the railhead; (b): broken rail foot (photo from I.Y. Shevtsov); (c): Broken clips; (d): Uneven ballast settlement.

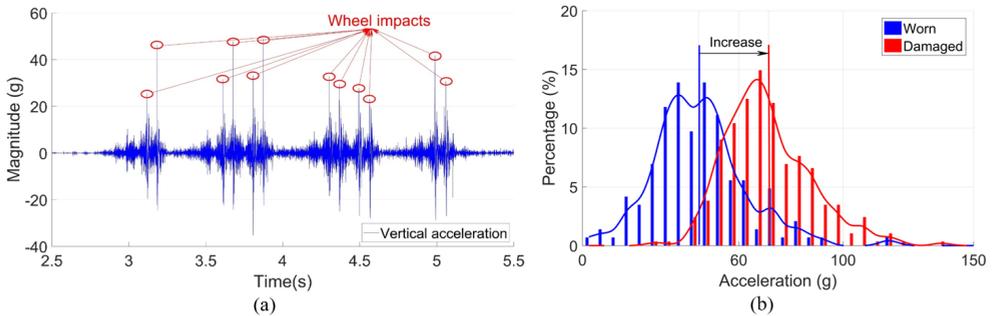
The wheel impact is reflected by the vertical accelerations, which are obtained on the crossing and processed through statistical analysis. This indicator is mainly based on the magnitude of the impacts due to each passing wheel (Figure 2.3 (a)). The distribution of the impacts due to multiple wheel passages can then be used to estimate the condition of the monitored crossing. Figure 2.3 (b) shows an example of the measured impacts in a 1:15 crossing (Figure 2.2 (b)) in different condition stages. It can be seen that with the crossing condition was degraded from the “Worn” stage to the “Damaged” stage, the wheel impacts overall shifted to a higher level.

Figure 2.3. Indicator for the wheel impact. (a): Procedure for the obtainment of wheel impacts; (b): variation of the wheel impacts in different condition stages.

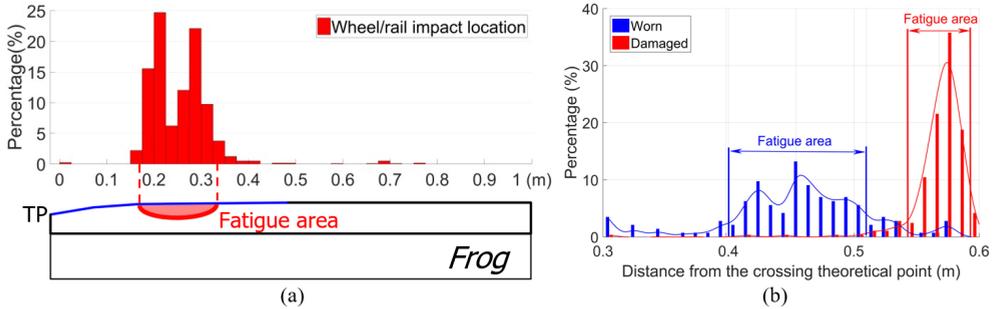
stage, the fatigue area became much narrower and shifted further from the TP.

Figure 2.4. Fatigue area. (a): Definition; (b): Development in different crossing condition stages.

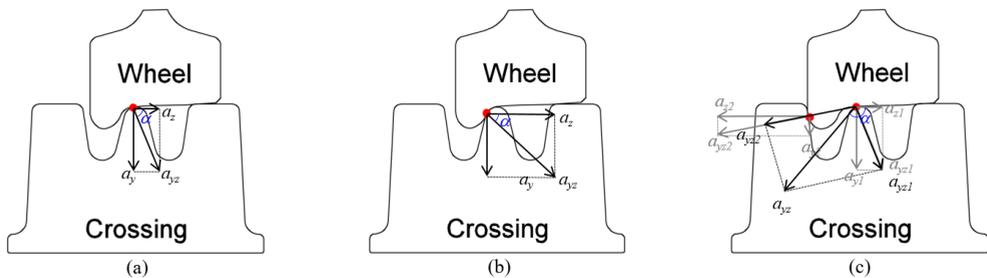
Additionally, it was found that the crossing performance is, to a large extent, determined by the wheel-rail interaction in the transition region. Normally during the wheel transition, contact occurs on the wheel gauge corner (Figure 2.5 (a)), and the dominant impact acceleration is in the vertical direction. However, in some cases, when the wheel enters the crossing with a certain angle, the impact can occur on the wheel flange (Figure 2.5 (b)-(c)). In these situations, the magnitude of the accelerations is much higher than that in the normal situation with largely increased lateral impact accelerations. Obviously, impacts on the wheel flange are more damaging for a crossing than the impact on the wheel gauge corner.

Figure 2.5. Wheel/rail contact situations. (a): Regular contact; (b): Irregular (positive) flange-nose rail contact; (c): Irregular (negative) flange-wing rail contact.

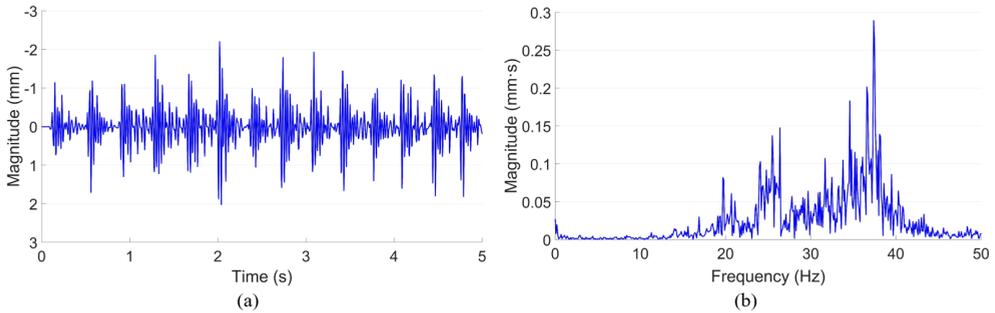
Figure 2.7. Ground activated camera vibration. (a): Time-domain signal; (b): Frequency domain responses.

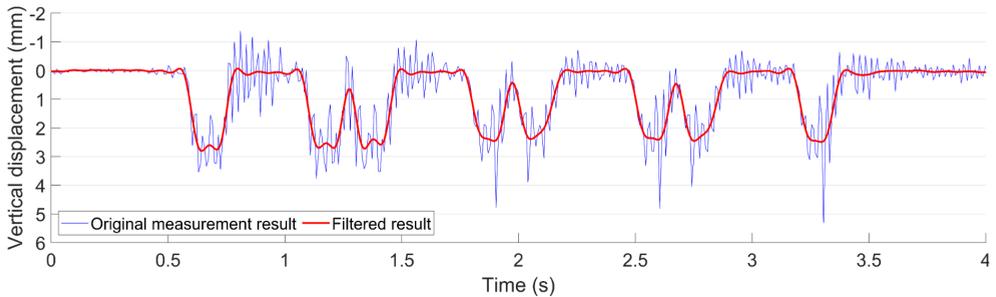
The magnitude of the vertical rail displacement directly reflects the intensity of the track movement due to the passing trains. By comparing the measured rail displacement with the reference level, the ballast settlement level of the monitored location can be estimated. The reference level of the rail displacement can be obtained from the numerical simulation with the validated MBS model using the parameters in the designed condition, which will be discussed in the next chapter.

Figure 2.8. Examples of the measured rail vertical displacement.

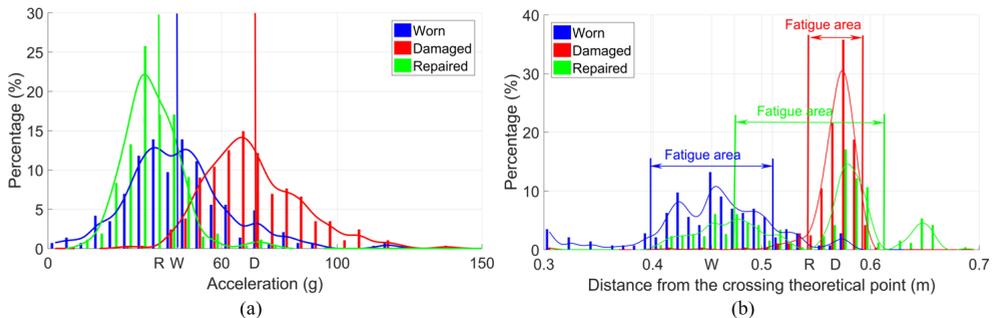
Based on the observed transition regions, the wheel impact accelerations and the fatigue area were calculated, as presented in Figure 4.10. Apparent changes can be seen from Figure 4.10 (a) that after the repair, the acceleration responses reduced to the level even below that of the “Worn” stage. These results indicate that the repair work had a positive effect, and the condition of the crossing was improved as compared to the condition in the “Worn” stage.

Figure 4.10: Dynamic responses of the monitored crossing. (a): Distribution of the impact acceleration; (b): Distribution of the impact location.

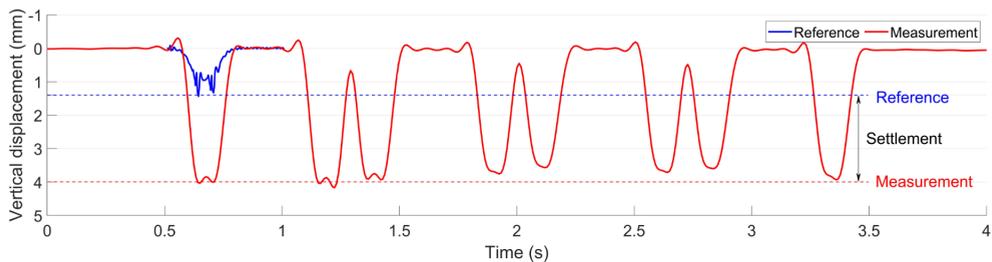
As mentioned in Chapter 1 that in the Dutch railway network, some problematic crossings are suffering from adequately short service lives. In a monitored 1:9 facing crossing, the service life was only around three years. In the face of such a situation, the local contractor frequently performed ballast tamping in this track section. To assess the ballast condition, and the effectiveness of the tamping operation, the vertical displacement of the crossing rail was monitored using the wayside monitoring system. The measured vertical displacements of the crossing rail are presented in Figure 4.11. The calculated displacement results using the MBS model are presented as well.

Figure 4.11. Ballast settlement in the monitored crossing.

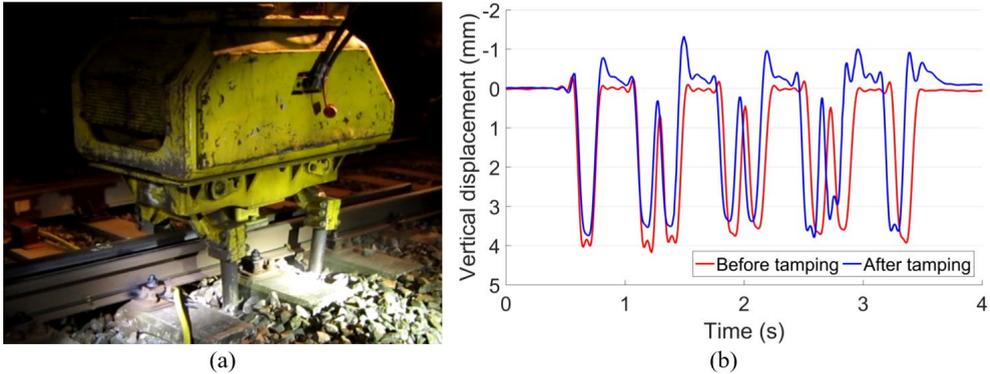
Due to the lack of maintenance facilities, the ballast tamping was mainly performed using the squeezing machine (Figure 4.12 (a)). In this case, the track geometry was not corrected. The comparison of the rail displacement results before and after tamping is presented in Figure 4.12 (b).

Figure 4.12. (a): Squeezing machine used for ballast tamping in the monitored crossing; (b): Measured rail displacement before and after ballast tamping.

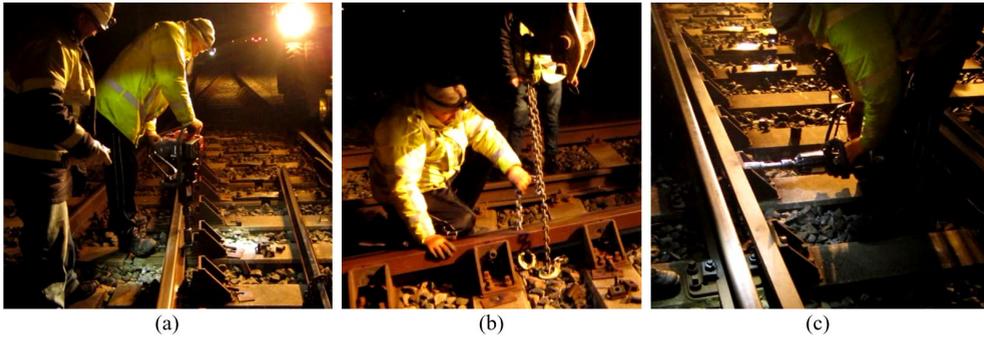
For the same crossing mentioned in Section 4.2.2, the fastening system was found to be degraded with some broken bolts during the monitoring period. Such degradation can affect the lateral stability of the track. Therefore, the fastening system, mainly the bolts in the guard rails and the clips, was renovated, as shown in Figure 4.13.

Figure 4.13. Fastening system renovation. (a): Remove the broken bolts; (b): Reposition the guard rail; (c): Install new bolts.

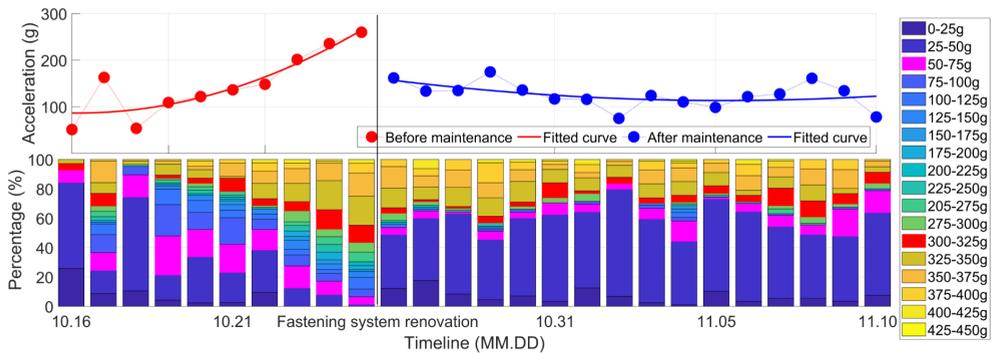
Besides wayside monitoring, the crossing was also monitored using the instrumentation. The development of the wheel-rail impacts before and after renovation is shown in Figure 4.14. In the upper figure, each point represents the mean value of the wheel impacts due to multiple wheel passages in one monitoring day, and the lower figure gives the ratio of different impact levels in each monitoring day corresponding to the value in the upper figure.

Figure 4.14. Effect of fastening system renovation on the dynamic performance of the crossing.

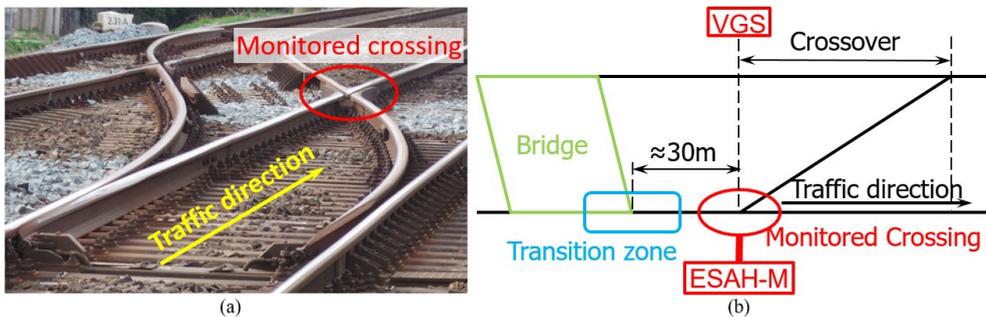
The monitored 1:9 crossing is part of a facing crossover, meaning that the trains mainly pass in the facing through route with the maximum velocity of around 140 km/h. The on-site view of the crossing is shown in Figure 5.1 (a).

Figure 5.1. Overview of the monitored crossing. (a): Sketch view; (b): On-site view.

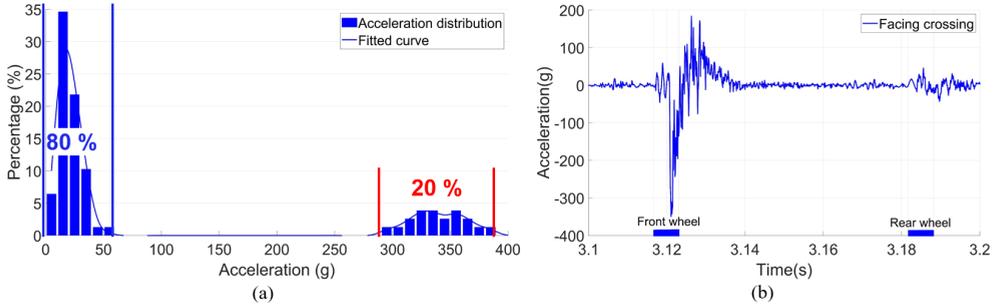
Figure 5.2. Vertical acceleration responses of the monitored crossings. (a): Distribution based on multiple train passages in one day; (b): Example of impacts due to one bogie.

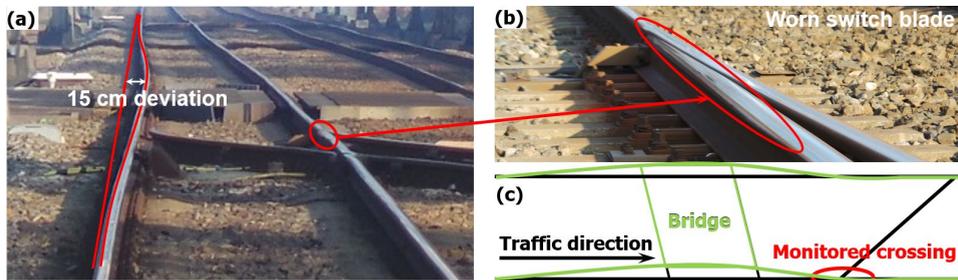
Figure 5.4. Track deviation in front of the crossing. (a): Inspected curve introduced by the bridge; (b): Worn switch rail; (c): Demonstration of the bridge deviation.

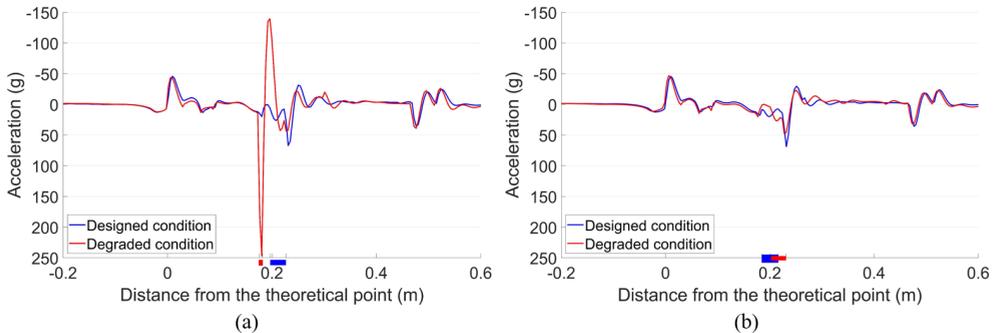
Figure 5.6. Impact acceleration responses and transition regions. (a): Front wheel; (b): Rear wheel.

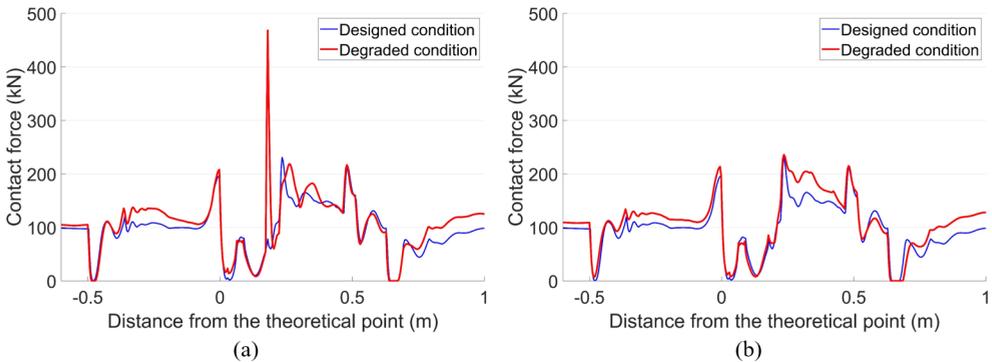
Figure 5.7. Vertical wheel-rail contact responses of the facing crossing. (a): Front wheel; (b): Rear wheel.

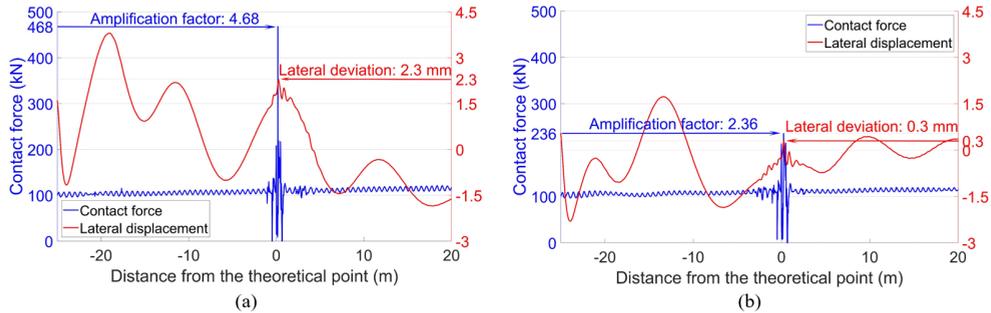
Figure 5.9. Wheel-rail contact forces and lateral wheel displacements. (a): Front wheel; (b): Rear wheel.

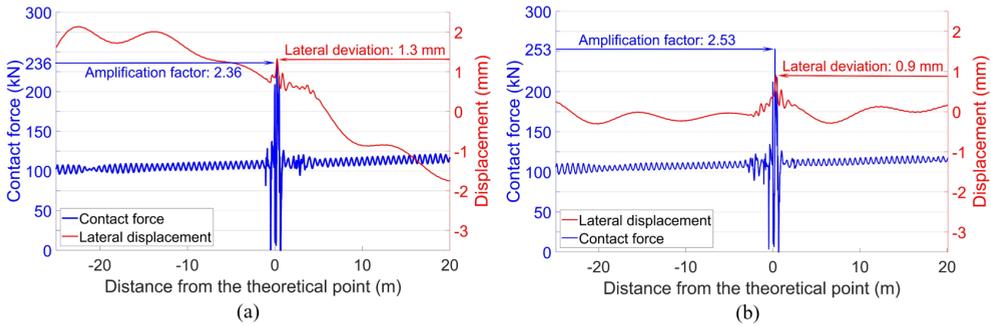
Figure 5.10. Wheel-rail contact forces and lateral wheel displacements. (a): Front wheel; (b): Rear wheel.

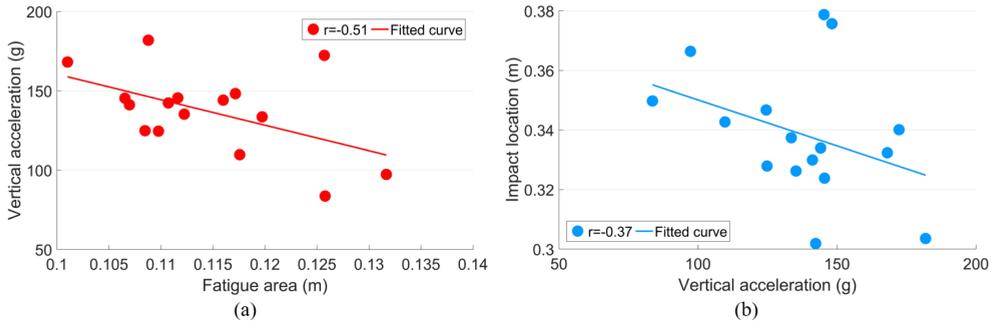
Figure 5.13. Correlation results between the dynamic crossing responses. (a):  $F_a - a_y$ ; (b):  $a_y - L_o$ .

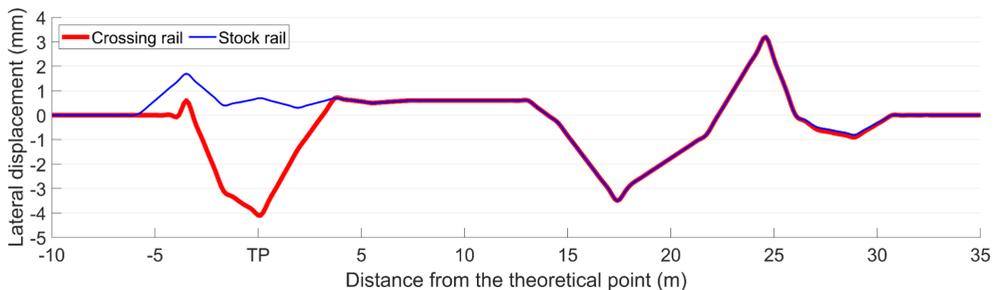
Figure 5.15. Temperature initiated lateral rail displacement in FE simulation (Figure 11.15 in [39]).

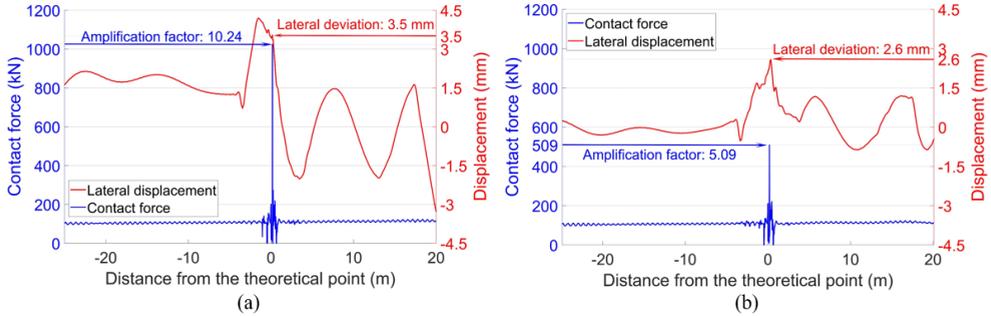
Figure 5.16. Wheel-rail contact forces and lateral wheel displacements. (a): Front wheel; (b): Rear wheel.

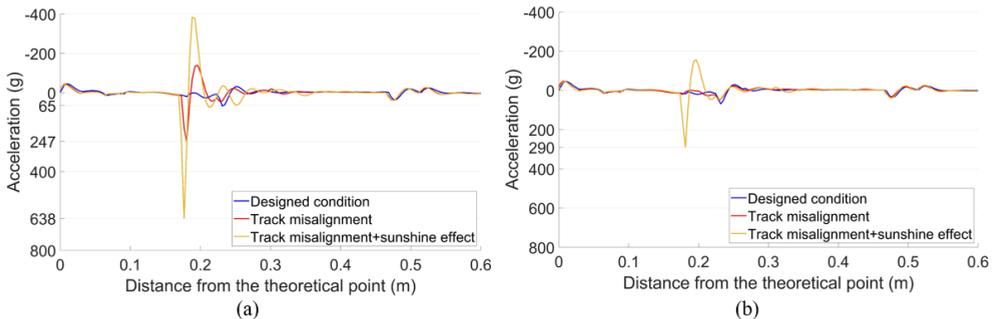
Figure 5.17. Vertical rail accelerations due to the passing wheels. (a): Front wheel; (b): Rear wheel.

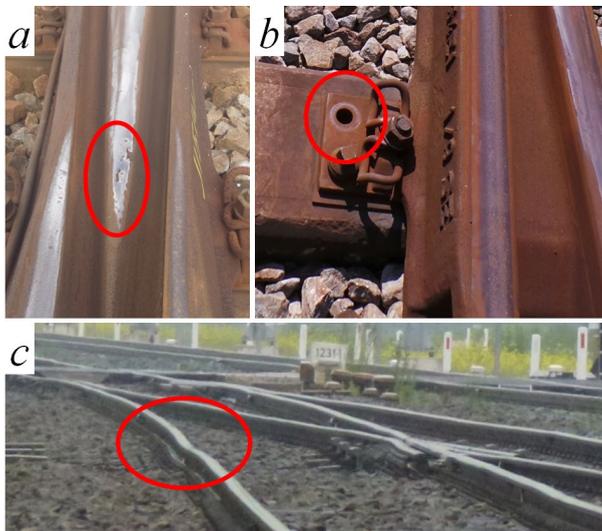
Figure 1.1. Typical problems in railway crossings.

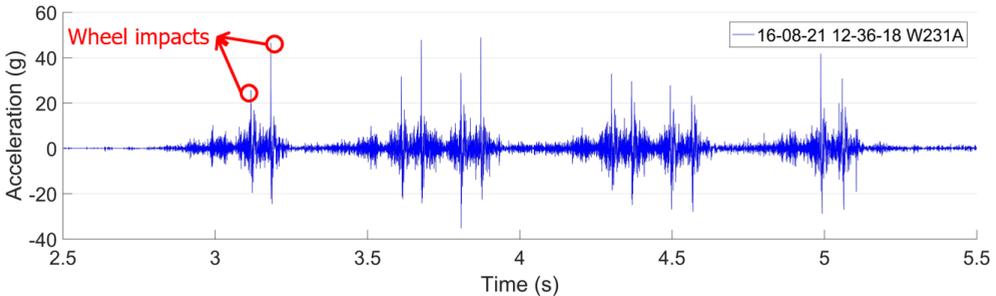
Figure 3.2. Vertical acceleration response of one train (12 wheelsets).

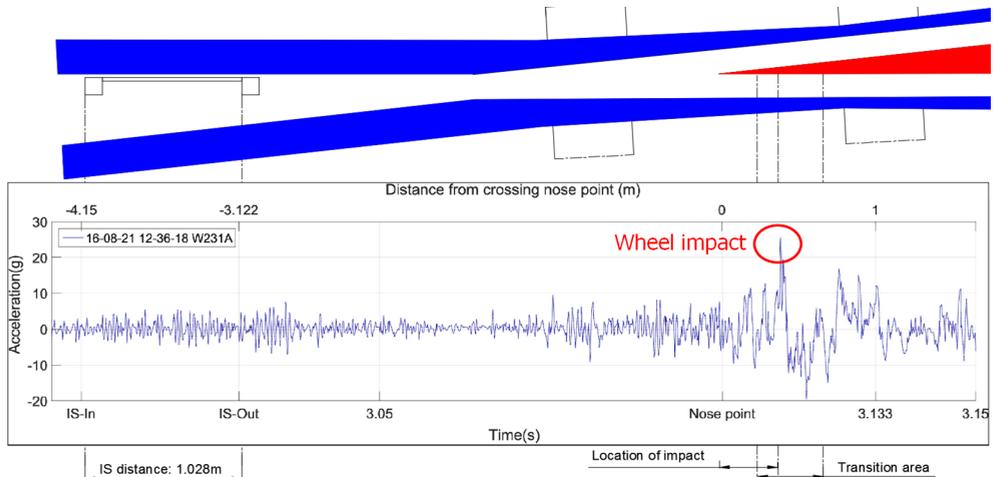
Figure 3.3. Detection of wheel impact and its location.

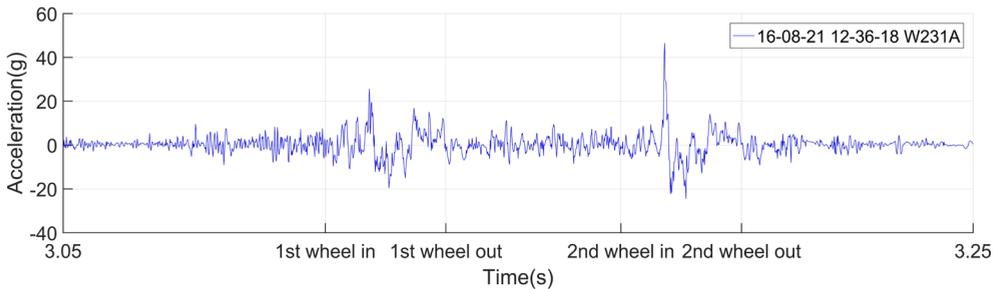
Figure 3.4. Vertical acceleration response due to the first bogie of a train.

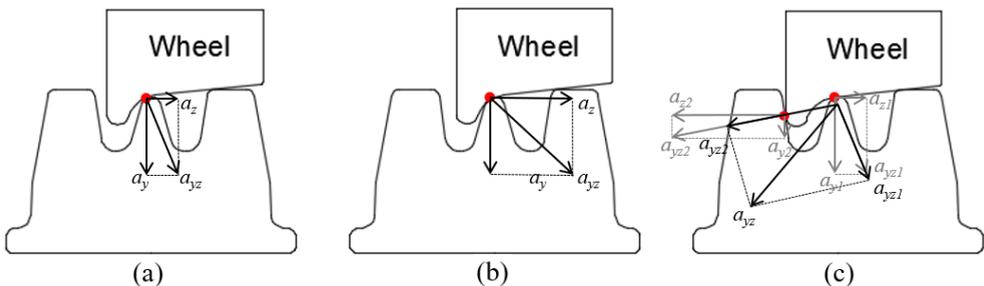
Figure 3.5. Wheel/rail contact situations: (a) Regular contact; (b) Irregular positive contact with wheel flange hit on the crossing nose; (c) Irregular negative contact with wheel flange impact on the outside wing rail.

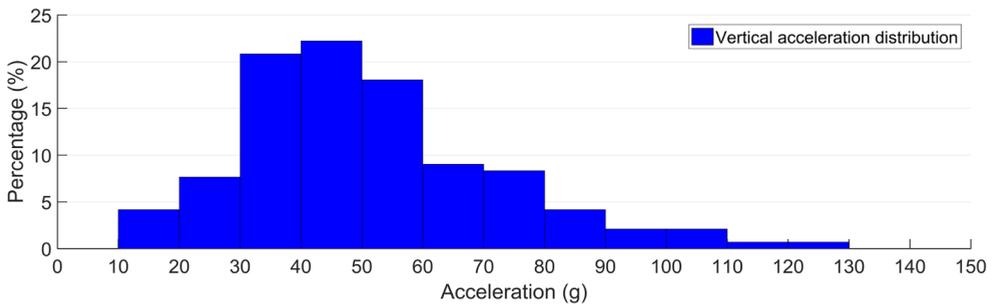
Figure 3.6. An example of vertical acceleration distribution of trains in one measurement day.

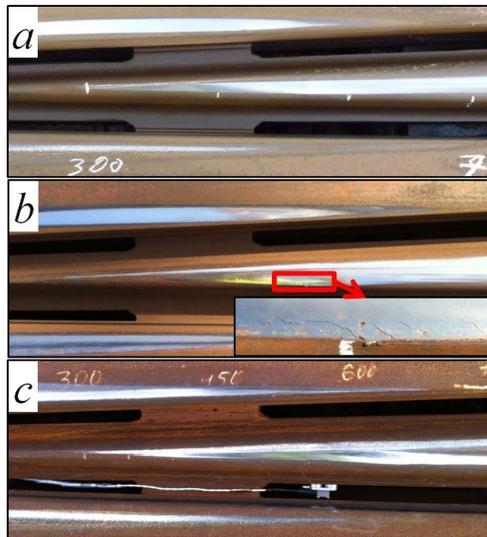
Figure 4.1. Different condition stages of the monitored crossing. (a): Worn; (b): Damaged; (c): Repaired.

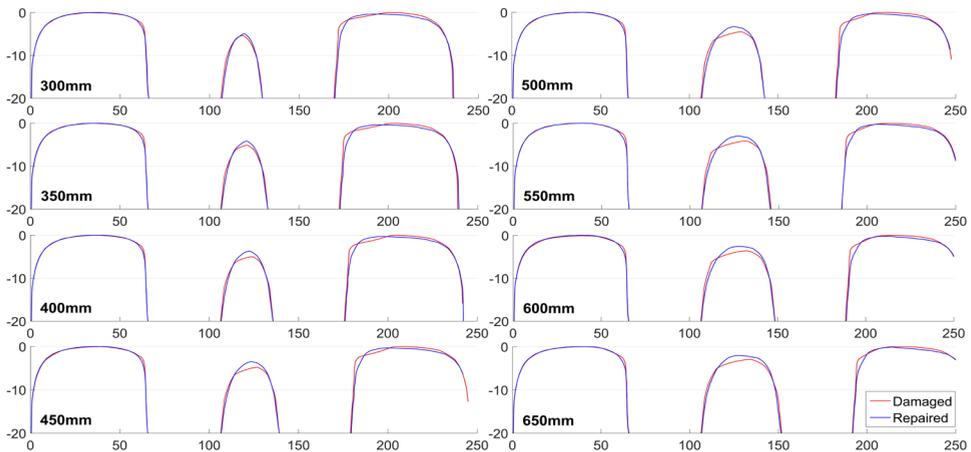
Figure 4.2. Measured rail profiles along instrumented crossing – examples for profiles at 300 mm to 650 mm from nose point.

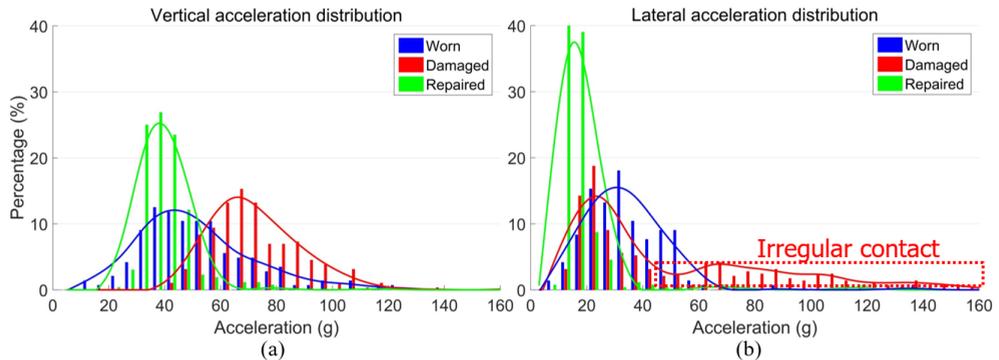
Figure 4.3. Vertical (a) and lateral (b) acceleration distributions.

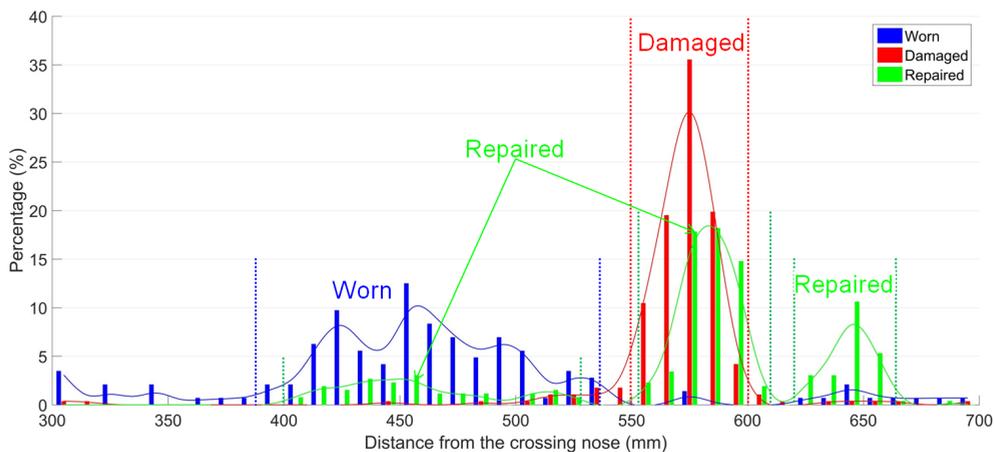
Figure 4.4. Fatigue area development.

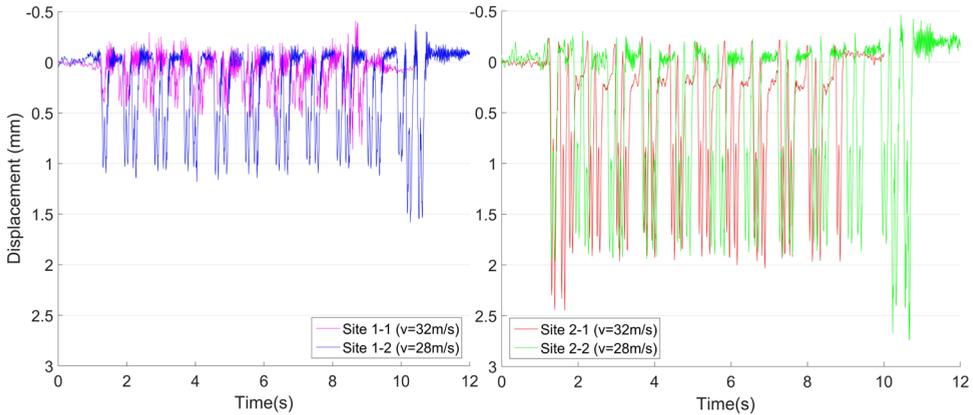
Figure 5.3. Displacement measurement results.

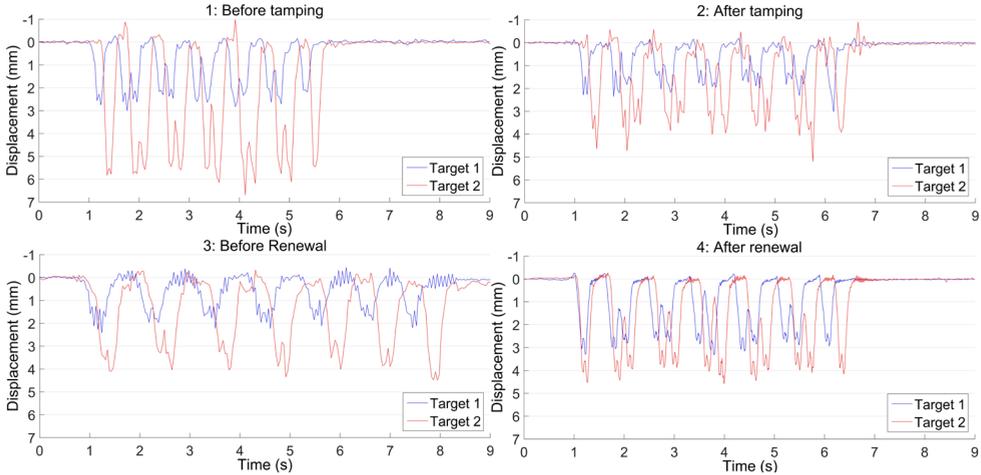
Figure 5.5. Rail displacement results.

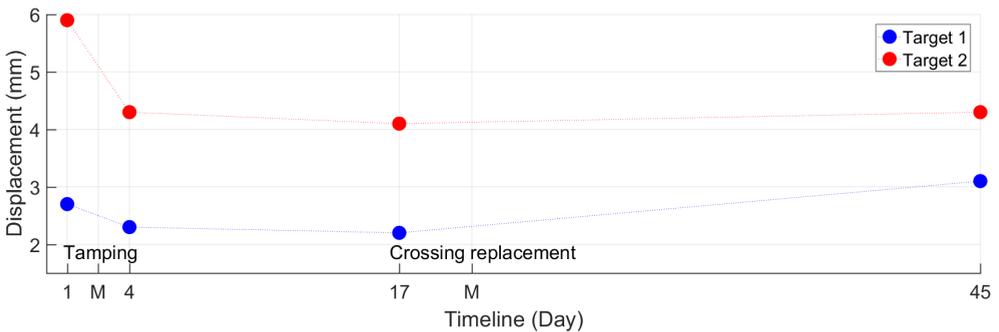
Figure 5.6. Rail displacements development of the monitored targets.

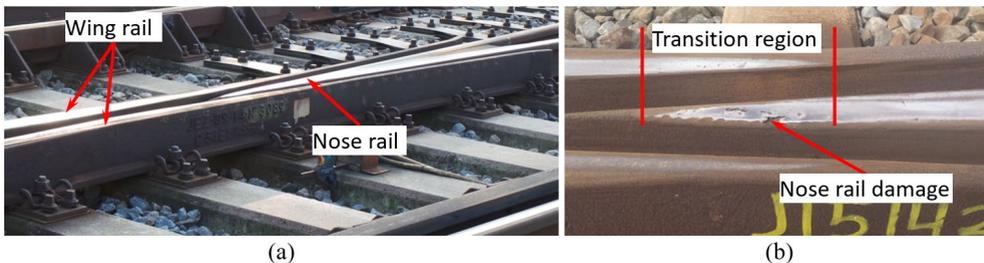
Figure 1.2. A 1:9 cast manganese steel crossing: (a) View of a wing rail and crossing nose rail; (b) Crossing nose rail damage in the transition region.

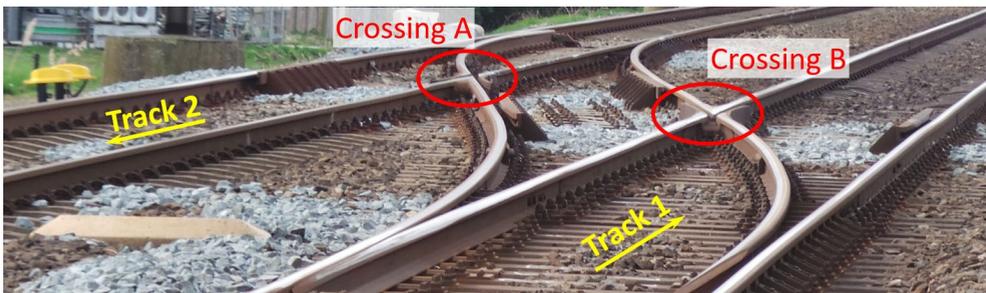
Figure 2.1. Typical crossover in the Dutch railway network.

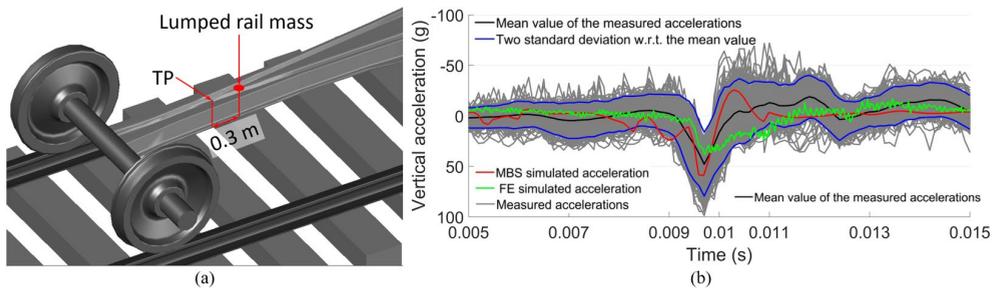
Figure 3.6. (a): Rail element for acceleration extraction in the MBS model; (b): Comparison of simulated accelerations with measured ones in the time domain.

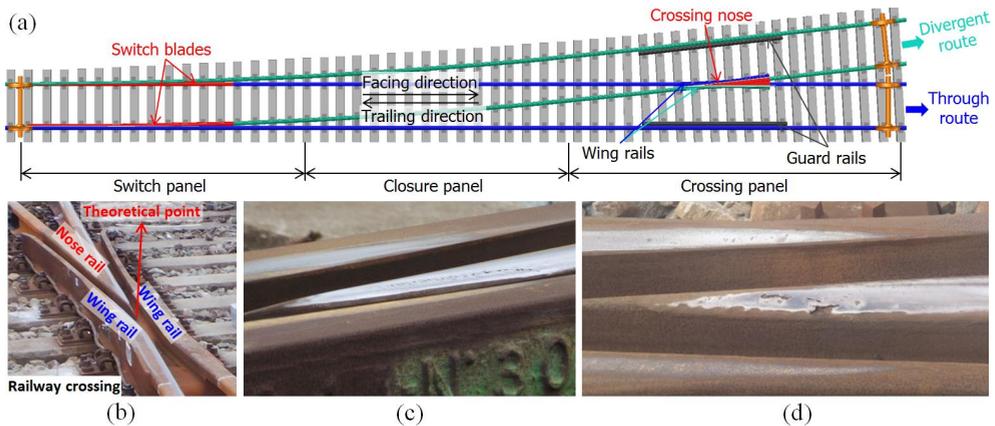
Figure 1.1. (a): Standard left-hand railway turnout with 1:9 crossing; (b): Crossing panel in site; (c): Plastic deformation with cracks; (d): Spalling.

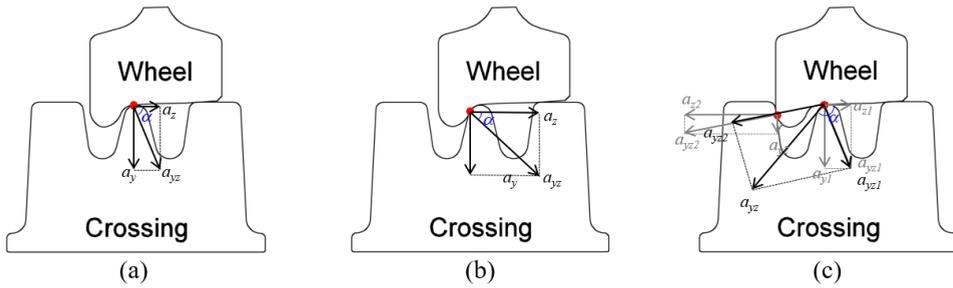
Figure 3.2. Wheel/rail contact situations. (a) Regular contact; (b) Irregular positive contact when wheel flange hits the crossing nose; (c) Irregular negative contact when wheel flange hits wing rail.

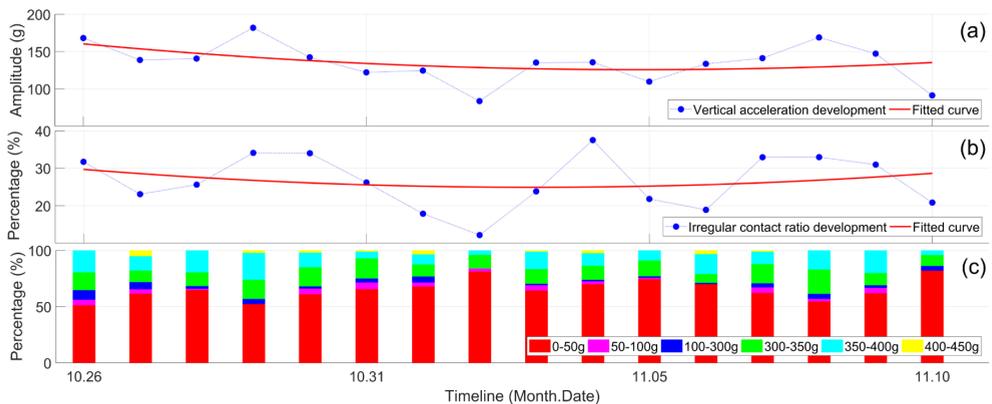
Figure 3.6. Development of the vertical acceleration responses in the monitored period. (a): Mean value of the vertical acceleration; (b): Irregular contact ratio; (c): Distribution of the acceleration responses in each day.

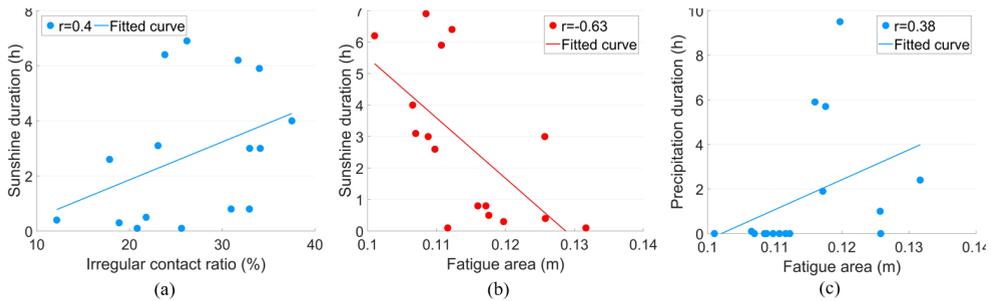
Figure 4.5. Cross-correlation results between dynamic responses and weather conditions: (a):  $I_r$ - $D_s$ ; (b):  $F_a$ - $D_s$ ; (c):  $F_a$ - $D_p$ .

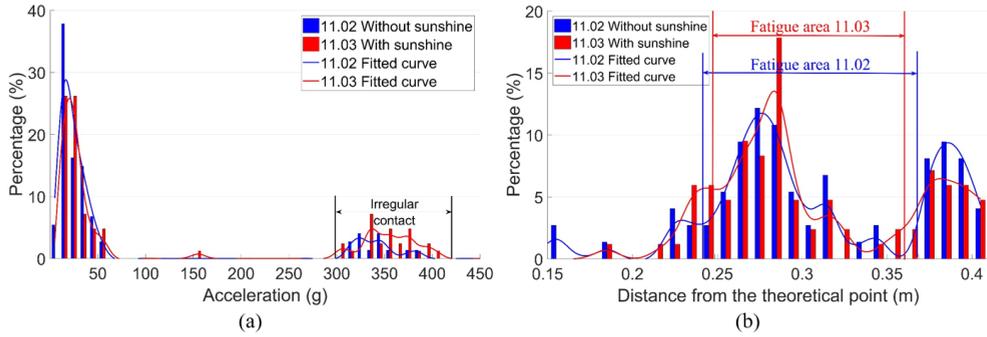
Figure 4.6. Influence of sunshine on the dynamic responses. (a): Vertical acceleration distribution; (b): Fatigue area analysis.

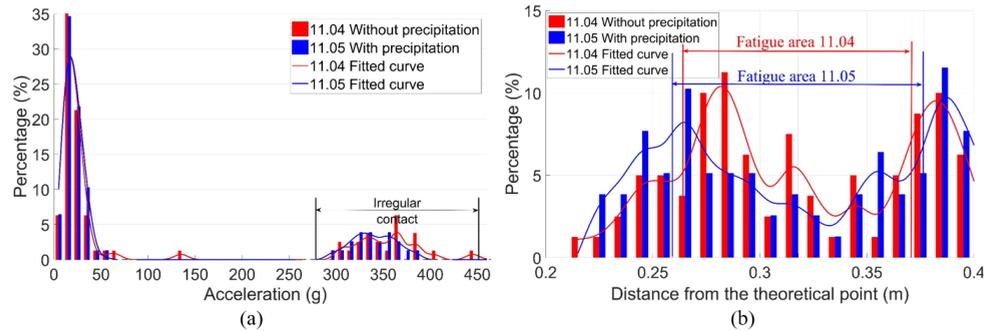
Figure 4.7. Influence of precipitation on the dynamic responses. (a): Vertical acceleration distribution; (b): Fatigue area analysis.

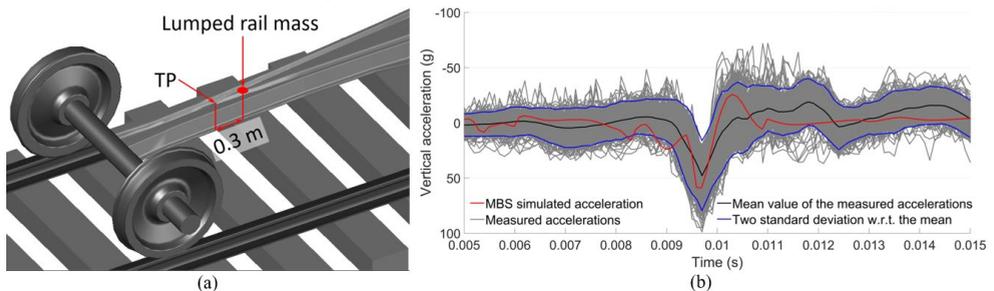
Figure 5.2. MBS model validation: (a): Rail element for acceleration extraction; (b): Comparison of MBS simulated acceleration with measured ones in time domain.

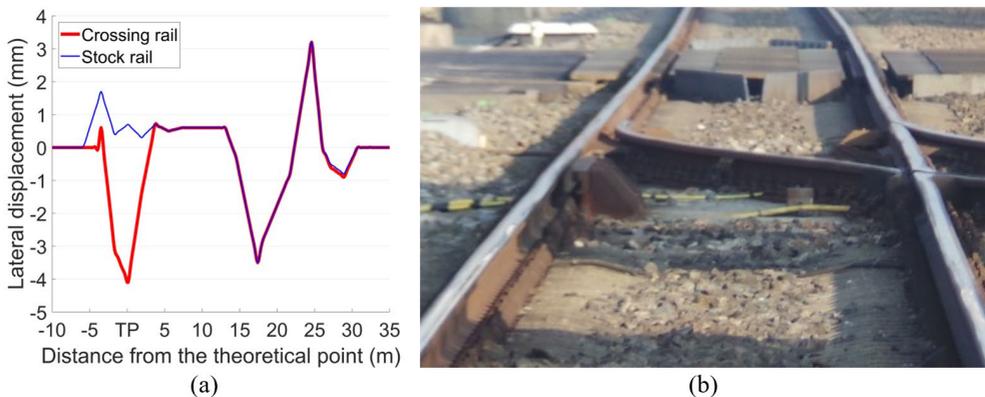
Figure 5.3. (a): Temperature initiated rail lateral displacement in FE simulation (Figure 11.15 in [35]); (b): Monitored crossing

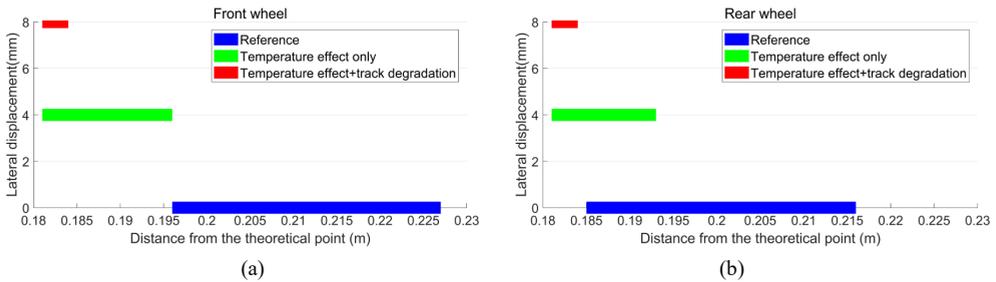
Figure 5.4. Transition regions of the crossing. (a): Front wheel; (b): Rear wheel.

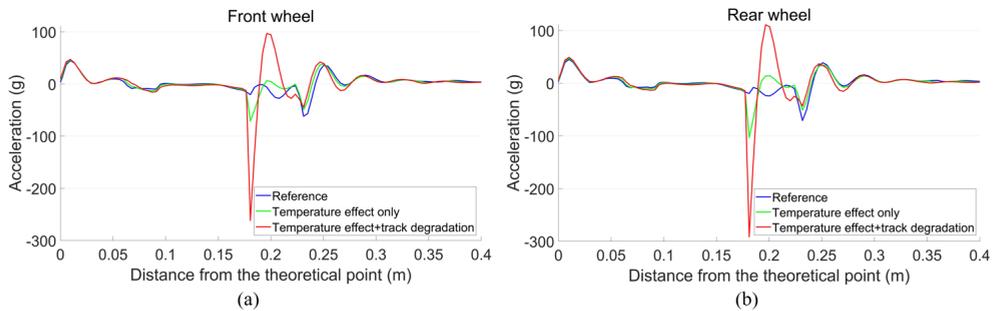
Figure 5.5. Vertical rail accelerations due to the passing wheels. (a): Front wheel; (b): Rear wheel.

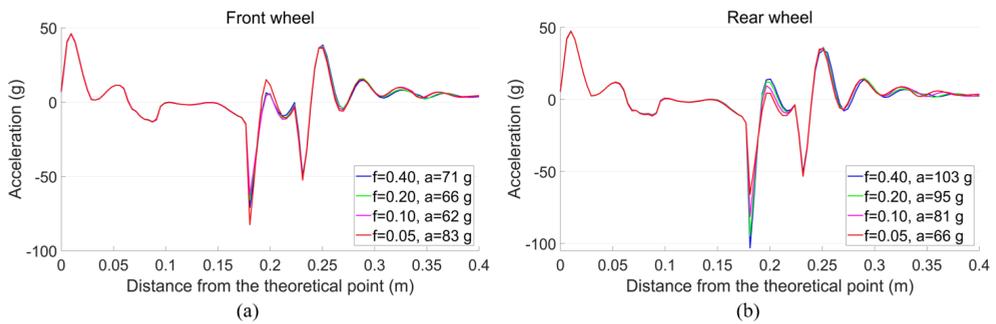
Figure 5.6. Vertical accelerations of the rail due to the passing wheels. (a): Front wheel; (b) Rear wheel.

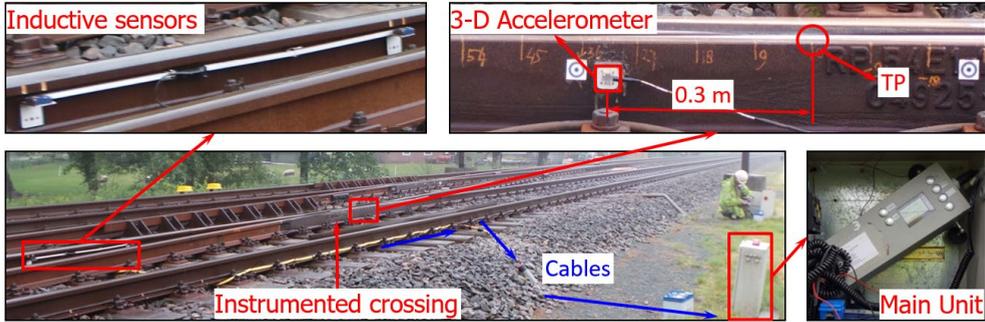
Figure 2.1. Crossing instrumentation based on ESAH-M.

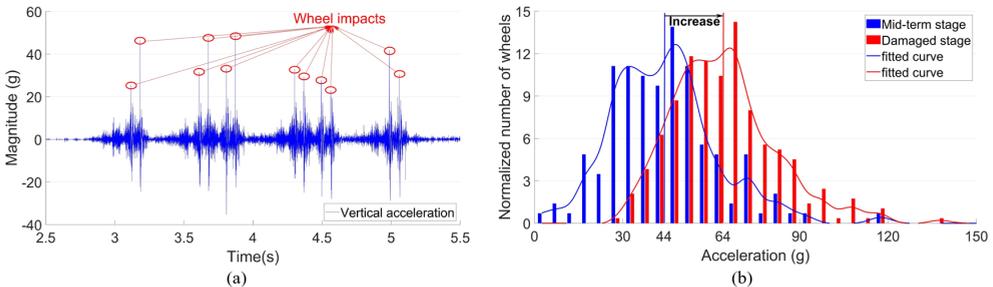
Figure 2.2. Indicator for the wheel impact. (a): Procedure for the obtainment of wheel impacts; (b): Example of the variation of the wheel impacts in different condition stages.

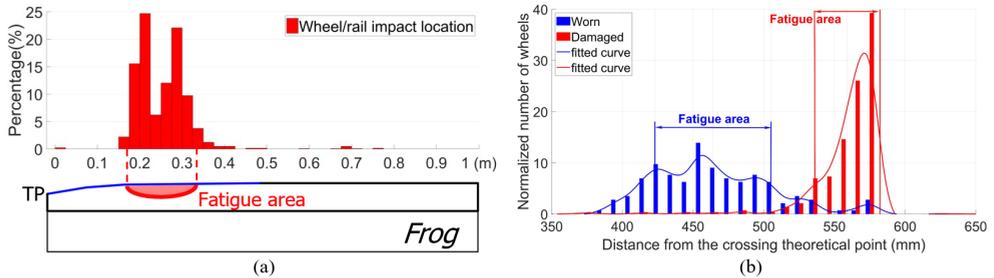
Figure 2.3. Demonstration of the crossing fatigue area detection; (a): Definition of the fatigue area. (b): Example of the fatigue area changes in different crossing condition stages.

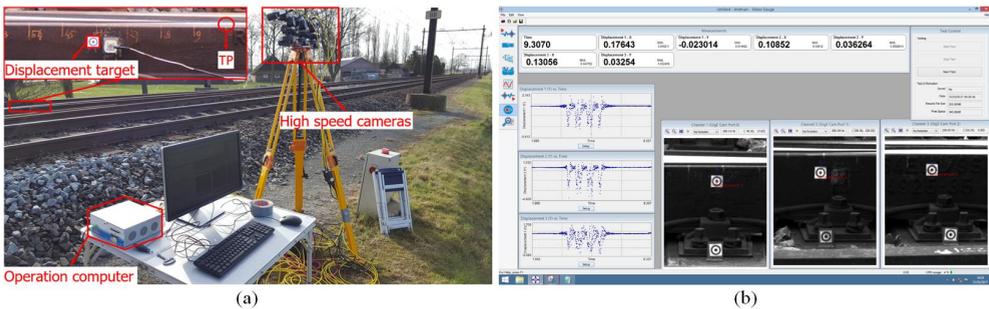
Figure 2.4. Wayside monitoring. (a): System setup; (b): The screen of displacement measurements.

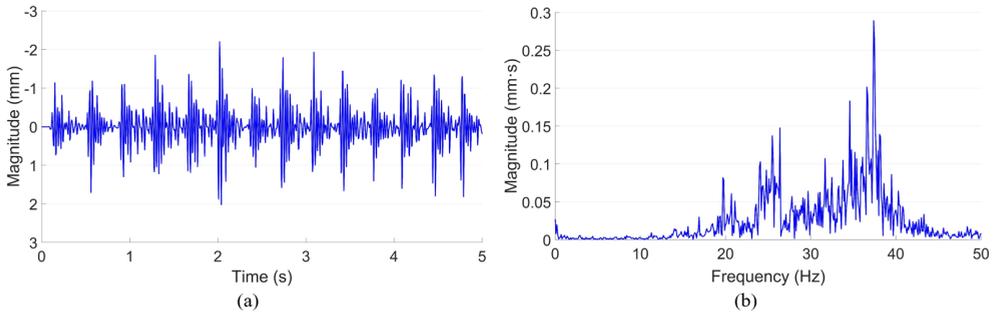
Figure 2.5. Ground activated camera vibration. (a): Time domain signal; (b): Frequency domain responses.

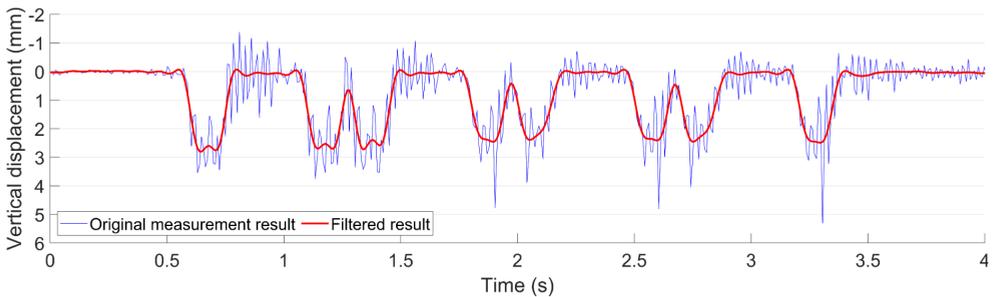
Figure 2.6. Examples of the measured rail vertical displacement.

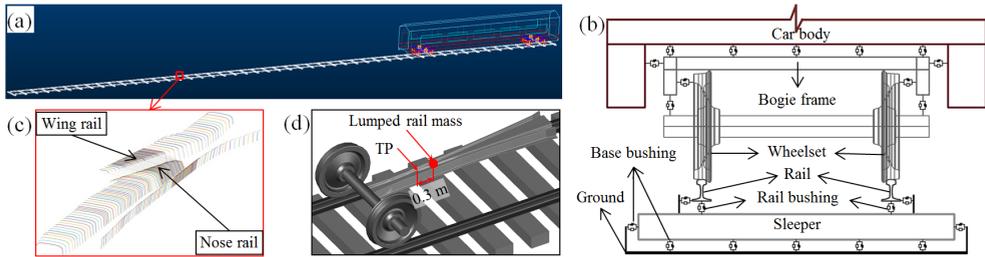
Figure 2.7. Multi-body system (MBS) model. (a): Vehicle-track model; (b): Flexible connections in the model; (c): Crossing profiles; (d): Rail element for acceleration extraction.

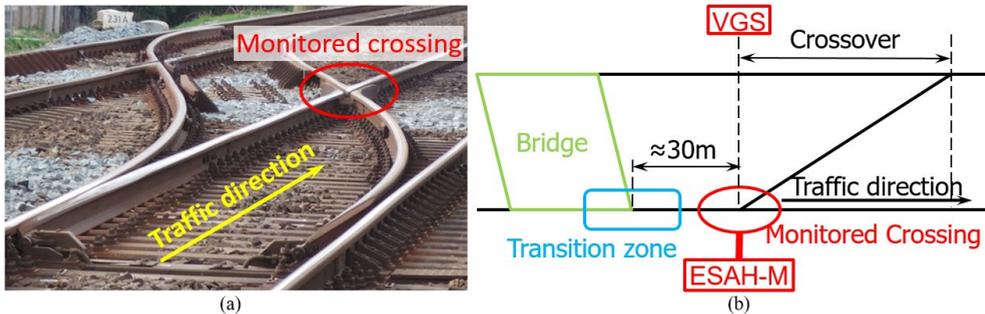
Figure 3.1. Overview of the monitored crossing. (a): On-site view; (b): Sketch view.

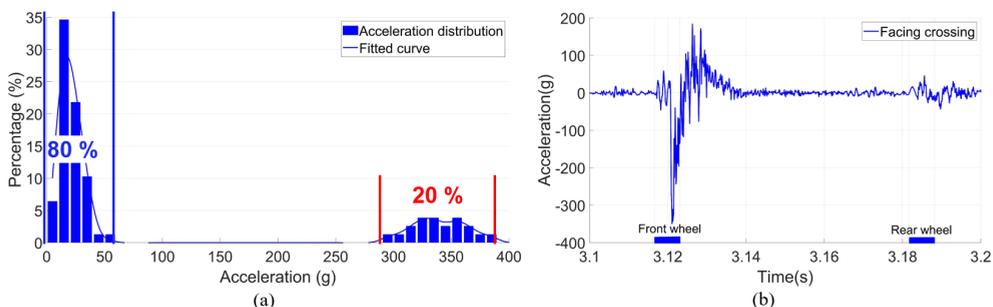
Figure 3.2. Vertical acceleration responses of the monitored crossings. (a): Distribution based on multiple train passages in one day; (b): Example of impacts due to one bogie.

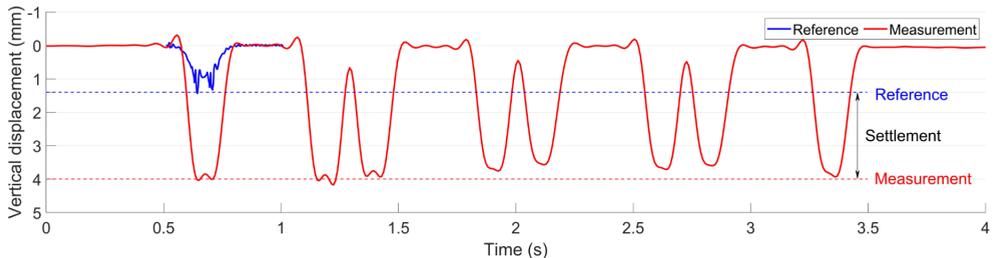
Figure 3.4. Ballast settlement in the monitored crossing.
