**Development of Condition Monitoring System for Railway Crossings  
Condition Assessment and Degradation Detection for Guided Maintenance**

Condition Assessment & Degradation Detection  
for Guided Maintenance

Keywords: railway crossing, condition monitoring, degradation detection, maintenance guidance

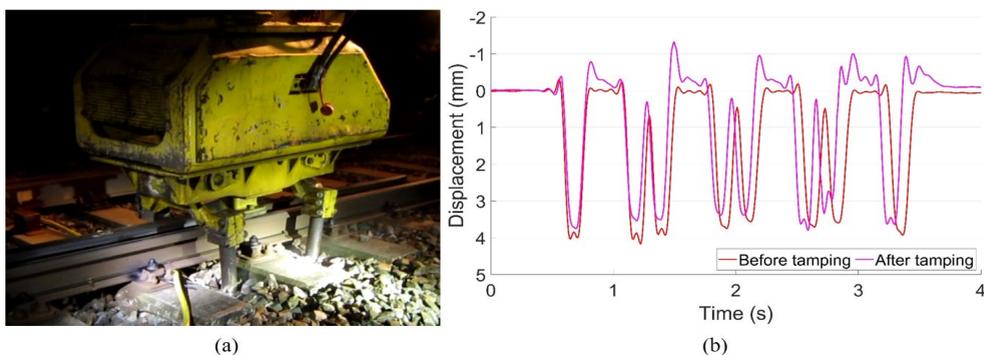
Figure 4.1. (a): Squeezing machine used for ballast tamping in the monitored crossing; (b): Measured rail displacement before and after ballast tamping.

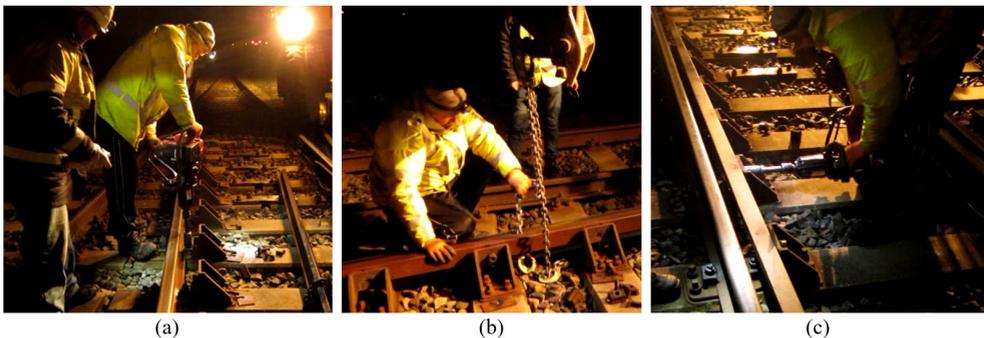
Figure 4.3. Fastening system renovation. (a) Remove the broken bolts. (b) Reposition the guard rail. (c) Install new bolts.

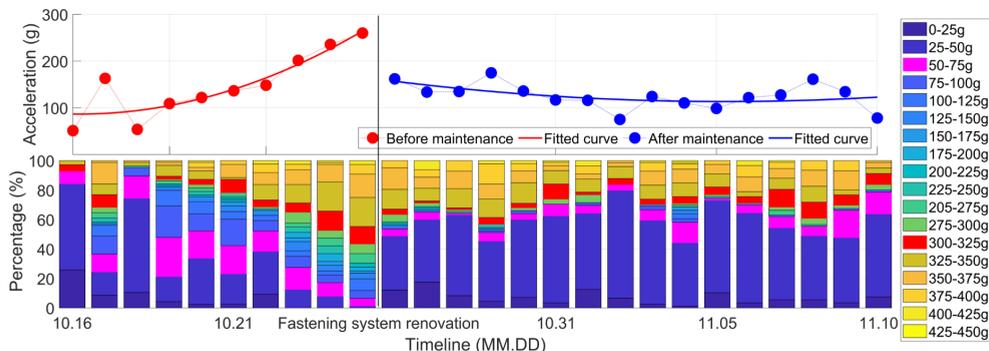
Figure 4.4. Effect of fastening system renovation on the dynamic performance of the crossing.

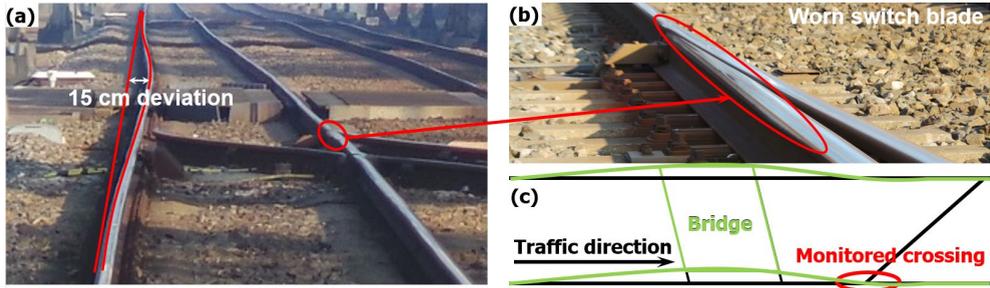
Figure 5.1. Track deviation in front of the crossing. (a) Inspected curve introduced by the bridge. (b) Worn switch rail. (c) Demonstration of the bridge deviation.

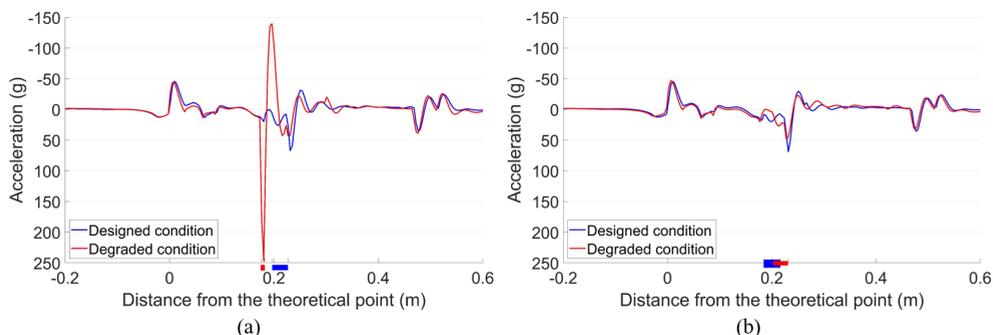
Figure 5.3. Vertical impact acceleration responses and transition regions. (a) Front wheel. (b) Rear wheel.

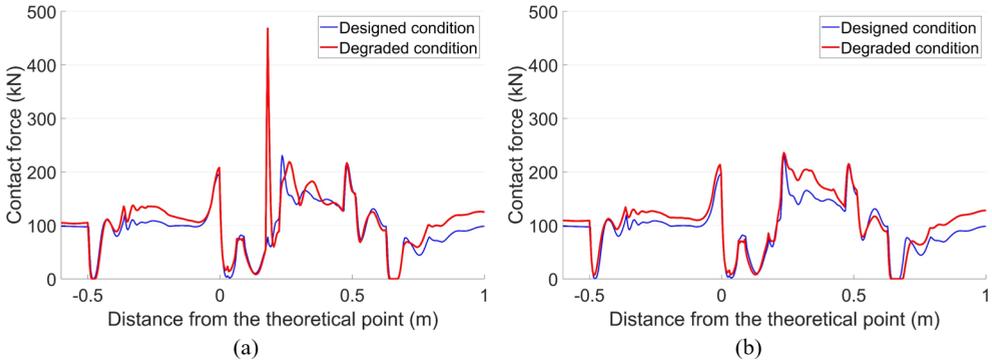
Figure 5.4. Vertical wheel-rail contact responses of the facing crossing. (a) Front wheel. (b) Rear wheel.

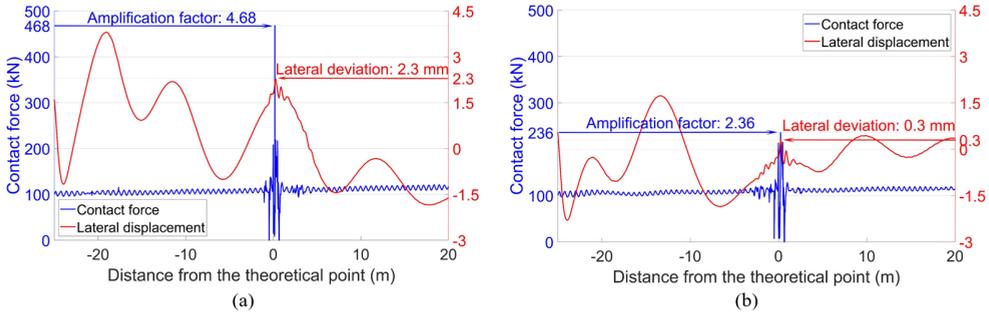
Figure 5.6. Wheel-rail contact forces and wheel lateral displacements. (a) Front wheel. (b) Rear wheel.

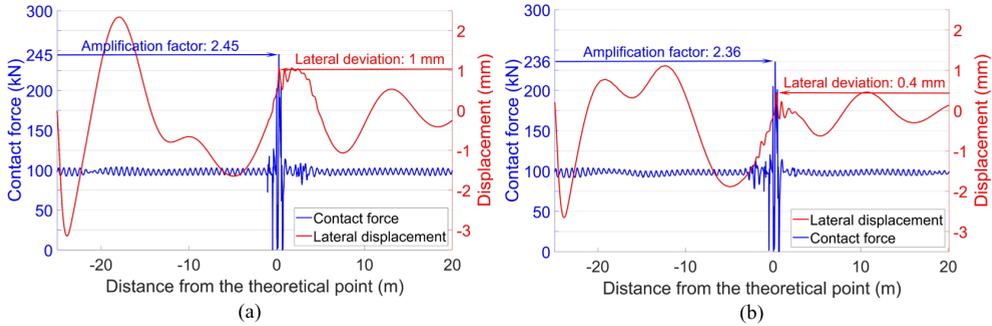
Figure 5.8. Wheel-rail contact forces and wheel lateral displacements. (a) Front wheel. (b) Rear wheel.

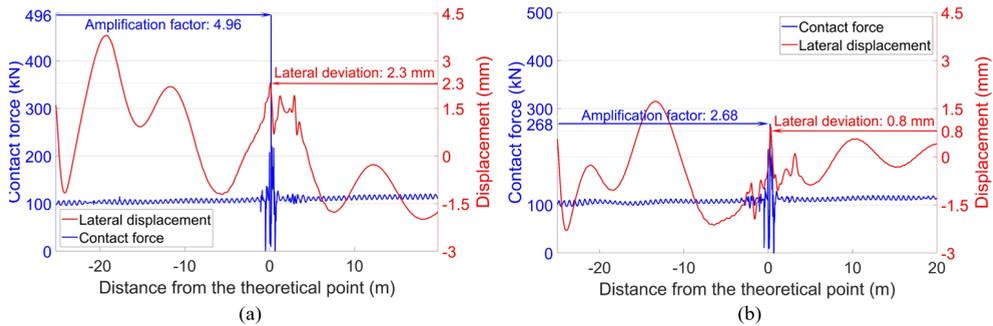
Figure 6.3. Wheel-rail contact forces and lateral wheel displacements. (a) Front wheel. (b) Rear wheel. Note: Ballast settlement was not taken into account.
