archimaera
architektur.kultur.kontext.online

**Paul Meurs and Marie-
Thérèse van Thoor**
(Delft)

The transformation of the Rijksmuseum Amsterdam

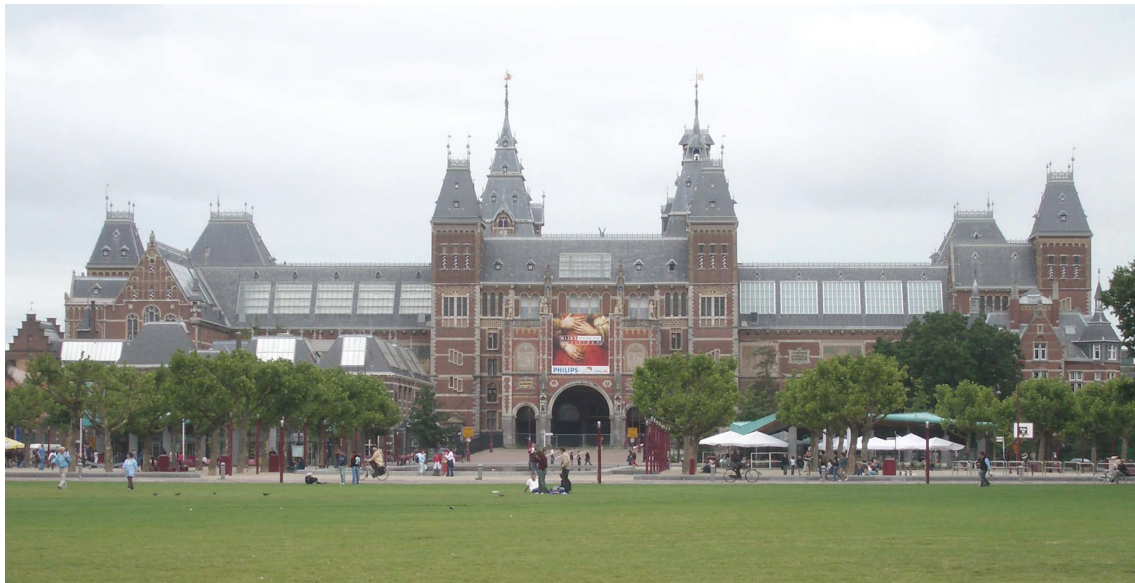
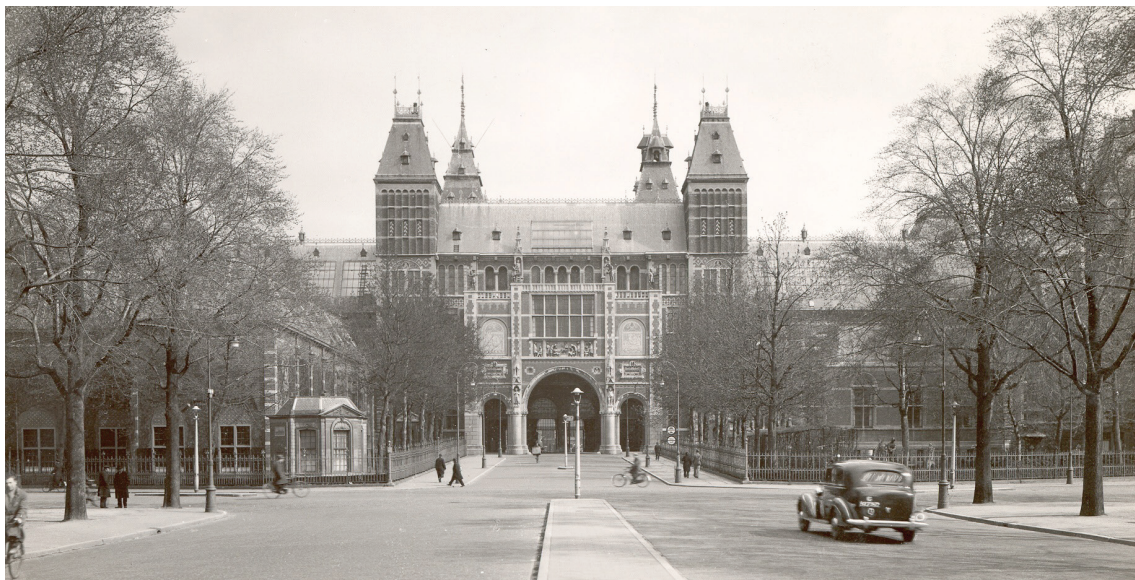
Fig. 1, 2. Exterior of the Rijksmuseum Amsterdam, south facade, today (above), Exterior in 1936 (below); above the passageway, in 1906, an extension was built for the *Night Watch*.

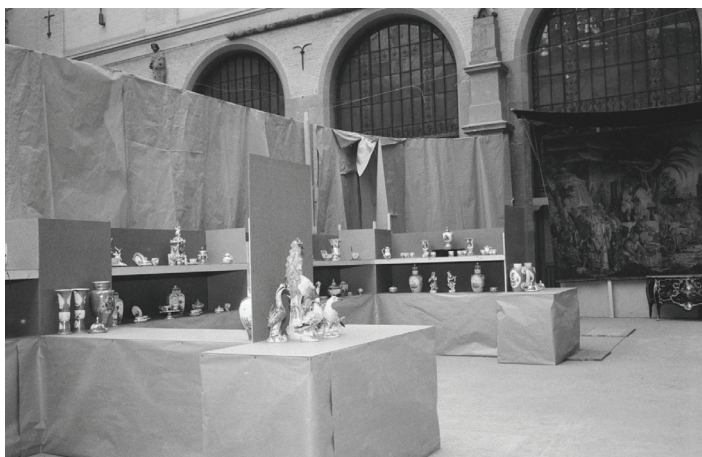
Fig. 3, 4. The west courtyard housed a Meissen porcelain exhibition in 1957; the courtyards were soon in use for storage and exhibition space (above). The *Night Watch* exhibited on the west wall of the Night Watch Gallery (below).

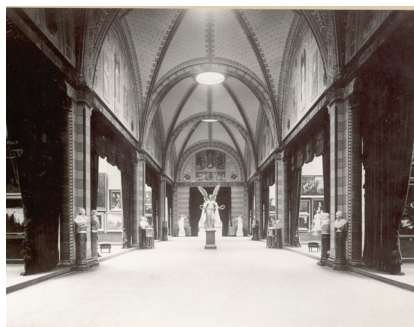
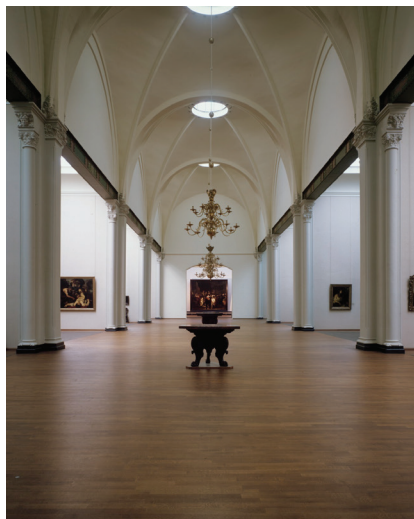
Fig. 5, 6. The Gallery of Honour, ca. 1920 (above). The Gallery of Honour after the renovation under Wim Quist, ca 1984 (below).

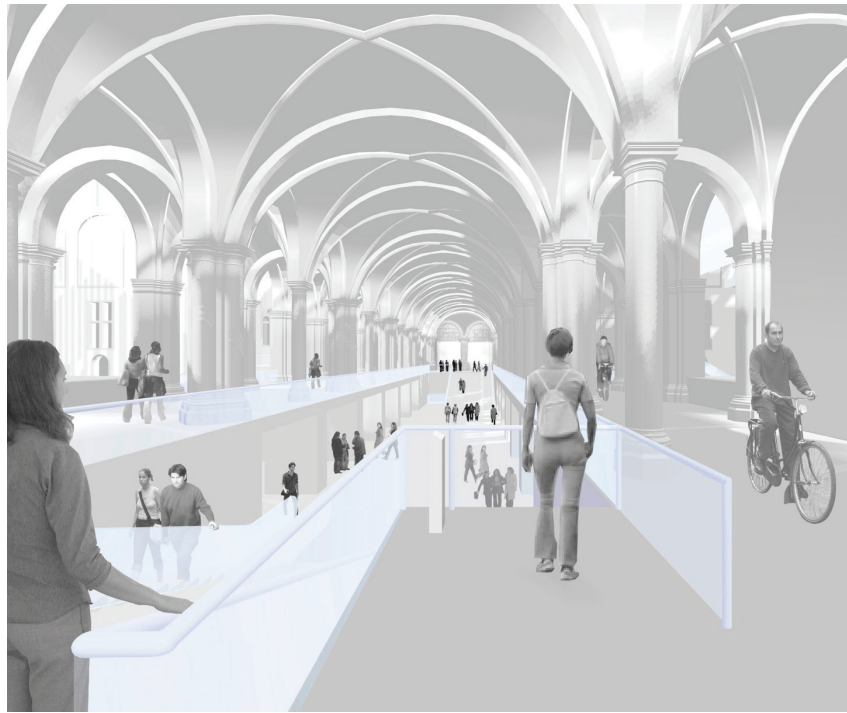
Fig. 11. Design for the entrance area from the Preliminary Design, Cruz y Ortiz 2002.

The original concept of Cruz y Ortiz's vision remained essentially intact: a central entrance in the passageway with stairs to the sunken entrance hall (fig. 10, 11). There was a new solution involving housing cables and ducting in an underground services tunnel around the main building, from where the entire building could be serviced via vertical shafts. One striking addition was the Studiecentrum (Study Centre), a tower over thirty metres high next to the main building, between the director's villa and the Teekenschool. This tower was intended to become an important node, with access to the engine rooms and the energy centre in the basement, the staff entrance on the ground floor and on the floors above reading rooms and a library tower. In the elaboration of the passageway, the cycle path remained in the open air, but the entrance zone and the footpath were incorporated into the building. The result was that behind both facades a revolving door was placed in three of the four archways

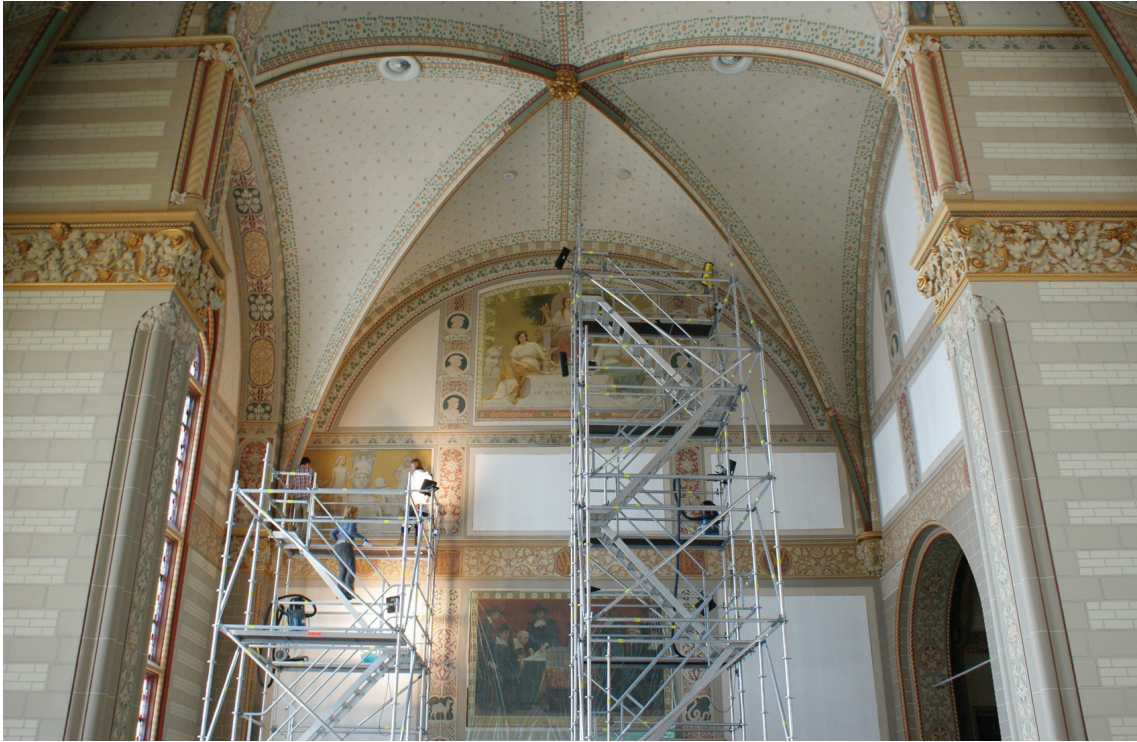
Fig. 12. Employees of the SRAL at work on the scaffolding in het Great Hall.

In the PD Van Hoogevest largely agreed with Cruz y Ortiz on the rehabilitation of Cuypers’ spatial structure, the restoration of the historical surface and the service engineering. Regarding the restoration of Cuypers’ decorations, Van Hoogevest focused on the experience of the building as a whole. It had changed considerably as decorations were ‘white-washed’ and coats of paints had been chipped away. As the make-over of the whole building was extensive, and the building process already was faced with a considerable delay, elaborate research was possible. The Foundation Restoration Studio Limburg (Stichting Restauratie Atelier Limburg, SRAL) had been commissioned by the *Rgd* to start research into the wall paintings in several galleries (fig. 12). The SRAL’s in-

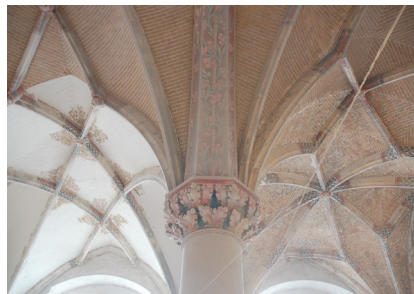
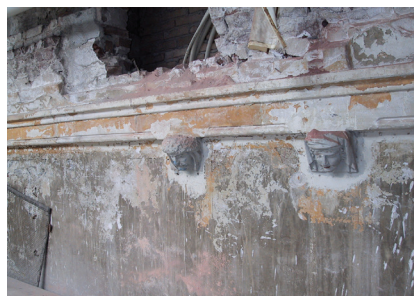
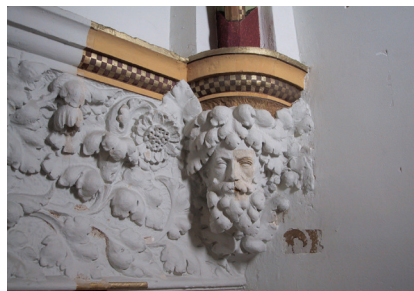
Fig. 13-15. Fragments of original paintings and masonry vaulting in the former ecclesiastical architecture department (top). Two sculptured heads under the cornice in the former Waterloo Gallery on the upper floor (middle). Trial reconstruction in a corner of the Great Hall, 2003 (bottom).

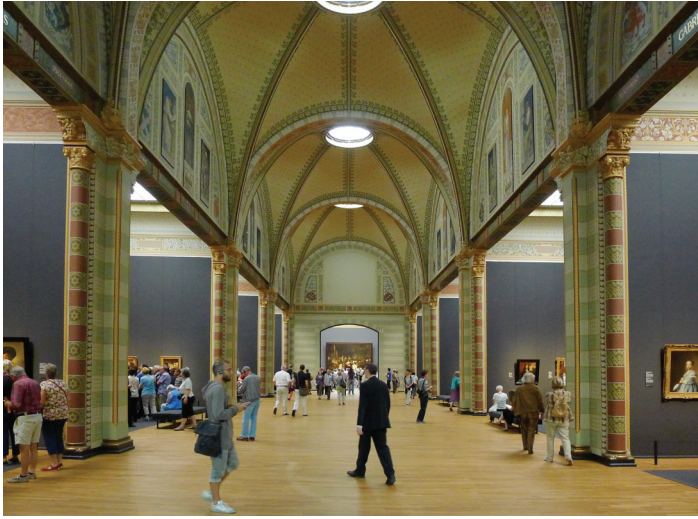
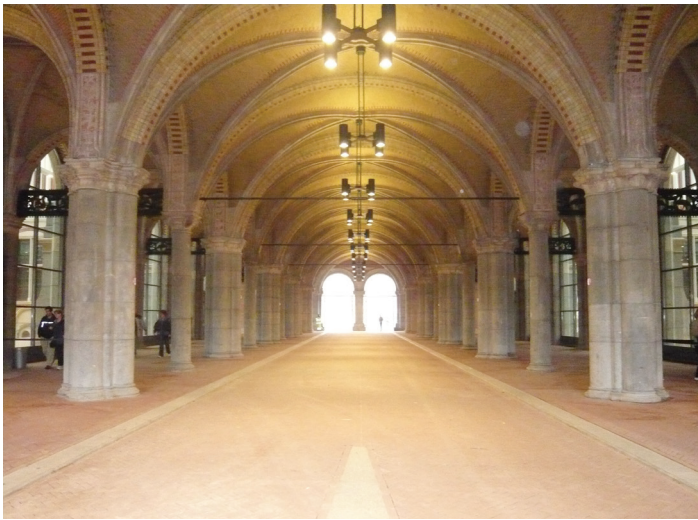
Fig. 16, 17. The Gallery of Honour after the renovation (above); most of Cuypers decorations have been reconstructed. The passageway shortly after the reopening of the Rijksmuseum in April 2013 (below).

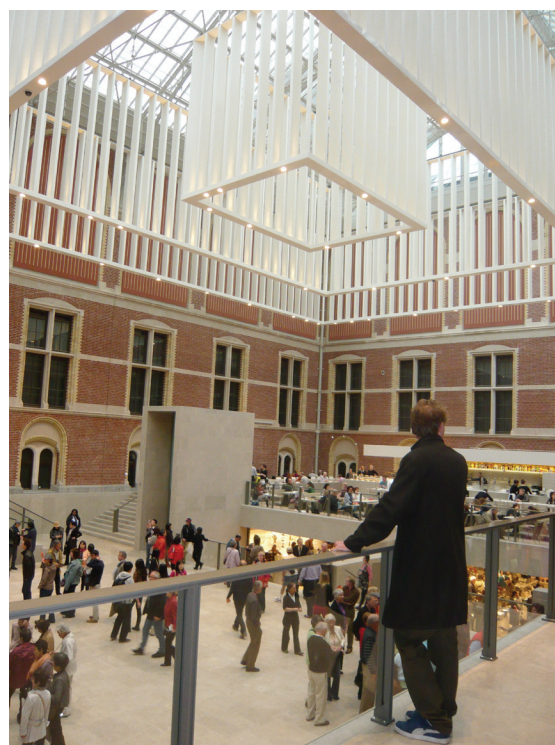
Fig. 18. Visitors descend to the Atrium via newly added stairs in the courtyards; the huge chandeliers provide light, sound attenuation and a sense of coherence.

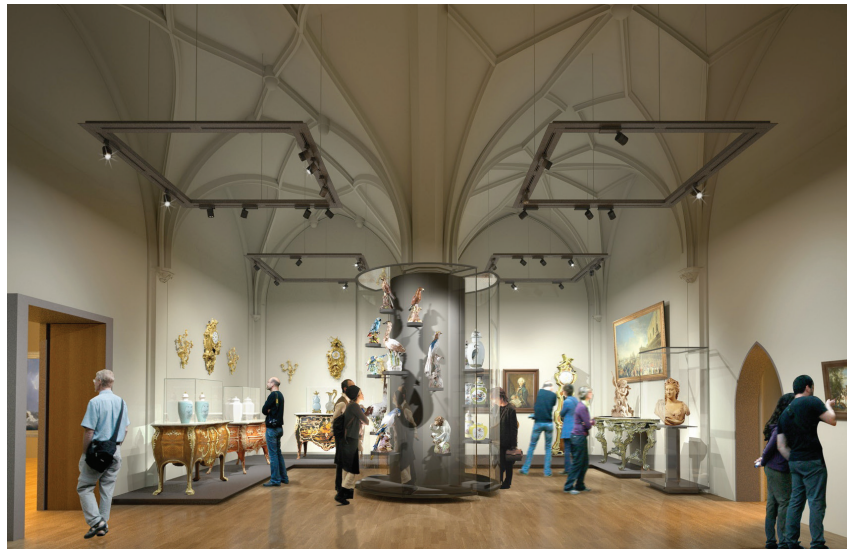
Fig. 19. Impression of the Wilmotte colours in the Gallery of the eighteenth Century.

gested, had changed in six new shades of grey. Both walls and vaultings were painted (fig. 19). In the interior Cruz y Ortiz and Cuypers were faced by a third layer. Also more windows in the building were blocked to give more space to the exhibition. The carefully restored Aduard Chapel disappeared behind a 'box-in-a-box construction'. The chronological presentation according to a serpentine model made way for an elective model, also more fitting to the spatial layout of the building that is 'interrupted' by the passageway.
