The effectiveness of thermal buffering systems in the monumental Panorama Mesdag museum

Elke Mulders  
4615212  
Building Technology  
Graduation

## The Panorama Mesdag Museum

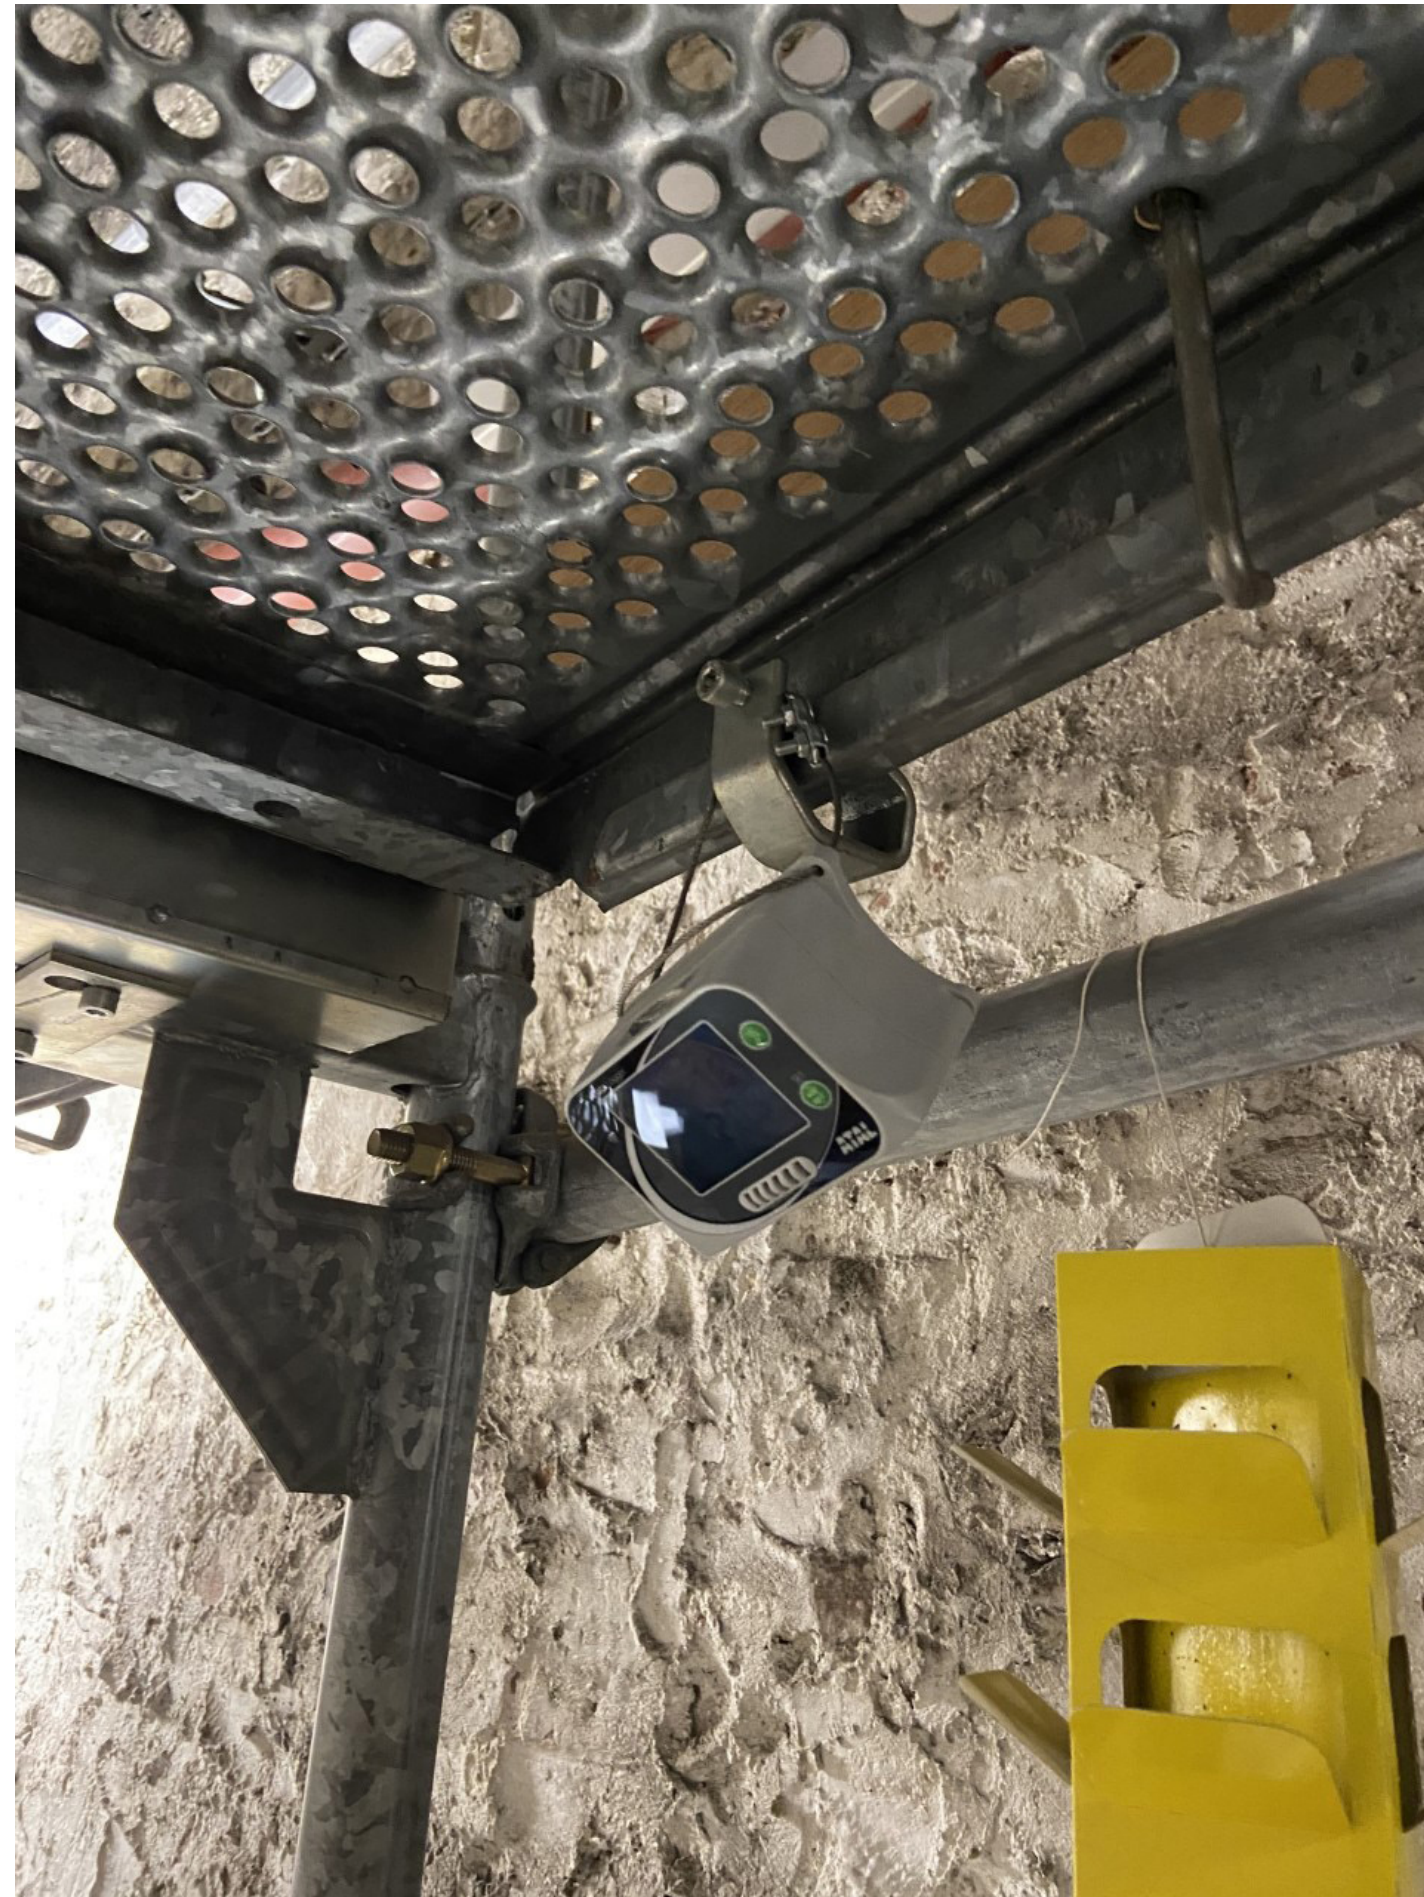
Temperature and relative humidity logger

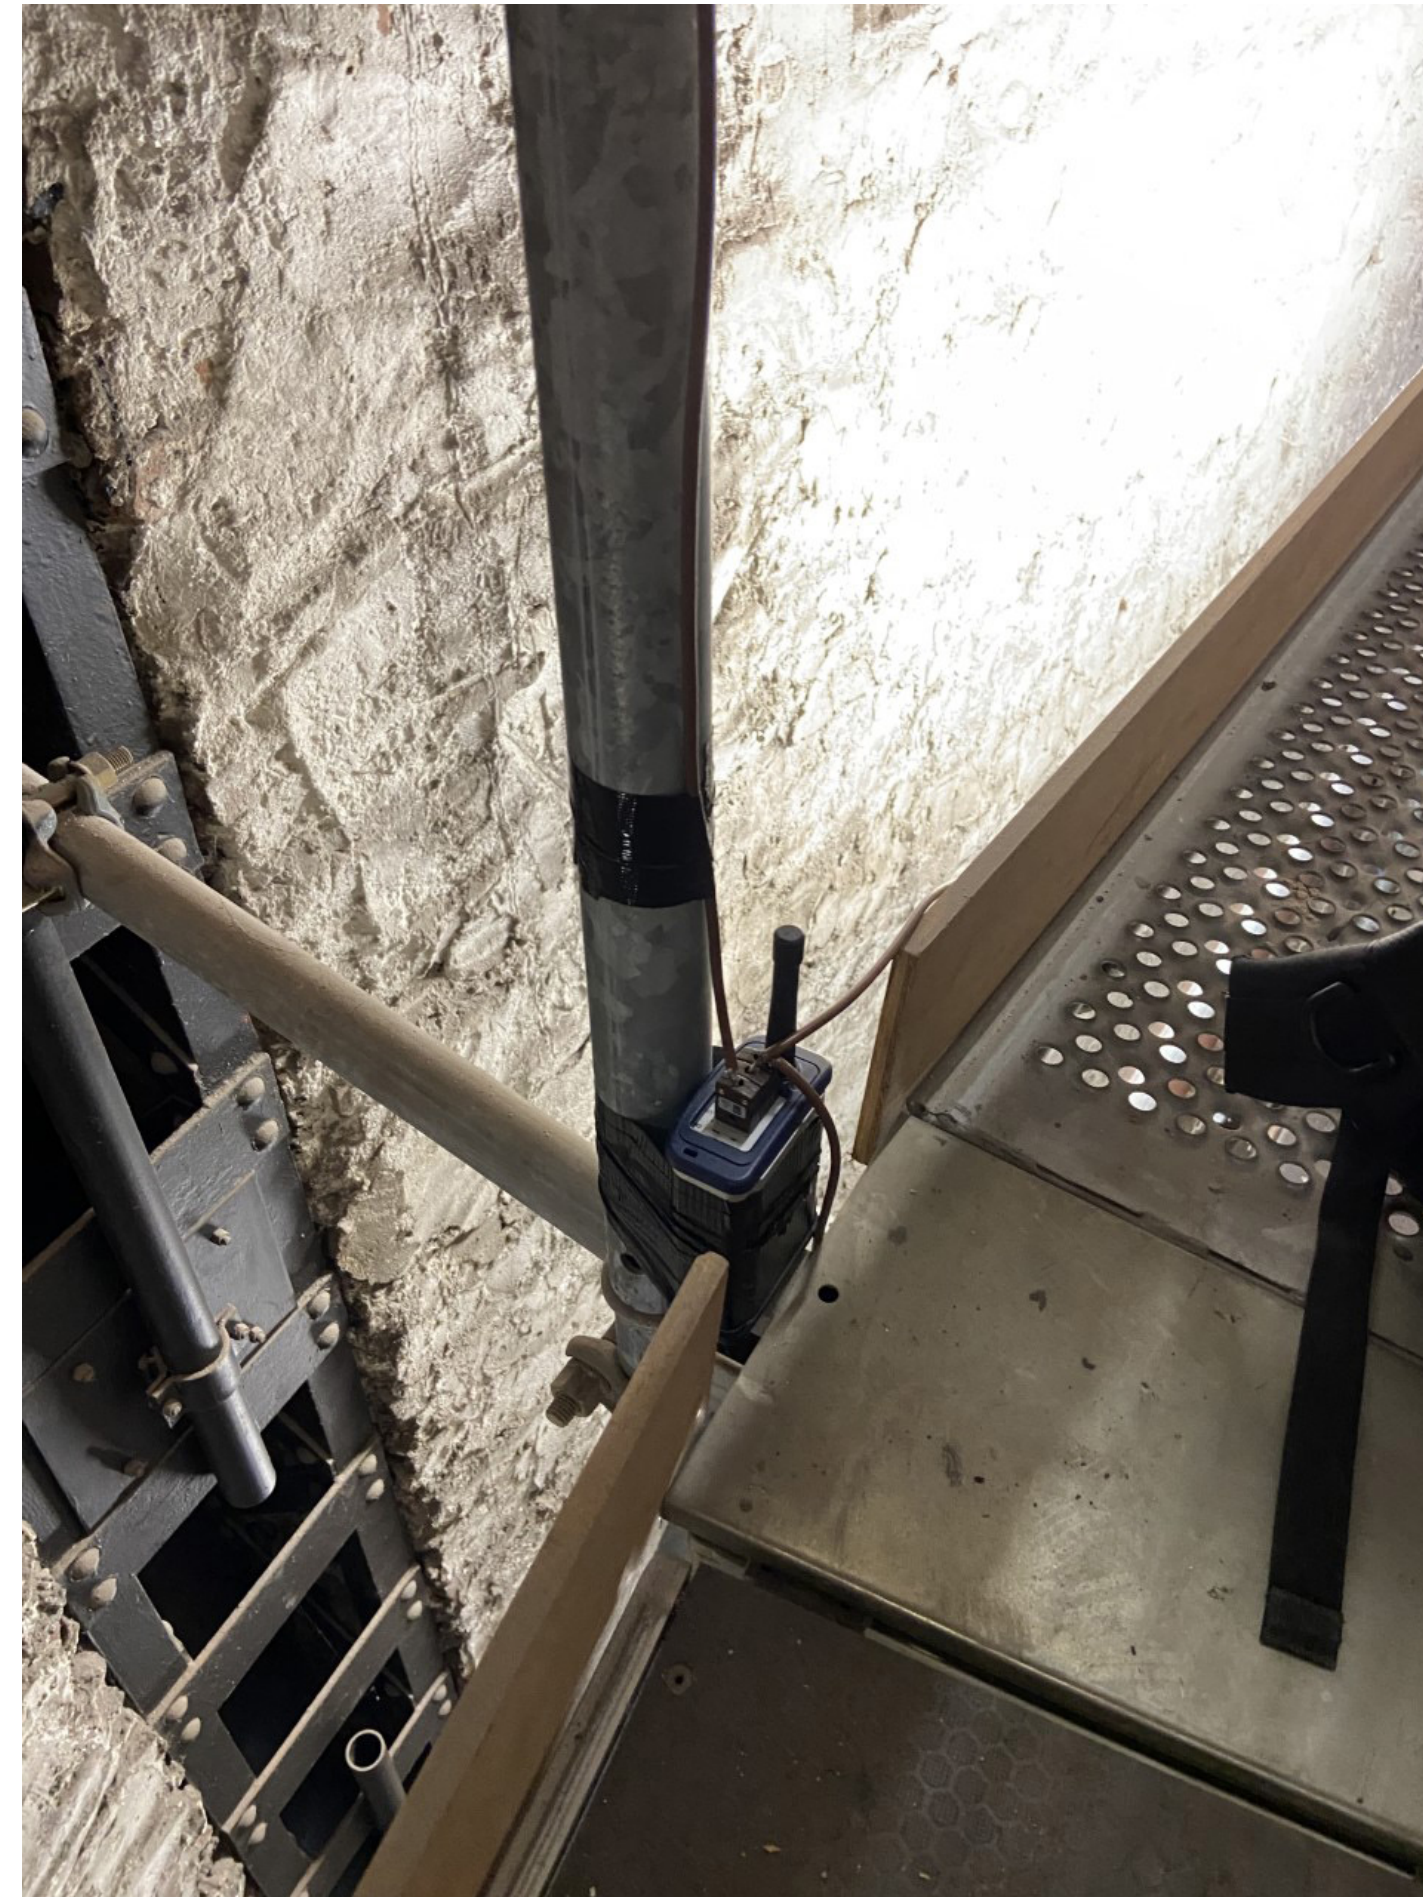
Data receiver

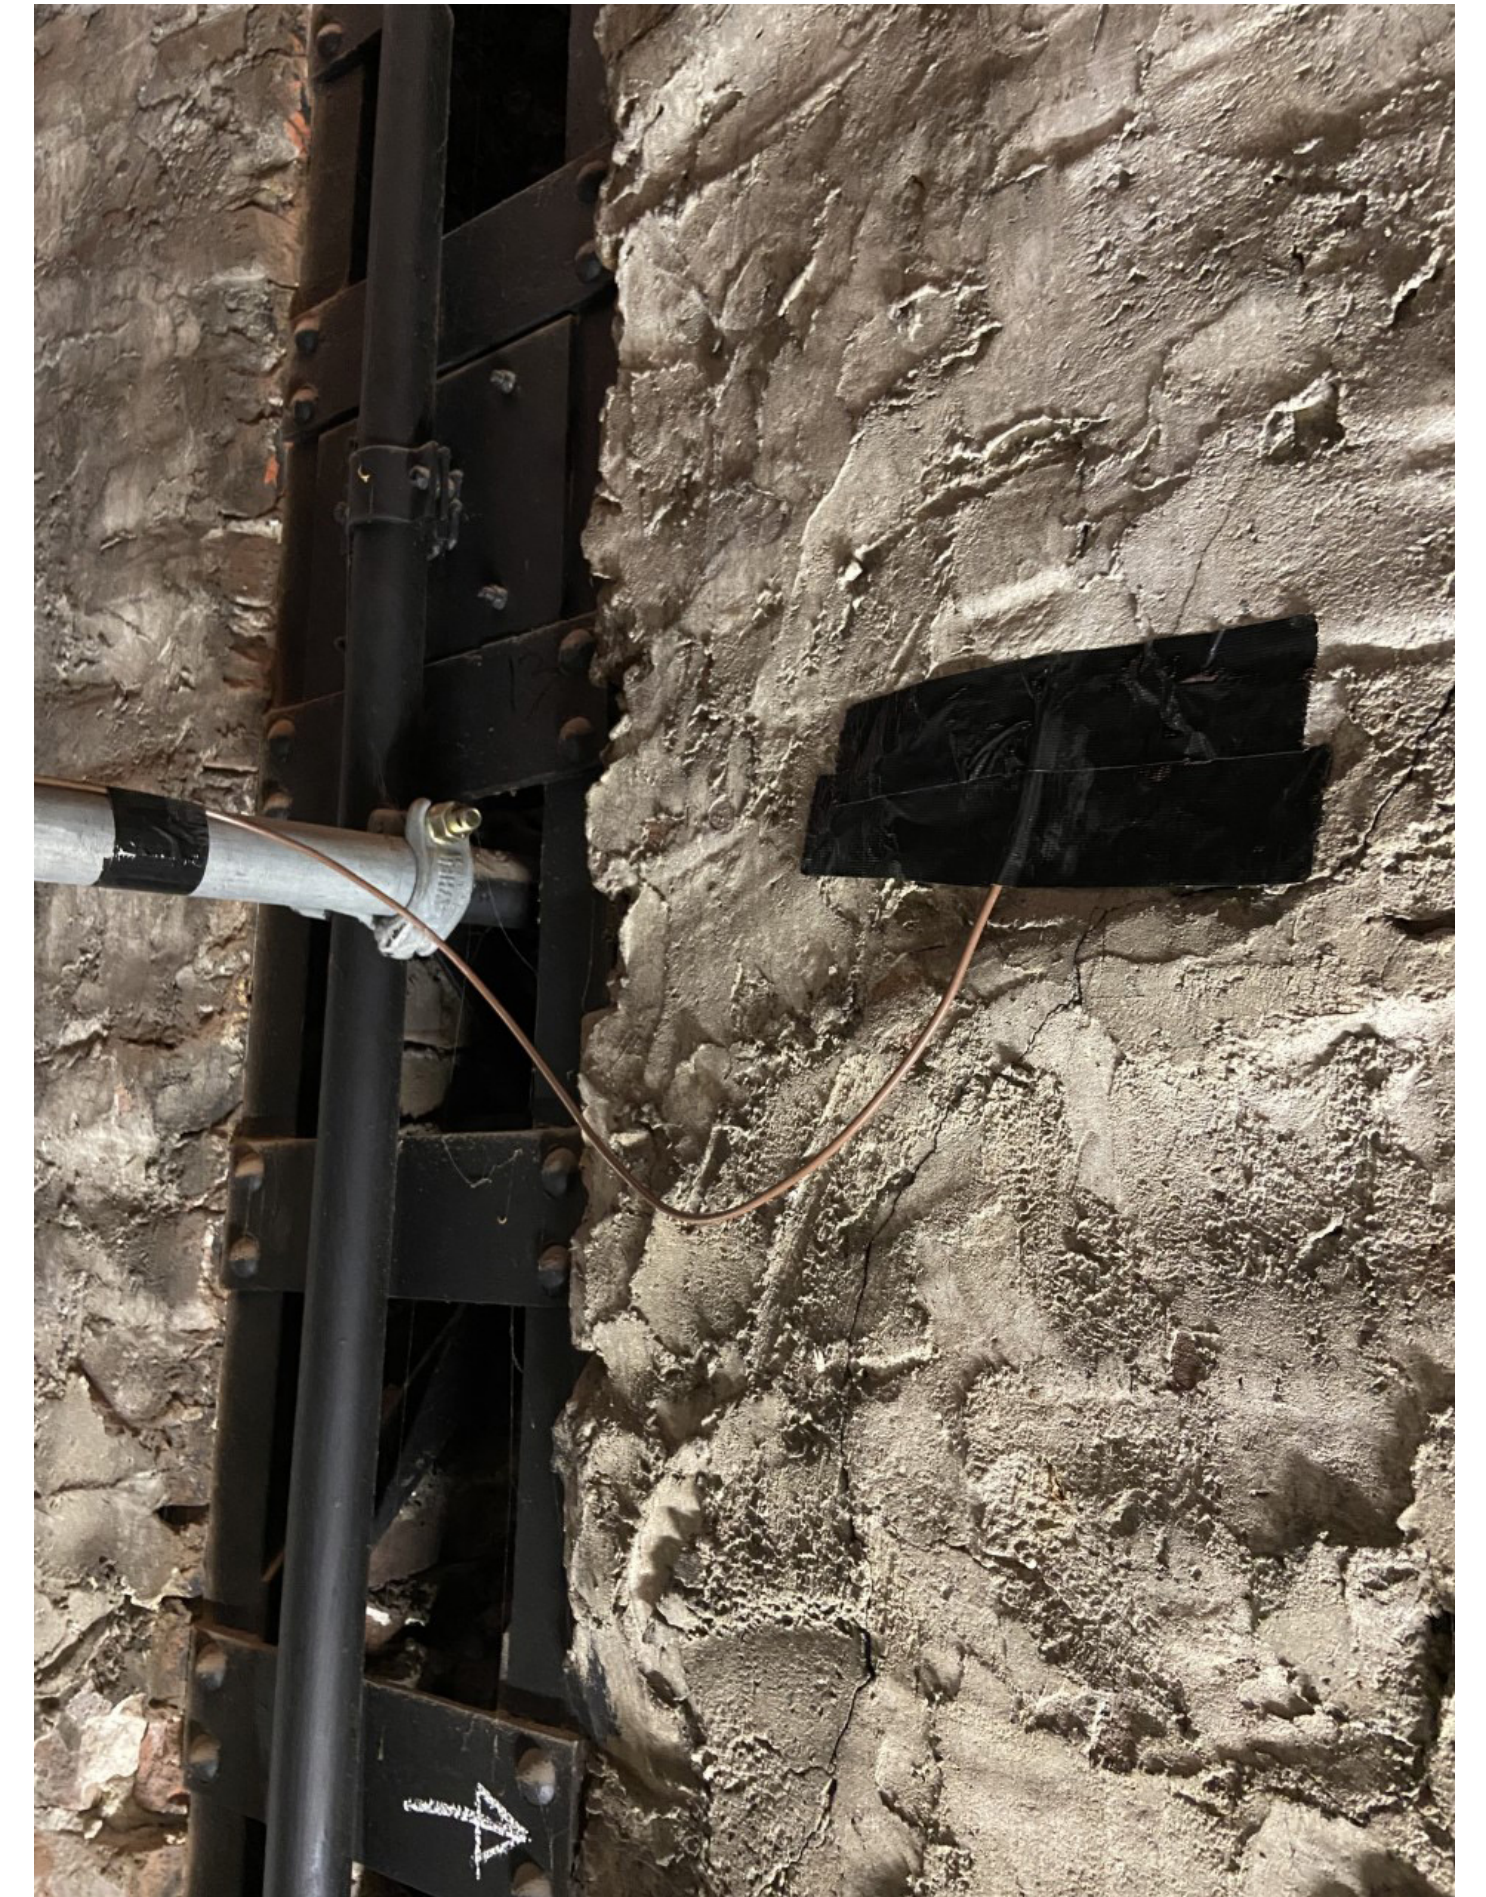
Surface temperature logger

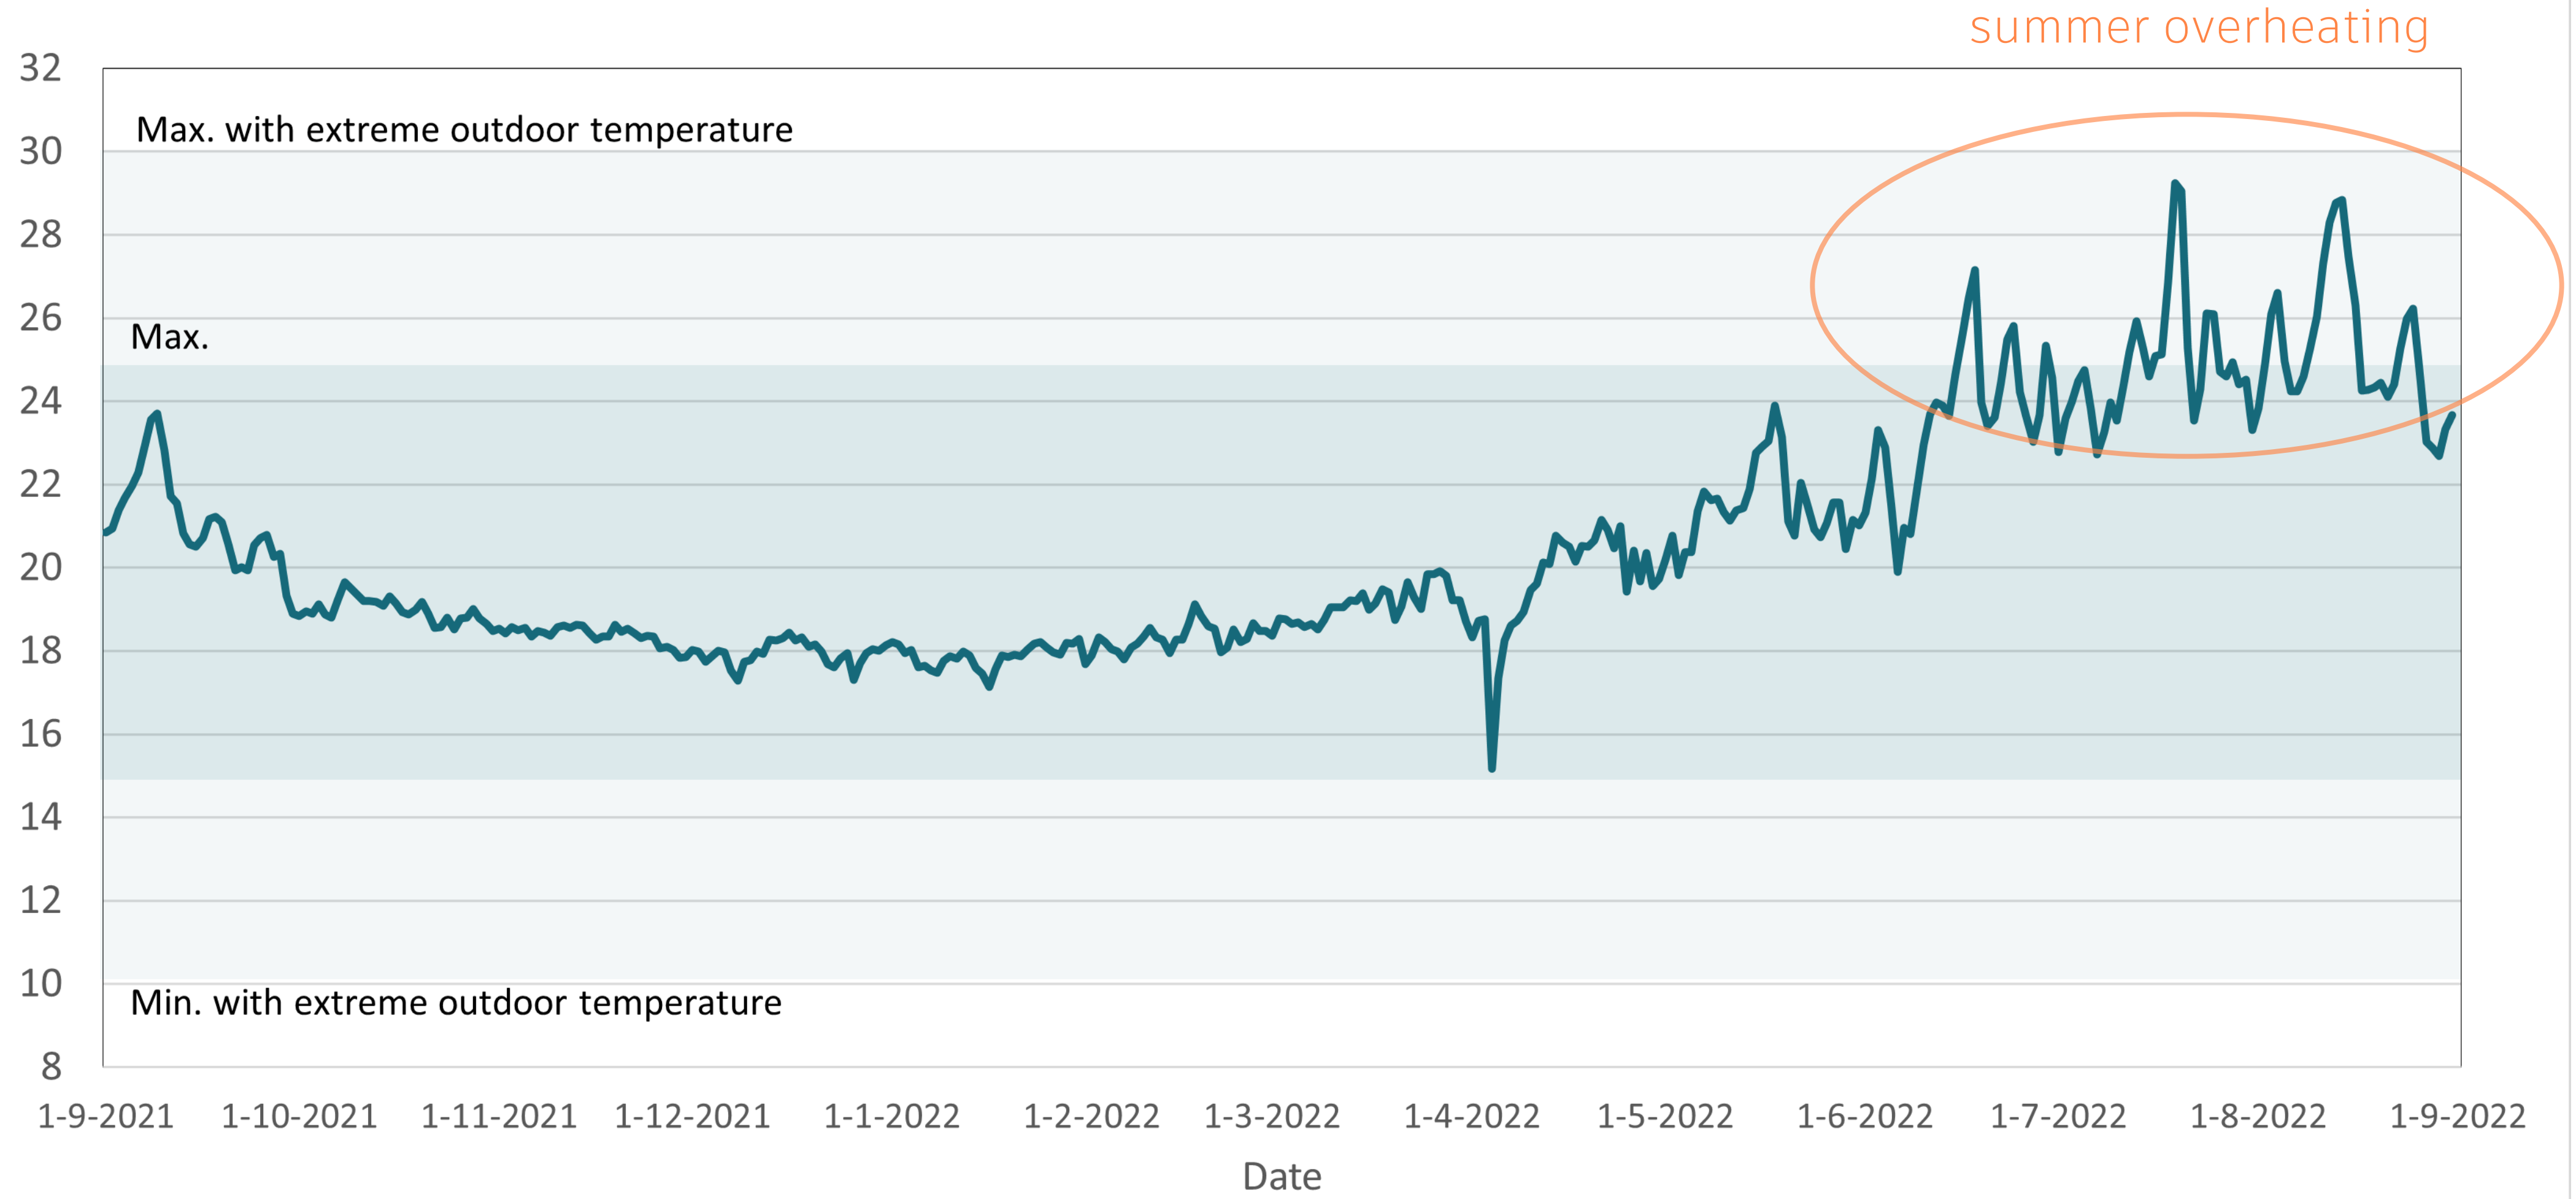
# Measured operative temperature

Average behind the canvas between september '21-'22

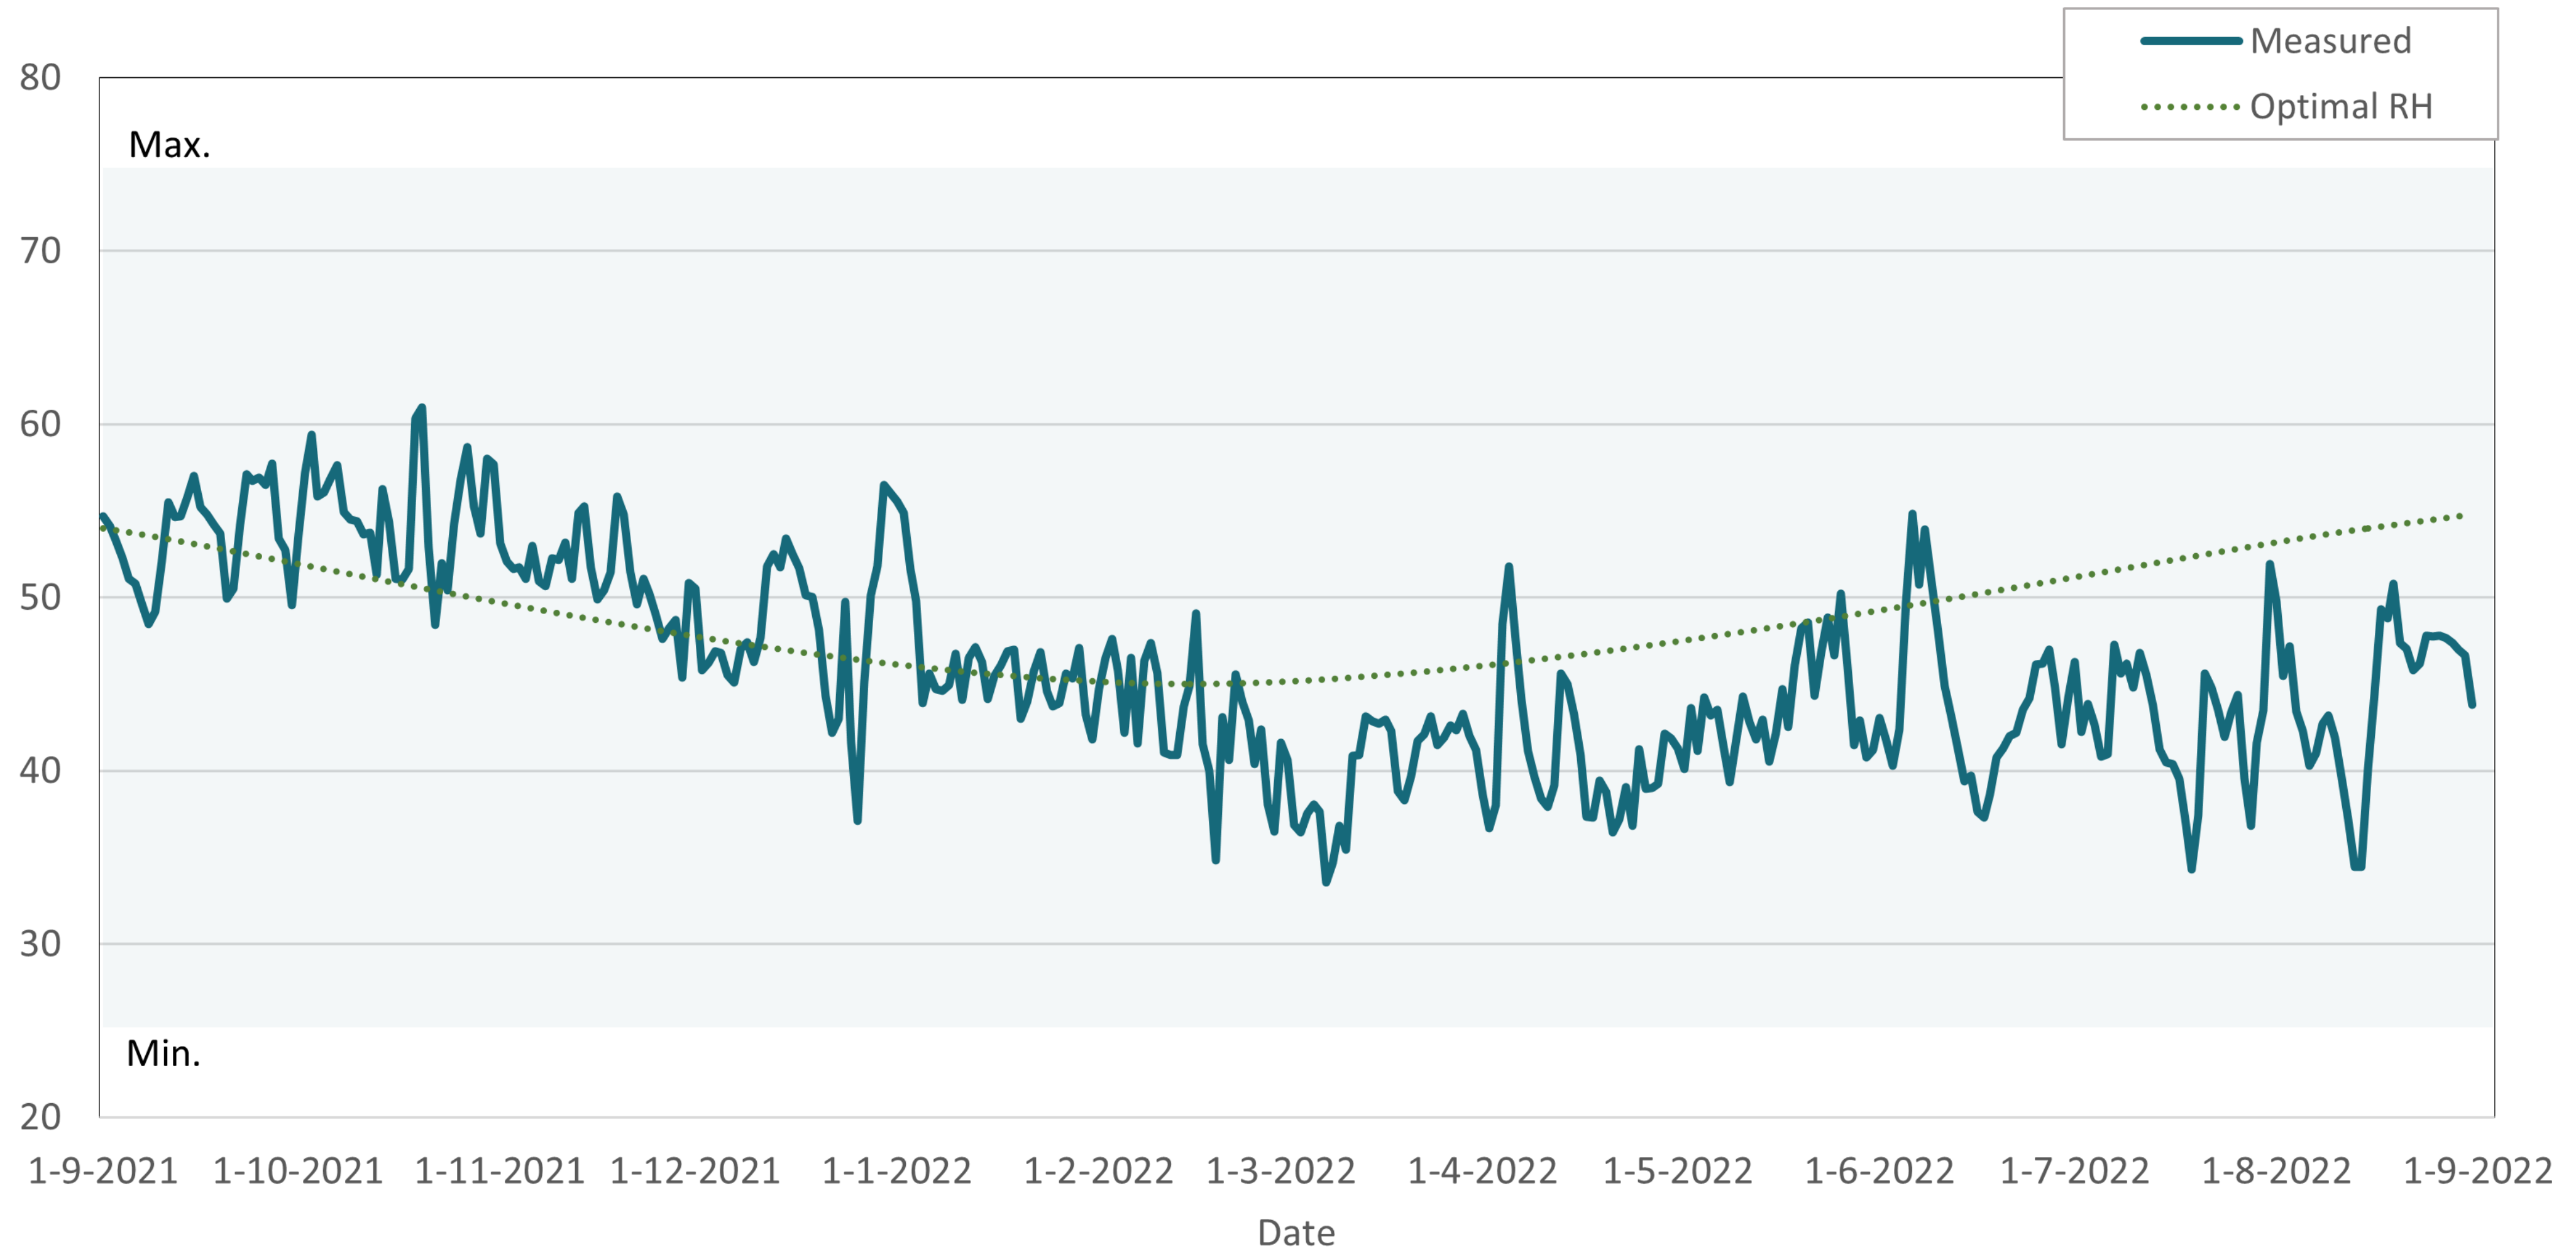
# Measured relative humidity

Average behind the canvas between september '21-'22

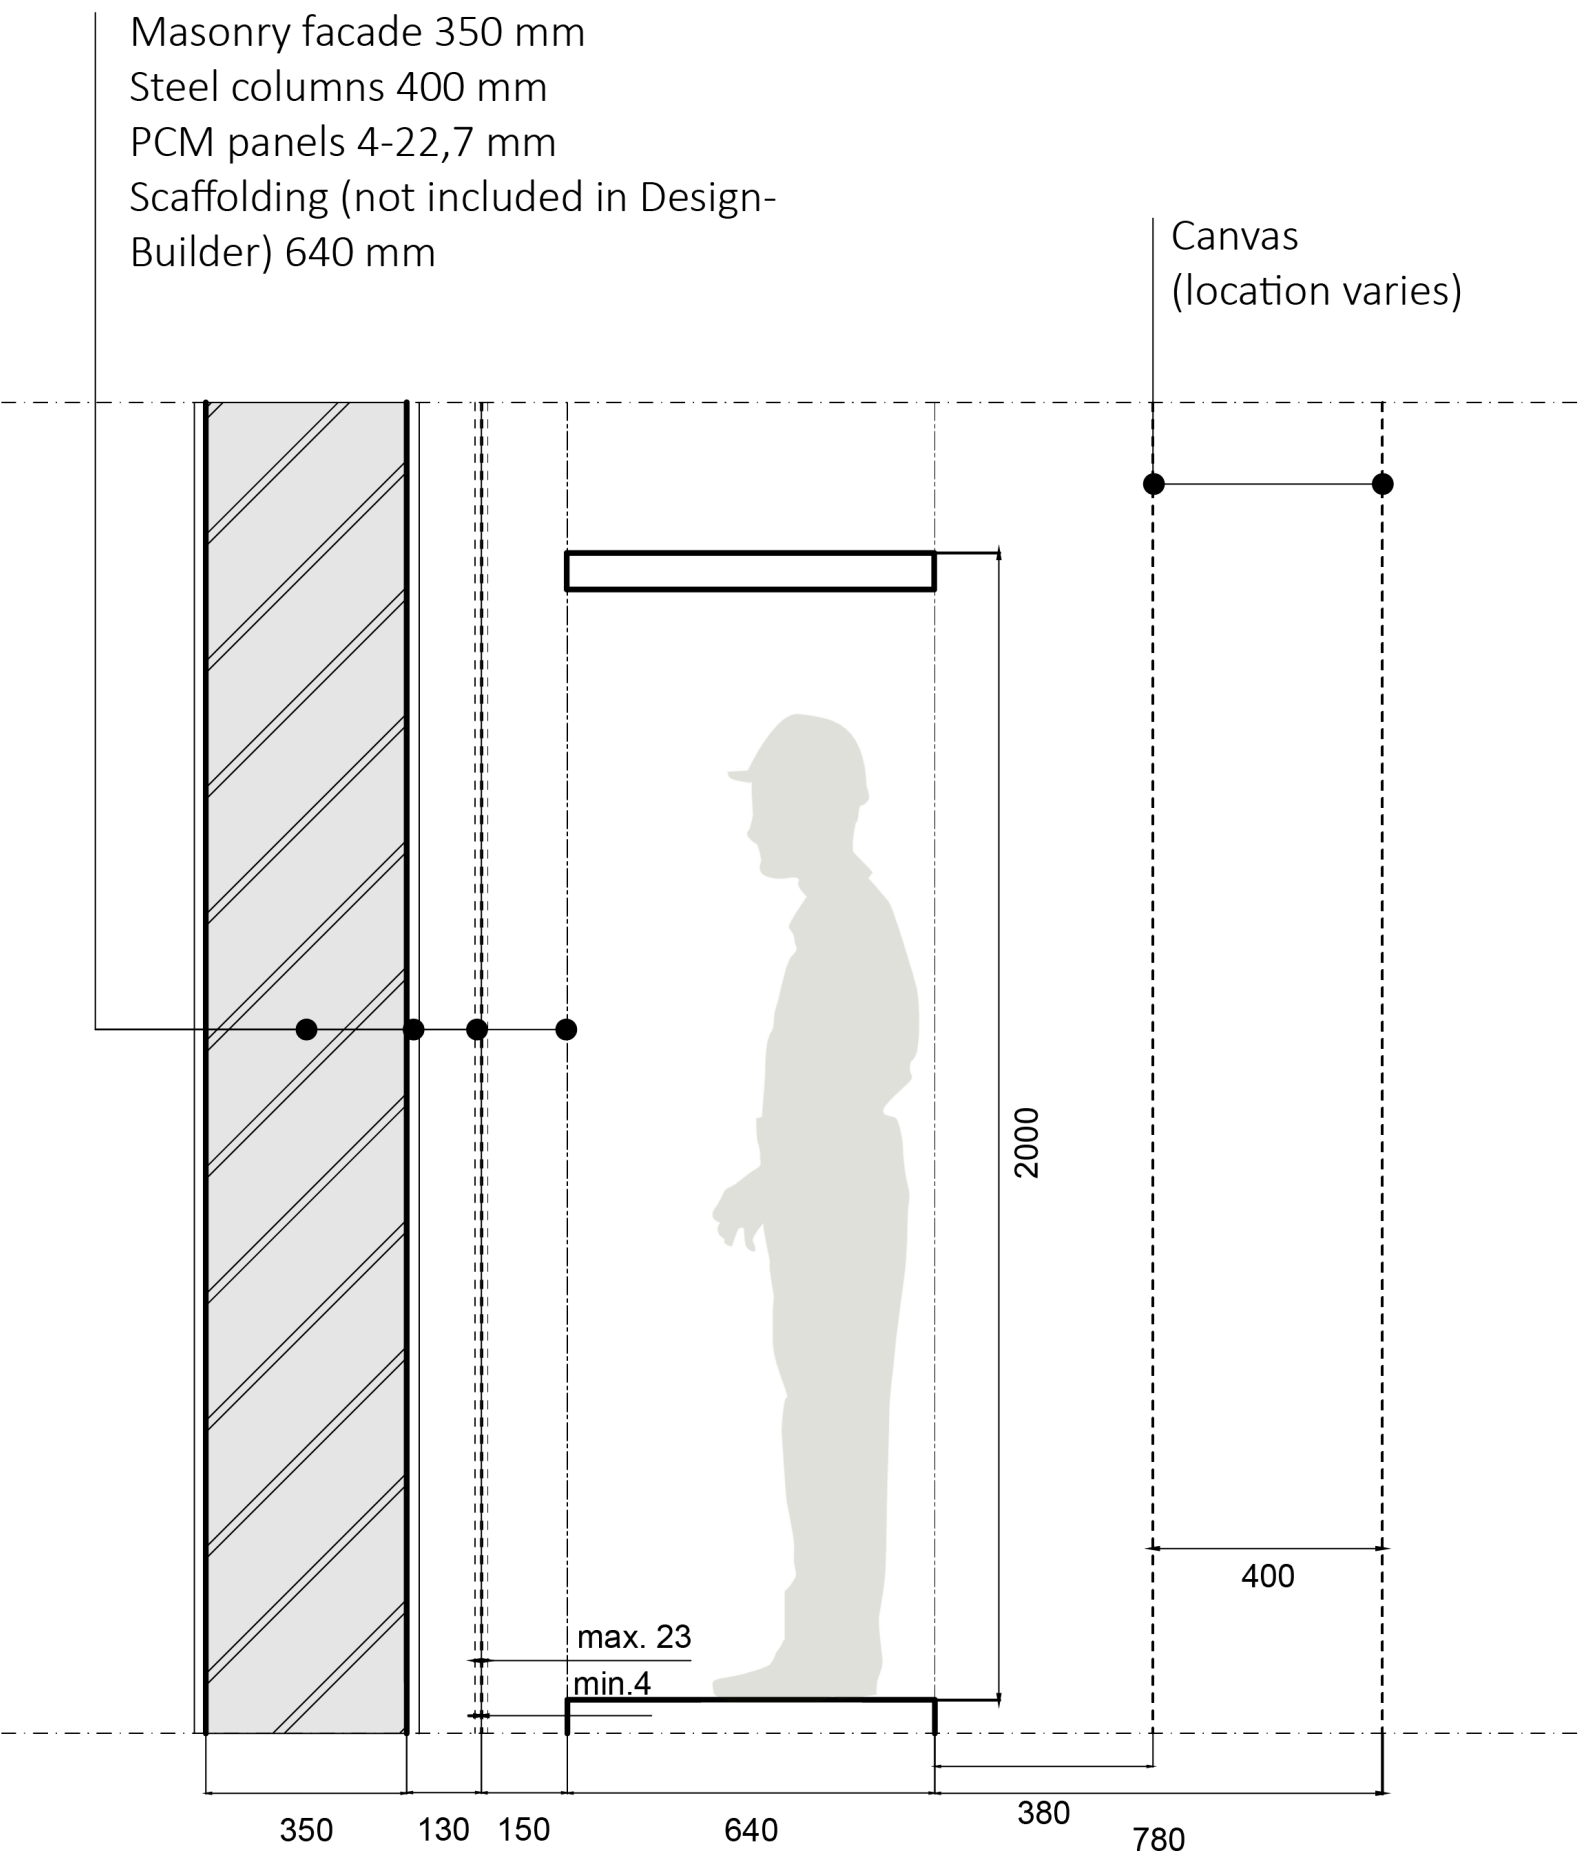
## Section PCM panels 1:10

**Air flow around PCM panels**

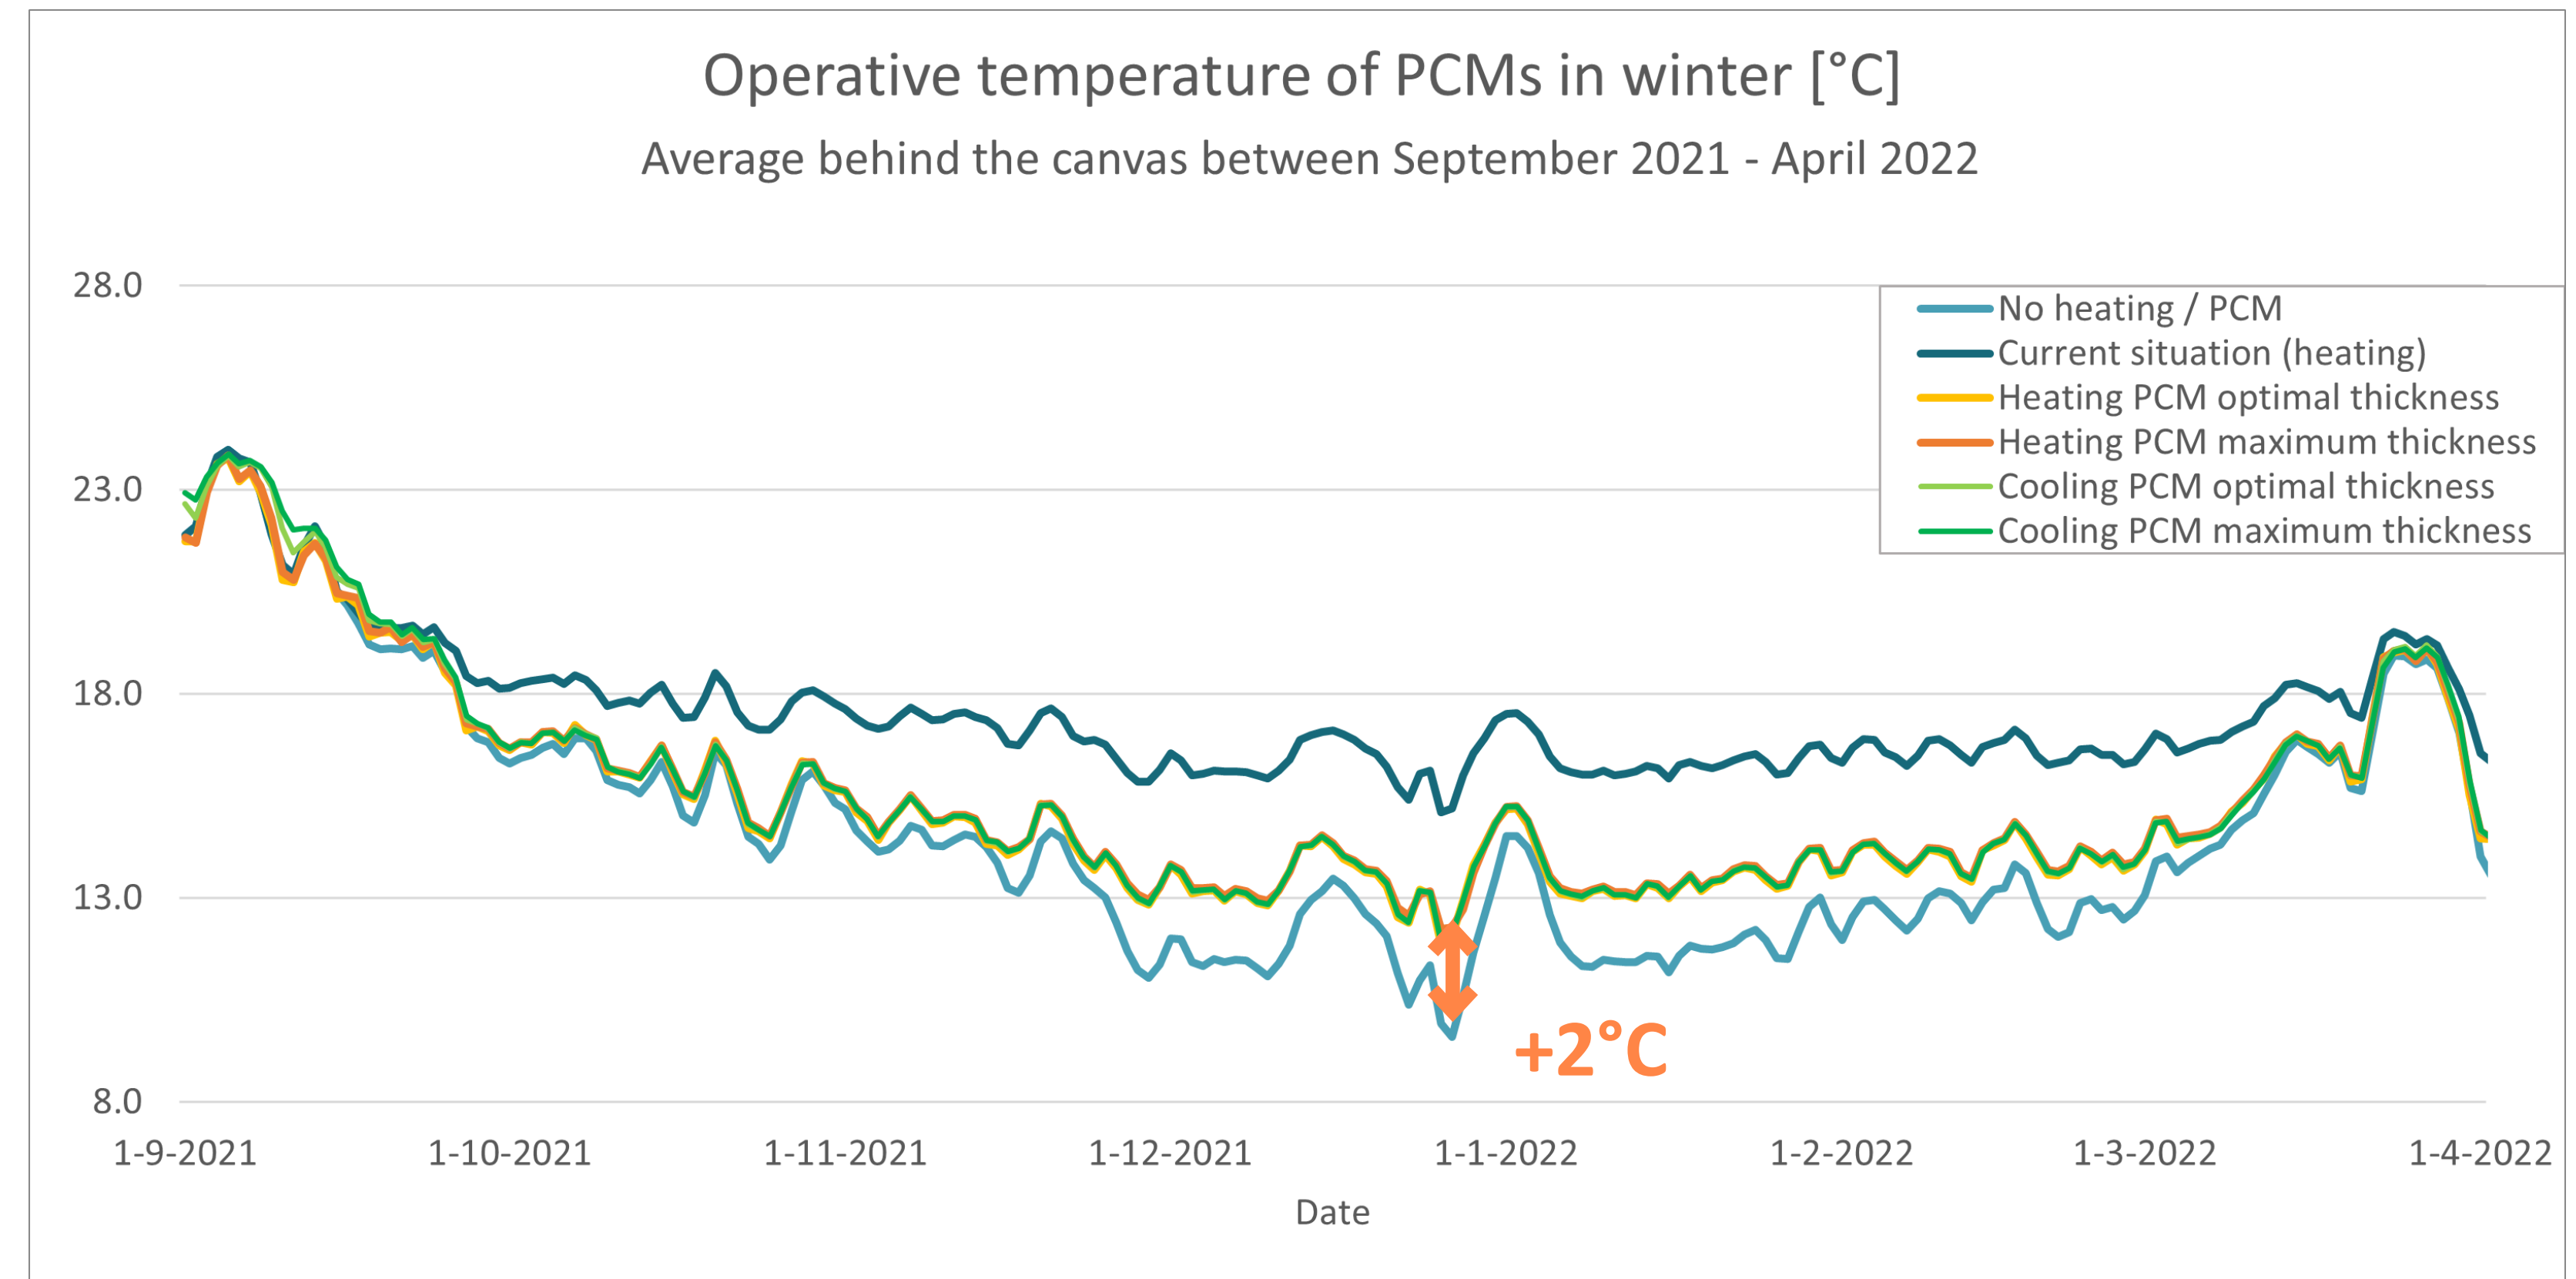
## Simulation results winter - PCMs

Minimal difference between cooling and heating PCMs

PCM have no effect in winter, so not advised.
