The effectiveness of thermal buffering systems in the monumental Panorama Mesdag museum

Elke Mulders  
4615212  
Building Technology  
Graduation

## The Panorama Mesdag Museum

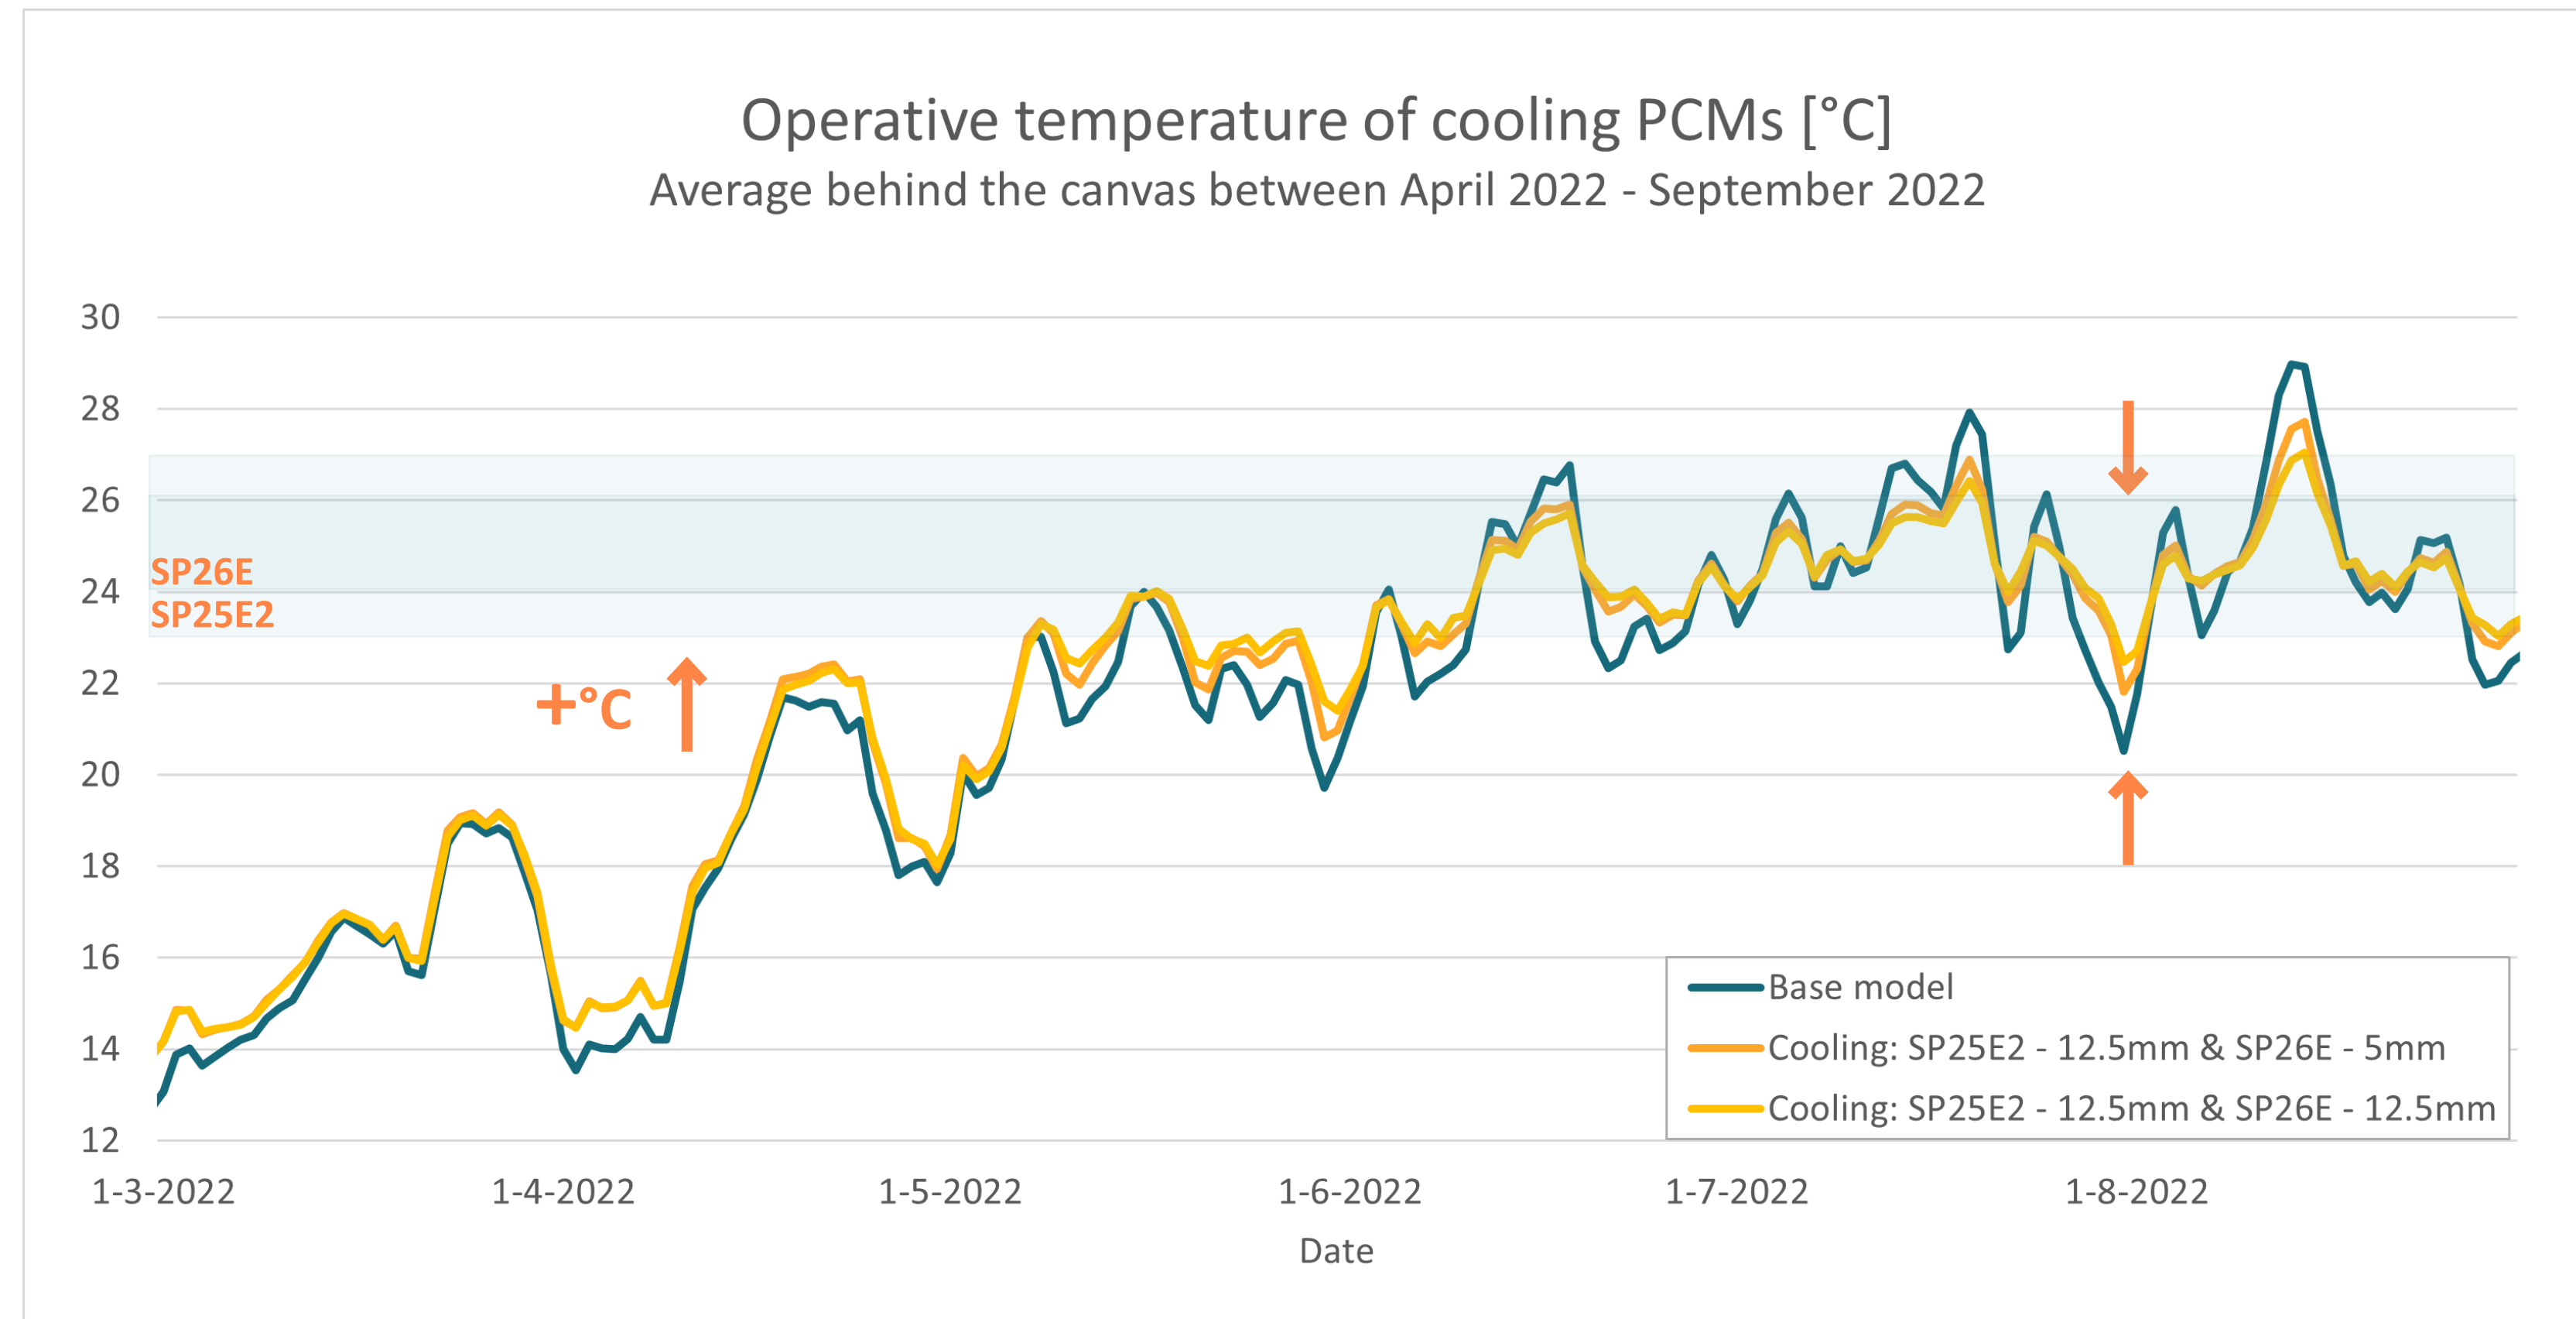
## Simulation results summer - Cooling PCMs

- Sufficient cooling effect when in T range.
- Outside T range negative heating effect.

Cooling PCMs should be active on more days per year.

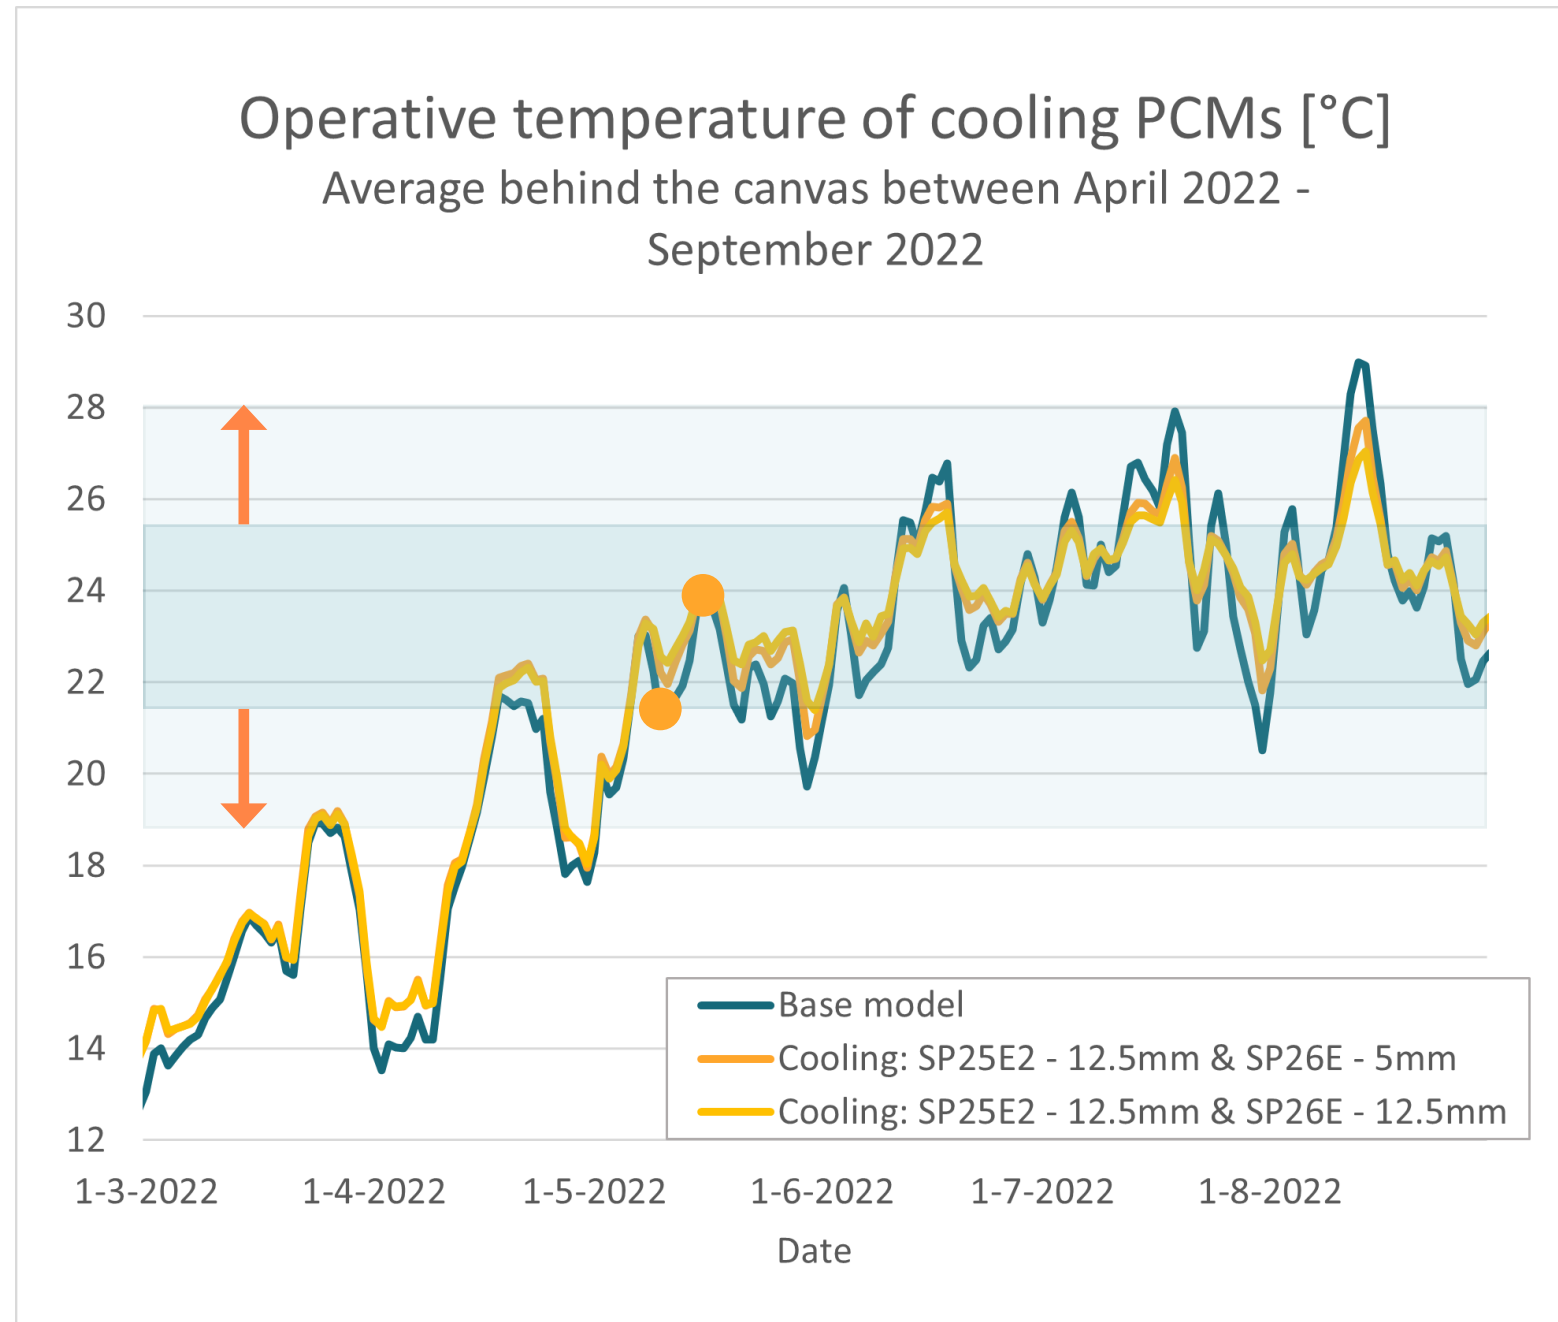
## PCM with larger T range

PCM does not fully charge & discharge

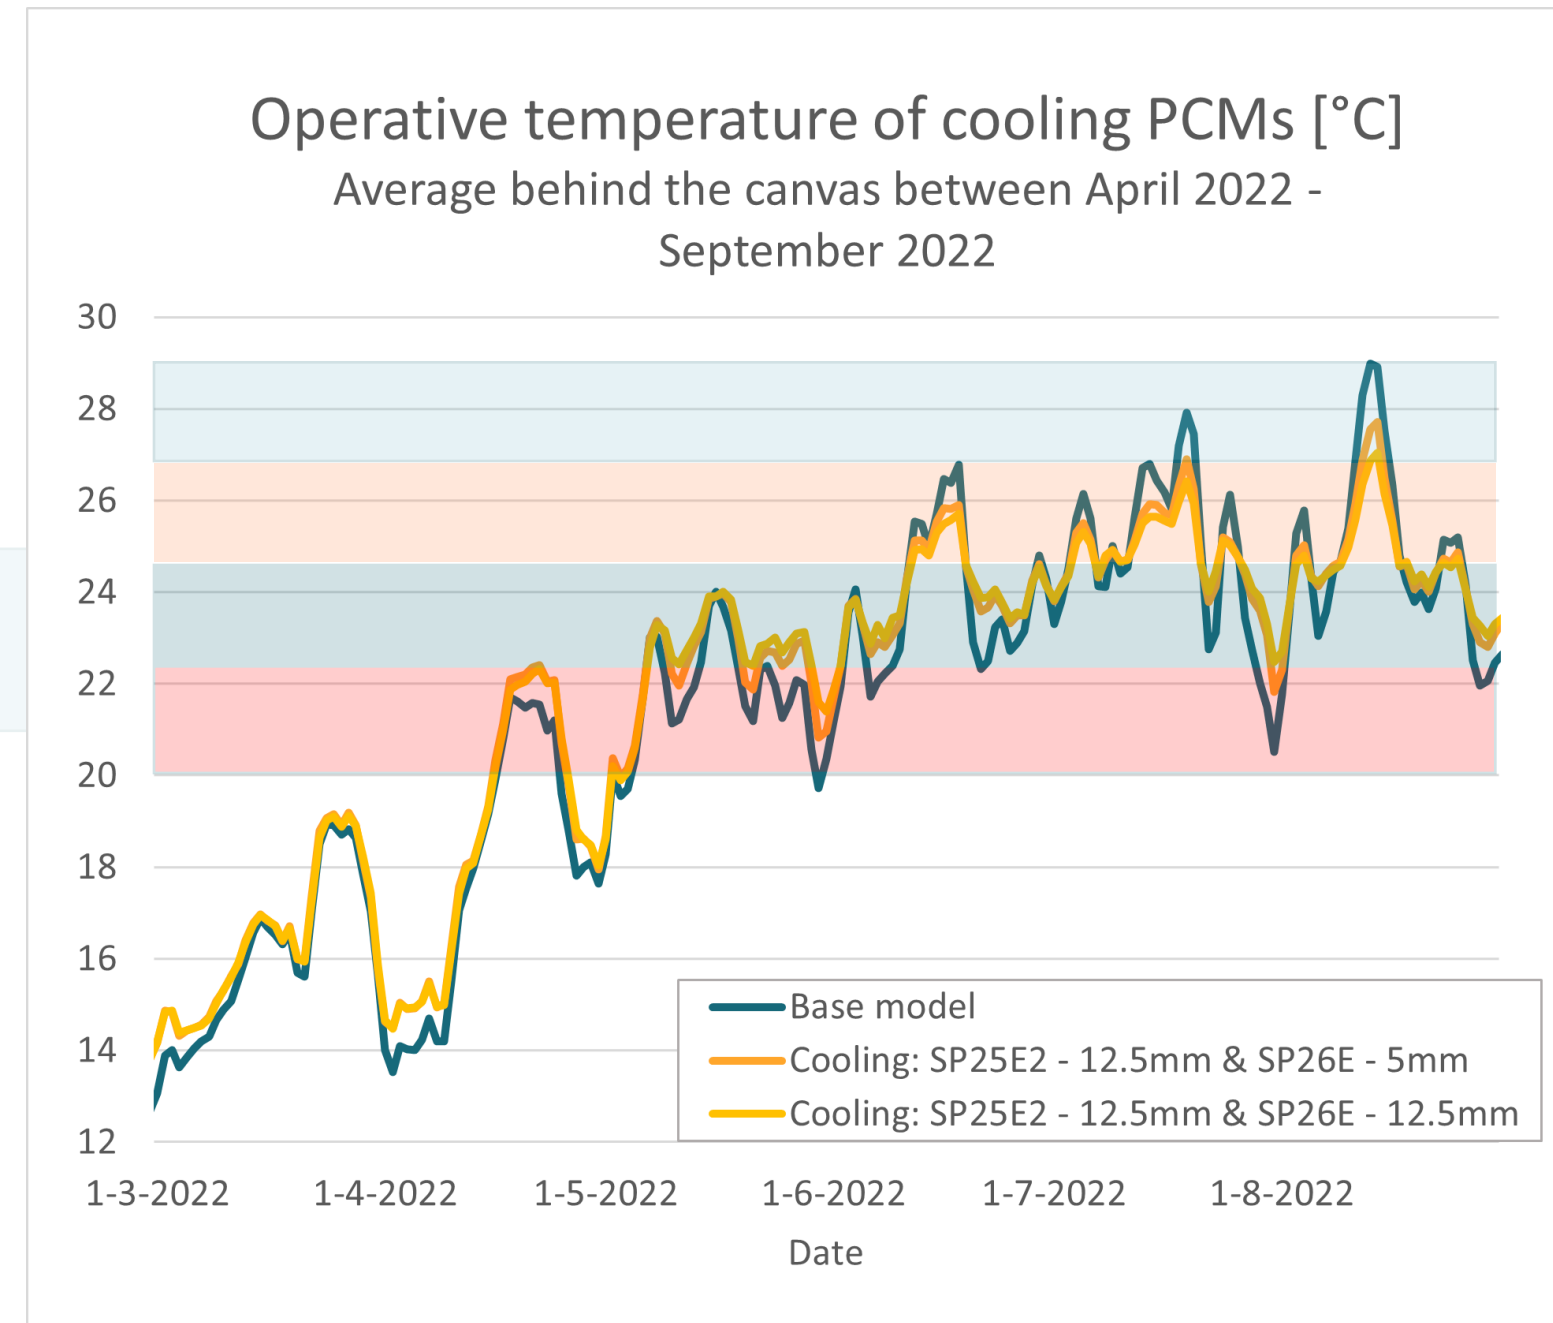
## Multiple PCMs with different T range

Decrease in capacity and effect on indoor climate

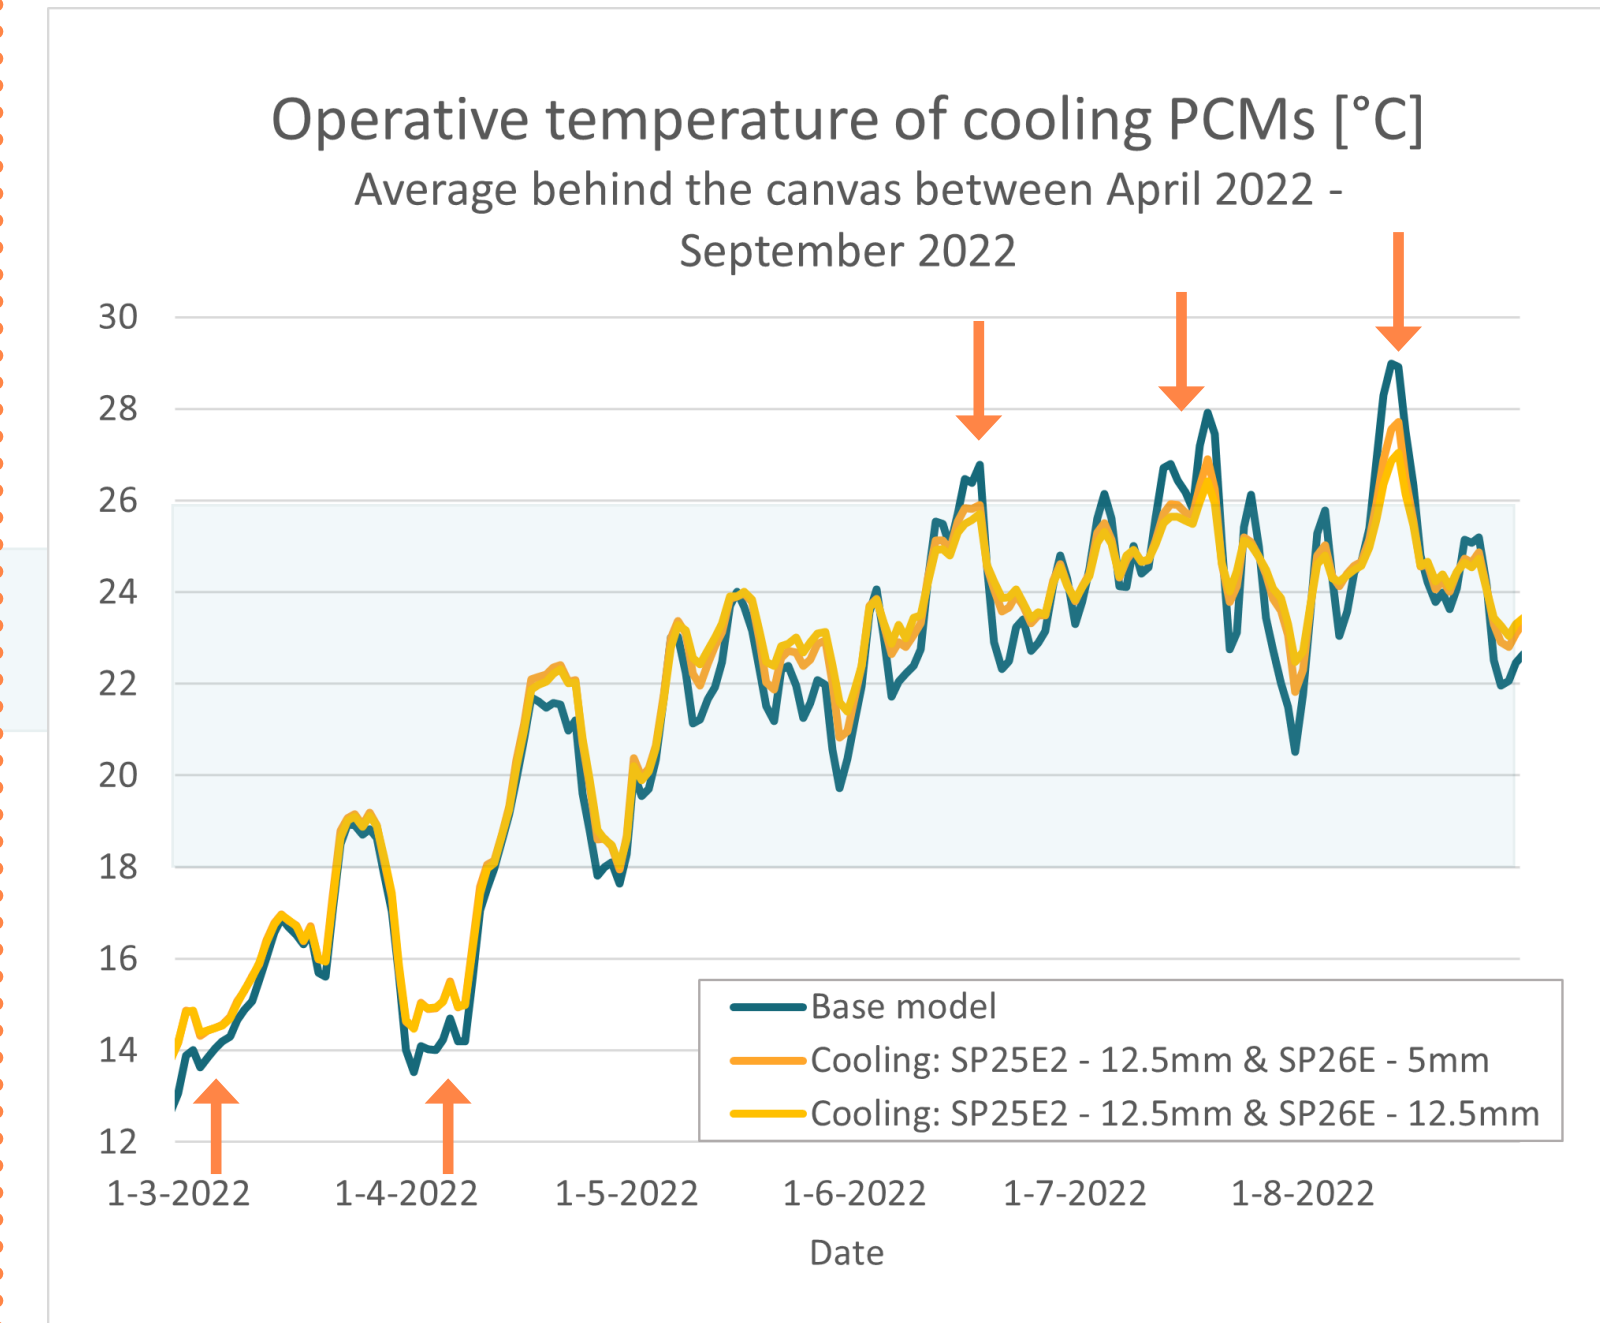
## Increase consistency of daily fluctuations

PCM active on more days per year -> increase of effect on indoor climate

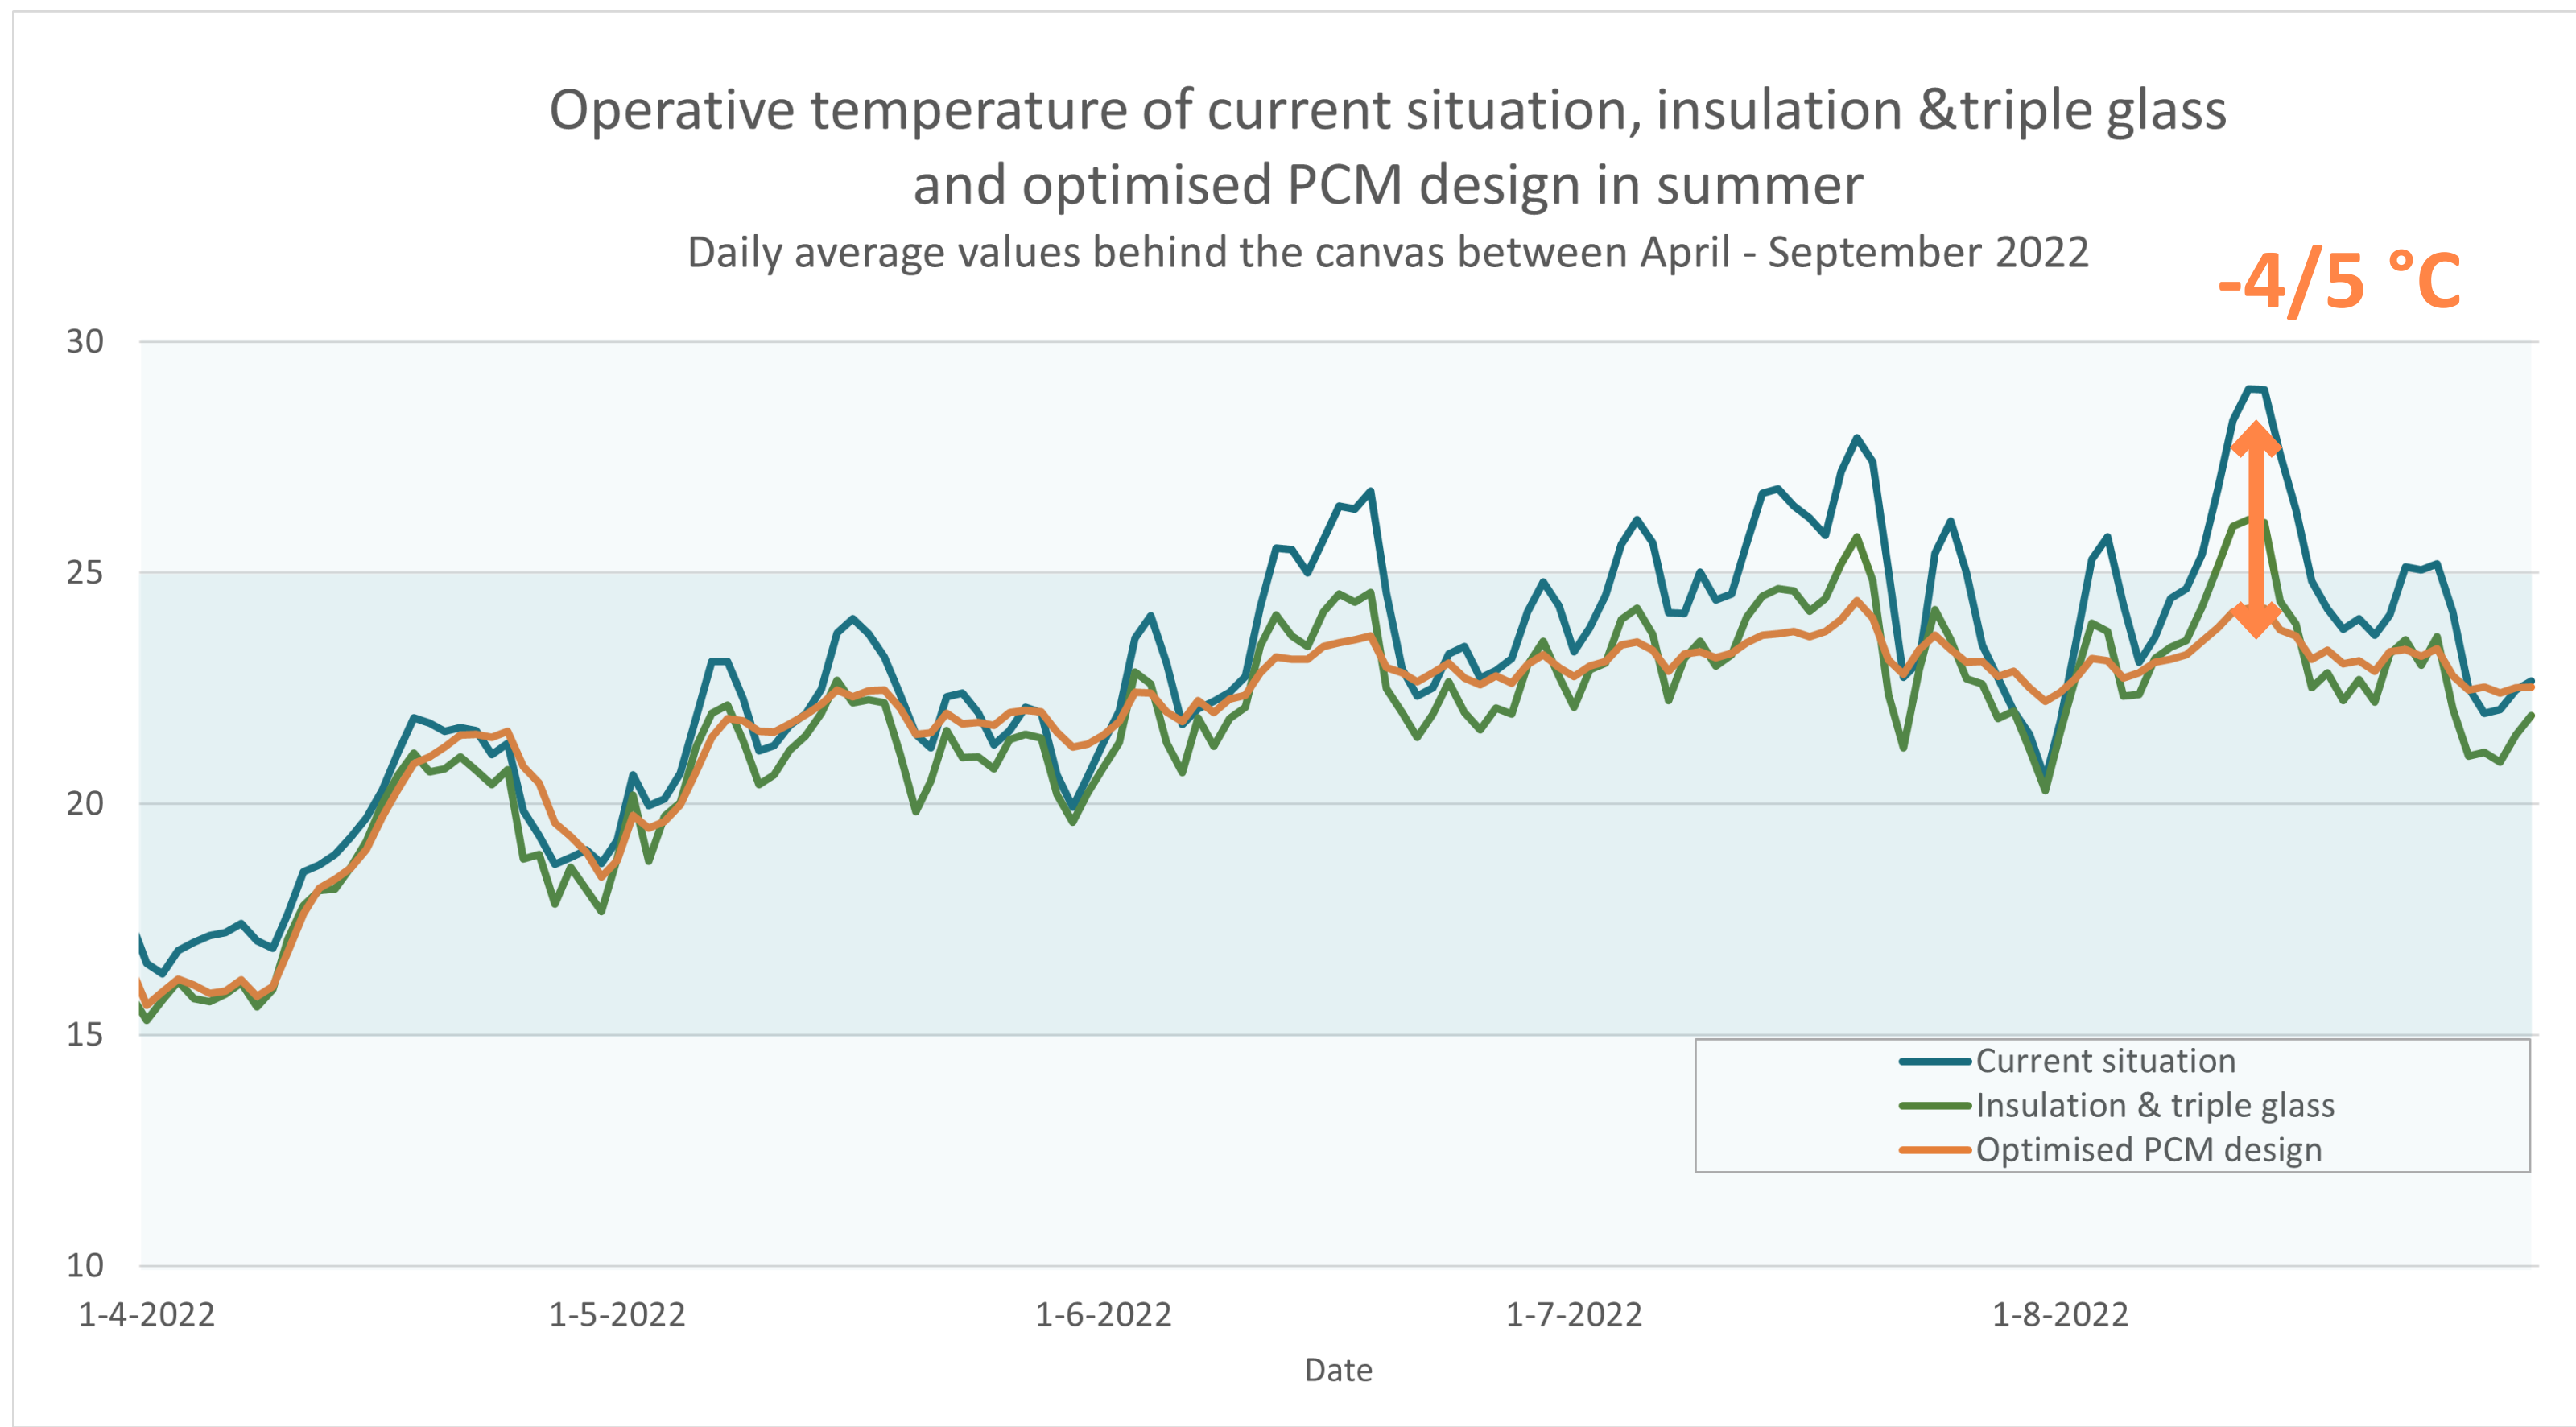
**PCM SP24E Rubitherm 12.5 mm**

- Melting: 24-25
- Solidifying: 21-23

- Temperature - 4 to 5 °C on **peak summer days**
- **Average temperature -1.5 °C**

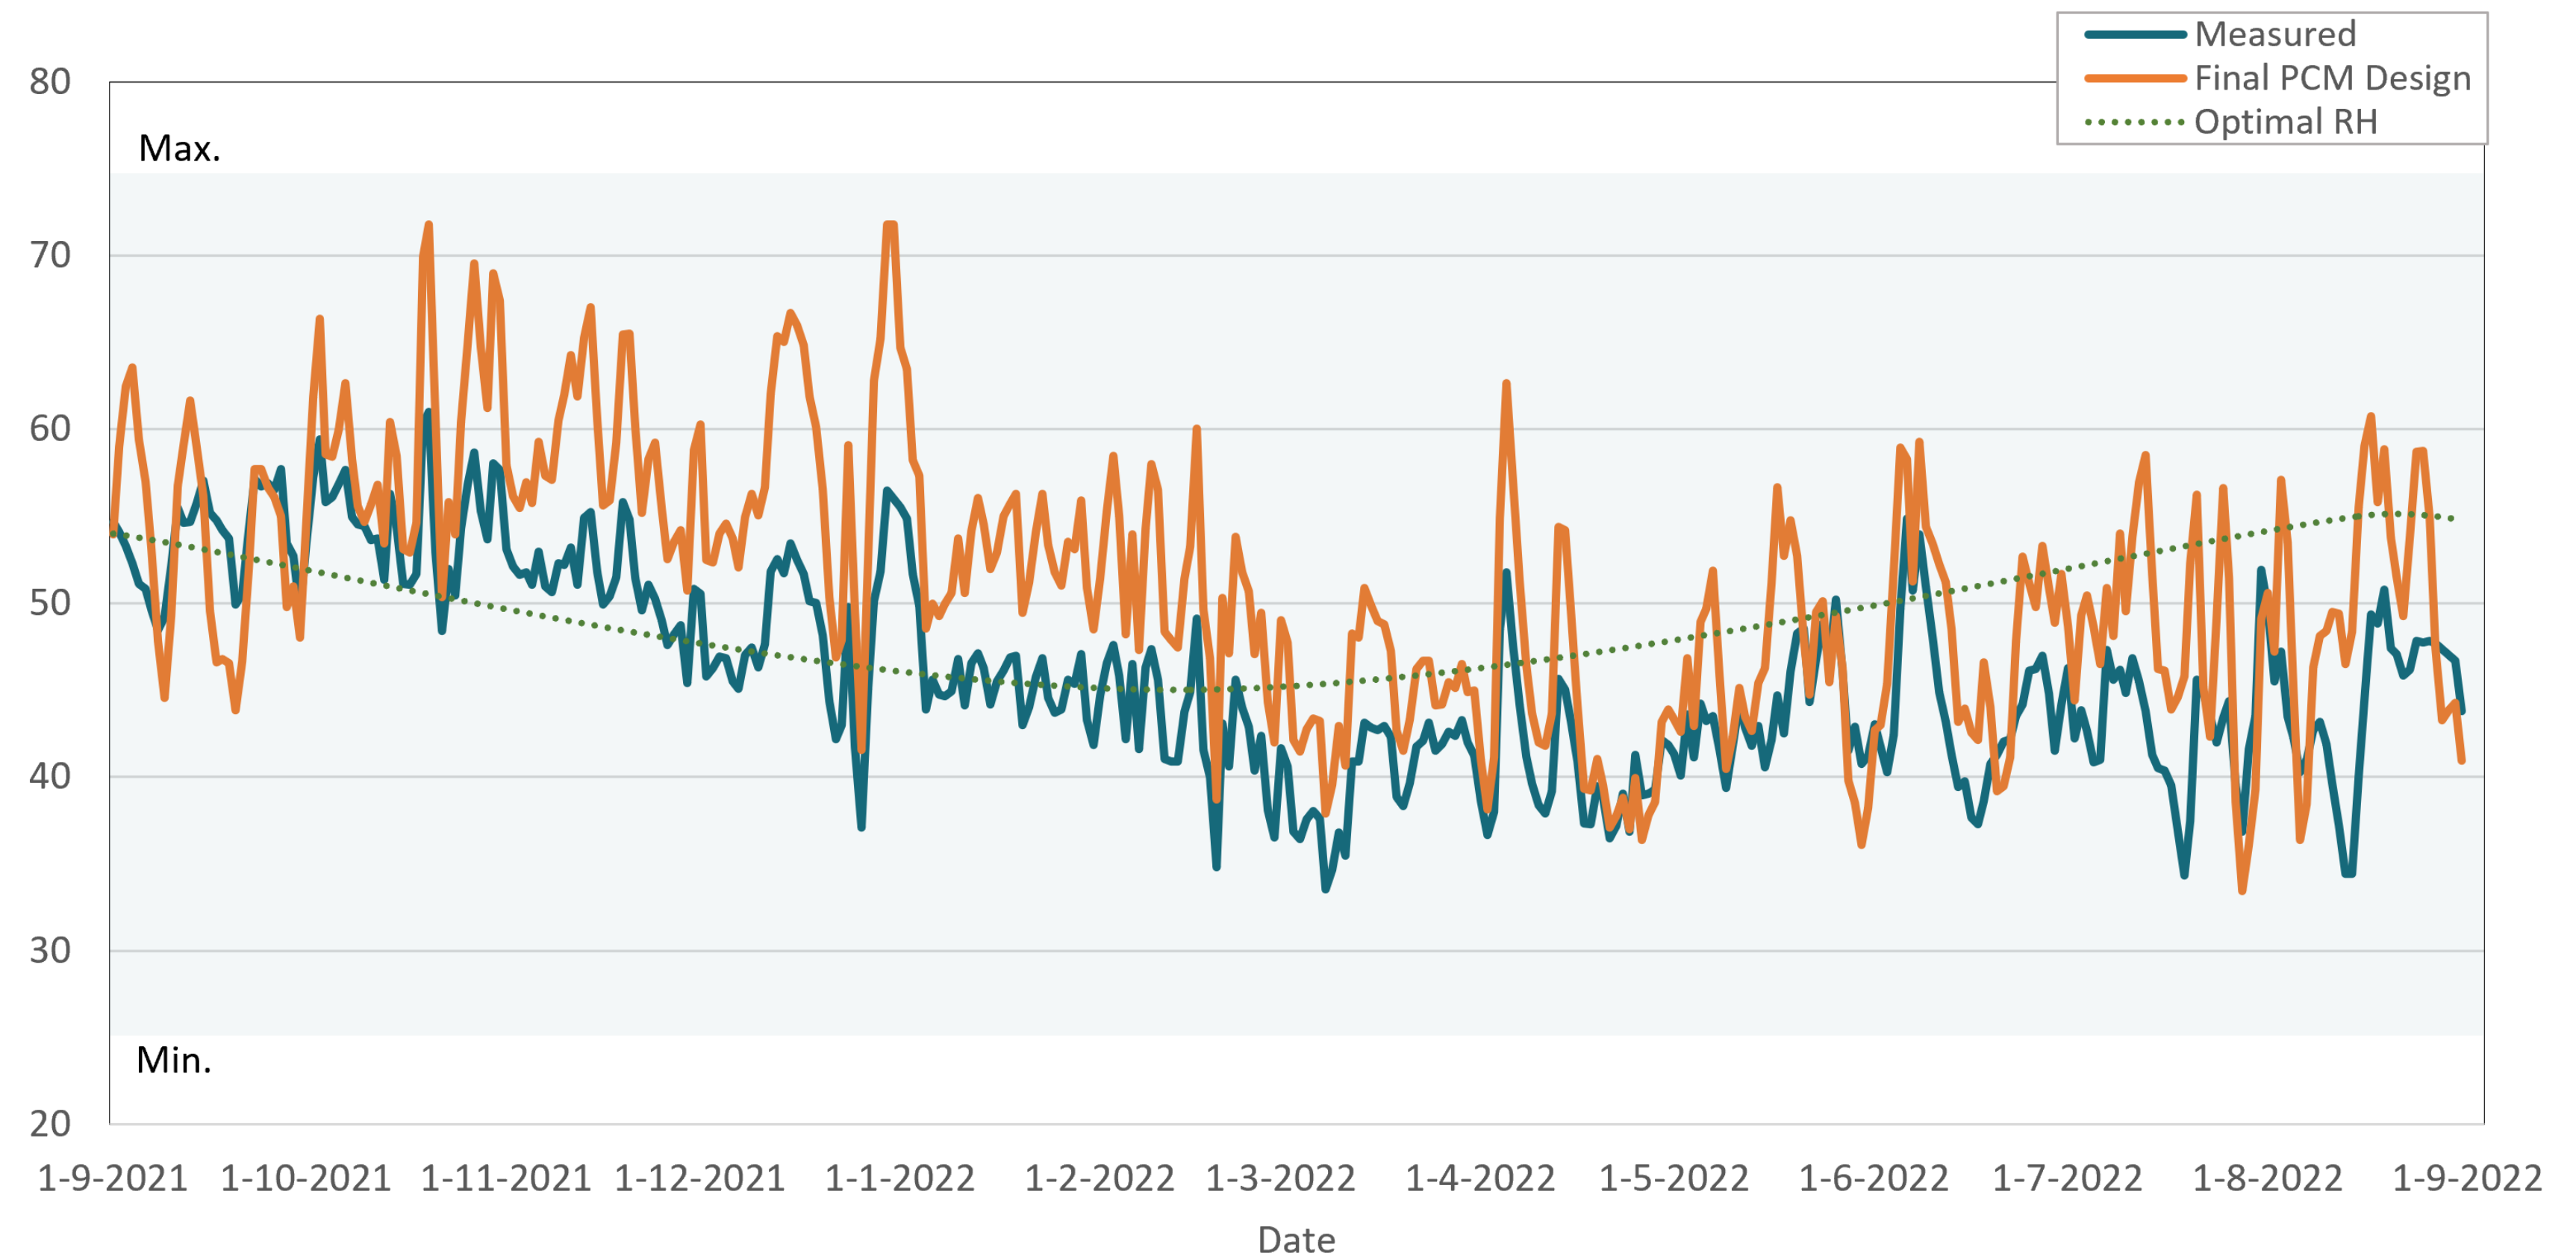
### Measured and estimated final PCM design relative humidity

Average behind the canvas between september '21-'22

- winter **dehumidification** advised

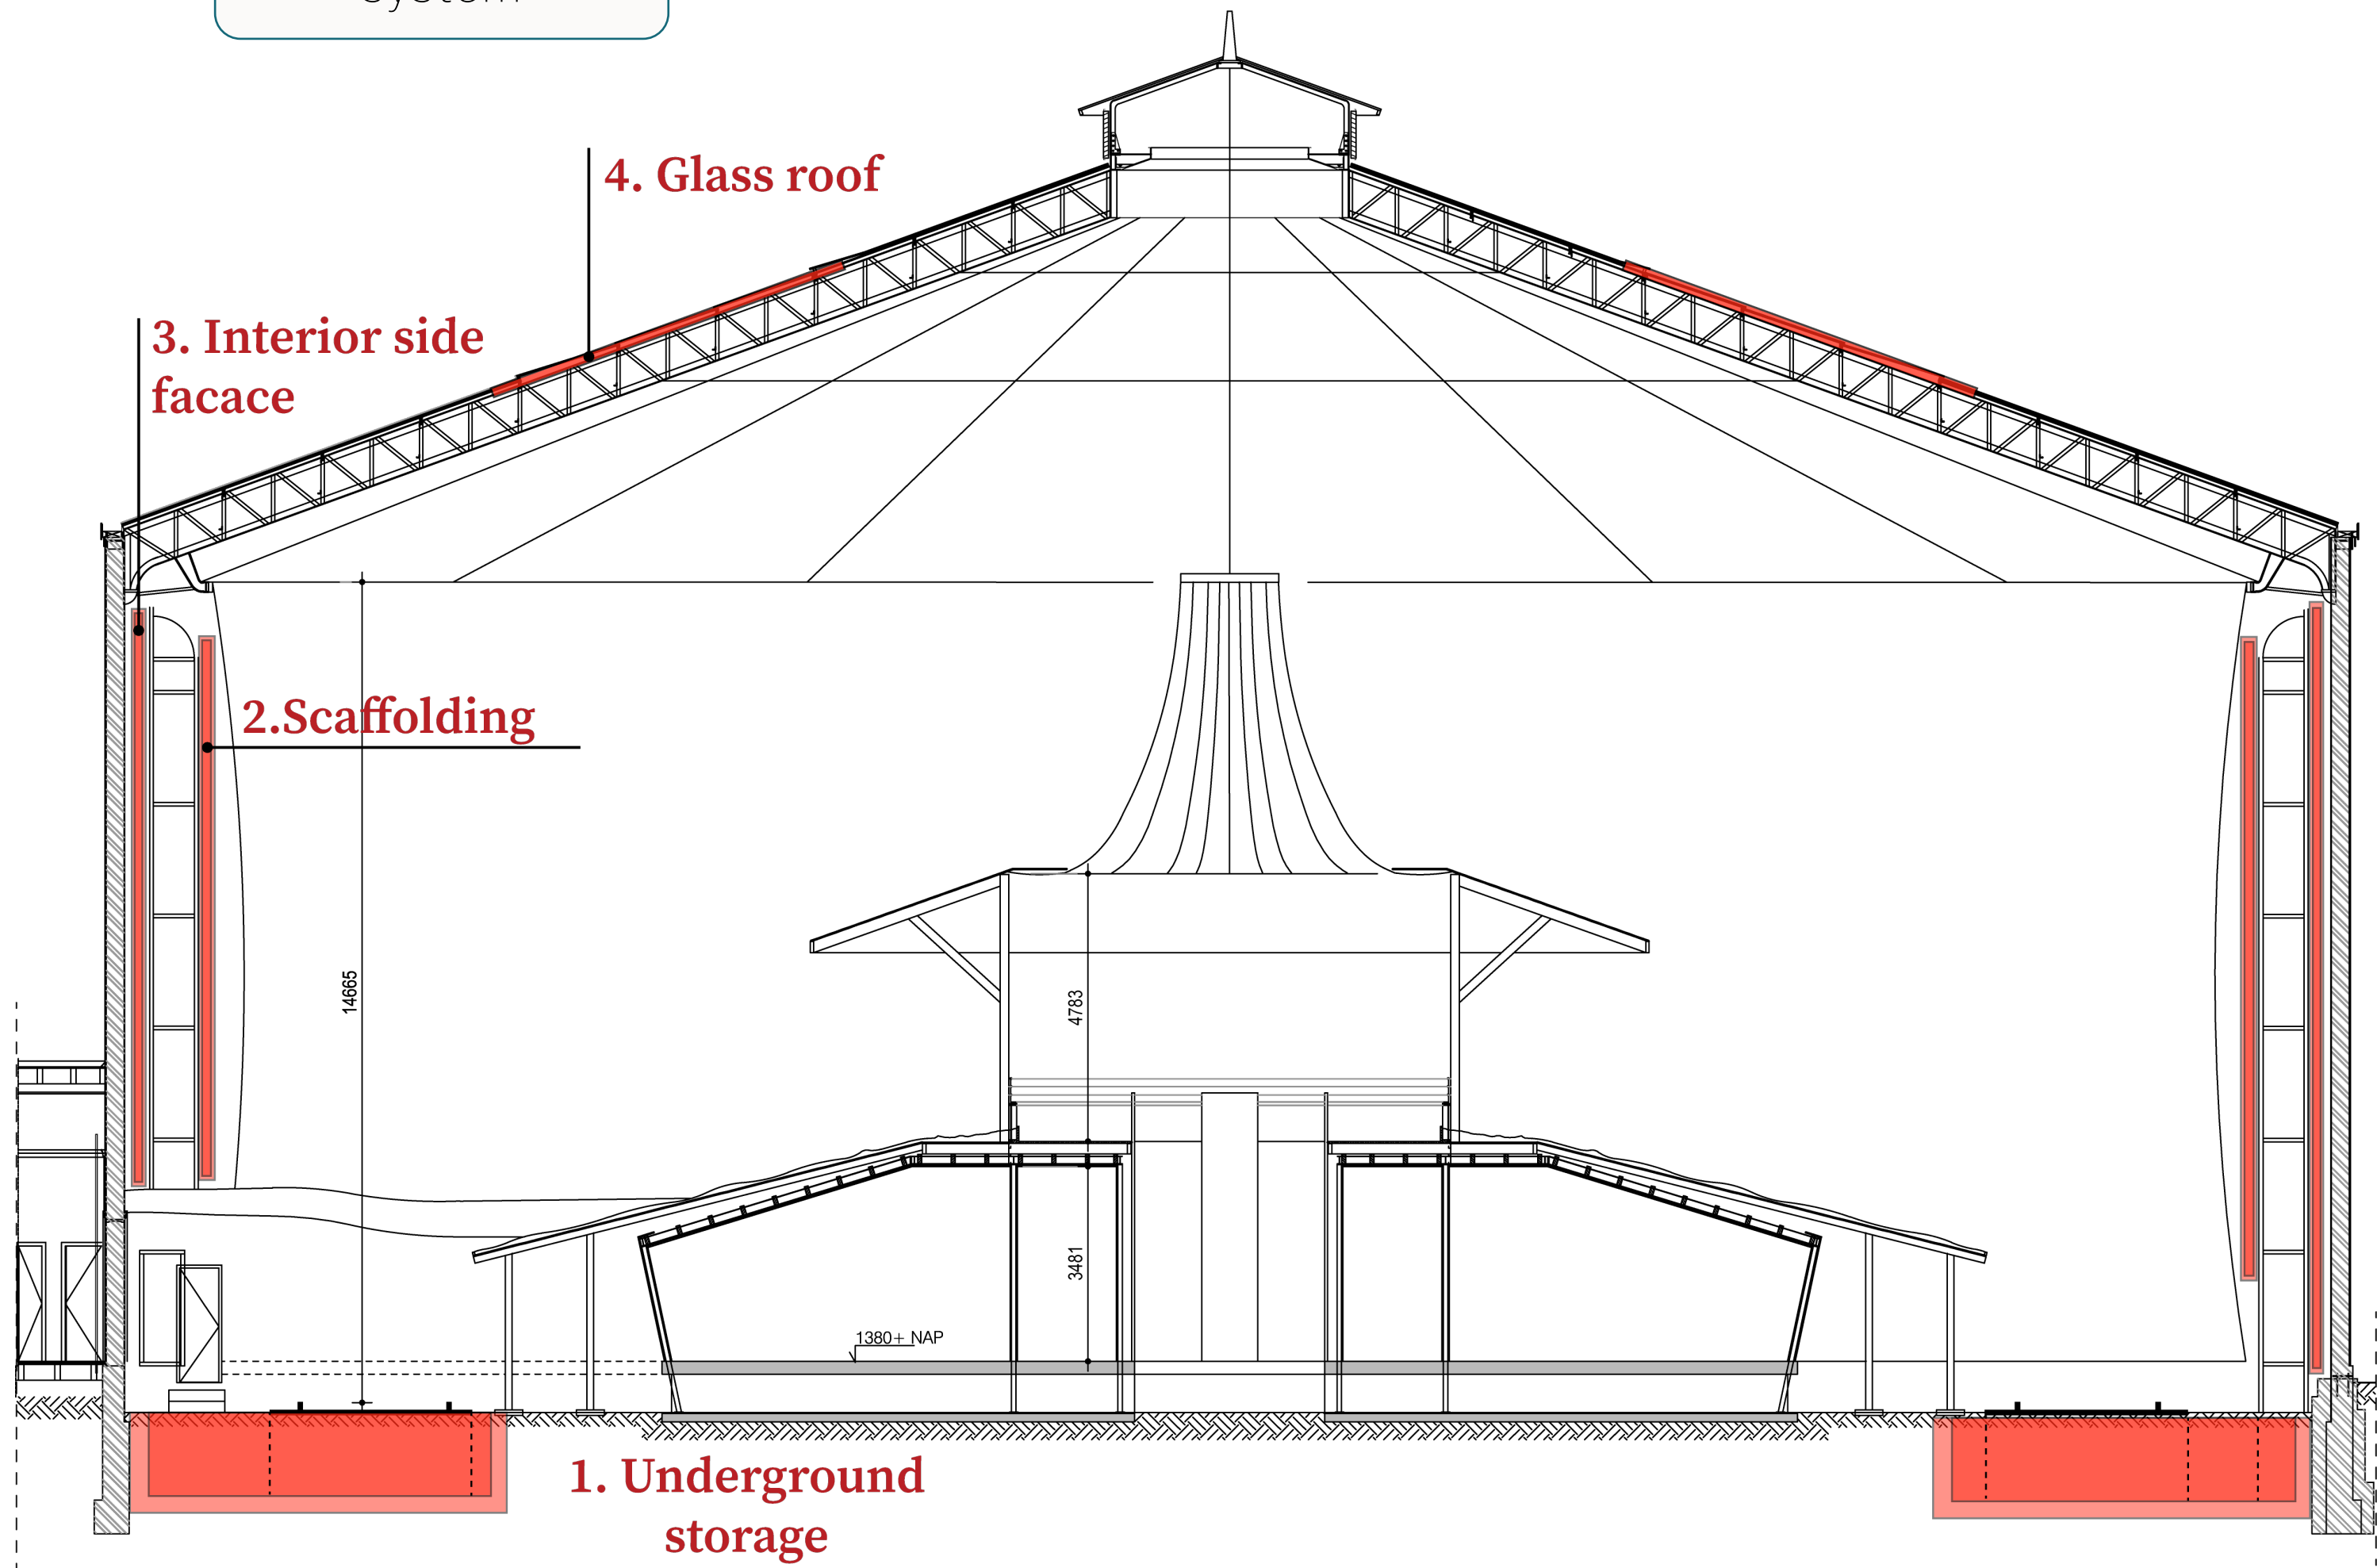
**PACKED-BED**

MEDIUM: PEBBLES (BRICK/  
ETC.)  
ACTIVE SYSTEM  
450 M2, 1M DEPTH

450 M3  
3,600 MJ

80-90% EFFICIENCY  
STORING FOR HOURS-DAYS  
5K temperature difference
