The effectiveness of thermal buffering systems in the monumental Panorama Mesdag museum

Elke Mulders  
4615212  
Building Technology  
Graduation

## The Panorama Mesdag Museum

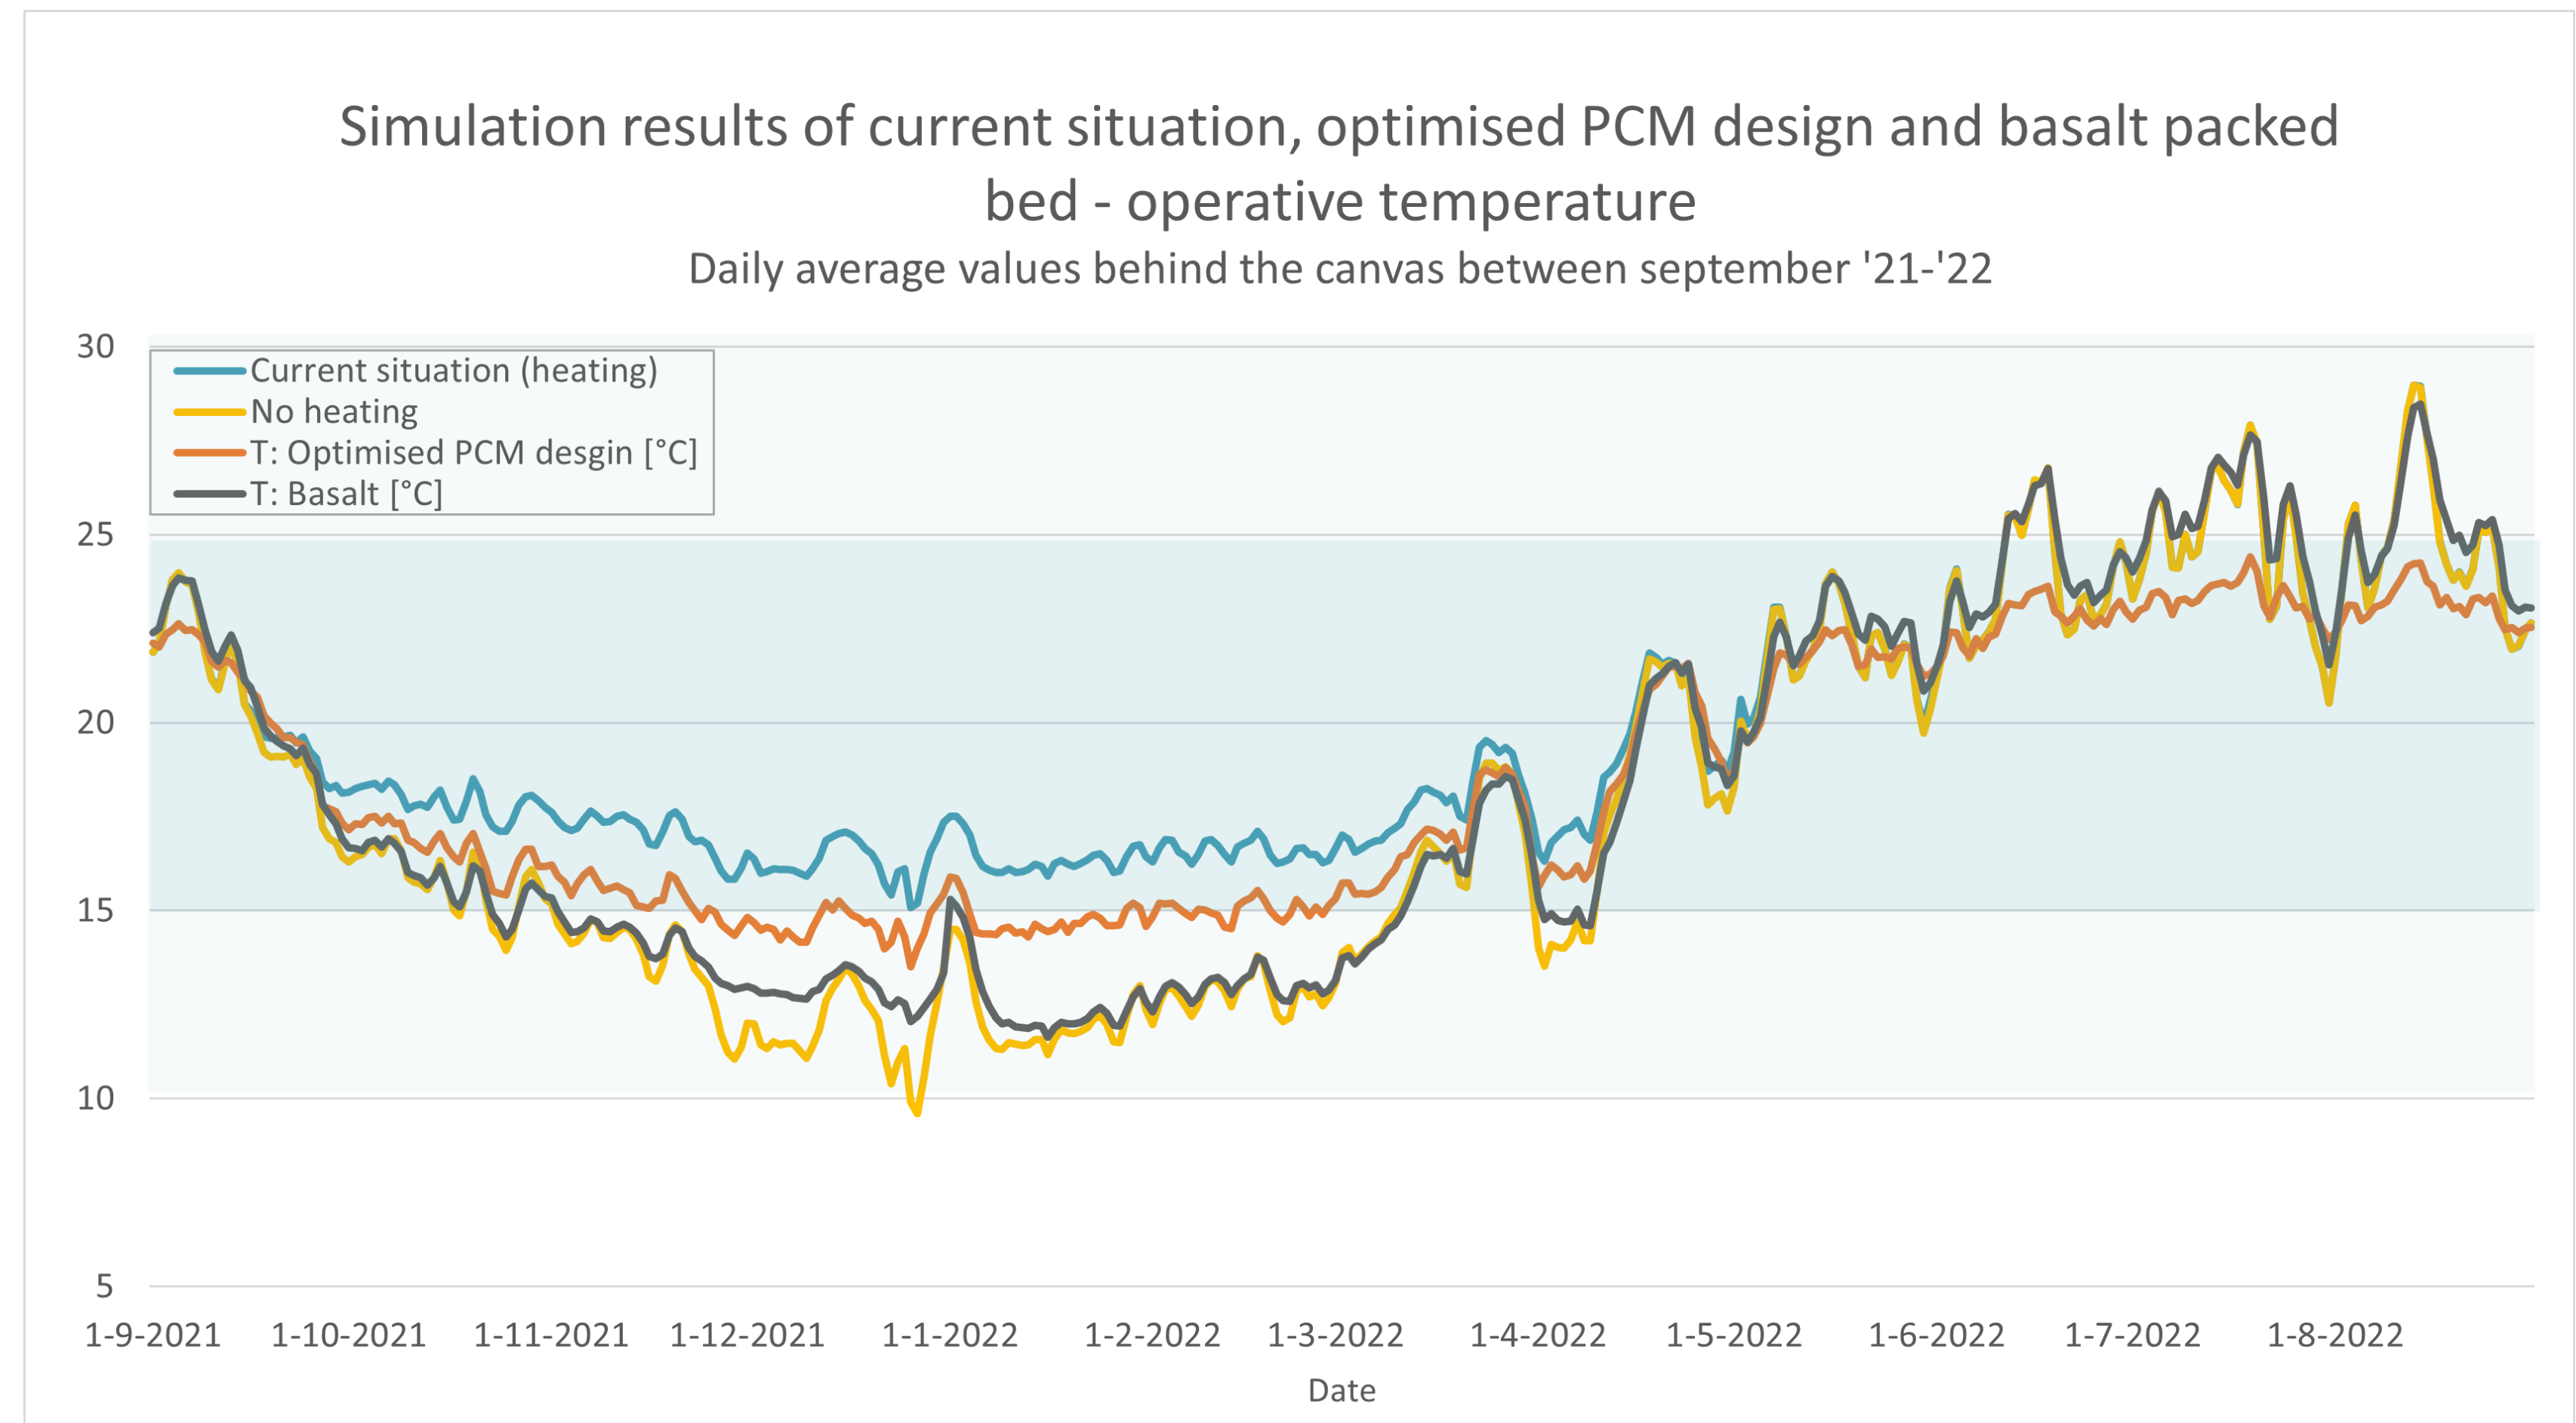
- minimal cooling
- minimal heating effect

- **Not advised** for implementation **by itself**
- Further research needed: **insulation & triple glazing**

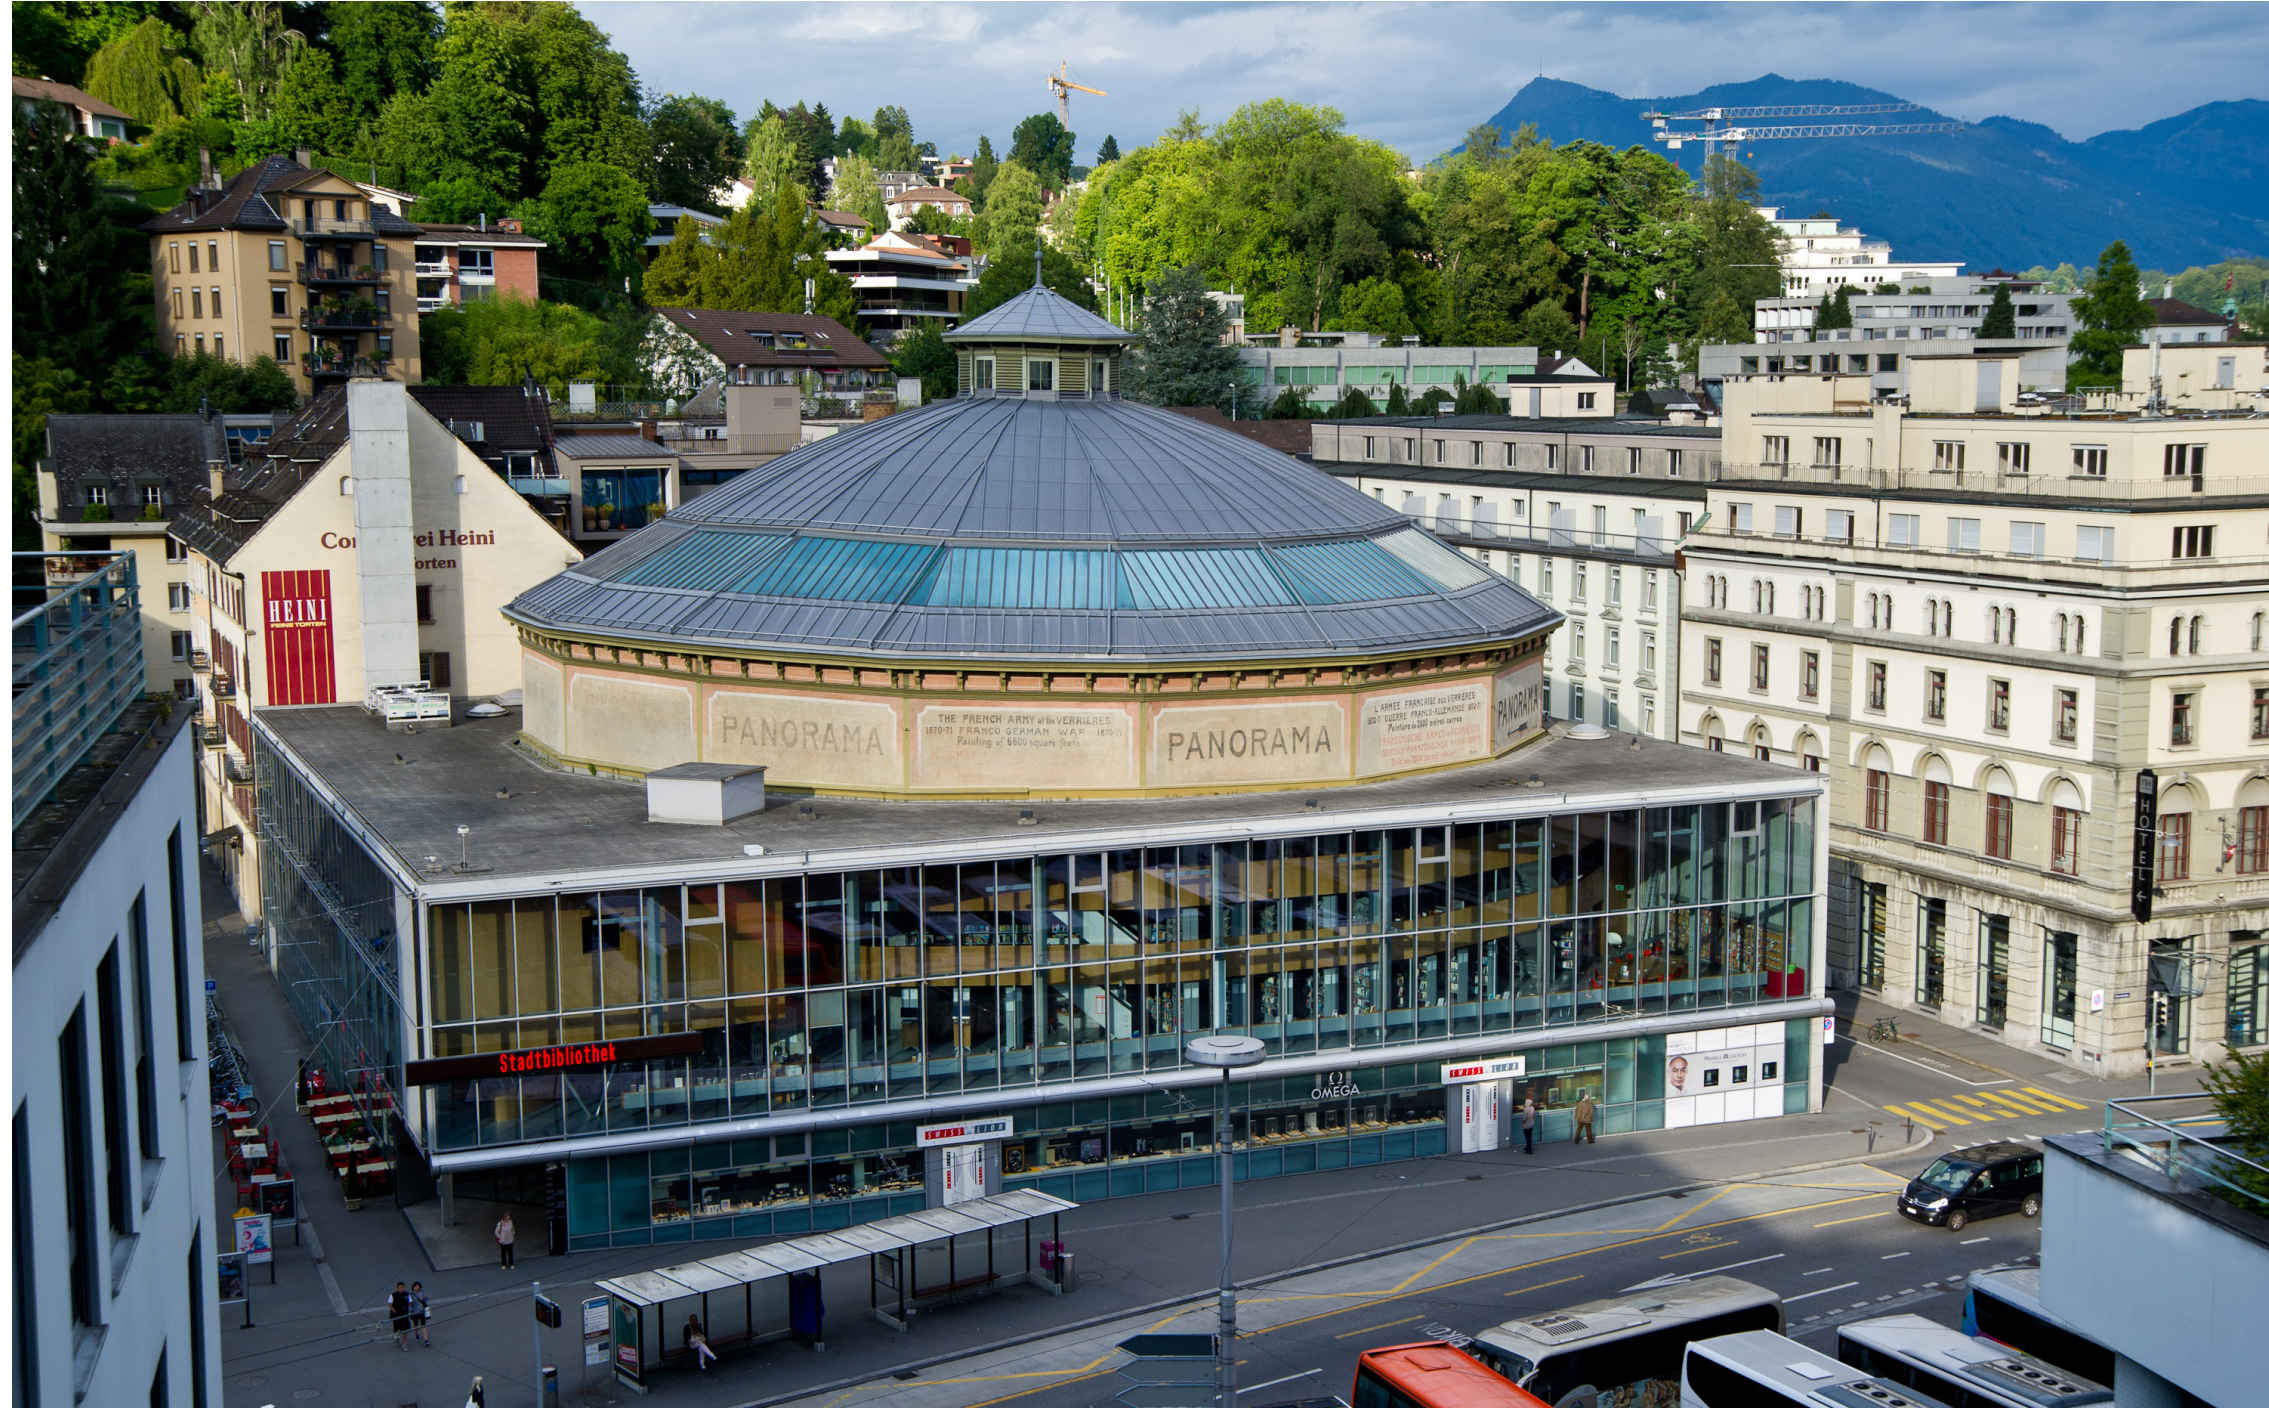
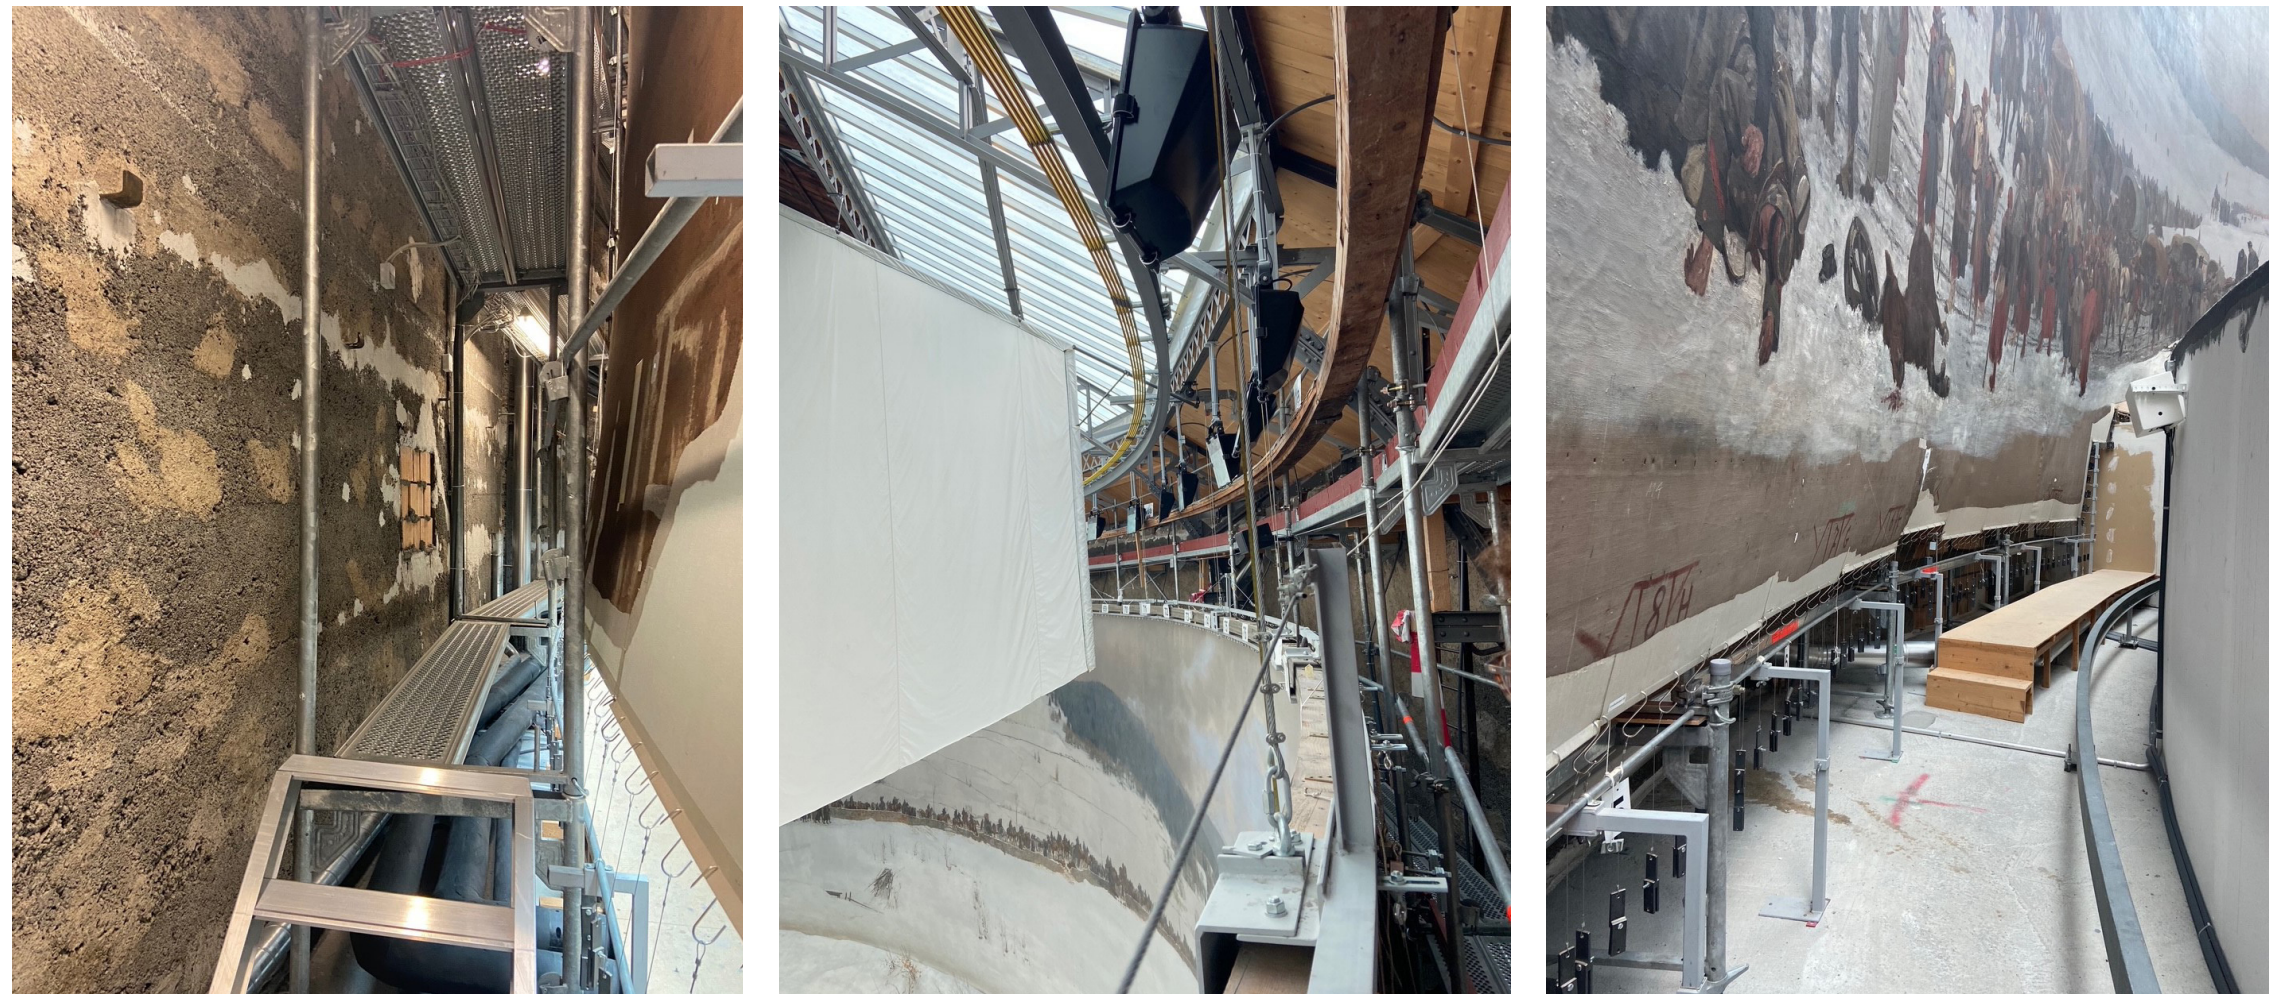
ORIGINAL FACADE

Original: steel H-columns and concrete walls

Original: steel truss structure and wooden panels

Renovated: single glazing with uv-protective layers in aluminium frames
