# BEACH RESPONSE TO THE PRESENCE OF A SEAWALL; COMPARISON OF FIELD OBSERVATIONS

James F. Tait, Gary B. Griggs

Department of Earth Sciences and Institute of Marine Sciences  
University of California  
Santa Cruz, California 95064

Final Report

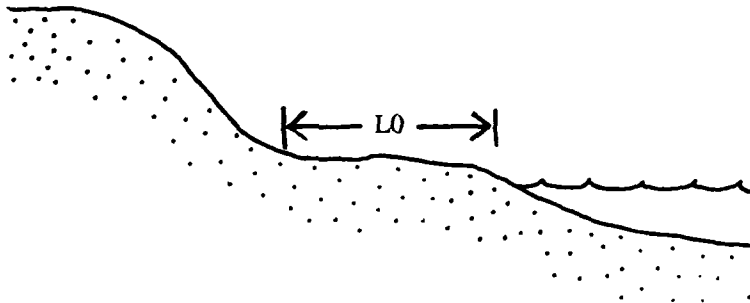
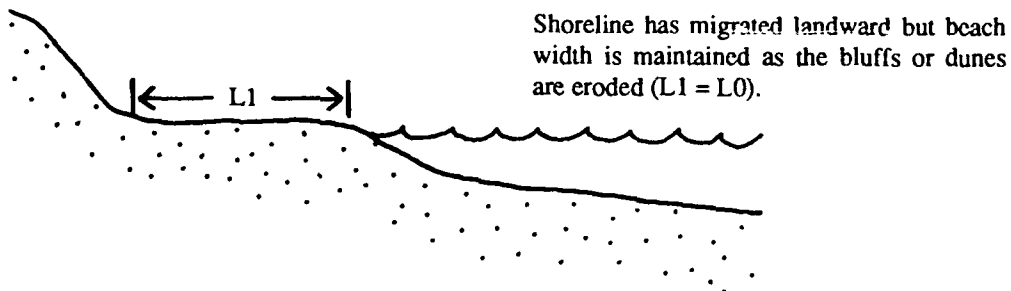
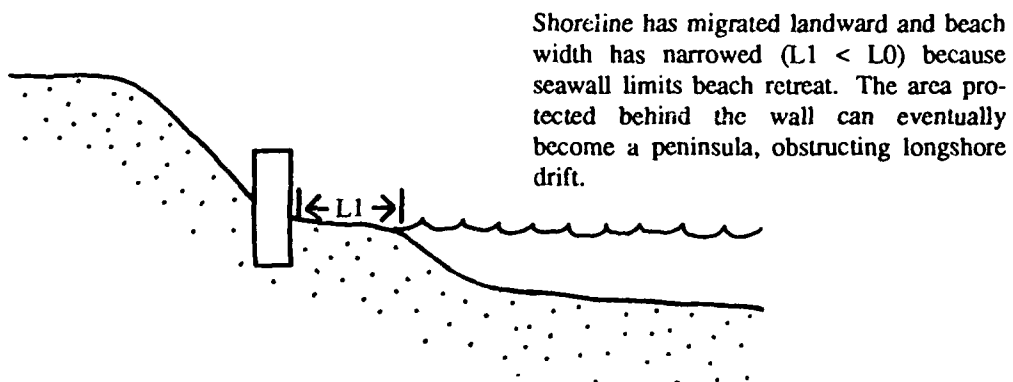
Figure 21. Long term effects of a seawall on a retreating shoreline

CASE I: ERODIBLE BLUFFS OR DUNES, SEDIMENT DEFICIENCY AND SEA LEVEL RISE, WALL AT BACK BEACH.

INITIAL SHORE PROFILE

SHORE PROFILE AFTER SHORELINE RETREAT

SHORE PROFILE AFTER SHORELINE RETREAT WITH SEAWALL

30. When a seawall is built on a shore which is experiencing long-term erosion, has large seasonal fluctuations in beach width, or is subject to severe storms, shoreline retreat may cause the wall to project into the surf zone to an extent sufficient to interrupt the longshore transport of sediment. In effect, it may begin to act as a groin. In the field studies literature, only Birkemeier (1980) and, to some extent, Griggs and Tait (1988) discuss this effect. Quantitative data on volumes trapped, longshore transport rates, original position on profile, shoreline variability, etc., are scarce.

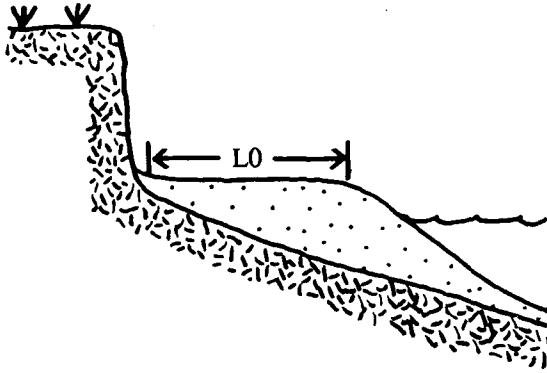
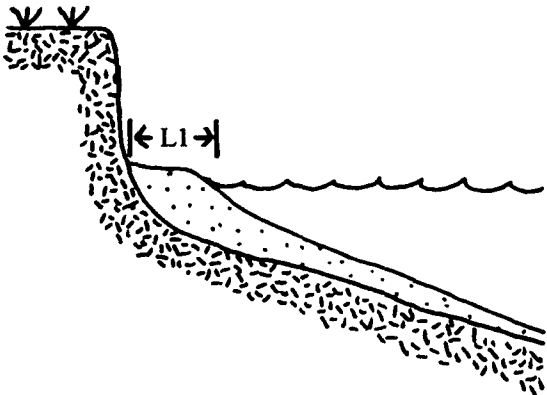
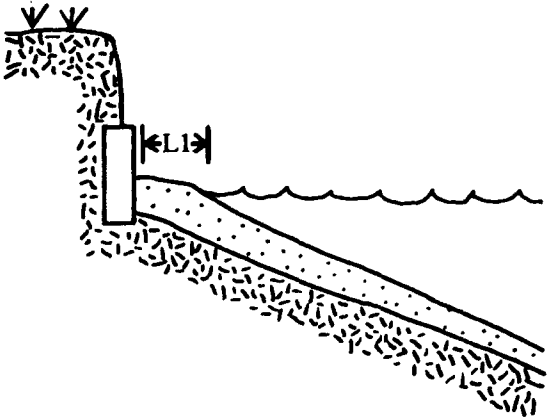
Figure 22. Long term effects of a seawall on a retreating shoreline

CASE II: RESISTANT SEACLIFF, SEDIMENT DEFICIENCY AND SEA LEVEL RISE, WALL AT BASE OF CLIFF.

Shoreline migrates landward and beach narrows because seacliff limits beach retreat ( $L_1 < L_0$ ).

Seawall has approximately the same effect on the beach as would the seacliff ( $L_1 < L_0$ ). If the wall is more resistant than the seacliff, the seawall could become a small headland over time. If the shoreline is stable or advancing, the wall has little effect.

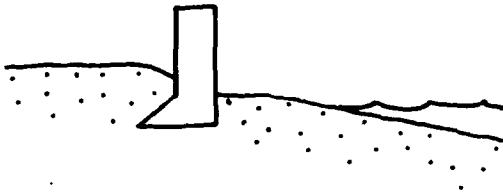
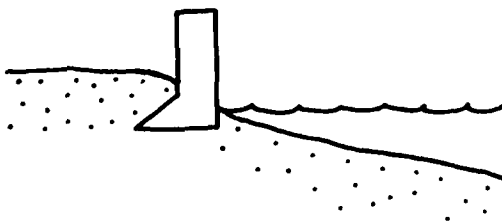
Figure 23. Long term effects of building a seawall well seaward on the beach profile

Seawall is placed well seaward on beach profile; a narrow summer berm exists. The beach in front of the wall is very sensitive to changes in sediment supply or sea level.

If there is net shoreline retreat, the area behind the wall may become a peninsula, obstructing longshore transport. Under seasonal changes, the wall may similarly lose the beach in front of it, project into the surf zone, impound littoral drift, promote down-coast erosion, and obstruct alongshore beach access (Griggs and Tait).

67. In their study which compared several seawalls, Griggs and Tait (1988) comment that the wall which projected furthest seaward was the first to lose the beach in front of it with the onset of winter waves, experienced the greatest scour or deflation, and was the last to recover during the summer months. It is interesting to note that a catwalk had to be built along the length of this wall because it is dangerous, if not impossible, to walk in front of it during winter wave conditions or during high tides.
