RILEM TC 277-LHS report

lime-based mortars for restoration—a review on long-term durability aspects and experience from practice

Groot, Caspar; Veiga, Rosario; Papayianni, Ioanna; Van Hees, Rob; Secco, Michele; Alvarez, José I.; Faria, Paulina; Stefanidou, Maria

Materials and Structures/Materiaux et Constructions

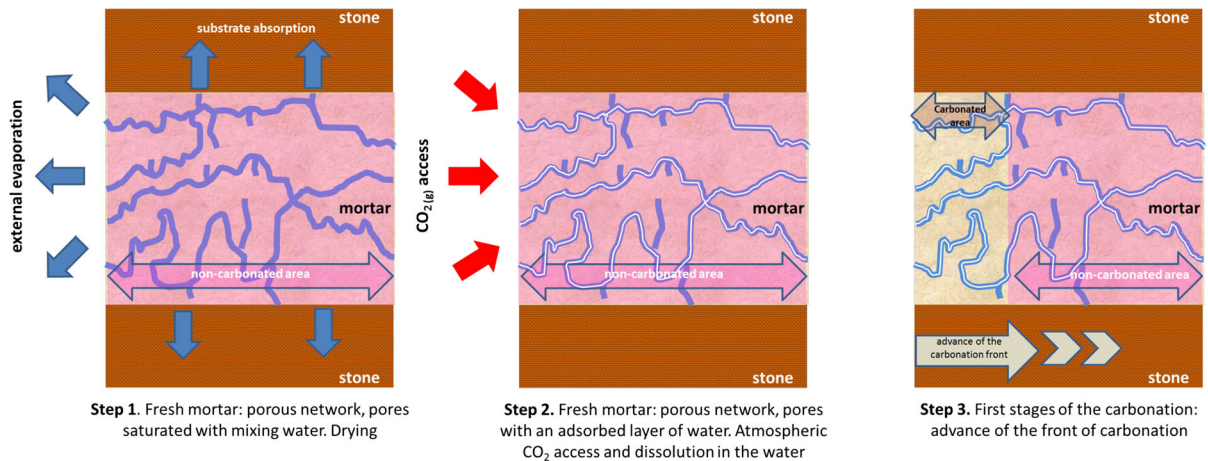
Fig. 1 Scheme of the carbonation process of an air lime bedding mortar of stone masonry. Step 1: drying; Step 2: CO_2 access and dissolution in the adsorbed layer of water; Step 3: carbonation front advance

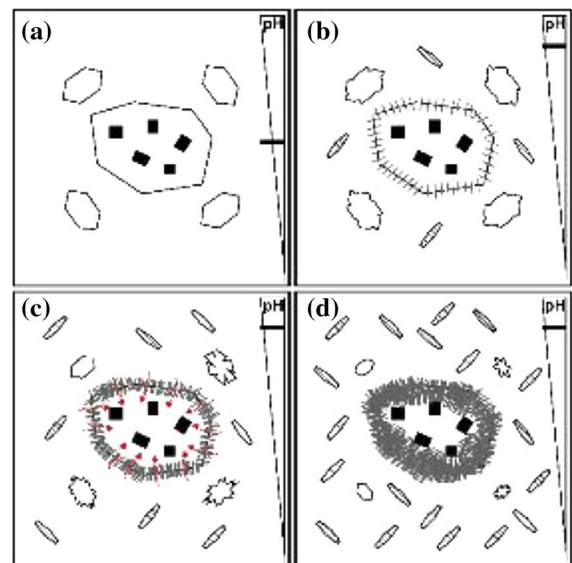
Fig. 2 Scheme of the pozzolanic reaction process: **a** Initial state (portlandite crystals depicted as hexagonal polygons, pozzolanic particle depicted as a large polygonal shape with non-reactive mineral constituents in black); **b** Initial dissolution period (C-S-H crystals depicted as grey lines, C-A-H crystals depicted as elongated textured polygons); **c** Induction period (red dashed arrows indicating water diffusion through osmosis); **d** Main reaction period

form hydrated reaction products (calcium silicate and calcium aluminate hydrates) with marked binding properties related to their crystalline structure [44]. Pozzolanic reaction processes can be subdivided into three reaction stages (Fig. 2) [45], namely initial

dissolution period, induction period and main reaction period.

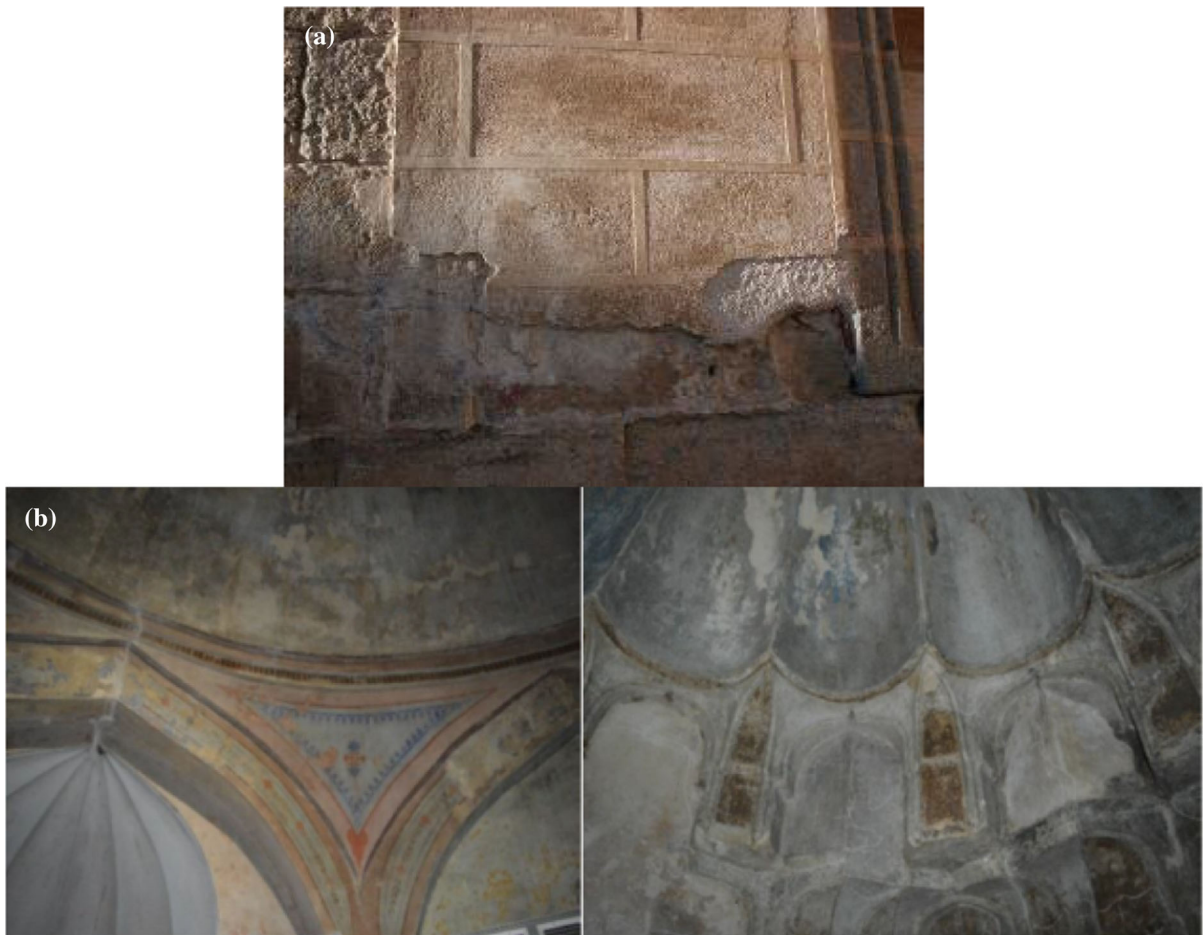
Fig. 3 **a** Durability of air lime render imitating stone over stone masonry in Évora Cathedral, in Portugal (seventeenth century); **b** Interior of Pasa Hamam, Thessaloniki (1530 AD), with well-

preserved air lime renders ($\text{CaO} \geq 55\%$) although soluble salt content was high $\geq 1\%$

Many ancient constructions, all over the world, are composed of masonry with air lime mortars, thus proving the high durability and fitness for use of this material [74–79]. Due to their low modulus of elasticity, air lime mortars can follow the movements of the structures with minor cracking, also ensuring optimal adhesion. Furthermore, the high porosity and water vapour permeability of the mortars allow quick drying of walls, with evaporation of internal moisture to the exterior, thus contributing to a healthy internal environment and to the good condition of the walls. The slow hardening mechanism by carbonation ensures an improvement of performance along time and contributes, together with the self-healing properties, related with dissolution–recrystallization cycles of calcium carbonate, to a high durability, if destructive actions (by nature or by human activity) do not occur (Fig. 3).

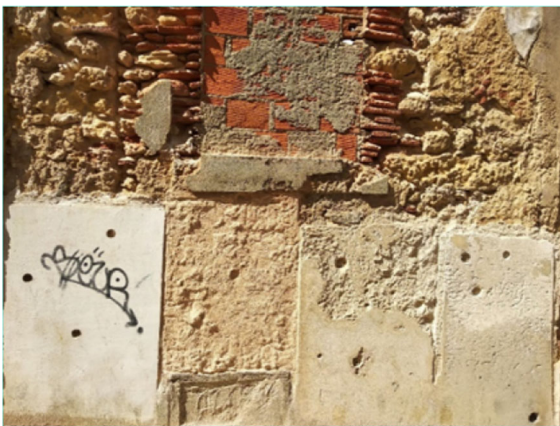
Fig. 5 Experimental panels applied on an ancient wall in the Historic Centre of Palmela (Portugal), 12 years after application: second from the left is air lime + MK and third from the left is has air lime as the only binder

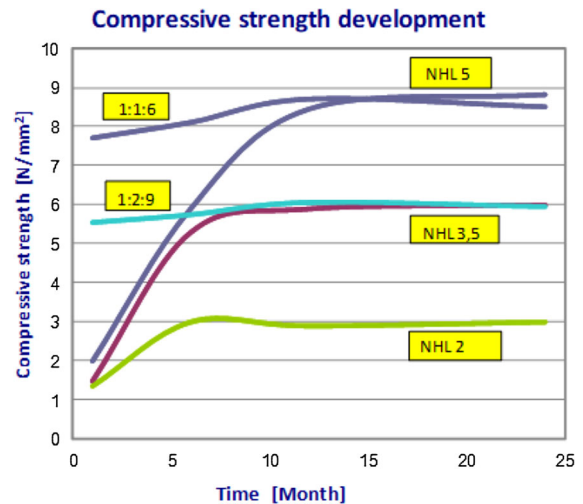
Fig. 6 Slow strength development for the NHL mortars and quick hardening of the cement-lime mortars: NHL mortars, 1:2.5 (NHL: sand) in vol.; cement-lime mortars e.g. 1:1:6 (cement: lime: sand), in vol.; curing conditions 20 °C and RH 90% [99]

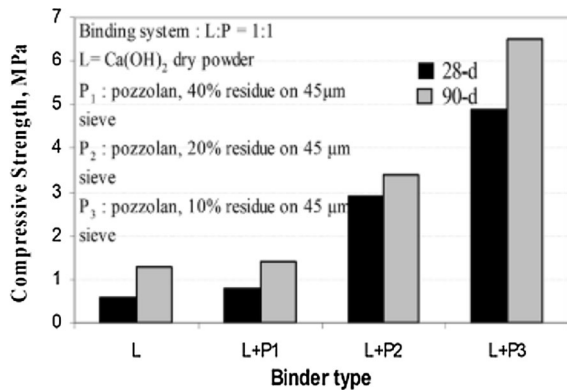
Fig. 7 Influence of fineness of pozzolan (after grinding) on mortar's strength development

tested by preparing mortar mixtures with lime and siliceous sand 0–4 mm (L:P 1:1, B/A 1:3 by mass). The water added responded to a flow of 15 cm (according to EN 1015-3). Curing conditions were the following: moist curing > 90% RH for P1, P2, P3 mortars and dry curing 60–65%RH for L mortar [100].

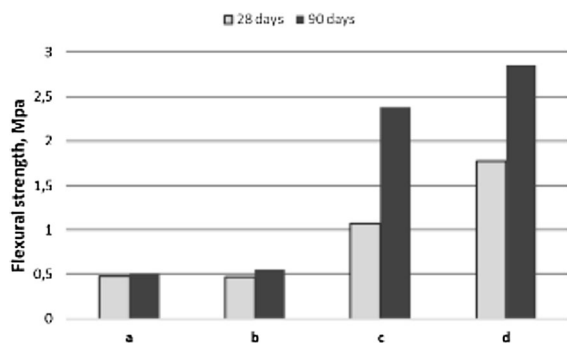
Fig. 8 Effect of curing regime on flexural strength development of lime:pozzolan (1:1) mortars. a: natural curing; b: based on EN 459–2, 2015 “Building lime”, concerning standard mortar; c: concerning hydraulic lime; d: based on ASTM C 311, strength activity index with lime

Furthermore, as previously mentioned, moist curing conditions are essential for pozzolanic reaction, as showed in Fig. 8. Volcanic natural pozzolan (after grinding to 10% residue on 45 μm sieve) was used with lime powder (CL90) for the manufacture of the mortar, together with a standard CEN sand (B/A ratio 1:3 by mass). The water content was adjusted to have 14.5 cm flow (measured according to EN 1015-3).

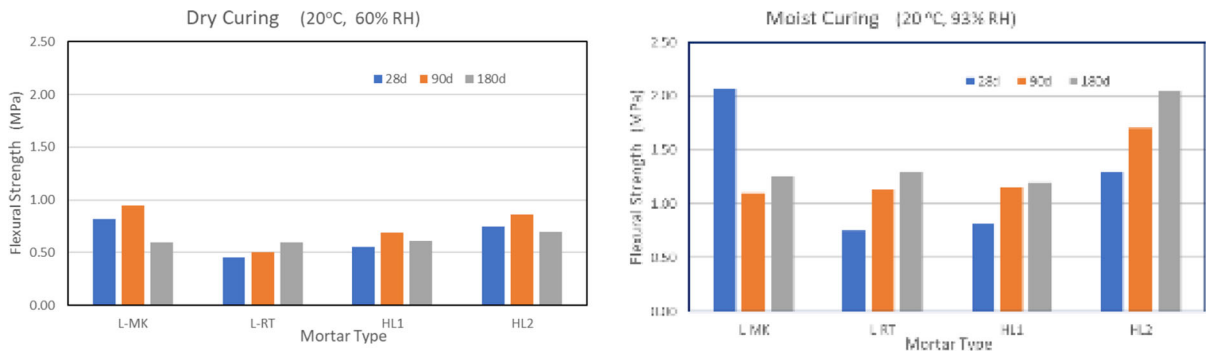
Fig. 9 Flexural strengths values for Lime-Metakaolin (L-MK), Lime-Rhenish trass (L-RT), and two types of Natural Hydraulic Lime (HL1 and HL2) mortars, for 2 curing conditions: dry curing and moist curing (adapted from [58])

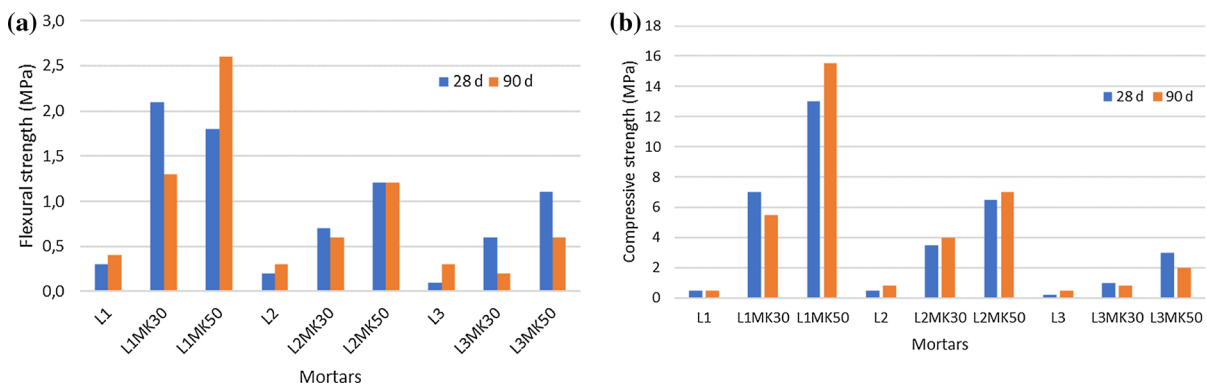
Fig. 10 Flexural a) and compressive b) strengths of air lime-metakaolin mortars with ratio b/a 1:1, 1:2 and 1:3 (wt) and ratio MK/L 0, 0.3 and 0.5 (adapted from [68])

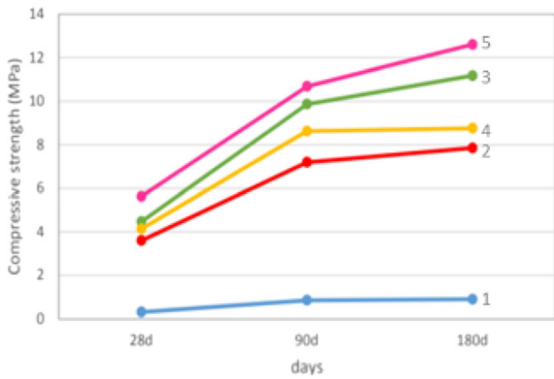
Fig. 11 Long term strength of lime-based mortars with: 1 lime powder CL90, 2 lime:natural ground pozzolan (1:1), 3 lime:natural ground pozzolan (1:1) (with coarse aggregates), 4 NHL 3.5, 5 lime:pozzolan:cement (1:0.7:0.3)

The long-term strength and porosity of lime-pozzolan repair mortars with different binder/aggregate ratio (R1 1:1, R3 1:3) has been studied by testing mechanical characteristics at 3, 12, 24 and 60 months [103]. The results were compared with pure lime (CL 90)

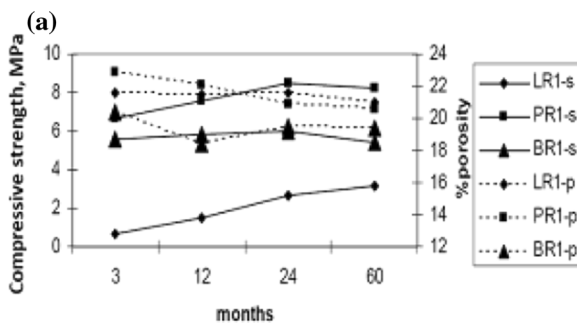
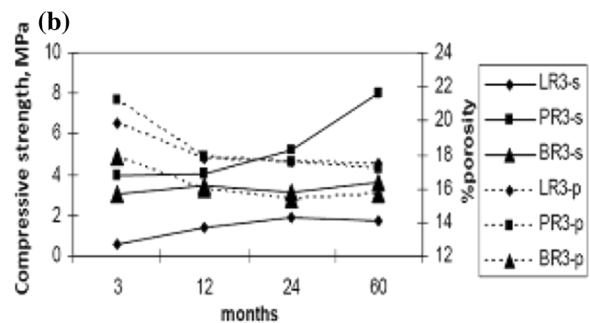
Fig. 12 **a** Evolution of compressive strength (-s) and porosity (-p) in mortars of binder/aggregate ratio 1/1(R1); **b** Evolution of compressive strength (-s) and porosity (-p) in mortars of binder/

aggregate ratio 1/3(R3). L: Hydrated lime CL90, P: Lime-natural ground pozzolan (1:1) (by mass), B: Lime:pozzolan:brick dust (1:0.5:0.5)

mortars of comparable ratio. Indicative results of compressive strength are reported in Fig. 12. It seems that strength evolution is in general stabilized at the age of 12 months. The slight differences in strength with age (up or down) are related rather with microcracking due to drying shrinkage of specimens.

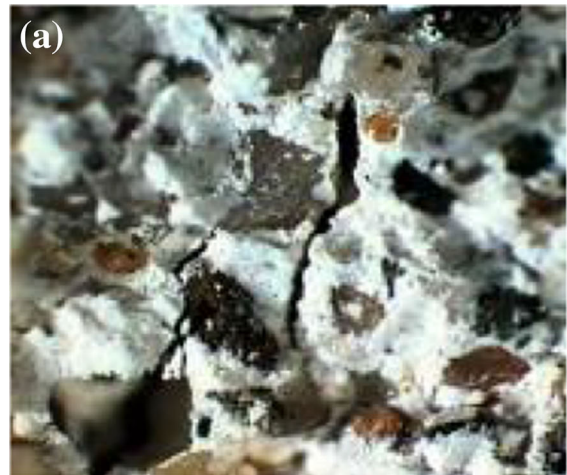
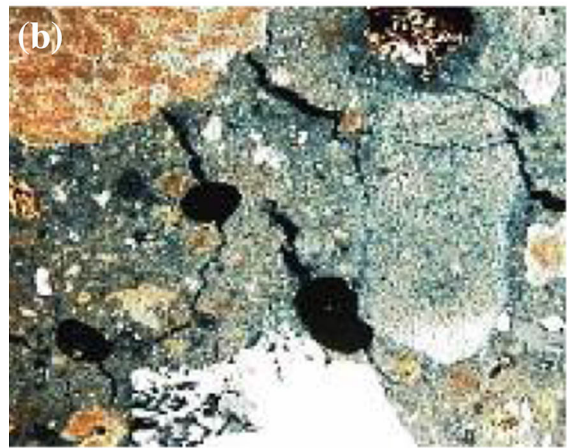
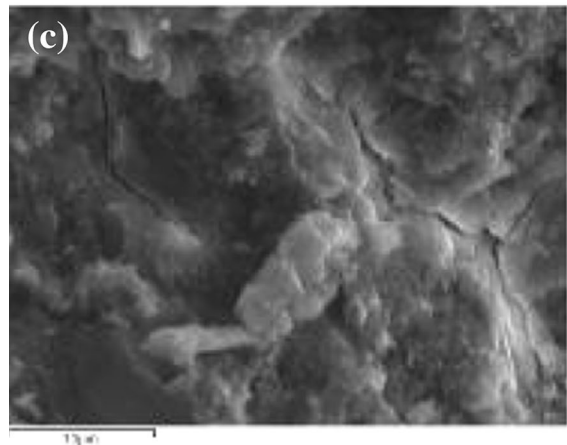
Fig. 15 **a** Shrinkage in a lime mortar (stereoscope $\times 8$); **b** Mortar cracking under polarized microscope ($\times 150$); **c** Mortar cracking under SEM ($\times 1000$)

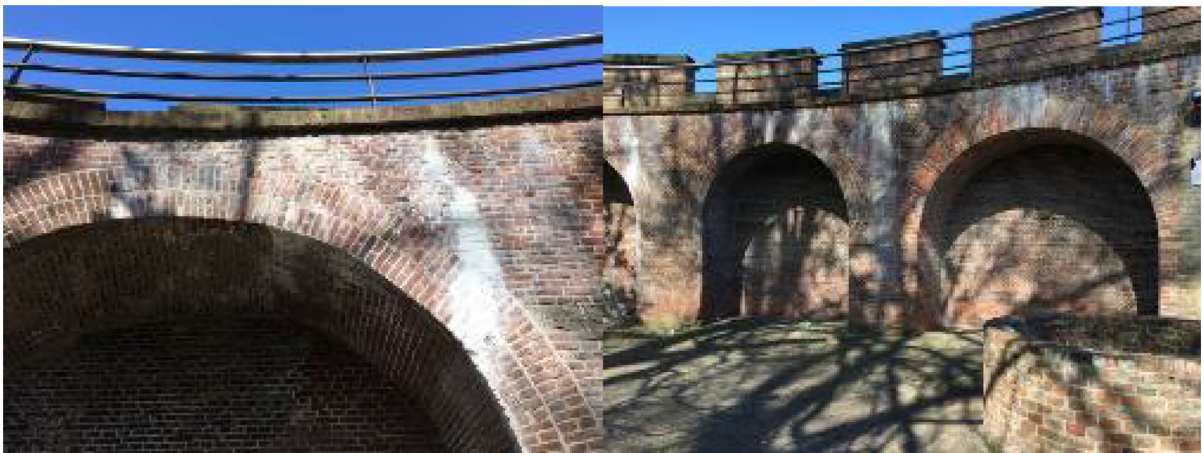
Fig. 16 Lime leaching after repair of historic masonry; see also 4.7

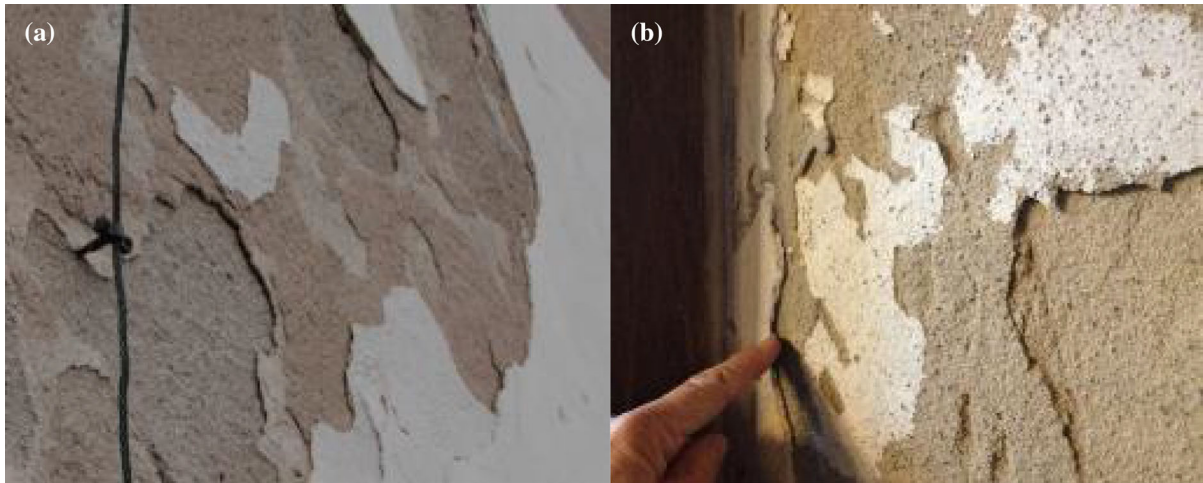
Fig. 17 Typical forms of layering in renders and plasters. Separate render layers coming off due to freezing temperatures in a saturated and porous render (a), [110]; similar damage, due to salt crystallization in a plaster, applied on a wall with capillary rising damp (b)

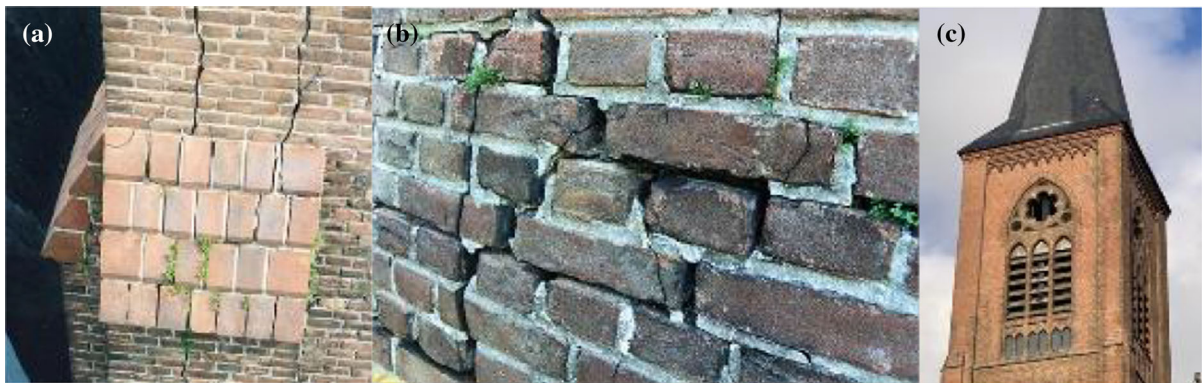
Fig. 19 Cracks in masonry, caused by expansion of bedding mortar, deeper in the wall section, due to formation of thaumasite (a); push out of the pointing is a secondary effect (b); situation several years after repair: no recurrence (c)

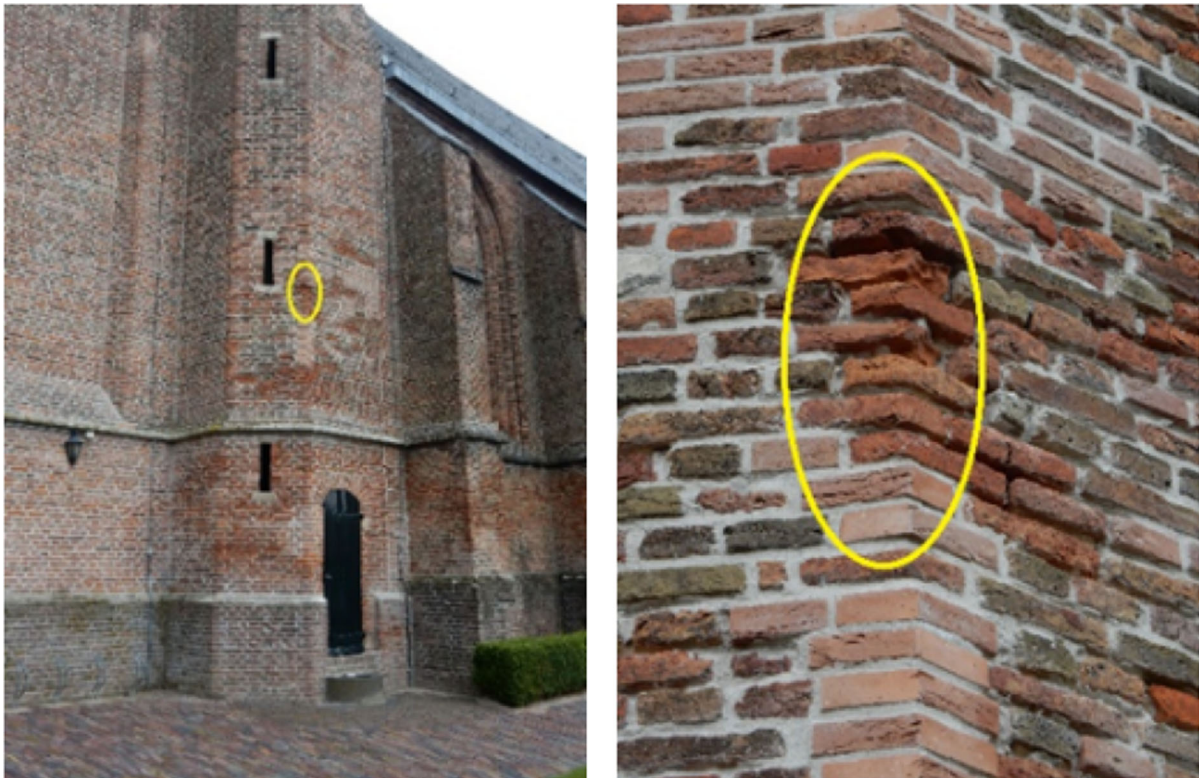
Fig. 21 Situation of the damage in 2016. Left, the reddish parts of the masonry indicate where the repointing is damaged. Right, detail of one of the spots with damaged repointing

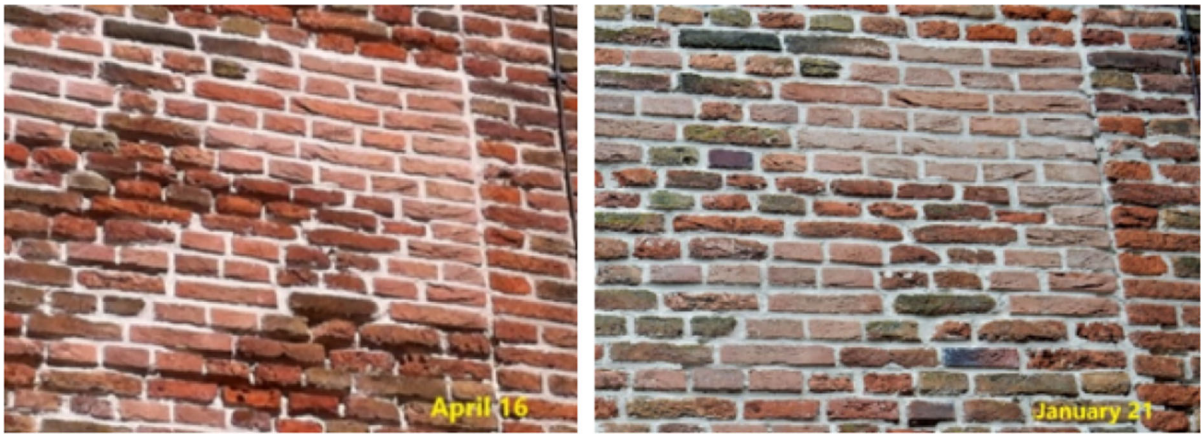
Fig. 22 Comparison of part of the south wall in April 2016 (before repair), respectively January 2021. Most of the underfired bricks are still in place (some of the weakest were replaced). The repair repointing performs rather satisfactorily

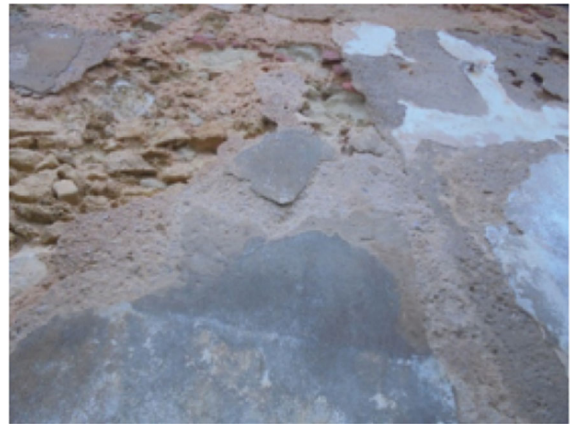
Fig. 24 Detail of the degradation showing cementitious repair mortars

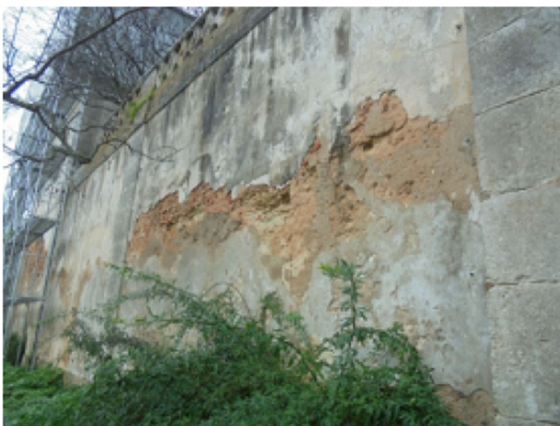
Fig. 23 Degradation on the East façade

The main types of degradation observed on the most degraded façade consist of crumbling and loss of adhesion of the render, in a zone of the wall in between 1.40 and 1.80 m from the soil.

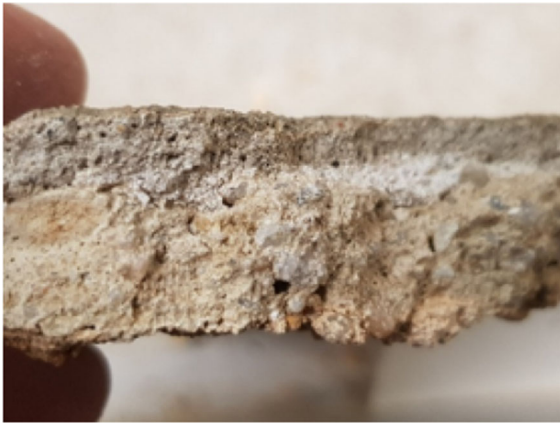
Fig. 26 Sample of the render of the East façade with a cementitious repair coat

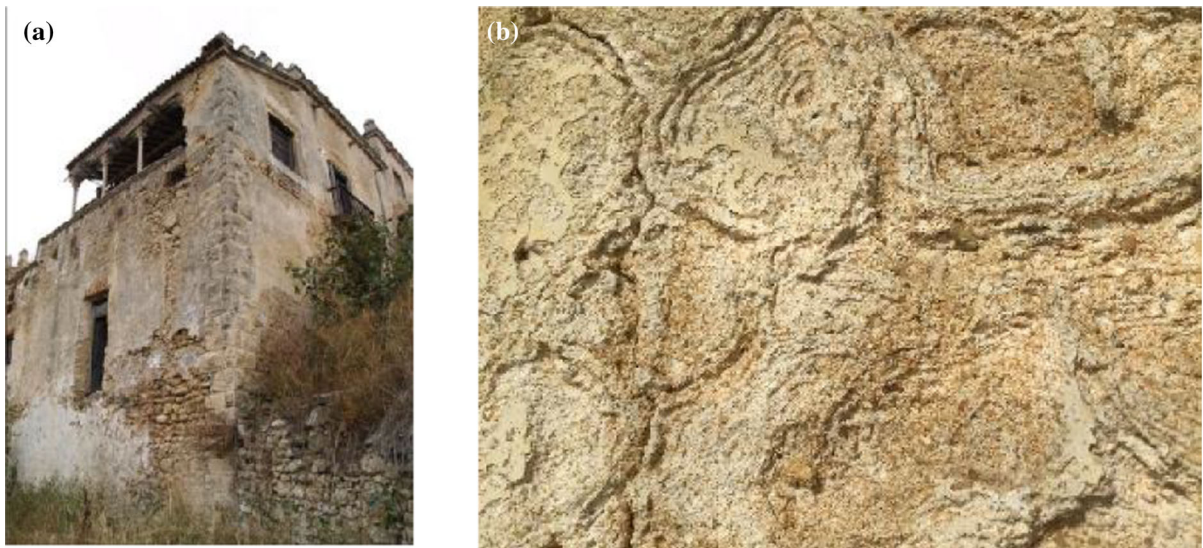
Fig. 27 Valflores Palace in St. Iria da Azoia, Loures, Portugal (a), and Liesegang phenomenon in a rendered façade (b)

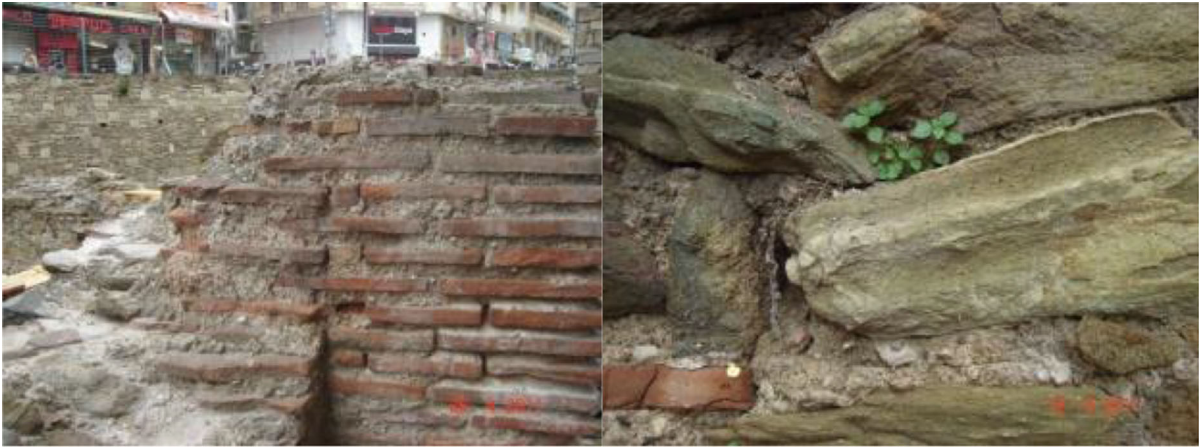
Fig. 29 Deterioration problems of the masonries before the intervention works

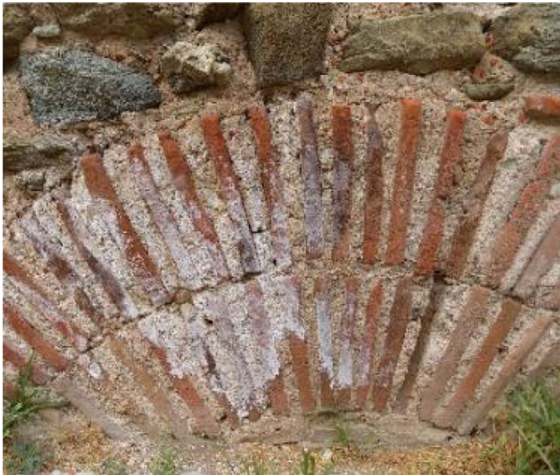
Fig. 31 Efflorescence near to the ground level

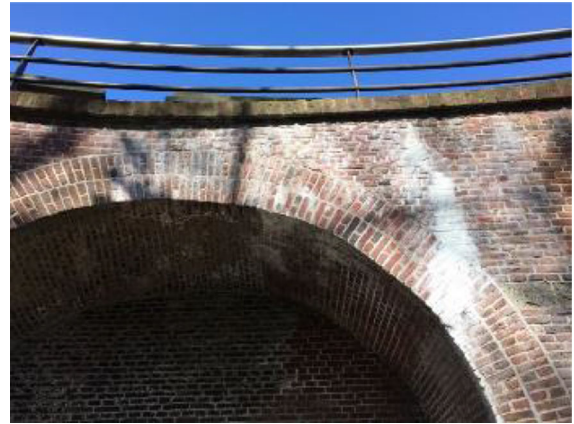
Fig. 33 Arch section in the masonry of the motte castle of Leiden, after reconstruction of the section

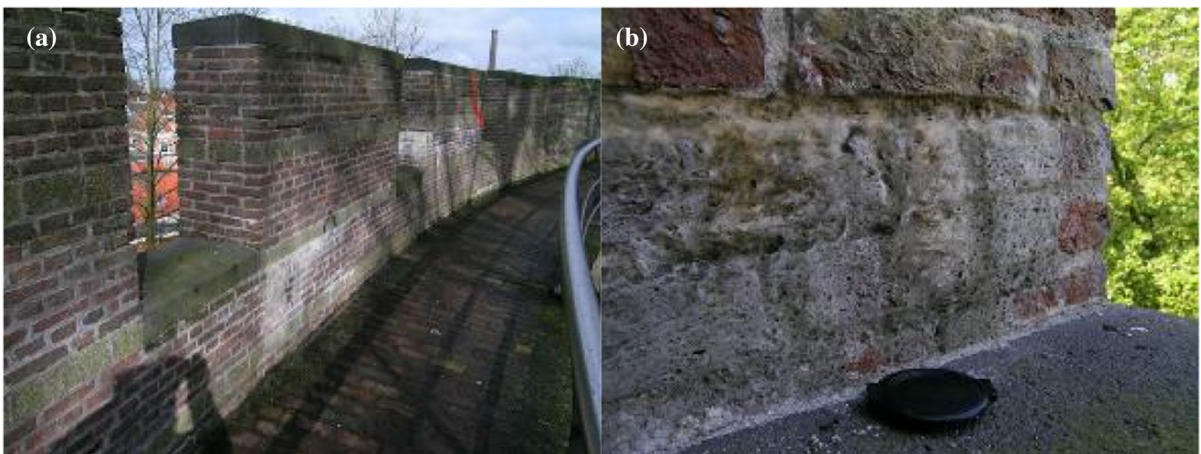
Fig. 32 a) Encrustation, due to leaching of mortar in very exposed masonry, the battlements of a motte castle; b) Detail

Leaching of lime is a phenomenon that may cause considerable esthetical damage to repaired sections in historic masonry. The example described, shows that it is not always easy to avoid this problem.
