## Analysing Damage from Quasi-static and Dynamic Ground Movements on Dutch Masonry Buildings via Numerical Models

Korswagen, Paul A.; Longo, Michele; Prospero, Alfonso; Rots, Jan

**15<sup>th</sup> Canadian Masonry Symposium**  
**Ottawa, Canada**  
**June 2-5, 2025**

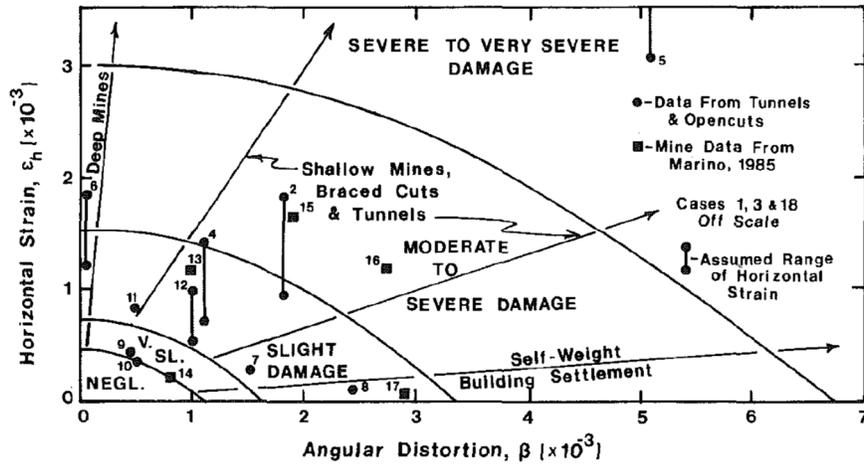
Figure 1: Diagram from Boscardin and Cording [1] with damage predictions at combinations of horizontal strain and angular distortion.

By separating the ground deformation and structure interaction phases, this approach allows for efficient exploration of different scenarios. Additionally, the two-step method aligns with geotechnical engineering practices, where greenfield deformations are often used as inputs for structural damage models. In this manner, a relationship between greenfield and building damage is established as in Figure 1 [1].

- 22 Loading Scenarios: Combinations of pure strain, pure curvature (hogging and sagging), and mixed strain-curvature paths (see diagonal lines in Figure 1).
- Ground Types: Stiff sand and soft clay/peat profiles, representing the extremes of soil stiffness in Groningen (see profiles in Figure 2).
- Masonry Properties: Weak, average, and strong masonry to account for material variability.
- Wall Geometries: 26 façade types with varying lengths, heights, and opening configurations; see Figure 4.

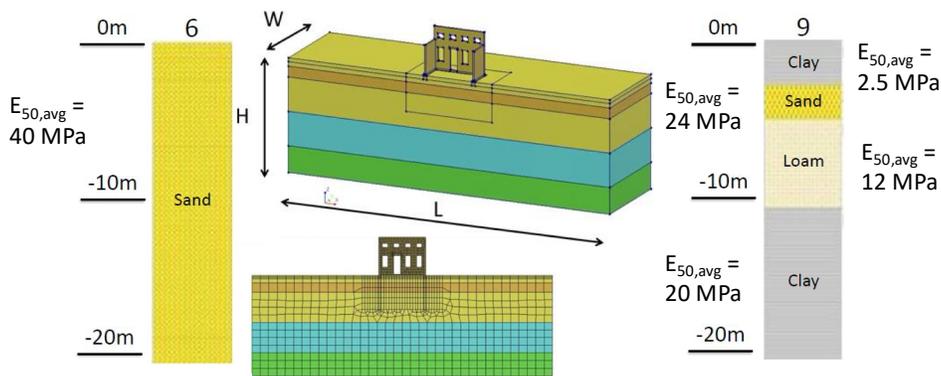
To capture the complex interactions between ground deformations and masonry structures, the research employs 3D non-linear finite-element models, linking soil and structure interaction; see Figure 2. Unlike traditional linear models, which assume elastic material behavior, these models incorporate non-linear material properties for both ground and masonry. The models account for critical factors such as:

Figure 2: View of the model, symmetrical on the XZ plane, for one type of façade.

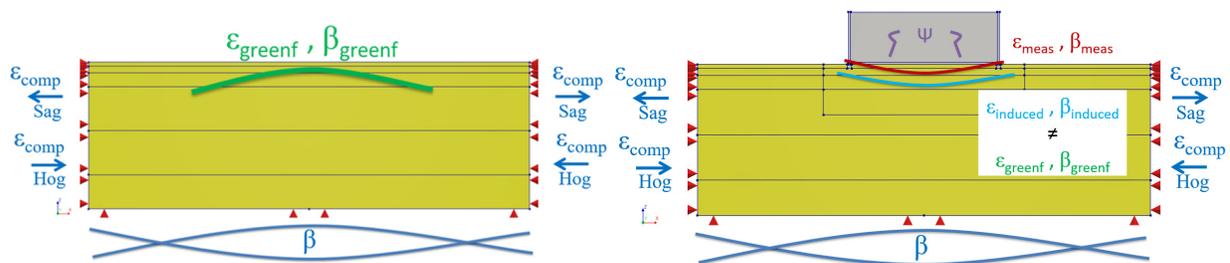
The analysis follows a two-step computational approach; see Figure 3. In the first step, a ground-only model is used to calculate the boundaries required to generate free-field or greenfield ground strain and curvature under imposed static loading conditions at the location where the building would be. These deformations represent the ground's response to mining activities in the absence of any structures. In the second step, the exact boundaries which generate these greenfield deformations are applied to a coupled ground-structure model to evaluate their impact on a masonry wall. The soil model is sufficiently large that the presence of the building does not affect the boundaries of the model.

**Figure 3: Two-step model: left, only greenfield, and right, soil+building.**

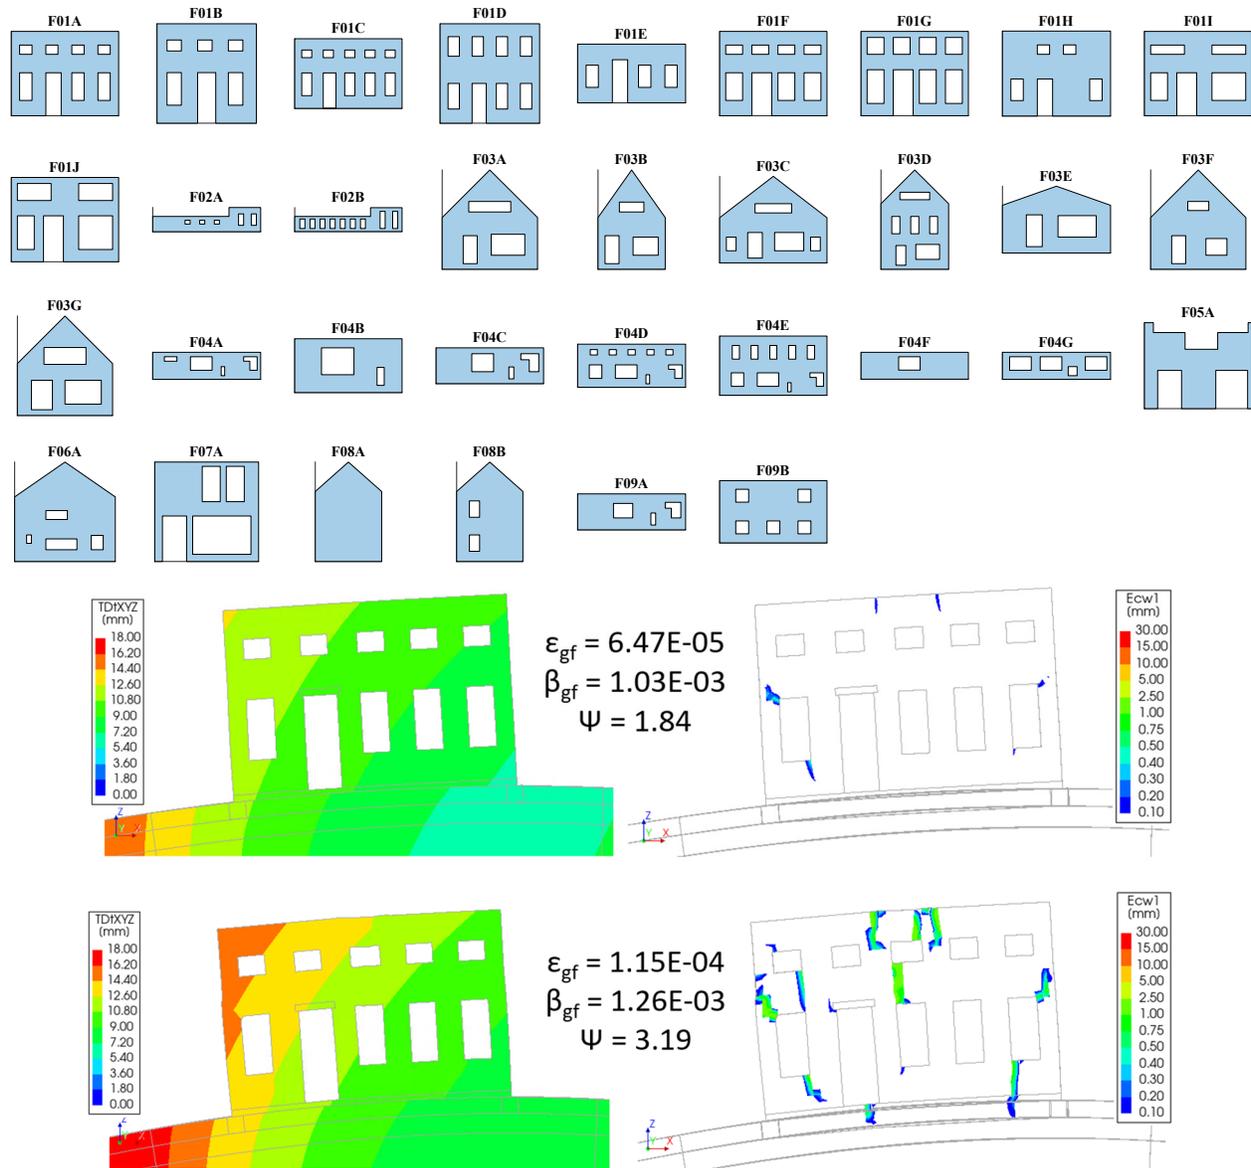
**Figure 4: Variations of façade geometries and deformation of façade F01C subjected to strain/curvature and its measured damage.**

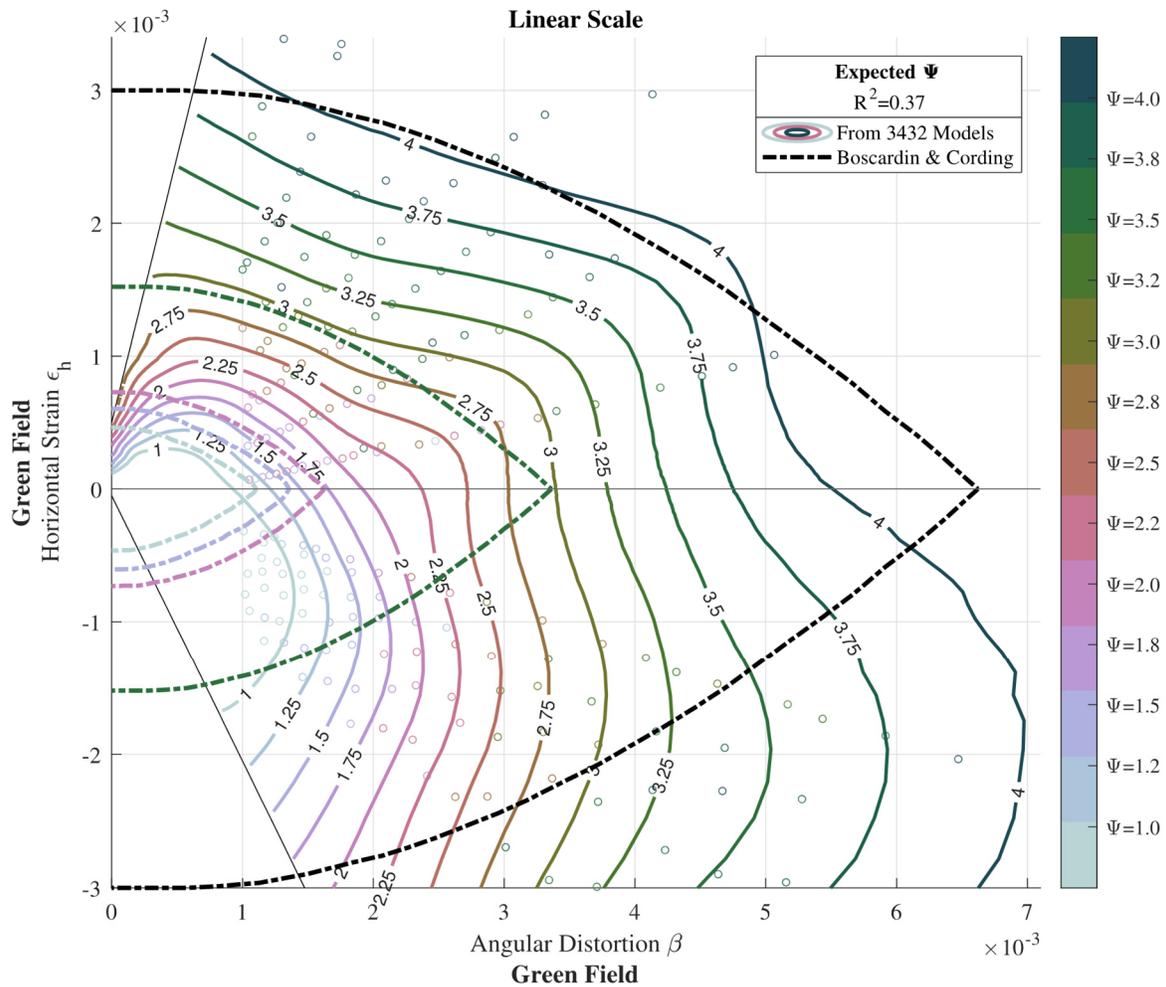
Building on the deterministic results, a probabilistic analysis, to account for variability in input parameters, was performed. By weighting the results according to realistic distributions of soil properties, masonry strength, and wall geometries, iso-contour plots were developed to represent the expected damage level ( $\Psi$ ) as a function of strain and curvature; see Figure 7.

These surfaces highlight the distinction between hogging and sagging effects and provide confidence in the updated framework. Notably, the results align well with Eurocode limits for angular distortion ( $\beta=1/2000$  to  $1/300$ ), which provides further validation to the approach in the study. For instance, Eurocode limits of angular distortion for light damage align closely with the damage thresholds identified for  $\Psi$  values around 1.0 and 2.5. Other contours, showing the probability of exceeding specific damage thresholds could also be generated but are not included here due to brevity.

Figure 7. Iso- $\Psi$  contours showing the expected value of  $\Psi$  at combinations of  $\epsilon$  and  $\beta$ .

The iso-contour plots also reveal how damage probabilities change with increasing strain and curvature. For hogging scenarios, even small tensile strains can initiate damage, whereas sagging profiles demonstrate greater tolerance due to the compressive strains. The probabilistic analysis further confirms that soft soils reduce the transfer of ground deformations to buildings, providing a natural mitigation mechanism [8]. These findings are crucial for decision-makers tasked with assessing damage risks and prioritizing mitigation measures.

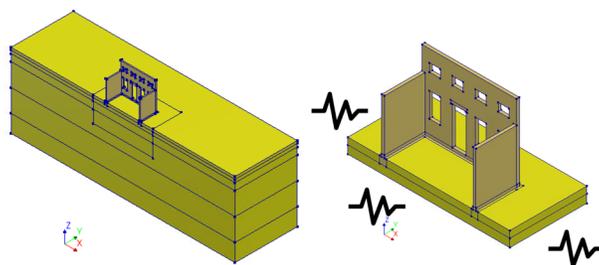
To assess the impact of seismic vibrations on pre-damaged structures, non-linear time history analyses (NLTHA) were conducted; see Figure 8. These simulations revealed that at low PGV levels—up to 4 mm/s—the additional damage caused by vibrations is minimal, even in walls with pre-existing cracks. In most cases, the increase in the  $\Psi$ -damage index ( $\Delta\Psi$ ) remains below 0.2, which corresponds to just visible changes. However, as PGV levels increase to 8–16 mm/s, the amplification of damage becomes significant, particularly in walls already weakened by hogging-induced tensile strain. At these levels,  $\Delta\Psi$  values of 2.0 or higher are observed, indicating visible cracks that affect repairability.

**Figure 8. Model simplification for NLTH Analyses.**

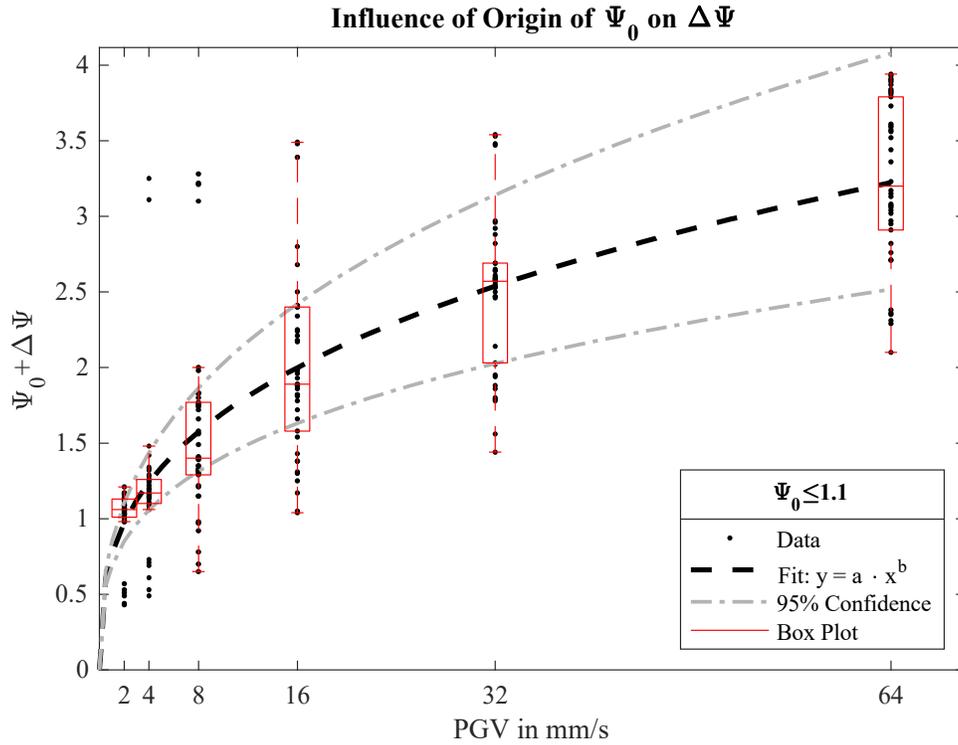
The cumulative effects of static ground deformations and seismic vibrations were explored to understand how vibrations amplify pre-existing damage. In the limited number of simulations, buildings subjected to strain and curvature first developed a baseline damage level, represented as  $\Psi_0$ . Subsequently, seismic vibrations were imposed to evaluate the incremental damage ( $\Delta\Psi$ ). Models with similar value of damage but caused by different combinations of strain and curvature were subjected to identical earthquake vibrations of increasing intensity. Figure 9 shows the results. The graph shows that the increase in damage can be approximated using a power law. Moreover, most of the damage increase is captured by a 95% confidence margin of about 10% of  $\Psi_0$ , suggesting that the cause of the damage has little but not insignificant importance. Because of the expense of the models, only 270 cases were analysed.

**Figure 9. Increase in damage ( $\Delta\Psi$ ) due to vibrations for various initial values of damage.**

Indeed, the fact that the origin of  $\Psi_0$ , be it from pure horizontal strain, pure curvature, or anything in between, did not lead to a strong variation for  $\Delta\Psi$ , is a useful observation. It means that existing fragility curves for earthquake vibrations, which consider an initial value of  $\Psi_0$ , can be directly applied considering a small uncertainty value [3]. Nevertheless, additional insight into the effect of the initial cause on further aggravation of damage is still required. Causes other than strain/curvature combinations, such as temperature or shrinkage effects, should be explored.
