Explorative nonlinear pushover analyses for historical unreinforced masonry churches

A Case Study in Zandeweer,
Groningen

in Structural Engineering at the Delft University of Technology,
to be defended publicly on Wednesday, November 13th, 2019.

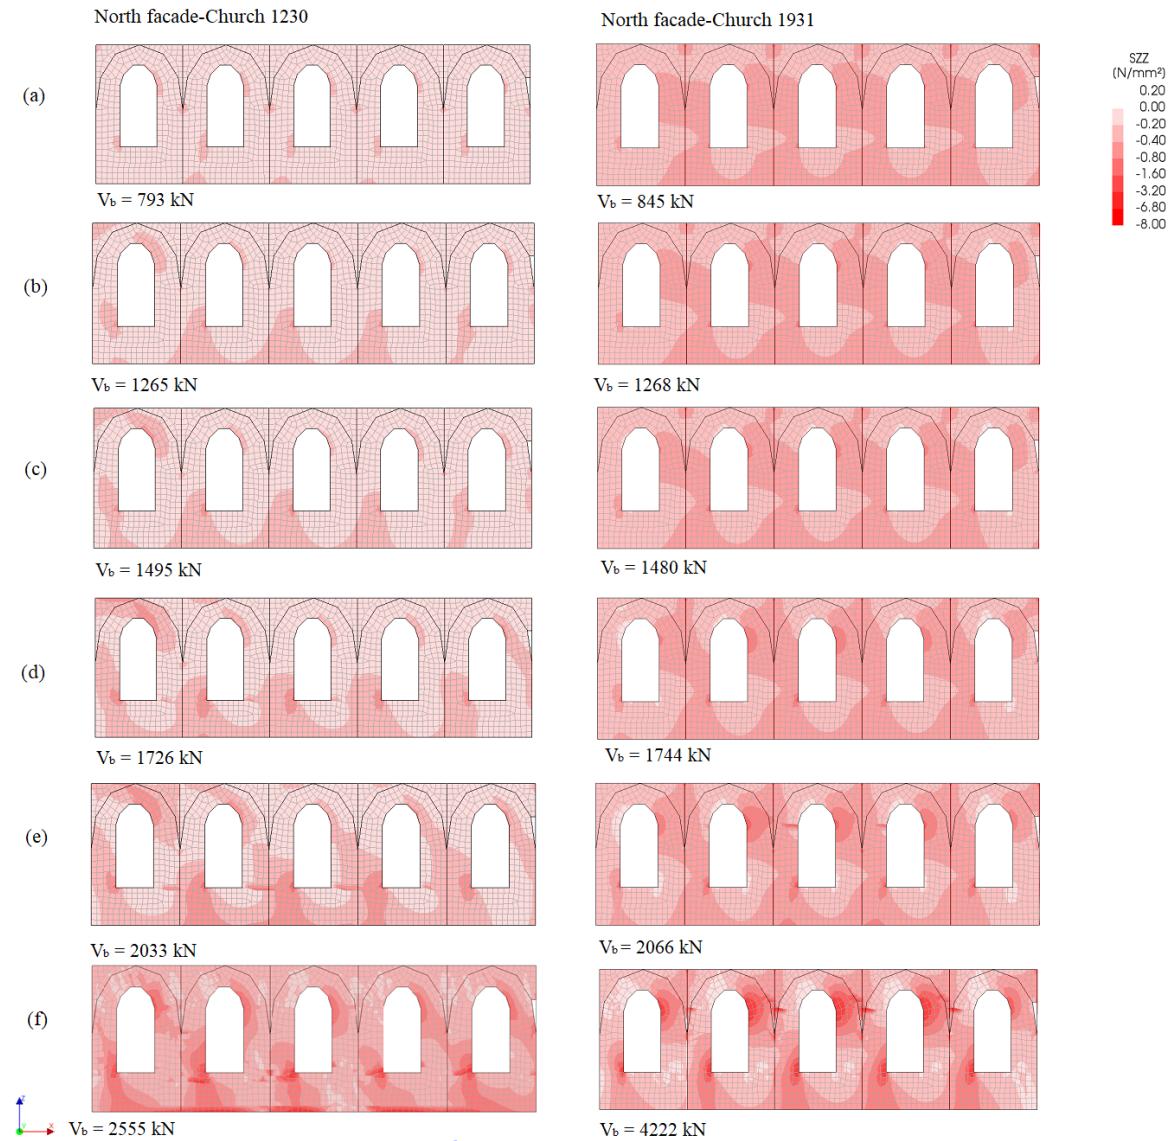
Figure 9.15: Compressive stresses for the due to pushover loading for the Northern facades, [scale factor=0.05]
