Validation of Non-Destructive Testing methods for reinforced concrete

A practical case study on the Ardeweg viaduct

Master thesis

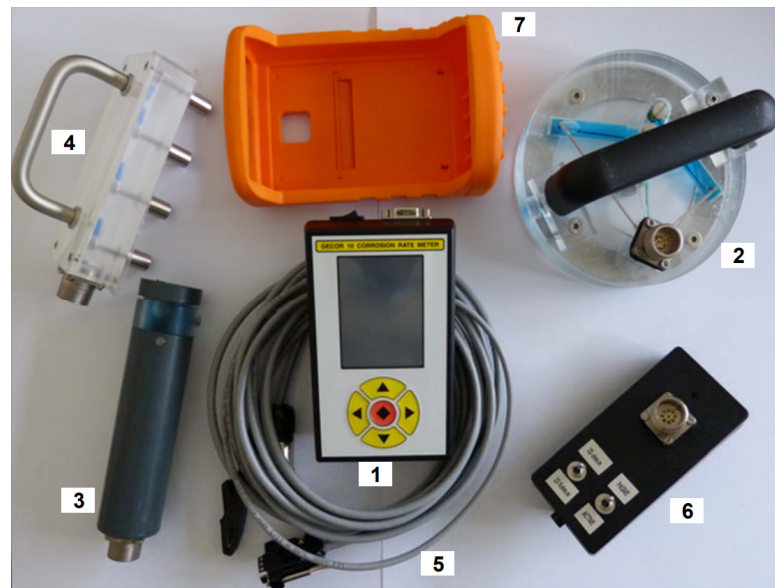
The Gecor-10 is a linear polarization corrosion rate measurement instrument developed in Spain by Geocisa. It measures the polarization resistance R_p using the modulated current confinement technique. This entails using a guard ring to confine the applied polarization current to a known reinforcement section. The device is capable of measuring all the required parameters for the corrosion rate in one measurement by combining the electrochemical potential, resistivity, and corrosion current density. The Gecor-10 device with its components can be seen in Figure 2.6.

Figure 2.6: The Gecor-10 measurement device with all its components: 1) Gecor-10 main unit, 2) confinement sensor, 3) Potential sensor, 4) 4-tip resistivity sensor, 5) cables, 6) calibration box, and 7) protective housing. [44]

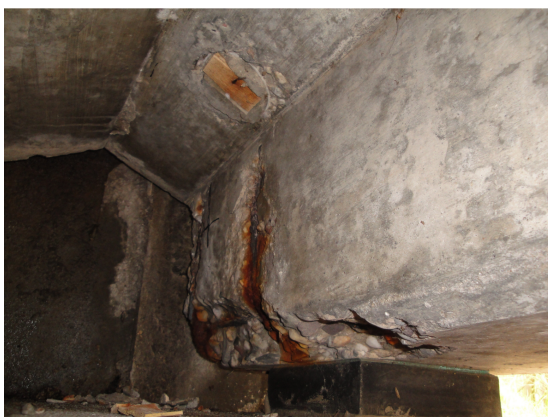
(a) Spalling concrete and corrosion damage to the beam head

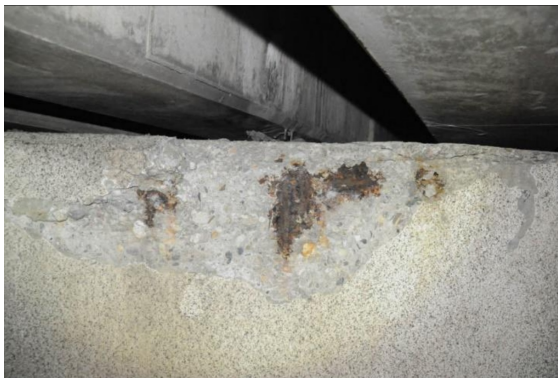
(a) Damaged concrete corner at support beam 4 (STP4) with signs of corrosion

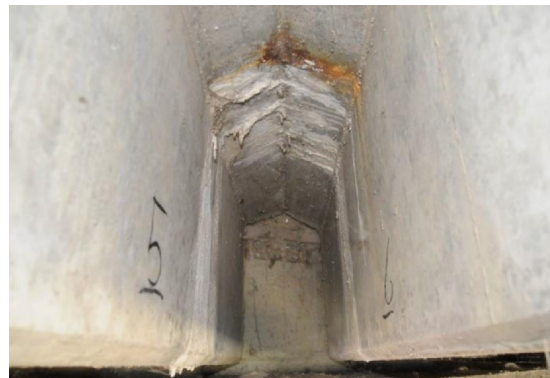
(b) Visible leakage between the beam heads of beam 5 and 6 at STP5

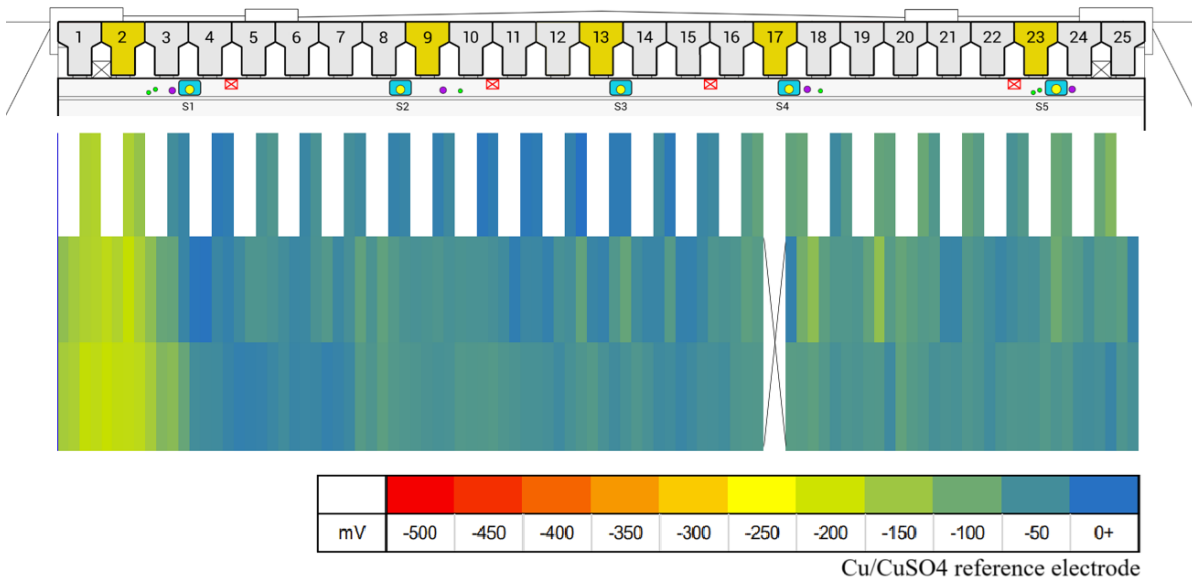
Figure 3.11: Potential map of the STP5 support beam from the 2019 measurements [50].

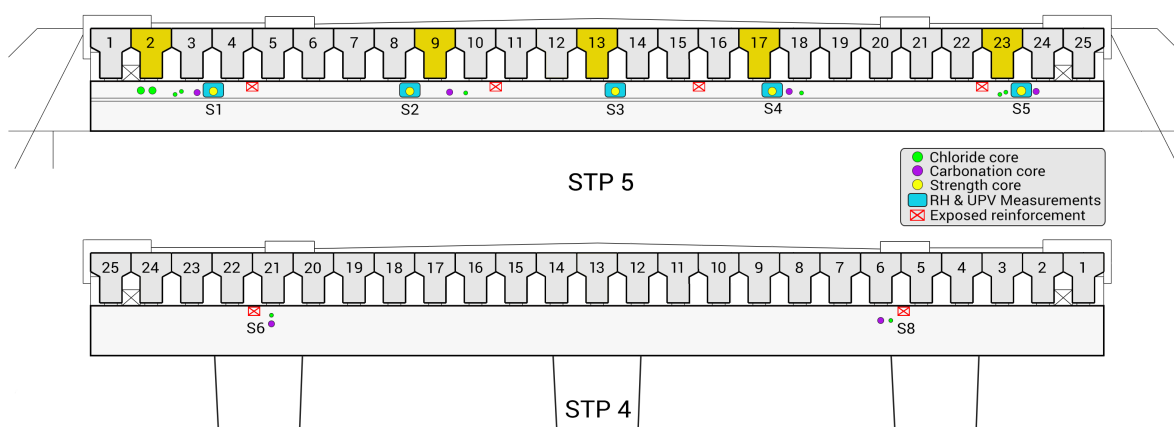
Figure 4.1: Schematic of the measurement locations for support beam 5. The colored circles indicate the different types of extracted cores. The investigated beam heads of the T-beams are highlighted in yellow.

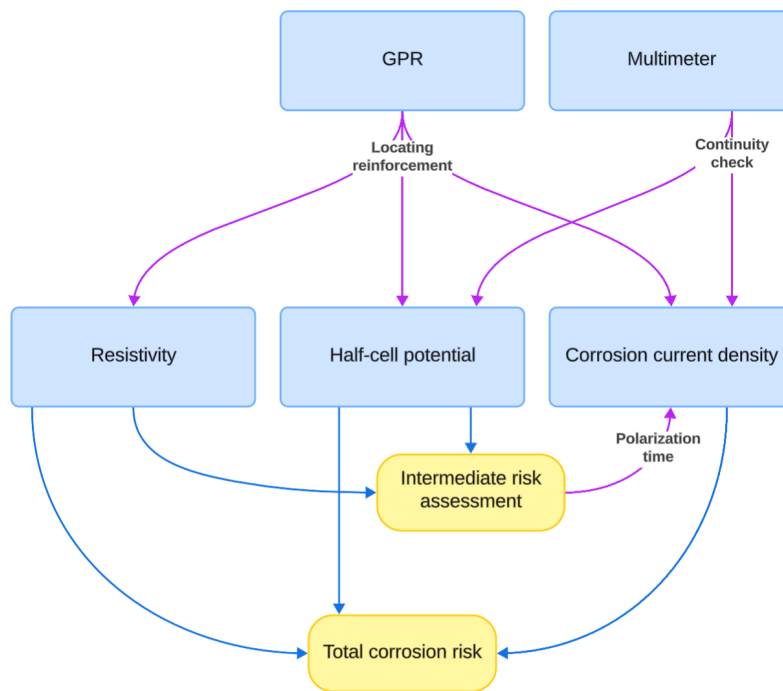
Figure 4.3: Overview of the workflow for the corrosion risk assessment.

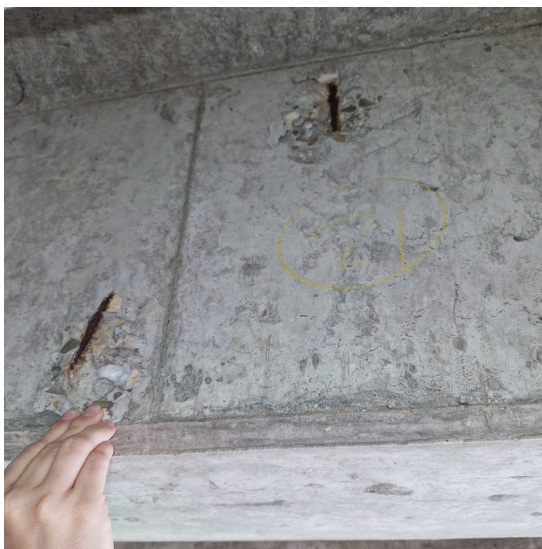
(a) Minor corrosion damage on the side of beam 21

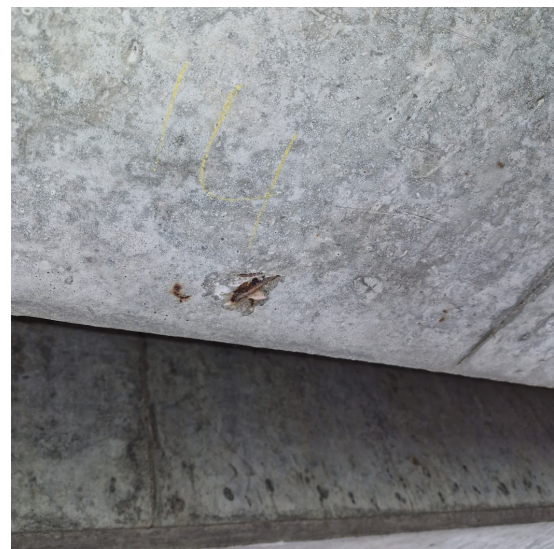
(b) Minor corrosion damage on the bottom of beam 14

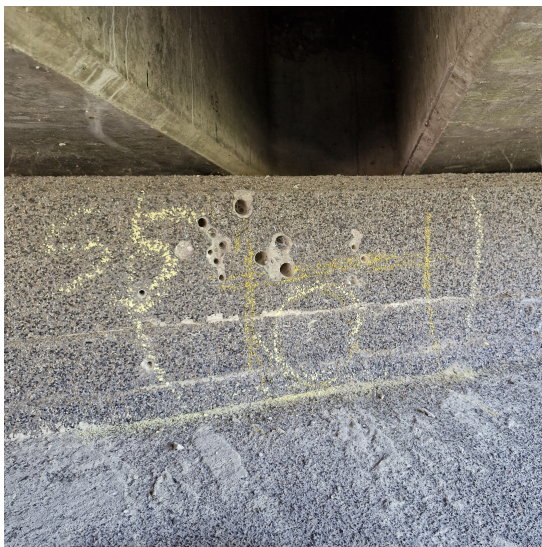
(c) Existing boreholes from previous experiments at location S5

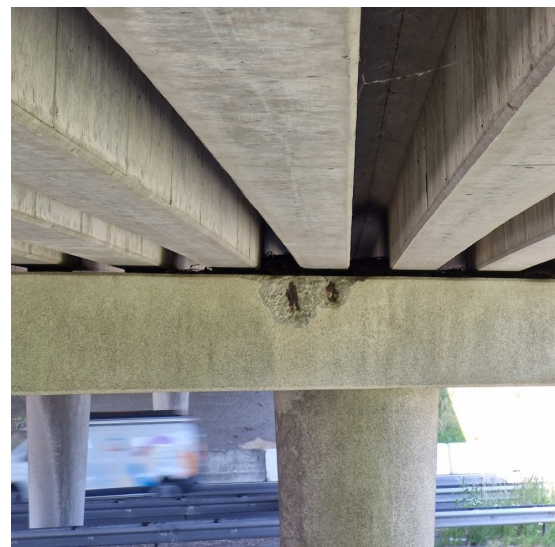
(d) Exposed reinforcement at the right side of support beam 4

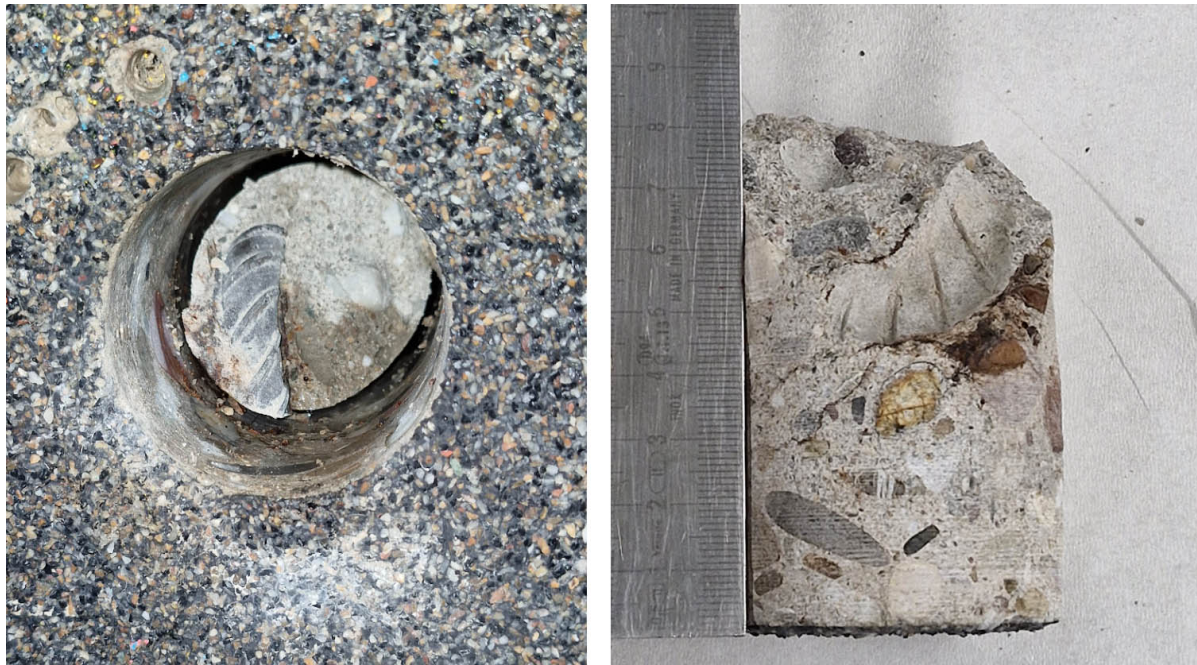
Figure 5.10: Location of S1* showing signs of corrosion products.

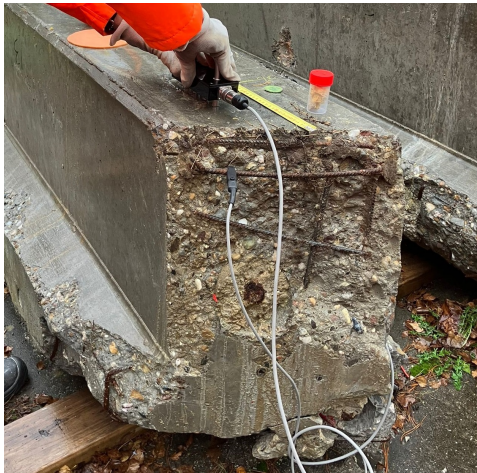
(a) Absent concrete cover at the end of the beam head of L13 with exposed reinforcements. Resistivity test is being performed.

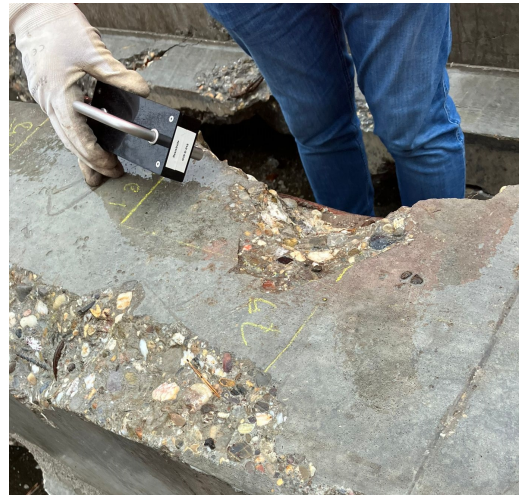
(b) Broken edges and surface damage at the top surface of beam L23, making measurements at this location difficult.

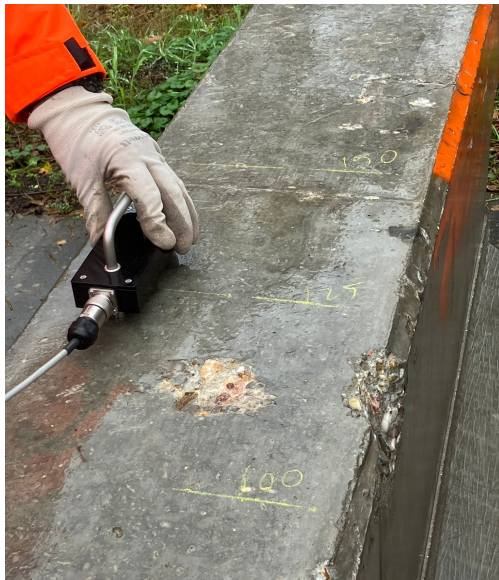
(c) Minor surface defects on beam L2. Markings for the measurement grid can be seen in yellow.

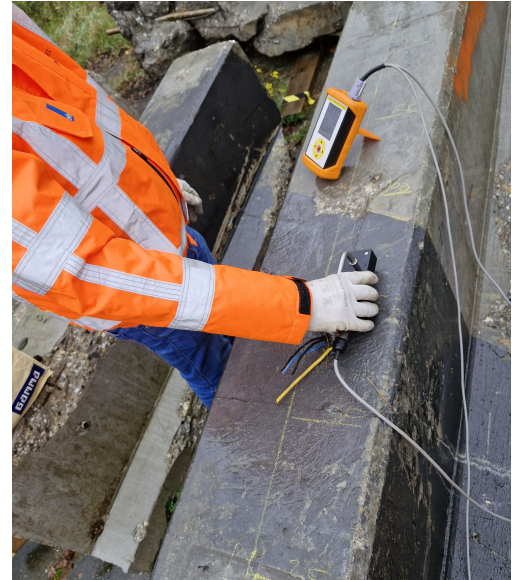
(d) Resistivity measurement being performed with the Gecor-10 on the cathodic protection coating on beam L17.

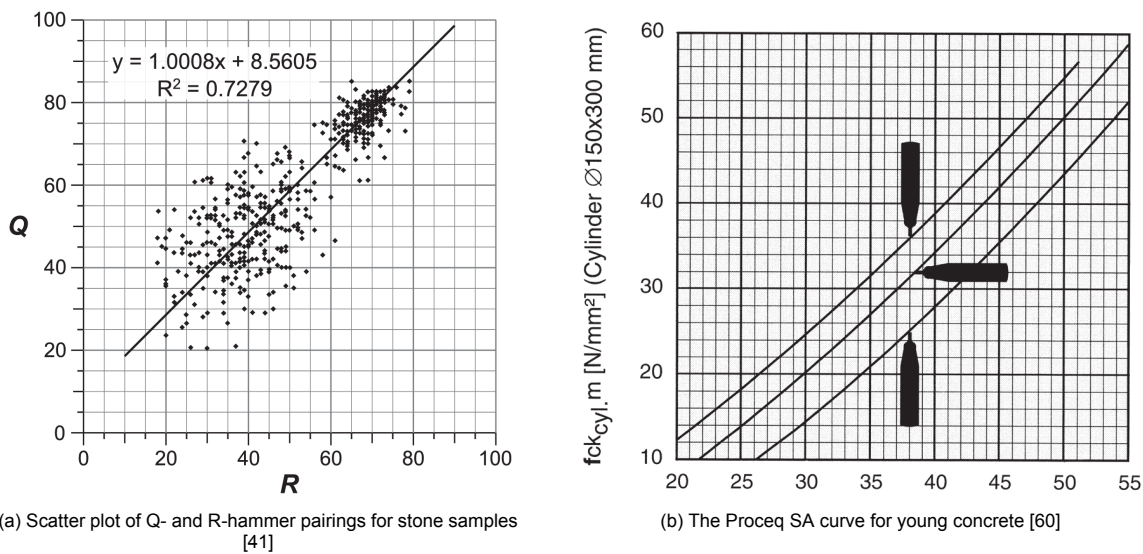
Figure 7.3: Winkler et al.'s correlation curve with Q- and R-type hammer pairings on the left, with the Proceq SA curve on the right.

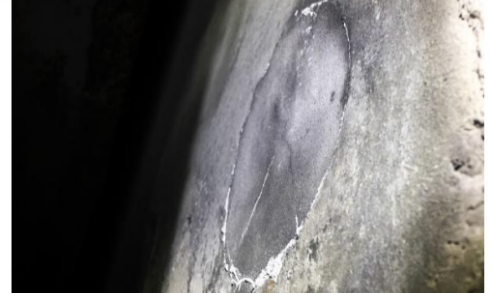
1: Gescheurde hoeken van de ligger	C1: Conus gescheurd

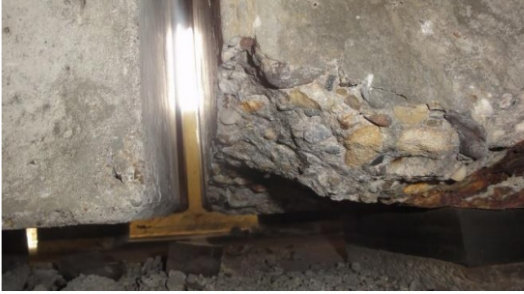
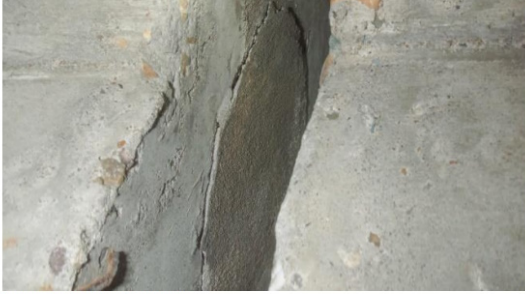
2: Afgesprongen delen van de hoeken van de ligger	C2: Conus los-/uitgedrukt

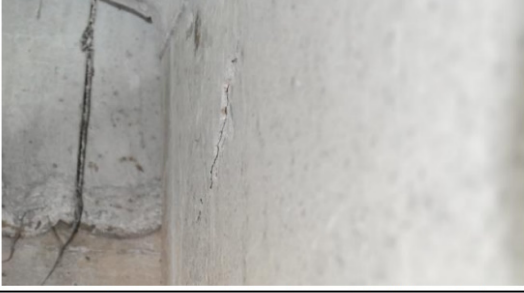
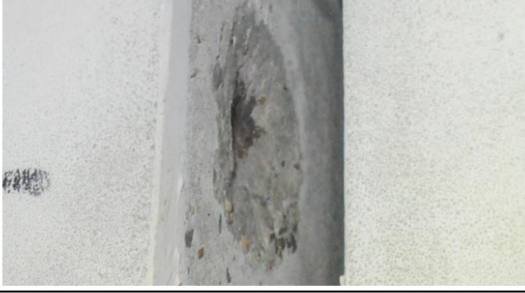
3: Gescheurde hoeken en verticale scheuren in het lijf van de ligger	C3: Conus ontbreekt (deels)

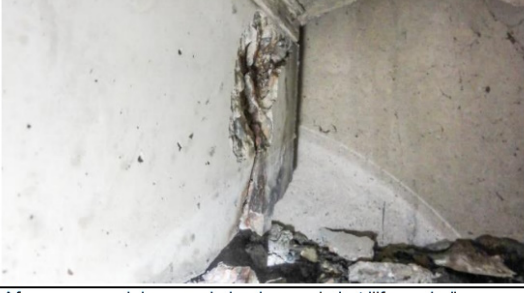
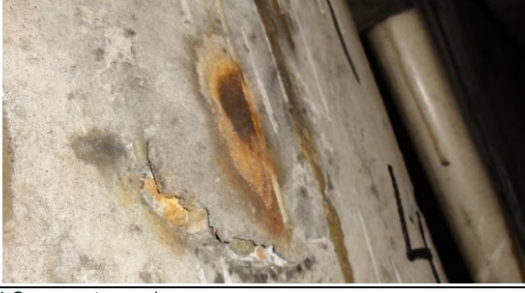
4: Afgesprongen delen van de hoeken en in het lijf van de ligger	C4 Conus met corrosiesporen

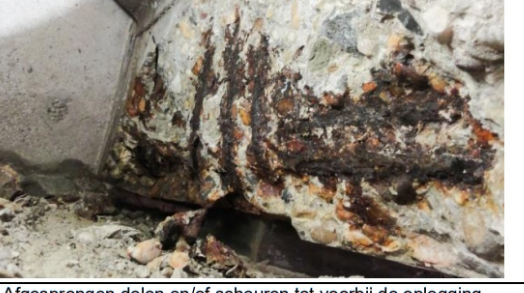
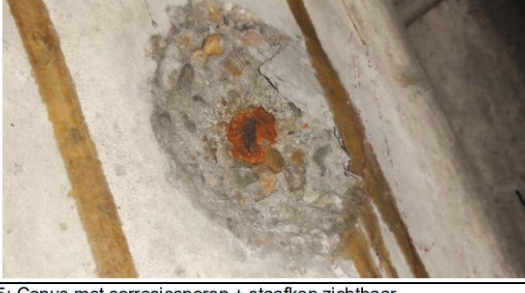
5: Afgesprongen delen en/of scheuren tot voorbij de oplegging	C5: Conus met corrosiesporen + staafkop zichtbaar
