Exploring the influence of sand storage dams on hydrology and water use

A case study in the Kiindu catchment in Kitui, Kenya

Master of Science

in Civil Engineering

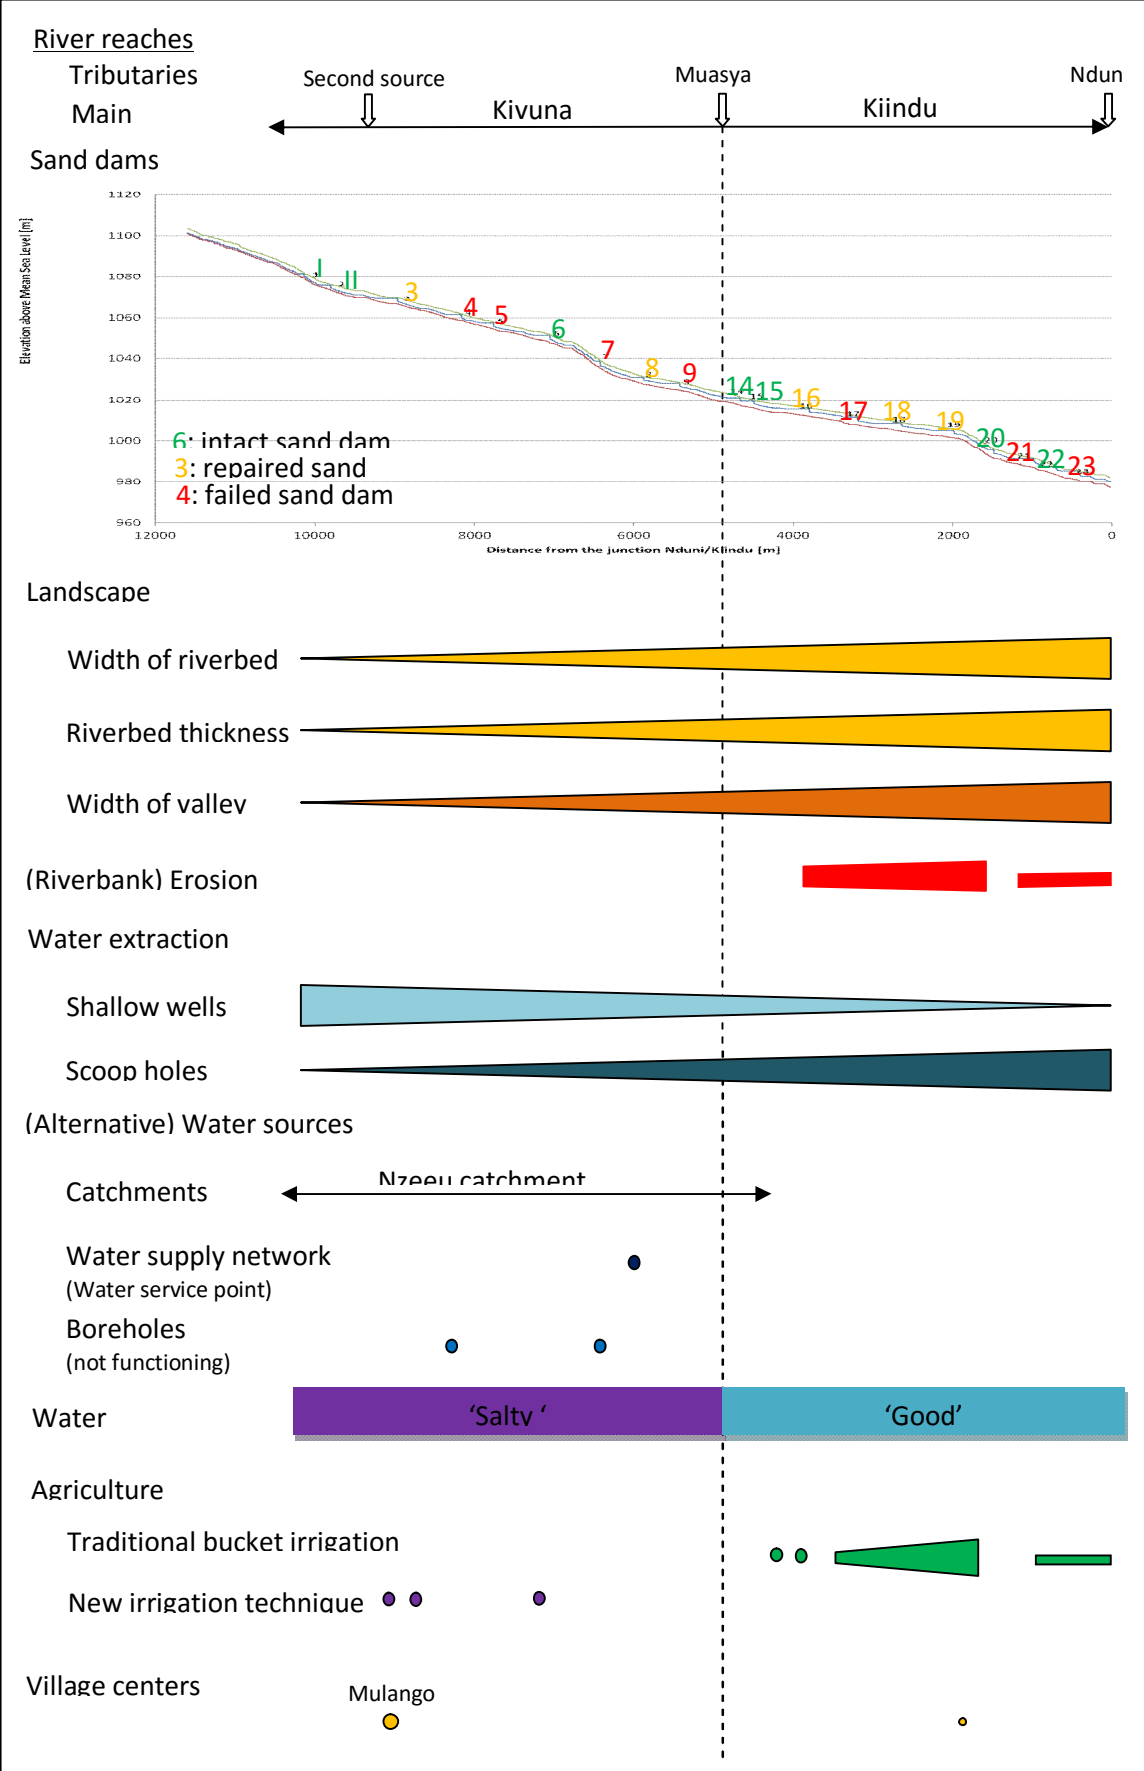
Figure 4 Findings along the Kivuna/Kiindu reach

In the Kiindu catchment the valley is wide and the riverbed broad. Most sand dams could not be built on rock. Therefore all but one (sand dam 22) sand dams failed and needed to be repaired in the course of the years (see Figure 4).

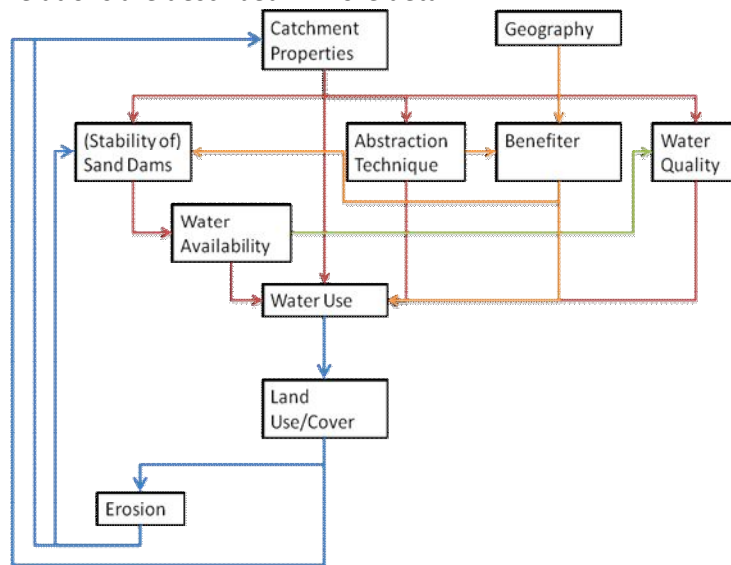
After identifying the local differences of the various components, the cause and consequences of these differences are analyzed. The information suggests relations between landscape, sand dams, water cycle, water use and human agency. Figure 5 illustrate probable relations between the single components. The relations are divided in 4 groups indicated in Figure 5 by different colors.

Figure 5 Proposed dependencies

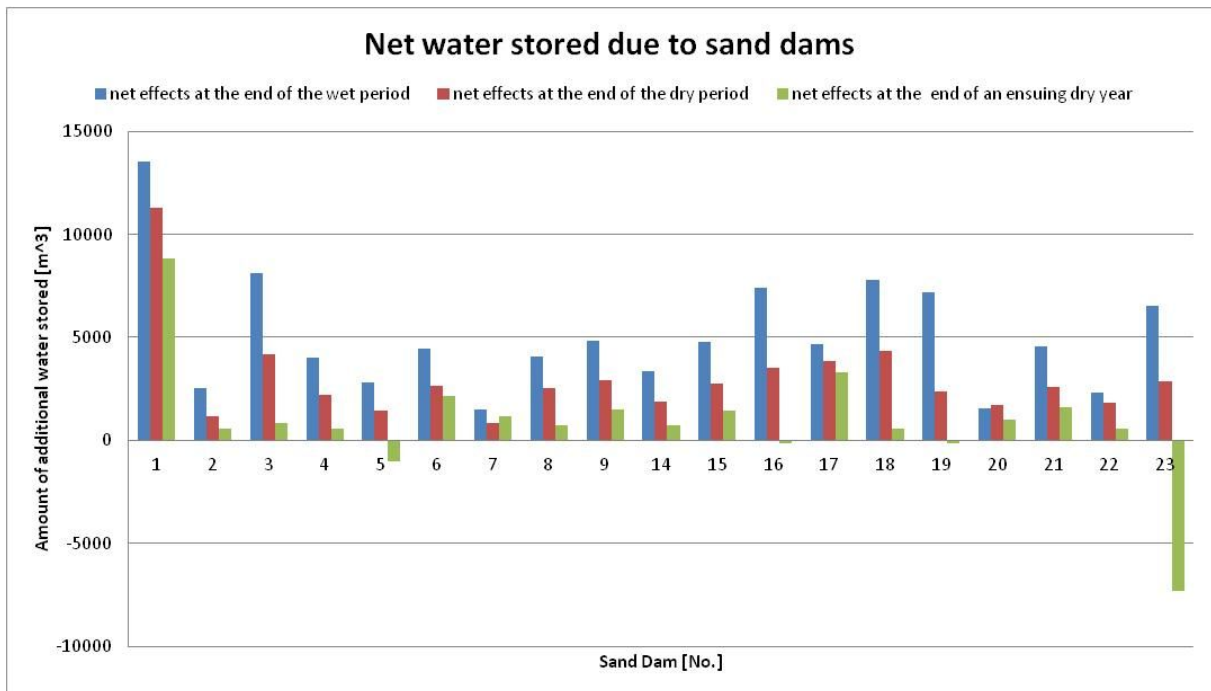
Figure 11 Net effect of the single sand dams in m³

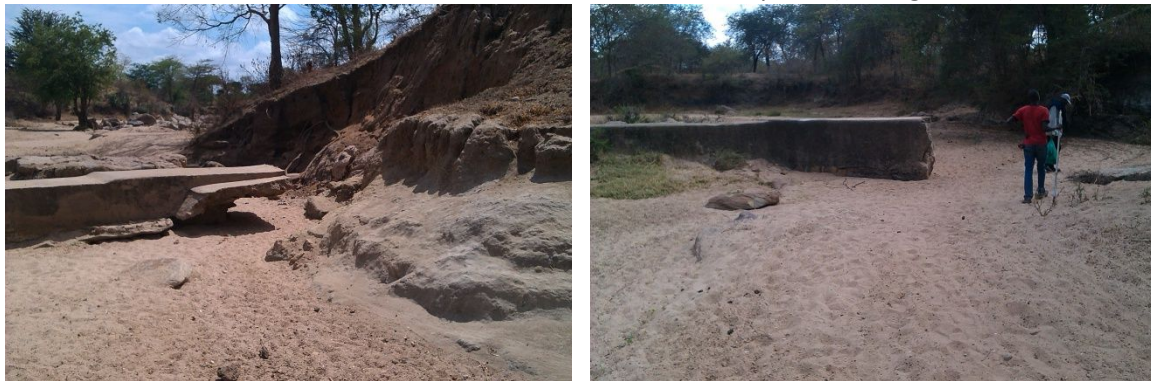
most cases the wing walls in the riverbanks were washed out during floods, so that water can bypass the dams. After erosion of the sides walls some sand dams collapsed. (see Figure A.2)

Figure A.2 Failed sand dams (left: sand dam 21, right: sand dam 9)

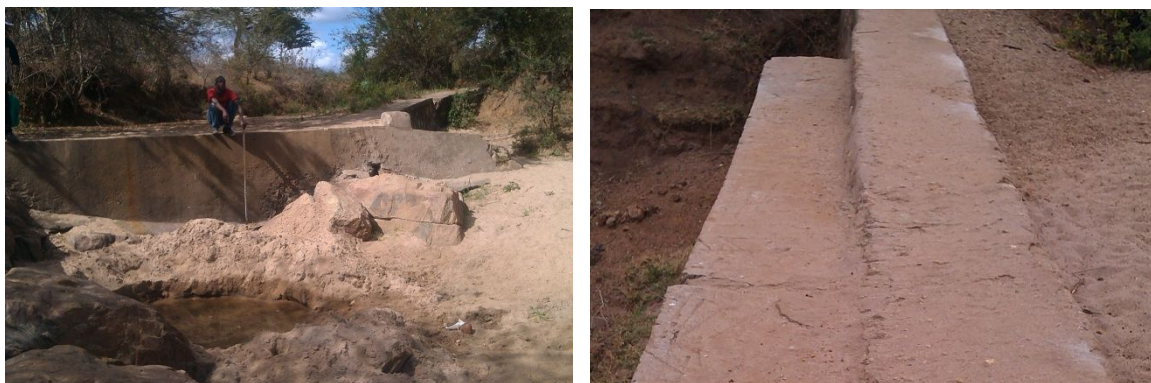
Some sand dams are restored by building a new wing wall that is extended into the riverbank. (see Figure A.3 left) Sand dams which run the risk of breaking in the center are strengthened by an additional wall. (see Figure A.3 right) After restoration the sand dams store water in their upstream again. But high water tables downstream indicate that water leaks through the repaired sections as could be observed in the case of sand dam 8. (see Figure A.3 left)

Figure A.3 Repaired sand dams (left: sand dam 8, right sand dam VI)

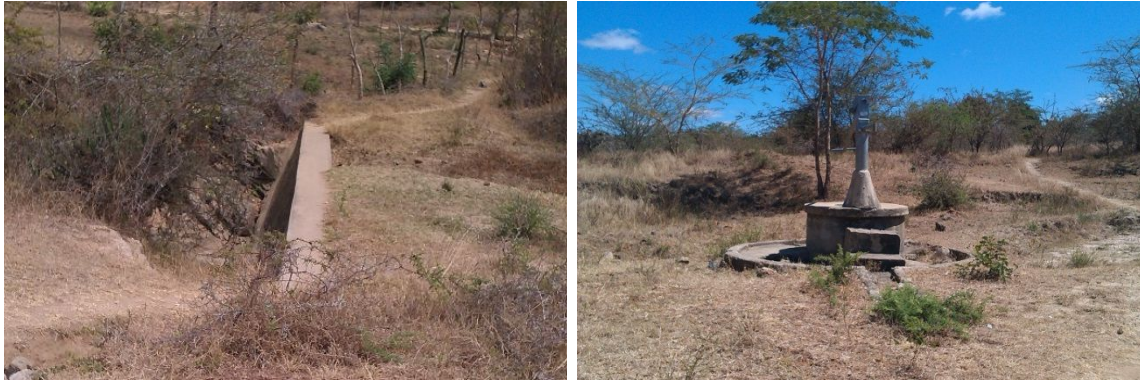
Sand dam I was built in 1996 and is still intact. According to local people the sand dam was constructed on the initiative of the former chief assistant, who lives about 150 m upstream the sand dam. The height of the crest is almost on river bank level. Upstream of the dam, the river is filled with sand. Downstream of the sand dam the sand is washed out. The slopes of the riverbanks are steep. The associated well is dried out at the time we visited it and is filled with branches. The pump of the well is broken.

Figure A.4 Sand dam I (left) with associated well (right)

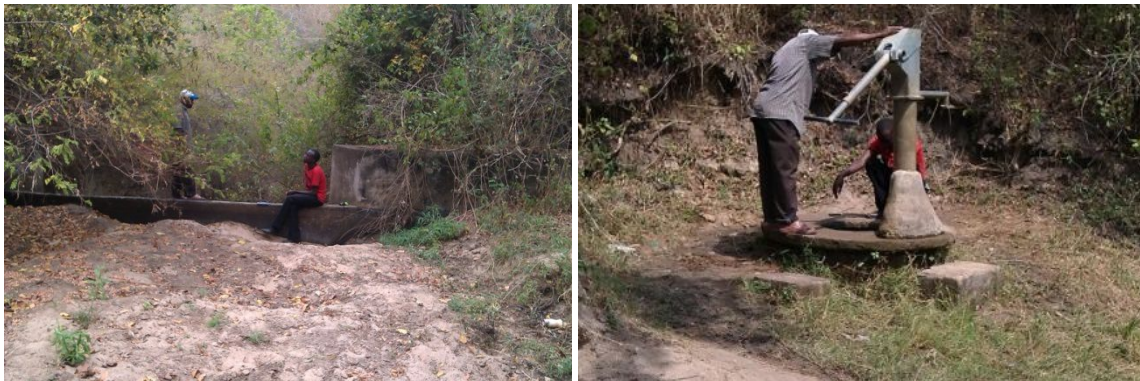
Sand dam II, which is still intact, was built between 2000 and 2006 on initiative of Janet Mumo who works in the field of development aid in Kitui and lives in this area. It has already a modified profile with a spillway to guide the water to the center of the stream. Upstream, sand has settled up to about 40 cm below the crest. The associated well still delivers water. The pump is functioning and makes water abstraction easy. Therefore the well is used intensively by the local people. On the other side of the stream another (private) well is dug into the ground which is also filled with water.

Figure A.5 Sand dam II (left) with associated well (right)

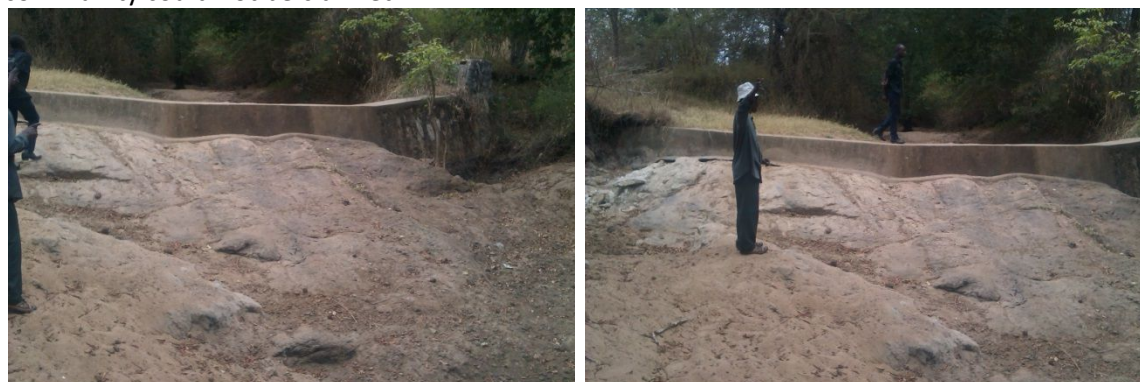
Sand dam 3, which is built in 1996, is repaired due to the initiative of Mr Muthoka , who lives about 200 m upstream. Several years after construction, the river bank on the left hand site was washed out and the sand dam collapsed. There is one well on private property upstream of the sand dams, which still contained water at the time of the visit. Whether or not the well was built by Sasol for the community could not be clarified.

Figure A.6 Sand dam 3

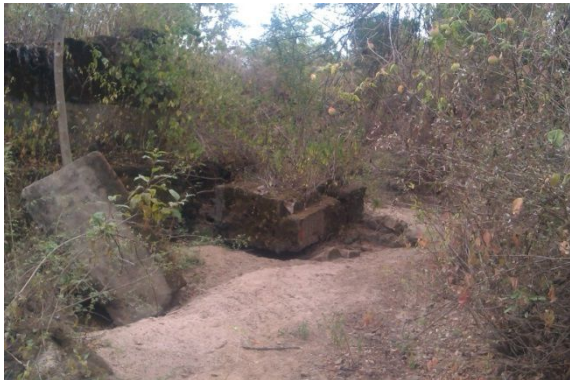
Sand dam III: When this 'ancient' sand dam was constructed could not be figured out. The people I spoke to could not remember the time when it functioned. It was about 2 meter high with respect to the current riverbed level.

Figure A.7 Ancient sand dam

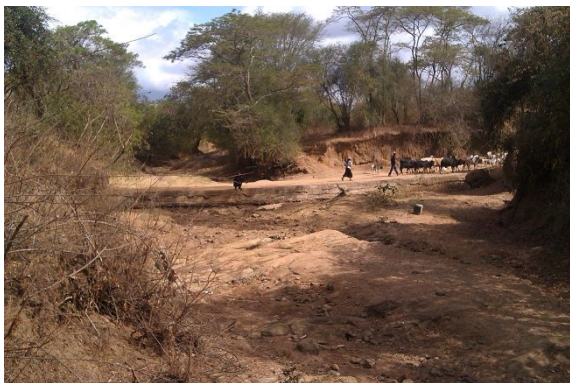
Sand dam 4 was built 1996 south of the village of Mulango. It was intended to serve also as a bridge connecting the primary school of Mulango with the main road. Therefore the construction site was shifted several meters downstream where the river is better accessible. According to local people this was a big mistake because now the dam on the right hand site needed to be extended into the clayey riverbed instead of rocks some meters upstream. This was the main reason for a lot of erosion and the failure of the sand dam. Now the sand dam is replaced by a road which is not constructed to be water tight. The sand which accumulates upstream is regularly harvested for building purposes since access is easy. A public well which is associated to the construction of the dam is not found. However there are several private wells on plots upstream.

Figure A.8 Bridge at the original location of sand dam 4

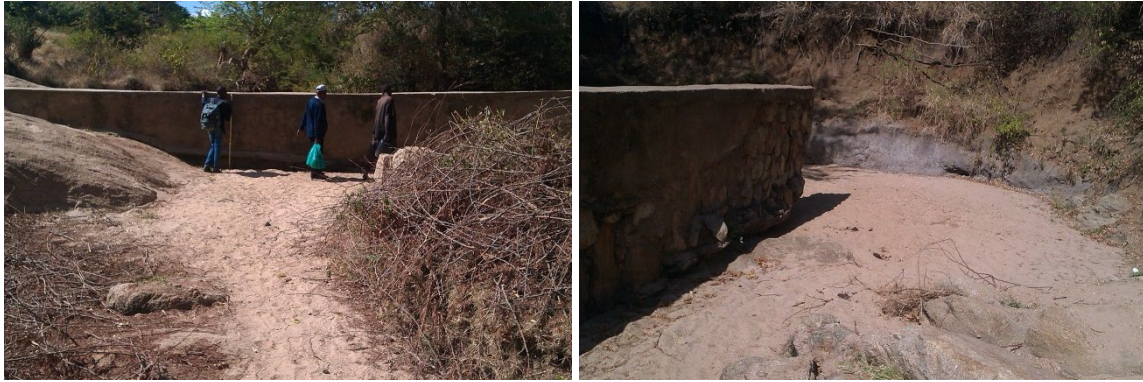
The foundation on the right hand site of **sand dam 5** (built in 1996), was eroded during heavy floods in 1998. In the following years the riverbed was eroded even below original riverbank level. The dam still causes erosion by guiding the water along the riverbank on the right hand site. The owner of the plot on this side already tried to remove the dam to prevent further erosion. Wells that are associated to the sand dam could not be found.

Figure A.9 Sand dam 5 (left) with eroded wing wall (right)

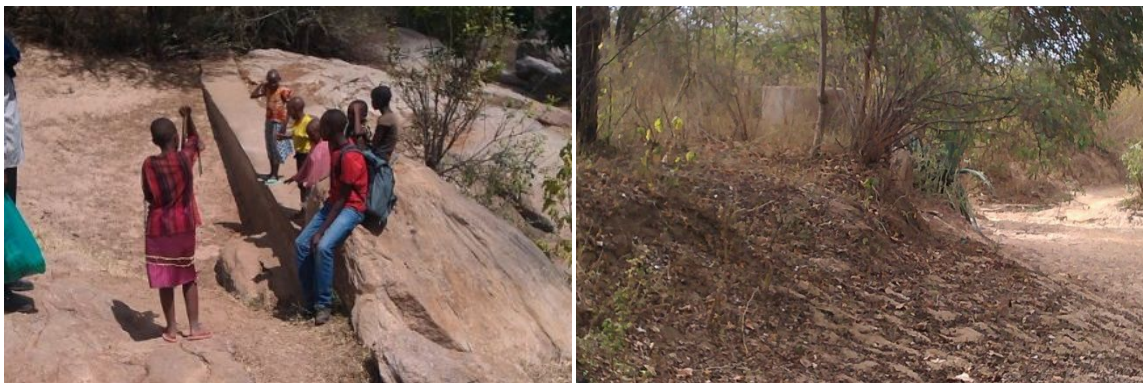
Sand dam 6, which is constructed upstream of a steep river section and founded on top of a rock bare, is still intact. The associated well is sited about 100 m upstream on private land. According to the owner of the land (who lives further upstream) the well is not used by the local people even if it has water throughout the year and is easy accessible. Moreover he reports that some neighbors even contaminate the well with dead animals because of enviousness.

Figure A.10 Sand dam 6 (left) with associated well (right)

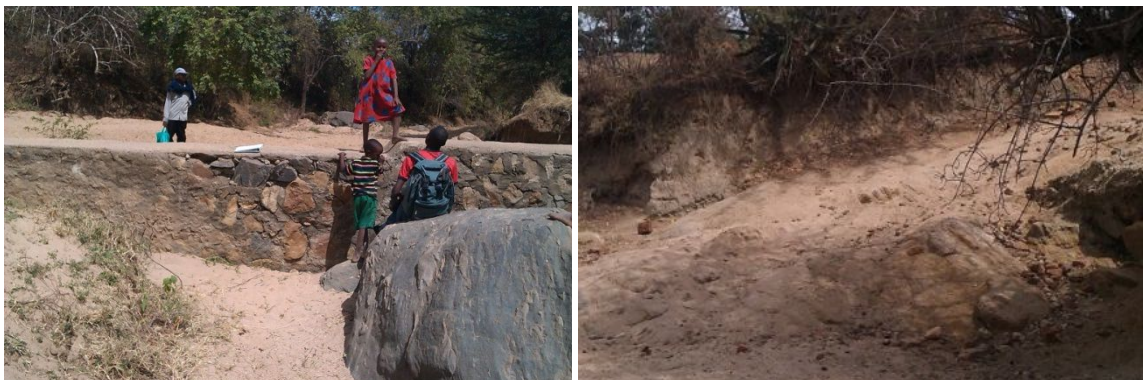
The riverbank on the right hand site of **sand dam 7**, which is located downstream of a steep river section, is eroded. Now water is flowing around the sand dam. The sand which had been settled upstream is washed out. A public well which was constructed together with the sand dams could not be found. According to local people, the sand dam functioned for a couple of years but erosion started short after the construction.

Figure A.11 Sand dam 7 (left) with eroded wing wall (right)

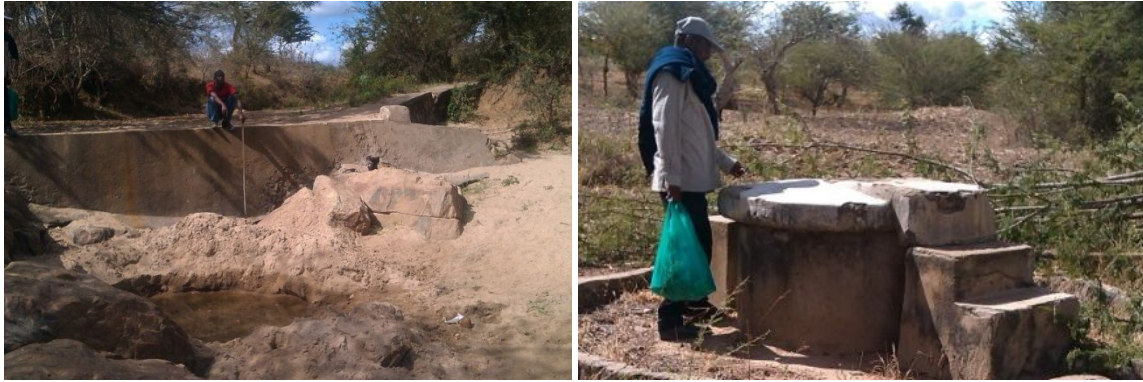
Sand dam 8 broke on the left side. However it was repaired afterwards and is now functioning again. Water tables are almost on surface level downstream of the sand dam. The storage in the upstream is completely filled with sediments. The public well is filled with branches and is dried up and therefore not used.

Figure A.12 Sand dam 8 (left) with associated shallow well (right)

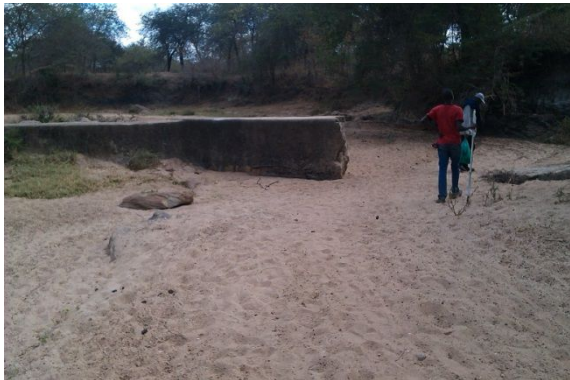
Sand dam 9 is the most downstream sand dam in the Kivuna catchment. Like in the case of sand dam 7, the riverbank on the right hand side is washed out. The riverbed around the sand dams is back on original level; about 1,5 meter below the crest of the sand dam. No public well associated with the sand dam could be found in its vicinity.

Figure A.13 Sand dam 9

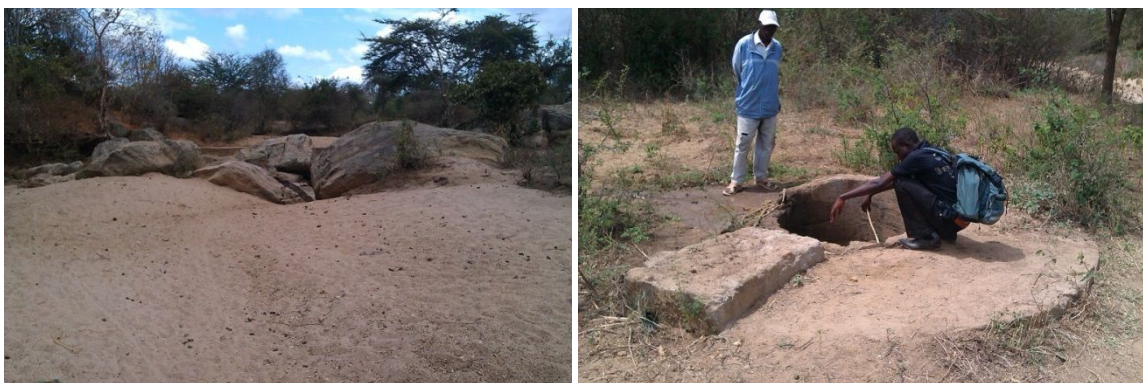
Sand dam 10 is located just upstream of big rocks. It is still intact and the storage upstream is filled with sediments. The well in the upstream associated to the sand dam is highly damaged. Even the walls of the well above the surface are washed away.

Figure A.14 Sand dam 10 (left) and well nearby (right)

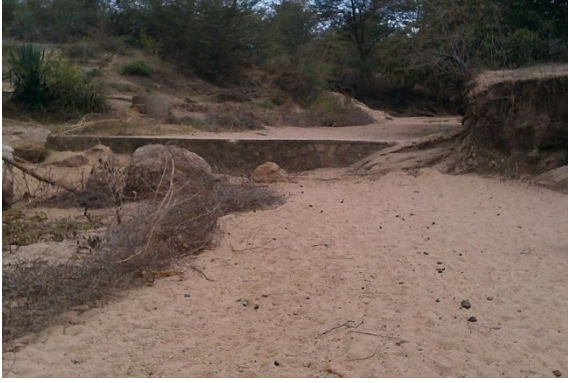
Sand dam 11 is still intact. Sediments have filled the storage in the upstream till crest level. The water level in the small scoop hole just downstream is about 60 cm below the surface of the riverbed. The associated well is damaged and dry during our visit.

Figure A.15 Sand dam 11 with associated well

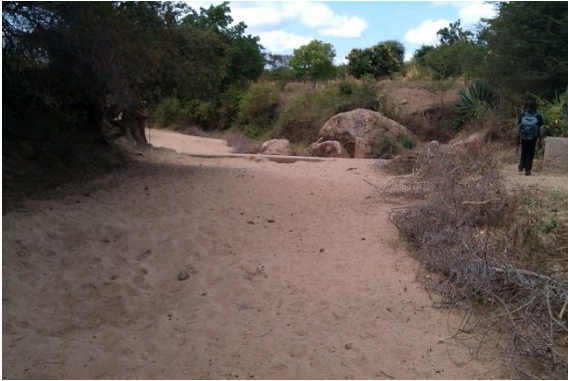
Sand dam 12 is still intact. There are several depressions in the riverbed upstream where sand is harvested but did not serve as scoop holes. The associated well on the right riverbank is damaged but still delivers water for making bricks.

Figure A.16 Sand dam 12

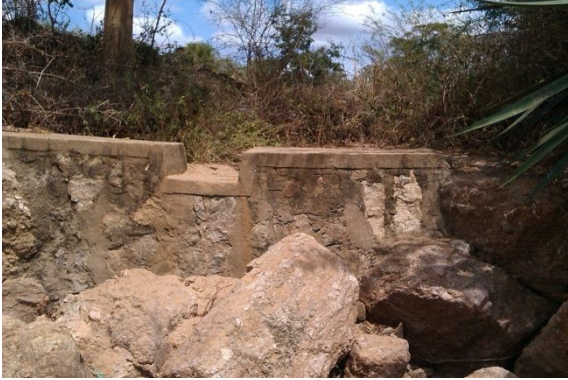
Sand dam 13 is built in a small tributary of the Muasya stream. It is still functioning but there could no indication of water abstraction be found in it its vicinity.

Figure A.17 Sand dam 13

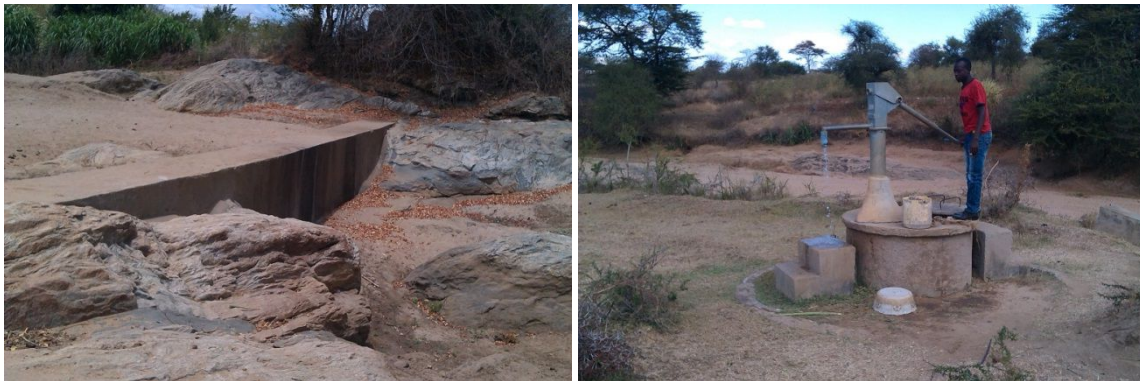
Sand dam 14 is sited about 200 m downstream of the junction of the Muasya tributary. It is still intact and the storage upstream of the sand dam is filled with sediments. The first public well was constructed on the riverbank next to the river. But the well was destroyed after the storage was filled up with sediments and water levels rose during floods. To compensate the community for the loss of the first shallow well, Sasol build a second public well further uphill. This public well is equipped with a still functioning pump. It is located on private land and only members of families, which were involved in the construction of the dam have the permission to use it. The people, which are not allowed to use the public well, have to dig scoop holes into the riverbed to fetch water.

Figure A.18 Sand dam 14 (left) with associated well (right)

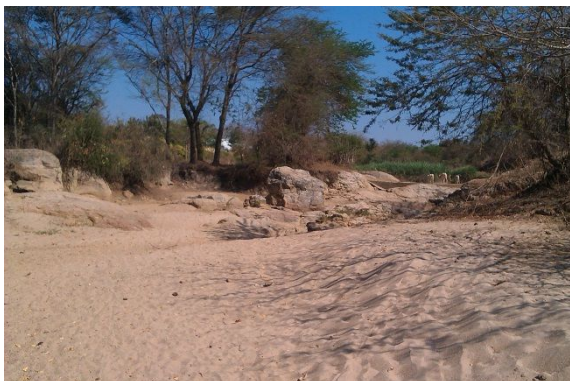
Sand dam 15, which is built only about 50 m downstream of sand dam 14, is also still intact. According to people the dam was supposed to be built several hundred meter further downstream. The people suspect that corruption may be the reason for the change of the construction site. Due to the short distant to sand dam 14 the length of the storage is rather small. An associated well was not found.

Figure A.19 Sand dam 15

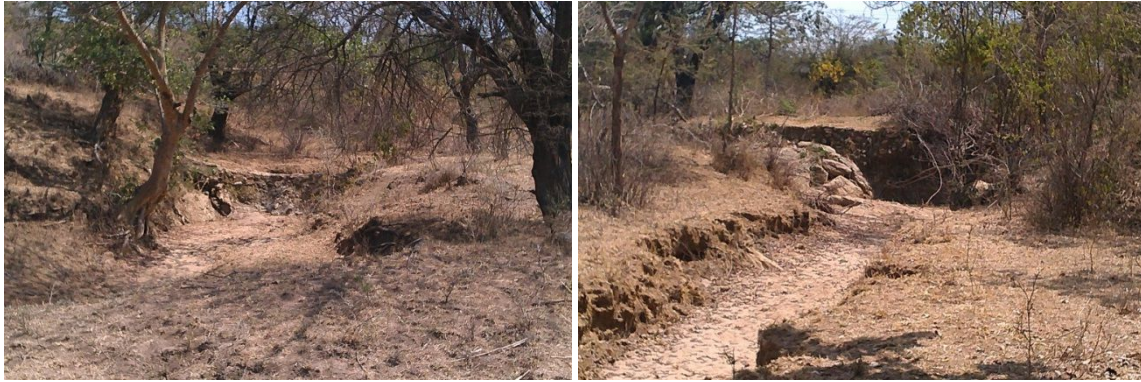
Cascade of three sand dams: About 100 meter downstream of sand dam 15 there are cascades of sand dams built in a small tributary. The sand dams function properly and the tributary is for large parts is filled up with sediments. The owner of the plot, which borders the tributary, worked for a land conservation authority. He built the sand dams some 20 years ago. According to him, the sand dams lead to higher groundwater levels, but he does not take advantage of them because he has several other sources of income.

Figure A.20 First (left) and third sand dam (right) of a cascade of three private sand dams in a tributary

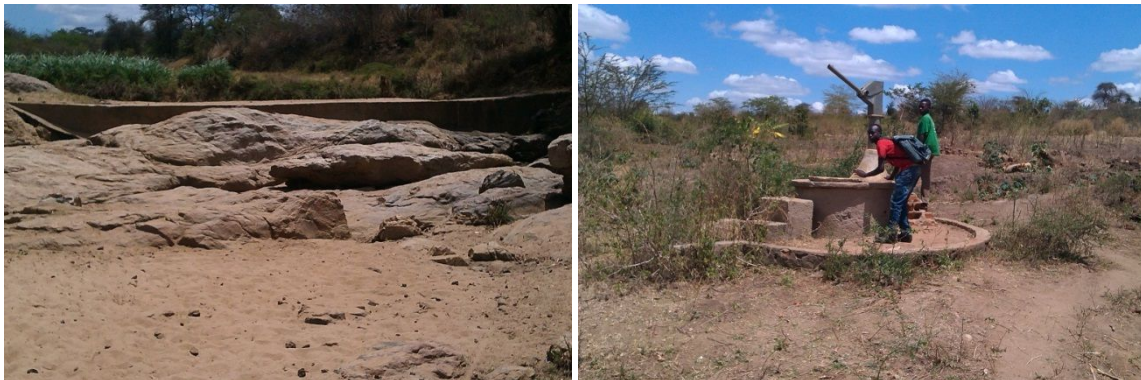
The associate public well is located some 150 m upstream on private land. The owner of the land does not live in the area anymore and prohibited the people to enter his land and fetch water. Therefore the well is not used and children throw stones and branches in it. As compensation the local community together with Sasol build a new well for the community. The well is about 10 m downstream of the former public well. The riverbank on which the well was founded was washed out during the last rainy season. It is now restored and the walls will be rebuild at the end of the dry season.

Figure A.21 Sand dam 16 (left) with associated Well (right)

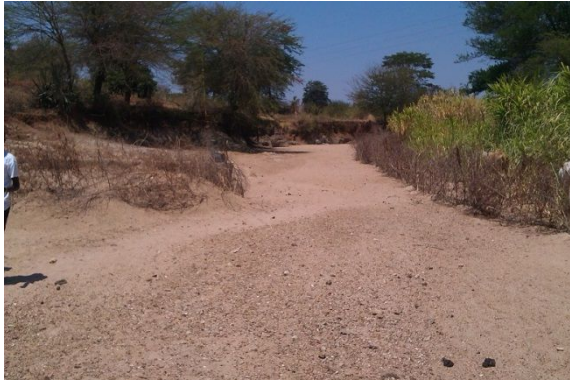
Sand dam 17 broke last rainy season. Upstream of the sand dam people had dug a scoop hole to fetch water. We found no shallow wells in the vicinity of the sand dams.

Figure A.22 Sand dam 17

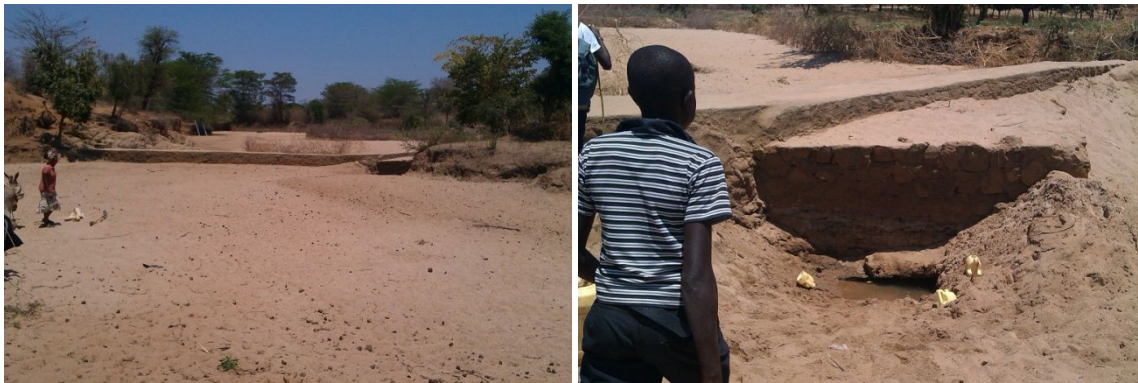
Sand dam 18 is repaired several times. The storage in the upstream is not filled up with sediments. People dig scoop holes on both sides of the sand dam to fetch water. At the end of the dry season people from distant areas come to get water. The queue may become very long in those days. The public well which is usually built together with the sand dams could not be found and people did not report about it. In the future there is the risk that the river will form a new course and flow around the sand dam.

Figure A.23 Sand dam 18 (left) with repaired wing wall (right)

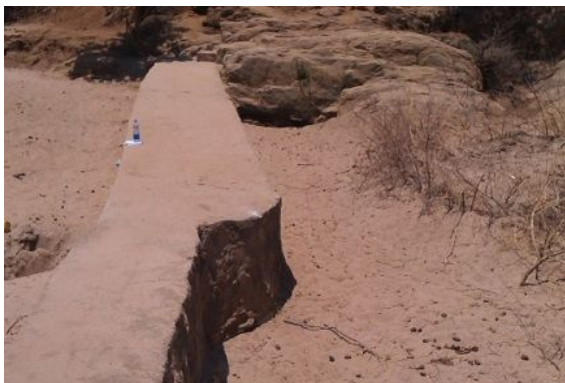
Figure A.24 Extension of Sand dam 18

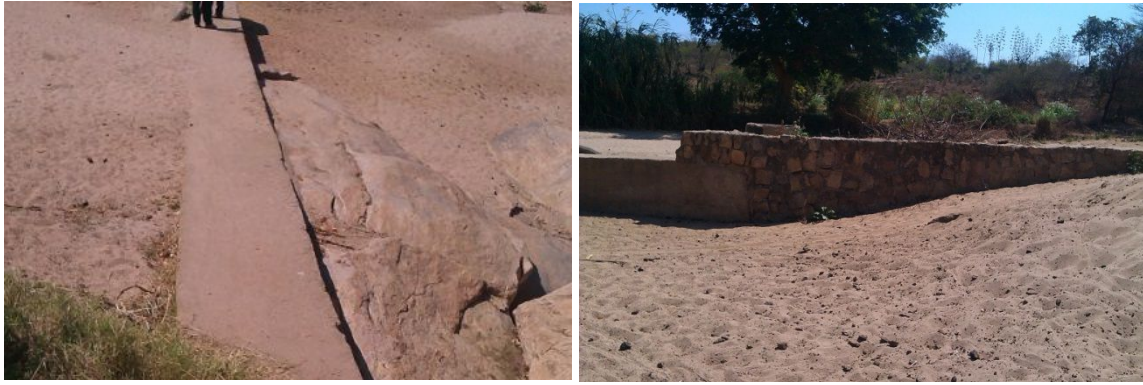
Sand dam 19 is repaired, and sited just upstream of a larger tributary. It is found on rocks, but at the left hand side the stream eroded the riverbank. Now the sand dam is extended so that it is working again. Sand is accumulated up to crest level. The associated public well just upstream of the sand dam is destroyed by floods. Upstream of the sand dam a farmer has dug his own private scoop hole. The water level in the scoop hole is about 30 cm below the surface of the riverbed.

Figure A.25 Sand dam 19 (left) with extended wing wall (right)

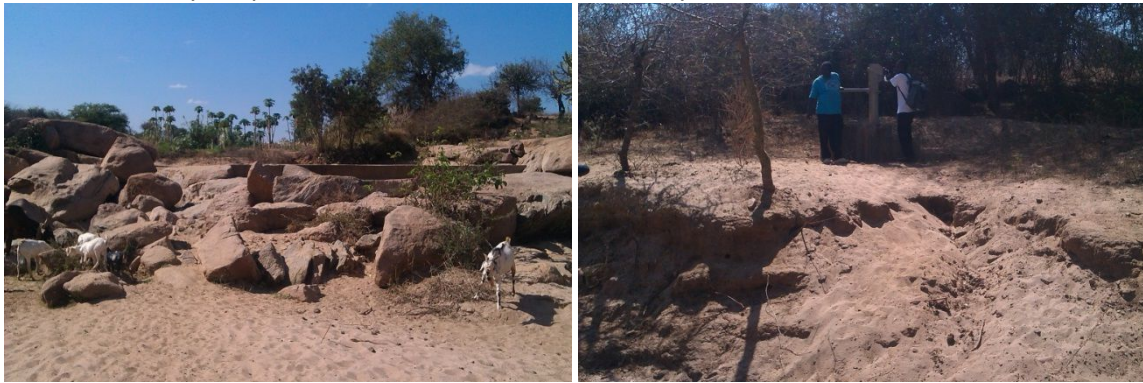
Sand dam 20 is located upstream of a steep river section and founded on rocks. According to local people it was constructed in the 1950s by missionaries. Since then it functions properly. Sasol built a shallow well in the upstream which is equipped with a hand pump. The handle is removed by the local community to spare the water for the end of the dry season.

Figure A.26 Sand dam 20 (left) with associated well (right)

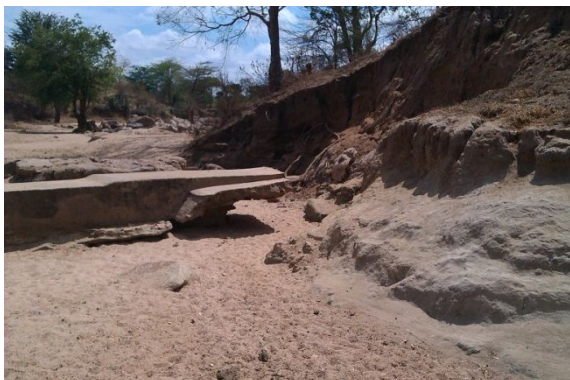
Sand dam 21 is located downstream of a steep river section. The foundation on the left hand side was eroded during the last years, so that the sand dam does not function anymore. About 100 meter upstream there is a single scoop hole which delivered water for an irrigated plot on the riverbanks during the last years. Since the dam broke the scoop hole dried out and even deepening the well into the weathered rock was not sufficient to recover the water source.

Figure A.27 Sand dam 21

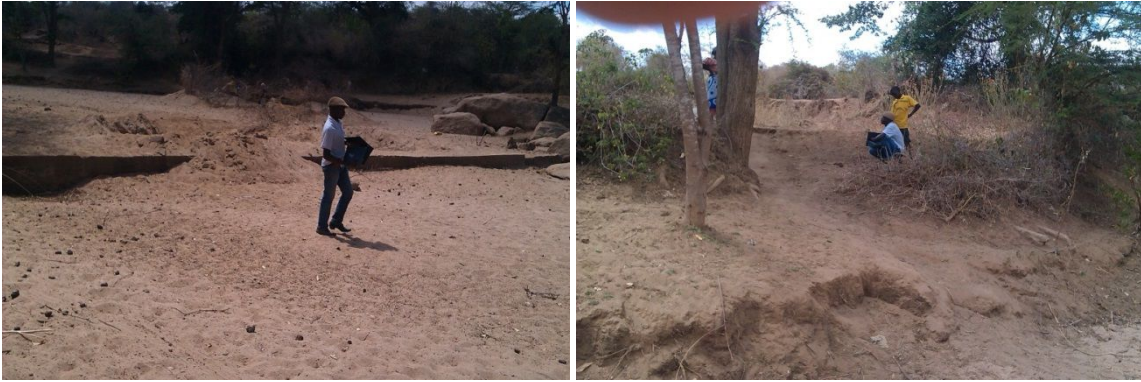
Sand dam 22 is still intact. It stuck out of the riverbed only several centimeter. On the left riverbank a public well is located on private land. The well was maintained by the owner, but since the community is responsible for its maintenance the well is in bad condition and delivers no water anymore. (see section A.2.5.3.3)

Figure A.28 Sand dam 22 (left) with associated well (right)

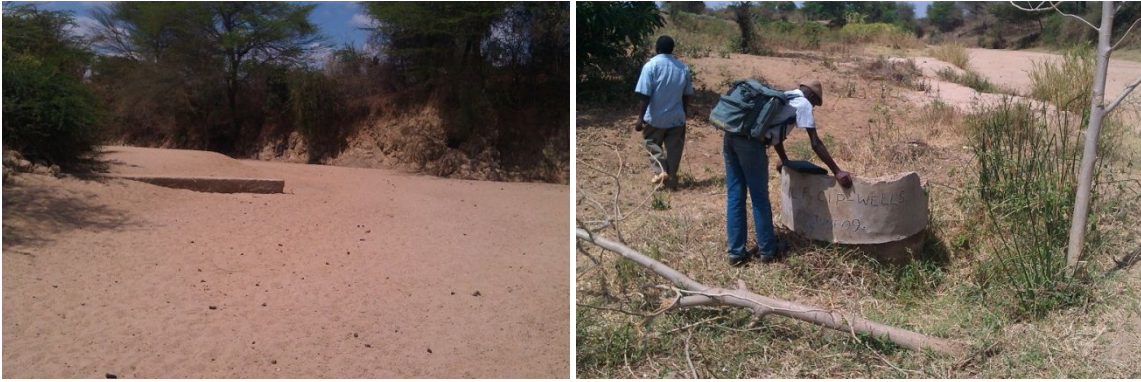
Sand dam 23 is located just upstream of a big tributary. In 2009 the sand dam was damaged by a heavy flood. The attempt to restore it failed. (see section A.2.5.3.3). Now the people still fetch water from a scoop hole upstream of the sand dam. But the water table in this scoop hole dropped considerable after the failure of the sand dam. Even if the people have to deepen the public scoop hole regularly it dries not out completely and attracts people from the Nduni tributary where water is even more scarce. The well associated with the sand dam is destroyed by heavy floods.

Figure A.29 Sand dam 23 (left) with associated well (right)

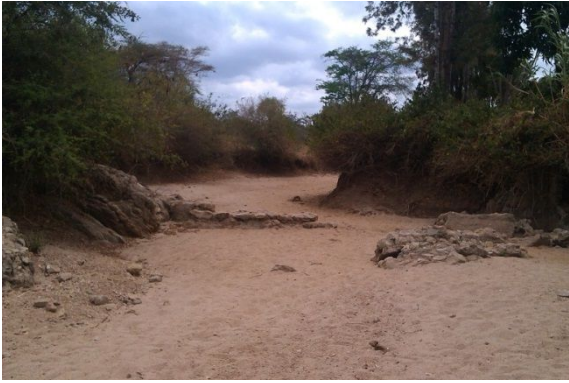
Figure A.30 Private sand dam in a tributary

In a rather big tributary of the Nduni stream the remains from a sand dam were found. According to local people the dam was build 10 to 15 years ago by one of the owners of the plots bordering the tributary. It was approximately 2 meter high with respect to the current riverbed. When the sand dam was matured the vegetation around the sand dam became green. However the sand dam failed after several years and the situation restored to the original state.

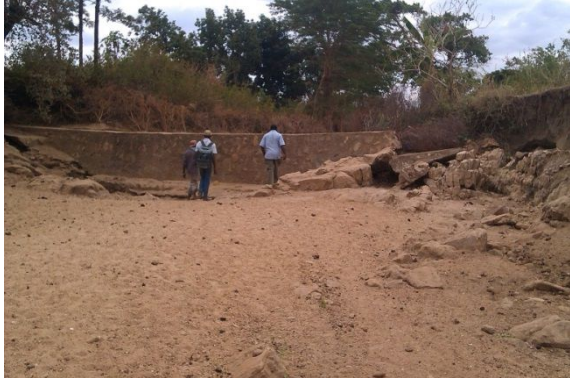
Figure A.31 Sand dam 24

Sand dam 24 was built by Sasol in 1996. The edges of the sand dam became a bit eroded. On the left side the outer part broke so that the water can pass the dam lower than crest level. Nevertheless the storage volume is still filled with sediments and scoop holes indicate that at least early in the dry season people can get water here. At the time of the visit the about 1,5 meter deep scoop hole was already dried up. A public well could not be found. But there are some private shallow wells in its vicinity.

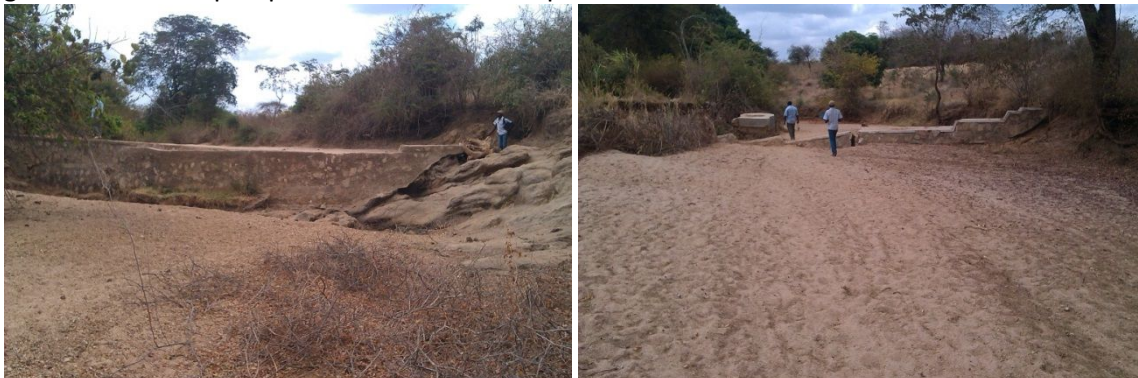
Figure A.32 Sand dam V (Left) and Sand dam VI (Right) sponsored by a donors

Upstream of sand dam 24 there are two sand dams (**sand dam V and VI**) which were sponsored by donors. Sand dam V is still intact but like sand dam 24 the sides of the sand dam are somewhat eroded and need to be maintained. Sand dam VI is broken. The few scoop holes in this area were already dried up at the time of the visit. There was no shallow well found that can be associated to sand dam V. The shallow well upstream of sand dam VI is damaged and filled with sediment. However in this area donors also sponsored several covered shallow wells on private land which are equipped with a pump. Most of these shallow wells still have water, but there is no indication of intensive use. According to some local people the donors promised that every owner of a well would get a cover and a pump for his well. Others reported that the whole well was donated.

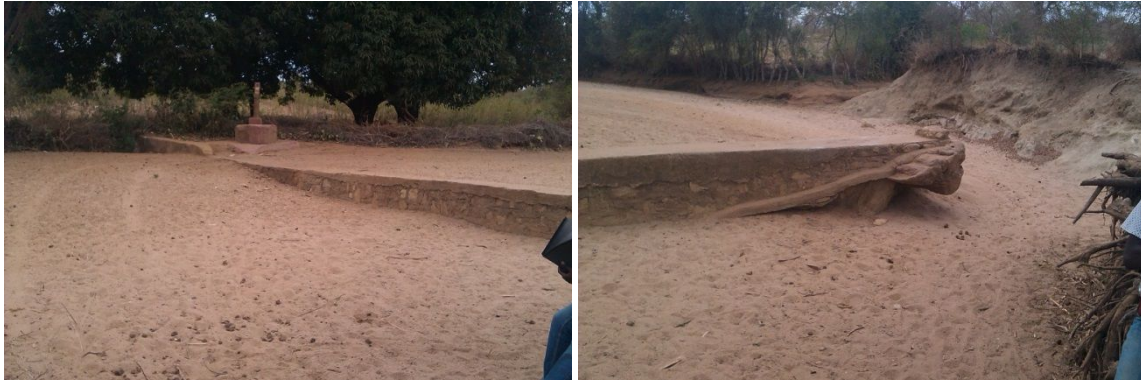
Figure A.33 Sand dam 25 (left) with eroded wing wall (right)

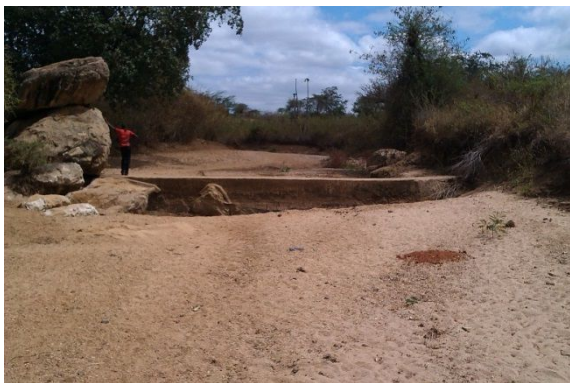
Figure A.34 Sand dam 26

Even if water can flow around the big rocks on the right hand side, **sand dam 26** is still intact. Upstream of the sand dam some scoop holes are dug into the riverbed. Wells associated with the dam could not be found.

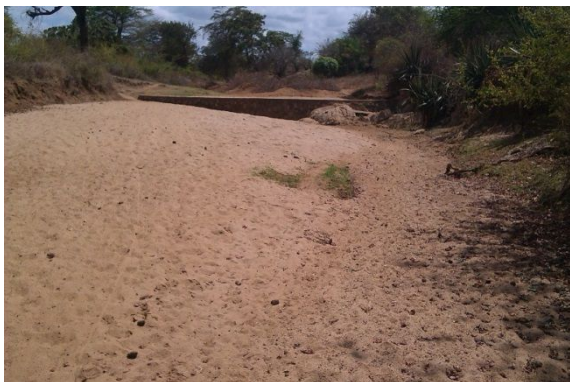
Figure A.35 Sand dam 27

Sand dam 27 is also still intact. In the upstream there are four 2 meter deep scoop holes dug into the riverbed that have little water. Next to the scoop holes there is a deep (private) shallow well. Its water depth is more than one meter.

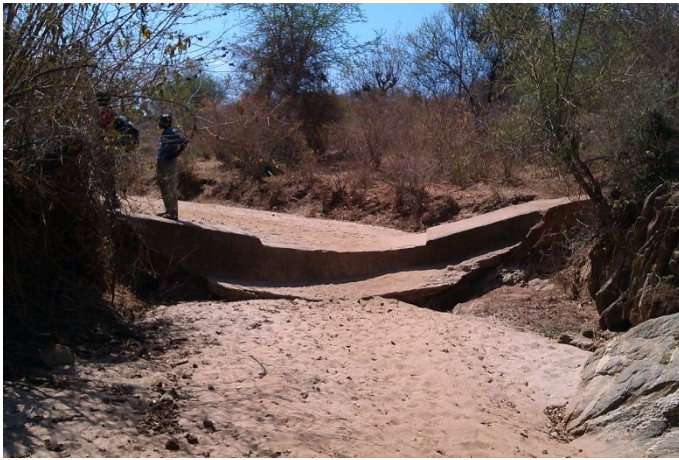
Figure A.36 Sand dam 28

Sand dam 28 is a small sand dam further upstream which is still intact. According to the local people Sasol used the remaining material to built the last sand dam in the area. It is also constructed to compensate for the lack of shallow wells in the area. People reported that Sasol faced difficulties to dig the wells to the necessary depth, which is deeper than in the other steams. Therefore Sasol decided to build an additional sand dam with the residual material. Originally there was no shallow

well near the sand dam. A couple of years ago donors sponsored a well for the community. After controversial discussions the well was built next to sand dam 28. The well could not be deepened enough to reach water because of the hard rock layer.

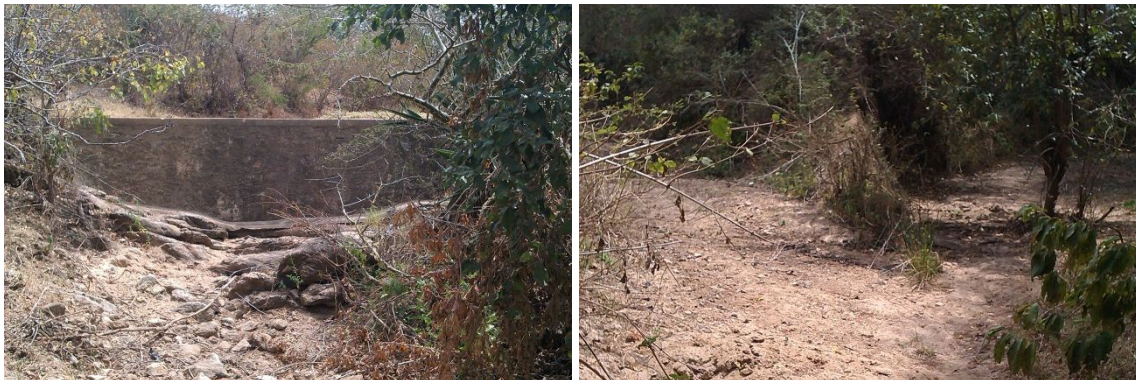
Figure A.37 Left: Eroded riverbed downstream of sand dam I; Right: Junction of the streams of the two main sources

The most northern part of the Kiindu catchment is called Kivuna. The Kivuna has two main sources. The stream starting in the far north, where sand dam 1 and sand dam 2 are sited, is not visited. The second source is located more to the west. Here a flow channel has developed just downstream of sand dam I. Upstream of sand dam I, sand has been accumulated in the flow channel between the two hill slopes. Downstream of the sand dam, the sandy riverbed is washed away and the bare rock in the riverbed is exposed (See Figure A.37 left). The width of the riverbed is between 2 and 4 meter.

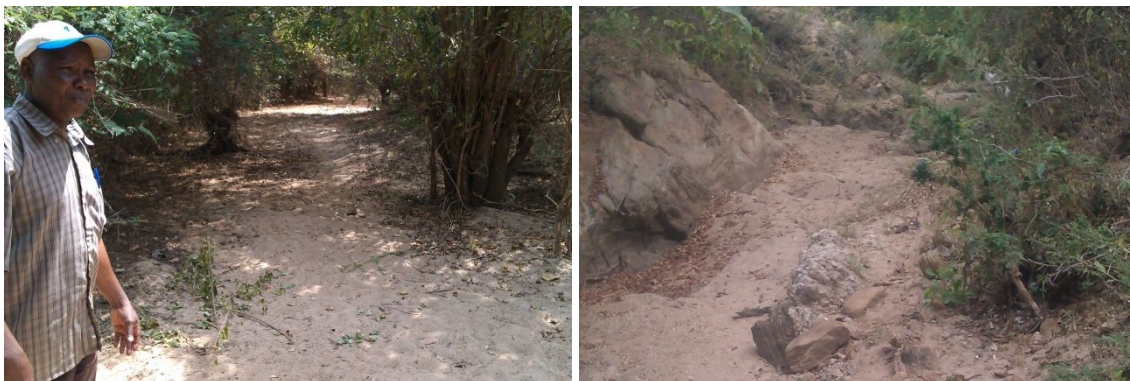
Figure A.38 Left: Sand dam upstream of sand dam 3; Right: Kivuna between sand dam 3 and 4

Further downstream the sandy riverbed becomes thicker. Due to the dense vegetation the riverbed could not be assessed entirely. Between sand dam II and 3, the streams of northern and western sources unite (see Figure A.37 right). Upstream of sand dam II, 3 and 4 the thickness of the riverbed increased due to the sand dams (see Figure A.38). Upstream of sand dam 3 the process of accumulation of sediments is not completed after its repair.

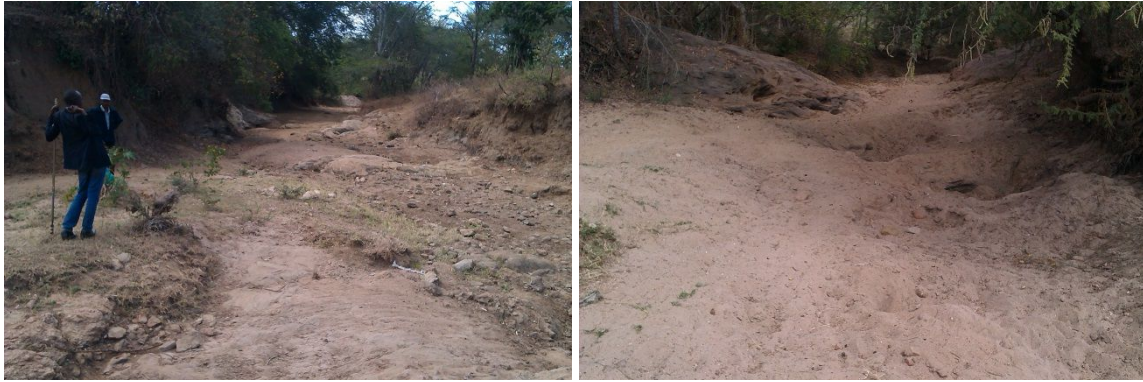
Figure A.39 Left: highly eroded river section downstream sand dam 4; Right: Sand harvesting upstream of sand dam 4

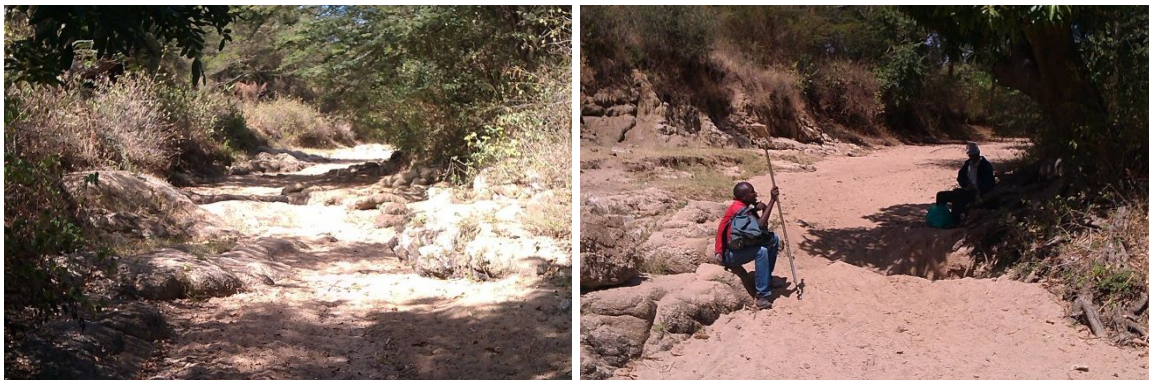
Figure A.40 Kivuna stream

Downstream of sand dam 4 the riverbanks are eroded and the channel is widened (see Figure A.39 left). The riverbanks have steep slopes. The thickness of the riverbed increases gradually. Due to the irregular base rock the thickness varies considerably from a few centimeters to more than one meter. Till sand dam 6 the river winds between the riverbanks. The slopes of the riverbanks become milder. In this section only sand dam 5 disturbs the natural morphological balance. On the left hand side, the sand dam is properly founded on rock while on the right side it is washed out. Now every rainy season the right riverbank is eroded bit by bit. According to interviewees the riverbed rose after the construction of the sand dam but now it is below original level today.
