Exploring the influence of sand storage dams on hydrology and water use

A case study in the Kiindu catchment in Kitui, Kenya

Master of Science

in Civil Engineering

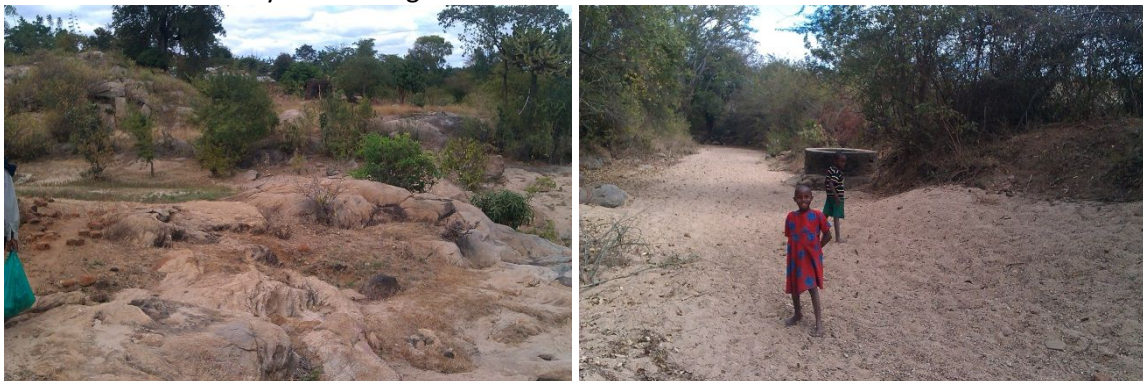
Figure A.41 Left: steep rocky river section downstream sand dam 6; Right: stream downstream of sand dam 7

Just downstream of sand dam 6 a steep rocky section starts (see Figure A.41 left). Here the riverbed is more a lane on which the water flows downstream. At the downstream end of this river section the river forms a sandy riverbed again.

The broken sand dam 7 downstream of the steep section also causes erosion on the riverbanks next to it. The width of the riverbed in the section ranges between 5 and 10 meters. (see Figure A.41). The sandy riverbed in most parts is thicker than 1 meter. Before the stream unites with the Musaya tributary, two larger tributaries (see Figure A.42). Till the junction with the Musaya the width of the Kivuna stream increases to more than 10 meter (see Figure A.42).

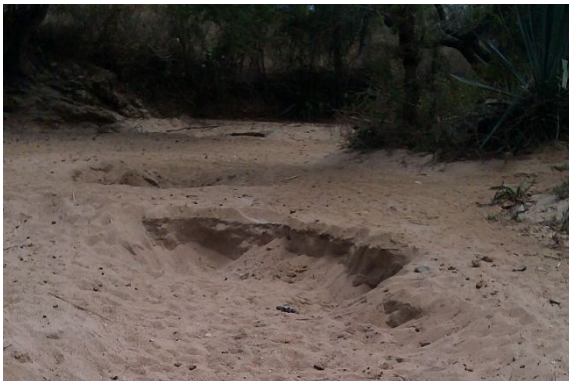
Figure A.43 Riverbed upstream of sand dam 12

The Muasya tributary is visited from sand dam 12 till its mouth into the Kiindu. Upstream of sand dam 12 its riverbed is between 6 and 8 meter wide. The holes in the riverbed indicates that the people use the riverbed as a source of sand for construction sites.

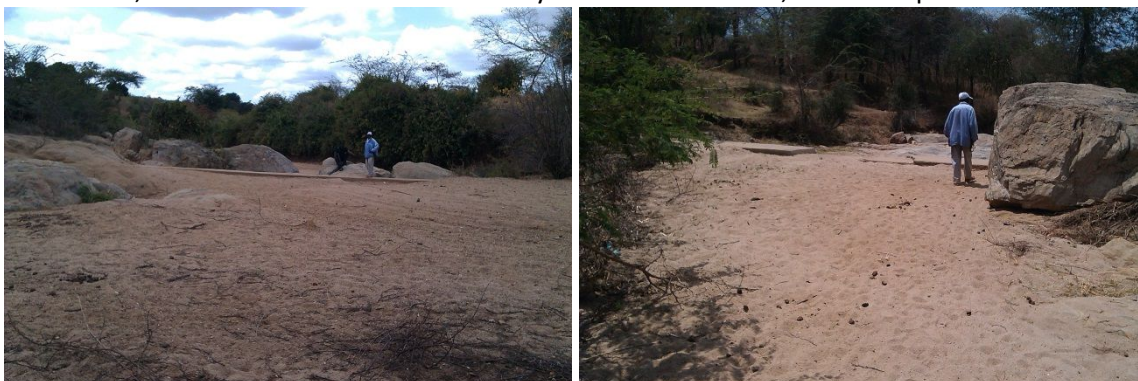
Figure A.44 Left: Riverbed upstream of sand dam 11; Right: Narrow riverbed upstream of sand dam 10

Upstream of sand dam 11 the riverbed becomes broader to about 12-15 meters (see Figure A.44), while at several rocky locations the width becomes smaller, like in the vicinity of sand dam 10 (see Figure A.44). The thickness of the riverbed varies, because of the irregularities of the underlying rock formations, from several centimeters in rocky sections to about 1,5 meters upstream of sand dams.

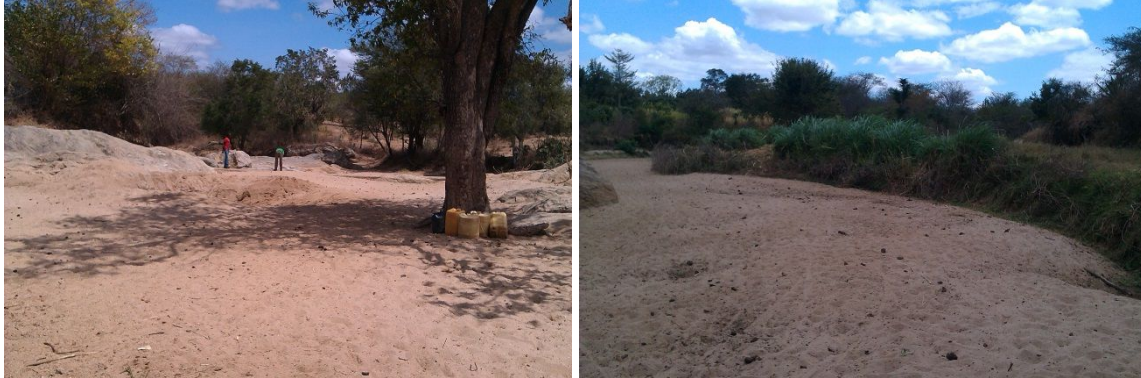
Figure A.45 Left: Riverbed upstream of sand dam 14; Right: riverbed between sand dam 15 and 16

Downstream of the junction of the Muasya and Kivuna, the Kinduu (which is what the stream is called now) is more than 20 meter wide. The thickness of the riverbed is hard to estimate but in many parts larger than 1.5 meter. About 100 meter downstream of the junction sand dam 14 and 15 are sited about 100 m apart. They are founded on rocks and mark the up and downstream of a short steeper section.

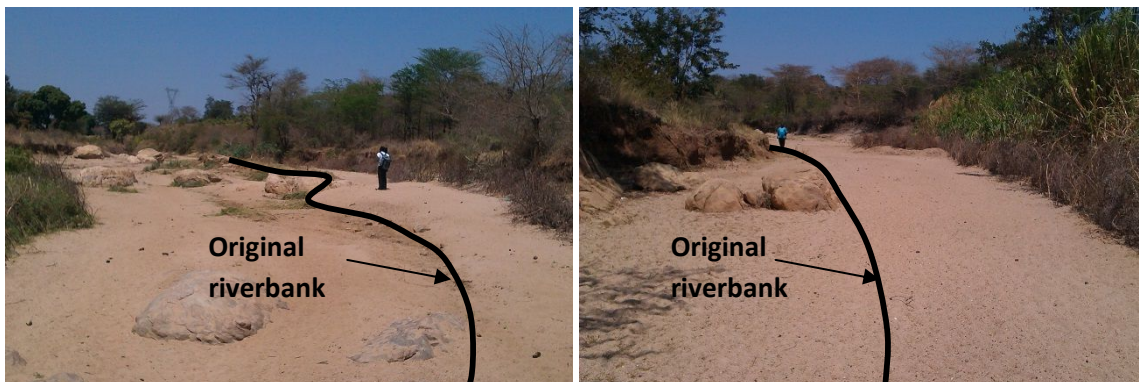
Figure A.46 Eroded riverbanks downstream of sand dam 16

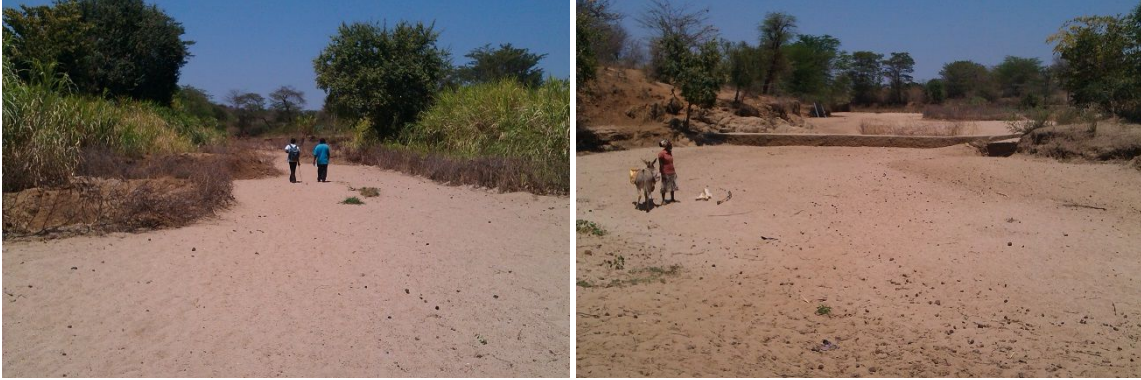
Figure A.47 Left: irrigated riverbank; Right: Riverbed upstream of sand dam 18

Between 100 and 200 meter upstream of sand dam 18 both riverbanks are intensively irrigated and protected by Napier grass (see Figure A.47). In the vicinity of sand dam 18 only small plots are irrigated (see Figure A.47).

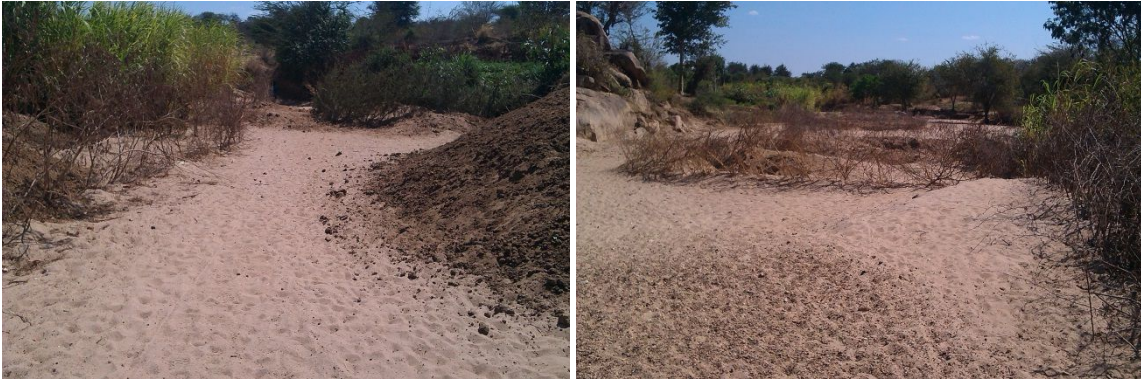
Figure A.48 Riverbed scattered with scoop holes to supply the irrigated riverbanks upstream of sand dam 19 (left) and sand dam 20 (right)

According to people the river changed its course downstream of sand dam 18. Areas next to the former riverbed dried up, while plots along the new river bed have now enough water for irrigation (see Figure A.48). In this area the river becomes narrower again (see Figure A.48). Around sand dam 19 only a few short sections of the riverbanks are protected by Napier grass. Upstream of sand dam 20 almost riverbanks are protected by Napier grass and the riverbed is blotched with private scoop holes.

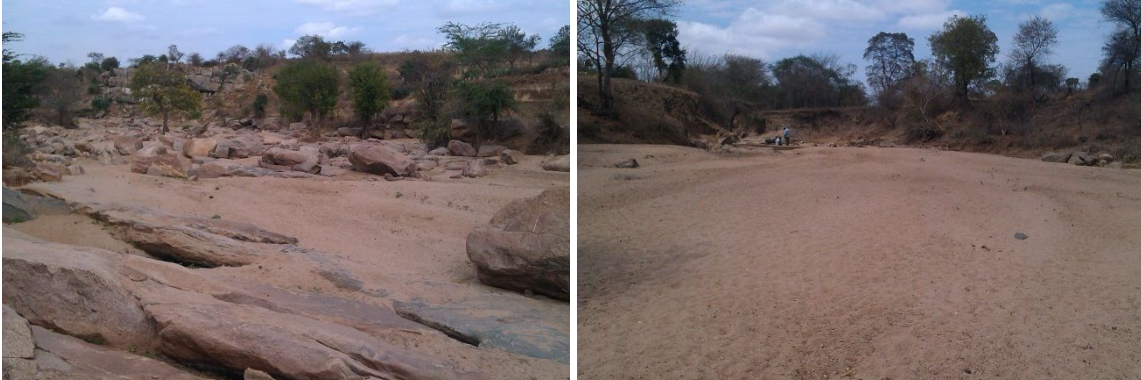
Figure A.49 Left: Steep rocky river section; Right: Riverbed upstream of sand dam 21

Downstream of sand dam 20 there is a steep rocky section (see Figure A.49). The riverbed is now rocky and up to 60 meter wide. Downstream of this steep section the river forms a sandy river bed again (see Figure A.49). The river now is between 20 and 30 meter wide. The thickness of the riverbed is hard to estimate but can be considered that it is for large parts to be around 2 meter.

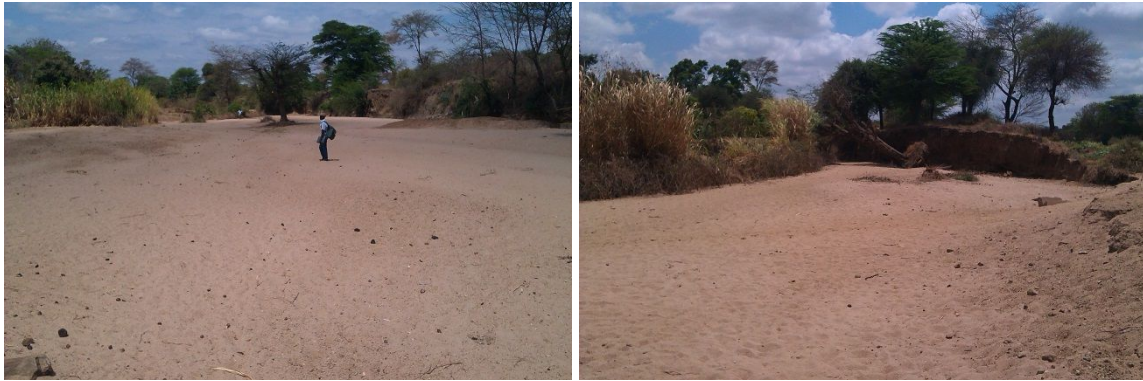
Figure A.50 Left: riverbed upstream of sand dam 23; Right: Large tributary just upstream of sand dam 23

The riverbanks are exposed to heavy floods, which threatens the irrigated plots on the riverbanks. Just upstream of the broken sand dam 23, a large tributary enters the stream (see Figure A.50).

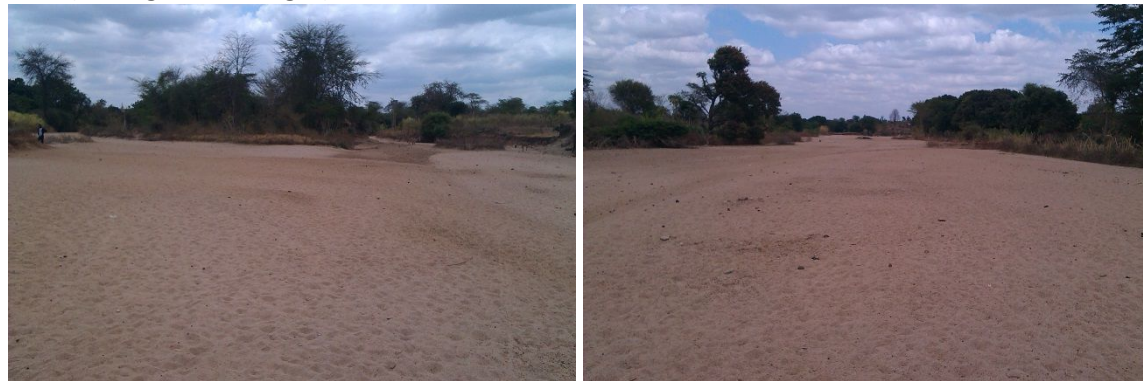
Figure A.51 Left: junction of the Nduni and Kiindu; Right: Kiindu downstream of junction with the Nduni

Until the junction of the Kiindu with the Nduni the river stays about 30 -50 meter wide (see Figure A.51 left). Through the measurements conducted in this area, the thickness of the riverbed could be estimated more than two meters. Downstream of the junction the Kiindu becomes about 100 meter wide (see Figure A.51 right).

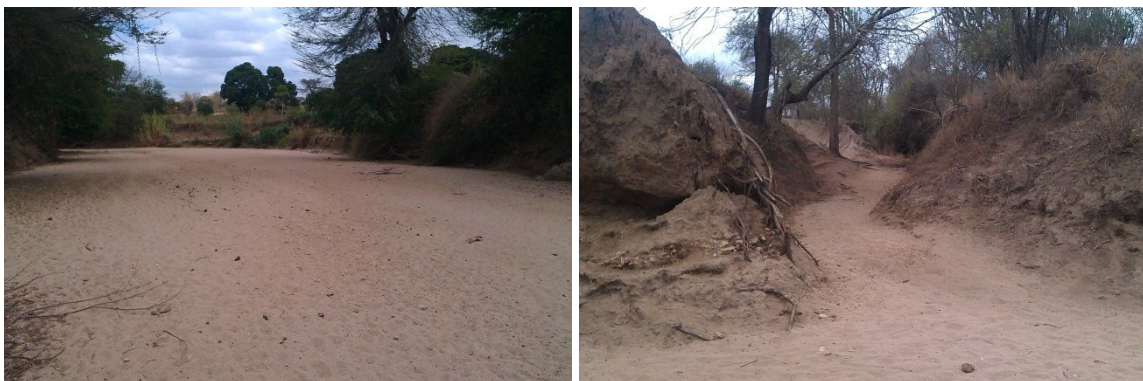
Figure A.52 Left: Riverbed in the downstream part of the Nduni; Right: Tributary

The Nduni tributary was visited from the junction with the Kiindu in upstream direction. According to local people the downstream part of the Nduni is free of human interference. Therefore it can be considered as reference area for the natural state of the catchment. Only sand dam 29 further downstream may have influenced the stream. But there are no human activities along the downstream of the Nduni. Large trees and often dense vegetation protect the river banks against erosion. (see Figure A.52). Often the riverbanks are more than one or even two meter above bed level. The stream is about 30-40 meter wide and several tributaries enter the main stream.

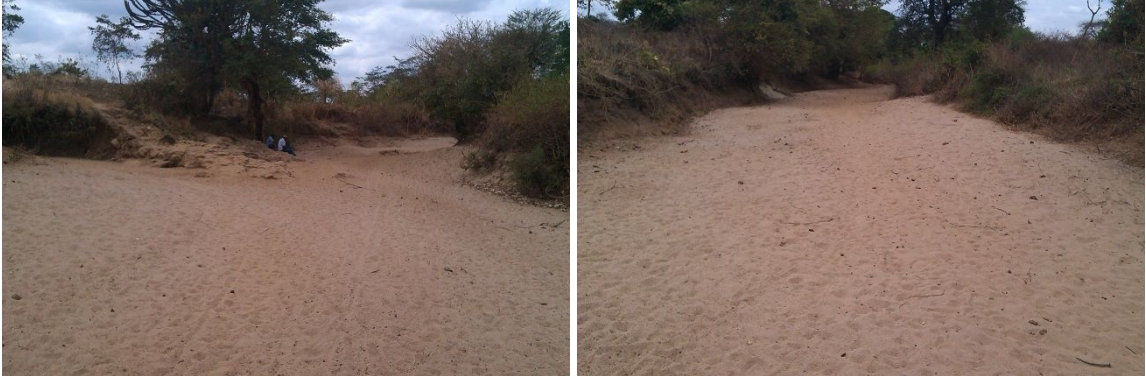
Figure A.53 Riverbed downstream of sand dam 25

Further upstream Sasol built four sand dams. Upstream of the sand dams, which are higher than the sand dams in the Kiindu, the channel is filled with sediments. Level differences between the riverbed and the riverbank become smaller (see Figure A.53) and increase again in upstream direction. According to the local people the Nduni could only be called a river after their construction of the sand dams. Originally it was a narrow streamlet with a thin riverbed.

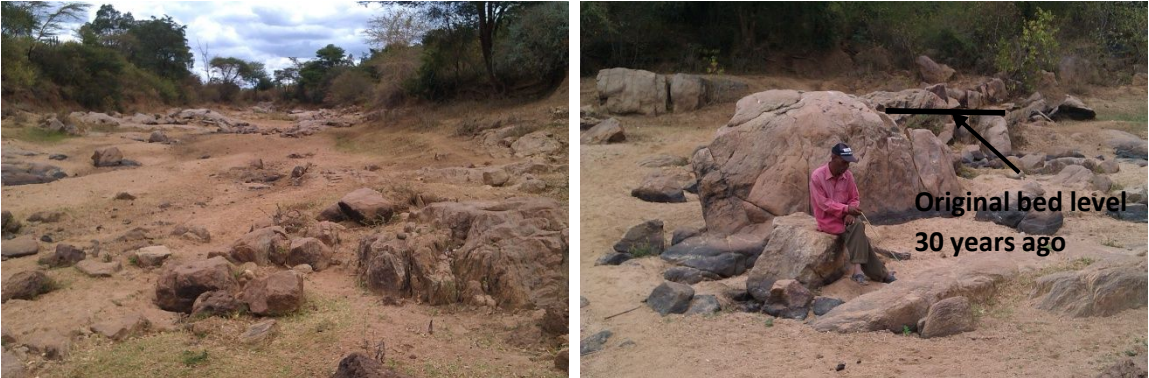
Figure A.54 Left: Rocky riverbed of the Nzeeu river Right: Indication of the old riverbed level

I spend one day to visit the Nzeeu river, which is an alternative water source for the upper parts of the study area (see section A.2.3). In the inspected reach no sand dams are constructed. The local people here do not report about erosion of the riverbanks. In the Nzeeu river it is the riverbed that is washed away. People told me that 30 years ago the riverbed was mainly covered by sand. Only the tops of the rocks in the riverbed could be seen. Now the riverbed is about one meter lower than 30 years ago (see Figure A.54). People are uncertain, if the riverbed of the Nzeeu will supply enough water for the neighboring communities in the future.

The reason for the erosion of the riverbed in the Nzeeu catchment is as unclear as the erosion of the riverbanks in the Kiindu catchment. Possible explanations for the riverbed erosion are the construction of dams in the upstream and the massive extraction of sand near Kitui for construction purposes.

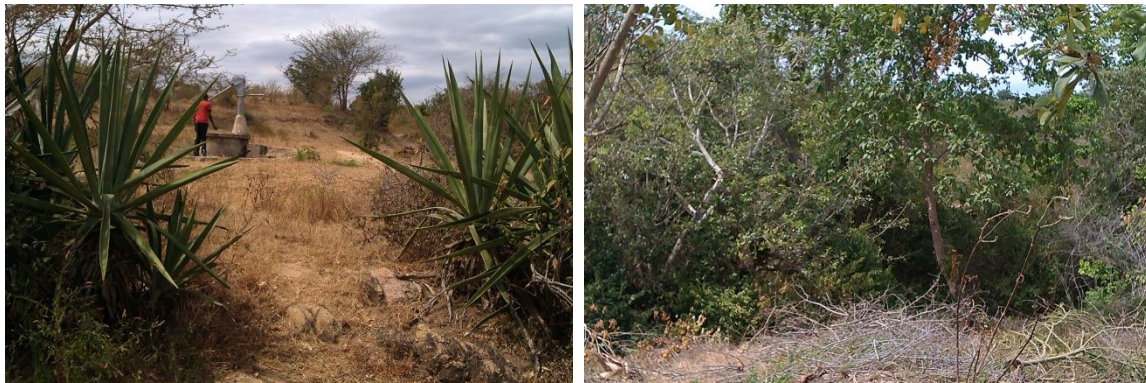
Figure A.55 Left: mild sloped landscape with sparse vegetation around sand dam I; Right: naturally green vegetation along the stream

The trans-sectional walks started in the vicinity of sand dam I. Here the slopes on the hilltops are mild and used for rain fed agriculture. Closer to the stream naturally dry vegetation dominates. (see Figure A.55). Between sand dam I and sand dam 4 the slopes along the river are steep and the vegetation is 'naturally green'. Large parts of the river in this section are overgrown by vegetation and the river is partly difficult to access from the riverbanks (see Figure A.55). Mulango, a small village with shops and bars is located east of the stream. Most people on the east side have some fruit trees in their gardens but do not do extensive agriculture. On the hill slopes on the western side people grow rain fed crops like beans and peas.

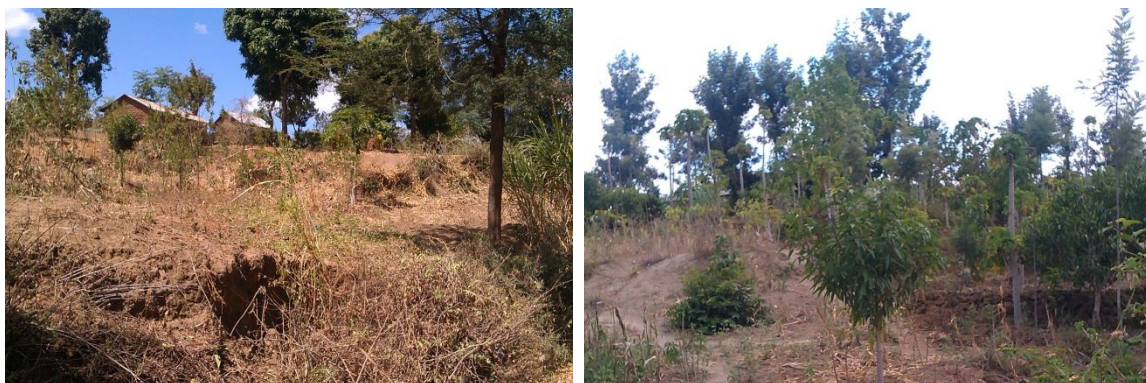
Figure A.56 Left: rain fed agriculture: beans and papaya trees

Downstream of sand dam 4 the vegetation becomes less dense. The stream is not completely overshadowed by vegetation anymore. Rain fed agriculture is now applied on both sides of the stream. Since the slopes become milder the beans and pea fields reach further to the stream. According to the people, the vegetation became less dense during the last years. Some blame the poor rain of the last years for it, while others also mentioned that people cut more trees to make charcoal for burning bricks. Next to sand dam 6, about 100 meter uphill, a farmer irrigates his garden with water from his well.

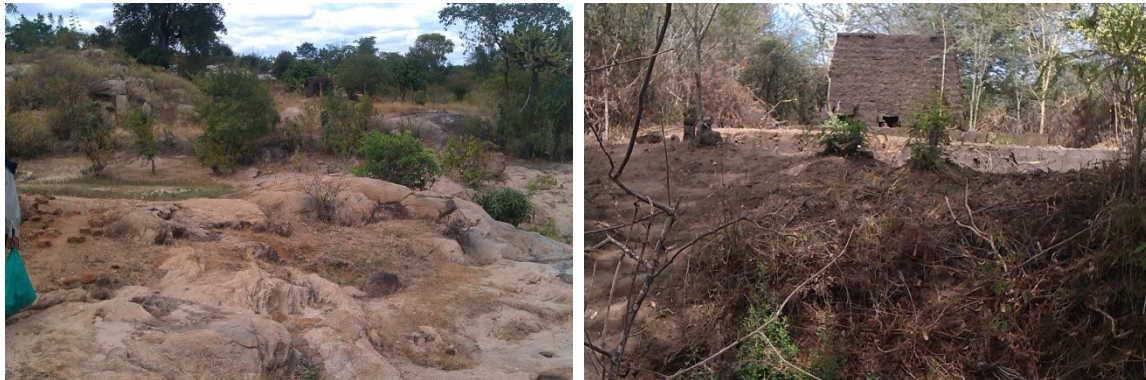
Figure A.57 Left: Dry resistant vegetation on the steep river section; Right: brick making site on the riverbanks

The slopes along the steep river section downstream of sand dam 6 are covered by naturally drought resistant vegetation. Due to the deep slopes the area is not used for agriculture. Further downstream a small strip on the riverbanks is covered by trees and bushes. Behind this strip people use the land for rain fed agriculture and brick making.

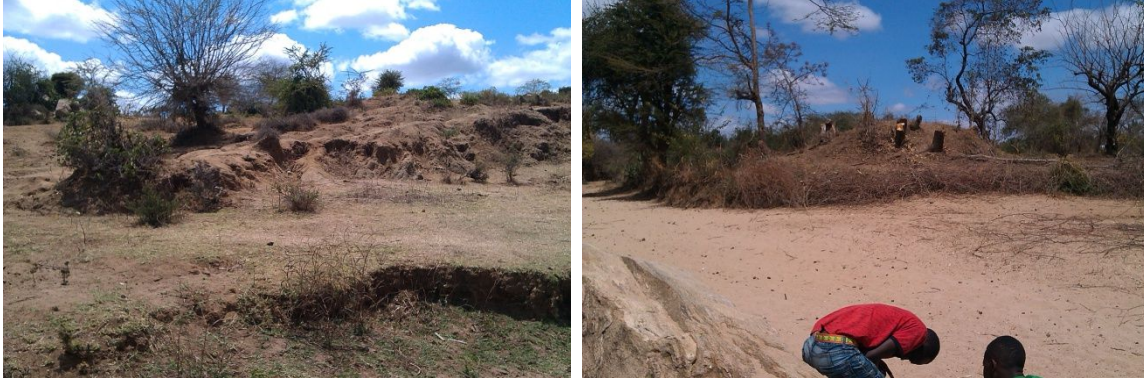
Figure A.60 Left: Riverbank unprotected against erosion; Right: Cut trees on the riverbanks

Downstream of the junction of the Kivuna and the Muasya the strip of natural vegetation that covers the riverbanks in the Kivuna and Muasya disappears almost completely. The area upstream of the sand dams 14 and 15 are dominated by brick making sites. The trees on the riverbanks are cut for the production of charcoal (Figure A.60 right). On the hill slopes and the riverbanks the soil is bare and not protected against erosion (Figure A.60 left).

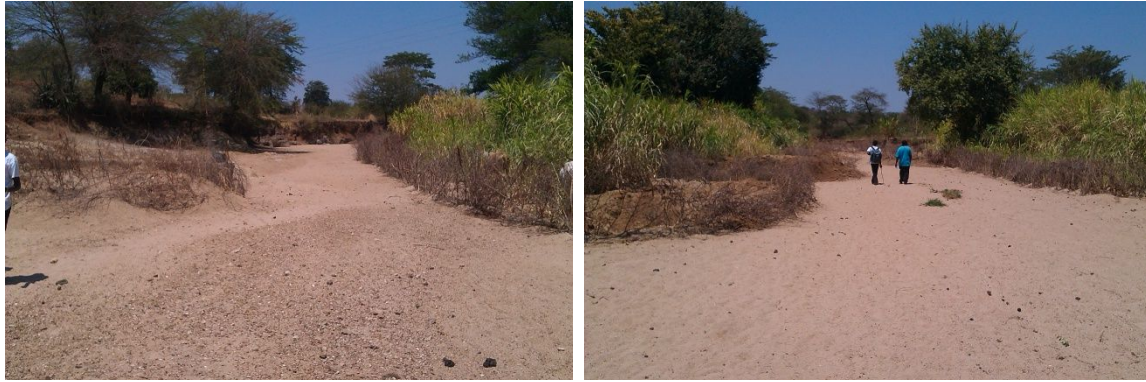
Figure A.62 Left Napier grass next to sand dam 17; Right: Napier grass protects irrigated plots on the riverbanks

Till sand dam 16 several short sections of the riverbank are protected by Napier grass against erosion. Only one farmer irrigates his plot on the riverbank. Next to sand dam 16 another farmer irrigates his vegetables. Downstream of sand dam 16 the vegetation consist of trees and bushes. The Napier grass which protects the riverbanks around sand dam 17 also serves as food for the cattle at the end of the dry season (Figure A.62 left). Further downstream the plots behind the protected riverbanks are irrigated with water from scoop holes in the riverbed (Figure A.62 right).

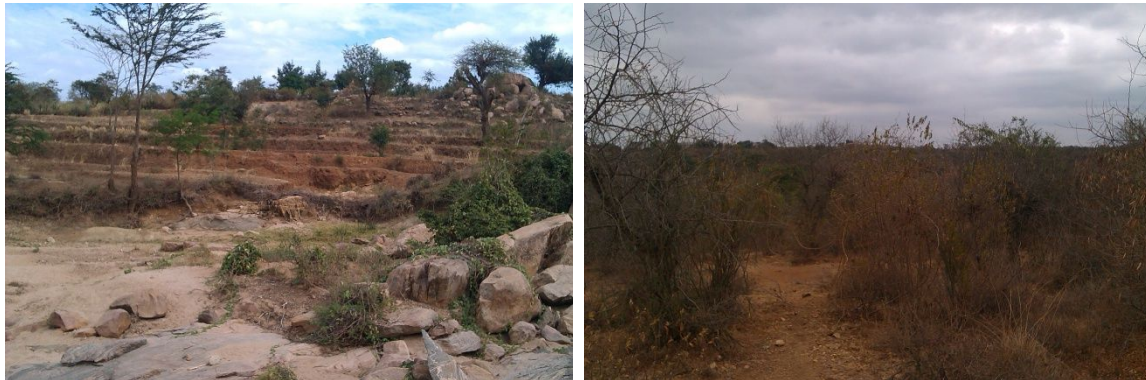
Figure A.65 Left: Terraces on the hill slopes; Right: Bushes on higher elevations

The area downstream of sand dam 20 is sparsely populated. It is dominated by steep slopes which are covered by dry trees and bushes (Figure A.65 right). On the slopes in the steep section, the people dug terraces for rain fed agriculture (Figure A.65 left).

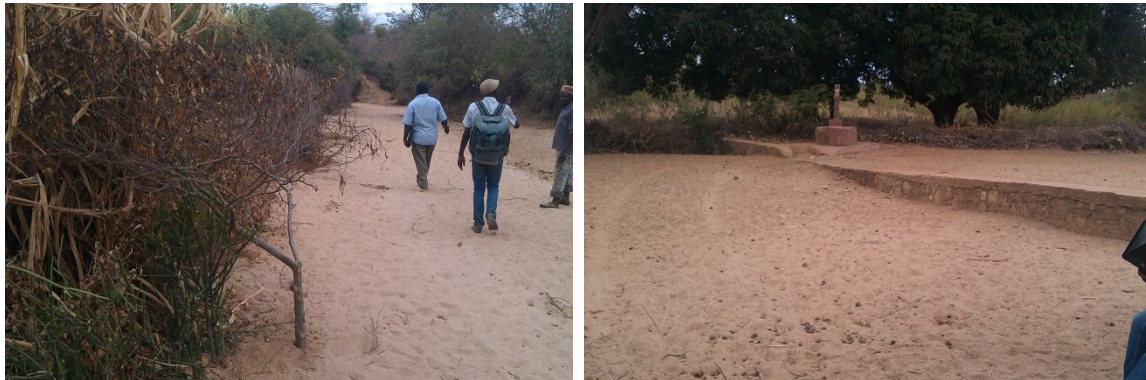
Figure A.68 Left: Protected riverbank; Right: big mango trees next to sand dam 25

Upstream of the sand dams V and 24 the area becomes more populated. Further upstream the people start to do rain fed agriculture on the hill slopes. The private land along the river is protected with bushes and Napier grass (Figure A.68). In addition to rain fed crops several people planted mango trees especially in the area around sand dam 25 (Figure A.68).

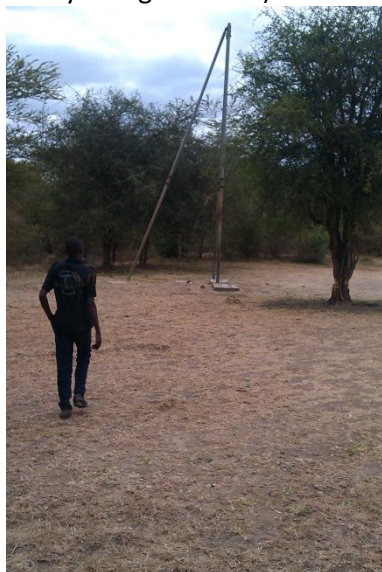
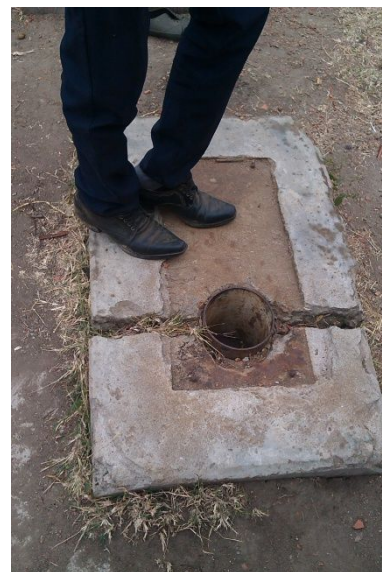
Figure A.71 Borehole next to Mulango

The first borehole was drilled next to Mulango in the nineteen fifties by missionaries under the colonial power to supply the secondary school in Mulango with water. The water from the borehole is salty like the water in the river at this location. But it was still suitable for use at school. About 10 years ago another borehole was drilled in the Nzeeu catchment closer to the secondary school. The pump and all other equipment was removed from the old borehole. The ownership of the borehole after removing the pump was not clear (at least nobody I spoke to knew it exactly). The attempt of two neighbors to cover the borehole and to conserve the borehole for the future failed. Other members of the community removed the cover, because they feared, the borehole would be claimed by these individuals. Now the borehole is filled up with stones which children have thrown into the pipe. According to one of the neighbors, now, cleaning the borehole is more expensive than drilling another one. (This history of the borehole next to Mulango was reported by Mr. Mutua during an interview on Tuesday 6 August 2014.)

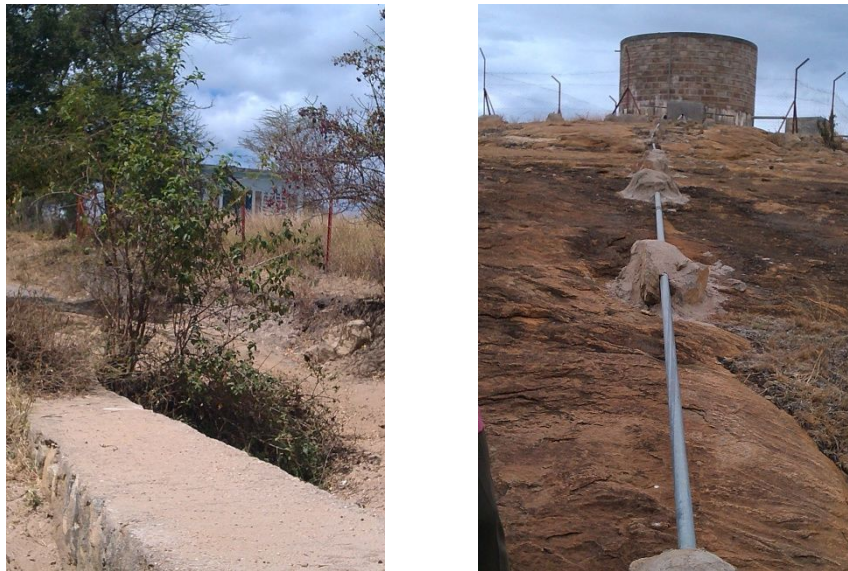
Figure A.72 left: Pumping Station Right: Storage tank on top of a hill

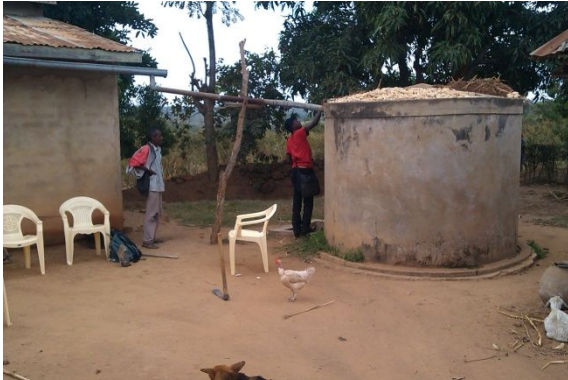
Figure A.73 Roof water harvest tank

Roof water harvesting becomes more and more common in the area. Especially in the more developed areas, which are better connected to the road network, many houses are equipped with tanks, in which the collected rain water from the roof is stored.

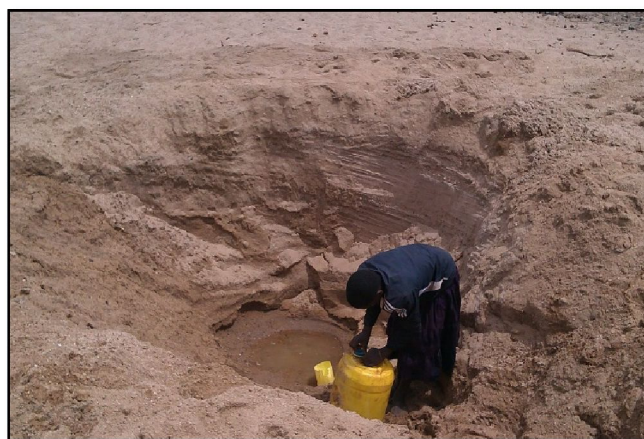
Figure A.74 Public scoop hole

Traditionally the people dig scoop holes in the riverbed until groundwater is reached and fetch water manually from these holes. This technique is still widely used when public wells are broken or people are prohibited to use them. In several areas the distance between the wells and their homestead is very large, so that people prefer to fetch water from nearer scoop holes. Another advantage of the scoop holes is that it is easier. Pulling up buckets a couple of meters at wells without function pump is too hard for some people (especially children).

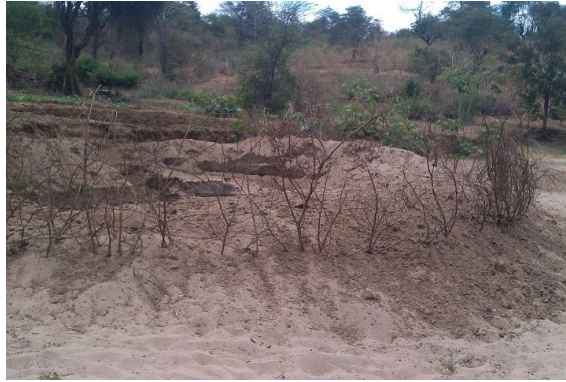
Figure A.75 Private scoop hole next to irrigated plot protected by thorny branches

In the upstream parts most of the scoop holes are public and everybody can use them to fetch water or to water goats and cows. In the downstream parts (especially from the junction Kivuna/Muasya downwards), scoop holes become more applied. Here often different scoop holes are used for different purposes. Scoop holes for domestic use are in general public, while scoop holes for watering goats and cattle and irrigation are often private. These private scoop holes are protected by a fence of thorny branches which are put into the sand.

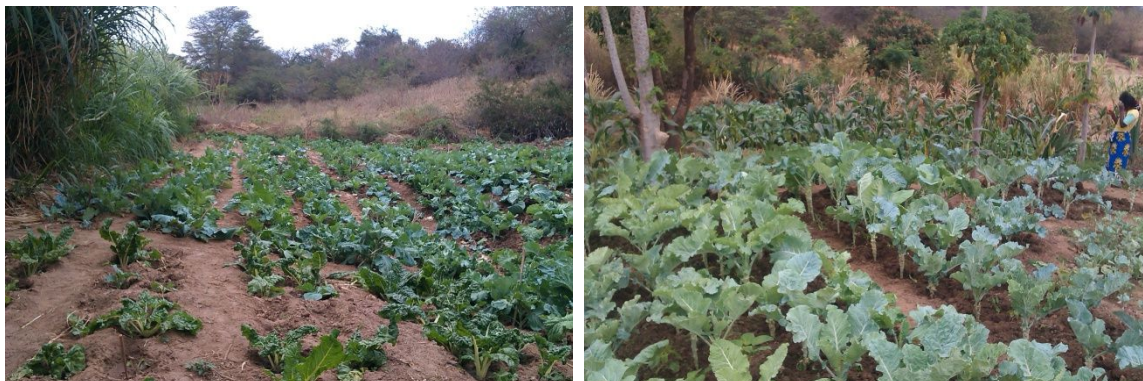
Figure A.77 Traditional irrigated vegetables

The common grown crops are peas and beans which do not need irrigation. Apart from common agricultural praxis of growing rain fed crops, several people apply irrigation to grow vegetables. Most farmers who irrigate use buckets to fetch water from scoop holes and pour it in depressions next to the vegetables.

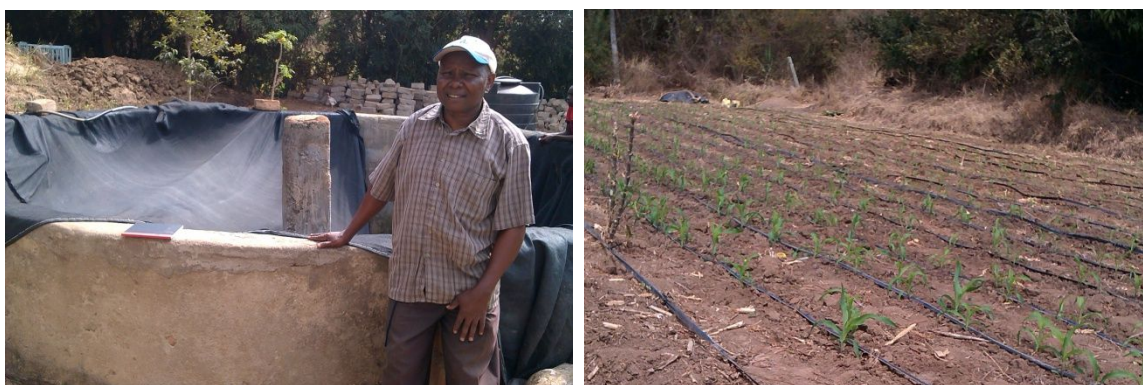
Figure A.78 Mr. Muthoka next to his tank (left) to irrigated his fields (right)

In the Kivuna catchment upstream of sand dam 3, Mr. Muthoka is pumping water from his well next to the stream to a tank next to his house uphill. He installed a pipe network over his whole plot to apply drip irrigation by gravity on his fields. In total he has 6 fields. Each field is divided into two subplots that are 10 broad and 30 meter long. During the fieldtrip he irrigated 2 of these plot. But he plans to irrigate all plots, which are in total 3600 m² in the future.

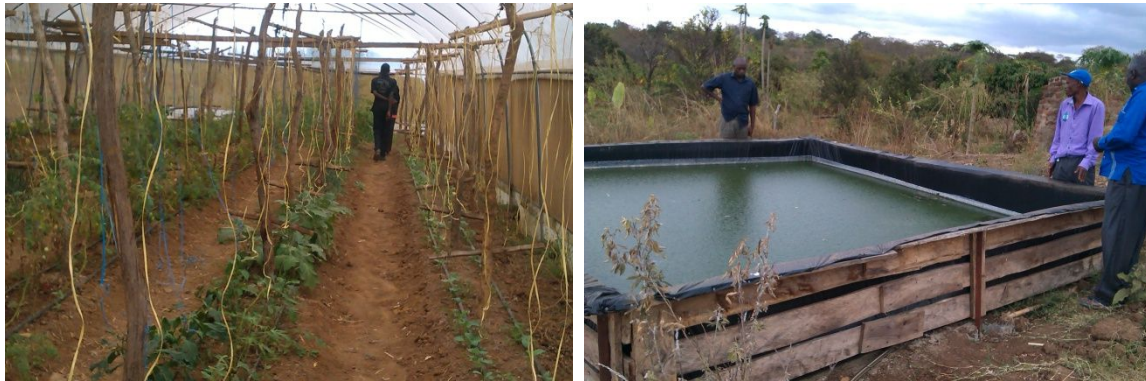
Figure A.79 Greenhouse and Fishpond supplied by water from shallow wells

Next to sand dam 4 his brother Mr. Muimi invests in wells. He plans to irrigate his land after his retirement. At the moment he has two wells. One is used to pump water into a tank next to his house to supply his greenhouse with water. The diameter of the other well is too small to efficiently

pump water. Therefore people use buckets to pull water to the surface for domestic use. Now he is investing in a well with a diameter of about 5 meter which will be 58 feet deep. In the end when all wells are constructed at the calculated depth he will be able to pump approximately 78 drums (7800l) every three hour. With this well he plans to irrigate the rest of his plot. Next to agriculture he experiments with a fishpond as an alternative business.

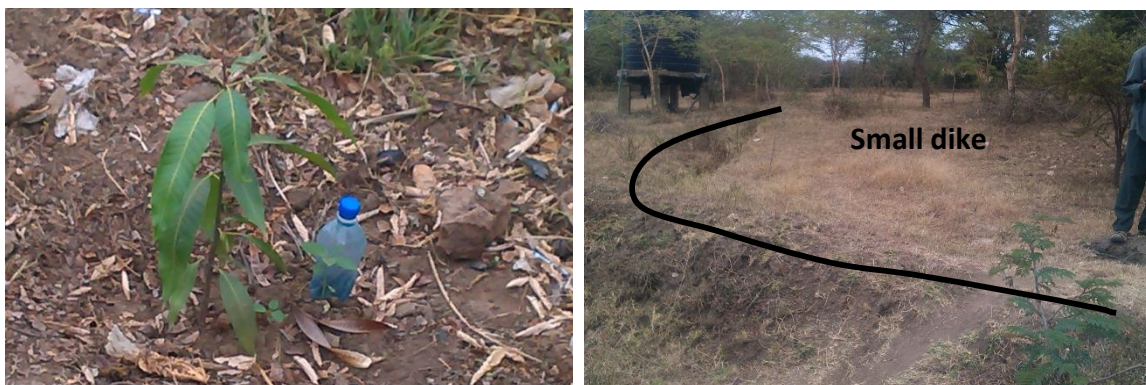
Figure A.80 Left: Bottle drip irrigation; Right: Earthwork to guide overland flow towards a collection pit

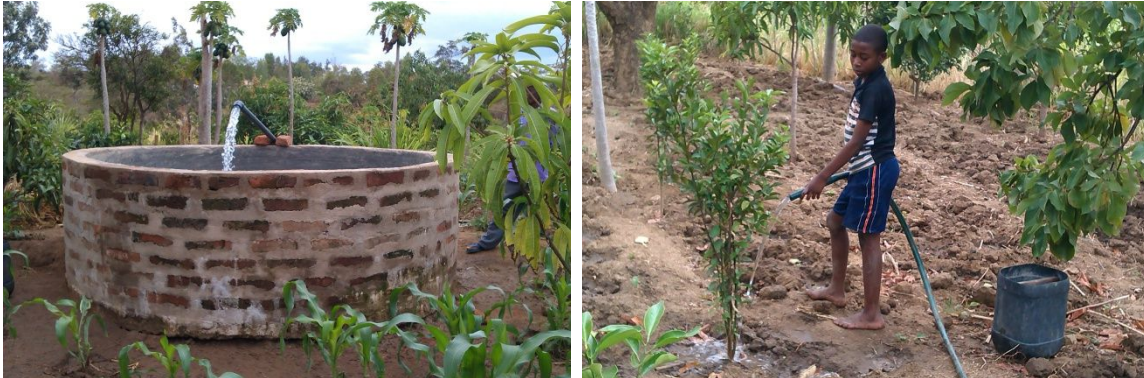
Figure A.81 Water tank (left) to irrigate vegetables by gravity with a garden hose (right)

Next to sand dam 6, Mr. Wambua invests money he earns in Nairobi in a well next to his house. He equipped the well with a pump and pumps once a week about 7m³ to a tank next to his house. From this tank his family, who takes care of the garden, irrigates vegetables and fruit trees with a garden hose. In the future he wants to extent the irrigated field and probably also construct a fishpond.

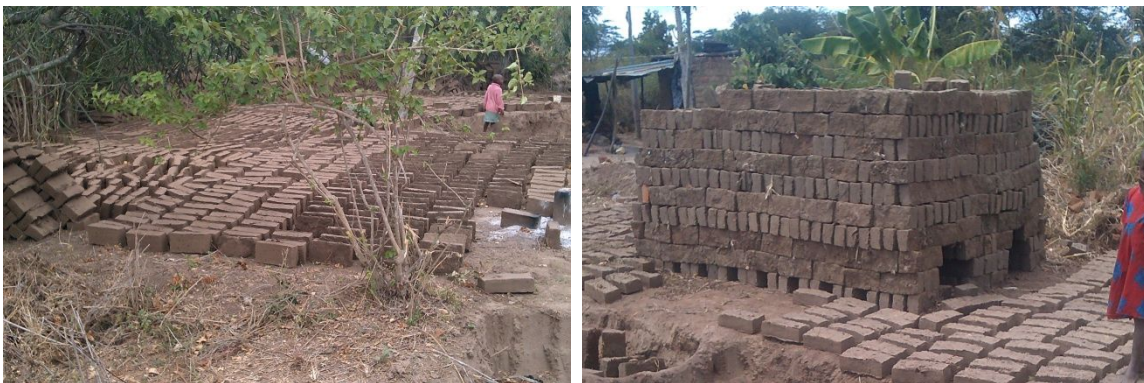
Figure A.82 Brick making site. Bricks drying (left); preparation for burning the brick (right)

Throughout the catchment people make bricks to build new or extent old houses. Brick making is also an opportunity to generate income. For making bricks the dry soil needs to be mixed with water until the soil becomes soft. Then the soft soil is pushed into a standard form. The wet brick is removed from the form and laid in the sun to dry (Figure A.82). After drying the brick is stapled and burned (Figure A.82).

From one jerrycan (20 liters of water) about 6 bricks can be made. In contrast to agricultural water use, water needs to be available for the period of brick making only. Also the water quality is considered less important than for agricultural purpose.

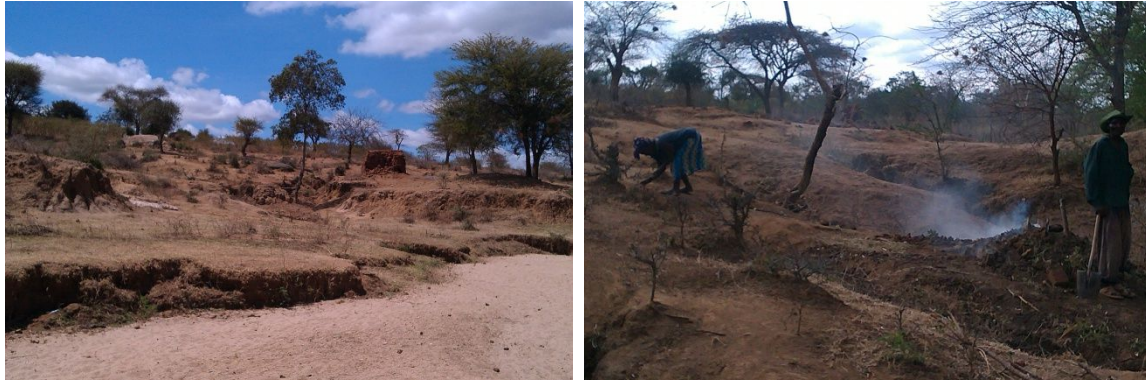
Figure A.83 Left: Brick making site cleared from natural vegetation; Right: cut trees for charcoal production

A major problem with making bricks is that the vegetation of the location of brick making is cleared and the soil is left behind unprotected against erosion (see Figure A.83 left). Another point of concern is that large amounts of charcoal are needed to burn the bricks. Areas where bricks are made are therefore often have fewer trees and soil erosion in these areas is stronger(see Figure A.83 right).

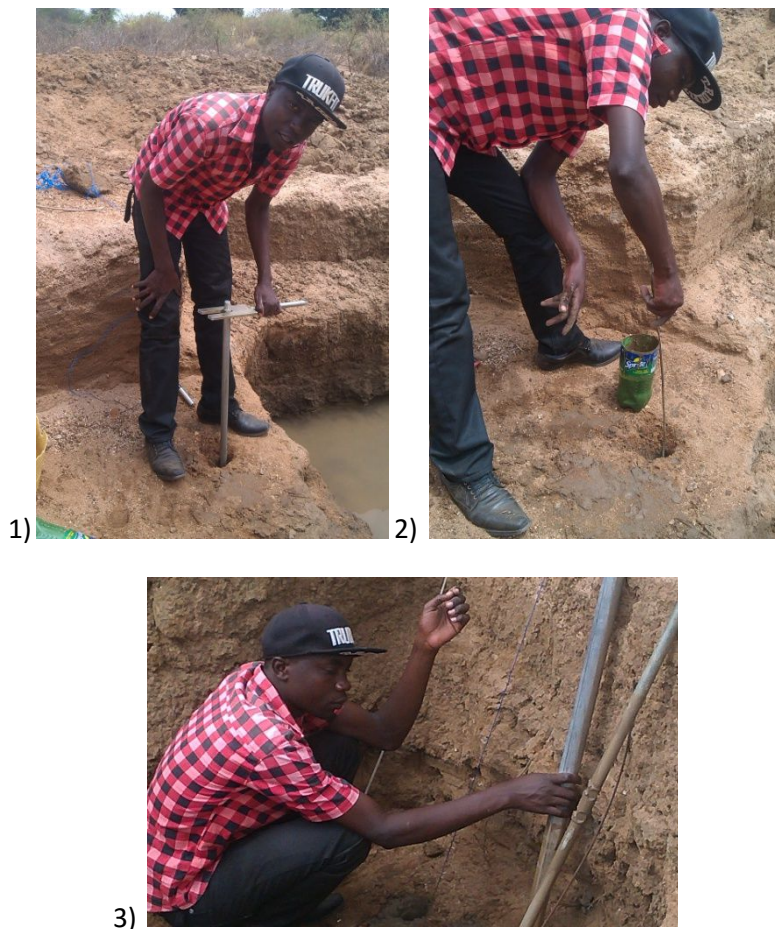
Figure C.2 Execution steps of the Auger hole method

3. Measurement of the rate of rise.

Directly after the removal of the water the measurements starts. In regular time steps the water level in the hole is recorded with a diver.

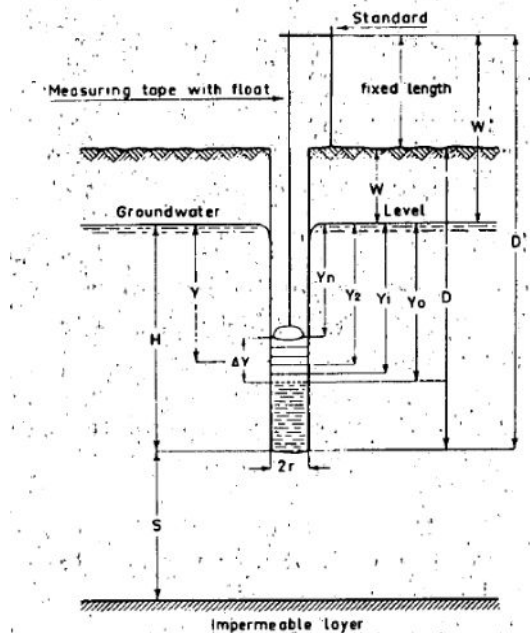
Figure C.3 Measurement settings according to the auger hole method (source: Van Beers, 1983)

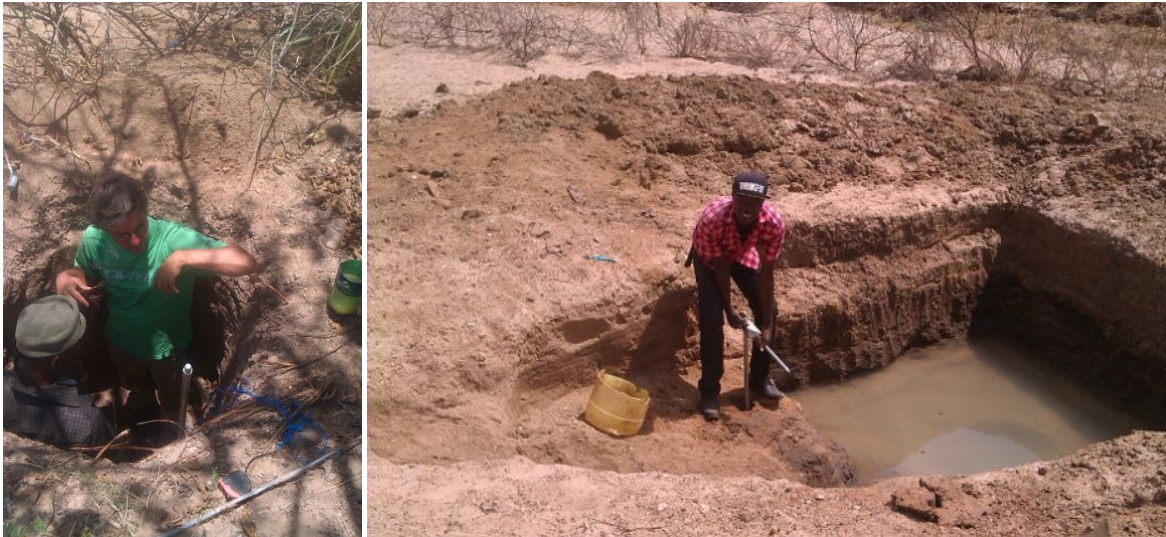
The third and fourth site is located upstream of sand dam 20. Here we found two private scoop-holes in the riverbed. At this location the water table lay in a sandy clay soil below the riverbed. Direct next to the water surface, a small flat area was carved to reach the water and fetch it. The owner of the scoop holes allowed us to drill a bore hole and to do our measurements. Also these boreholes needed to be stabilized by the perforated pipe. In total we conducted 6 measurements; 3 in the first and 3 in the second scoop hole. Only during three of the six measurements the divers recorded a recovery curve. During the other measurements the pressure fluctuated and became constant afterwards.

Figure C.4 Measurement site 1 (left) and site 3 (right)

At the third site the measurement was repeated 3 times. Two times the measurements failed. The recovery curve of the successful measurement is 24 m/d.

At the fourth site the measurement was repeated 3 times. The first measurement failed. The recovery curve of the second and third measurement is presented in the Appendix D. The calculated hydraulic conductivities are 23 and 33 m/d.

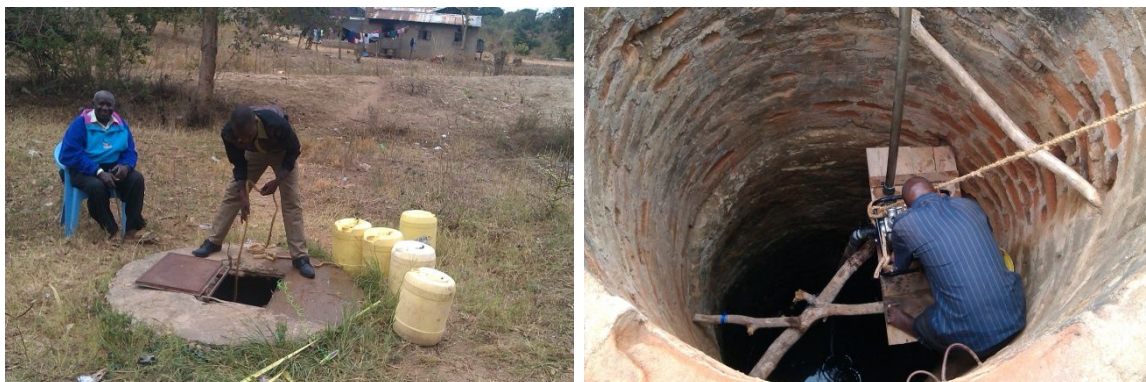
During the field trip four wells in the Kivuna catchment (where shallow wells are more often applied) could be identified. In two cases the water was removed by hand through pulling buckets out of the well. In the other two cases the water was pumped out of the well.

Figure C.6 Water abstraction by hand (left) and by pump (right)

For the measurements I made appointments with owners of shallow wells in the morning before they wanted to extract water from their well. Before the extraction a diver was installed in the well. This diver were left in the well for about 24 hours to measure the recovery of the water table every 30 seconds. The farmers told me that there was no intensive use of the well the day before and that, at least for the rest of the day, no water will be extracted from the well, so that the measurement will not be disturbed. To be able to compensate for atmospheric pressure variations, a second diver was placed in the houses of the well owner.

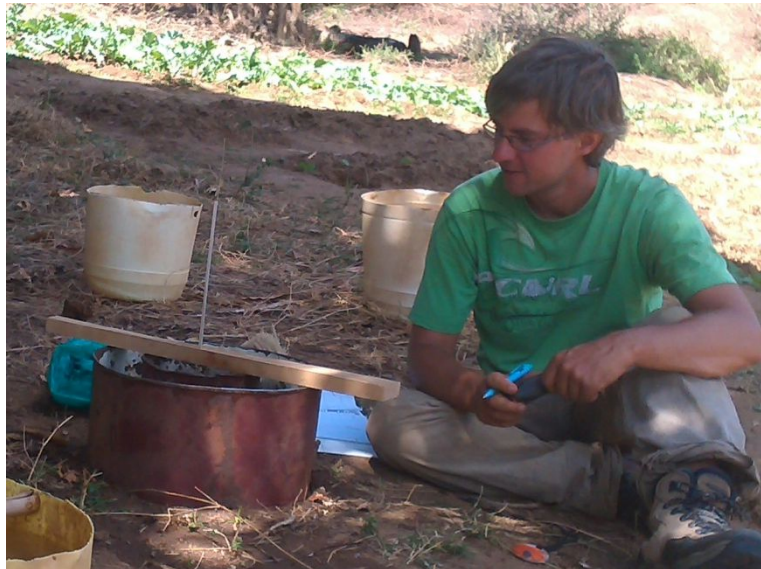
Figure C.7 Execution of the double ring infiltration test
