## Crack initiation and propagation in unreinforced masonry specimens subjected to repeated in-plane loading during light damage

Bulletin of Earthquake Engineering

**Keywords** Unreinforced masonry structures · Earthquake damage · Crack analysis · Digital Image Correlation · Damage scale · Material degradation

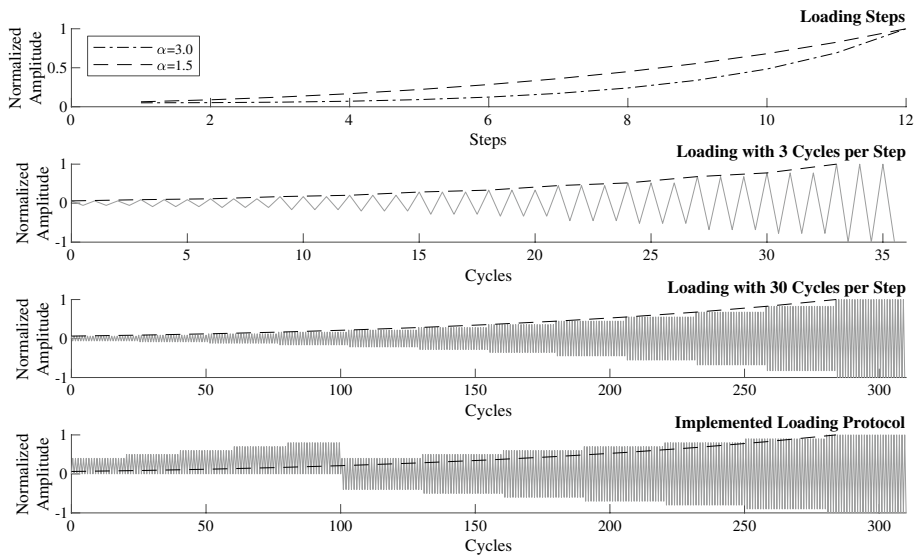
**Fig. 4** Comparison of proposed loading protocols in this study with the methodology of Beyer and Mergos (2015). Top to bottom: Loading steps according to Beyer for 12 steps and two different values of ‘alpha’; loading cycles according to the aforementioned methodology with 12 steps and 3 cycles per step at  $\alpha = 1.5$ ; adapted loading with 30 cycles per step; and, loading as implemented for the walls of this study consisting of a repetitive and a cyclic part with a total of 310 cycles

Figure 4 compares the function proposed by Beyer and Mergos (2015) with the chosen loading protocols. Note that: firstly, the number of cycles has been increased in comparison to the values suggested by Beyer and Mergos (2015) under the assumption of a history of multiple earthquakes (ten equal earthquakes). Here, however, the earthquake cycles have been re-arranged to better observe the potential degradation effect. Also, Bal et al. (2018) note that while induced earthquakes do not differ significantly from tectonic earthquakes, damage accumulation may be present due to repetitive induced events.

Secondly, the initial, repetitive part of the test does not fit with the suggested protocol by Beyer and Mergos (2015). Nevertheless, the seemingly large amplitude, because it corresponds only to a displacement in one direction, is likely to lead to lower overall damage than the same amplitude in two directions, and could thus be seen as actually having a lower amplitude. Moreover, trial tests showed that the very small amplitudes that would need to be selected when following the proposed methodology precisely (Beyer and Mergos 2015) would remain in the fully-elastic region of the test specimen and would have thus been unimportant. Note that the consulted methodology includes an ‘alpha’ parameter

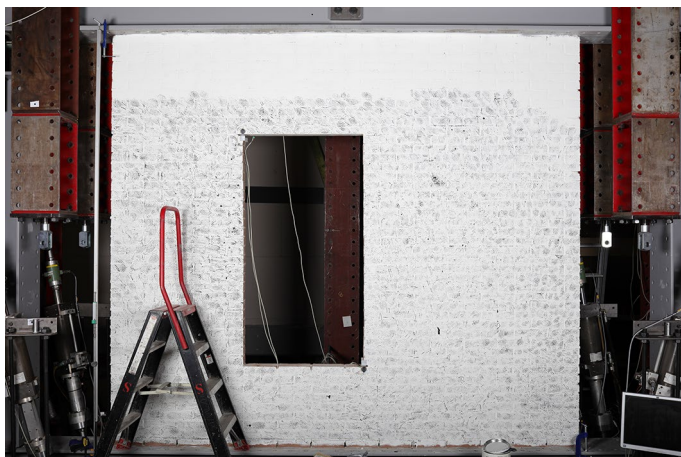
**Fig. 5** Photograph of one of the experimental walls, before the application of the DIC pattern has been finished

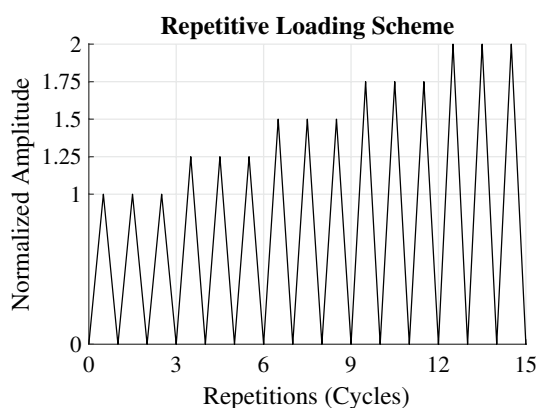
**Fig. 6** Displacement-control scheme of the top beam lateral displacement: repetitive loading protocol. The first amplitude corresponds to a first crack of 0.1 mm measured at any of the crack-mouth opening sensors. Protocol shown for 5 steps of 3 repetitions per set (TUD-Comp 40)

to span the actual crack locations. Subsequent steps consisted of an increase of 25% of the first displacement up to 200%.

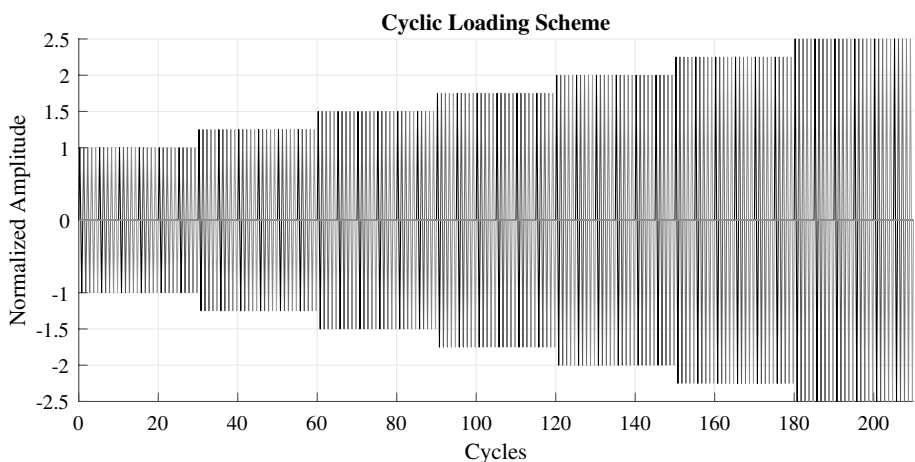
**Fig. 7** Displacement-control scheme of the top beam lateral displacement: cyclic loading protocol with seven steps of 30 cycles each (210 total). The first displacement amplitude corresponds to a crack of 0.1 mm in width measured at any of the crack-mouth opening sensors

The second section of the protocol comprised cyclically applied top displacements in seven sets of 30 cycles (Fig. 7). Preliminary repetitive tests showed that the observed degradation stabilised after approximately 30 repetitions, hence this value was chosen for all cyclic loading schemes.

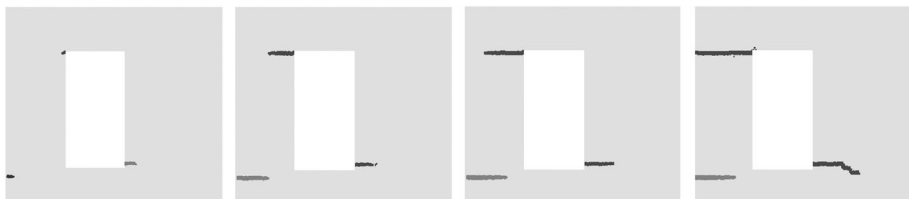
**Fig. 15** Sequence of crack propagation for different steps in the repetitive test of TUD-Comp 41

developed (in the case of the top crack crossing the entire pier horizontally), the crack at the bottom right of the window grew significantly (see Fig. 15).

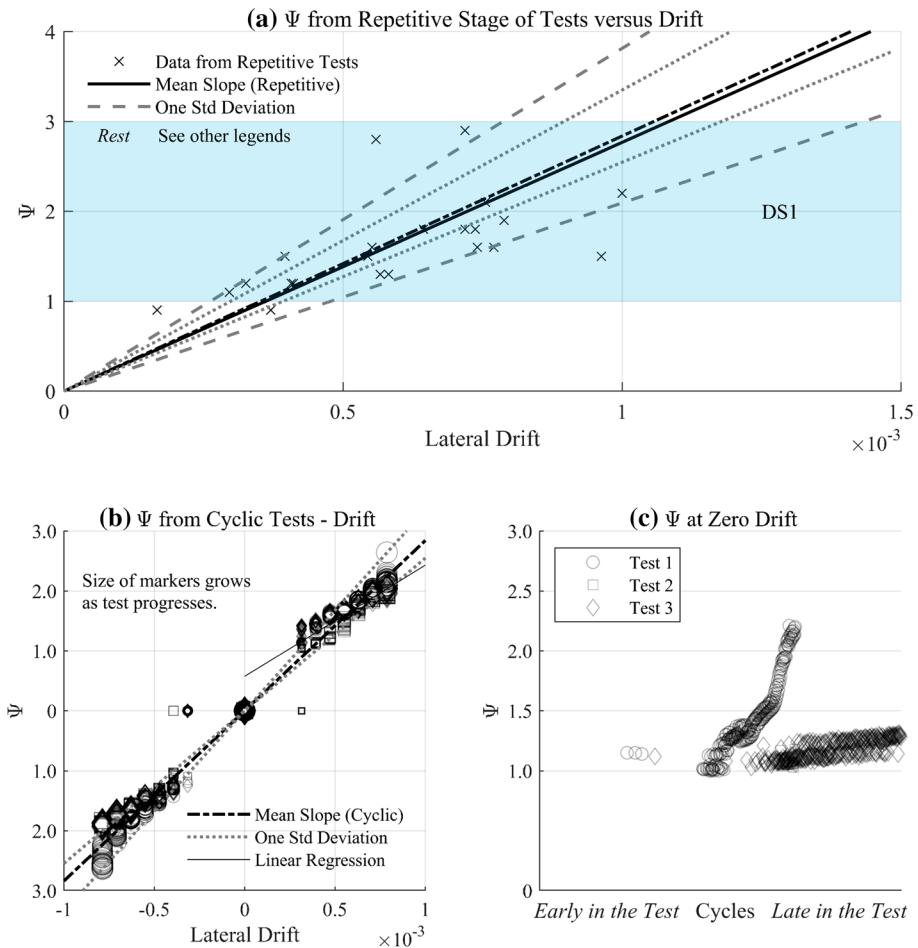
**Fig. 17** **a** Linear regression (Theil-Sen method) of results for the damage parameter  $\Psi$  against lateral drift of masonry test walls showing only random drift values during repetitive tests and highlighting the zone corresponding to damage state one (DS1, light damage). **b** Results from the cyclic part of the tests; and **c** values of  $\Psi$  at zero drift due to residual damage from a high number of cycles towards the end of the test

After analysis of DIC results for multiple values of in-plane lateral drift of the walls, a relationship between drift and the intensity of damage could be observed. In Fig. 17a, this relationship appears to be linear. To avoid the bias introduced by considering many points at values of equal drift, and to minimise the influence of the progressive damage on the specimens, only the pictures taken at random points during the repetitive test have been considered. Since it is expected that at zero drift, no damage will be present, the Theil–Sen method for regression of slopes has been used (Theil 1950). This method is more robust against outliers than fitting of a linear model with the least squares method. For the slope,

When observing the data points obtained from the cyclic portion of the test in Fig. 17b, a linear trend not passing through from the origin can be observed and is highlighted with a linear regression line. This is expected, since the wall has experienced damage and shows

signs of residual damage already at zero values of drift, the latter is shown in Fig. 17c. Nonetheless, fitting a slope model to all the available points yields a similar result as when only the initial, random points during the repetitive portion of the test are considered, see the dotted line in Fig. 17b which is also reproduced Fig. 17a where it appears next to the solid line. The accumulated damage also explains why the standard deviation of the fewer points is greater than that of the cyclic data.

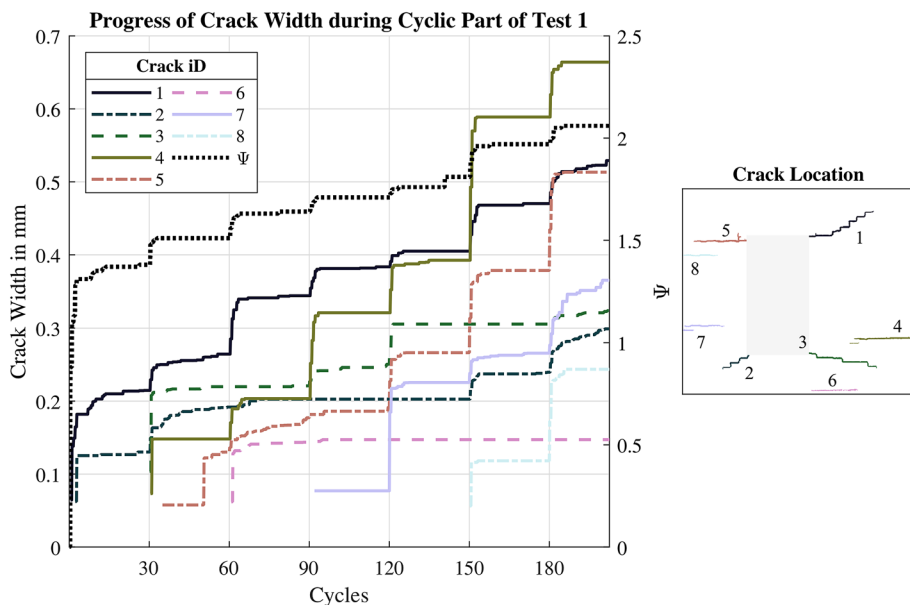
**Fig. 18** Evolution of maximum crack width of various cracks on a wall during the cyclic part of the loading protocol as monitored with DIC
