Bending performance of concrete beams retrofitted with mechanochromic glass/carbon hybrid composites

Combining structural reinforcement and visual health monitoring

Construction and Building Materials

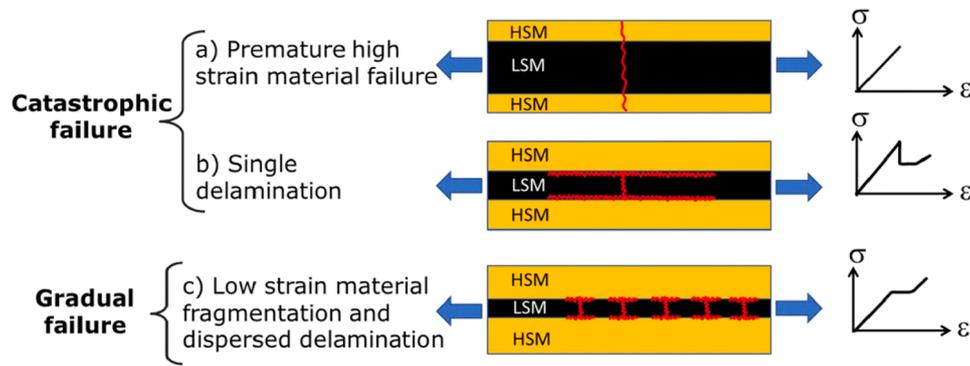
Fig. 1. Illustration of various failure modes in a three-layer, unidirectional hybrid laminate made of high-strain and low-strain materials, with red lines marking the fractures. The scenarios depicted include: (a) a single fracture spanning the entire specimen; (b) a single fracture occurring solely in the low-strain material, leading to immediate delamination; and (c) numerous fractures accompanied by a stable, localized pull-out within the low-strain material [30].

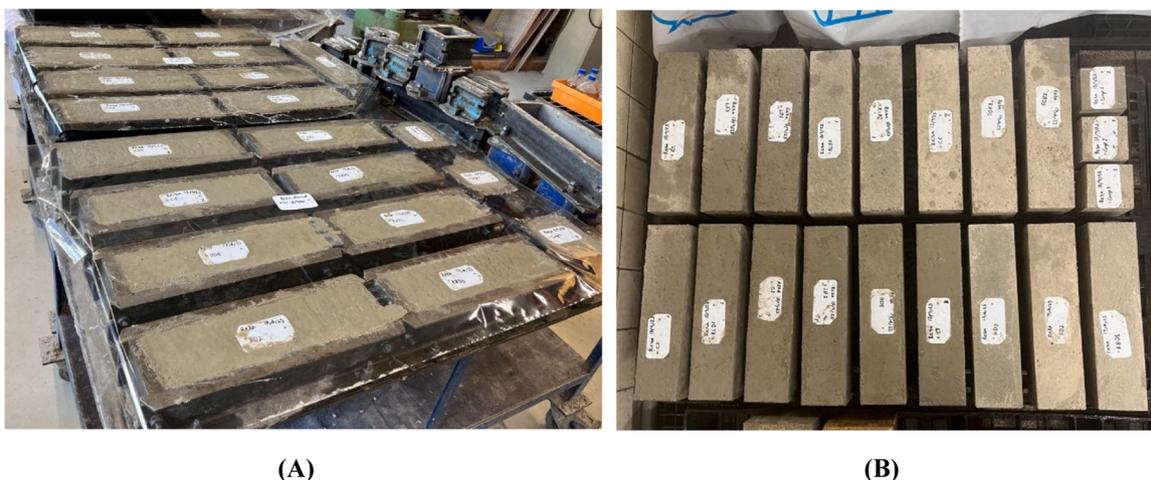
Fig. 2. Curing of the concrete prisms: (a) under plastic sheets, before unmoulding; and (b) in the moisture chamber, after unmoulding.

The specimens were produced using a uniform concrete mixture. The mix proportions by weight were cement: water: sand: gravel = 1:0.42:1.4:2.50. Crushed limestone that passed through a 15 mm sieve served as the coarse aggregate, while natural river sand with a fineness modulus of 2.3 was used as the fine aggregate. The steel molds have been used for casting process. The dimensions of the prisms are $10 \times 10 \times 40 \text{ cm}^3$. After curing all the prisms under a relative humidity of 95 % for a period of 28 days, under plastic sheets for the first 24 hours, before un moulding, (Fig. 2-A) and in a moisture room for the

next 27 days (Fig. 2-B), all of them were taken out of the room for further preparation prior to testing including cutting the grooves and retrofitting.

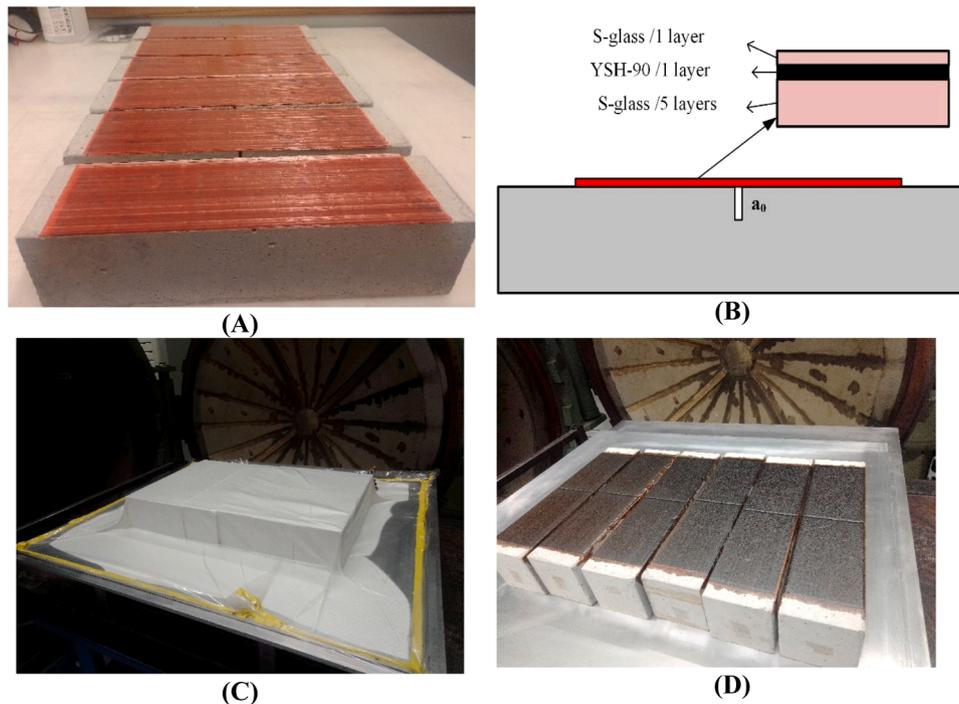
Fig. 3. Retrofitting process with hybrid composite: (A) lamination process (B) Schematic of sequence layers (C) Vacuum process (D) Retrofitted specimens after curing and unmolding process.

retrofitting layers. Then, an YSH-90 carbon prepreg layer was added as a sensor layer. Finally, another S-glass prepreg layer was applied on top as a visual detector for damage in the YSH-90 carbon layer. The thickness of all retrofitted layers was 1 mm. After lamination, all specimens were placed on an aluminum plate, fully vacuum-sealed, and then cured in an autoclave. The epoxy resin system used in both prepreg was Hexply@913. According to the data sheet [31] for this epoxy system, the specimens were cured at 125 degrees Celsius for 60 minutes. Fig. 3 illustrates the retrofitting process with composites: lamination (Fig. 3-A), sequence of hybrid composite layers (Fig. 3-B), vacuum and autoclave

curing process (Fig. 3-C), unmolding and cleaning after curing (Fig. 3-D).

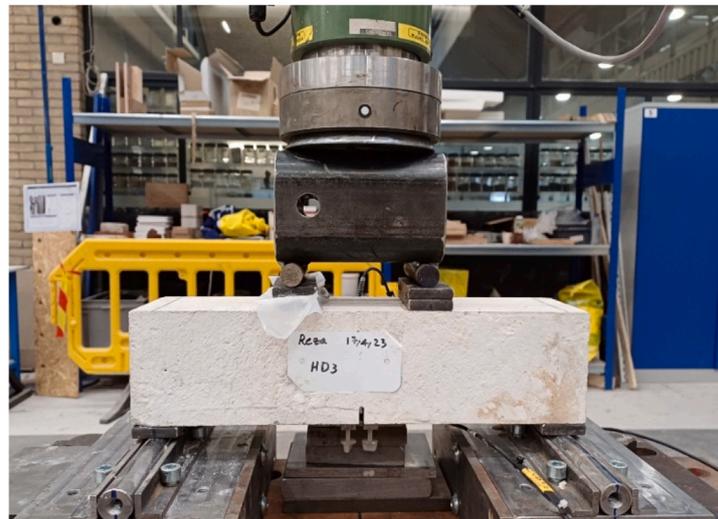
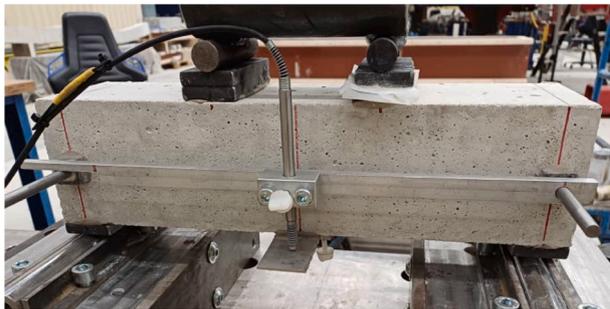
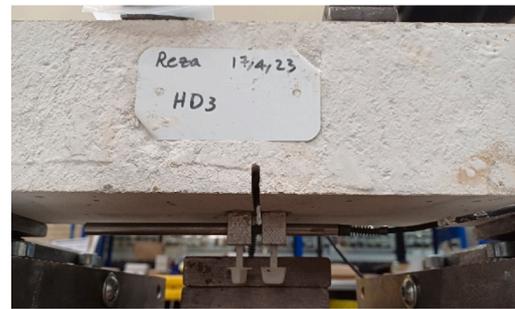
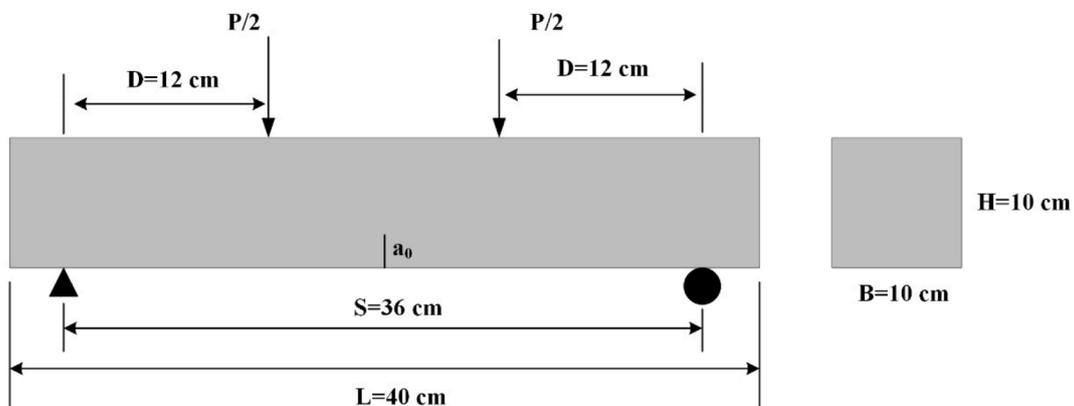
Fig. 4. Four point bending test setup for concrete specimens A) The whole setup B) the connection of LVDT for measure of mid span deflection C) the connection of LVDT for measure of CMOD D) the schematic of four point bending test and related dimensions.

Fig. 4-A depicts the four-point bending test setup. The setup includes a rigid support beam, two supporting rollers, two loading rollers, a loading beam, and a hinge to ensure that the load is applied parallel to the loaded face of the prism. All rollers are aligned parallel, with a distance of 360 mm between the supporting rollers and 120 mm

Deflection at the center of the prism, where the maximum displacement is expected, was measured using a linear variable differential transducer (LVDT) mounted on the lateral face at mid-span. The connection of the LVDT to the prism was carefully designed and executed. The LVDT was attached to an aluminum ruler (Fig. 4-B), which was connected to the prism with two pins at the ends. This setup prevented translation of the ruler in all three primary directions while allowing it to rotate around one pin, with the other end free to move longitudinally. This configuration ensured that the ruler, serving as the LVDT base, remained stable without restricting the prism's rotation on the supporting rollers.

For specimens with an initial crack, the crack mouth opening displacement (CMOD) was recorded using LVDT sensors (Fig. 4-C). Fig. 4-D schematically shows the dimensions of the four-point bending test setup. To create initial damage, a 2 mm wide notch was cut across the thickness of the specimens using a diamond grinding disk. The crack lengths were 5 mm and 15 mm, representing 5 % and 15 % of the cross-sectional area, respectively. The prisms were cast from normal weight concrete with a relatively high compressive strength of 68 MPa, as determined by testing cubic samples. A displacement-controlled loading protocol with a constant rate of 0.005 mm/s was used to apply the flexural load using a universal testing machine with a 200 kN load capacity.

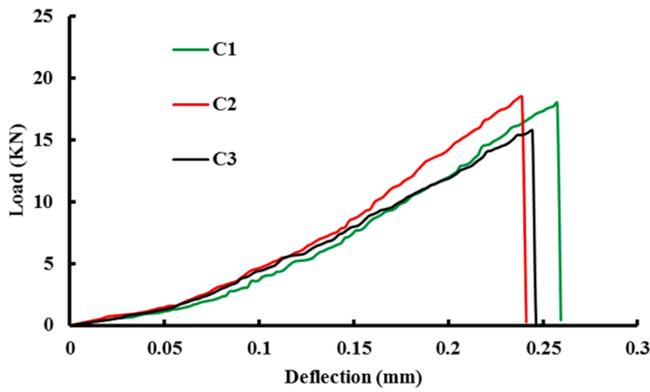
Fig. 5. the load-deflection curves for reference specimens.

In this section, the load-deflection curves of all specimens are analyzed together. The maximum load capacity and maximum deflection values are determined for each type of specimen. Fig. 5 presents the load-deflection curves for the reference specimens. The mechanical behavior, including stiffness and maximum load (F_{max}), is consistent across the specimens. The average maximum load and deflection values for this group are 17.43 kN and 0.246 mm, respectively. To validate the maximum load value of 17.43 kN, a theoretical method was applied. The maximum load in the four-point bending test was calculated using the following equations. The theoretical calculation yielded a maximum load of 18.88 kN, indicating a 7.7 % error between the theoretical and experimental results.

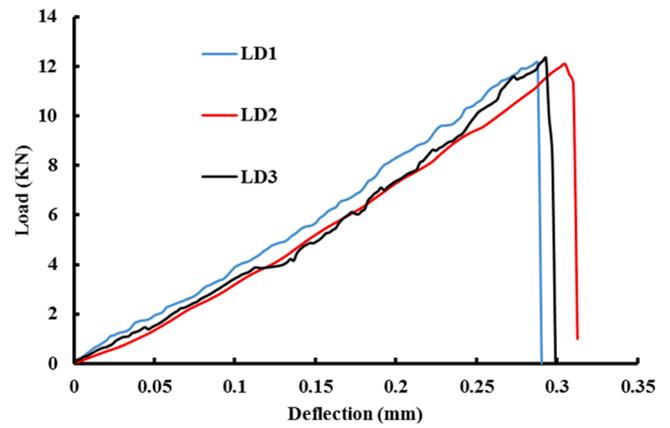
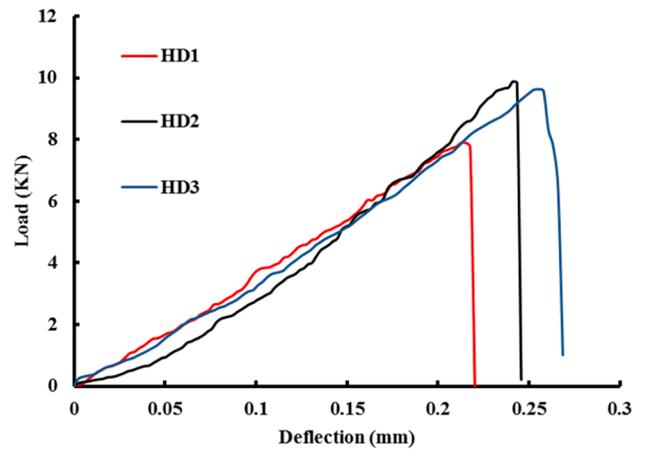
Fig. 6. the load-deflection curves for A) light damage B) Heavy Damage specimens.

Fig. 6 illustrates the load-deflection curves for specimens with 5 percent (Figs. 6-A) and 15 percent (Fig. 6-B) damage. It is evident that the maximum load capacity for specimens with Heavy Damage is lower compared to those with Light Damage. The average maximum loads for

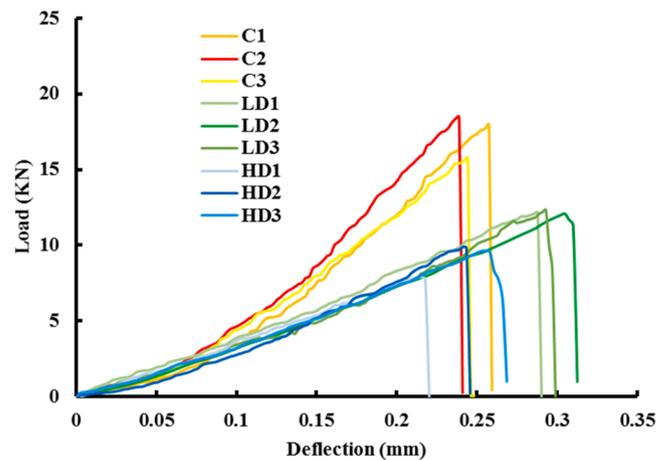
Fig. 7. Comparative of load-deflection curves for reference and damaged specimens.

specimens with light damage (LD) and heavy damage (HD) are 12.18 kN and 9.10 kN, respectively. These values are significantly lower than the 17.43 kN load capacity observed in the reference specimens. To compare the load-deflection behavior, particularly the slope of the curves, the graphs for all three groups were plotted in Fig. 7. As shown in the figure, the stiffness of the reference specimens is significantly greater than that of the damaged ones. This is expected, as damage typically leads to a reduction in structural stiffness. Additionally, there is no significant difference in stiffness between the LD and HD specimens,

although the deflection in the LD specimens is greater than in the HD specimens. The average deflection at the failure point, for the Ref, LD, and HD specimens, is 0.246, 0.293, and 0.237 mm, respectively.

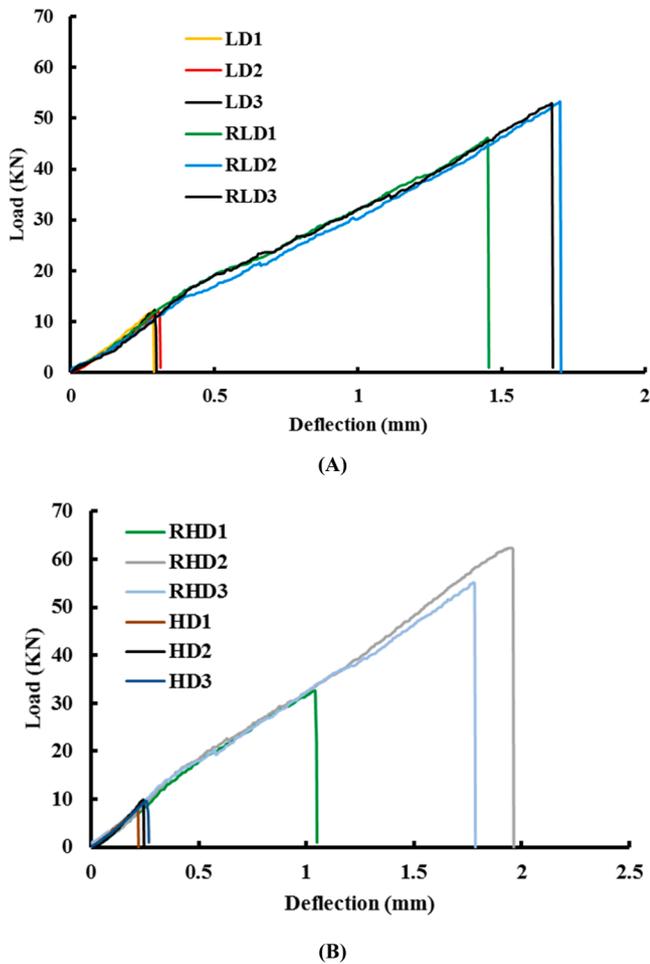
Fig. 8. The load-deflection curves for A) Retrofitted light damage and B) Retrofitted heavy damage specimens.

Fig. 8 illustrates the load-deflection behavior of retrofitted light damage (RLD) and retrofitted heavy damage (RHD) specimens. It is evident that both the maximum load capacity and the corresponding mid-span deflection have significantly increased in the retrofitted specimens. To compare the variation in the curves between retrofitted and non-retrofitted samples, both graphs were plotted together. The average maximum load for the RLD and RHD samples is 50.73 and 50.03 kN, respectively, indicating a 416 % and 550 % increase in load capacity with the addition of just a 1 mm thick layer of hybrid composite material.

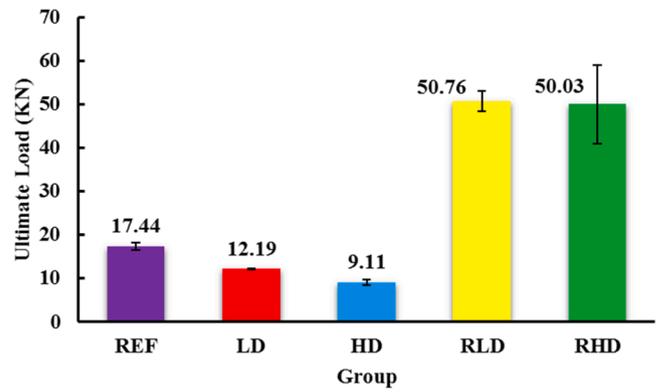
Fig. 9. Visual representation of the average ultimate loads.

The comparison of the ultimate loads for different groups can be seen visually together in Fig. 9, where the average value for the REF group is 17.43 kN. It can be observed that a 5 mm deep crack (the LD group) reduced the load-bearing capacity by 30 % in average and a crack with a depth 15 mm (HD group) decreased the load-bearing capacity up to 48 %. On the other hand, retrofitting the damaged specimens by mechanochromic composite improves the load-bearing capacity by 208 % and 204 % for RLD and RHD groups, respectively, compared to the REF (non-damaged) group. What is interesting in this regard is that the level of pre-damage (the depth of the crack) doesn't have a significant influence on the load-bearing capacity once the prism is retrofitted with the mechanochromic composite.

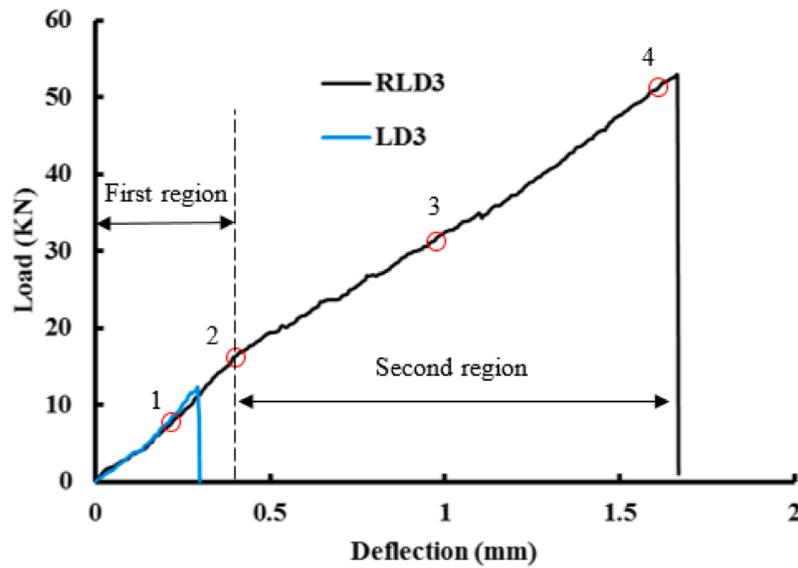
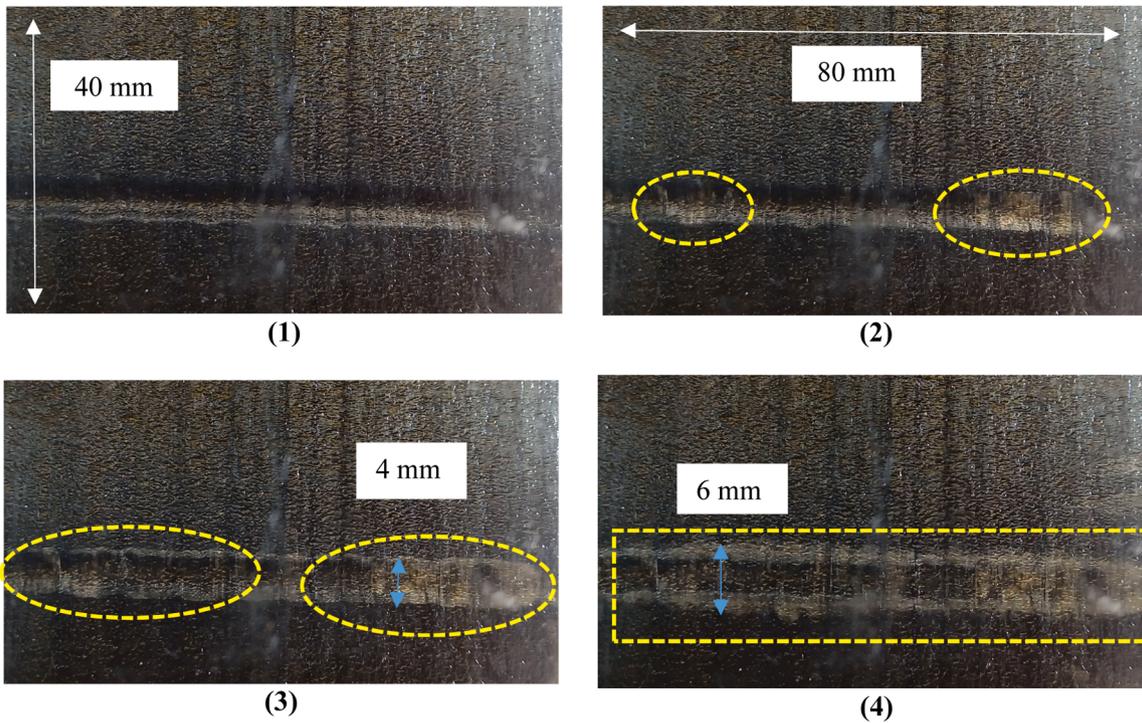
Fig. 10. Color change in the sensor of composite laminates shows the variation of load deflection curves in RLD3 specimens.

Focusing on the retrofitted specimens, it is evident that the load-deflection curves exhibit a change in stiffness. To illustrate this, the load-deflection graph for the RLD3 specimen is shown again in Fig. 10. The curve can be divided into two distinct regions. In the first region, the curve's stiffness is high and matches that of the LD3 specimen. However, as the load increases beyond that of LD3, the slope of the curve changes, and in the second region, the curve exhibits a lower stiffness compared to the first region. During the test, a digital camera was positioned beneath the specimens to capture the color changes in the sensor layer of the retrofitted hybrid composite. The camera images clearly show that there is no damage at point 1, but the color of the composite surface changed (indicated by yellow bevels) at point 2. This suggests that the composite laminates at point 2 were subjected to load and experienced strain. At this point, load transfer occurs between the concrete and the composite laminates, resulting in a change in stiffness. As the load increases, the area of color change expands (as seen at points 3 and 4). It is important to note that this color change indicates damage in the high-modulus carbon layer, which has low strain-to-failure properties. The extent of damage in this layer reflects the strain level in the composite

layers. However, this does not imply that there is damage in the underlying S-glass layers. In fact, even after point 4, no damage has occurred in the retrofitted composite layers in this area.

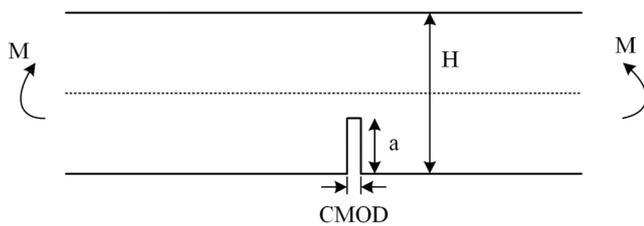
Fig. 11. The main parameters of specimens to calculate the fracture toughness in four point bending test.

In this section the stress intensity factor and fracture toughness of damaged specimens (LD1, LD2, LD3 and HD1, HD2, HD3) is calculated. The pure bending condition in the 4-point bending setup is applied around the initial notch (Fig. 11). Accordingly, to calculate the fracture toughness, the following equations (Eqs. 7–9) were used [32–34].

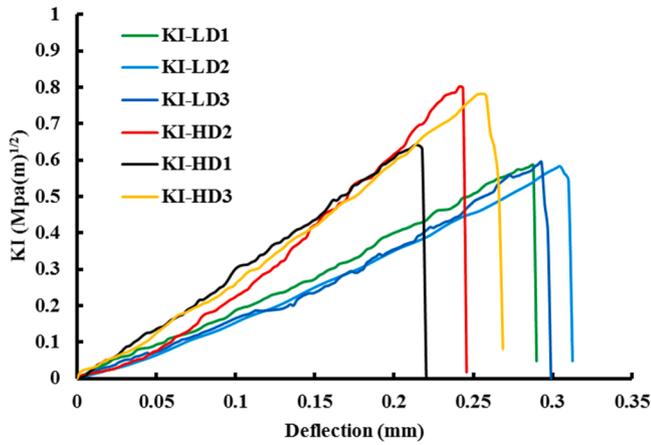
Fig. 12. The stress intensity curves of damaged specimens.

Fig. 12 illustrates the variation of the stress intensity factor (KI) for all pre-damaged specimens, with the maximum value defined as the fracture toughness (K_{IC}). Table 3 presents the fracture parameters, including maximum load, fracture toughness, and crack mouth opening displacement at maximum load ($CMOD_C$). It should be mentioned, in the retrofitted specimens, crack propagation did not occur, so fracture parameters were not calculated for these specimens. As shown in Table 3, the measured $CMOD_C$ values are 0.015 mm for light damage and 0.028 mm for heavy damage. An increase in the initial notch length results in a corresponding increase in the $CMOD_C$ parameters.

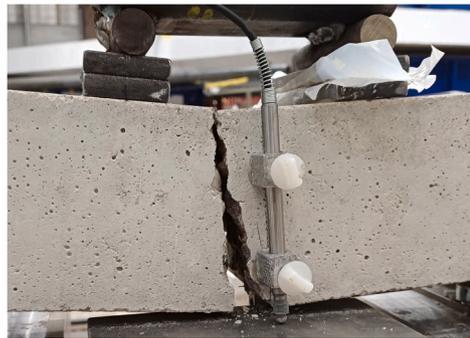
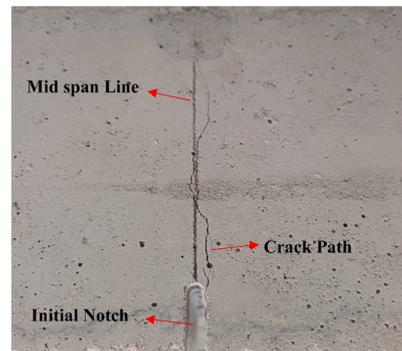
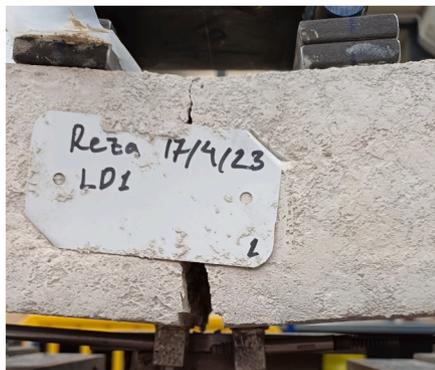
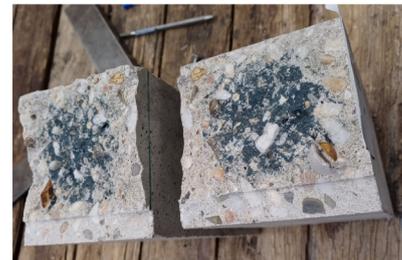
Fig. 13. The common failure mode (flexural failure) in non retrofitted specimens: A) without damage (C1) B) Light damage (LD1) C) Heavy damage (HD1) D) Cross section of HD1.

As seen in Fig. 13 A-D, all the specimens from non-retrofitted groups experience a common flexural failure pattern occurring in the mid-span of the prism, initiated from the tension face and progressing into the compression face until the complete failure and splitting the prism into halves. Fig. 13-A illustrates the failure mode of the reference sample without an initial damage, which fractured nearly at the midpoint under the tensile loading. Figs. 13-B and 13-C shows the failure modes of the samples with the initial damage of 5 mm and 15 mm, respectively. In these cases, the fracture initiated at the crack tip due to stress concentration and propagated almost linearly to the edge. Fig. 13-D shows the fractured surface of the HD1 specimen, where the failure surface runs parallel to the initial crack surface, with the distribution of sand and gravel particles clearly visible.

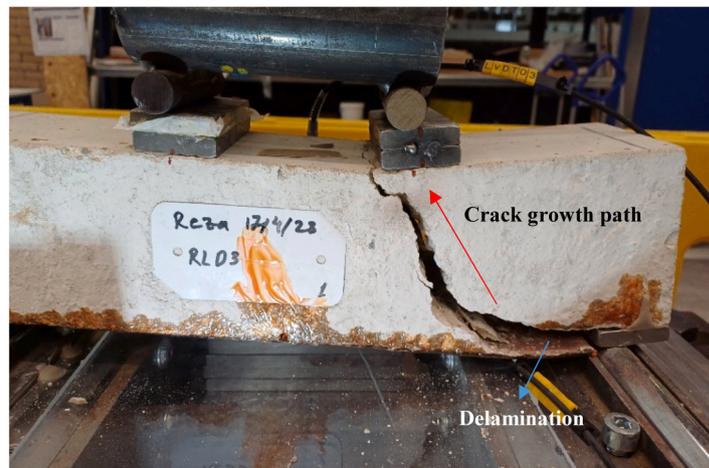
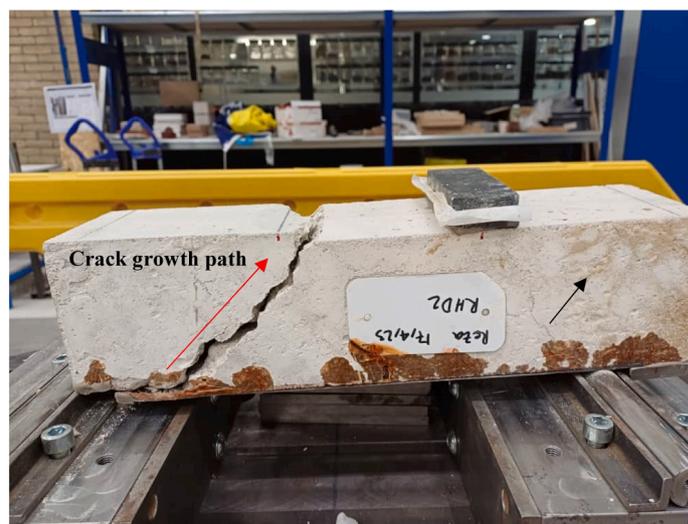
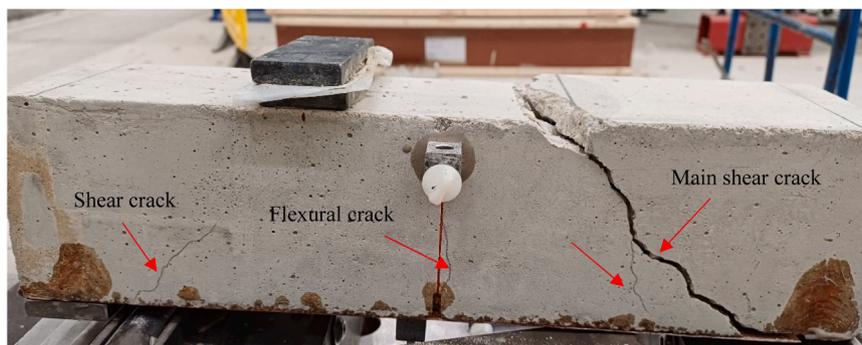
Fig. 14. The shear failure mode in retrofitted specimens A) RLD3 and B&C) RHD2.

However, the retrofitted prisms demonstrated different failure mode and they failed under shear which is originated from the end of the composite layer and near one of the supports on the tension face, towards the nearest loading roller on the compression face (Fig. 14-A&B) with an approximate angle of 45 degrees. Reinforced concrete beams experience two primary types of failure: flexural failure and shear

angle until the beam was fractured (Fig. 15-C). Additionally, the coalescence of microcracks at the ends of the composite layers leads to delamination between the composite and the concrete (see Fig. 14-A).

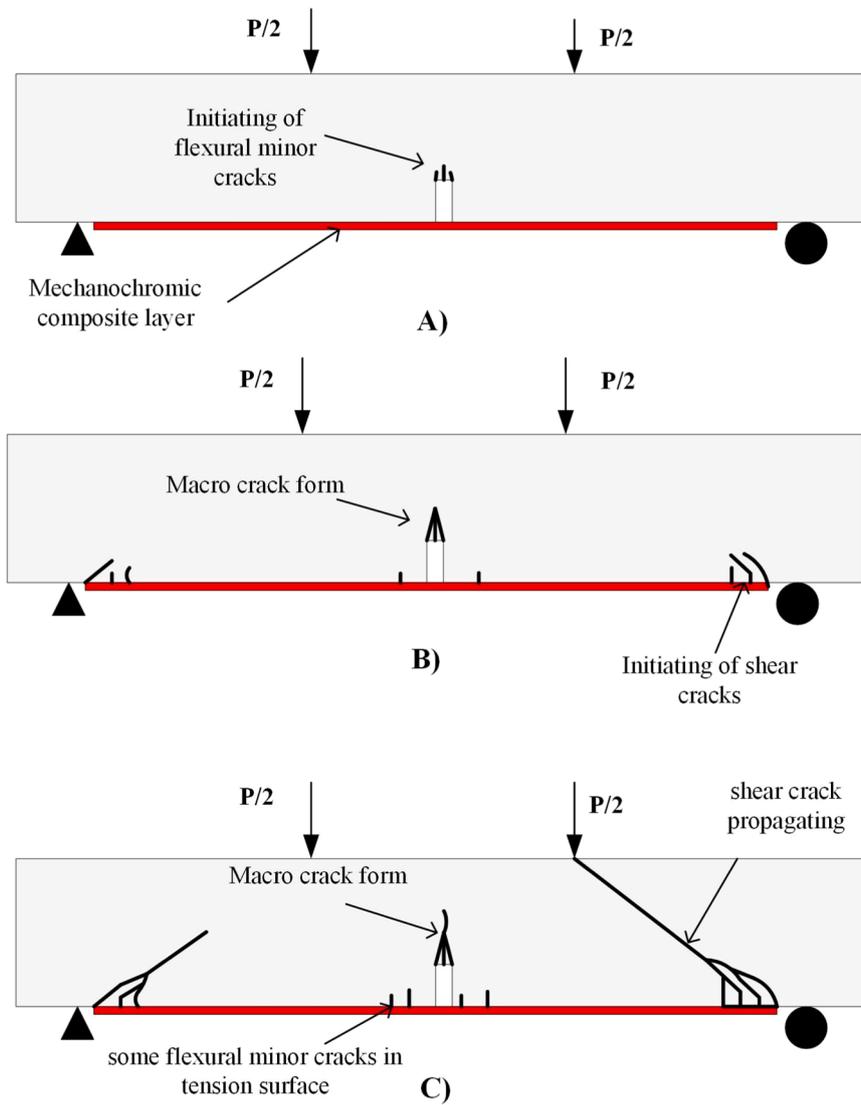
Fig. 15. The schematic of shear failure mechanism in hybrid composite retrofitted concrete beam.

Fig. 15 schematically illustrates the mechanism of shear failure in the retrofitted specimens. As shown in Fig. 15-A, a series of minor flexural cracks initially formed due to stress concentration at the tip of the initial notch. As the loading progressed, these minor cracks continued to develop, with some merging into macro cracks (Fig. 15-B). As the

applied load increased, the composite bonded to the tension surface of the concrete beam began to restrict the propagation of macro cracks, which in turn reduced the stress concentration at the notch tip. However, the shear stress at the interface between the concrete beam and the composite layer steadily increased as the load on the beam continued to rise. In the following, shear minor cracks were generated on the composite part because of the stress concentration in the free edge. These micro cracks were extend along 45-degree angle. The macro cracks

(shear cracks) developed rapidly towards the direction of the 45-degree

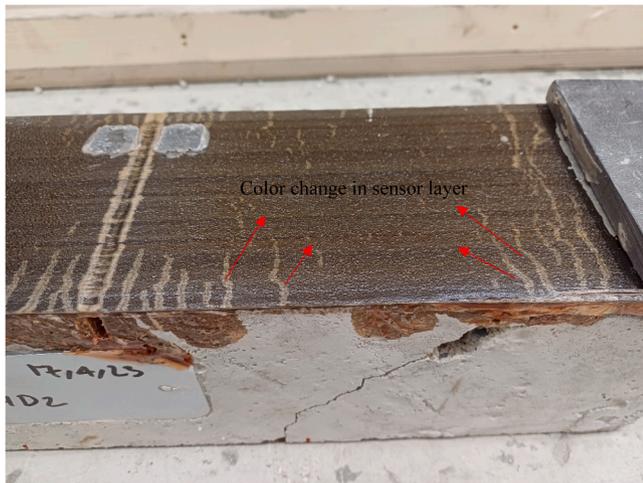
Fig. 16. Color change in the composite of a retrofitted prism, indicating a flexural cracks in concrete.

Although the failure primarily occurs in the concrete, the behavior of the mechanochromic composite and its color change at different stages of loading is significant. The color intensity increases as the load progresses, with notable changes occurring near collapse. Fig. 16 demonstrates the activation of the composite's self-reporting feature in response to the applied load. These color changes indicate the formation of flexural cracks on the tension surface of concrete (As discussed in Figs. 14-C and 15-C). This feature, which can be further optimized for improved visibility and sensitivity in various applications, offers valuable insight into the structural performance, serving as a passive indicator of stress accumulation, micro crack on the concrete surface and potential failure. This innovative approach can be employ as structural health monitoring (SHM) method to enhance the safety and durability of retrofitted concrete structures.
