# Eemdijk full-scale field test programme: ground dike and sheet pile dike failure test

Programme d'essai terrain à taille réelle Eemdijk: essais de déformation et de rupture pour une digue standard en terre et une digue renforcée avec palplanches

**ABSTRACT:** Dikes in the Netherlands have traditionally been constructed with soil. Climate change and subsidence requires heightening and or reinforcing these existing dikes. Traditional reinforcements demand additional space, which in some cases conflicts with existing buildings. Applying sheet pile walls in dikes allows for strengthening while minimizing the increase in footprint. However, a validated design approach that complies with relevant regulations lacks. To enable the validation of a proposed design approach, a full-scale field test programme (Eemdijkproef) was performed near the town of Eemdijk, The Netherlands. It consisted of a step wise approach: 1) sheet pile pullover tests, 2) ground dike stability test, 3) sheet pile dike stability test. All tests were loaded until failure occurred. The two similar test dikes were constructed at full scale (5m high, 25m wide, 60m long). In one dike an 18m long sheet pile wall was in

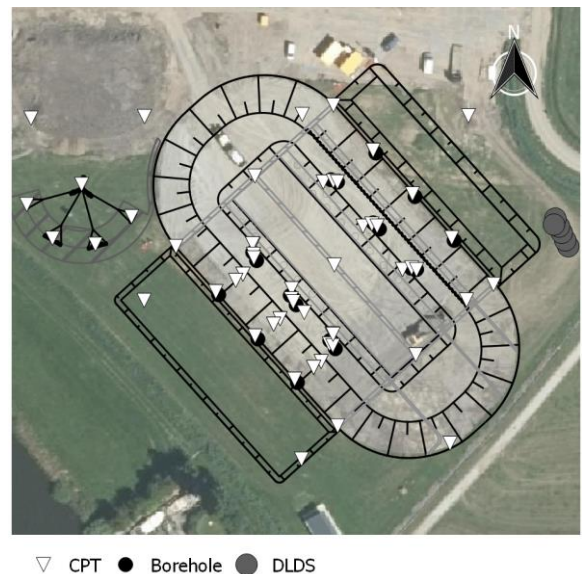
Figure 1 shows the FST site with the sheet pile dike at the NE-side and the ground dike at the SW-side. The POT is located at the W-side. Furthermore the soil investigation points are

presented with the Deltares Large Diameter Samples (DLDS) at the E-side.

Figure 1 Topview FST site with soil investigation points.

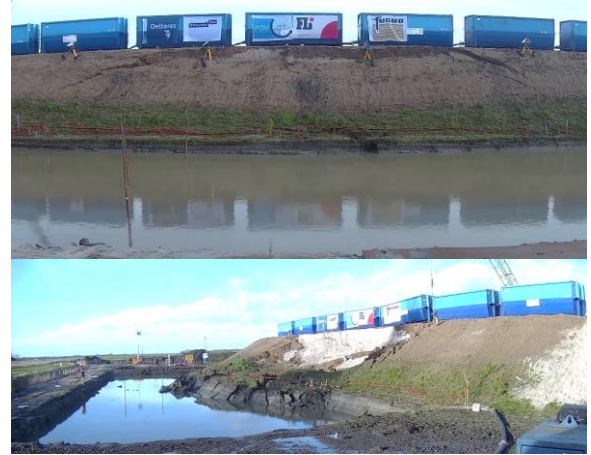
Failure became visually clear due to large cracks developing at the transition of slope and crest, accompanied with horizontal

displacements at the toe of the dike. The failure occurred over approximately the middle 30 m of the ground dike, see figure 9a. A large part of the total deformations (several meters) developed in the first hour after the first signs of failure, and steadily increase to its final position, see figure 9b.

Figure 9 Photo's of ground during failure (a) and after failure (b).

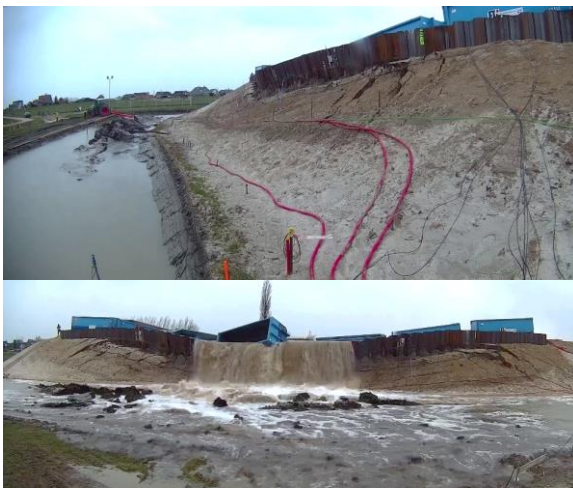
The deformations accelerated once the sheet pile failed due to local buckling. The slip surface exited in the bottom of the ditch, approximately 5m from the toe of the dike. The sliding ground mass was pushed upward even above the water level in the ditch, see figure 12a. Deformations stopped once the top of sheet pile was pushed over by 6m and down by 2m.

Figure 12 Photo's of sheet pile dike during failure, just before (a) and during (b) flooding.

Figure 11 presents the SAAF measurements at several times. At the early stages the slope provided enough support such that the cantilever wall deflected backwards at the top. Failure of the sheet pile starts after exceeding the maximum bending moment capacity which corresponds with a displacement of typically 0.5m at the top. After failure of the sheet pile, the large deflection finally caused flooding of the FST site (see figure 12b).
