## Ventilation and COVID-19 transmission risks on board of Dutch governmental ships

CLIMA 2022 - 14th REHVA HVAC World Congress

# Ventilation and COVID-19 transmission risks on board of Dutch governmental ships

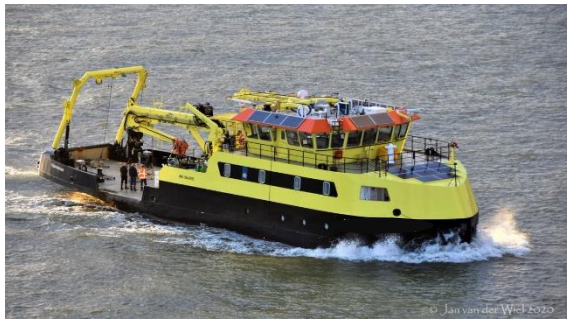
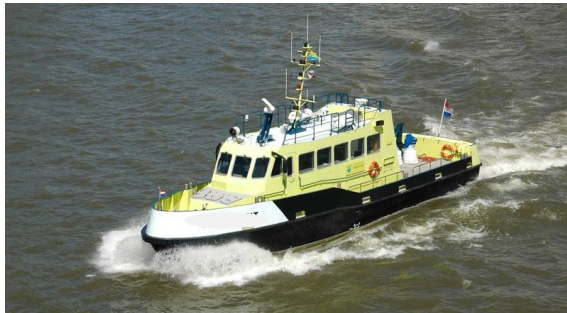
**Fig. 1** - Two example ships used by the Rijkssrederij; the upper one is for week patrols, the lower one is for day patrols

The Rijksrederij operates just under 100 ships, some smaller (used for day trips) and some larger (used for 'over-the-horizon' patrols that can last for up to one week). See figure 1 for an impression.
