The Noble Patina of Age

W.J. Quist^{1*}, A.J. van Bommel^{1,2}

Abstract: This paper discusses the aesthetical aspects of ageing and focusses on the use of the terms 'patina' and 'damage' to decide on the cleaning of historical facades and the application of artificial ageing. Conservation campaigns can be characterized by the wish to preserve an object, building or building complex as a coherent piece of Cultural Heritage. This paper discusses the professional debate on balancing between preserving values, i.e. represented by patina and the need to intervene from a technical point of view. Cases on cleaning of limestone and sandstone together with replacement of natural stone and the application of artificial ageing are used to illustrate the debate. The perception of professionals is compared with the perception of laymen.

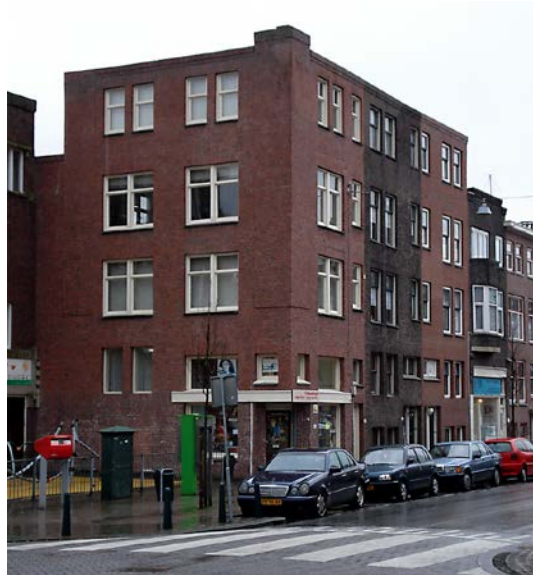
Figure 1 Although technically not necessary, visible traces of ageing are often removed, i.e. when cleaning brickwork facades (photo: W.J. Quist).

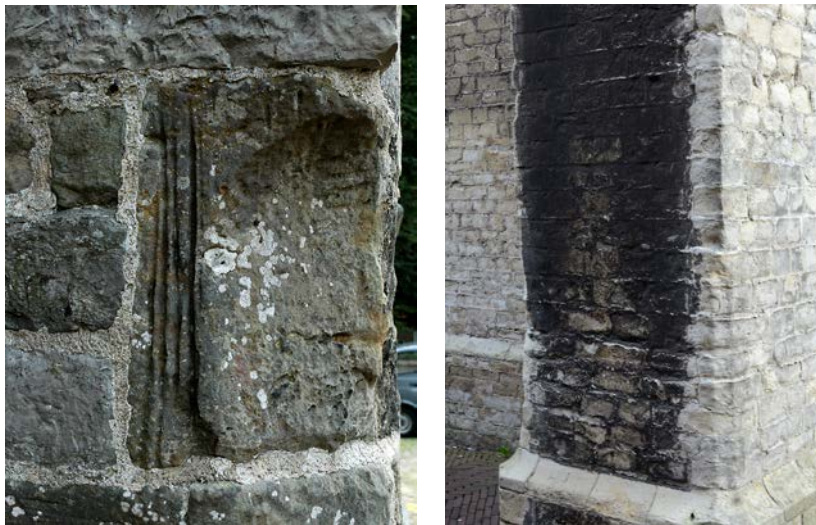
Figure 2 Left: Highly valued man-made traces at St. Bavo Church Aardenburg, right: black crust due to weathering at Old Church Delft (photos; W.J. Quist).

Article 11 of the Venice Charter states that "The valid contributions of all periods to the building of a monument must be respected, since unity of style is not the aim of a restoration. When a building includes the superimposed work of different periods, the revealing of the underlying state can only be justified in exceptional circumstances and when what is removed is of little interest and the material which is brought to light is of great historical, archaeological or aesthetic value, and its state of preservation good enough to justify the action. Evaluation of the importance of the elements involved and the decision as to what may be destroyed cannot rest solely on the individual in charge of the work" [24]. This article is often referred to in many ways to advocate the preservation of the 'architectural layers' in a historical building, but can it be used in favour of preserving a 'patina'? Figure 2 shows two different 'traces of time'. Carvings,

used to sharpen a knife or to gather stone powder with addressed healing capacities can be called 'mechanical damage', but due to its historical meaning the stone will never be repaired or replaced. The right image shows a black crust on sandy limestone. Is this 'damage' as safe as the first one? Although it is a comparable trace of time, the latter will often be cleaned away based on a hazy mix of technical and aesthetic reasons.

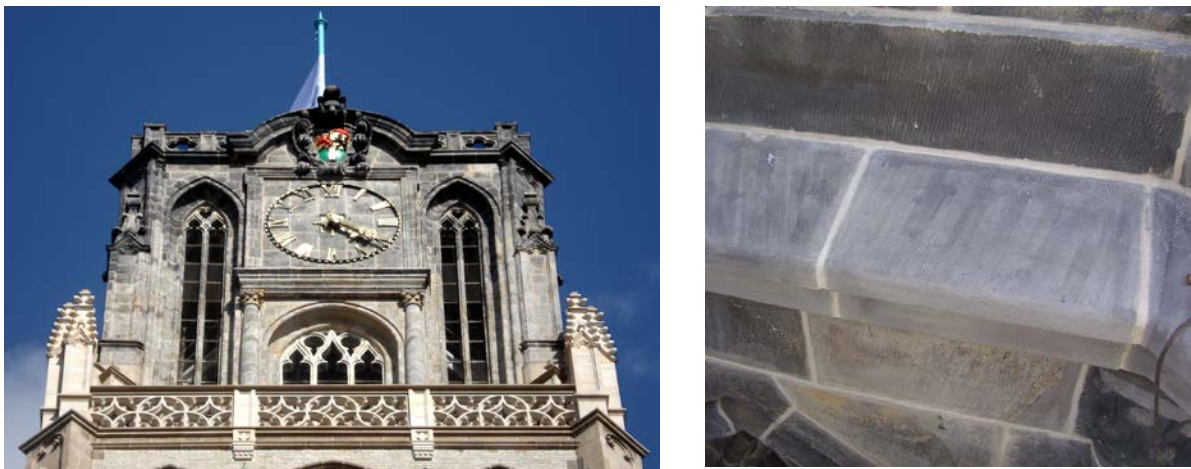
Figure 3 Application of an artificial patina on new sandstone to visually match old sandstone at St. Lawrence Church Rotterdam (photo left: W.J. Quist, photo right: T.G. Nijland)

Although only recently applied on several important historic Dutch buildings, the application of an artificial patina on restored facades has a long history. Among (stone)masons it was common to use dirt from gutters or ink to darken newly constructed masonry or pointing next to old masonry [29], but since a few decades the use of artificial products to colour stone became in use. Together with careful partial cleaning of old blocks of sandstone, the application of an artificial patina on the brightly yellowish looking new blocks of Bentheim sandstone helped to unify the architecture of the façade of the Royal Palace in Amsterdam [30, 31, 32, 33, 36]. Figure 3 shows the tower of the St. Lawrence Church in Rotterdam that has recently been restored in sandstone. Partially the new blocks have been aged artificially to aesthetically match the greyish old stones. The new sandstone for the balustrade and the pinnacles on the corners of the towers were seen as an architectural unity on its own and therefore not aged artificially.

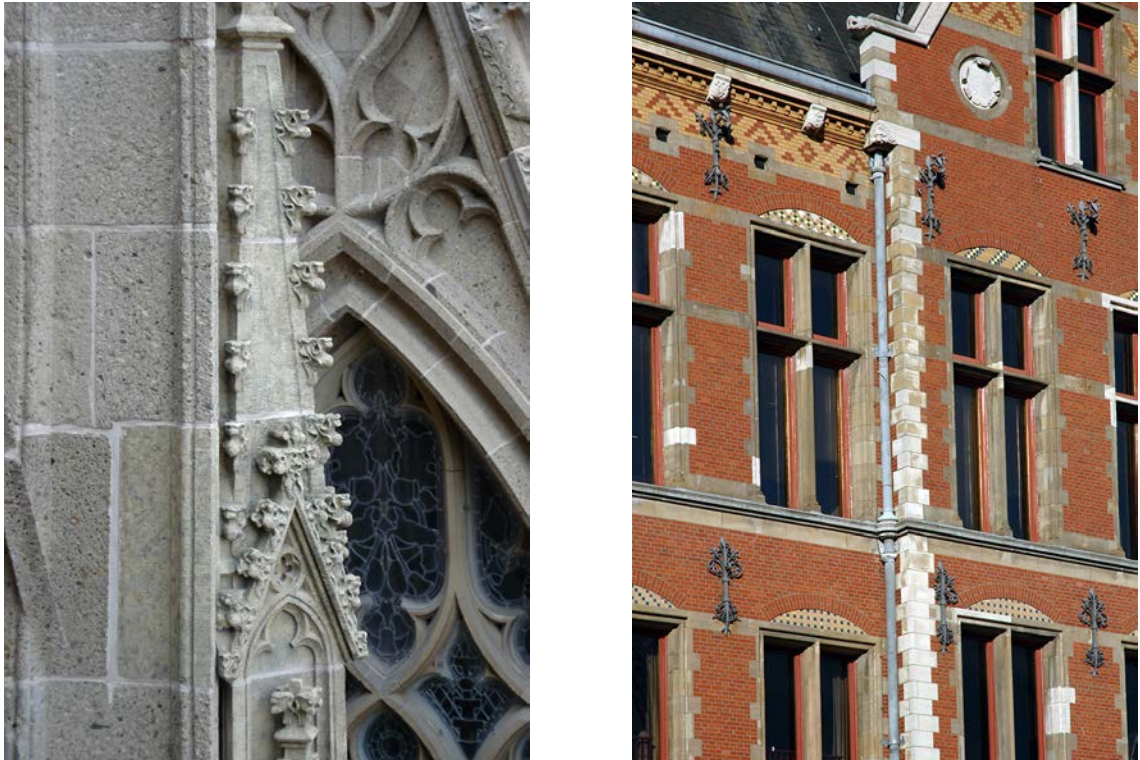
Figure 4 Left: colour on Peperino Duro to visually match Weiberner tuff stone (St. Johns' Cathedral, 's-Hertogenbosch), right: the applied artificial patina on limestone has been washed away by rain (Central Station Amsterdam), photo's W.J. Quist.

The technical possibilities of applying artificial ageing (i.e. by pigments fixated by ethyl silicate) imposes an ethical question. Can it also be used to colour a different type of stone to match its surroundings? Figure 4 shows two examples of types of stone that were coloured to match its surroundings, not by anticipating on its change of colour when ageing but by altering its natural colour. Figure 4 (left) shows a pinnacle in Peperino Duro coloured like it is Weibern tuff stone. A highly durable type of stone has been used and afterwards coloured to match. Is it fake, or is it an example of ‘making use of all possibilities there are’?

Figure 4 (right) shows the effect of ageing of artificial ageing. Due to an almost complete ban on the use of sandstone from 1954 onwards it was in many cases necessary to choose another type of stone for replacement of degraded sandstone [28, 34]. In the case of the Central Station of Amsterdam white limestone with an artificial colouring was chosen to replace brownish sandstone. After 25 years the colour on the limestone has been washed away and both types of stone can easily be distinguished. This example clearly shows that aesthetics were once a reason to apply colour, but is this treatment repeatable, both technically and financially?
