Preliminary Design for Restoration Plan

Restoration

Building Archaeological Research

Historical Colour Analysis

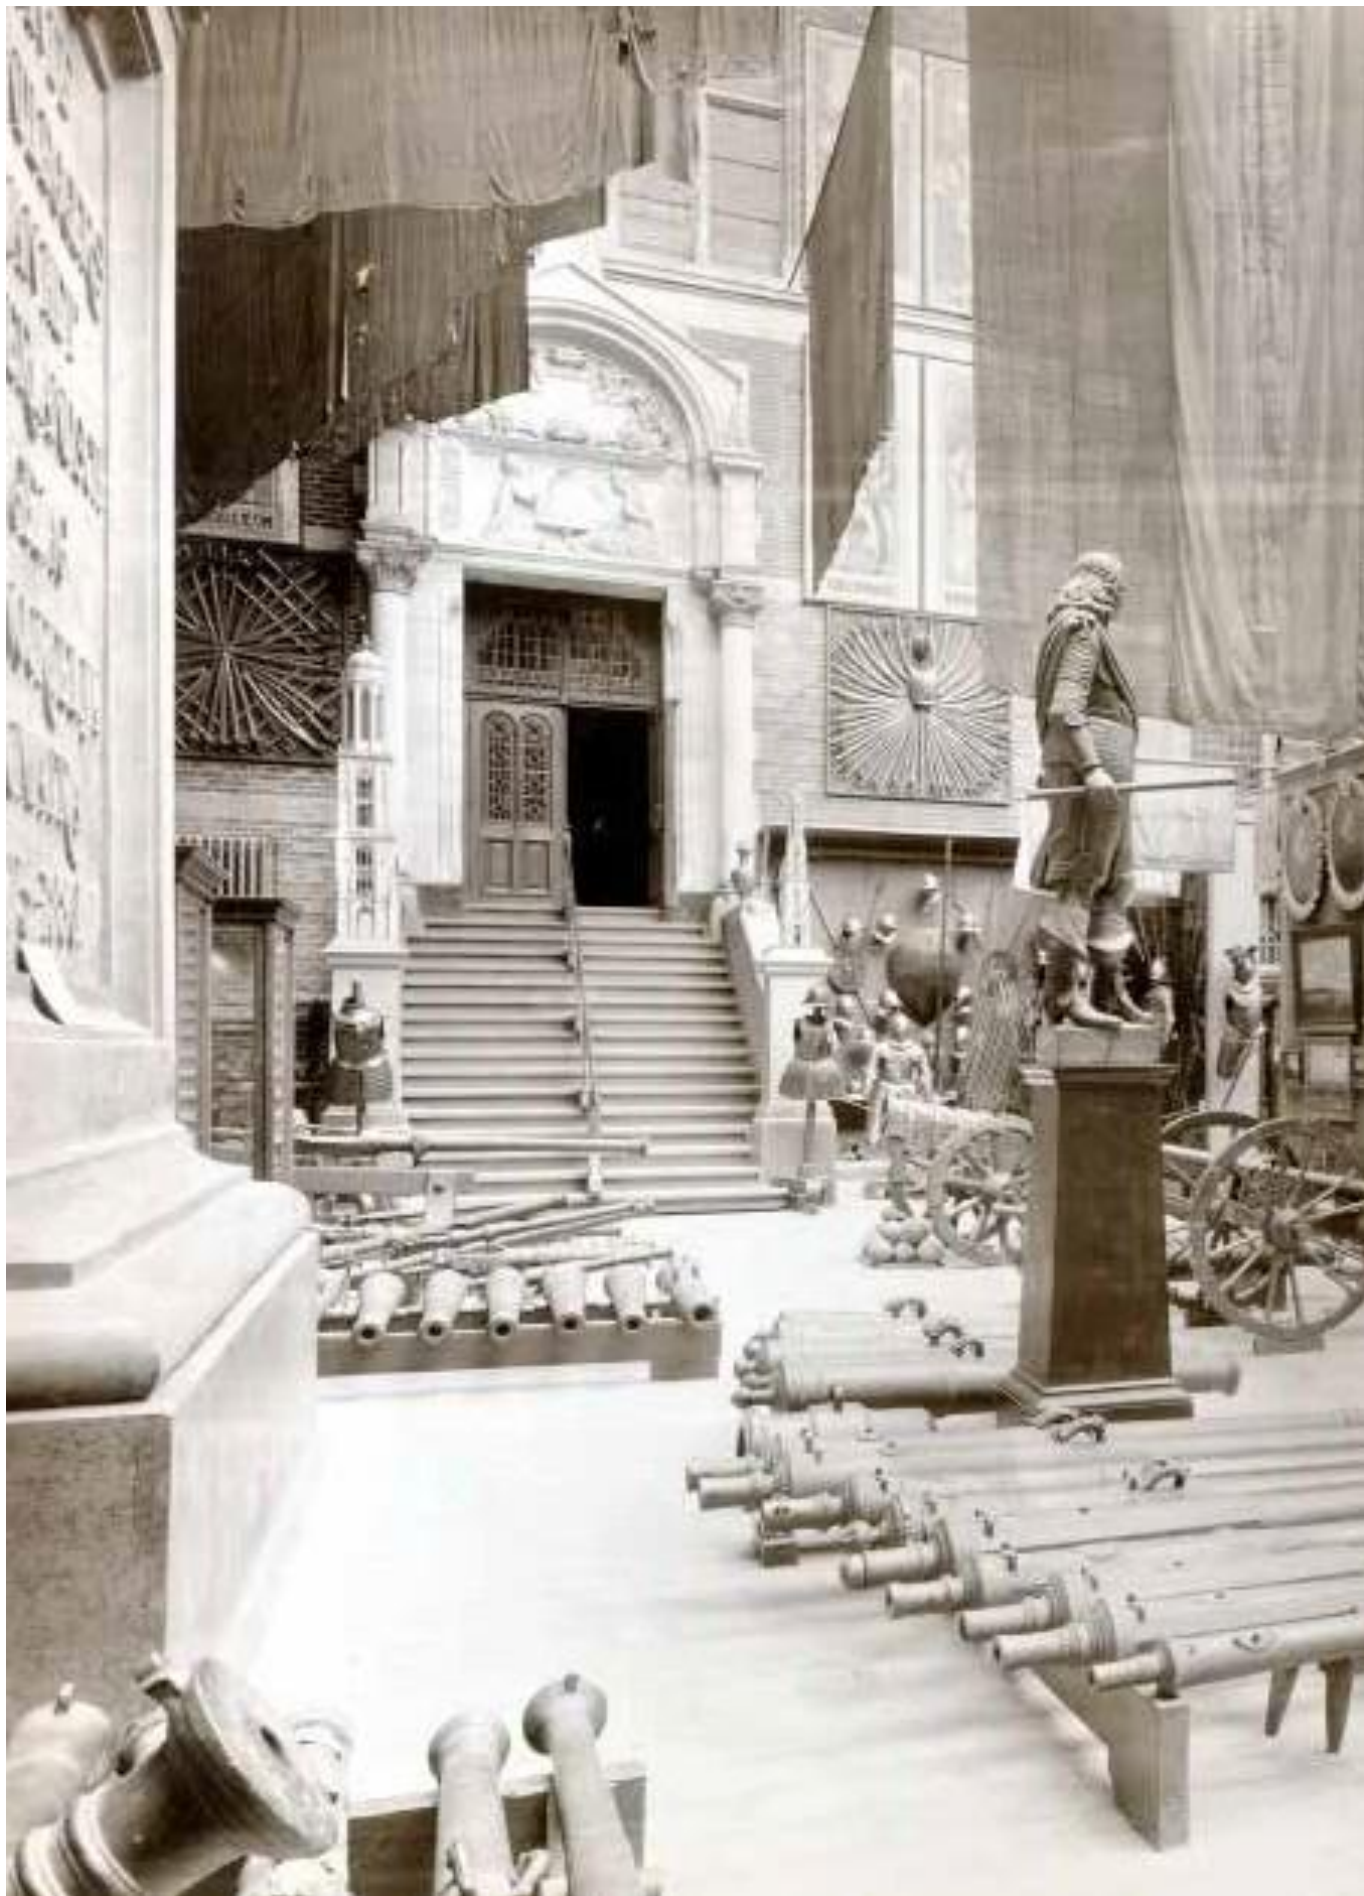
4.1 Original entrance in the north wall of the western courtyard.

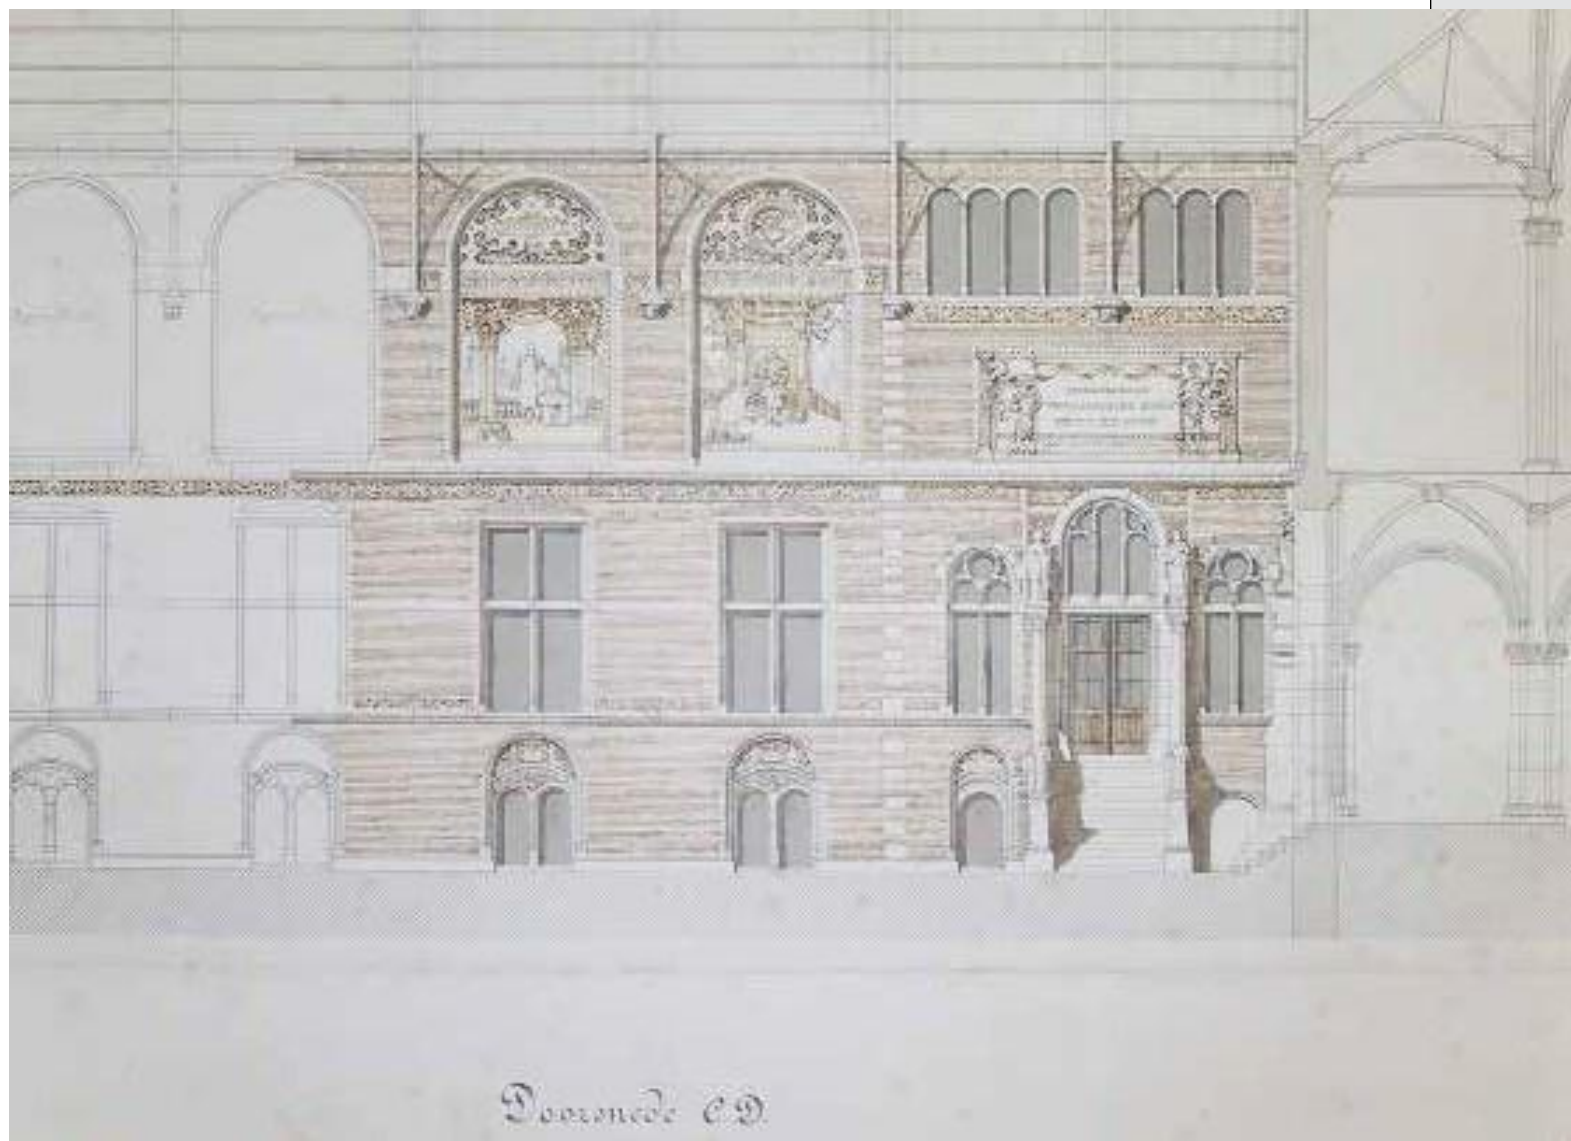
4.02

4.2 Design drawing by Cuypers for the south wall of the west courtyard.

In the course of 2002 Cruz y Ortiz and Van Hoogevest developed their ideas in preliminary plans for reconfiguration and restoration. The two firms differed with respect to the restoration premises, so Van Hoogevest presented a separate Preliminary Design (PD). Cruz y Ortiz's design comprised the firm's own restoration criteria. Both PDs appeared in December.¹³ In the restoration context, four areas were worked out in Van Hoogevest's PD. They were to form the body of that firm's planning process and activities. First and foremost, for Van Hoogevest the rehabilitation of Cuypers' spatial structure meant restoring the historic structure. That was largely bound up with the construction and the services. In fact, these three components were in line with the principal features of Cruz y Ortiz's plans, but in this case from the point of view of consequences for the historic building. The fourth area was the restoration of Cuypers' decorations (4.02, 4.03).¹⁴

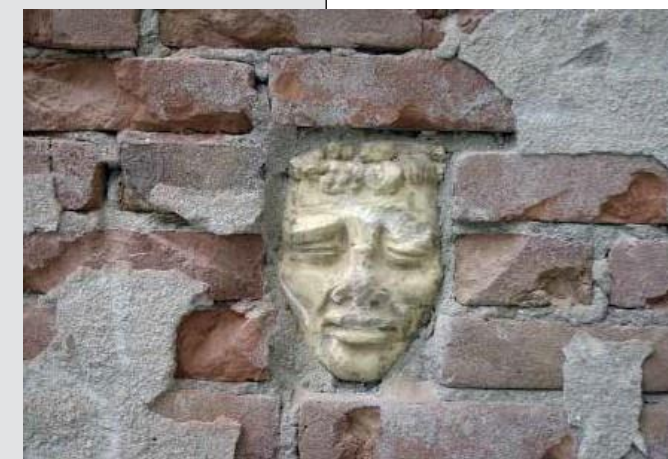
4.03

4.3 Rediscovered fragment of architectural sculpture.

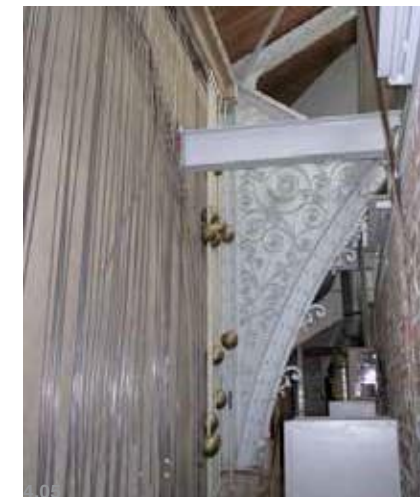
4.06

4.6 Elements preserved behind an added wall.

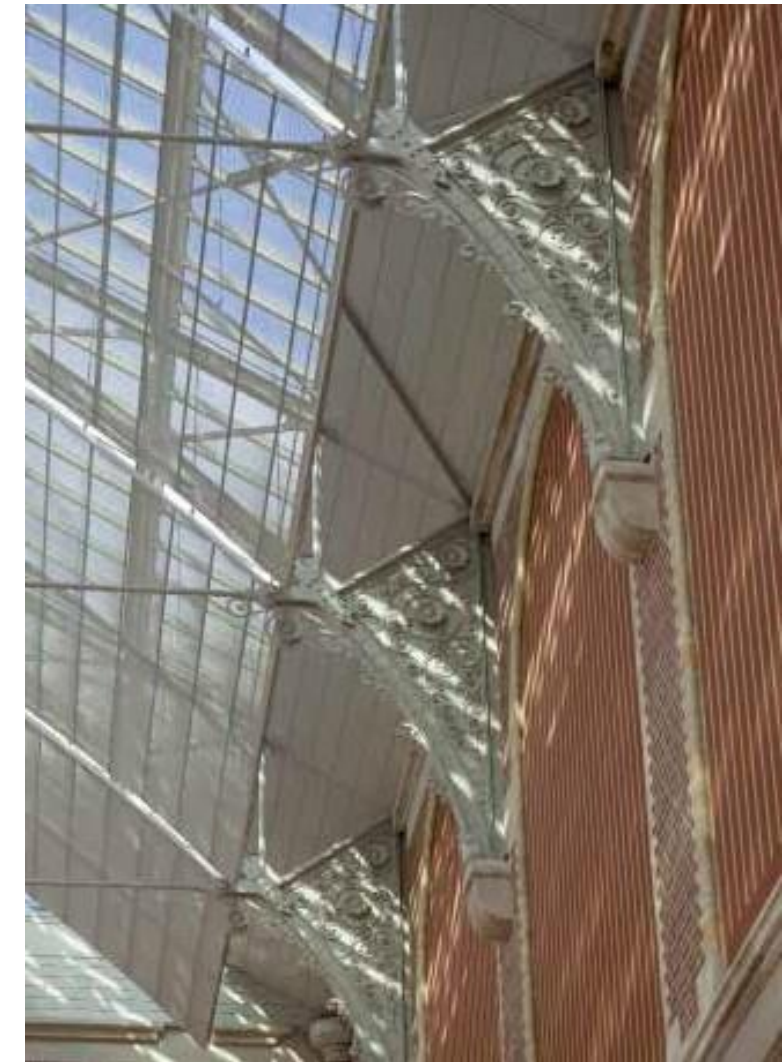
4.07

The decorated trusses of the restored roof structure above the courtyards.

4.7 The restored roof structure, now fully visible again.

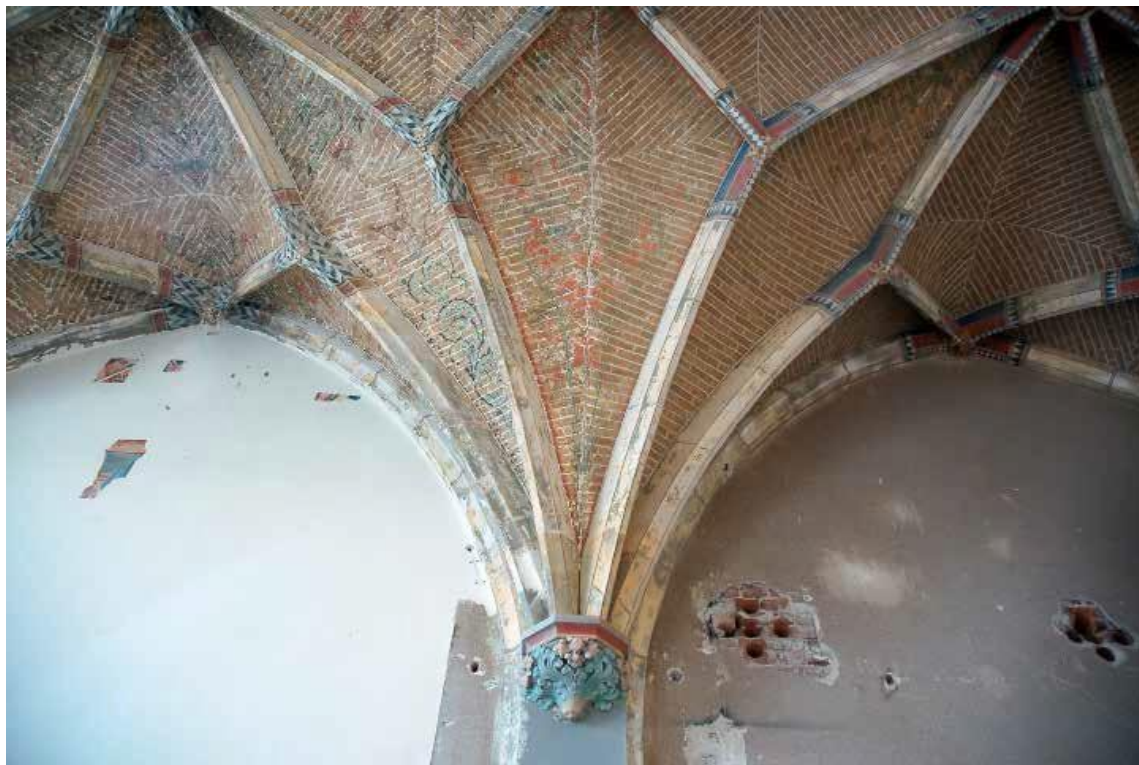
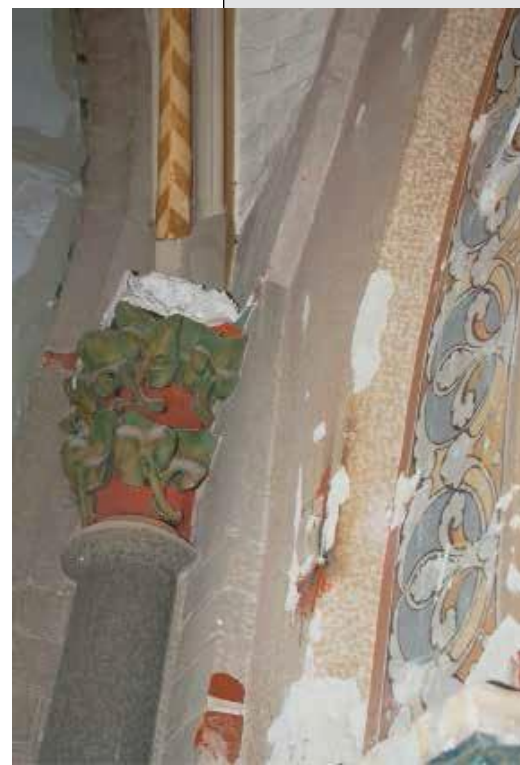
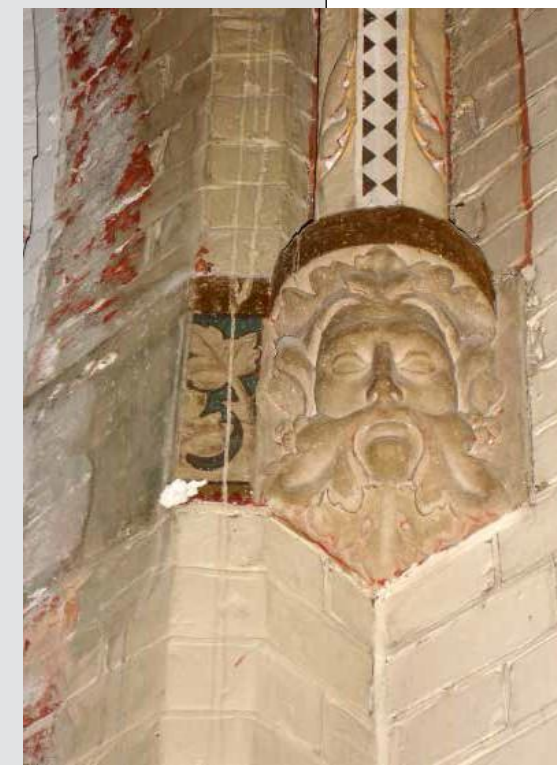
4.12-14 Sculpture and polychrome fragments that came to light after the building was dismantled and the walls and vaulting were cleaned.

At the start of 2002, the SRAL had already carried out initial research into the building's decorations and colours. Since its opening, the museum's layout had been altered frequently and the original finishes in the interior adapted regularly to changing ideas on museology. Consequently, many of the original decorations had disappeared – painted over or even completely removed. The SRAL's activities were aimed at determining whether there were still any original decorations left, and what condition they were in.³⁸ Their studies combined stratigraphical and topographical research (to expose paint layers in their spatial context) with the study of archival material including drawings, sketches and photographs. Wall paintings that were still present at many different places in the museum were examined, for comparison with areas where only stratigraphical research (scraping off the layers of paint) could reveal the original, often vulnerable decorations. For instance, the wall paintings in the library, Aduard Chapel, and remains of paintings behind the organs in the Great Hall and the upper part of the Night Watch Gallery supplied important information on the original surface, colour saturation and detailing of the paintwork in all of the museum spaces. The SRAL ascertained that much of the original paintwork must still exist. In the concluding report they noted: 'In spite of the wealth of motifs, the degree of stylistic unity in the various decorative paintings found at various locations in the Rijksmuseum is remarkable' (4.12-4.14).³⁹

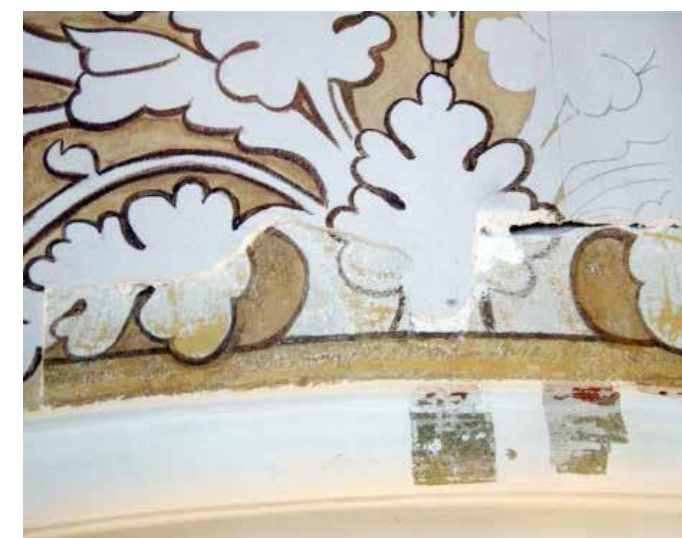
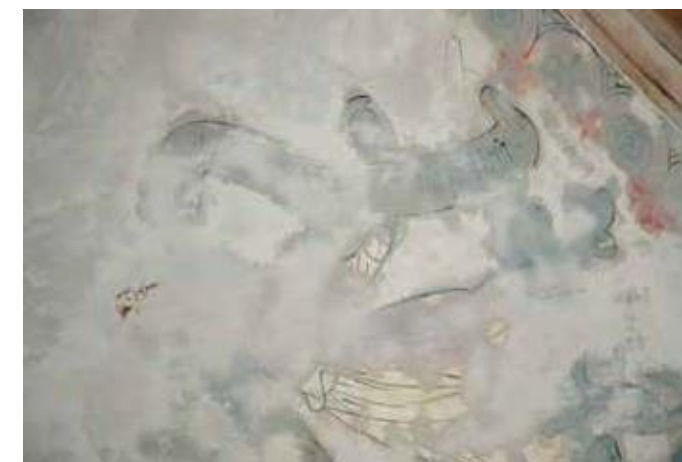
4.15-16 Details of the colour research by the SRAL restoration studio.

The authentic surface mostly comprised a matte distemper, alternating sometimes with bronze paint or gold leaf, and sections in oil paint (4.15, 4.16). Where still present, these authentic layers proved to have become darker and duller over time. However, the majority of the wall paintings in the museum were no longer visible and had disappeared under new layers of paint. In addition, the first layer of white lead painting had penetrated the underlying plaster so much that the bottom layer could not be revealed without causing damage. The layer of lead white had combined totally with the layer of plaster, and if the former were scratched off the top part of the plaster would come off as well. So the SRAL proposed reconstructing the decorations only where there were repetitive patterns, but not in the freely painted sections (4.17). However, more research was needed into the original templates, the historical context and, especially, into primary sources (wall paintings and painted canvases) if the possible reconstruction was to be conducted properly. For example, for the Great Hall and the Gallery of Honour, it was important to learn more about the quality and potential of the work done by Georg Sturm. His paintings had been installed in the first decade of the twentieth century, but had meanwhile been removed and stored away.

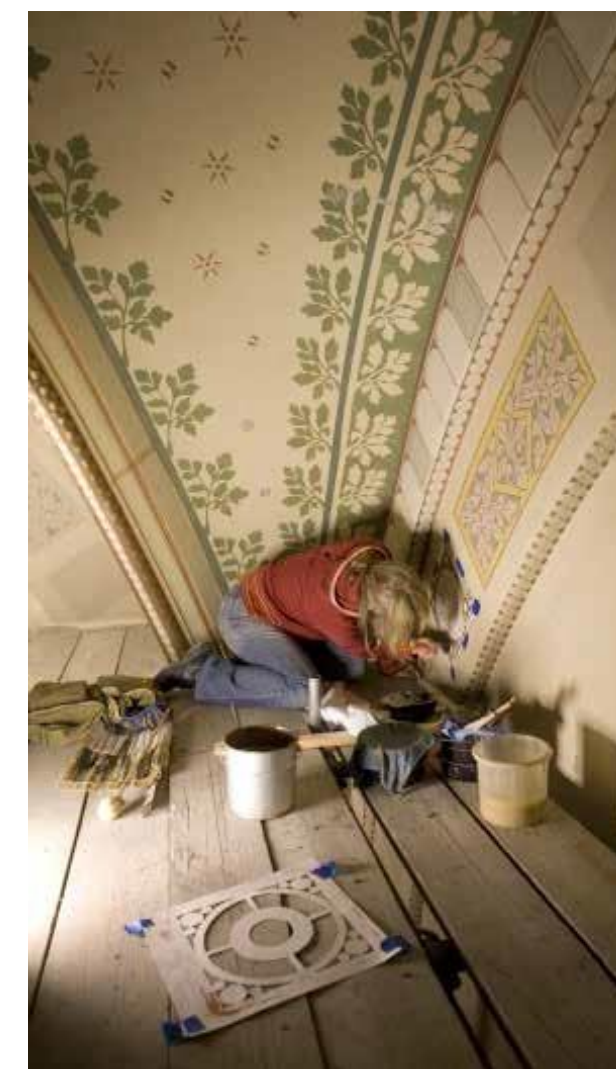
4.17 The application of reconstructions using templates.

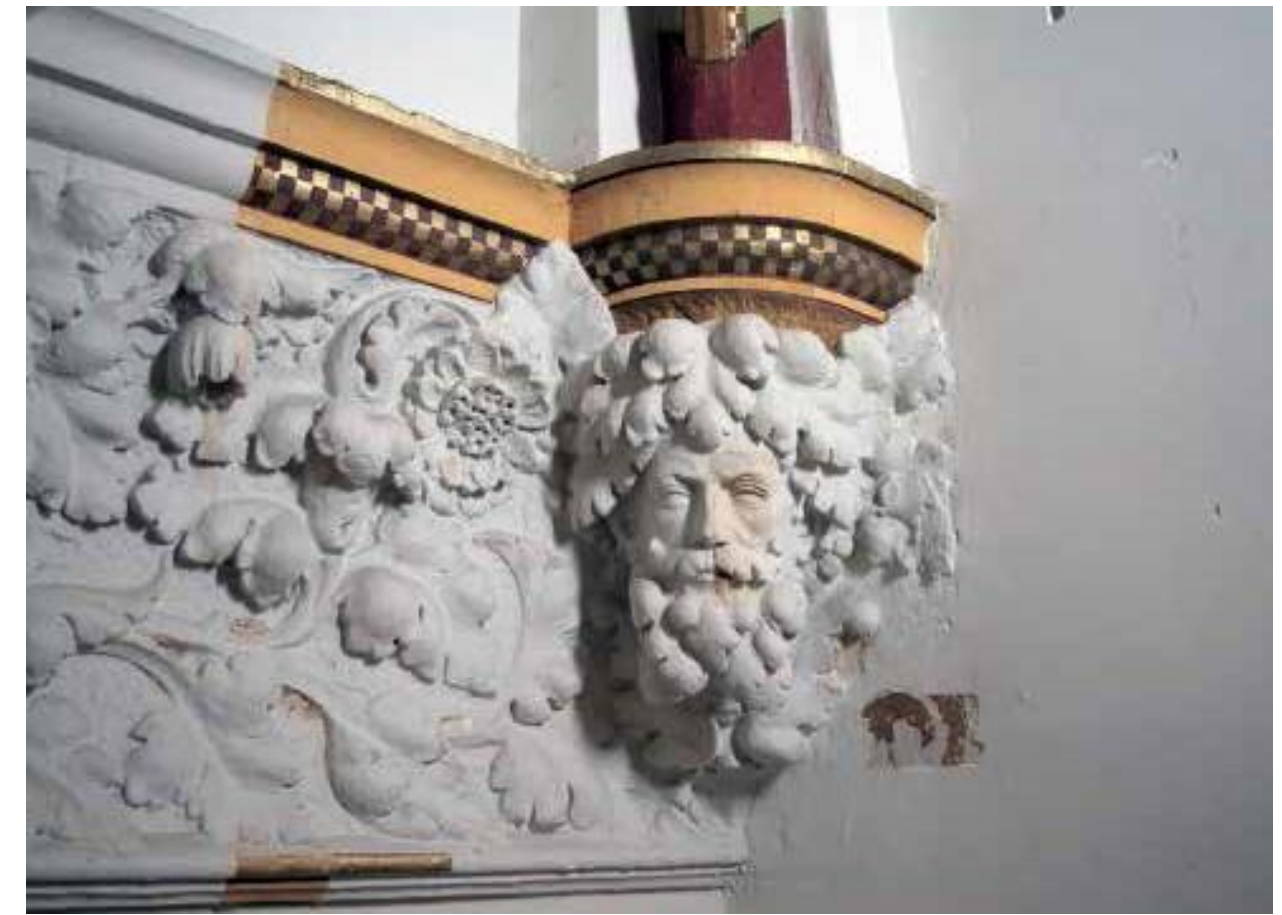
4.19 Trial reconstruction in a corner of the Great Hall, 2003.

In the spring of 2003 the SRAL was able to carry out an initial test reconstruction, in a corner of the Great Hall (4.19). One of Sturm's canvases was returned to its original place and the painting work was reconstructed around it (4.18). That brought to light the purpose of the decorations: thanks to the effect of the paintings on the cornice, painting and sculpture work and architectural elements seemed to blend seamlessly together. This approach – rather than remaining seated at the conference table – was a far better way for all concerned, including the Spanish architects, to get an impression of (and later be convinced by) Cuypers' decorative interior, the historical context and the aesthetic result.⁴¹ And in that year the SRAL was actually commissioned to carry out analyses in the Gallery of Honour, a side gallery and in the Night Watch Gallery. Their successive preliminary investigations

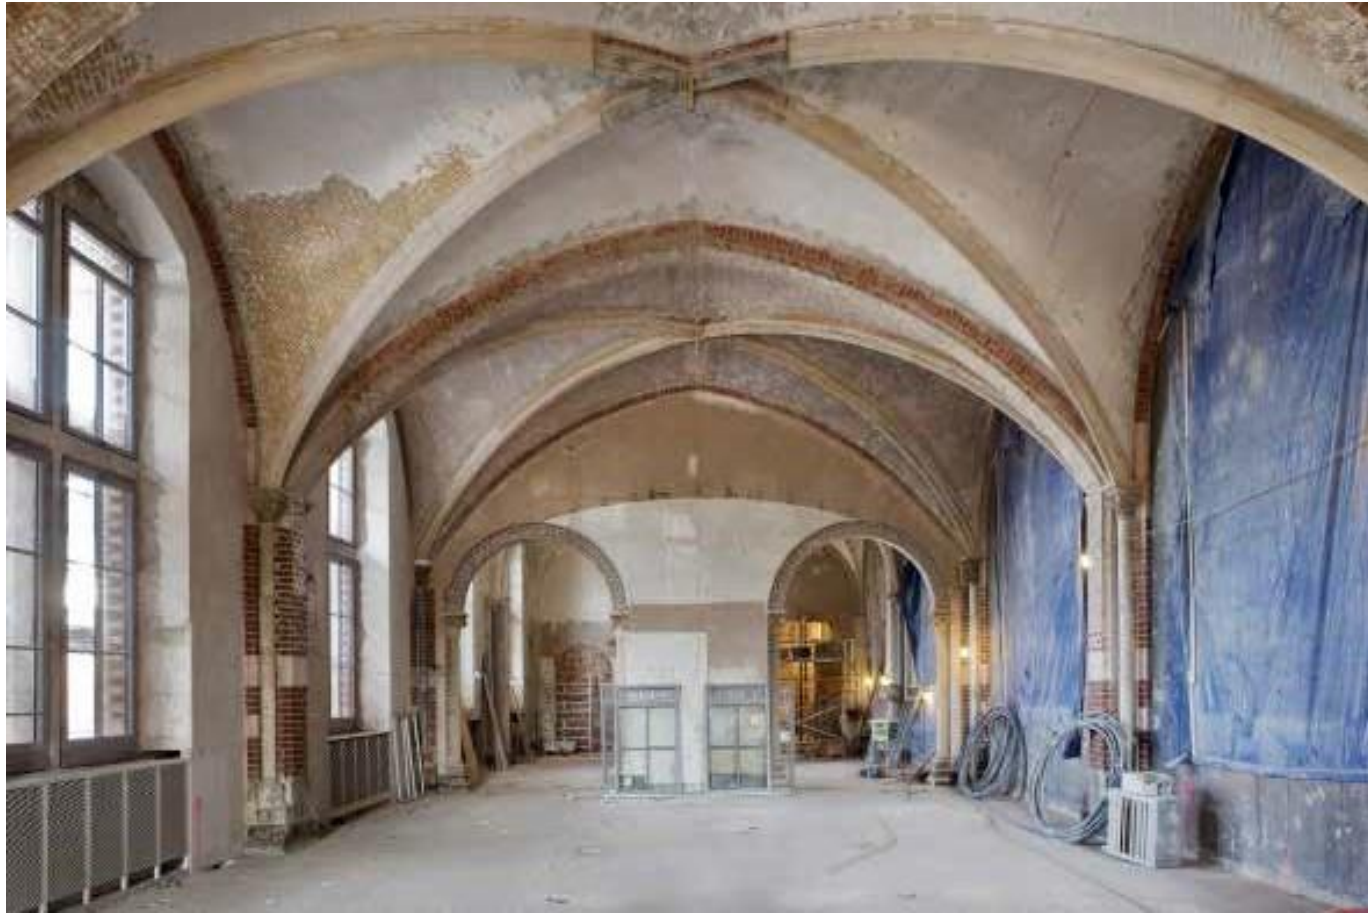
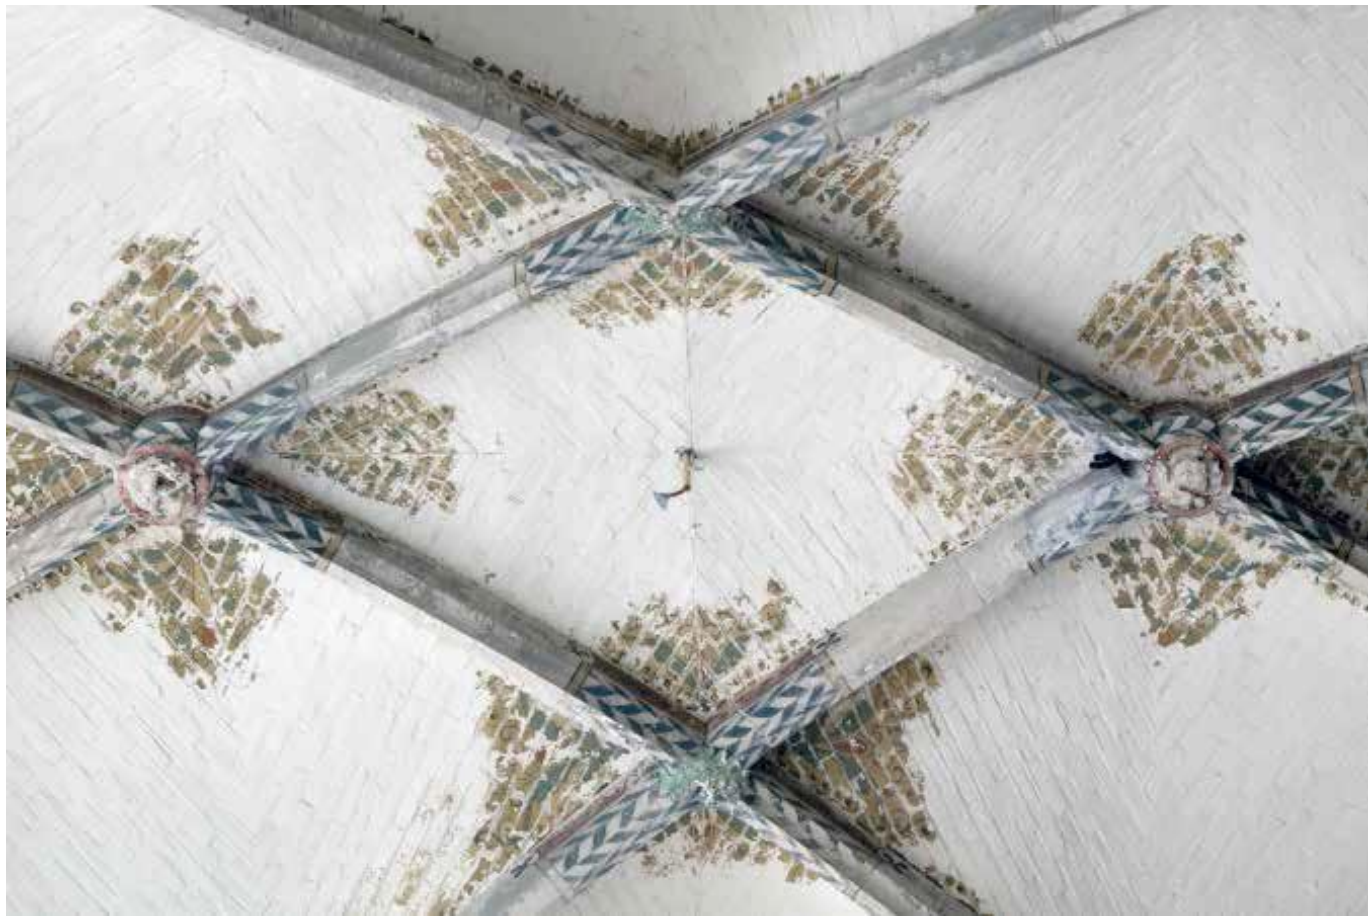
4.22-23 Masonry patterns and decorative painting in the ecclesiastical architecture section, visible now that the façades have been cleaned.

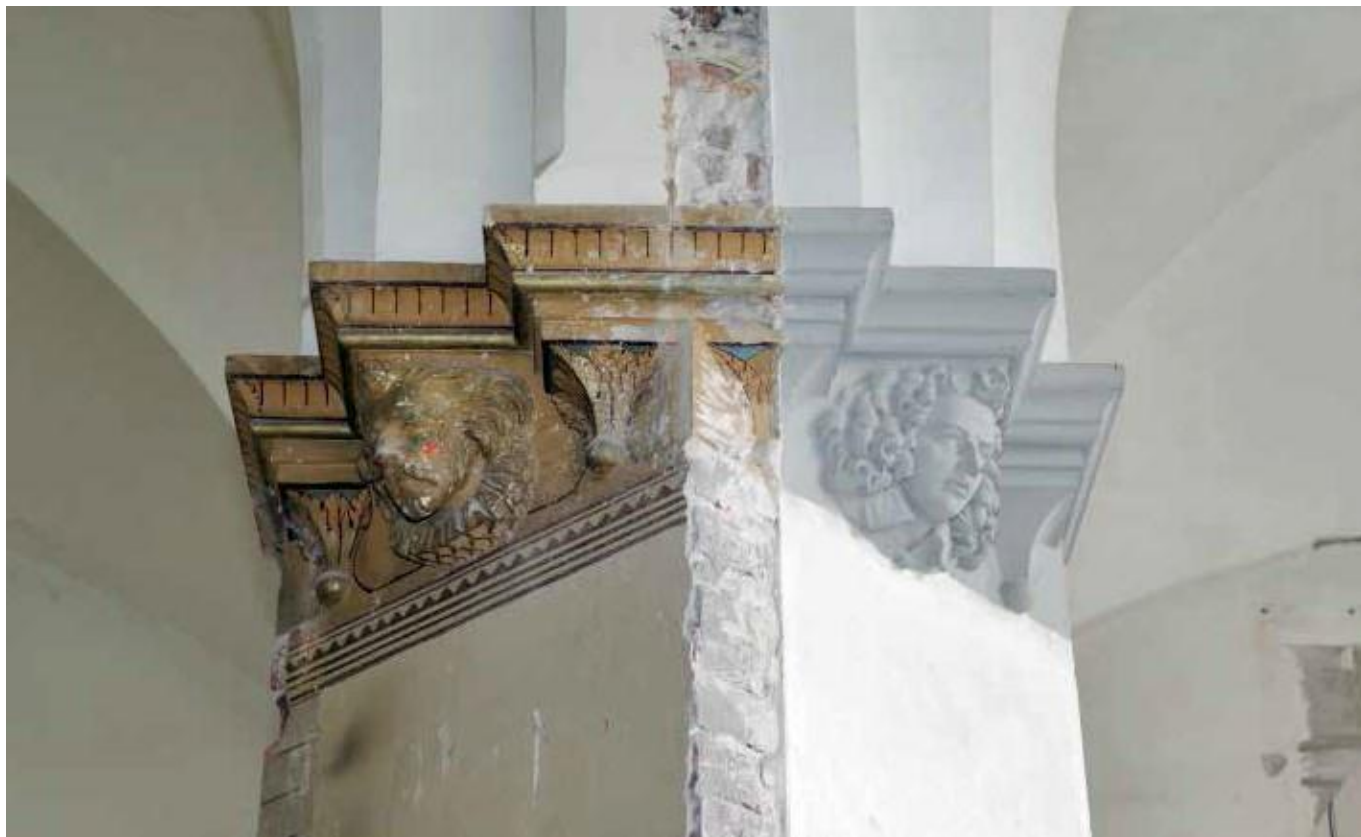
D.03

D.3 Pillar on the ground floor; the polychrome decoration has been partly preserved and partly painted over, 2005.

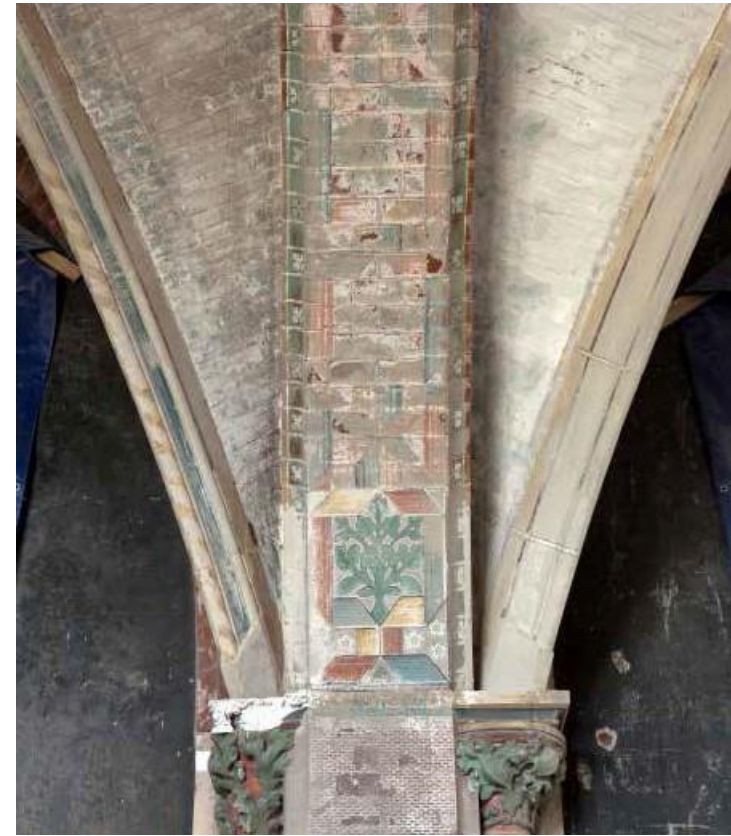
D.06

D.6 Fragments of the original painting and masonry vaulting in the ecclesiastical architecture department.

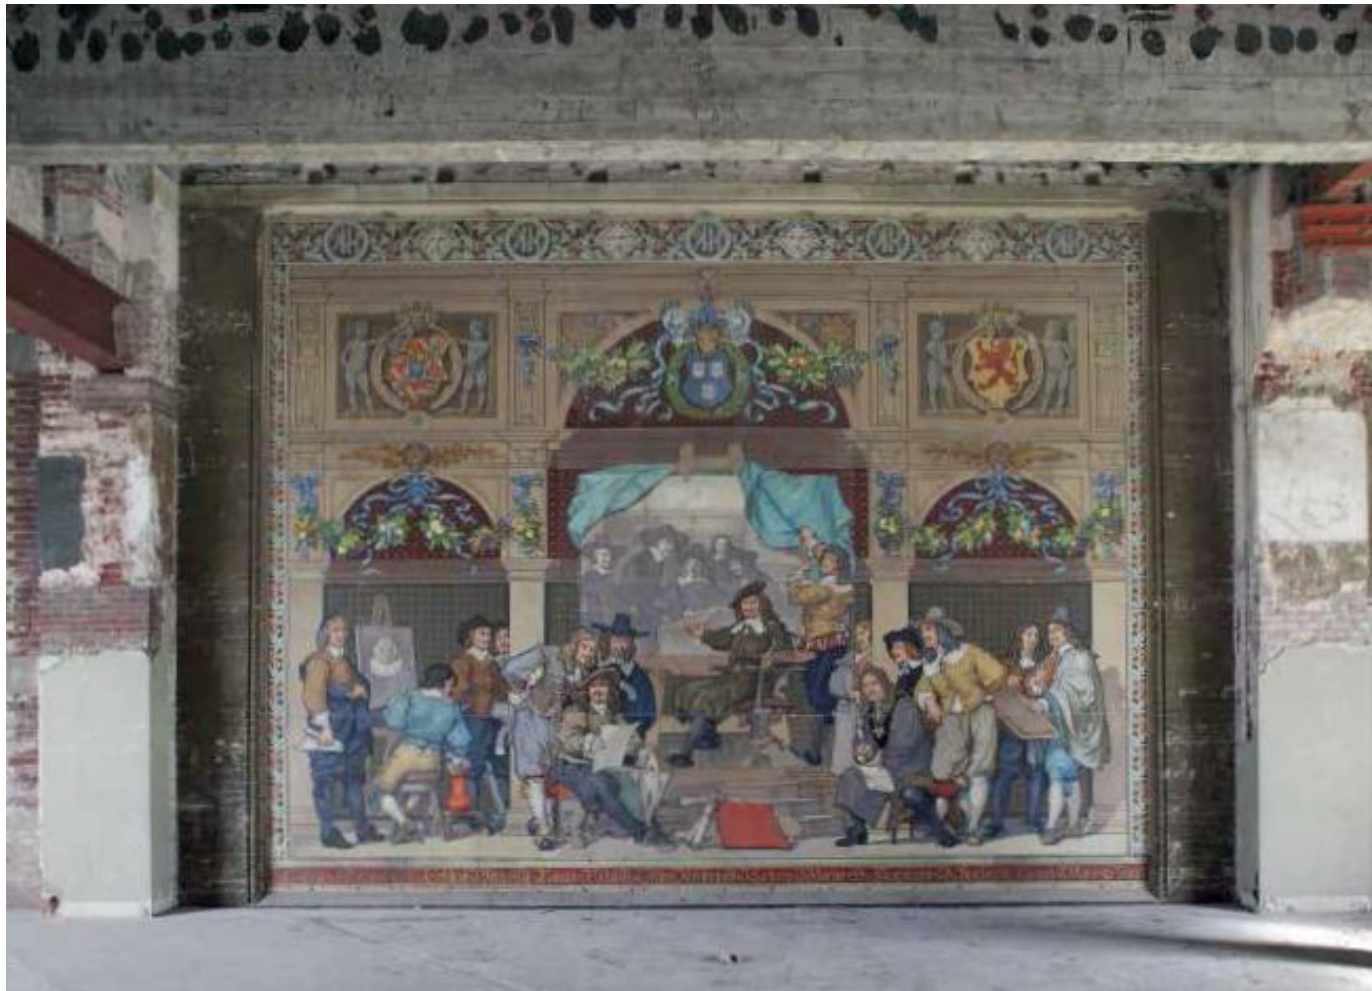
D.10 Tile panel based on a design by Georg Sturm on what was formerly an outer façade, rediscovered during renovation of the Vermeer extension.

When the original museum building was erected, tile panels (tableaux) designed by Georg Sturm were placed in the west, south and east façades at the main floor level. These depict key moments in Dutch art history. The three panels in the middle of the south façade, over the passageway, soon disappeared behind the Vermeer extension. This extension was initially connected to the main building in the spot where the rightmost panel had been, the other two were hidden from sight behind a wall. During the recent

renovation, it was hoped that fragments of these panels would come to light when the building was dismantled. When the false walls in the Vermeer extension were removed, the panels were found to be in much better condition than expected. A few fragments of the rightmost panel were found, and the other two had been preserved in their entirety. The Rijksmuseum chose not to integrate these panels into the building interior, however, because they would have dominated the space and hence made it unsuitable for exhibition purposes. One option considered was to remove the panels from the façade and exhibit them in the garden. But this proposal was unacceptable to the national and municipal agencies responsible for the preservation of historic buildings, which regarded the panels as an integral part of the main building. Furthermore, there was a risk that removing the tiles would damage them. The panels were ultimately left in place and hidden from view with a false wall.

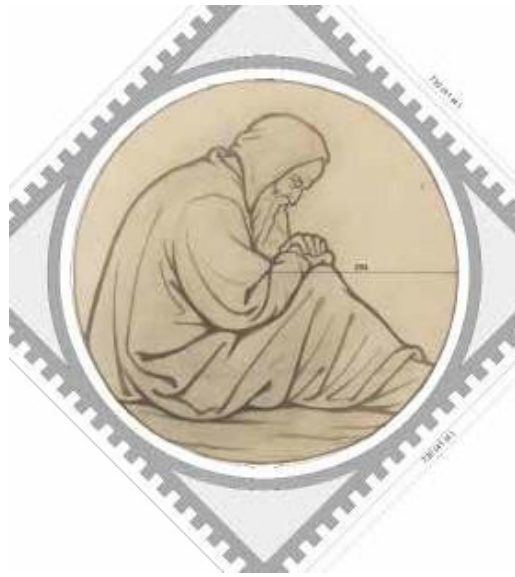
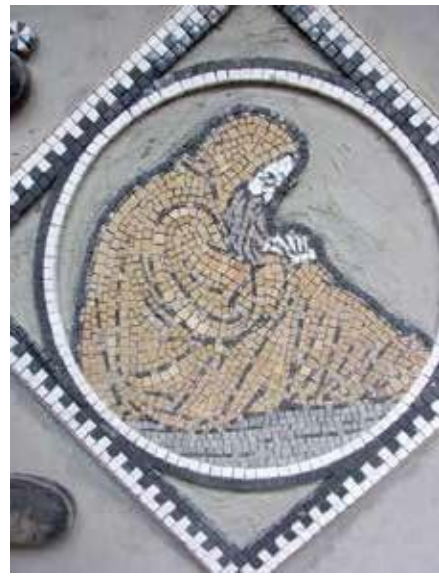
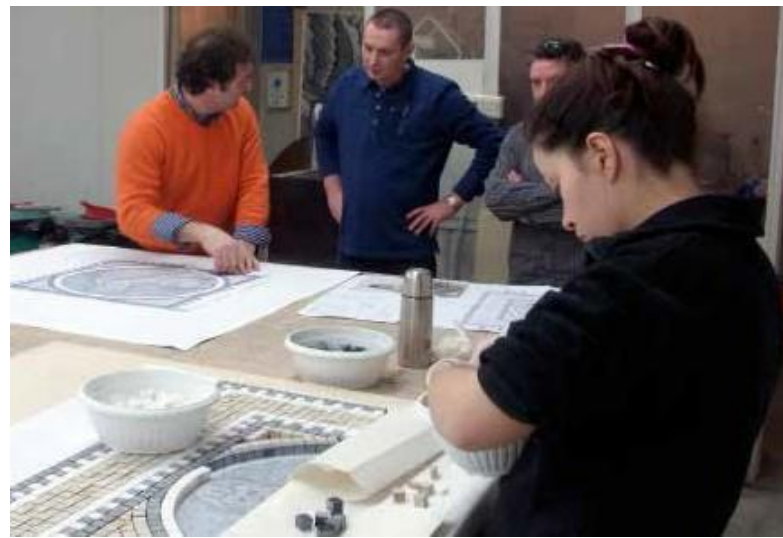
D.16-19 Designs and detail drawings for the reconstruction of the terrazzo floor in the Great Hall.

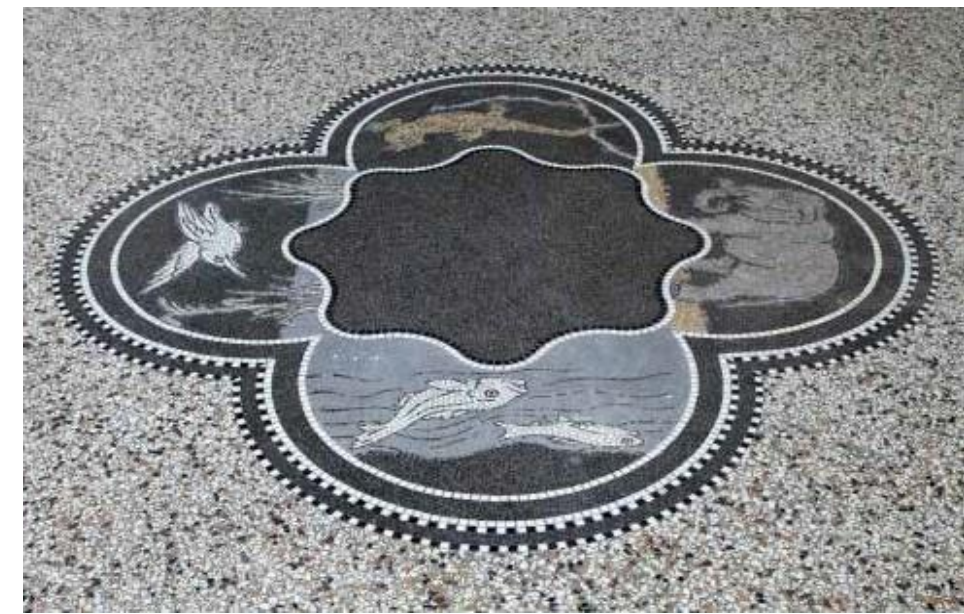
D.23 Detail of the reconstructed terrazzo floor.

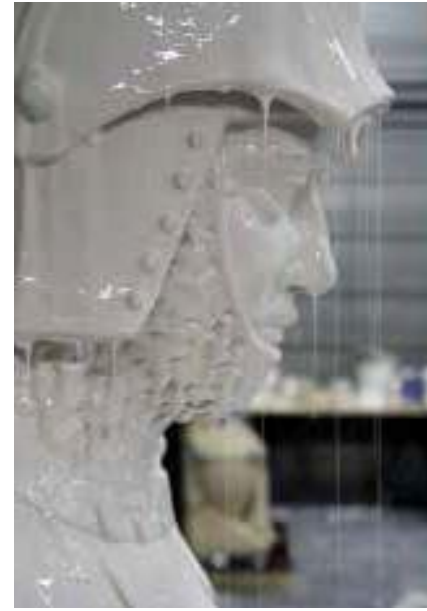
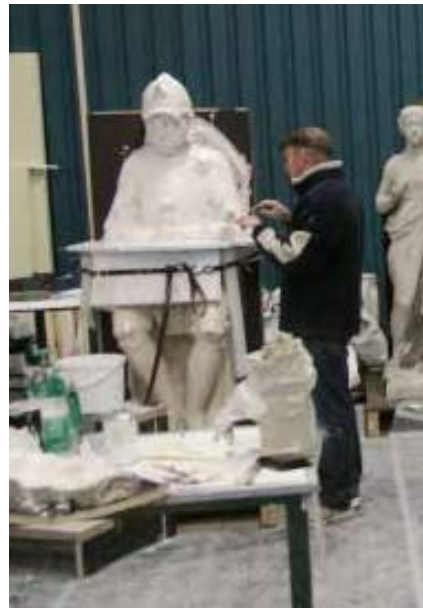
D.26-27 Making the acrylic replicas at the Replique studio.

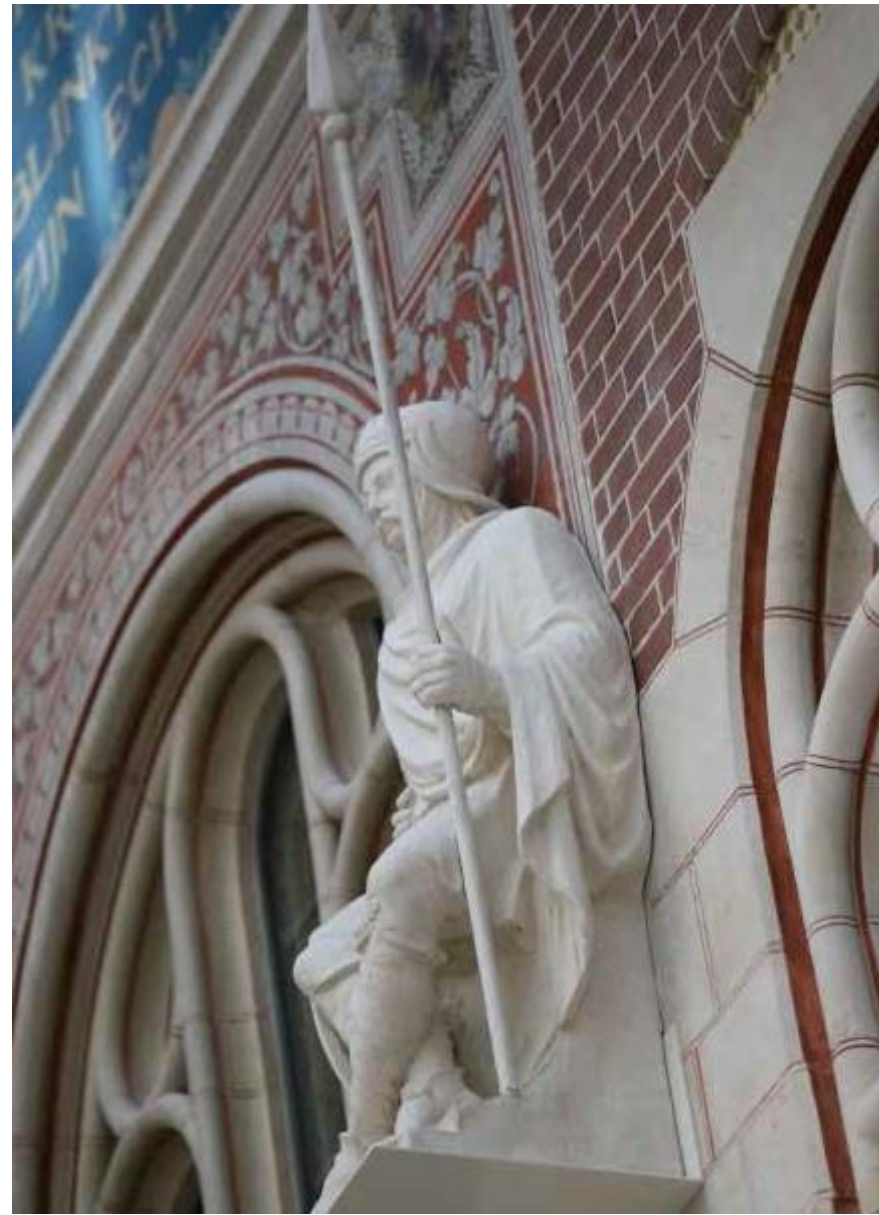
D.28 Sentry sculpture by Replique attached to the south wall of the west courtyard.

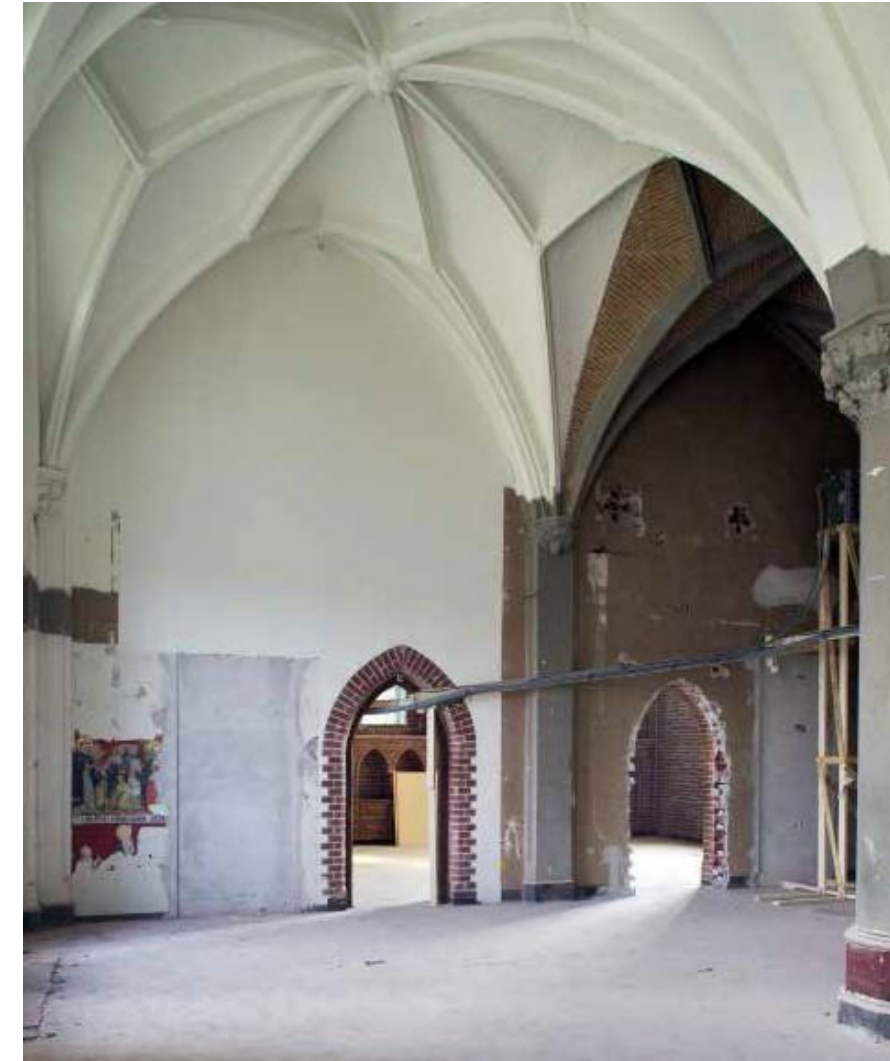
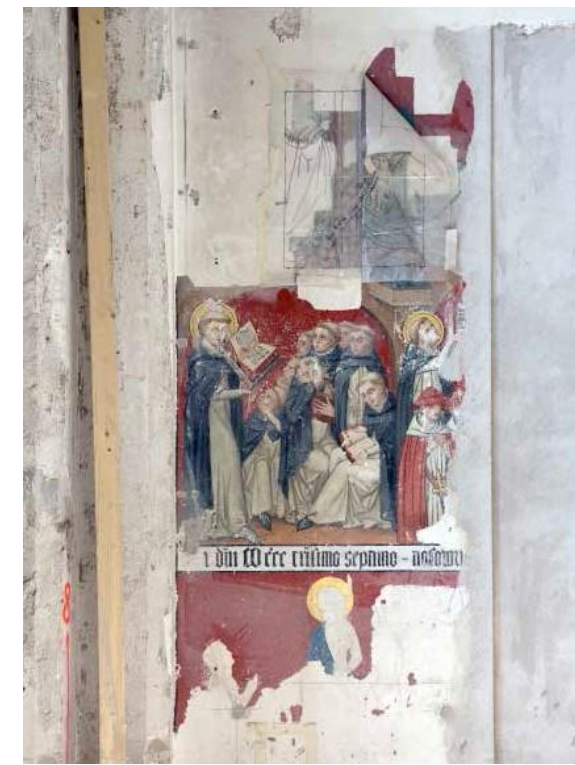
D.29-31 Fragments of original paintwork and masonry vaulting in the ecclesiastical architecture department.
