Investigation of Well Clogging during Managed Aquifer Recharge of Tile Drainage Water

An ASTR Pilot Study

Master of Science
Civil Engineering
Track of Urban Water Engineering

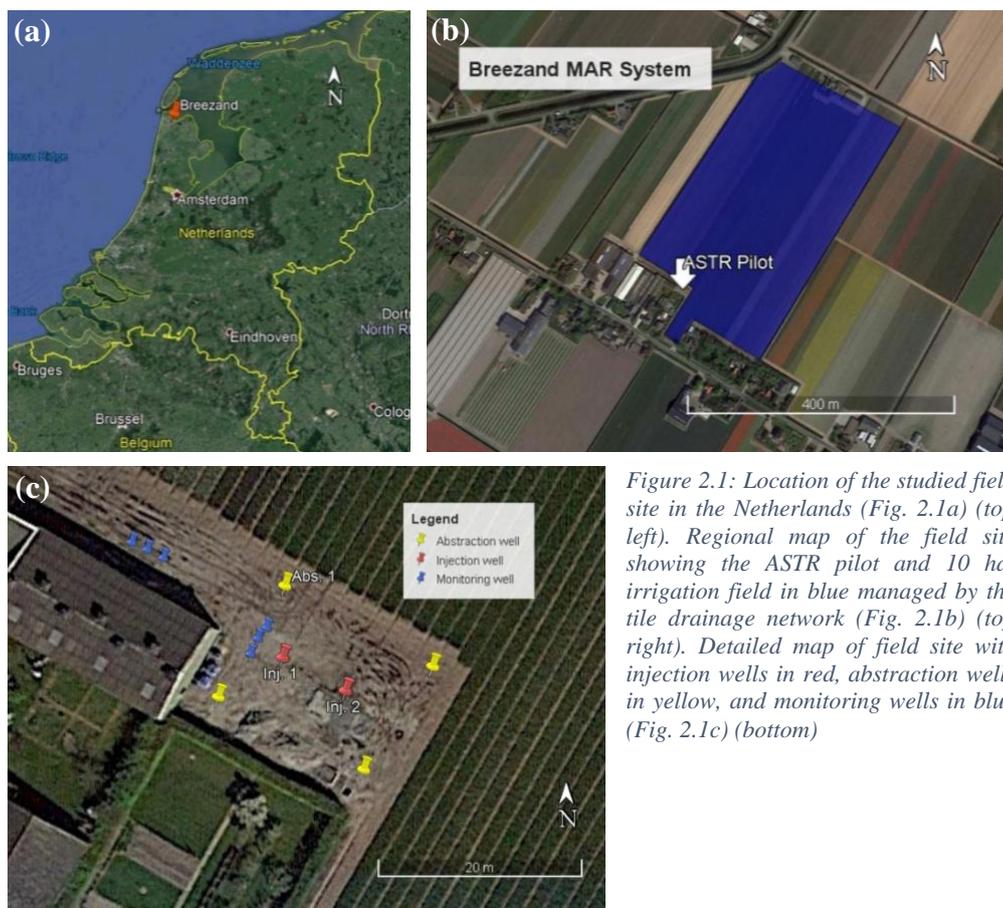
Figure 2.1: Location of the studied field site in the Netherlands (Fig. 2.1a) (top left). Regional map of the field site showing the ASTR pilot and 10 ha. irrigation field in blue managed by the tile drainage network (Fig. 2.1b) (top right). Detailed map of field site with injection wells in red, abstraction wells in yellow, and monitoring wells in blue (Fig. 2.1c) (bottom)

The trial site lies in a coastal agricultural polder in the town of Breezand located in the Province of North-Holland (Fig. 2.1a). The ASTR system is supplied by tile drainage water (TDW) discharged from a 10 ha. flower bulb field when excess water is available (Fig. 2.1b). The tile drainage network is situated 80 cm below ground level (BGL) and discharges TDW to a drain reservoir regulating the water level in the irrigation field. The topsoil consists of mainly fine sand from surface level (-0.1 m NAP) to approximately 2.2 m BGL (TNO lithological site survey, 2018 in the supplementary data (SD) adopted from E. Kruisdijk, Section 1).

The ASTR system started operation in October 2019 and consists of two injection and four abstraction wells (Fig. 2.1c). The injection well, screened between 11.5-33 m BGL (long filter) and abstraction well, screened between 12-23 m BGL, are each equipped with a piezometer inside the gravelpack, approximately 35 mm and 50 mm distance to the well screen, respectively. The piezometer is screened at 20.5-22.5 m BGL with 0.5 mm slot size and of PVC material. The injection well, of PVC material, has an inner diameter of 110 mm for the well riser to a depth of 11.5 m, and 100 mm for the well screen to 33 m BGL with 0.5 mm filter slot size. The annular gravelpack width is 70 mm and consists of 800-1200 μm packing material surrounding the well screen. The total bore diameter is 240 mm, with an infiltration surface area of 17 m² to the aquifer. A nested monitoring well is used for sampling at six depths between 12 m and 32 m BGL in the target aquifer.

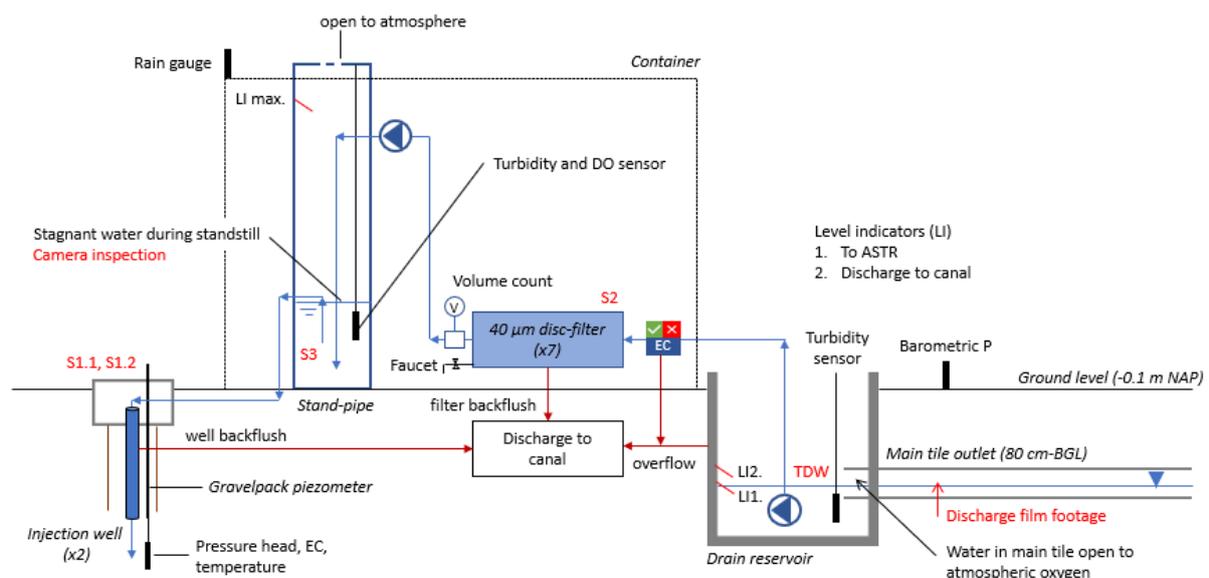
Figure 2.2: A schematic representation of the ASTR system (injection well) in Breezand from main tile outlet, pre-treatment, and injection well. Annotations provide information on system operation and data monitoring. TDW, S1.1, S1.2, S2, and S3 represent sample locations within the system described in Section 2.5.

A schematic of the ASTR system is presented in Figure 2.2. The tile drainage network regulates the groundwater level in the field when water is supplemented by precipitation events. The excess water is discharged and fills the drain reservoir at the main tile outlet (Fig. 2.2). Depending on the duration of drainage events, related to the intensity of precipitation events, the availability of TDW can vary significantly. Level indicators (LI. 1 and 2, Fig. 2.2) within the drain reservoir regulate the field drainage by respectively discharging water to the ASTR system and/or discharging to the surrounding surface

TDW, S1.1, S1.2, S2, and S3 codes denoted in Figure 2.2 represent sample locations within the ASTR system. Figure 2.4 summarizes the sampling in a timeline in relation to the two infiltration periods and well rehabilitations performed during the study.

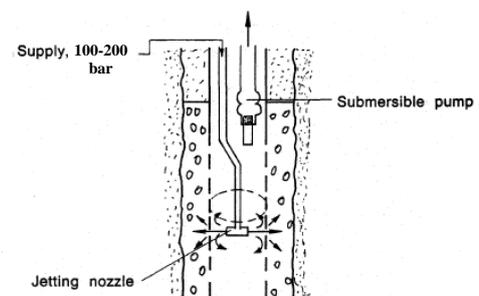
Figure 2.3: Schematic of high-pressure jetting procedure. Adopted and modified from Olsthoorn (1982)

The well rehabilitation was performed by the following regeneration cycle: (1) an initial backflush at 11 m³/h, (2) mechanical cleaning by high-pressure jetting nozzles (100-200 bar, Fig. 2.3) and simultaneous discharge at 3 m³/h. The

well screen was cleaned from top to bottom and back (0.20 cm/min, 1-hour procedure). (3) a post backflush at 11 m³/h. After the initial backflush, a buffer was filled with approximately 3 m³ abstracted water for the mechanical cleaning procedure.

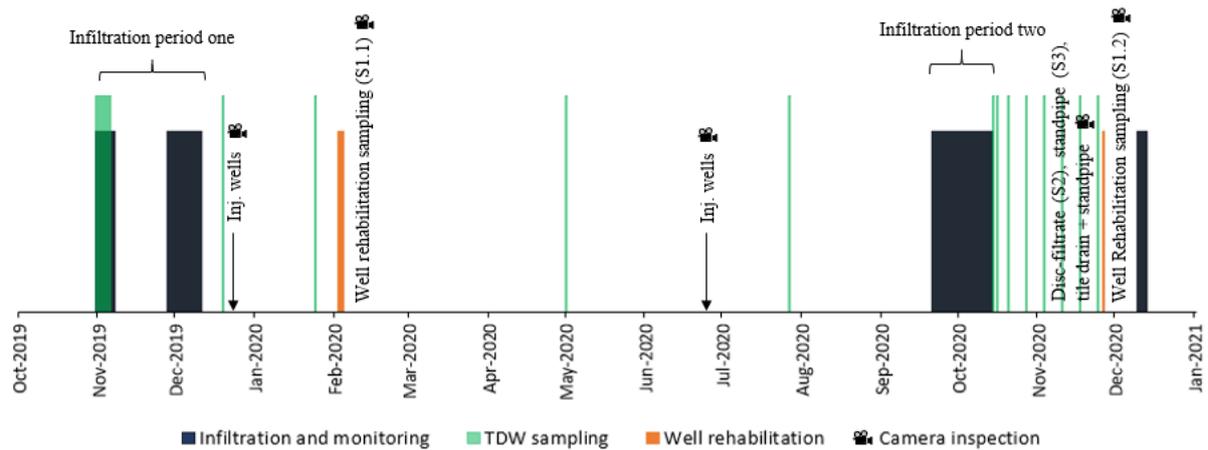
Figure 2.4: Timeline of the study indicating the two monitored infiltration periods, well rehabilitation, and corresponding sampling information as summarized in Table 2.1.

Figure 2.4 and Table 2.1 summarize the investigation in a timeline of the study. The clogging potential of tile drainage water as injectant source is evaluated on a suite of physicochemical parameters regarding clogging mitigation guidelines from literature. The impact of the 40 μ m Klin-disc filter in the pilot is evaluated on its viability to reduce the physical clogging potential. Considering the infiltration under gravity maintaining a constant hydraulic head in the standpipe, the risk of ASTR operation failure over the short term was considered by the deterioration of hydraulic performance during the two infiltration periods. The difference in hydraulic head rise method by Pyne (1995) is used to evaluate the clogging development. Moreover, the change in hydraulic head within the injection well gravelpack piezometer to that of the gravelpack piezometer in the abstraction well (dedicated monitoring well) at distance, was used to investigate the primary clogging location. An injectivity index ($m^3/h/bar$) by methods of Brehme et al. (2018) show the extent of the clogging problem in relation to implicating events during the infiltration periods. The index expresses a change in recharge flow to downhole pressure in response to clogging. Extensive submersible camera inspections aid in the recovering effects of the well rehabilitation and support the localization of clogging.

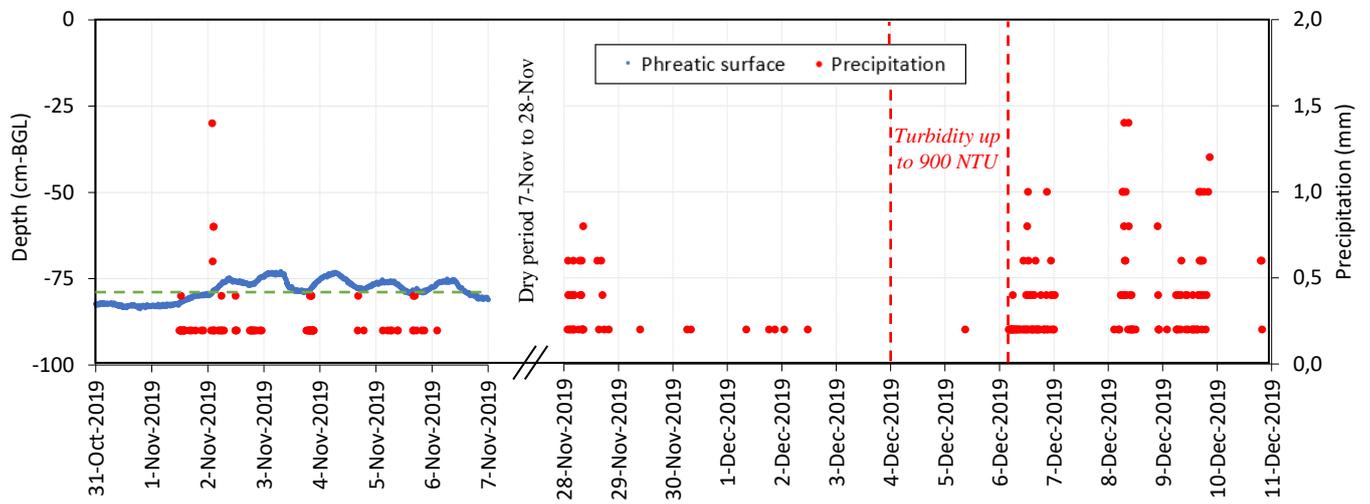
Figure 3.1: Precipitation (mm) and phreatic water level (cm-BGL) during infiltration period one. The green horizontal dashed line indicates the main tile depth at 80cm BGL. Phreatic water level data between 28-Nov-2019 to 11-Dec-2019 not available.

Figure 3.2 presents the injectivity index of infiltration runs supplied by field drainage events (Fig. 3.1). Generally, the injectivity decreased from approximately 6 m³/h/bar to approximately 2 m³/h/bar after infiltrating 1370 m³ per well over 20 days. This was caused by a decrease in recharge flow from 12 m³/h to approximately 4 m³/h because of an increase in head due to clogging.

From December 6th to December 10th, precipitation events provided a continuous infiltration run lasting four days (Fig. 3.1 and 3.2). Initially, a higher injectivity was realized by reaching hydraulic equilibrium (>3 h infiltration), although, showing a rapid decrease until both wells reached a clogged state of 4 m³/h injection on December 10th. Well one for that matter, showed clogging occurred to a larger degree compared to well two as indicated by the slightly higher injectivity for well two. The sharp injectivity decrease showed clogging developed rapidly within both injection wells. Across the four-day infiltration duration, the turbidity within the standpipe generally did not exceed 12 NTU (Fig. 3.3a). Remarkably, however, two days prior to the large infiltration event, significant turbidity readings were noticed in the standpipe between December 4th and 6th. These turbidity peaks showed consecutive readings of 110, 10, 900, 70 and 30 NTU at standstill between short infiltration runs (Fig. 3.3c). The trends in turbidity indicated the standpipe was subjected to a substantial amount of turbidity causing material, that slowly settled within the standpipe during standstill. No significant precipitation events coincide with these turbidity readings (Fig. 3.1), as shown by the short peaks in injectivity until December 6th.

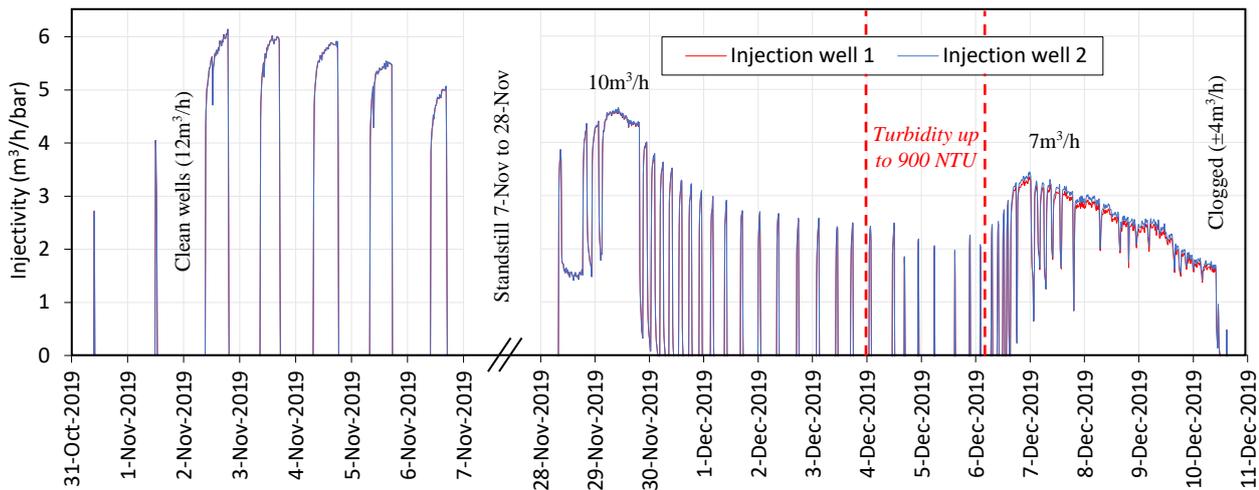
Figure 3.2: The decline in injectivity ($\text{m}^3/\text{h}/\text{bar}$) with time for injection well one and two during infiltration period one. Annotations provide information on operational conditions in black and implicating events in red.

Regardless of reaching hydraulic equilibrium by a longer infiltration run (>3 h), all infiltration runs for injection well one show head increased within the gravelpack while head decreased at the distant monitoring well. Because clogging did not occur at the distant monitoring well, it was assumed a reduction in head at distance indicates a reduction in recharge flow due to clogging at the injection well. This shows that regardless of infiltration duration, clogging of the injection well occurred at every infiltration run as shown by the general decreasing injectivity with time in period one (Fig. 3.2).

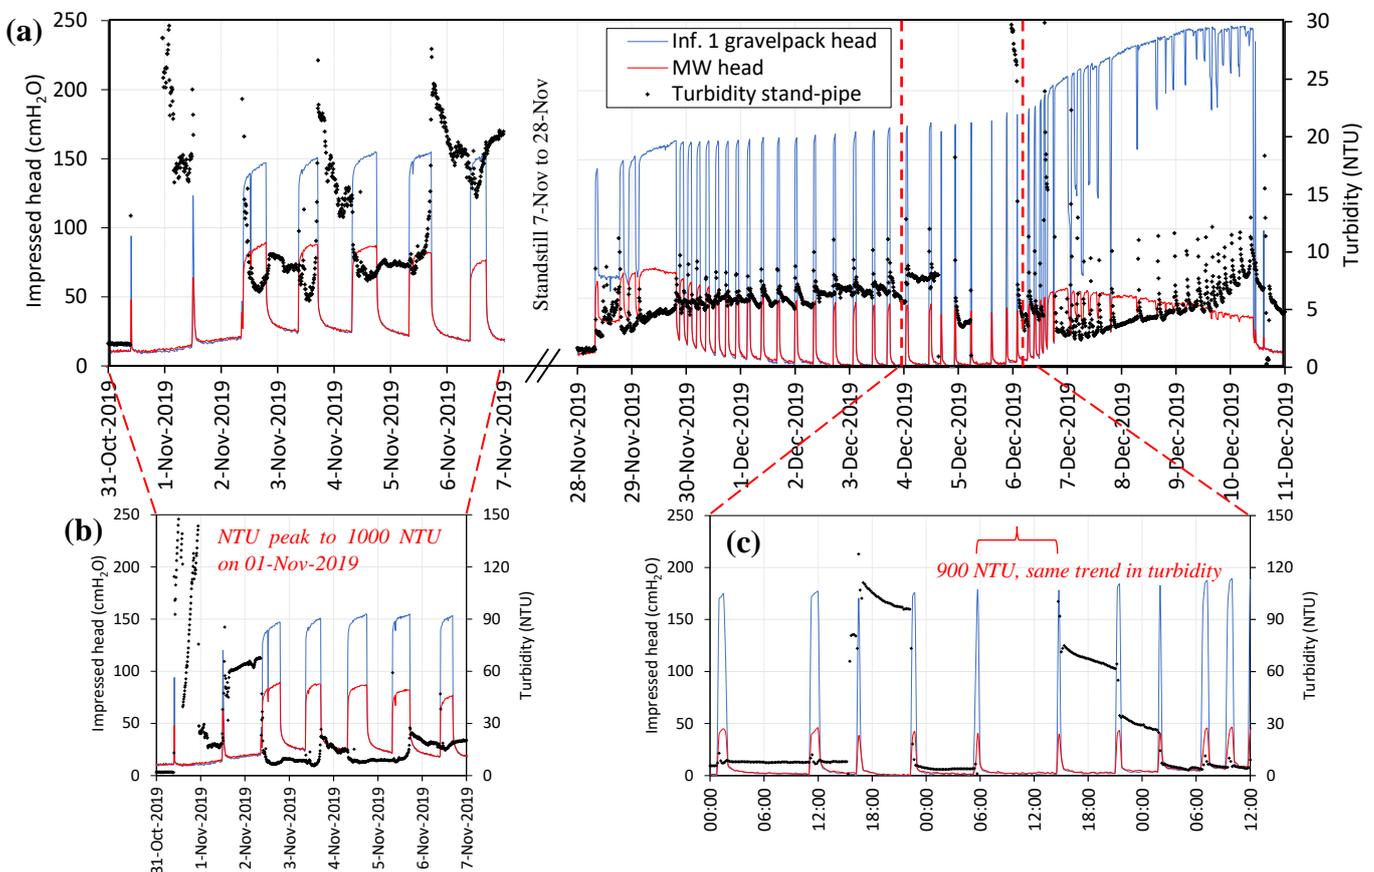
Figure 3.3: Plot 3.3a (top) shows the impressed head ($\text{cm H}_2\text{O}$) in the gravelpack piezometer of injection well one and the monitoring well at distance (7m), namely the abstraction well one gravelpack piezometer, in infiltration period one. The turbidity (NTU) in the standpipe is shown on the secondary y-axis. Plot 3.3b (bottom left) shows turbid events at the start of operation (31-Oct to 7-Nov-2019) See Fig. 2.3a in the supplementary data (SD) for turbidity peak to 1000 NTU. Plot 3.3c (bottom right) shows the extreme turbid events between 4-Dec to 6-Dec-2019. The turbidity event at 900NTU can be seen in SD. Fig. 2.3b.

At the beginning of the period, between October 31st to November 6th, both wells performed similar and showed a consecutive decrease in injectivity (head increase) with infiltration runs. As shown in Figure 3.3a and 3.3b, the conditions in the standpipe at the start of the ASTR operation measured relatively turbid conditions during the first few days. After a dry period between November 7th and November 28th, rainfall events supplied recharge water for a large infiltration run (approximately 20 h) on November 29th. Subsequent days until December 6th showed numerous short runs (1 h) and seemed too short to reach maximum head rise during infiltration. The runs, however, attained consecutive decreases in injectivity. Concurrently, the monitored standpipe turbidity showed a linear increase from approximately 3 NTU to approximately 8 NTU from November 29th to December 6th (Fig. 3.3a).

Figure 3.3a shows the trend in turbidity before and after the extreme turbid event between December 4th and December 6th. In parallel, a zoomed in graph shows the remarkably turbid occurrence within the standpipe (Fig. 3.3c). It is unlikely the turbidity is primarily caused by loosened material within the ASTR piping because the system was already operating for several days. The turbid material, therefore, likely originated from the drain network in the field. Due to the fact no precipitation events occurred; the turbid event could be caused by maintenance practices on the tile drains. A discussion with a drain tile maintenance worker on site stated the heavy loads induced by tractors during land preparation can cause deformations in shallow subsurface tile drains. Slumps within in the tile drains consequentially provide locations for material to deposit and accumulate in the network. To counter these depositions, farmers perform a periodic drain flush intended to mitigate local drain clogging in the network and maintain proper functionality. Because no significant precipitation events occurred during the turbidity events, it is plausible the network was subjected to a suchlike flush during the two days event. Instead of discharging the turbid wastewater to the surrounding canal, it was discharged to the ASTR system and infiltrated.

The rising head with consecutive injection runs in infiltration period one (Figure 3.3) and period two (Figure 3.6) show the wells succumbed to severe clogging in a rather short time frame (20 d). The onset of clogging occurred at the instance operation started as seen by the direct successive head increase in the first few days of infiltration. The automated backflush events in period two successfully removed clogging material as seen by the relatively maintained injectivity (Fig. 3.8), but showed residual clogging remained evidenced by the slight decrease in injectivity and continued rise in head over time (Fig. 3.6). The trend in head rise in period one and two is linear for respectively the first 15 and 11 days, typical for physical clogging by infiltrating suspended solids (physical clogging). This is supported by the persisting head rise in the gravelpack and decreasing recharge flow indicative of clogging occurring at the borehole wall. This forms the primary location to filter injected particles by the fine-grained to medium-coarse aquifer interface (Olsthoorn, 1982). The impressed head rise during the relatively long infiltration periods of five days at the end of both periods showed the clogging rate increased significantly. The process continued to attain a linear process suggesting a significant contribution of suspended material (turbid load) during large recharge volumes.

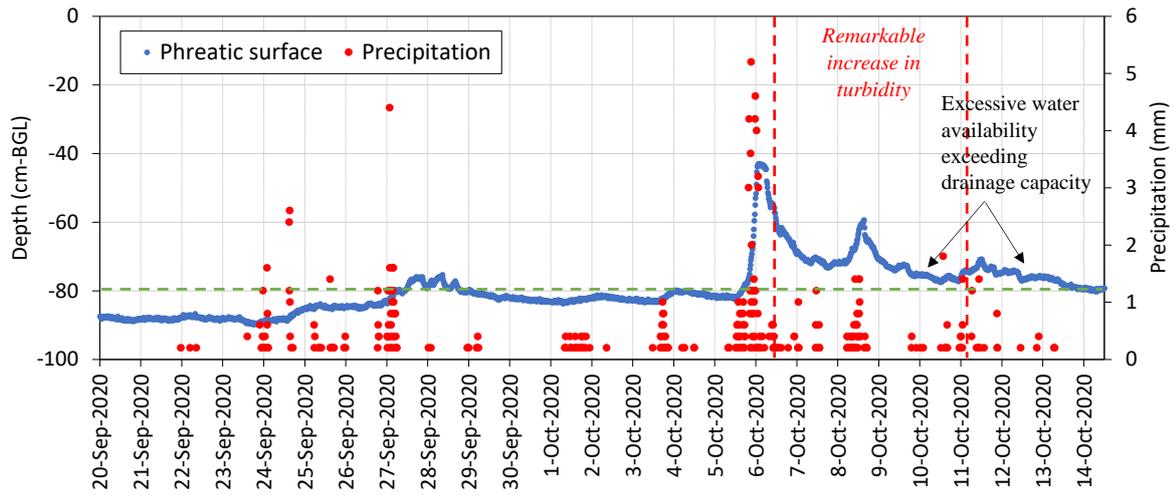
Figure 3.4: Precipitation (mm) and phreatic water level (cm-BGL) during infiltration period two. The green horizontal dashed line indicates the main tile depth at 80 cm BGL.

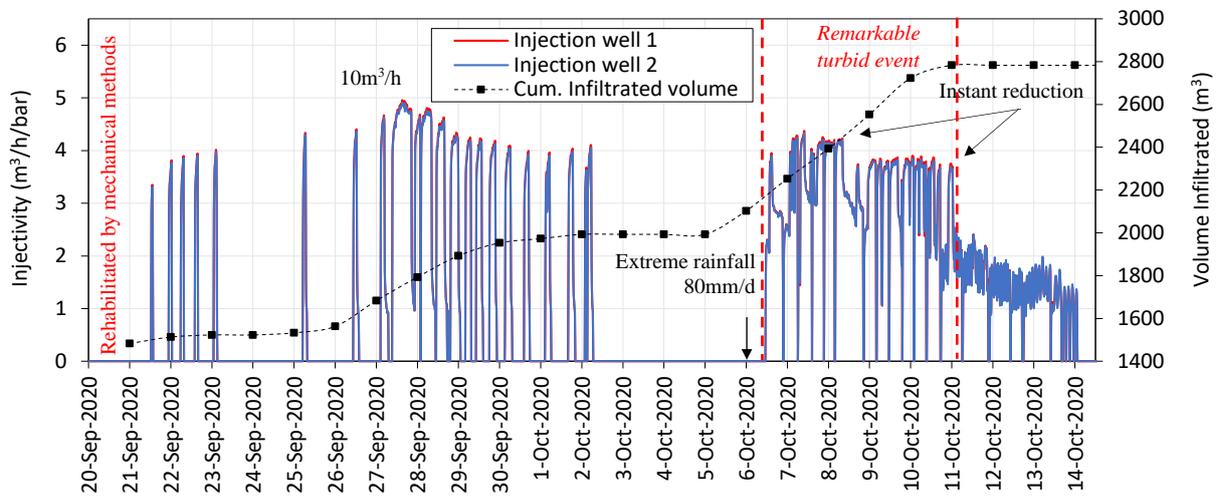
Figure 3.5: The injectivity index ($\text{m}^3/\text{h}/\text{bar}$) and accumulated volume infiltrated (m^3) per well with time for injection well one and two during infiltration period two. Annotations provide information on operational conditions in black and implicating events in red.

During the second infiltration period, both wells experienced an injectivity decrease from 5- to 1.5 m³/h/bar after infiltrating 1430 m³ per well over 20 days (Fig. 3.5). The well rehabilitation in February 2020 recovered the injectivity at the start of the infiltration period to 5m³/h/bar as shown on September 27th. From October 6th, an extreme rainfall event (80 mm/d) caused high water levels within the drain reservoir resulting in simultaneous infiltration and discharge to the surrounding canal. This is seen by the irregular injectivity patterns during the large infiltrated volume (approximately 700 m³ per well) between October 6th and October 11th (Fig. 3.5). Injection well two showed a larger rise in head rise within the gravelpack compared to well one. Indicating, on the contrary to infiltration period one, well two experienced more clogging in this period. This is also seen by the slightly higher injectivity for well one in the index. From late October 6th to October 11th, the turbidity in the standpipe consistently rose from 5 NTU to 160 NTU (Fig. 3.6) and seemed to cause two instantaneous reductions in injectivity (Fig. 3.5). First on October 8th followed by another event on October 11th. The recharge flow and impressed head decreased instantaneous during both events.

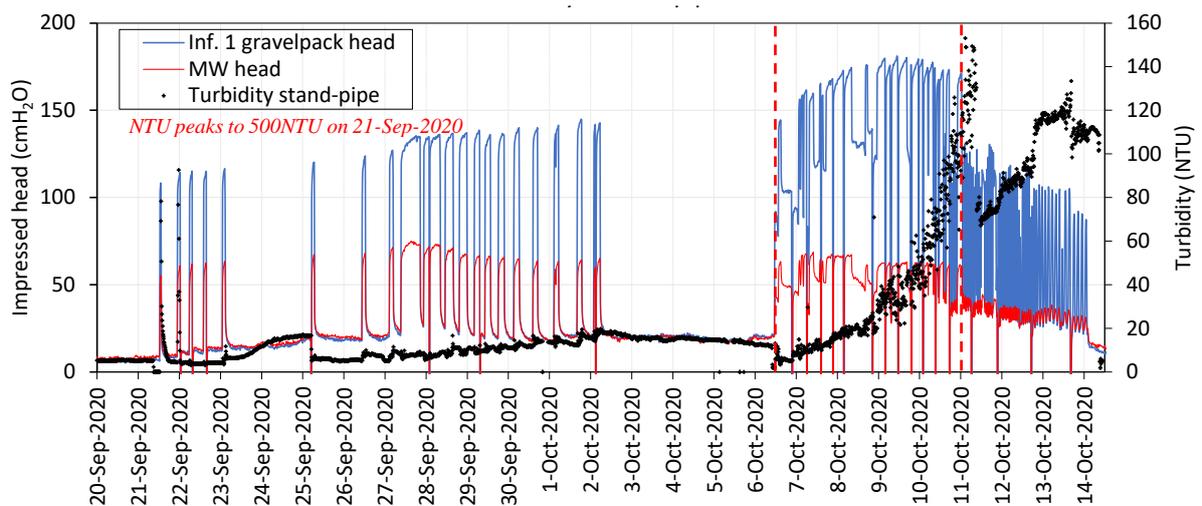
Figure 3.6: The impressed head ($\text{cm H}_2\text{O}$) in the gravelpack piezometer for injection well one and the monitoring well at distance (7 m), namely the abstraction well one gravelpack piezometer, for infiltration period two. The turbidity (NTU) in the standpipe is plotted on the secondary axis.

Figure 3.6 shows the turbidity events in infiltration period two. At operational start-up on September 21st, 2020 peaks in turbidity were noticed up to 500 NTU. From October 6th, the large discharge event likely resuspended significant amounts of turbid material from the drain network. Over time, the material gradually flushed from the network and collected in the drain reservoir, subsequently discharged to the ASTR system.

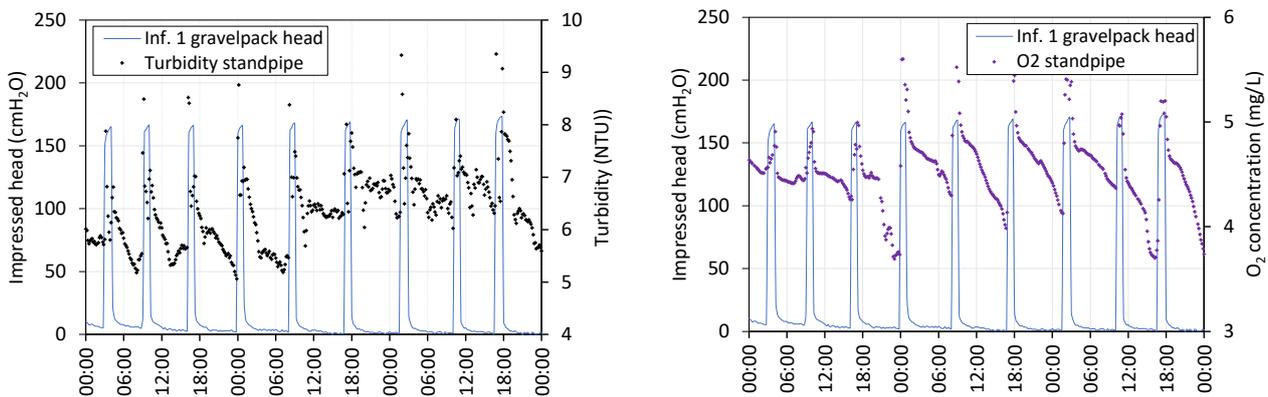
Figure 3.7: Plot 3.7a (left) and plot 3.7b (right) respectively show a typical pattern of turbidity (NTU) and dissolved oxygen (mgL^{-1}) during infiltration and standstill in the standpipe (1-Dec to 3-Dec 2019). A peak is noticed at the start of infiltration runs, while material settles in the standpipe during periodic standstill. During standstill, oxygen rapidly decreases regardless of introduced atmospheric oxygen in the standpipe.

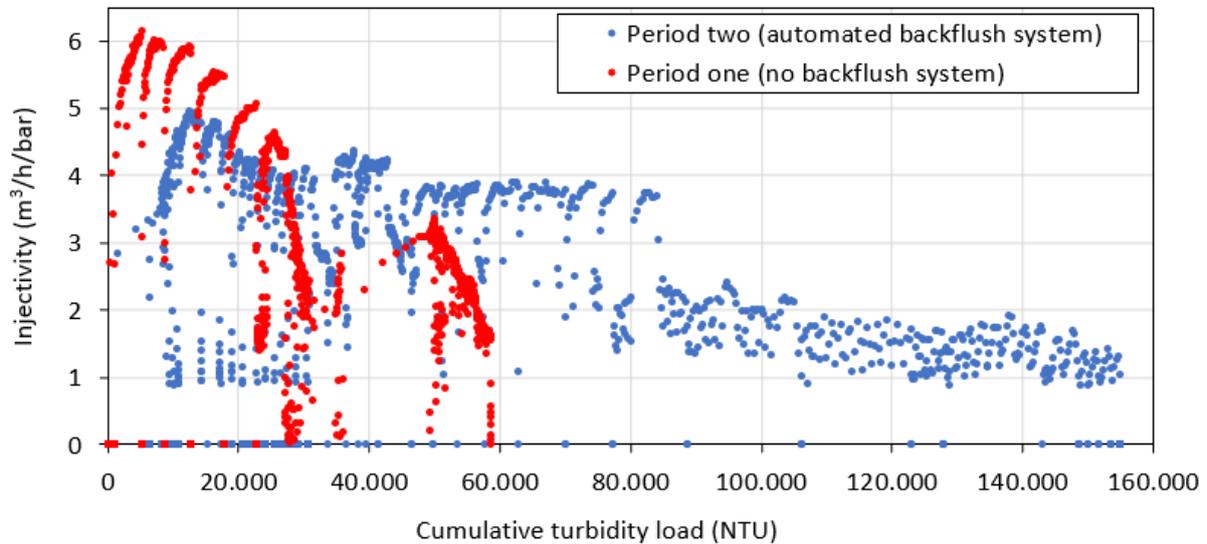
Figure 3.8: The injectivity versus the cumulative turbidity load for period two (blue) with the installed automated backflush system providing backflush, and period one (red) with no automated backflush system.

by clogging when subjected to high turbid loads. Another difference relates to the new automated backflush system in period two providing periodic backflush events. As shown in Figure 3.8, the automated backflush events resulted in maintaining the injectivity with increasing turbidity load (blue) compared to period one (red). No automated backflush system in period one resulted in a rather rapid deterioration of the injectivity. The continued injectivity loss in period two from 2- to 1 m³/h/bar while undergoing the (intensified) automated backflush regime (backflush after infiltrating a volume of 50m³ per well), shows not all clogging material could be removed and material resided in the well.

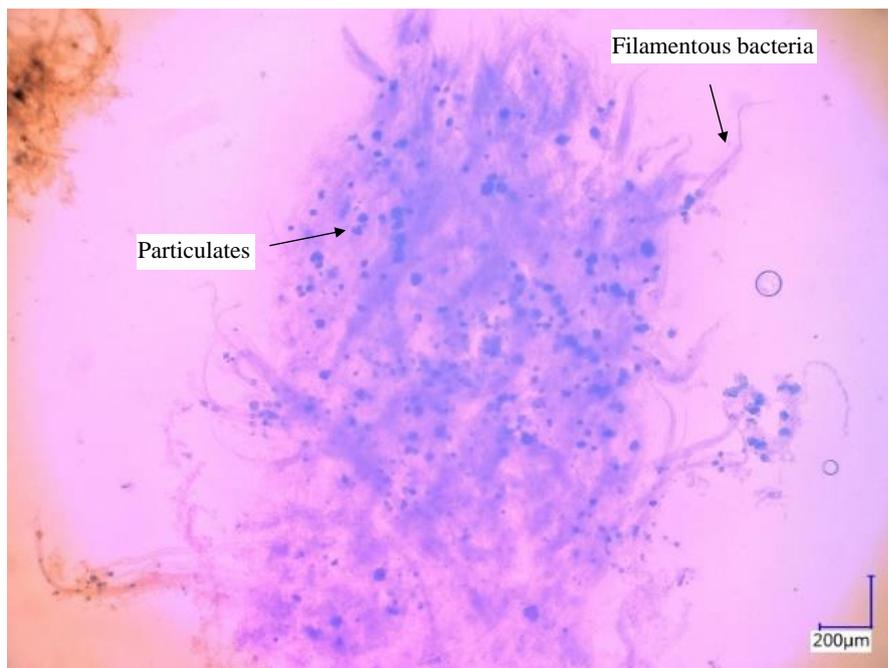
Figure 3.9a: Micrograph (x100 magnification – polarized) of material on disc-filters. Large (>1 mm) agglomeration of filamentous bacteria and particles.

The filamentous structures depicted in micrographs of sampled material retained on the disc-filters (Figure 3.9a and 3.9b) and material removed from the interior of the standpipe (Figure 3.10a and 3.10b) suggest the contribution of injecting biophysical material. The camera inspection within the standpipe after a 41-day standstill on November 25th, 2020 first showed a metallic sheen on the stagnant water surface before submerging the camera (SD. Fig. 5.1 and 5.2). Once submerged, an adhered mat covering the well interior was evident and revealed a thick structure of microbial deposits (SD. Fig. 5.3). The metallic sheen on the water surface is used as an indicator of iron-oxidizing bacterium present in nature (Emerson and de Vet, 2015). While the distinct morphology of filamentous structures associated with cells and the extensive formation of iron-flocs suggests the biochemical material consists of iron-oxidizing bacteria (FeOB) (Krempski et al., 2012; Emerson and de Vet, 2015). The conditions in the main tile outlet interior showed similar microbial structures as in the standpipe (SD. Fig. 5.5). This suggests the tile drainage system also contributes biochemical material to the recharge water, as sampled on the disc-filters. The significant biochemical material depicted support the rapid oxygen decrease in the standpipe in Section 3.1.3. When the ASTR system is stood still, the frequent on/off operation resuspends decayed or released material from within the drain network and ASTR piping, periodically increases turbidity.

The micrographs show the bulk material contained filamentous structures and biofilm, incorporating amorphous flocs and particulates smaller and in exceedance of 40 μm in disc-filtrate and below 40 μm in standpipe material. The discrete particles are assumed to comprise of inorganic material like clay and silt incorporated in inorganic flocs. A simple acidification test ($\text{pH} < 3$) with 1% HNO_3 showed a significant reduction in bulk material, indicating a large portion of the bulk consists of metal-oxide flocs (SD. Fig. 7.6).

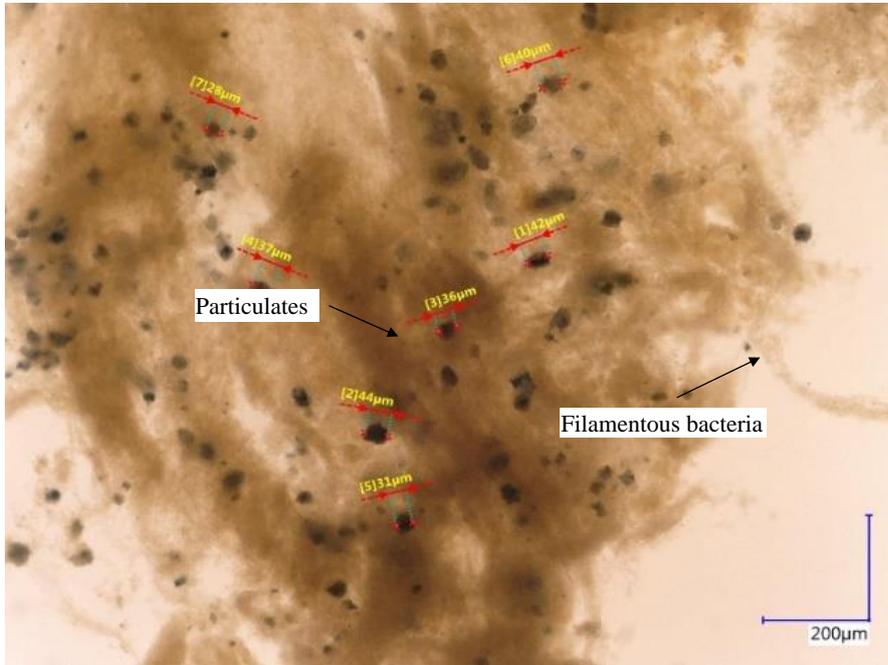
Figure 3.9b: Micrograph (x200 magnification) of material on disc-filters. Particles smaller and exceeding 40µm are depicted.

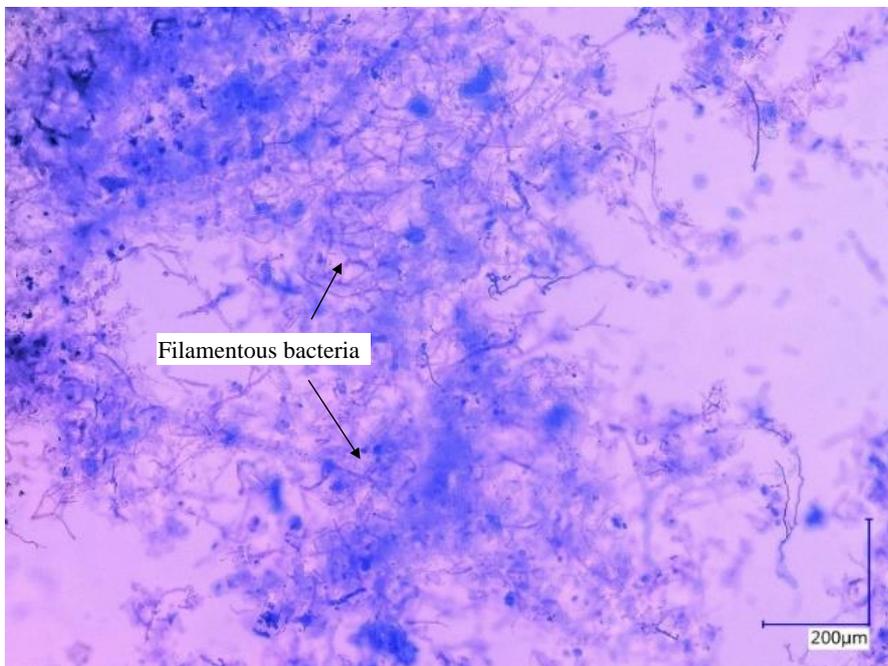
Figure 3.10a: Micrograph (x200 magnification – polarized) of material removed from the interior of the standpipe. An abundance of filamentous structures is depicted.

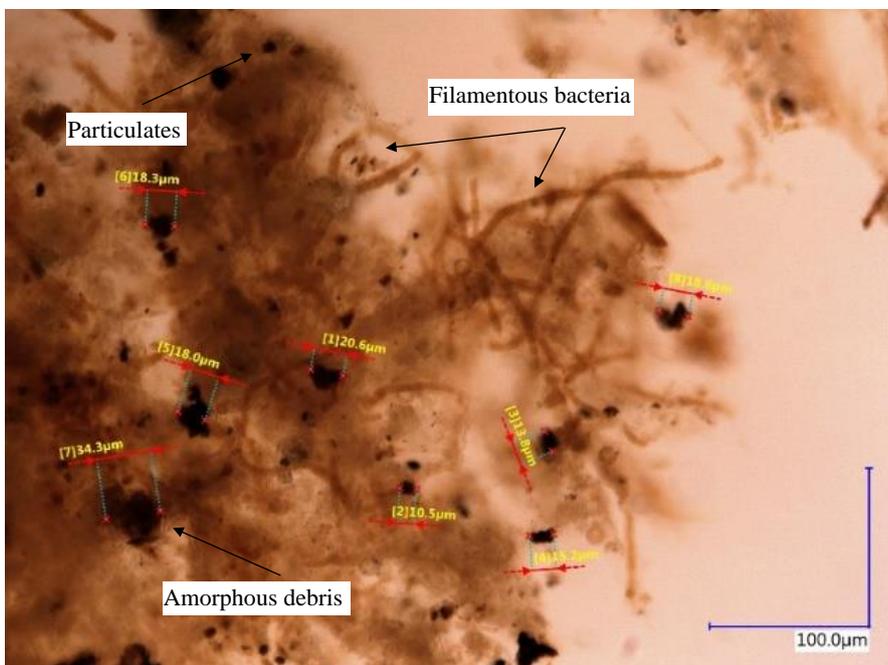
Figure 3.10b: Micrograph (x600 magnification) indicating particulates <40 µm incorporated by biochemical material (filamentous structures).

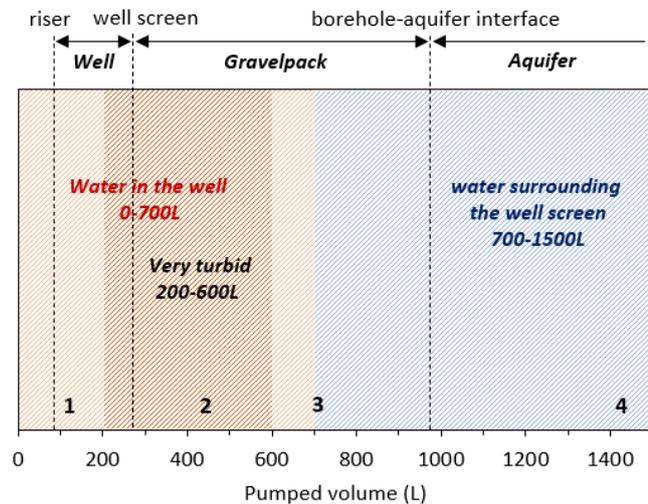
Figure 3.10: Schematic providing information on approximate backflush volumes and sampling points. Volume of riser, well screen, and well bore are respectively (accumulated): 90, 270, and 970 L. Sampling was done after pumping 90, 450, 720 and 1440 L, denoted by the numbering. Camera inspection during sampling showed a significant amount of suspended matter removed pumping 200-600 L. The material likely corresponded to removed material from the gravelpack and accumulated material at the bore bottom.

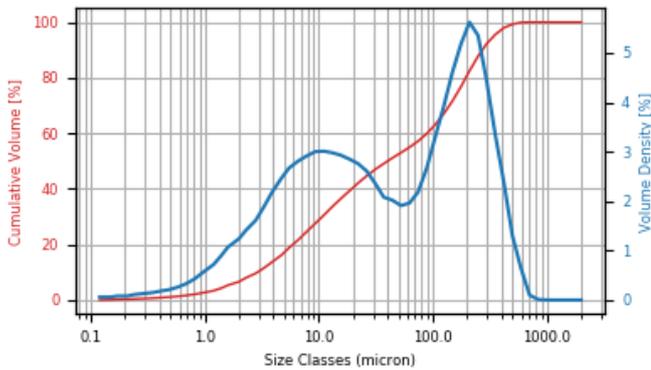
Figure 3.11a: Typical particle size analysis for the regeneration backflush sample in February 2020. The peak at 10-20 μm likely represents injected clay and silt while the peak at 200 μm corresponds to flushed aquifer fines.

Figure 3.11a and 3.11b show a typical particle size analysis for the first backflush and mechanical cleaning procedure, respectively. Injected silicious clay and silt was removed in the first backflush samples together with flushed aquifer fines as shown by the peak at 10-20 μm and 200 μm , respectively. The peak at 250 μm for samples taken during the mechanical cleaning show predominantly aquifer fines were removed, supported by the poorly graded distribution.

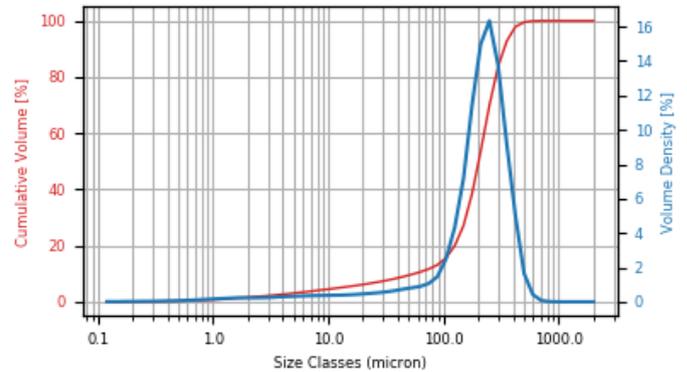
Figure 3.11b: Typical particle size analysis for the mechanical cleaning sample in February 2020. The peak at 250 μm and poor graded distribution suggest the predominant removal of aquifer fines.

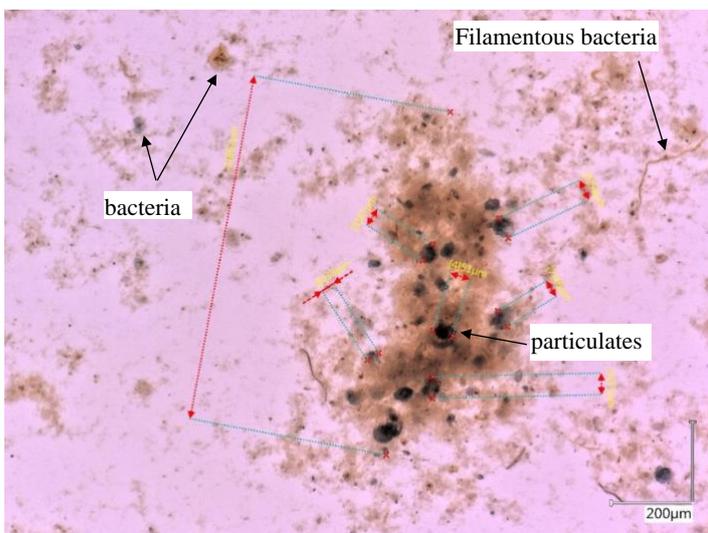
Figure 3.12a: Micrograph (x200 magnification) of suspended material removed during the mechanical cleaning on February 3rd, 2020. A large floc (~860 μm) incorporates particulates 30-50 μm . Bacteria are depicted.

Figure 3.12a and 3.12b show micrographs of suspended material removed during the mechanical cleaning procedure in February and November 2020, respectively. Brown/orange flocs incorporating particulates below 40 μm and microorganisms were depicted. Aside filamentous bacteria, disc-shaped bacteria of 50-60 μm size were seen (protozoa: soil testate amoebae (Foissner and Korganova, 1995)).

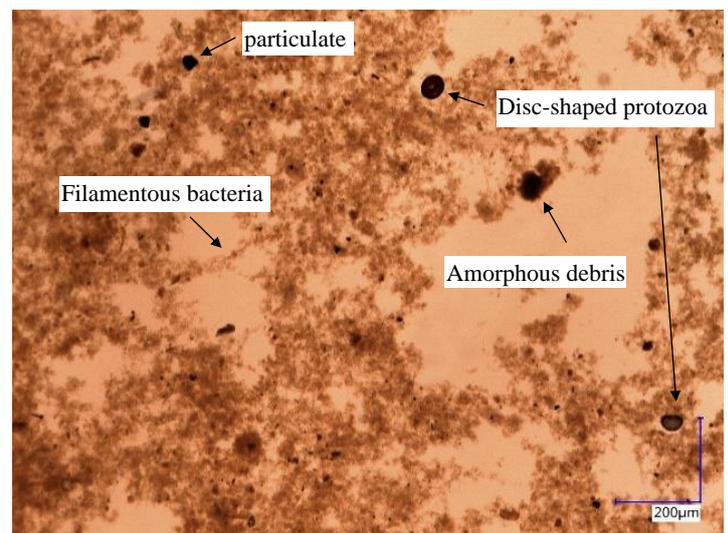
Figure 3.12b: Micrograph (x200 magnification) of suspended material removed during the mechanical cleaning on November 25th, 2020. Amorphous debris, filamentous bacteria, disc-shaped protozoa, and (few) particulates are depicted.

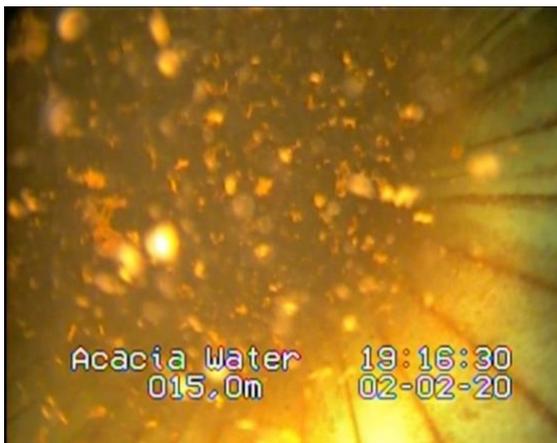
Figure 3.13a: Clogged state after infiltration period one. Image is of the top filter case, taken on February 2nd, 2020.

Figure 3.13 and 3.14 show the clogged and rehabilitated state of the injection wells by the regeneration methods applied. The long filter screen (21.5 m) showed internal well staining of predominantly ochreous (orange/brown) and dark (black/grey) material. Filter slots were filled 95% with both ochreous and dark material. As Olsthoorn (1982) states, regeneration with high-pressure jetting is suitable for removing material from filter slot, while proving less effective for removing clogging material at the borehole wall. The rehabilitation indeed showed near to complete recovery of filter slots, while at certain horizons internal well staining remained. Large sections of filter screen showed very clean conditions, effectively rehabilitated by the high-pressure jetting procedure.

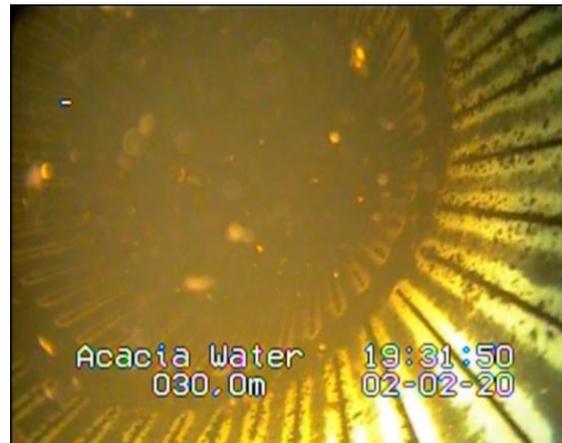
Figure 3.13b: Clogged state of the lower filter case, taken February 2nd, 2020.

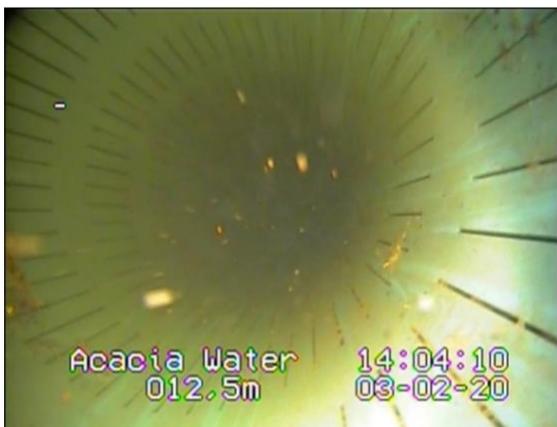
Figure 3.14a: In-well condition after the well rehabilitation. The horizon is the exact same as figure 3.13a, indicating 12.5m due to faulty camera calibration.

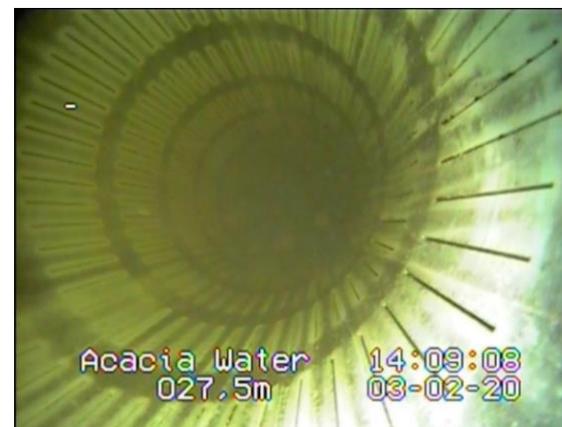
Figure 3.14b: In-well condition after the well rehabilitation. Horizon is the exact same as 3.13b.
