# SHEAR OR BENDING? EXPERIMENTAL RESULTS ON LARGE T-SHAPED PRESTRESSED CONCRETE BEAMS

**KEYWORDS:** experiment; prestressed concrete; T-shaped beam; bridge girder; shear; contest; non-linear analysis.

Experimental results of four shear tests on two large prestressed concrete beams are compared to non-linear analysis and design code calculations. The beams have a length of 12 m and a depth of 1.3 m and are reinforced with stirrups and pre-tensioning. The four tests consist of a single point load at a distance of  $2.7d$  from the support. A priori analyses using NLFEA and design formula predicted a shear failure. However a bending moment failure was predicted to be close to the shear failure and could not be completely ruled out. The prediction of shear or bending failure is further complicated by the presence of empty ducts in the top flange. The four test were the subject of an international “Shear Contest” held at the University of Parma Italy in November 2014.

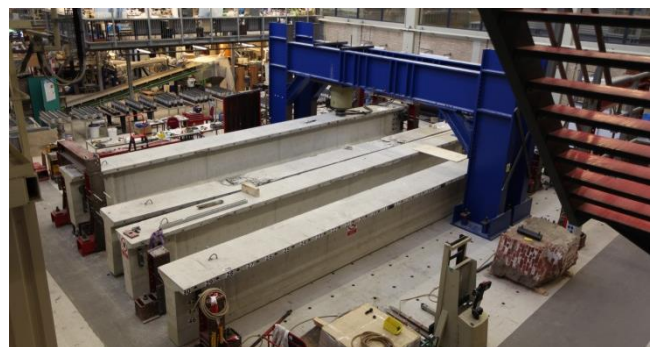
Fig. 5 Overview of test setup (first test beam 201)

In all experiments the center of the loading jack is positioned at a distance of 2950 mm from the center of the support (2.7d) see figures 4 and 5. The dimensions of the loading jack are  $250 \times 250 \text{ mm}$  whereas the dimensions of support plates are  $350 \times 280 \text{ mm}$  (support type A/B). Therefore the width of the support plate is equal to the width of the beam. The position of the load means the edge of the loading jack is slightly overlapping one of the empty ducts by 25 mm.

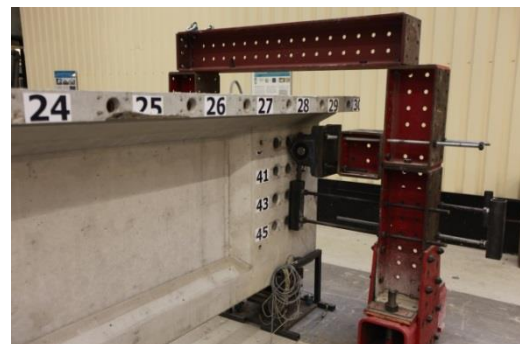
Fig. 7 Horizontal support at end of beam

Each beam is tested at both ends. After the first test of a beam is completed, although now largely damaged, the prestressing still prevents a complete fracture of the beam. To resist the forces of the second test the damaged area is outfitted with a support frame consisting of steel beams and vertical prestressing, see figure 6. In order to prevent excessive rotation or horizontal movement during testing a support frame with rollers is also fitted at both ends close to the top flange, see figure 7.

For the non-symmetric beam type 201 the load also introduces a torsional moment, which is resisted by the horizontal supports at the end of the beam, see figure 7. The centre of gravity of this beam is offset by just 15 mm. The constant torsional moment between the load and the support (see also figure 4) can be calculated by:

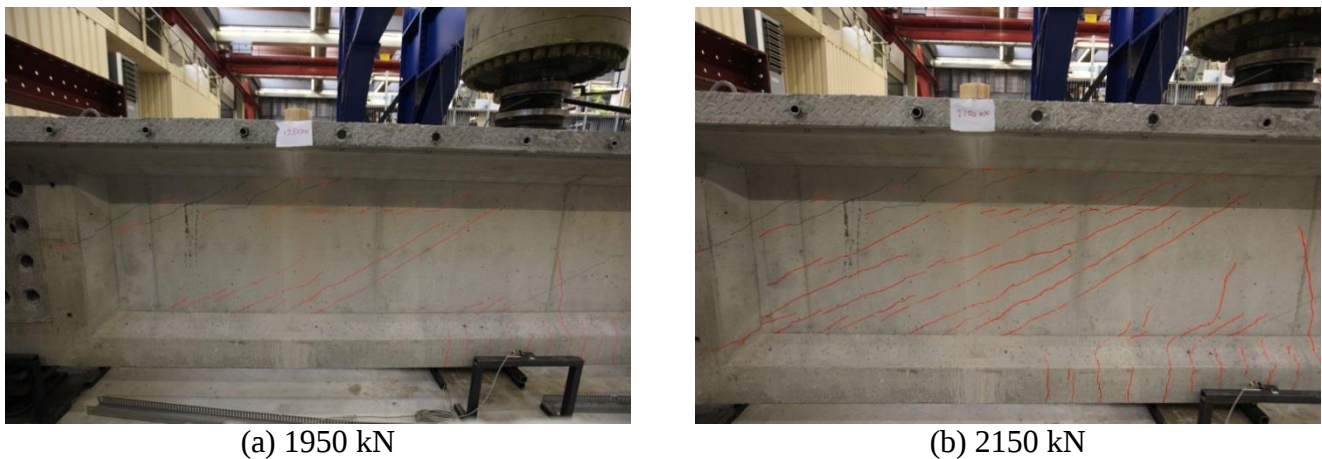
Fig. 9 Crack development beam type 101 (first test)

The displacements of the second test are much larger due to the “weak spot” created by the first test which is reinforced by the support frame (see also figure 6). This implies an insufficient stiffness of the support frame. The crack development from the first test is shown in figure 9. The measured crack width is given in table 2. The first bending cracks (hairline cracks) are visible at a load of 1700 kN. Next horizontal shear cracks occur in the web between the load and the support just below the top flange. Finally inclined shear cracks occur in the web that fan out at different angles towards the support. Also at a relatively low load level (1900 kN) a large vertical bending crack was observed in the web. This indicates that although the load is close to the support still a relatively large bending moment is present. The crack development of the second test is consistent with the first test and shows a similar crack pattern at equal load levels.

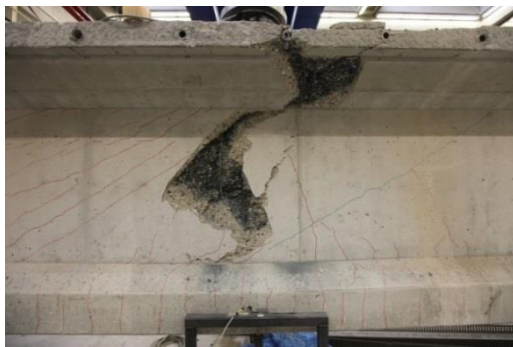
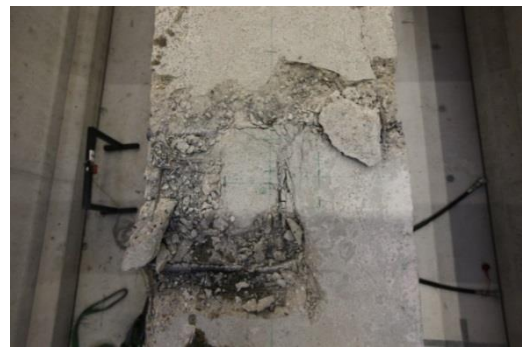
(a) side view

(b) top view

Fig. 10 Failure of beam type 101 (first test)

The fracture of the beam is shown in figure 10. Close to the failure load considerable crushing of the concrete near the empty ducts as well as flattening of the ducts themselves was observed (figure 10b). Of course this introduces a significant reduction of the capacity of the compression zone in the top flange. This phenomenon ultimately causes a bending moment like localized failure of the beam. The fracture of the second test is very similar to the first test.

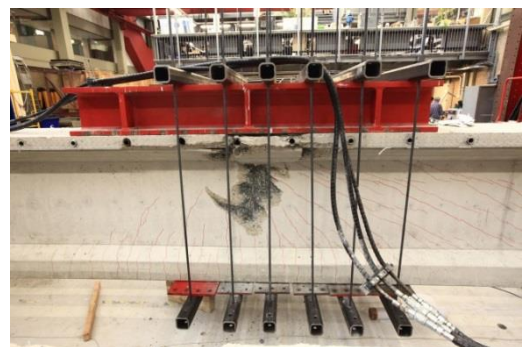
Fig. 12 Support frame with additional vertical prestressing

This beam has no existing cracks from previous experiments. In an attempt to prevent a premature failure of the compression zone three of the empty ducts at the position of the load are now filled with steel rods  $\varnothing 40$  mm see figure 11. The assumption is that the gap between the rods and the ducts will close at high load levels to create a continuous compression zone. Also the support frame used for the second test is strengthened with additional vertical prestressing (12  $\times$  100 kN), see figure 12 in relation to figure 6. Figure 13 shows the load versus displacement of the tests on beam type 201.

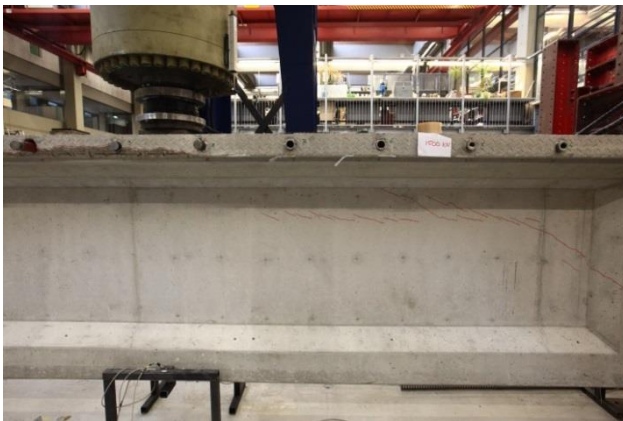
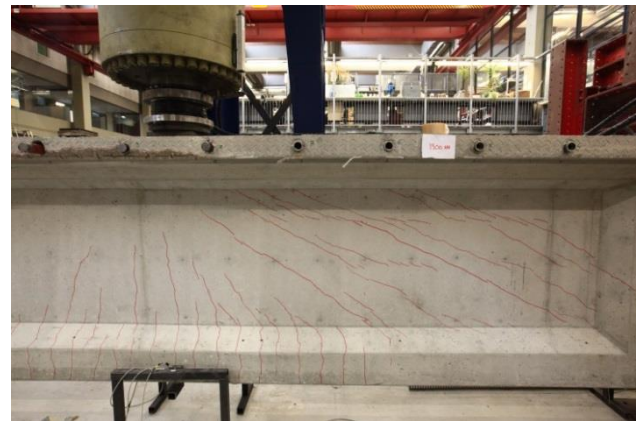
Fig. 14 Crack development beam type 201 (first test)

The crack development of the first test is shown in figure 14. The measured crack width is given in table 3. In this case the crack development of the second test is not consistent with the first test. In the first test, at 1500 kN, first horizontal shear cracks (hairline cracks) occur in the web between the load and the support just below the top flange, see figure 14a. Next bending cracks and inclined shear cracks occur almost simultaneously at a load of 1600 kN and continue to expand and grow until failure.

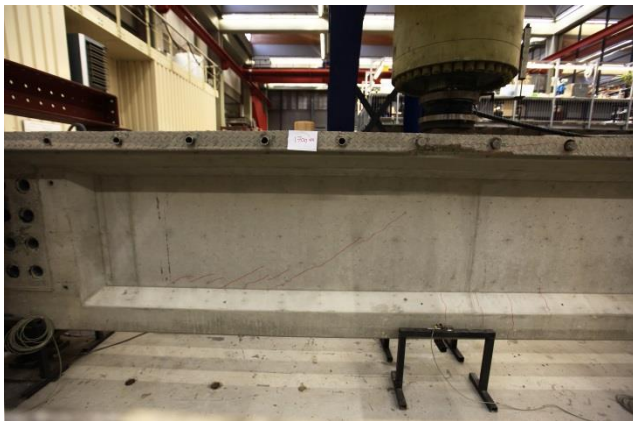
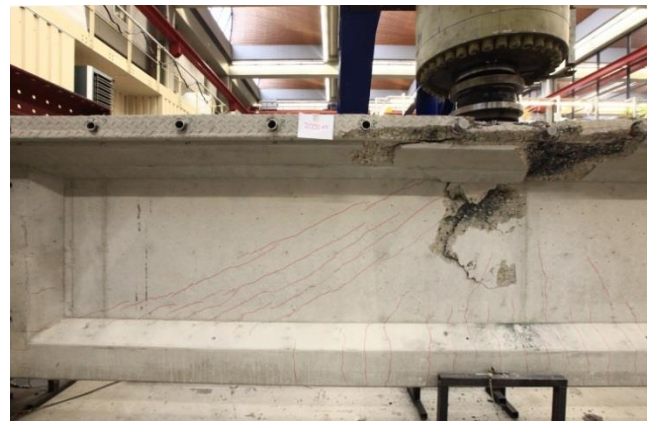
(a) 1700 kN

(b) 2000 kN

Fig. 15 Crack development beam type 201 (second test)

In the second test, at 1700 kN, first horizontal shear cracks occur in the web between the load and the support near the bottom flange together with bending cracks and an inclined shear crack (hairline cracks), see figure 15a. After this initial cracking stage additional inclined shear cracks and bending cracks occur until failure. However, the inclined shear cracks in this test are much more localized in a narrow band at an angle that does not go all the way to the support, see figure 15b (picture taken after failure).
