# Experimental Research and Failure Mechanism Detection on Temporary Flood Barrier

MSc Thesis Report  
Kou Wai Chan

Submitted as Part of the Degree Requirements for Master of Science in  
the Department of Hydraulic Engineering of the Faculty of Civil Engineering  
at the Delft University of Technology

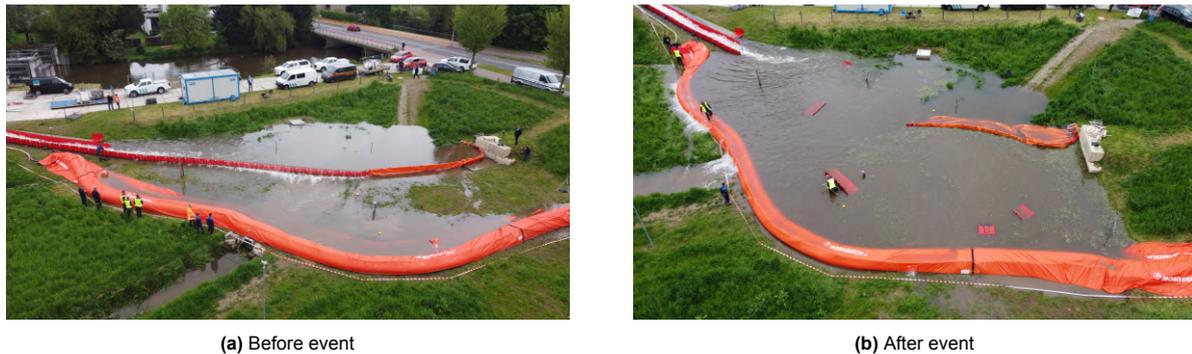
**Figure 1.3:** A visualisation of failure occurred during the experiment that took place in Roermond

Based on the tender results, three companies participated in the physical experiment held in Roermond, meeting all the requirements set by Waterschap Limburg. These companies were Geodesign Barrier, Waterschot (NOAQ Boxwall), and Mobiele Dijken (Mobile Dikes). Since the Geodesign Barrier did not experience any significant failure during the experiment, this thesis primarily focuses on the failure detection of the NOAQ Boxwall and Mobile Dikes. A visualisation of the failures that occurred during the experiment can be seen in Figure 1.3.

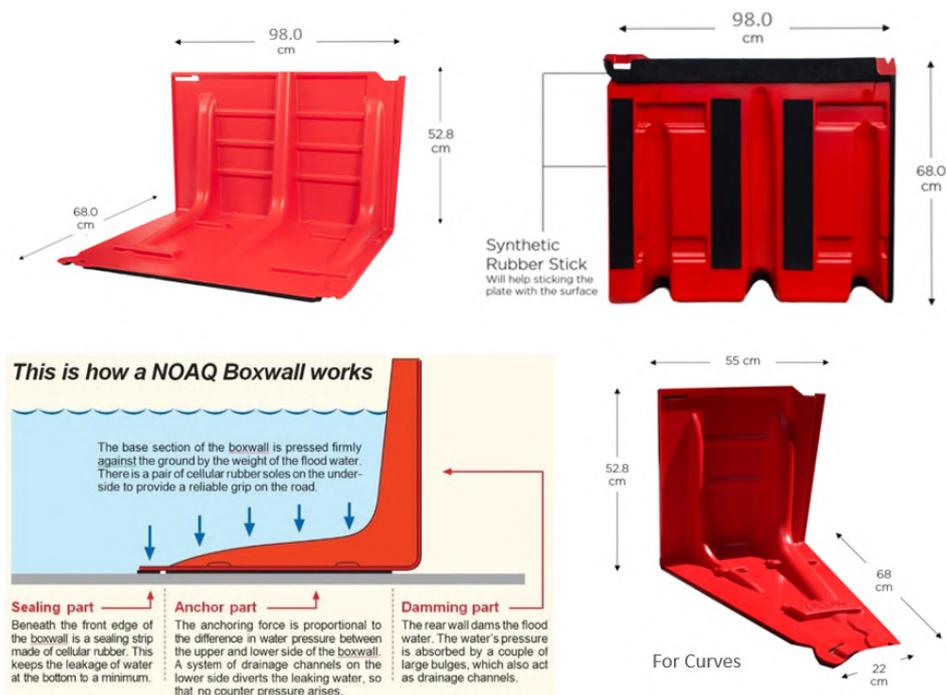
Figure 2.3: Schematization of NOAQ Boxwall Barrier [14]

Figure 2.3 illustrates the design and functionality of the NOAQ Boxwall. The images detail the dimensions and structural components of the Boxwall units, which include a sealing part, an anchoring part, and a damming section. The base is designed to press firmly against the ground with synthetic rubber soles, providing a reliable grip. The anchoring force is designed to be proportional to the water pressure, ensuring the Boxwall remains securely in place. The rear damming part is where the water pressure is absorbed, with large bulges that also serve as drainage.

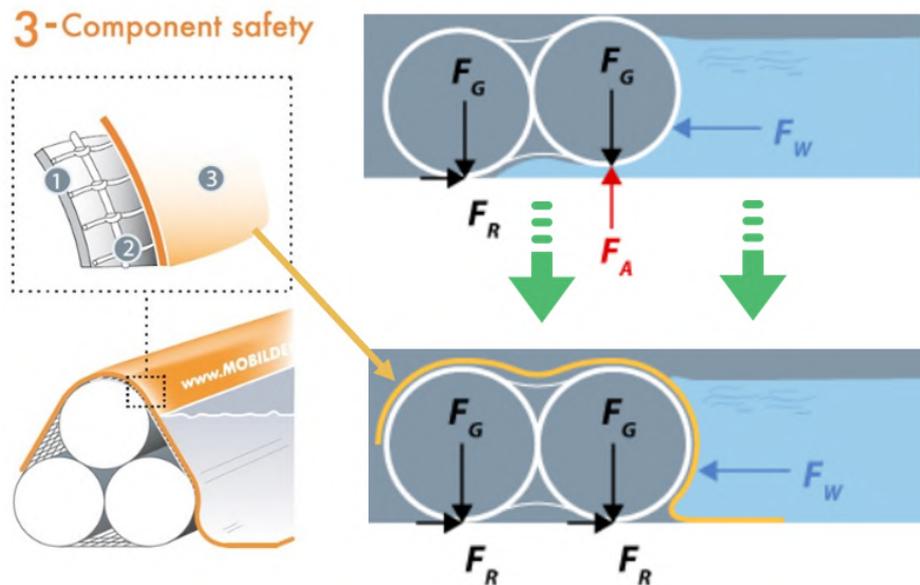
Figure 2.4: Schematisation of Mobile Dikes [16]

The experiment conducted in Roermond used the MD60-2 Mobile Dike model, which consists of two interconnected dike bodies. Each body is 1.2 m wide and 0.6 m high. When the sealing membrane is included, the width extends to 4.4 m. The first body was 36 m long, while the second body was 22 m long [17]. To compensate for the elevation difference at the test site, some tubes with a diameter of 15 cm were used to increase the height of the second body during the construction.

The diagram in Figure 2.4 shows the position of the three components for maximum safety of Mobile Dikes, including the ① Dyke body, ② Net cover and ③ Sealing membrane, as mentioned before. It highlights the critical role of the sealing membrane in preventing the barrier from floating under the pressure of rising water levels. Without this membrane, tube systems can become buoyant and begin to fail when the water level reaches 60-80% of their height. The sealing membrane effectively counters the upward pressure of water from beneath the dike, ensuring the system remains stable. This design ensures that the barrier remains effective and provides a reliable flood defence until water levels exceed the height of the barrier [16].

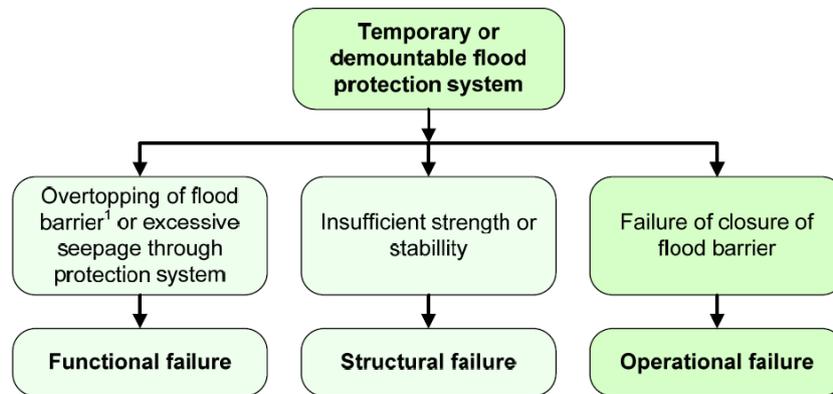
Figure 2.5: Fault tree for a temporary or demountable flood protection system [1]

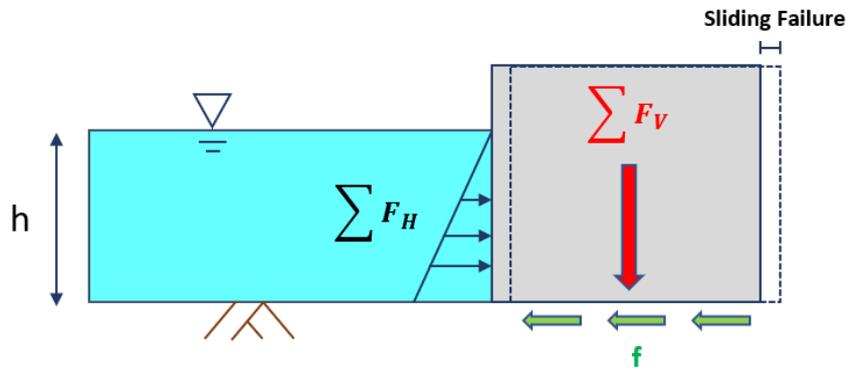
Figure 2.6: Schematisation of Sliding Principle

Where,  $\sum F_H$  is the sum of acting horizontal forces measured in  $[N/m]$ ,  $f$  is the dimensionless friction coefficient and  $\sum F_V$  is the sum of the vertical components of the force acting on the structure in  $[N/m]$  (For simplification, forces are calculated in Newtons per meter due to the varying lengths of barriers). By multiplying the total vertical force on the structure with the dimensionless friction coefficient, the friction force can be determined. If the horizontal force acting on the structure exceeds the friction force, the structure will slide. This is demonstrated in Figure 2.6.

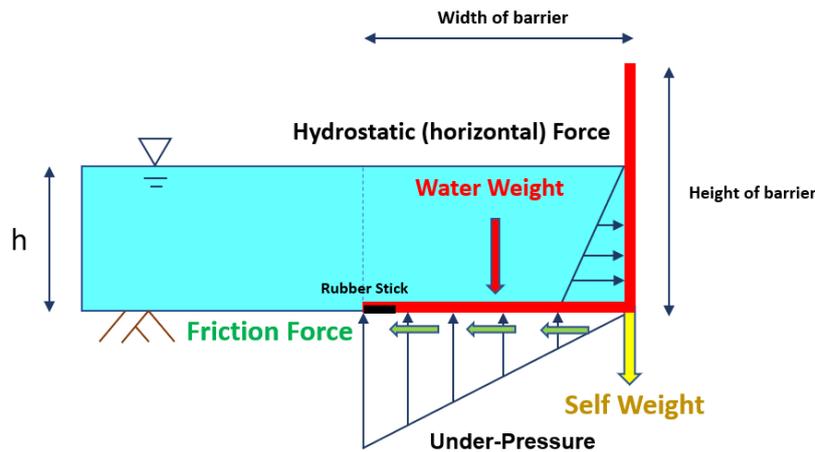
**Figure 2.7:** Schematisation of under-pressure with water on single side (Example: NOAQ Boxwall)

Under-pressure, also known as hydrostatic uplift force or buoyancy, is an upward force that is exerted on the bottom of a structure and has the potential to lift it from its foundations [19]. It occurs when the pore water pressure below the structure is higher than the overburden pressure [20]. This phenomenon is commonly observed in hydraulic structures where water infiltration at the foundation can lead to the overturning of the structure [21]. When there is a difference in water levels on either side of a barrier, and the waterproofing at the bottom of the barrier is inadequate, water can penetrate beneath the barrier [19]. Suppose the permeability of the soil is uniform throughout the barrier, and the downstream area has no water. In that case, the hydrostatic pressure along the base of the barrier will be the same as the upstream of the barrier and decrease to zero at the downstream edge [22]. This causes a linear change in water pressure along the path directly beneath the structure [19].

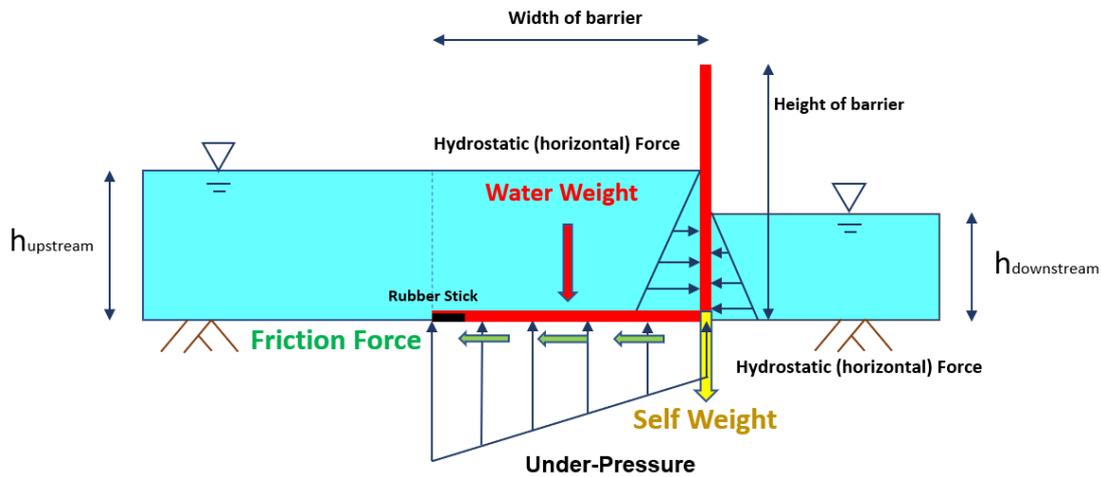
**Figure 2.8:** Schematisation of under-pressure with water on both sides (Example : NOAQ Boxwall)

With water present downstream of the barrier, the hydrostatic pressure on that side can also impact the under-pressure, changing the pressure distribution from a triangular to a trapezoidal profile. This conceptual transformation is illustrated in Figure 2.8.

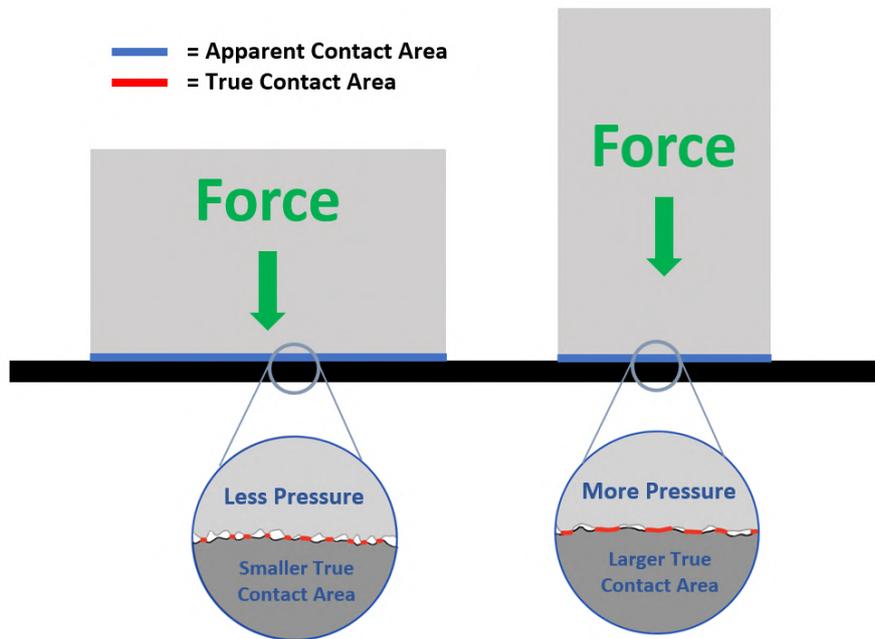
**Figure 2.9:** Schematisation of the contact area of an object under pressure

contrast, the vertical rectangle with more pressure has fewer bumps, but the area of each bump is larger due to the higher pressure. If two rectangles are pushed to determine the force required to move them, it would be found that the force needed to move both rectangles would be the same because their weight (vertical force acting by self-weight) and material are consistent, and they are sliding on identical surfaces. This suggests that the size of the apparent contact area, whether large or small, does not impact the amount of friction generated.

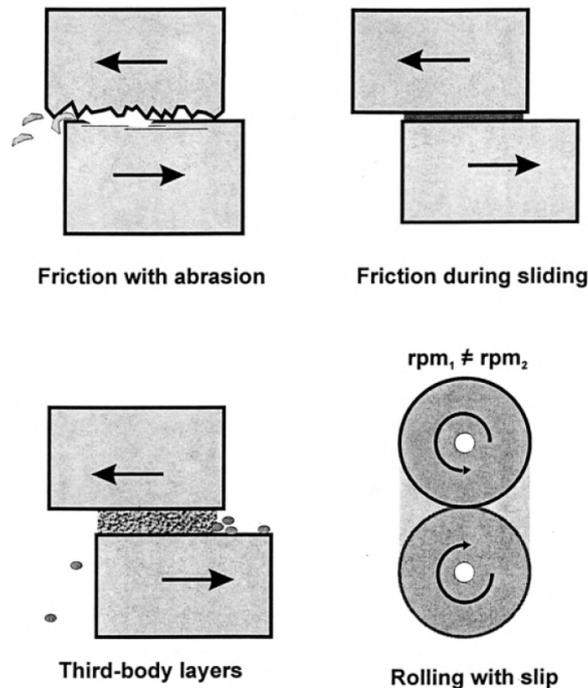
**Figure 2.10:** Four common interfacial conditions that arise in frictional systems [23].

Based on all the information discussed, it is evident that the friction coefficient significantly affects sliding failure, and the forces resisting sliding occur near and between the solid surfaces. In practical scenarios, it is frequently observed that frictional systems exhibit four distinct interfacial conditions, as illustrated in Figure 2.10 [23]. These conditions can vary depending on the materials and the environment in which the surfaces are in contact.

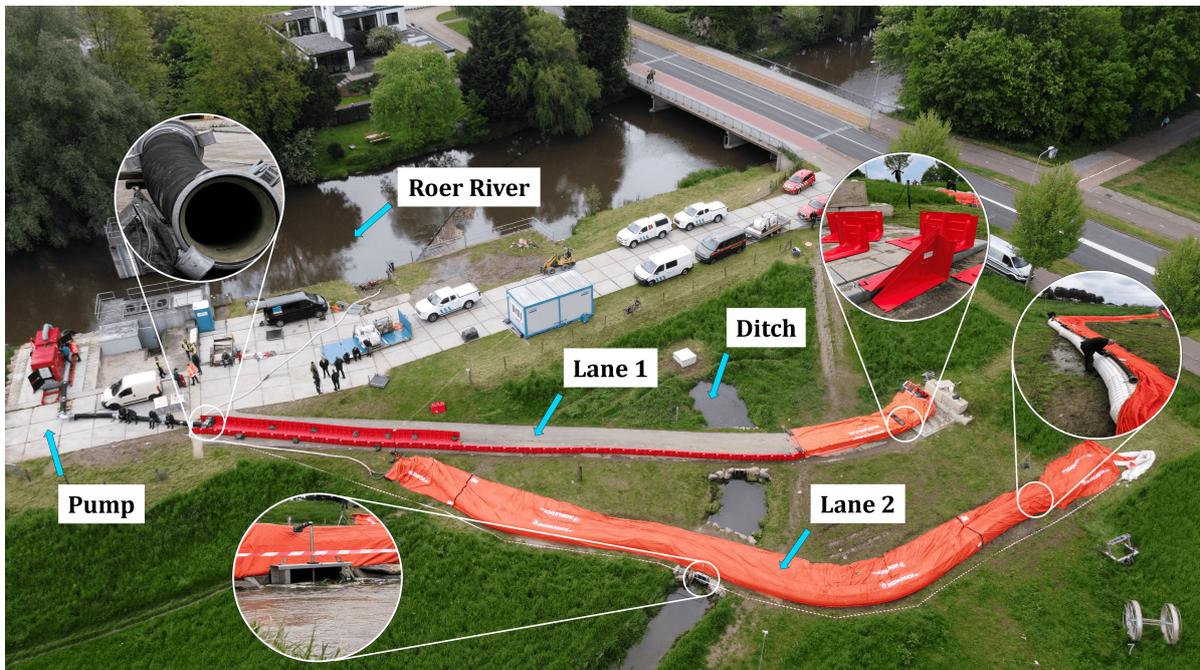
Figure 3.1: Top-view photograph of the Roermond Experiment Site

The experimental site was positioned near the northwest direction of the Burgemeester Höppenerlaan roundabout in Roermond. It was located adjacent to the Roer River, where water would be pumped directly to ensure sufficient water supply during the test. At the centre of the site lies a ditch, serving as a mean to alleviate water pressure in the hinterland. After completing the test, a valve was fully opened to allow water from the pump to flow back through the ditch and into the Roer River.

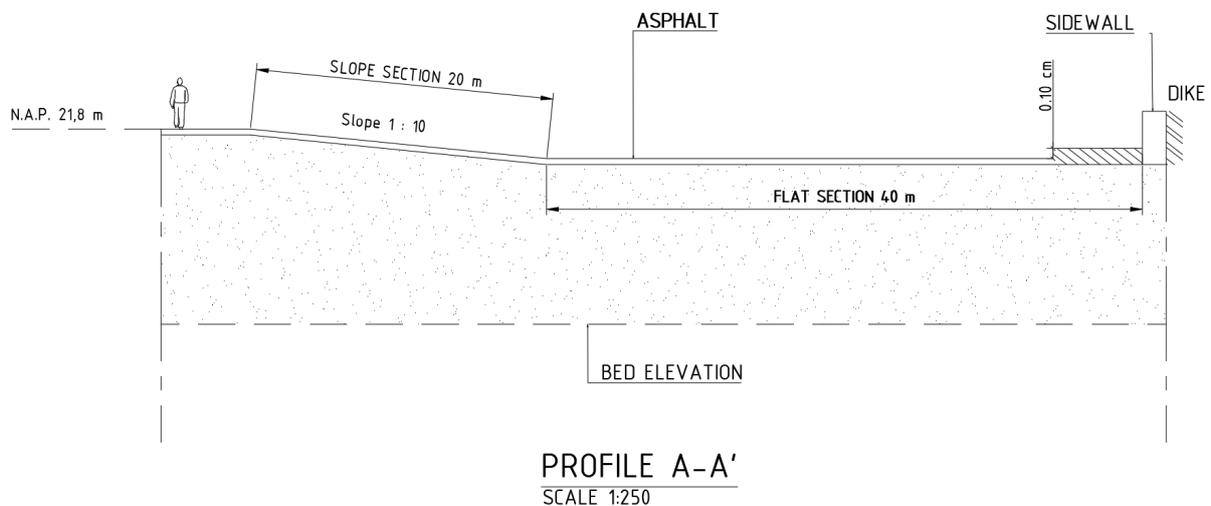
**Figure 3.2:** Schematisation of Lane 1 in Roermond experiment site, scale 1: 250 m

The performance of the barriers was assessed by measuring the amount of displacement. In order to be considered successful, the barrier must not exceed a maximum distance of 0.3 m from the original position to the marked area by spray, and the connection between each element must remain stable.

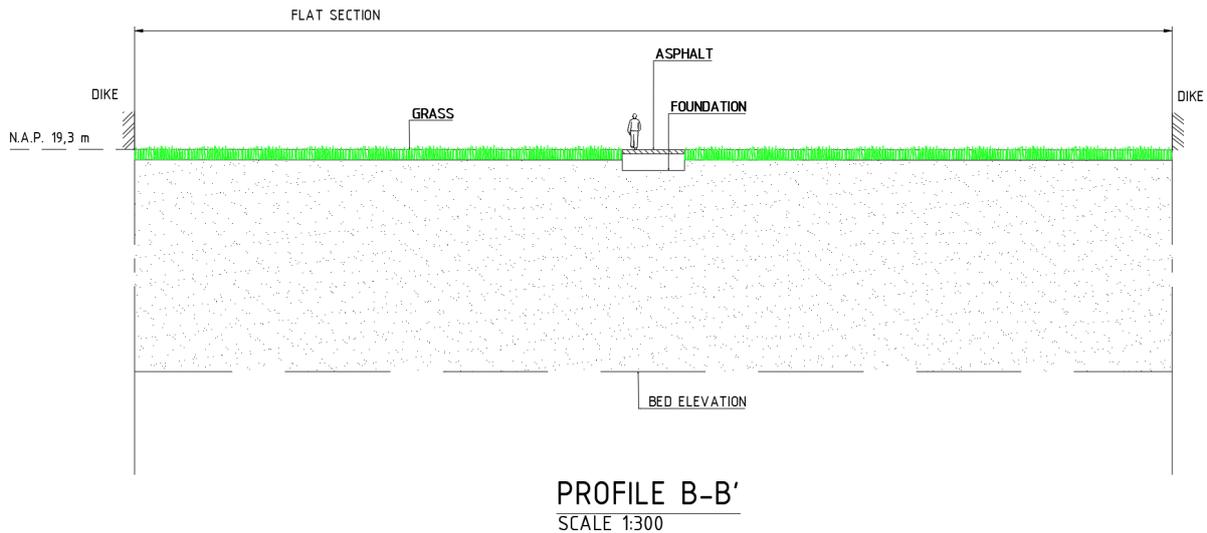
**Figure 3.3:** Schematisation of Lane 2 in Roermond experiment site, scale 1: 300 m

The primary goal of Lane 2 was to test the stability of the temporary flood barriers at a retaining water level of 50 cm and to observe any underflow caused by water leakage. In order to carry out the test, one or more barriers from the same supplier would be constructed simultaneously on a levelled soil body with grass. The barriers would have a minimum length of 25 m. The test would continue until the basin, which was created by the constructed barriers in Lane 1 and Lane 2, was filled with overtopping water and reached a height of 50 cm, and this level was sustained for at least one hour. The schematisation of Lane 2 can be viewed in Figure 3.3.

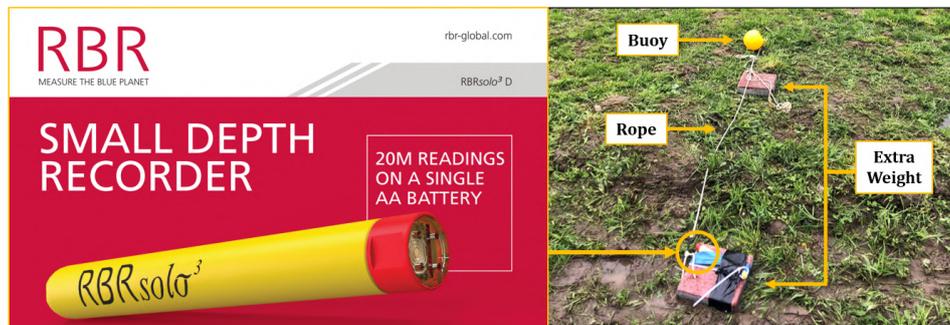
Figure 3.4: RBRsolo<sup>3</sup> logger information [34] and setup

As these diver sensors are designed to be submerged in water, it is not possible to attach them directly to the temporary flood barriers. This could cause damage or missing during the experiment. Extra weight was added to stabilise the sensor, and a rope was used to connect them to a buoy, which helped secure their location and enhance their visibility. All this information can be seen in Figure 3.4.

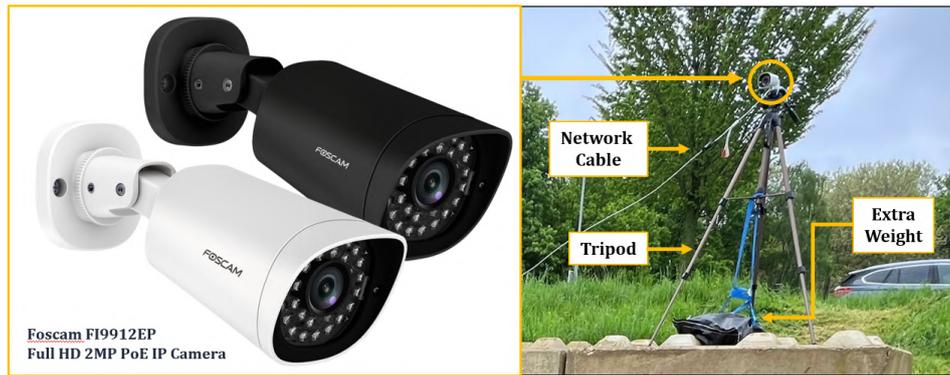
Figure 3.5: IP camera information and setup

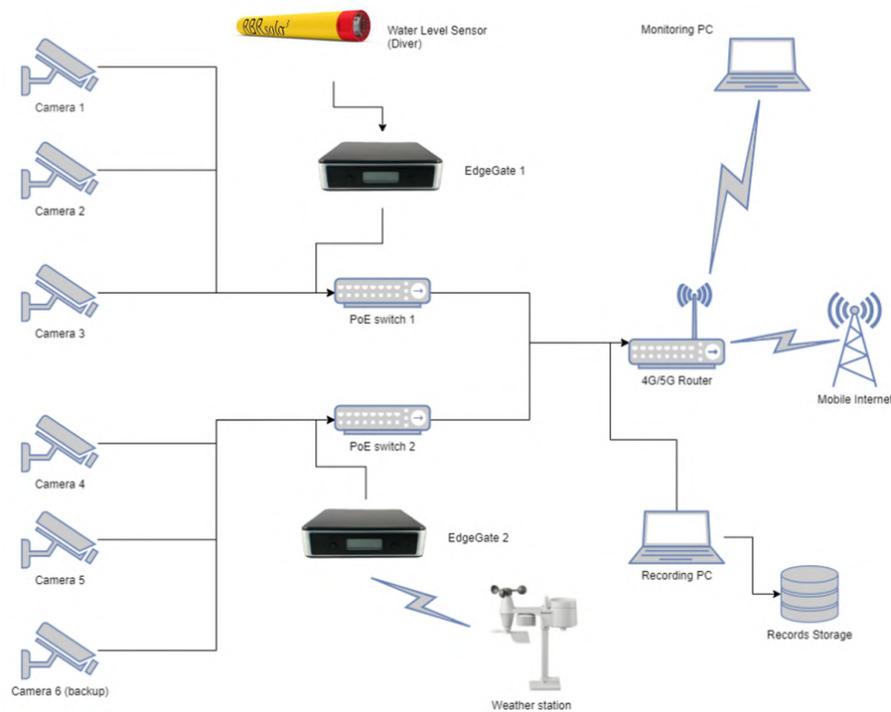
Figure 3.6: Monitoring system used in the experiment

A layout of the monitoring system used in the experiment is demonstrated in Figure 3.6. The system is made up of six cameras, with Camera 6 serving as a backup. These cameras are connected via two Power over Ethernet (PoE) switches, which provide both data and electrical power over an ethernet cable. The switches are then linked to two EdgeGate devices provided by AccessHub company, which help in transferring data to a monitoring PC. Additionally, there are two water level sensors and a weather station to provide supplementary environmental data. This setup ensures that comprehensive environmental readings complement the water level data.

The system is designed to ensure real-time data communication and mobile internet access. It accomplishes this by transmitting information through a 4G/5G router. The data collected from this integrated system is recorded and stored in a dedicated PC and a storage database. This data is likely to include video and sensor data. Once the preparation was complete, all cameras were synchronised to monitor the entire event. This sophisticated arrangement enables a complete monitoring approach to the experiment.

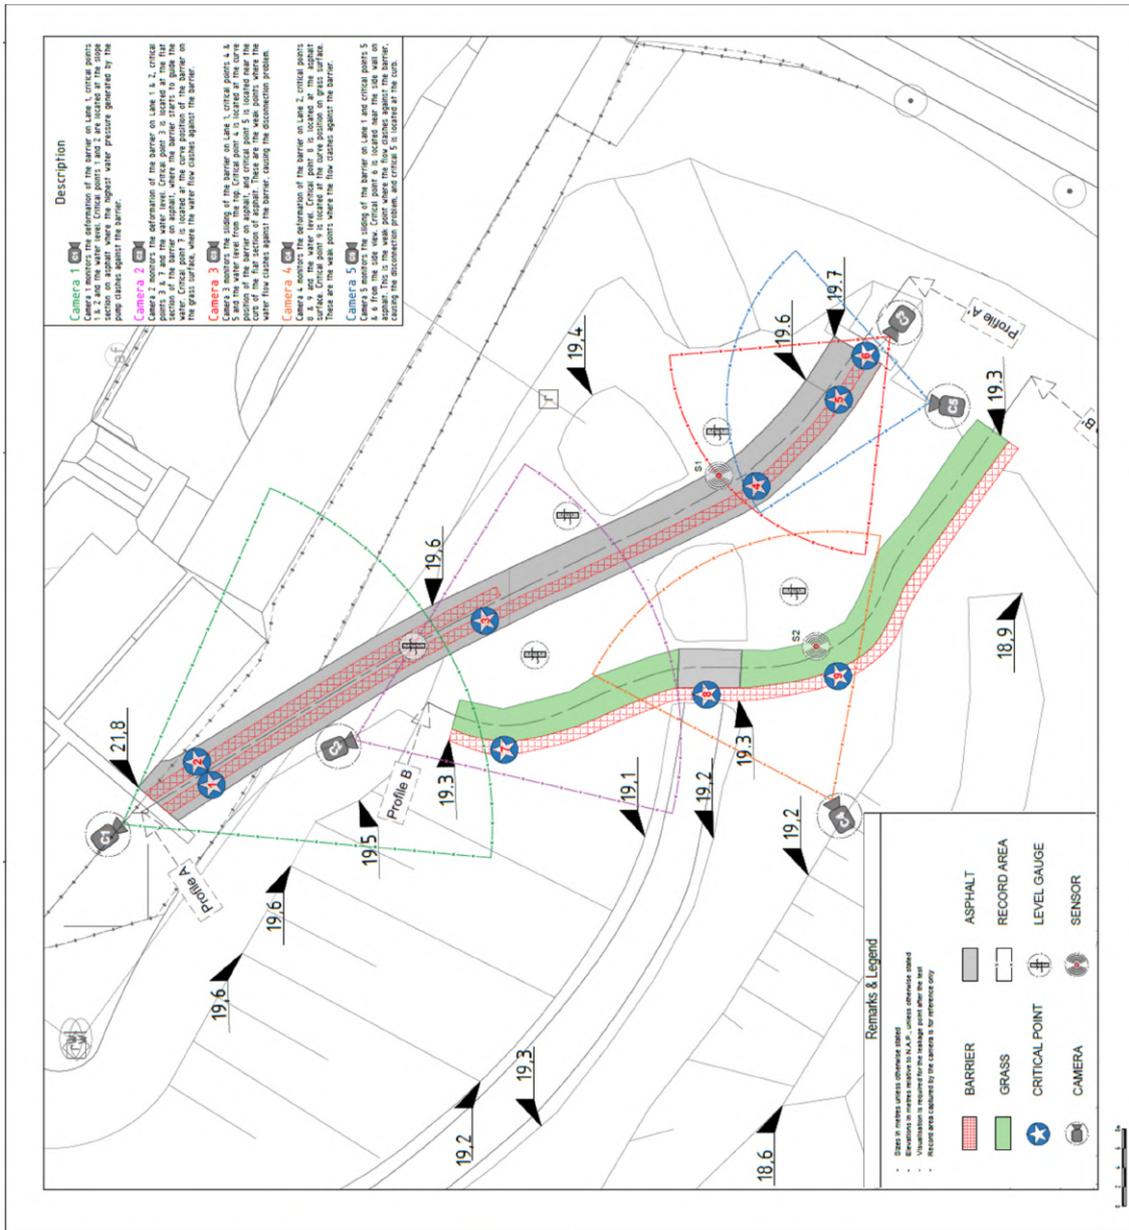
Figure 3.7: Detailed layout of the monitoring system position

The chosen placement of monitoring devices to observe vital sections of the temporary flood barrier is illustrated in Figure 3.7. Each camera was set at a different angle to capture specific parameters of different parts of the barrier. These cameras recorded data on water levels, leakages, displacements, and deformations. The comprehensive coverage ensured a rich dataset for subsequent analysis. Diver Sensor 1 and Diver Sensor 2 were used to measure water levels in different locations. Diver Sensor 1 was assigned to measure water depth within the basin formed by the barrier in Lane 1, whereas Diver Sensor 2 measured the water level in the basin between Lane 1 and Lane 2.

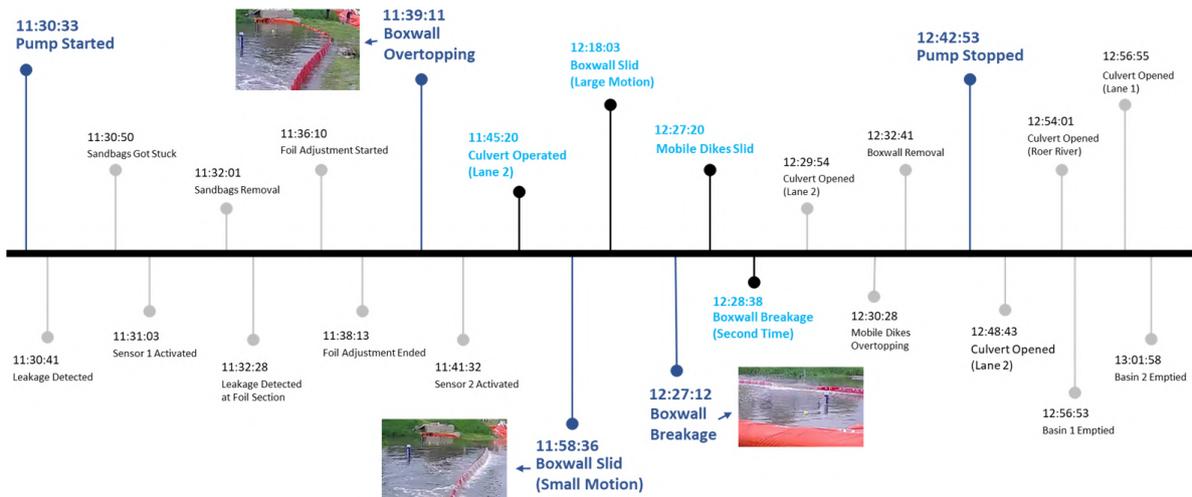
Figure 3.8: Detailed timeline of the experiment in Roermond

Due to the increase in water level, adjustments were made to the culvert in Lane 2 by additional open operation at 12:29:54. Despite this, the Mobile Dikes still suffered from overtopping at 12:30:28. In order to clean up the mess, the removal of the Boxwall barrier started at 12:32:41. As the experiment drew to a close, the pump was stopped at 12:42:53, signifying the end of water inflow. At 12:48:43, the culvert in Lane 2 was opened, followed by the opening of the culvert in the Roer River at 12:54:01 and the culvert in Lane 1 at 12:56:55. This redirection of water helped facilitate drainage. The final stages of the experiment involved emptying Basin 1 at 12:56:53 and Basin 2 at 13:01:58.

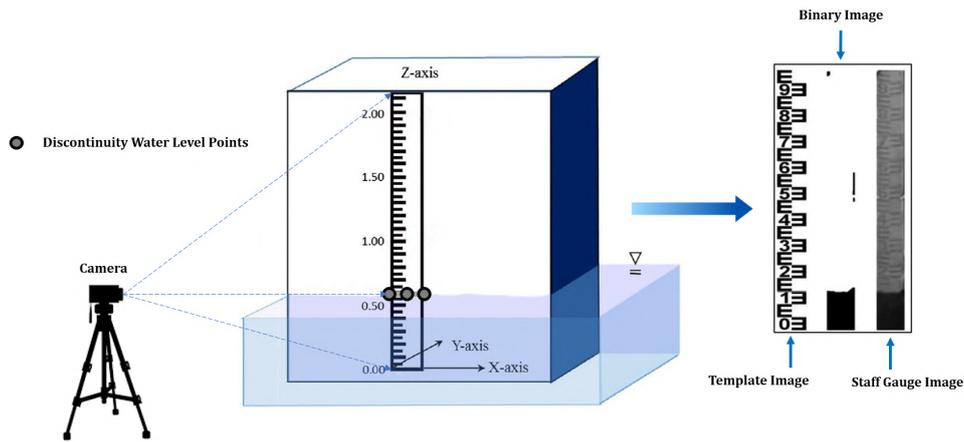
Figure 3.10: Schematisation of image segment method modified by the author, material obtained from [30][35]

The third sub-process is represented as the Multi-frame method, which utilises the contrast in grey-level variation between the staff gauge and the flowing water surface across consecutive frames [43]. Figure 3.10 demonstrates the procedure of the image segment method.

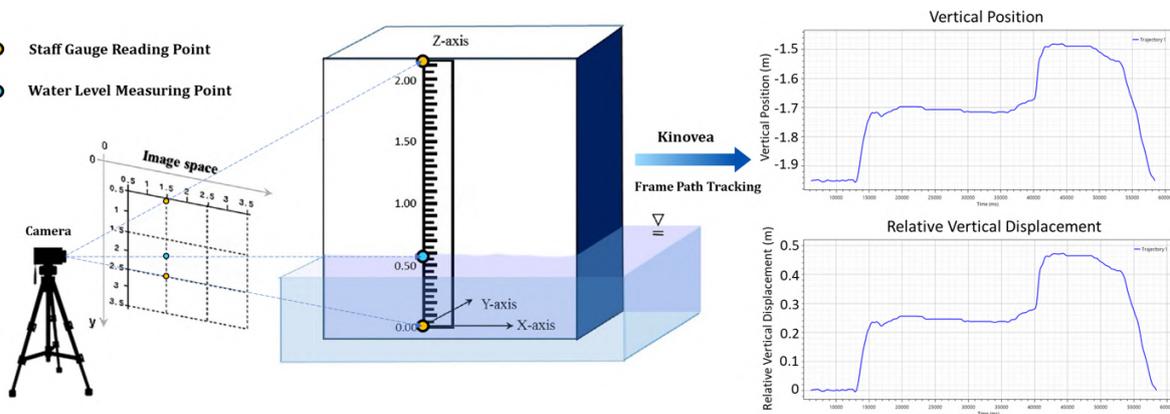
Figure 3.11: Schematisation of the water level measurement method using Kinovea credited by the author, material obtained from [30] and Kinovea

The step for distinguishing the staff gauge and the water surface as separate entities was determined manually within the video footage. This manual identification serves as a starting point for continuous water level tracking. Instead of relying on the contrast of grey-level variations over successive frames, the "tracking point trajectories" function in Kinovea is used. This function marks the water level measurement point on the video, tracking and visibly displaying its trajectory across frames, thus facilitating the observation of water level changes over time. A schematic representation of the water level measurement method as implemented by Kinovea is illustrated in Figure 3.11.

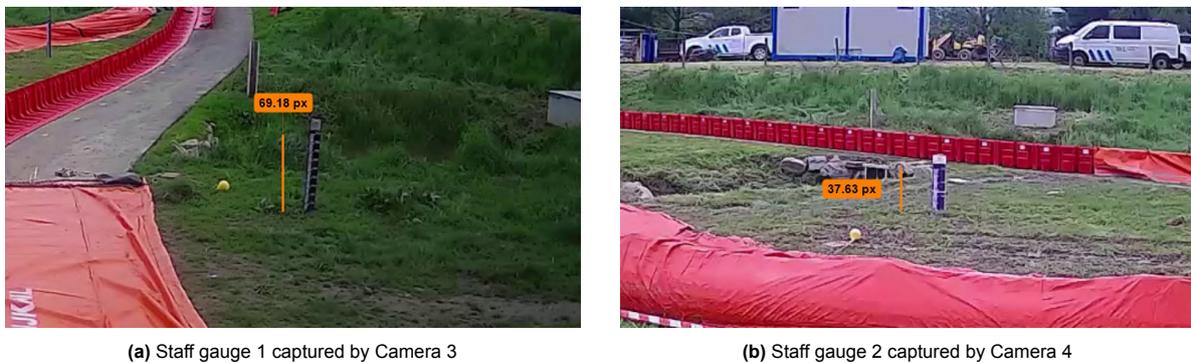
**Figure 3.12:** Pixel distance calculated by Kinovea — Water Level Measurement

However, the detection system in Kinovea can only begin its operation effectively once the dimensions of each pixel are known. Therefore, it becomes essential to measure the distance from the top to the bottom of the staff gauge in the program. This step is crucial for providing the software with the necessary reference points to assess the water level changes accurately. To achieve this, two vertical reference lines were drawn adjacent to the staff gauge within the videos. These lines are used to determine the size of the pixel distance in the footage. Once these lines are drawn, Kinovea automatically calculates and identifies the pixel distance of each line.

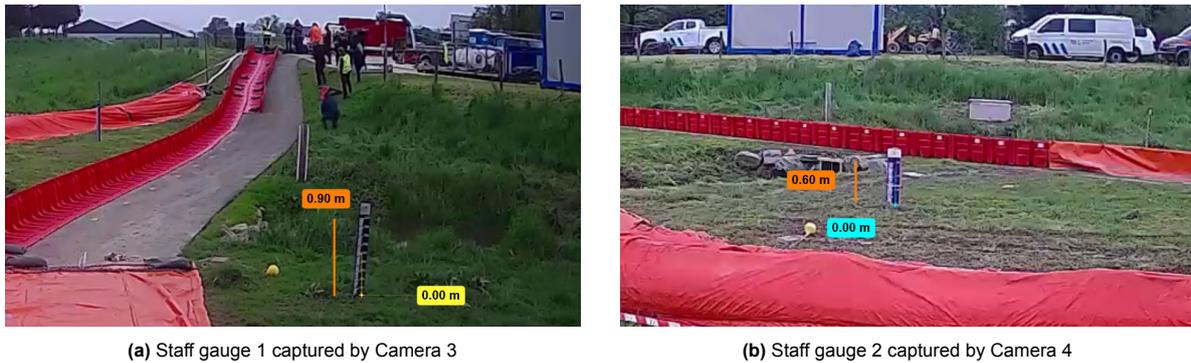
**Figure 3.13:** Establishment of tracking points and reference lines calibration in Kinovea — Water Level Measurement

Based on the actual dimensions of the water level gauges, the reference lines created in the images were calibrated to real-world measurements in meters. The real size of the gauge was input into the segment size field in Kinovea, and the coordinate system was aligned with the vertical axis seen in the video. With these preparations complete, the stage was set for water level tracking. To facilitate the identification of the water level, a tracking point was established at the bottom of the staff gauge. After this setup, Kinovea's "tracking point trajectories" feature was employed to monitor the water level over time. The process being described can be seen in Figure 3.13.

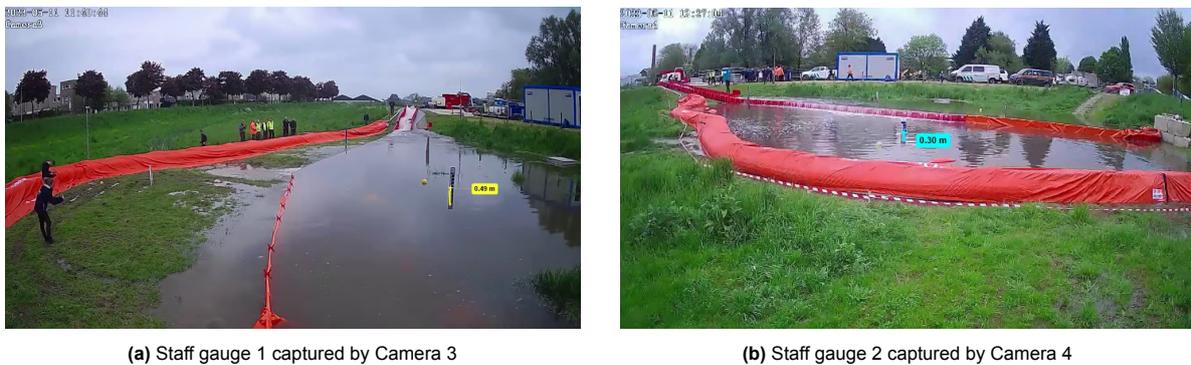
**Figure 3.14:** Visualisation of water level measurement in Kinovea

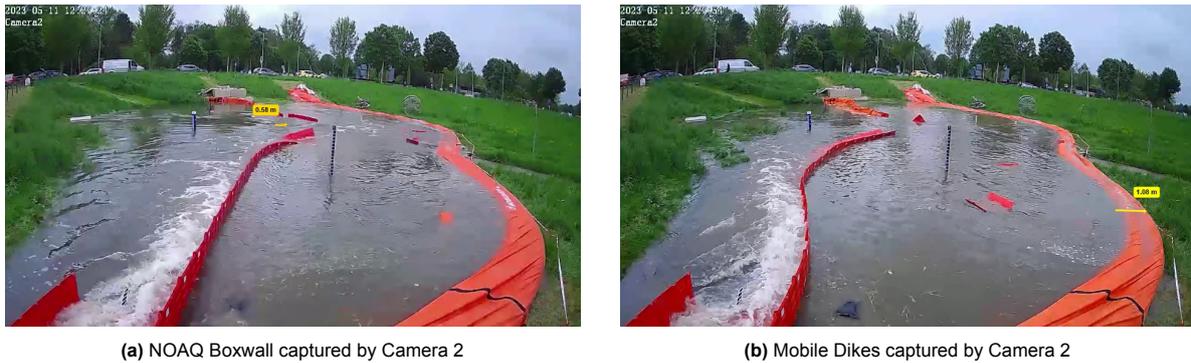
**Figure 3.17:** Visualisation of sliding distance measurement in Kinovea

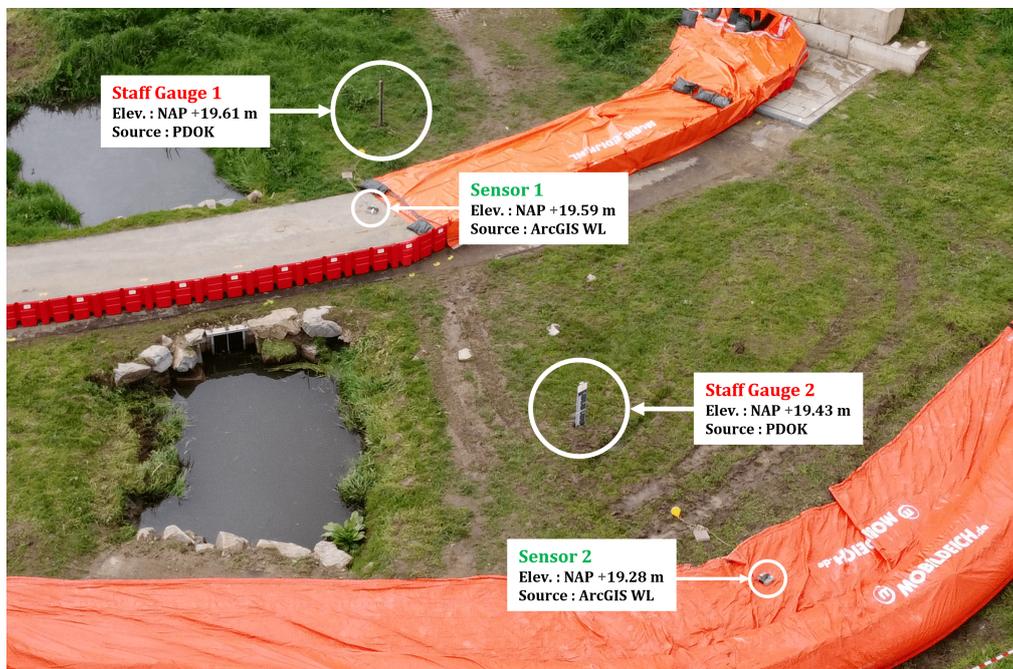
**Figure 4.1:** Positioning and elevation data of the instruments used in Roermond

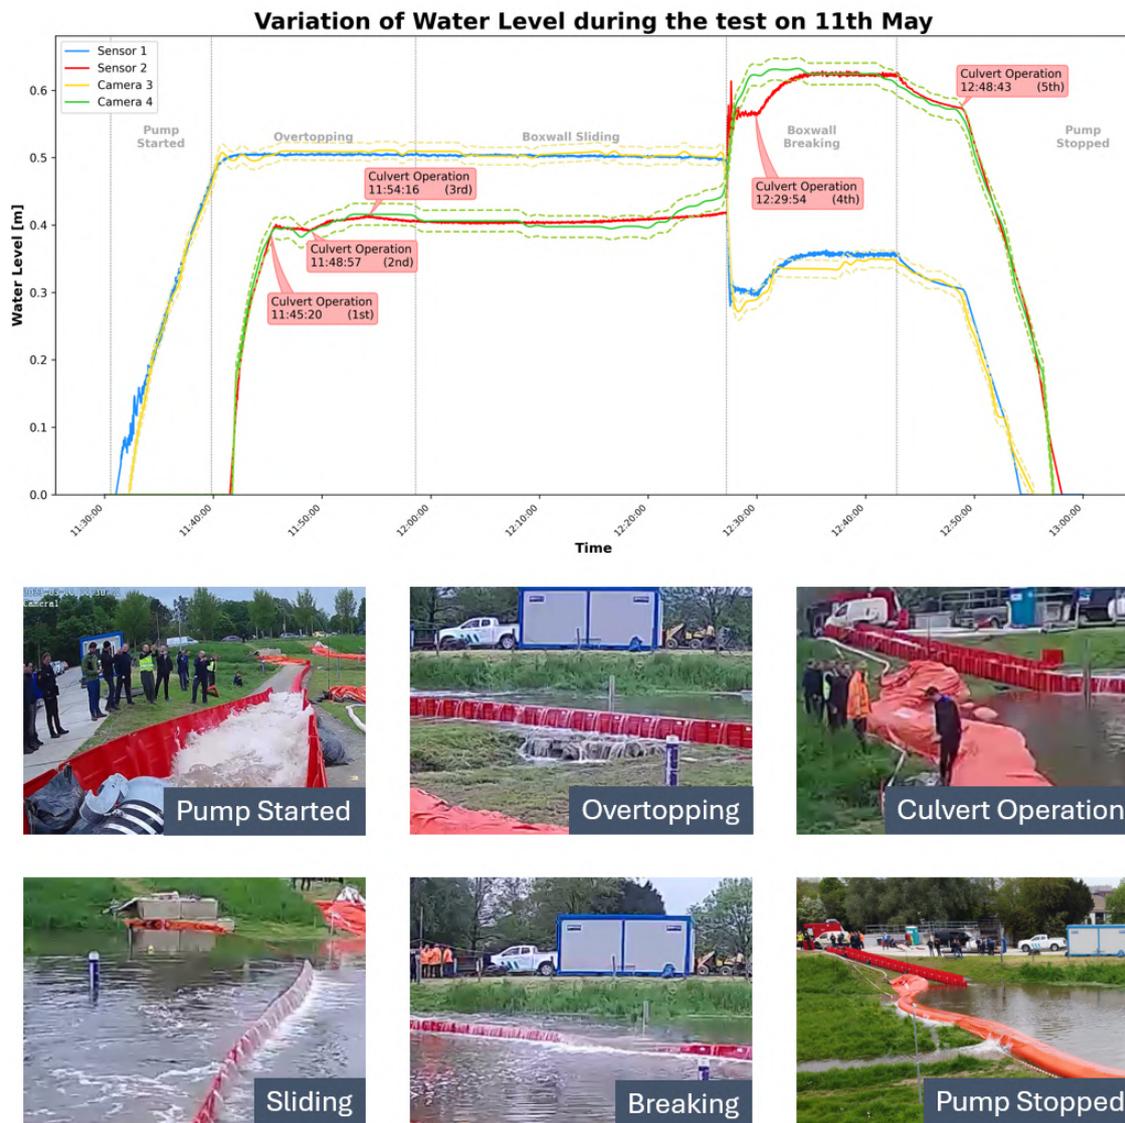
**Figure 4.2:** Water level measurement measured by RBRsolo<sup>3</sup> sensor and Kinovea software

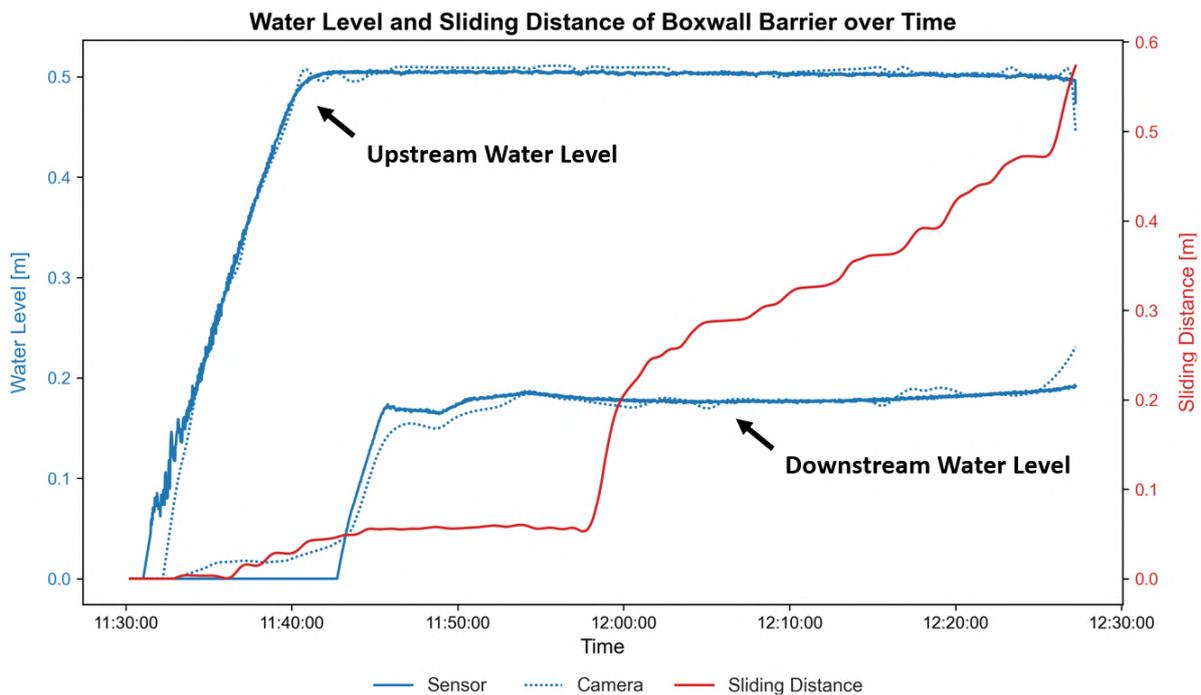
**Figure 4.3:** Correlation between Water level and sliding distance of NOAQ Boxwall Barrier over time

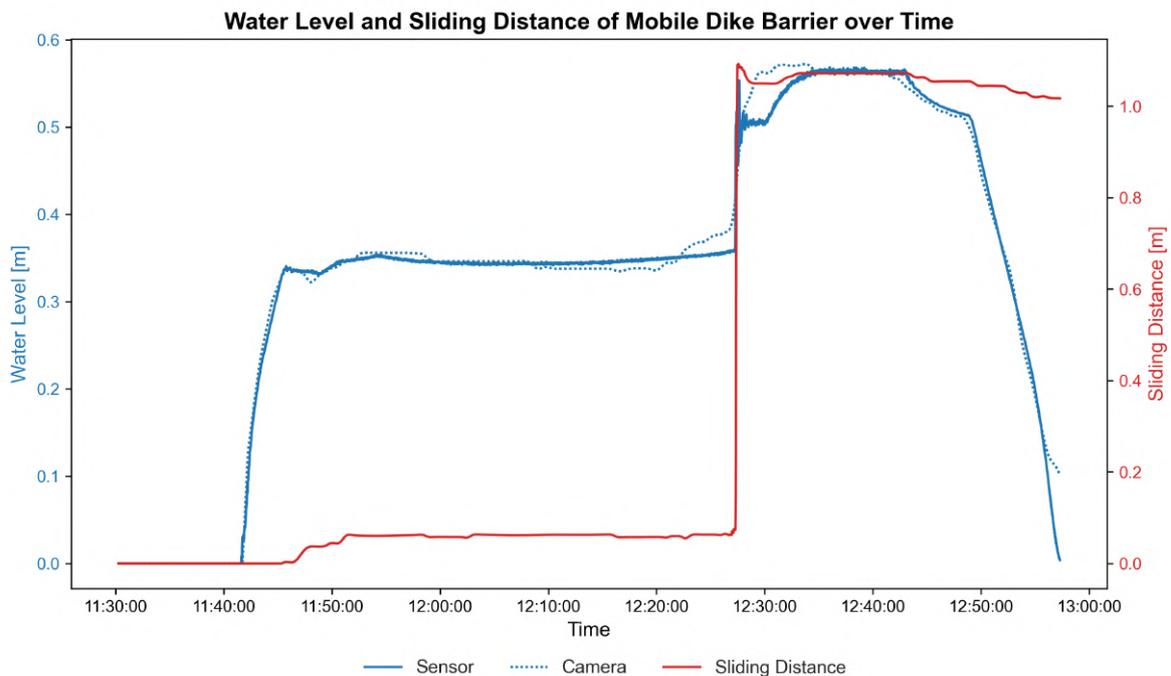
**Figure 4.4:** Correlation between water level and sliding distance of Mobile Dikes Barrier over time

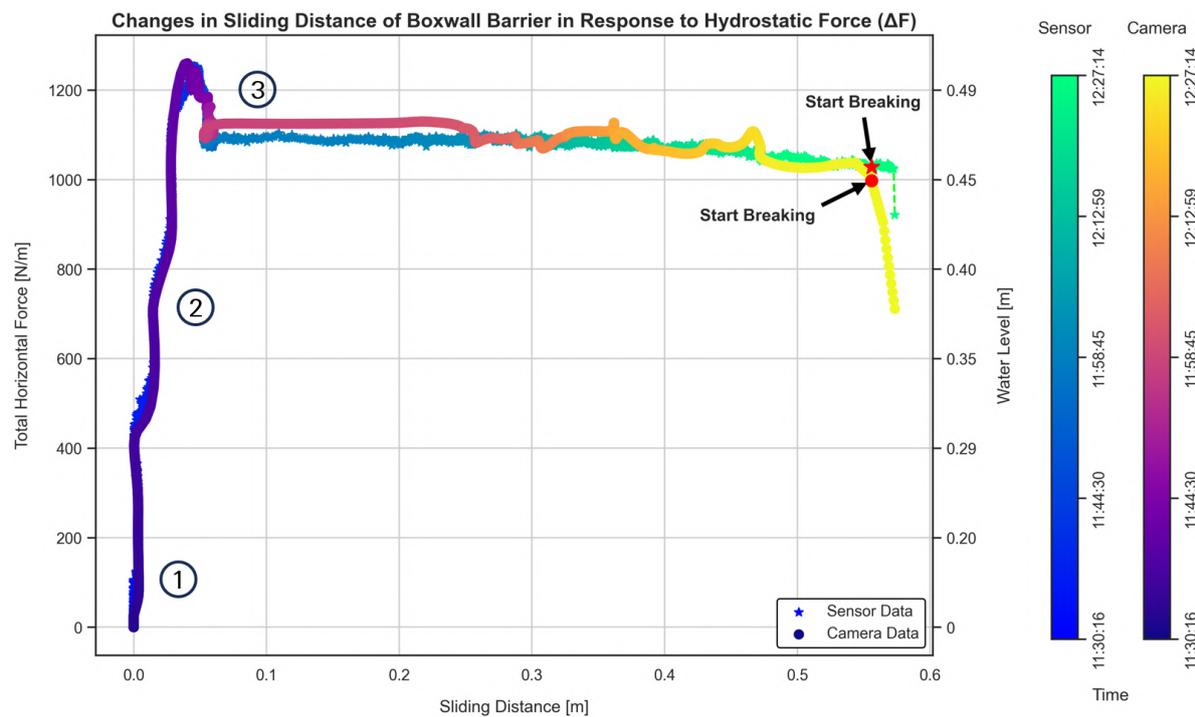
**Figure 4.5:** Correlation between total horizontal force and sliding distance of NOAQ Boxwall Barrier

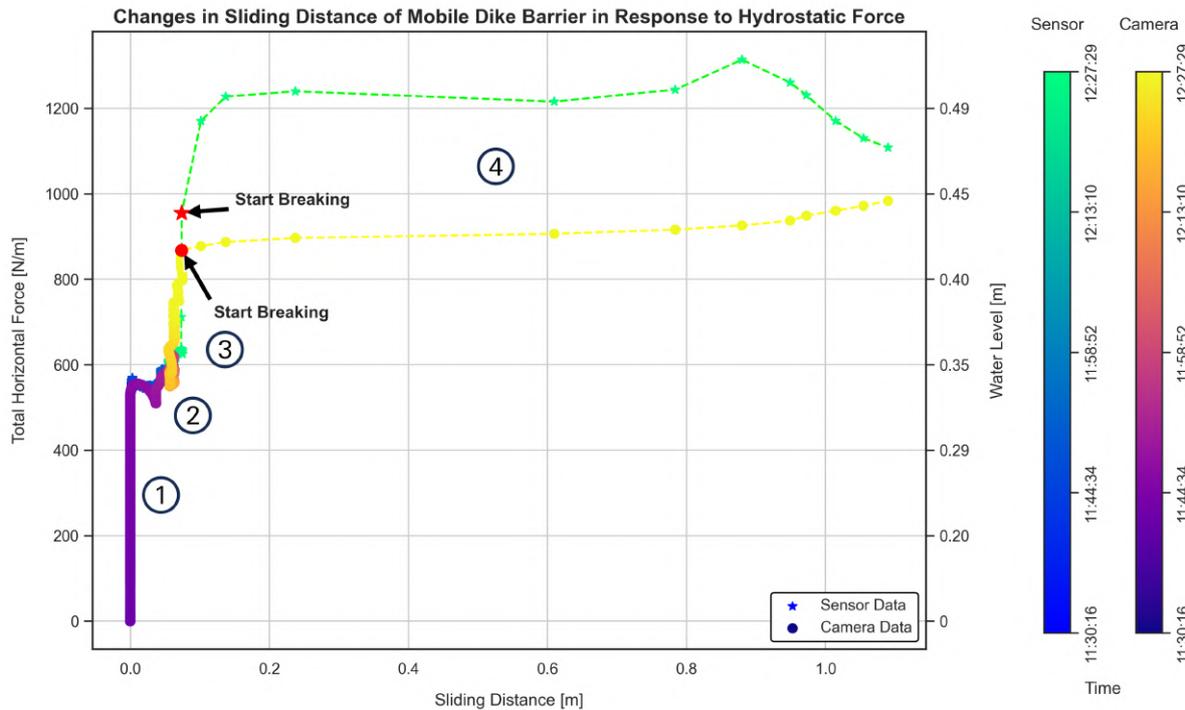
**Figure 4.6:** Correlation between total horizontal force and sliding distance of Mobile Dikes Barrier

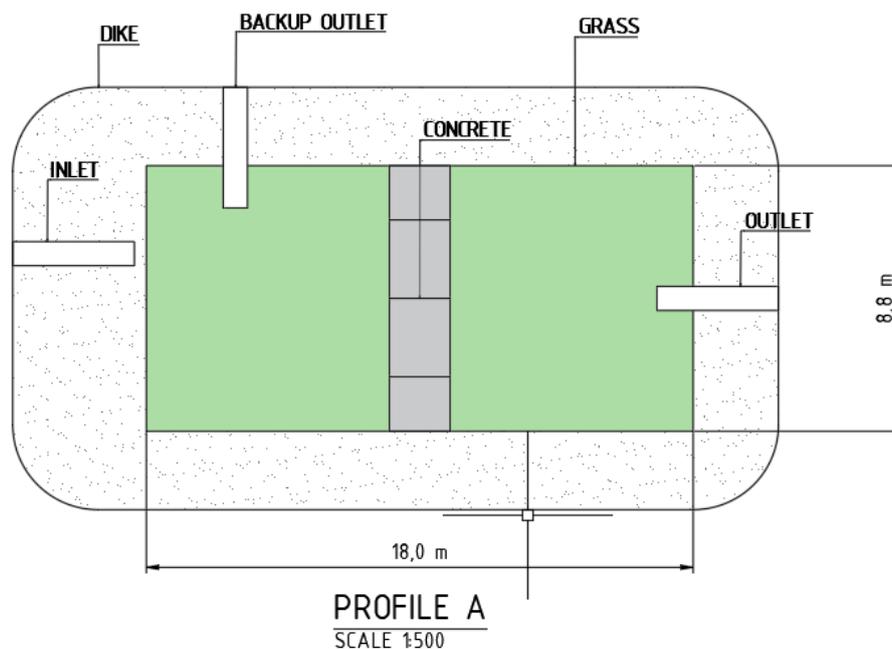
Figure 4.7: Top view of the Flood Proof Holland experiment site, scale 1:500 cm

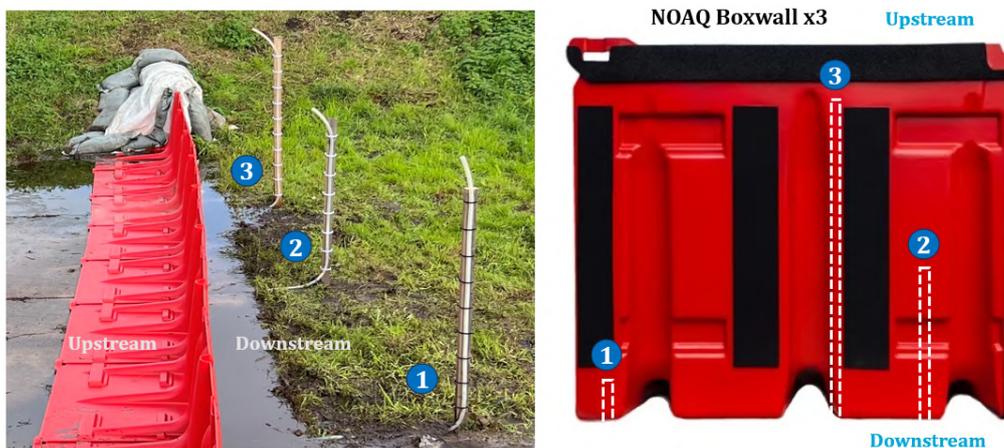
**Figure 4.9:** Position of the corresponding pitot tubes
