# Experimental Research and Failure Mechanism Detection on Temporary Flood Barrier

MSc Thesis Report  
Kou Wai Chan

Submitted as Part of the Degree Requirements for Master of Science in  
the Department of Hydraulic Engineering of the Faculty of Civil Engineering  
at the Delft University of Technology

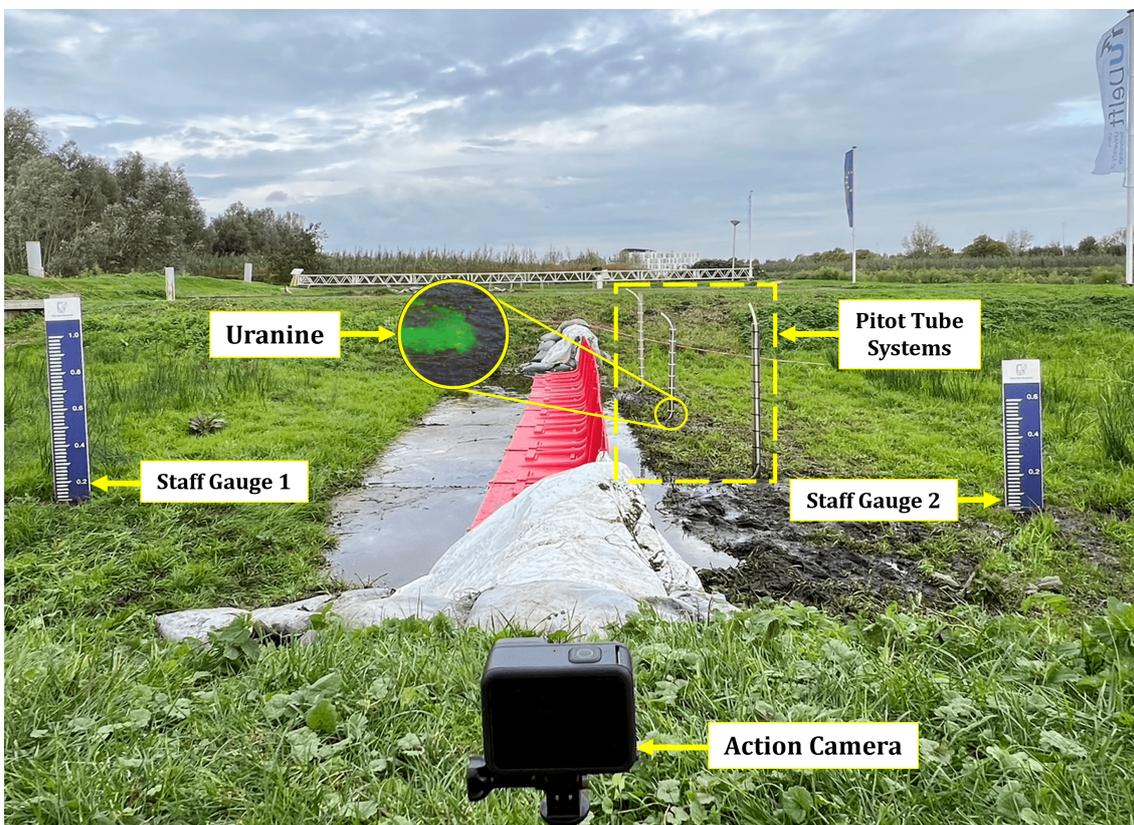
**Figure 4.10:** Position of the experiment setup in Flood Proof Holland

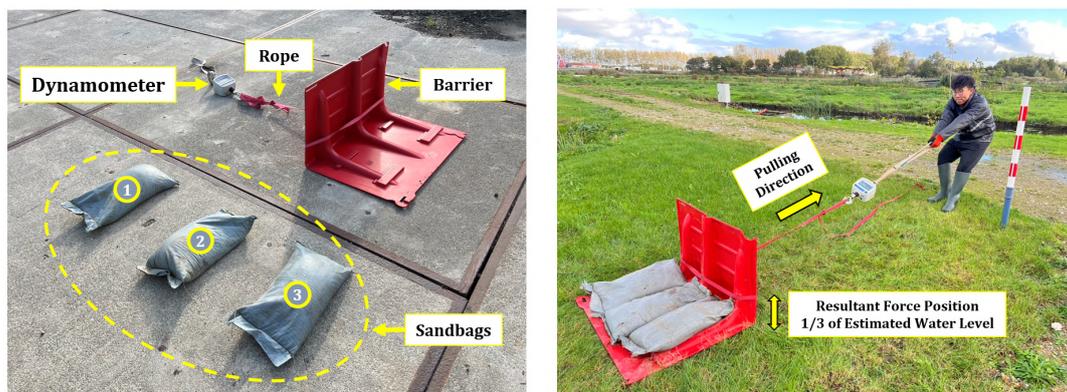
Figure 4.11: Setup of the friction experiment

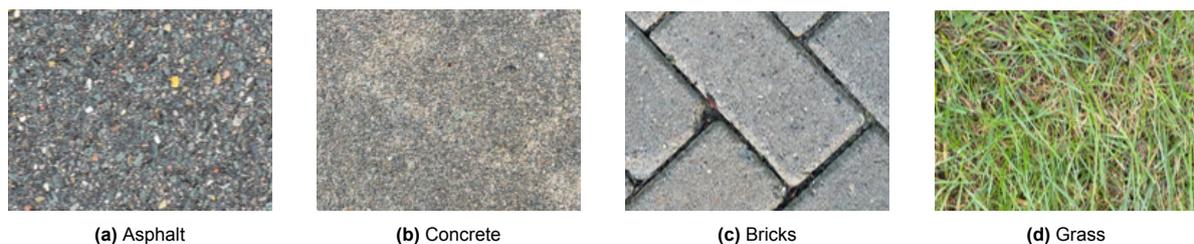
Figure 4.12: Experiment surfaces

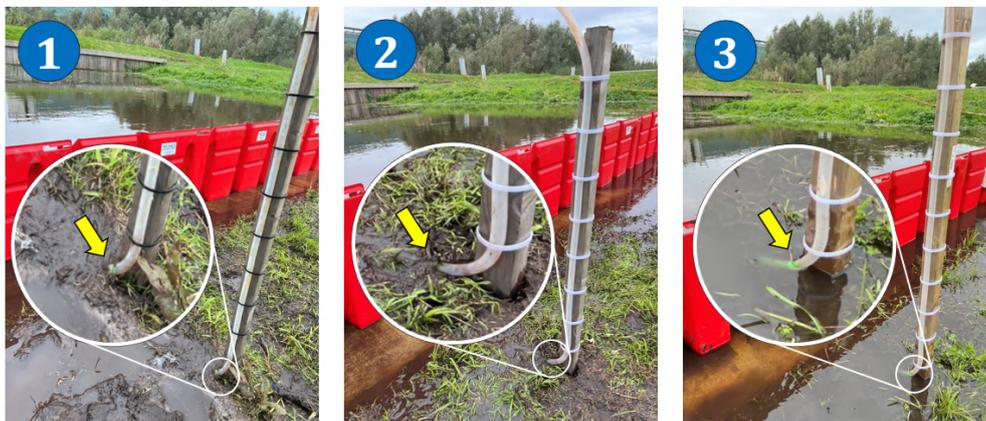
Figure 4.13: Initial water level observations in pitot tubes

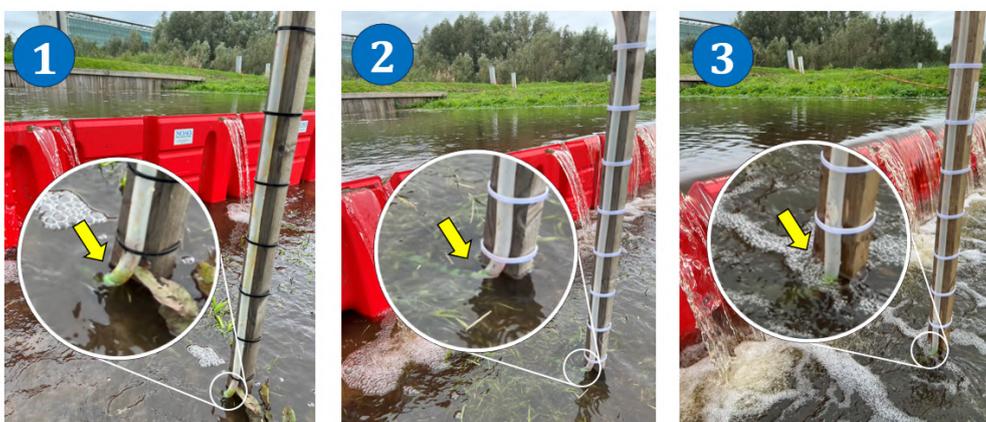
Figure 4.14: Additional water level observations in pitot tubes during overtopping event

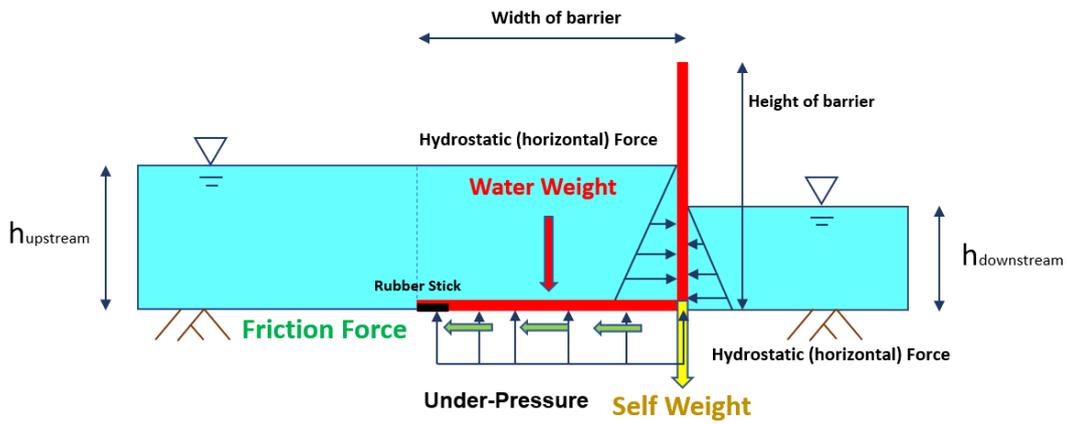
Figure 4.15: Revised schematisation of under-pressure with water on both sides (Example : NOAQ Boxwall)

Consequently, a revised schematic of the under-pressure dynamics of the NOAQ Boxwall, considering water presence on both sides, is shown in Figure 4.15.

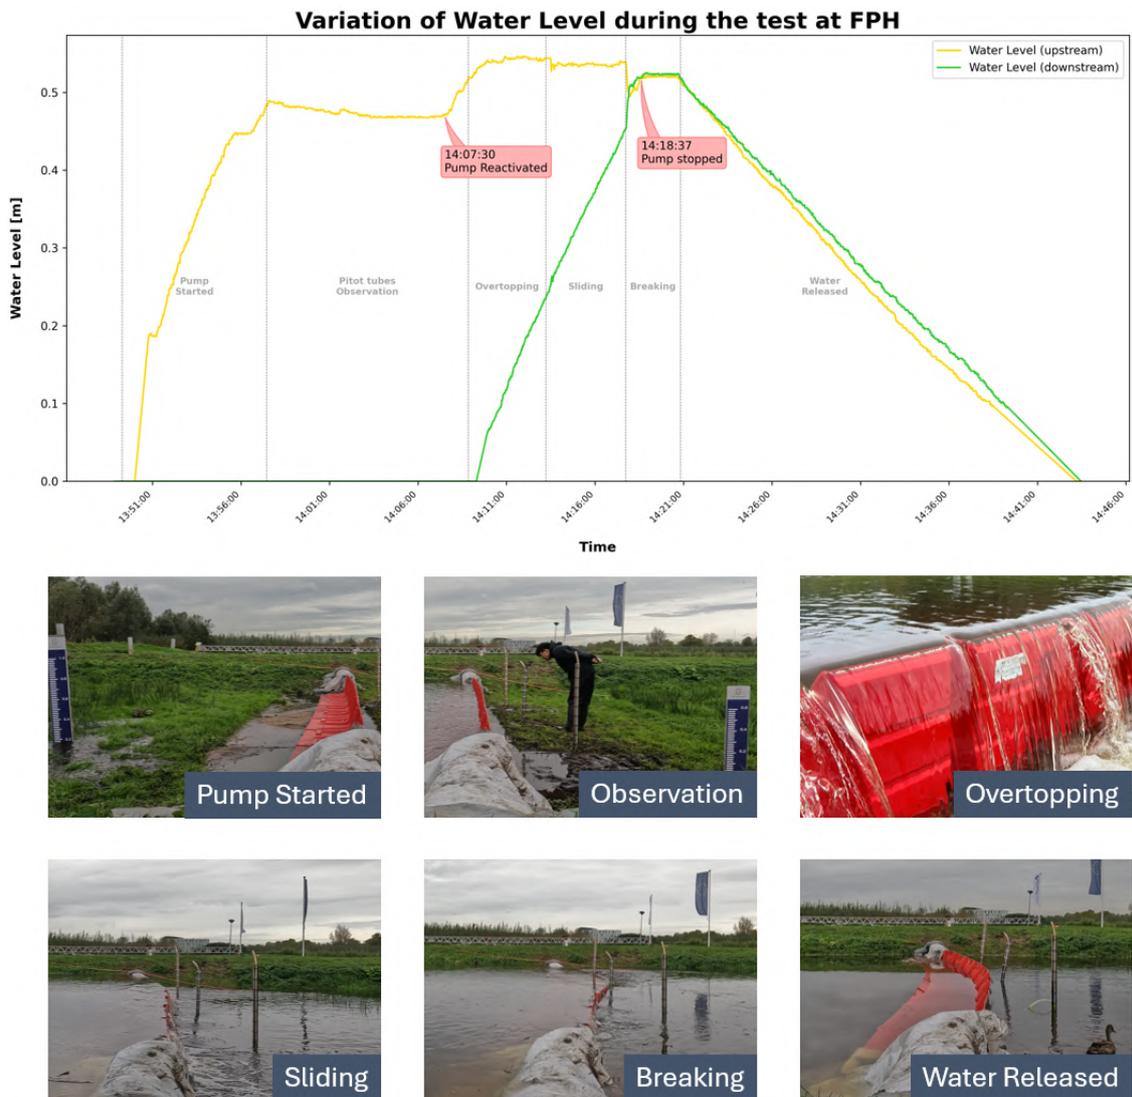
Figure 4.16: Water level measurement measured by Kinovea software at Flood Proof Holland

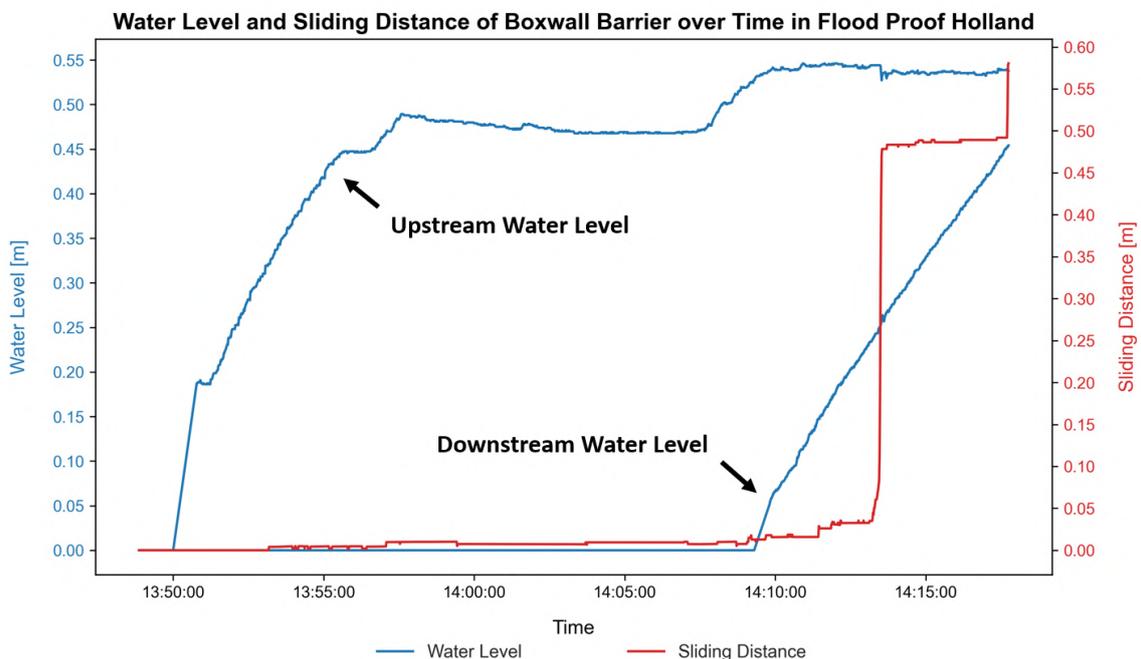
**Figure 4.17:** Correlation between Water level and sliding distance of NOAQ Boxwall Barrier over time in FPH

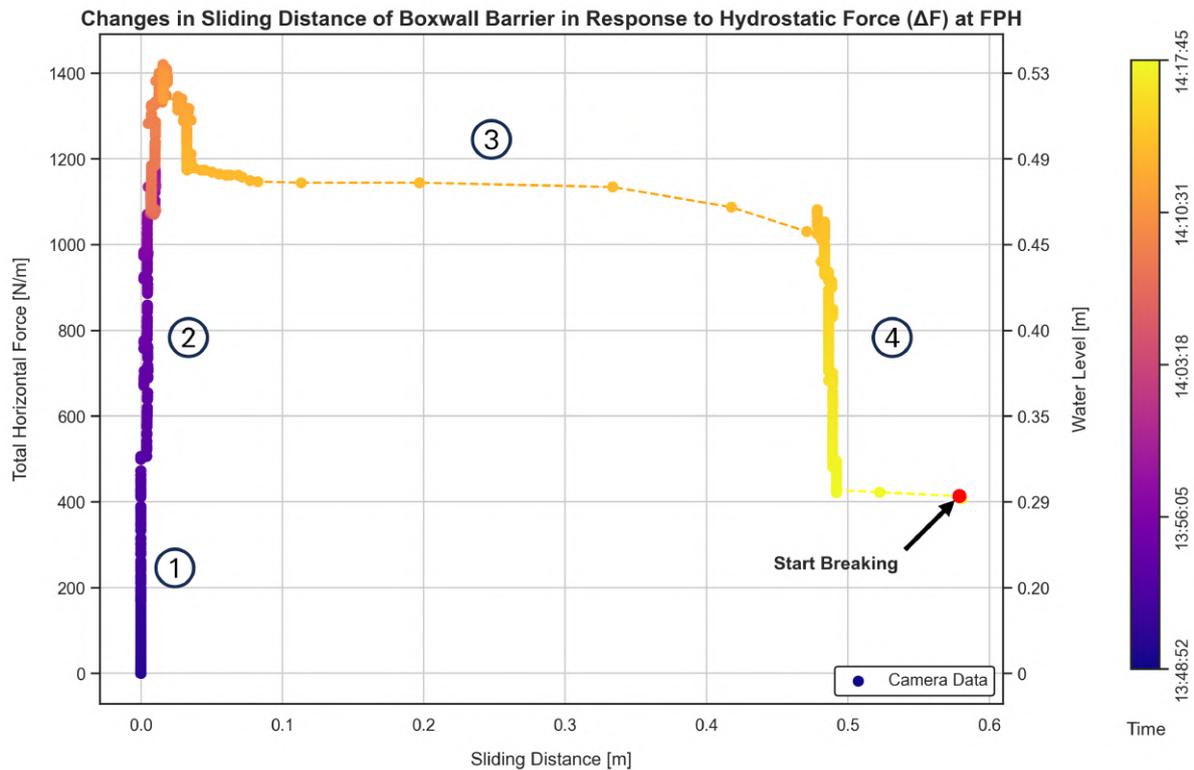
**Figure 4.18:** Correlation between total horizontal force and sliding distance of NOAQ Boxwall Barrier at FPH

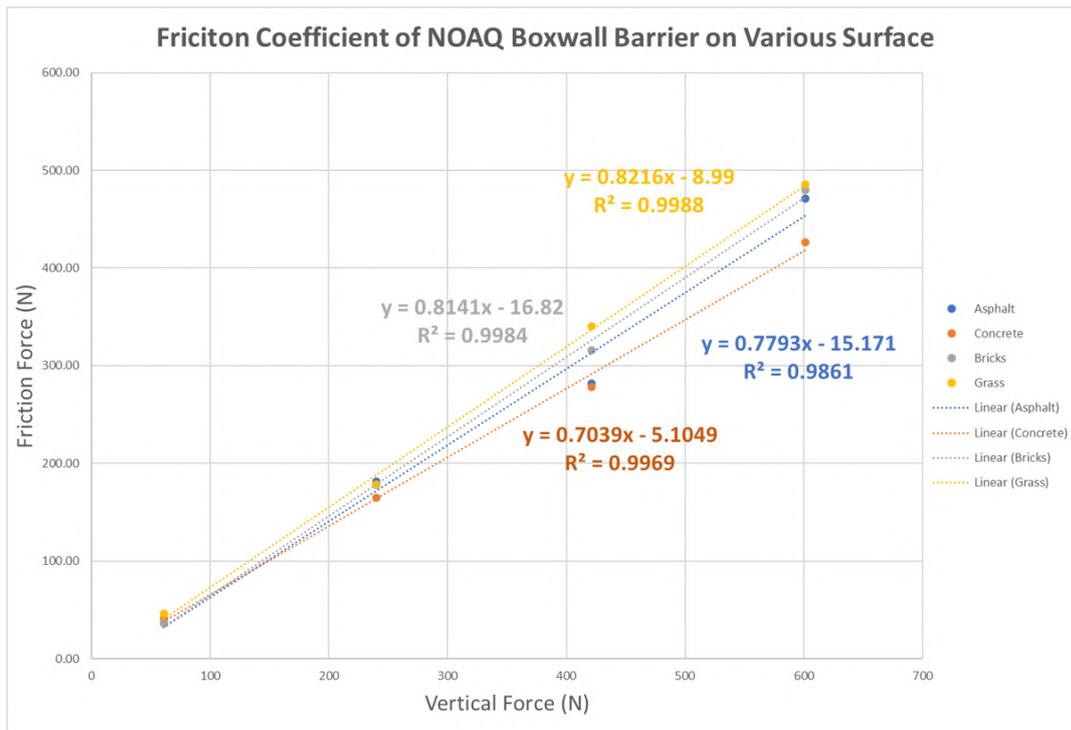
**Figure 4.19:** Static friction coefficient of the NOAQ Boxwall barrier on four different surfaces obtained at Flood Proof Holland

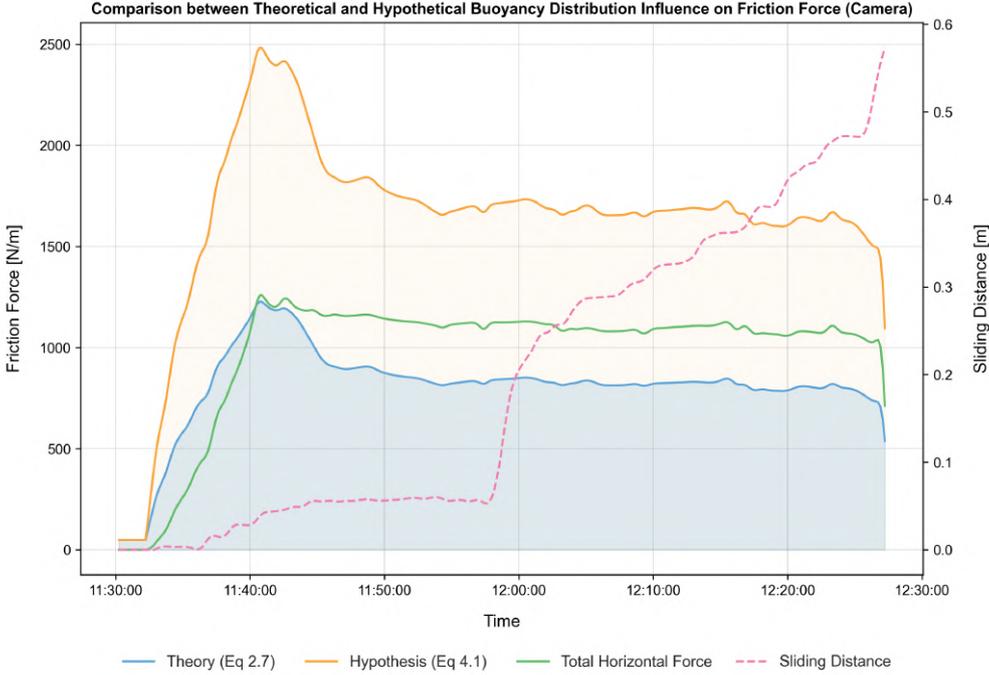
Figure 4.20: Result of calculated friction force from two under-pressure distribution approaches at Roermond (Camera)

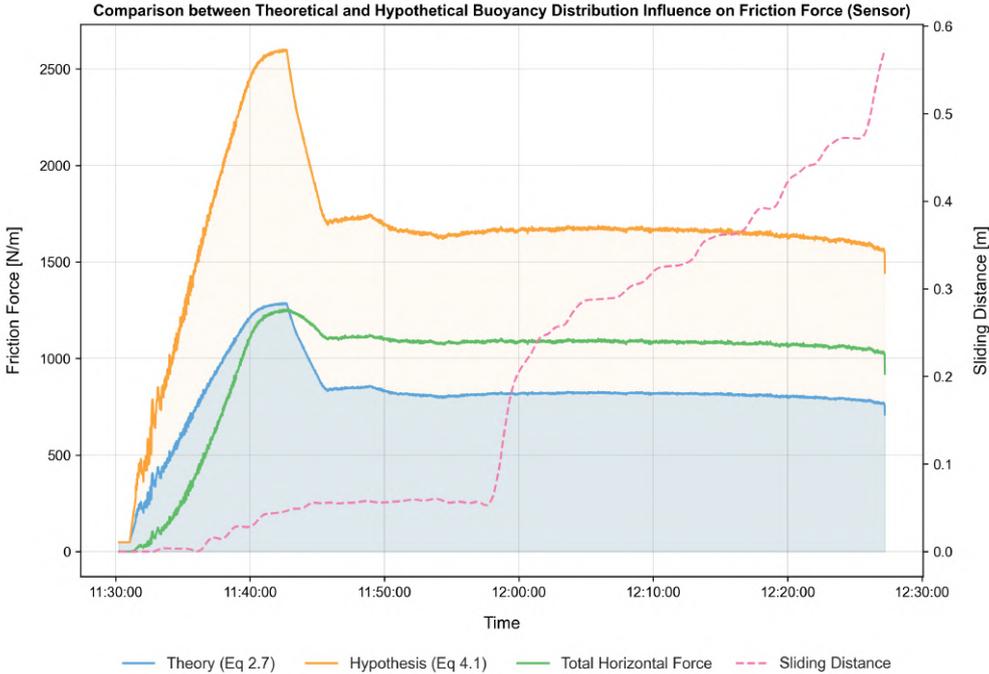
Figure 4.21: Result of calculated friction force from two under-pressure distribution approaches at Roermond (Sensor)

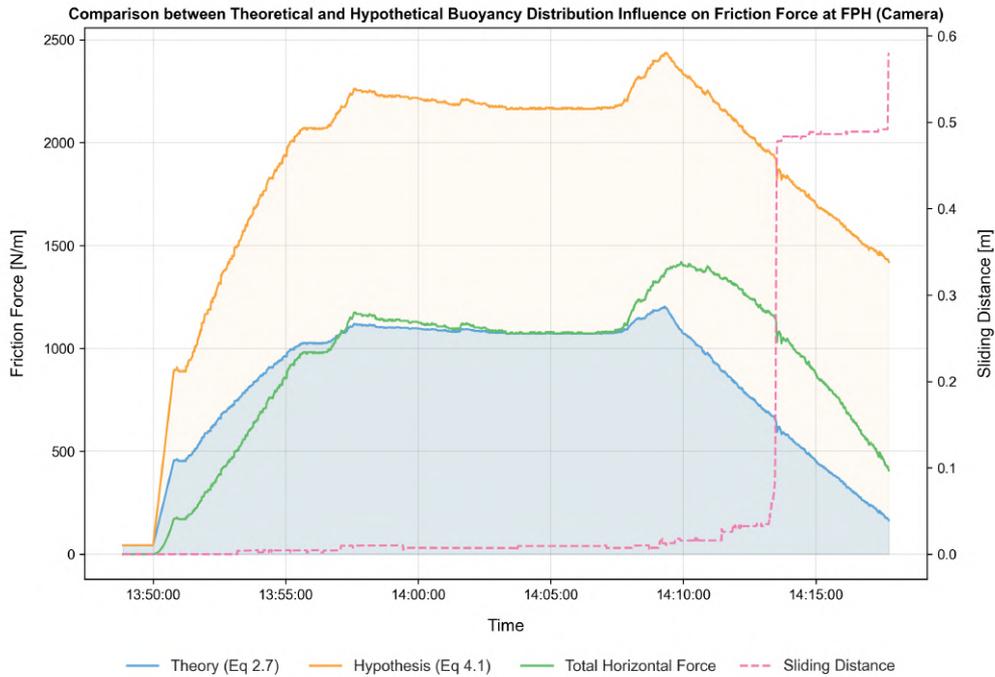
**Figure 4.22:** Result of calculated friction force from two under-pressure distribution approaches at FPH

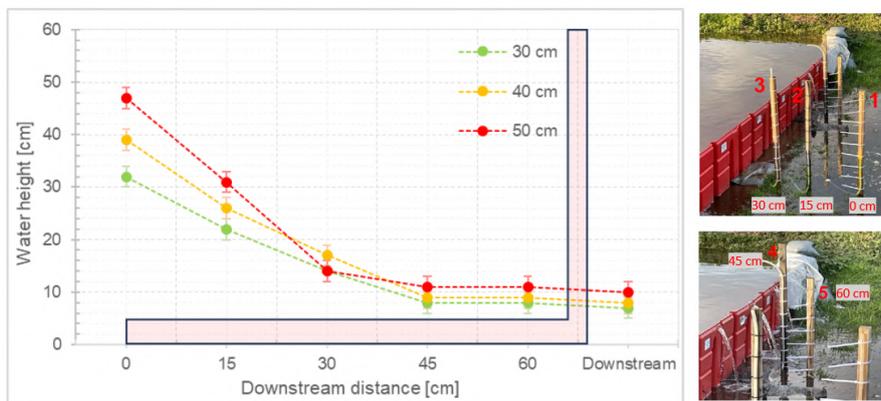
**Figure 4.23:** Result of pressure distribution underneath the NOAQ Boxwall Barrier obtained from Ulenkate [46]

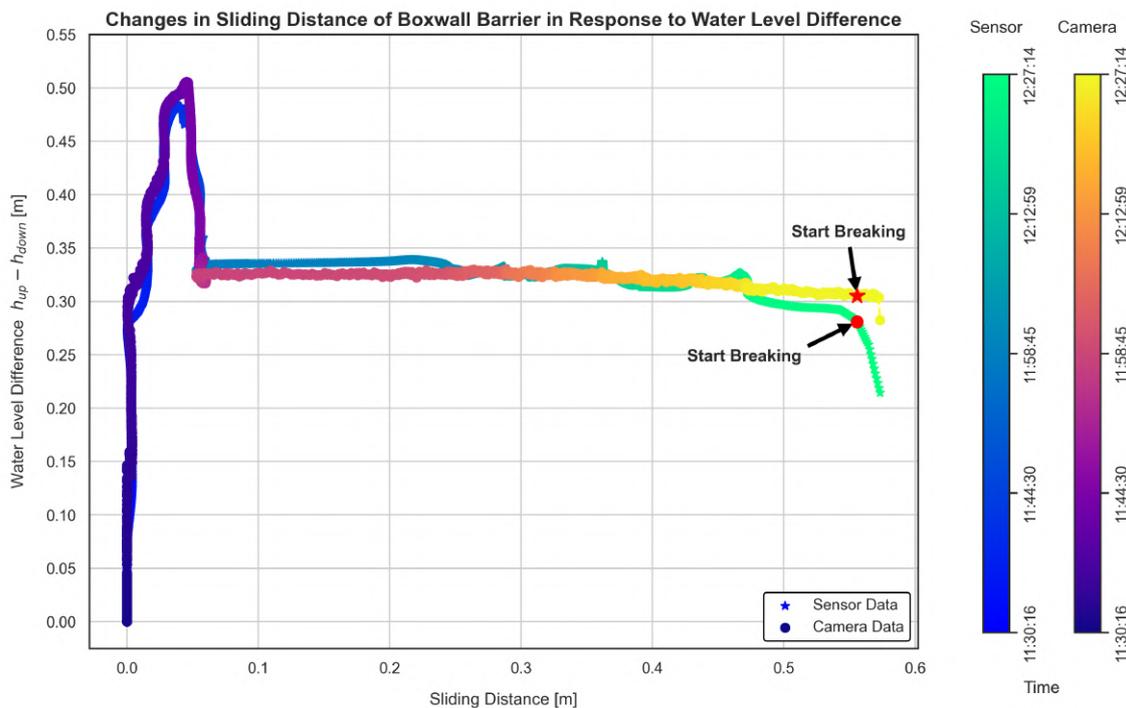
**Figure 5.1:** Correlation between water level difference and sliding distance of NOAQ Boxwall Barrier at Roermond

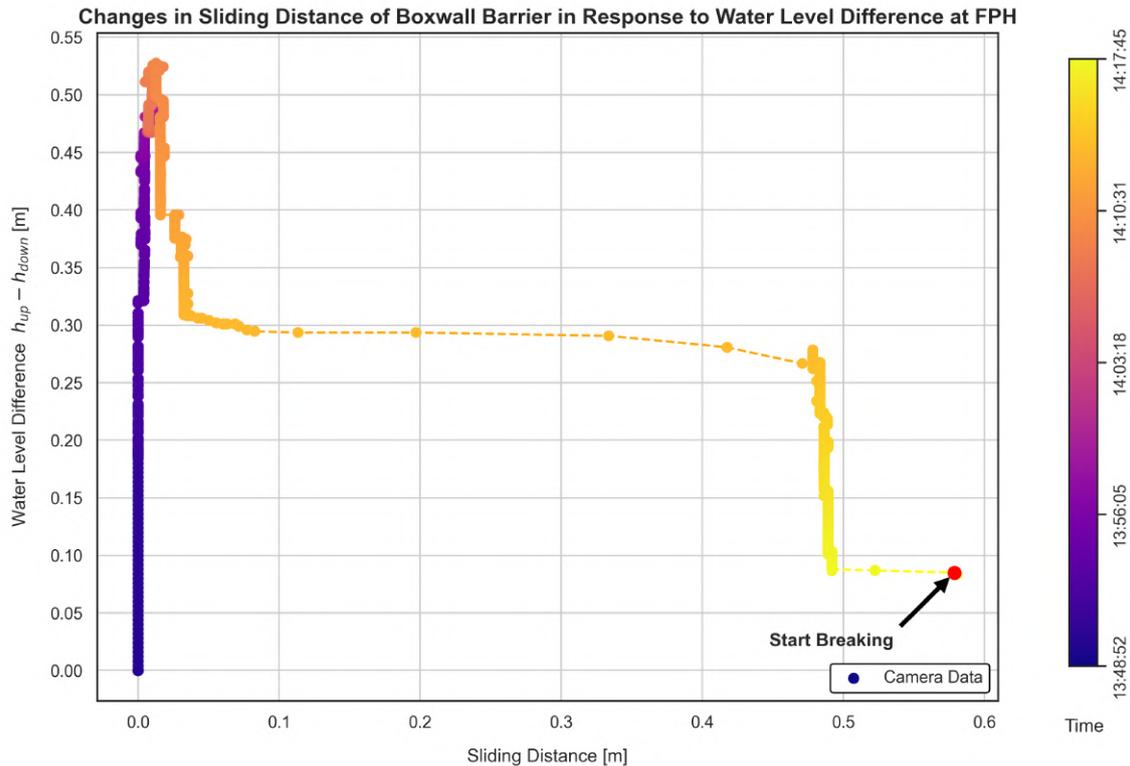
**Figure 5.2:** Correlation between water level difference and sliding distance of NOAQ Boxwall Barrier at FPH
