Analysis and testing of a thermoplastic composite stiffened panel under compression

Proceedings of 22nd International Conference on Composite Materials (ICCM22), Melbourne, AU, August 11-16, 2019

ANALYSIS AND TESTING OF A THERMOPLASTIC COMPOSITE STIFFENED PANEL UNDER COMPRESSION

Kevin S. van Dooren^{1*}, Edgars Labans¹, Bas H.A.H. Tijs^{1,2}, Jan E.A. Waleson² and Chiara Bisagni¹

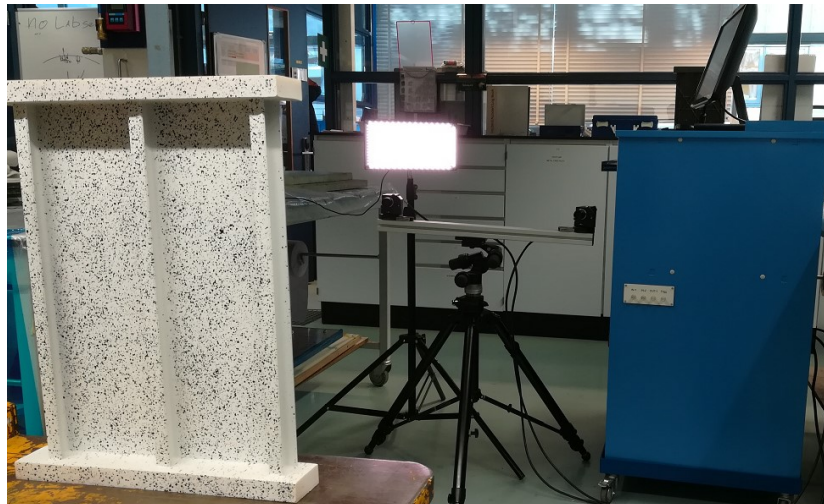
Figure 3: DIC measurement setup.

The geometrical imperfections of the panel were measured by the use of Digital Image Correlation (DIC). The DIC setup is shown in Figure 3. The measured imperfections can be seen in Figure 4, where they are projected onto the actual panel as a contour plot. The measurement shows a maximum out-of-plane imperfection of 0.62 mm in outwards direction, and a maximum of 1.21 mm inwards for the skin region. The panel presents a slightly V-curved shape in the transverse direction and a slight curvature in the longitudinal direction. This curvature is most likely caused by internal stresses due to the potting curing process and the mismatch in stiffness of the different materials.
