Book of abstracts

NCR days 2017
February 1-3, 2017
Wageningen University & Research

Bank erosion processes in waterways

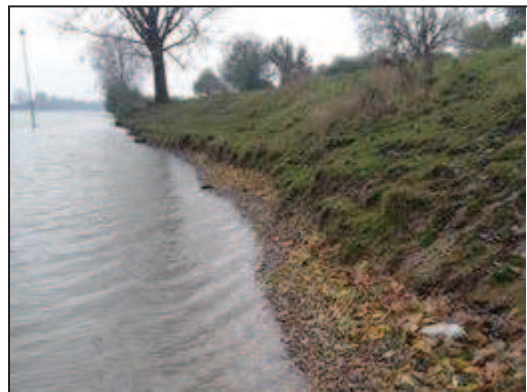
Figure 1. Uniform erosion pattern characterized by short grass-covered banks with gravel at the toe.

Two distinct patterns are identified after six years of their restoration: uniform (Fig. 1) and bay-shaped (Fig. 2). The uniform pattern has low or zero erosion rates at present, hypothetically due to the toe protection of a gravel layers, whereas the embayments are hit by ship waves, especially in areas where the base level is low enough to allow them reach the banks virtually without energy dissipation. The primary ship waves also induce shear stresses onto the banks, in particular over terraces where the wave energy dissipation occurs. It is noticeable the presence of trees along the banks that delays the erosion rates in some cases, but not in others.

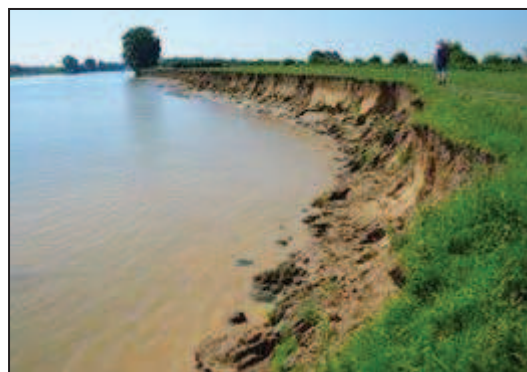
Figure 2. Bay-shaped erosion pattern characterized by high banks and contrasting erosion rates.
