Bachelor of Science Thesis

# Sediment-petrographical analysis of the Delft Sandstone

August 2009  
Applied Earth Sciences  
TU Delft  
Supervised by dr. M.E. Donselaar

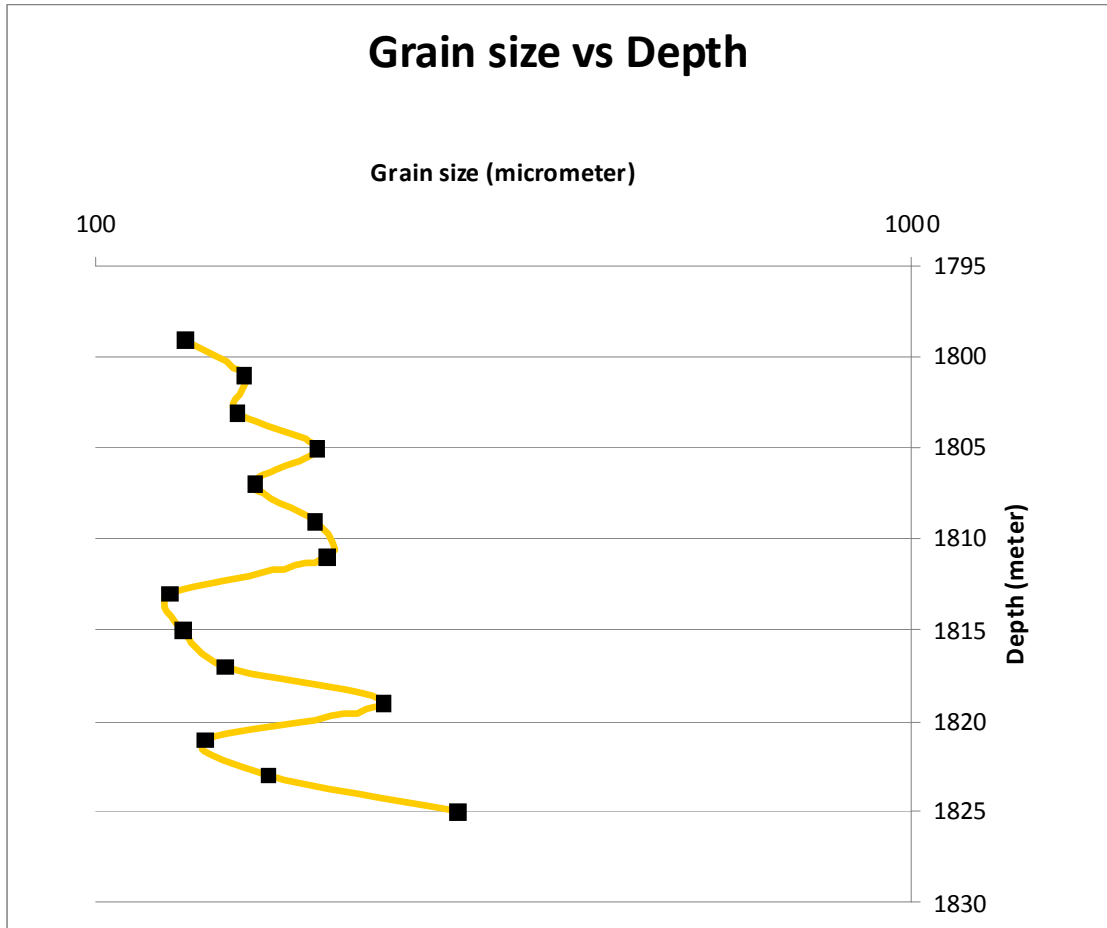
The diagram gives a graphic representation of the grain size distribution.

Figure 5.02: Diagram that shows grain size versus depth.

Sadly, there is no statistic significant result which concludes that we deal with a series of stacked fining upward sequences. These fining upward sequences would have represented one point bar each. The section of the borehole would show a river with a changing course where point bars cut into each other. The overall fining upward trend of figure 5.02 represents a continuing rise of the sea level. The transgression is also observed in the slabs of the MKP-11 at the core shed of NAM. So the sediments were deposited relatively close to the coast, and therefore smaller in grain size.

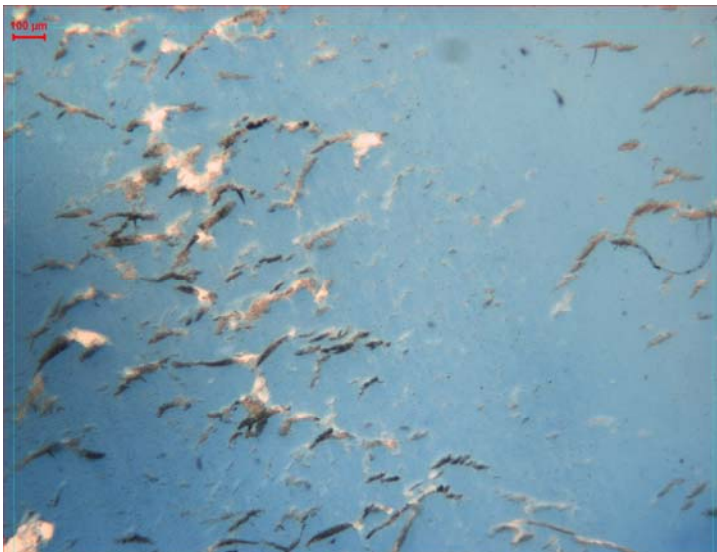
**Figure 6.01**

*Cracks in the epoxy due to bad casting or a bad solidification process.*

In the cuttings and the thin slides are some artifacts present, as can be seen on the two pictures on the bottom of this page. Some thin slides were badly polished or were not filled up correct with the blue epoxy. This resulted in loss of a couple of thin slides or parts of thin slides which cannot be described anymore. The photo on the right shows some metal pieces which were separated from the sediments with a magnet. Some other obscurities in the cuttings were leaves, twigs and plastics.

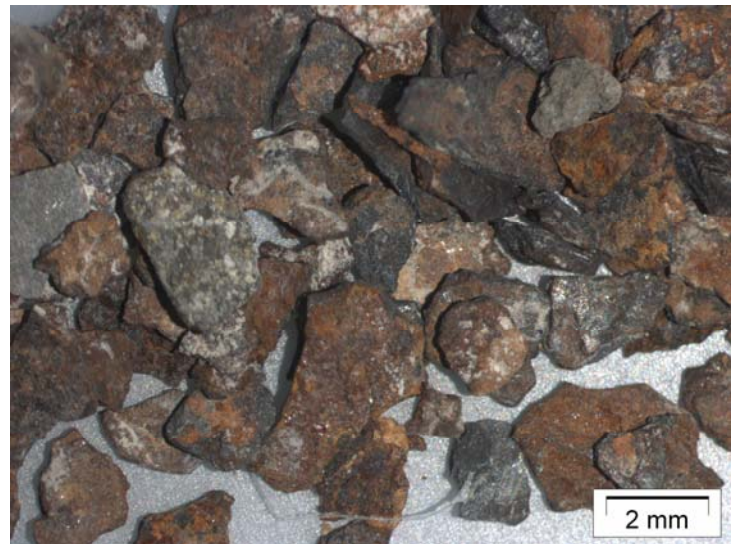
**Figure 6.02**

*A collection of metal pieces which broke of the drill bit during drilling and came to surface with the cuttings and ended up in the cutting samples.*

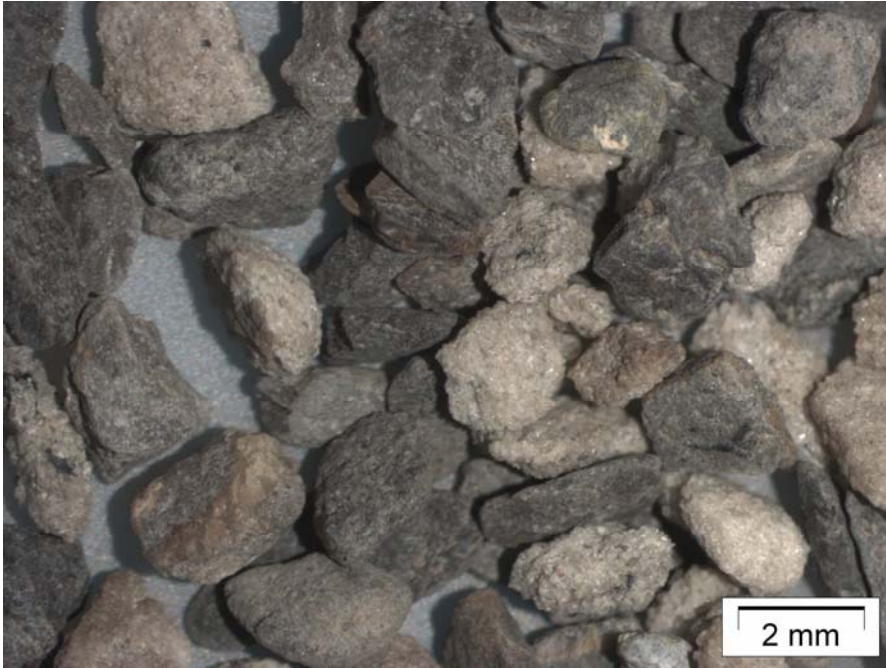
**Figure 1798a**  
*This is an overview of the 1-2 mm fraction. It is evenly divided in sandstone and claystone cuttings. Some sandstone cuttings do have very high porosities.*

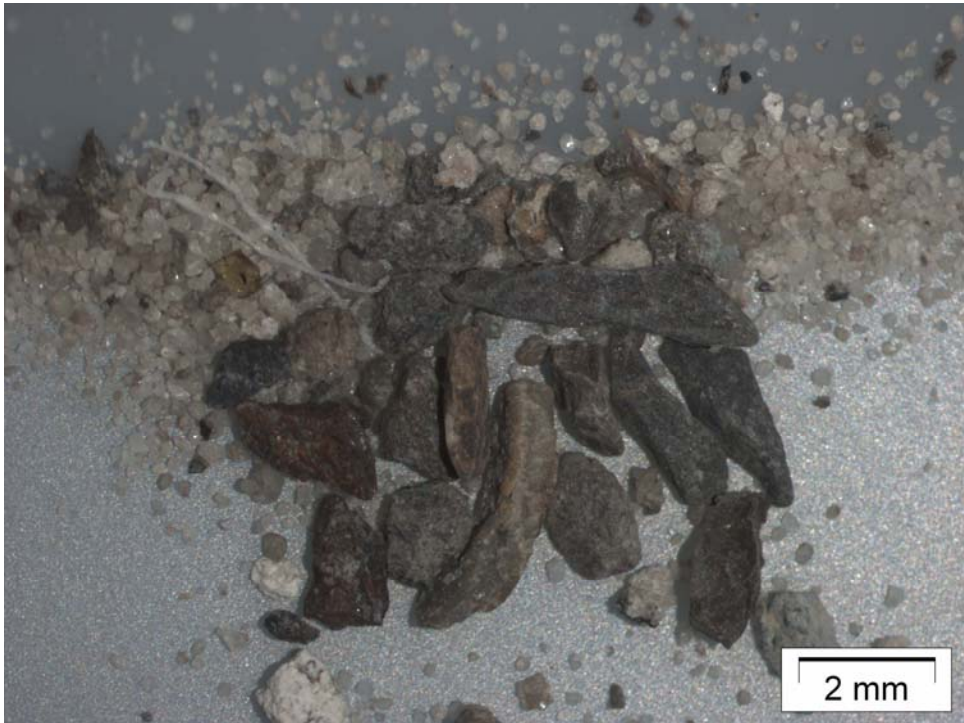
**Figure 1798b**  
*< 1 mm fraction, containing a high amount of loose quartz grains and elongated claystone cuttings.*

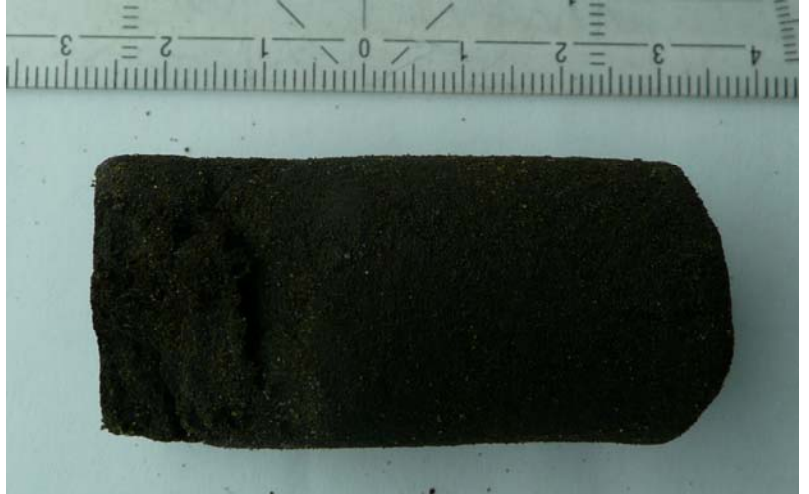
1. 5 cm
2. Some small cracks and a piece came off at one end.
3. Does not look shiny.  
Dark-brown to black
4. Pretty friable, if you touch it some small grains stay behind on you finger.
5. Upper fine.

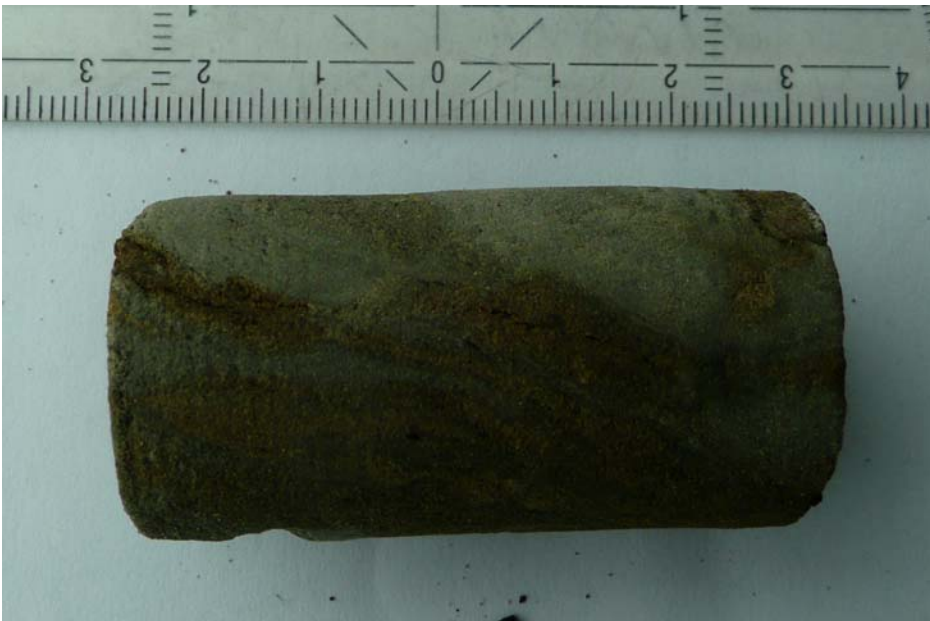
**A02**  
**903.85**

1. 4.5 cm
2. Different permeability zones can be observed by watching at the colors. Darker brown or blackish means more residual oil so a higher perm. There are also medium grey zones, these look cementated or at least not permeable. In both zones carboniferic remains are present.
3. Brown tints to black, medium grey
4. Little friable, the plug is pretty stable.
5. Upper fine

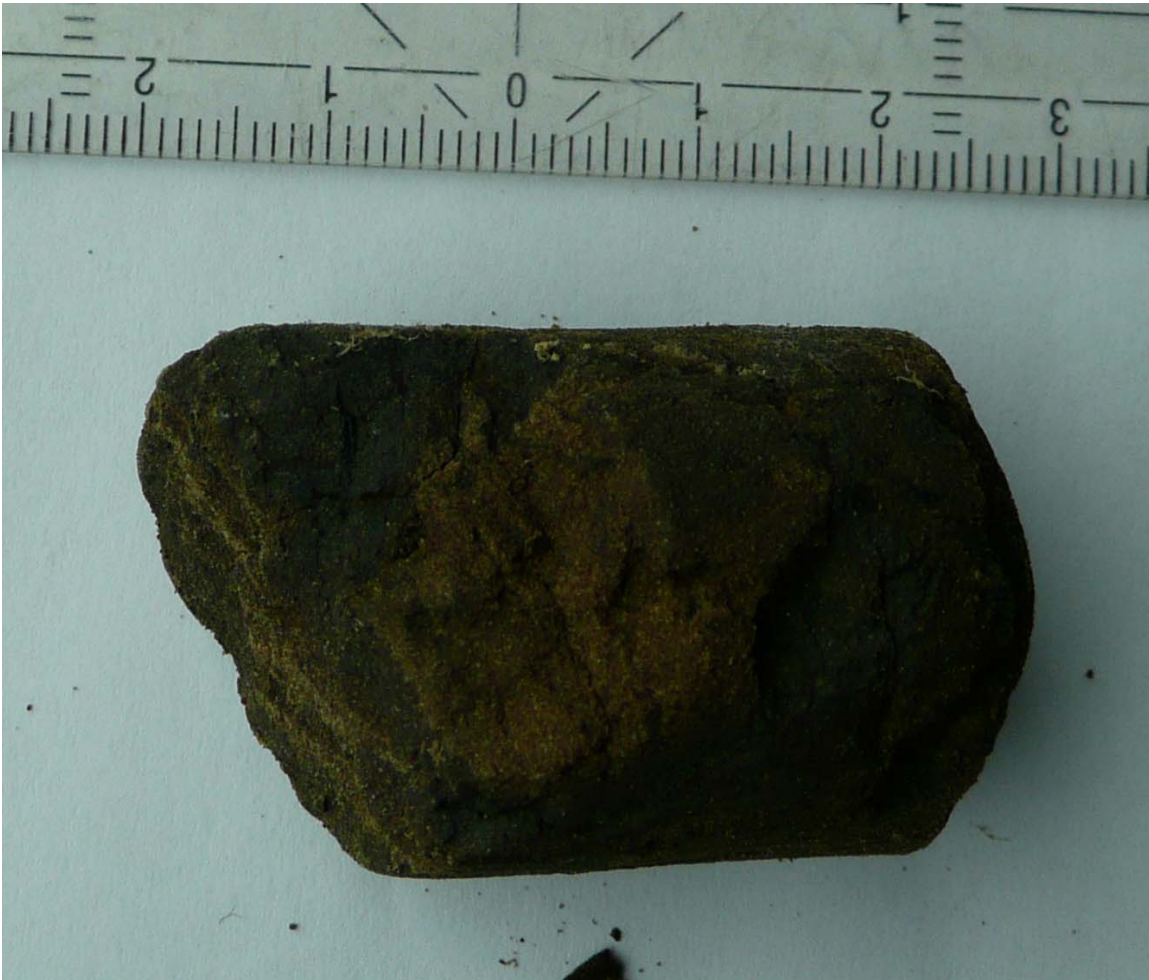
**A03**  
**903.70**

1. 3.5 cm
2. Largely fallen apart, cracks everywhere. Large coal remains spotted (rectangular).
3. Different zones from yellowish brown to black. The zones do not merge into one another but have sharp boundaries.
4. Not really friable, but the sample is weak. A possibility is that the particles are held together by the bitumen which is present in different quantities in the different zones.
5. Upper fine

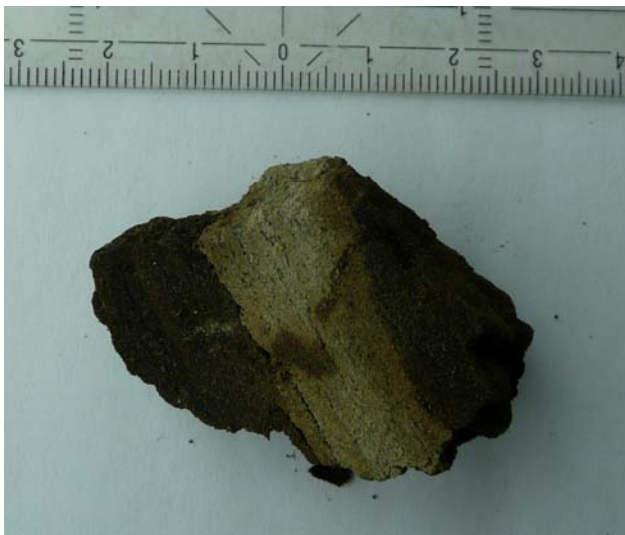
**A04 / 1**  
**903.40**

1. Little chunk of 3x2 cm
2. A dark brown-black sandstone intervened by a layer of light grey material of 1.3 cm thickness. Lots of cracks parallel to transition from brown to grey. Brown blurs in the grey. Light grey consists of very fine particles.
4. Sandstone is friable.
5. Lower fine.

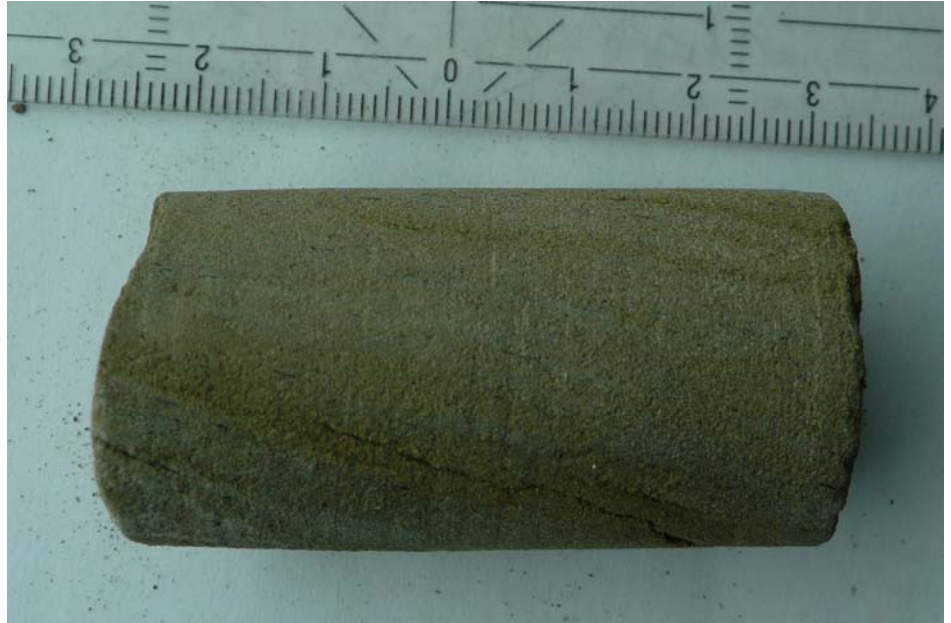
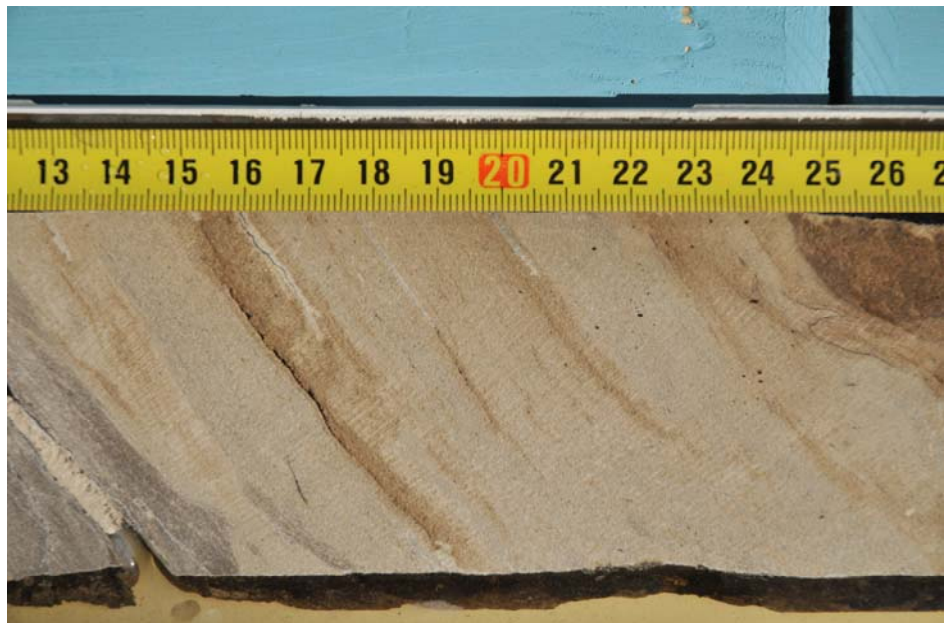
**A07**  
**902.40**

1. 4.8 cm
2. A steep dip in an orientation can be seen if one looks carefully. It is not obvious though, may also look that way because of a crack in this direction. The angle with the plug axis is 20 degrees.
3. Light brown to medium grey colors. Also light grey (possible cemented parts) observed. Coal particles present.
4. Not friable
5. Fine lower
