## FOUNDATION REPAIR

In search of a more cost-effective construction method

This research was initiated by Kenniscentrum Aanpak Funderingsproblematiek.

**Delft University of Technology**

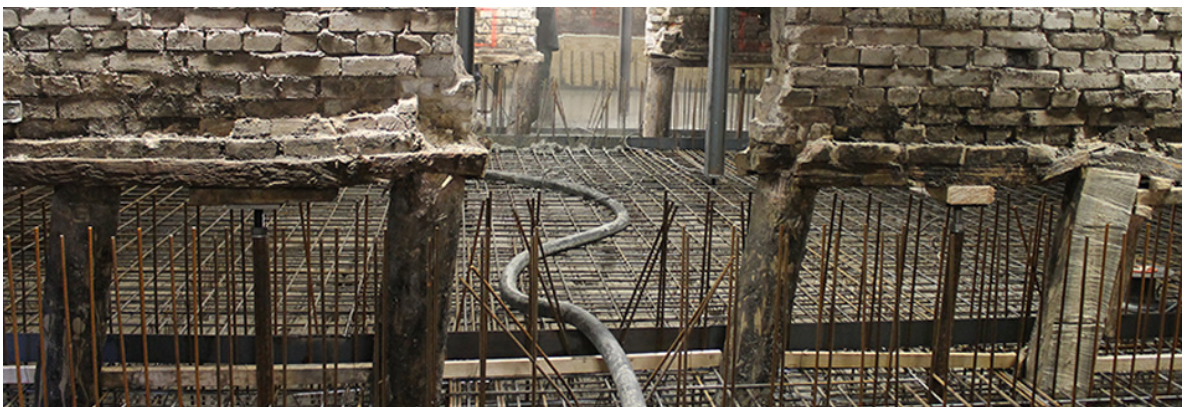
*Figure 1.1.1 Construction of new concrete floor slab on piles (Brefu, 2014).*

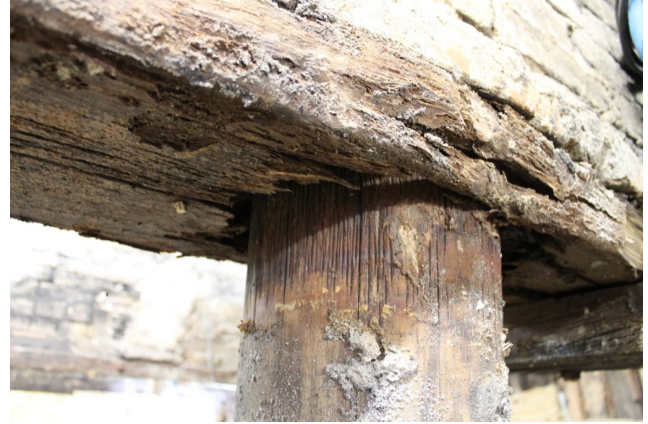
Figure 4.2.2 Rotten pile heads due to decay by fungi (**left**) and rotten head beam punctured by pile head (**top**) (CURNET/SBR, 2007) (Vasiljevski, 2012).

which fungi are the most active. Among wooden pile foundations soft rot fungi is the most liable for the decay of wood. This fungus needs less oxygen to survive than do brown rot and white rot fungi and therefore prosper in wood exposed to soil and water (Bijen, 2003). For wooden pile foundations in the Netherlands mainly pine and spruce were used. They are both equally vulnerable for decay. The degradation stops when the water table is well above the wooden pile foundation again.

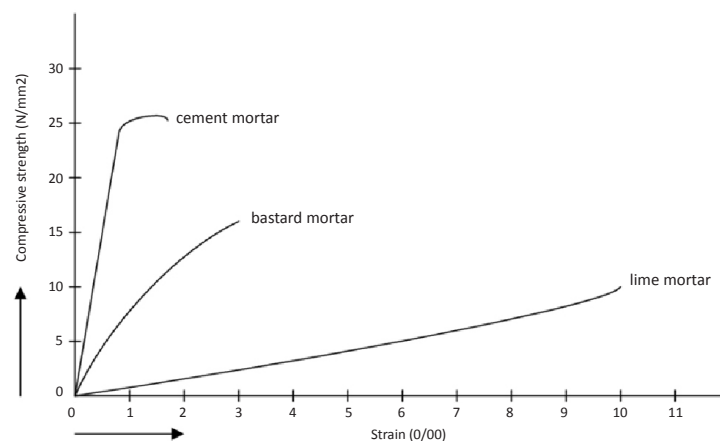
Figure 4.4.1 Stress-strain diagram mortar (Fraaij, 2000).

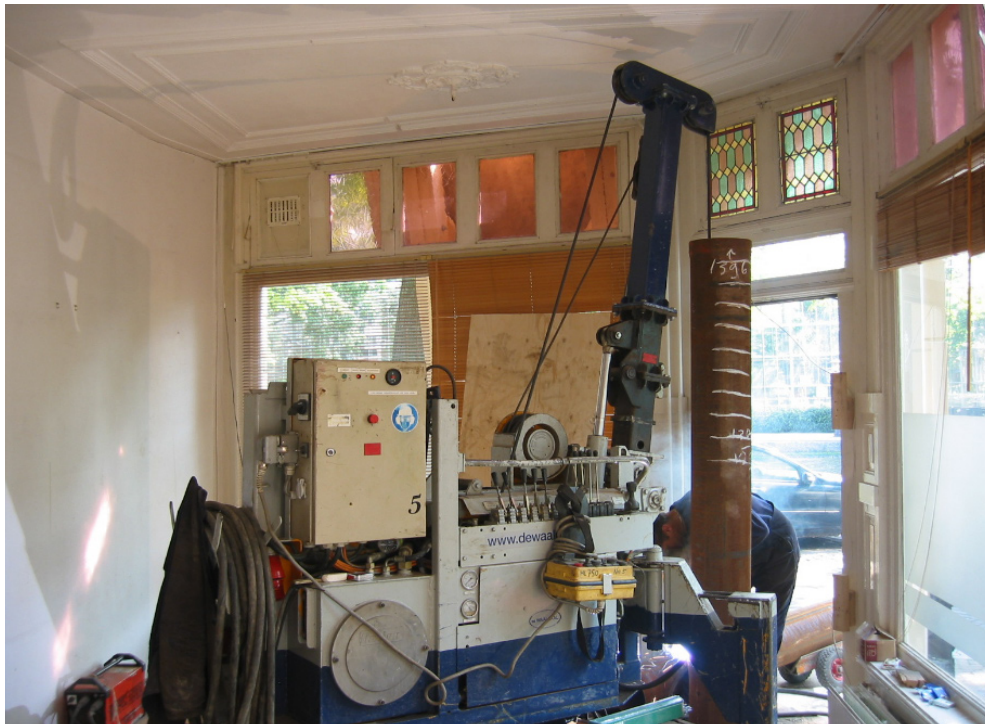
Figure 5.2.2 Bottom driven pile (Waalpaal, 2014).

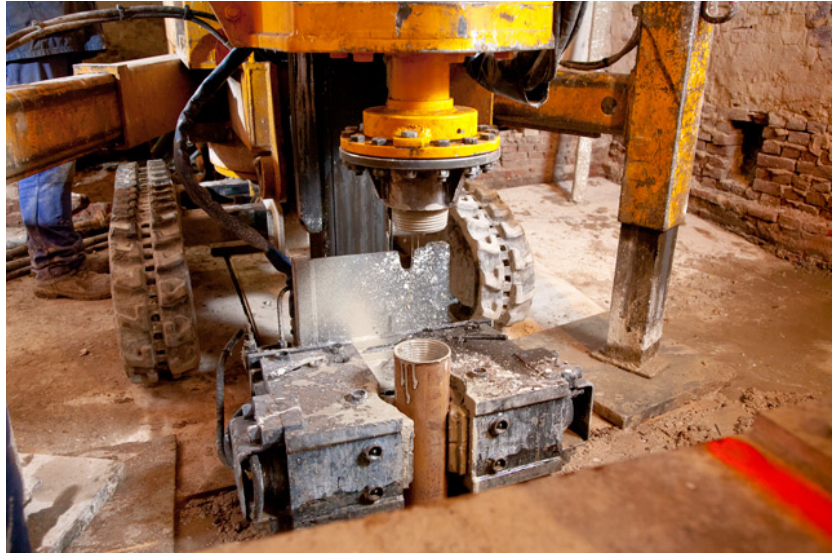
Figure 5.2.3 Screw injection pile (Goorbergh, 2014).

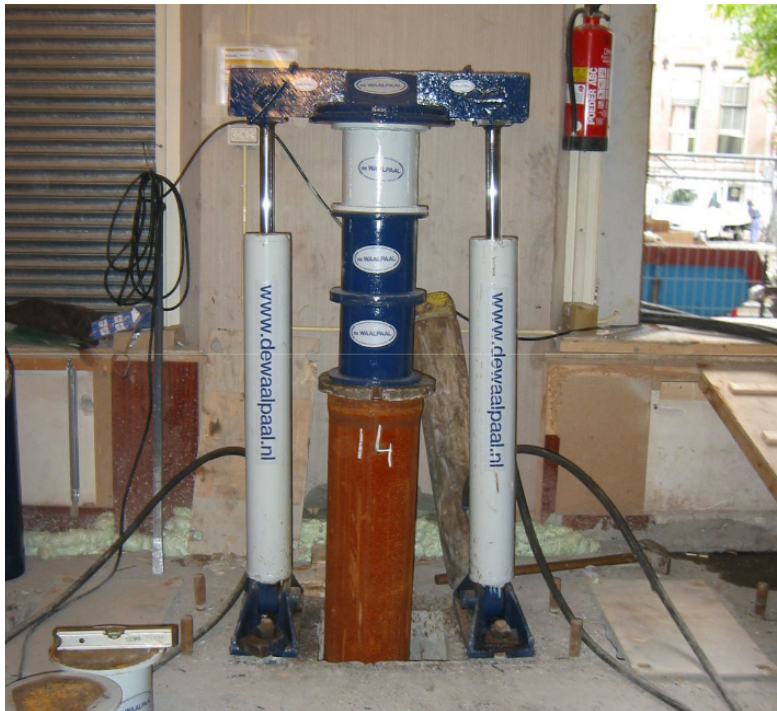
Figure 5.2.4 Jack-down system anchored to the floor (Waalpaal, 2014).
