## A multiscale experimental characterisation of Dutch unreinforced masonry buildings

Messali, Francesco; Esposito, Rita; Jafari, Samira; Ravenshorst, Geert; Korswagen Eguren, Paul; Rots, Jan

Proceedings of the 16th European Conference on Earthquake Engineering

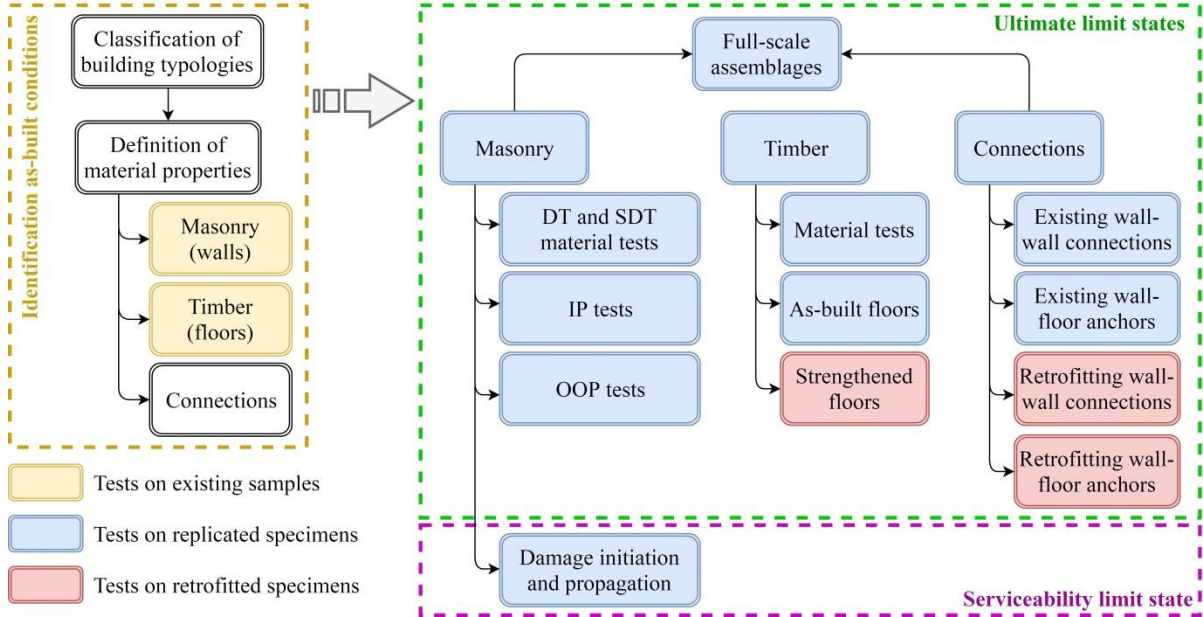
Figure 1. Conceptual diagram of the testing campaign performed at TU Delft laboratory in 2014/17

characterization at material level of masonry and timber samples extracted from existing buildings. The obtained data allowed to select the properties of the replicated masonry that was tested in a second phase to investigate the response with specific focus on the structural behavior up to near collapse (NC). Finally, a third phase, focused on the serviceability limit state to identify the damage initiation and propagation, has been carried out. Figure 1 shows a concept map that represents the connection between the different performed tests.

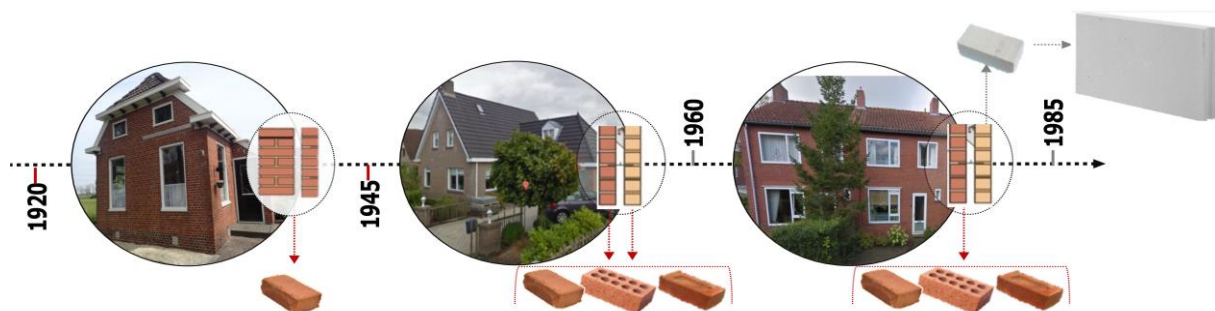
Figure 2. Correlation between different building typologies and construction materials

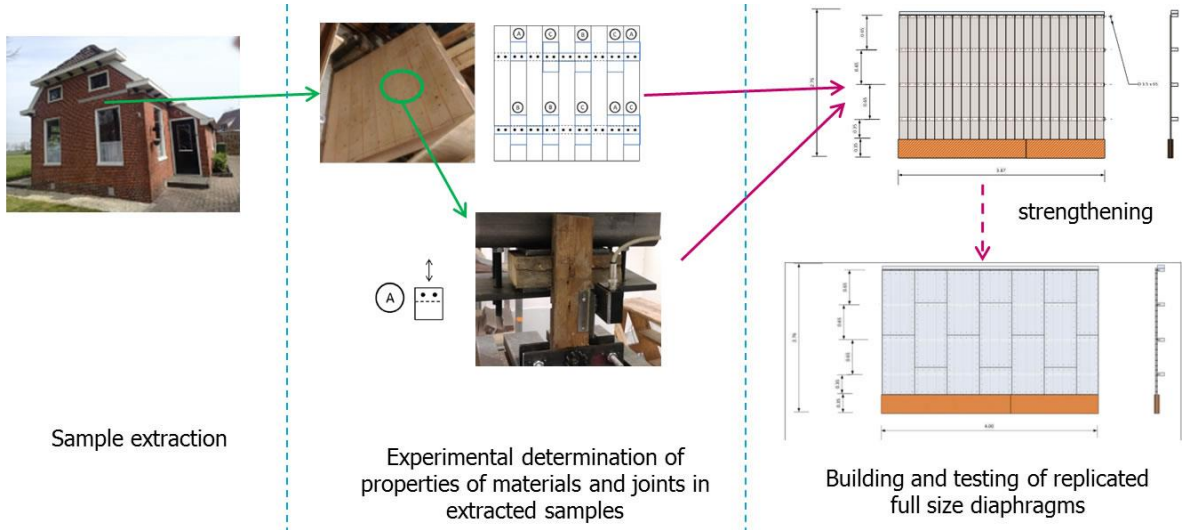
Figure 3. Principle of the procedure from sample extraction to replicated full size timber diaphragms for testing

For timber floors some formulas for basic joists-planks configurations are reported by e.g. Brignola et al. (2008). In Giongo et al. (2011) the influence of different strengthening techniques on timber floors are presented. The stiffness of timber roofs and floors strongly depends on the specific characteristics (sizes of joists and plank, number and diameter of nails and screws) that are traditional in each single region. Due to lack of input data for typical Dutch roofs and floors, samples were extracted from dwellings that were intended to be demolished. Since it was not possible to extract entire roofs it was chosen to cut out squared samples of approximately 1.5m side. The configuration of the samples were then identified and then cut to specimens to be tested at the laboratory of the Delft University of Technology to determine the stiffness and strength of the inner connections. The samples were extracted from two houses representing two typologies: roof and floor samples from a pre-WW2 clay brick detached house, and roof and attic floor samples from a post-WW2 CS brick terraced house. The floors in the detached house consisted of traditional joists and planks, while in the terraced house the floor joists were made with chipboard panels and the roof with roof boxes on purlins. illustrates the procedure followed for a floor sample of a detached house: from the sample extraction to the construction of the replicated full size specimen.

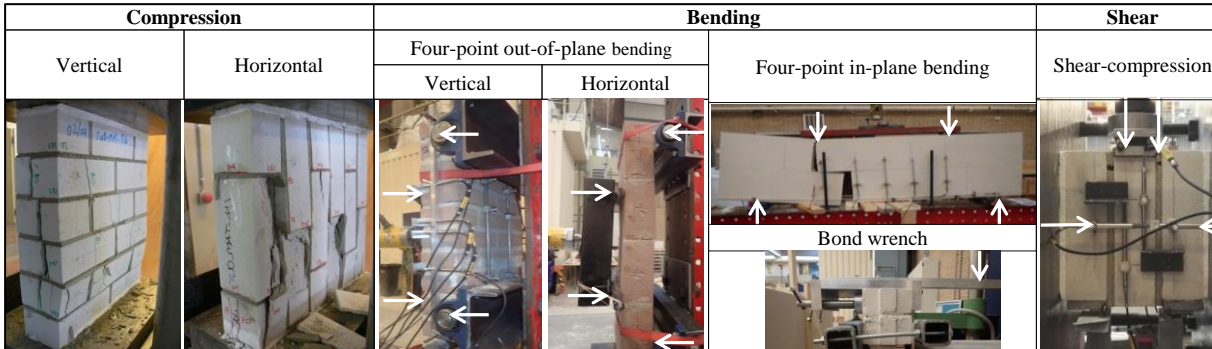
Figure 4. Overview of the destructive tests performed at material level

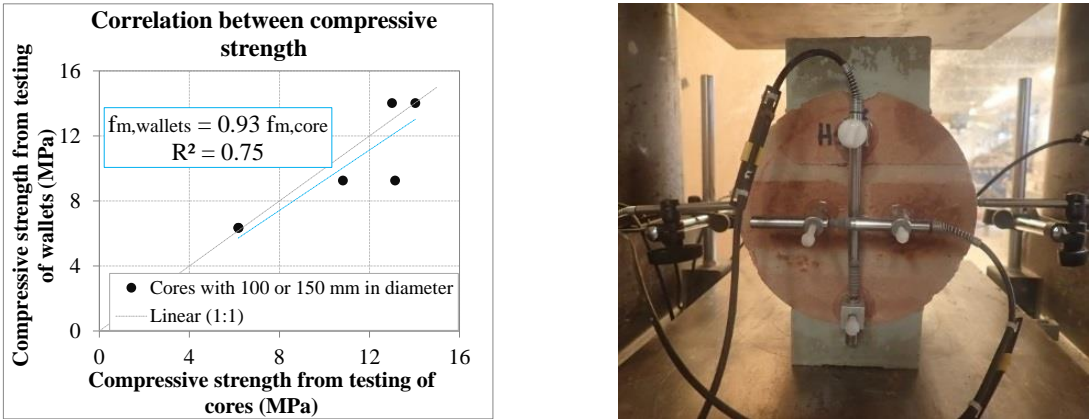
Figure 5. Correlation between the compressive strength derived by core tests and destructive tests on wallets

Besides destructive tests, standardized slightly-destructive tests (single and double flat-jack test, and shove test) as well as of non-standardized slightly-destructive tests (tests on masonry cores with small diameter) were investigated. These tests were performed on replicated masonry specimens in a controlled laboratory environment. By comparing the results obtained from the different destructive and slightly-destructive testing techniques, the suitability of the in-situ tests for the case of Dutch masonry can be investigated (Jafari et al 2018b). Using the standardized slightly-destructive techniques, the stress-state, and the compression and the shear properties of the brick-mortar interface can be assessed without altering the structural integrity of the walls, while non-standardized testing of masonry core allows more direct estimation of the mechanical properties (Jafari et al 2017b). The compression and the shear properties of the brick-mortar interface can be evaluated using the core testing technique. The compressive strength of the masonry cores, and the corresponding values obtained by destructive tests on wallets are shown in Figure 5 (Jafari et al 2018b); a good correspondence can be observed.

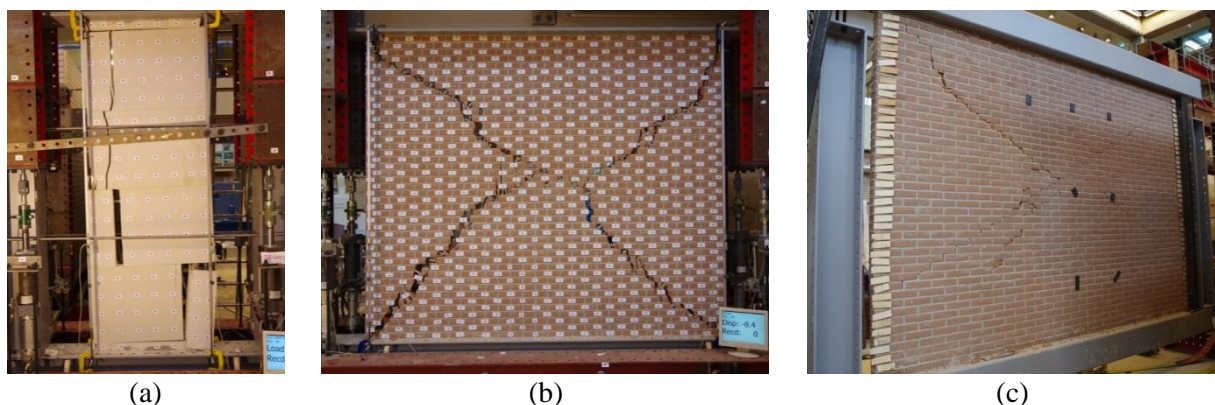
Figure 6. Example of outcomes of in-plane (a,b) and out-of-plane (c) tests performed on URM walls

Thirteen URM walls were tested to study the in-plane behavior of piers under quasi-static loading conditions. The impact of several factors was investigated: aspect ratios (slender and squat walls), boundary conditions (cantilever and fixed-fixed walls), overburden loads (from 0.3 MPa to 0.7 MPa), materials (CS brick masonry, CS element masonry, solid clay brick masonry), type of mortar layers (regular joints and thin mortar layers), thickness of the wall (single and double wythe walls), and openings. The performed tests allow assessing the accuracy of predictions based on simple analytical procedures, included in international standards and guidelines, and provide a suitable dataset of benchmarks to validate numerical models. On the basis of the outcomes of both these tests and of the tests at material level, a new constitutive model for brick masonry has been recently proposed and validated (Rots et al 2016). Figure 6a,b show two examples of the outcomes of in-plane tests performed on a CS element masonry wall and a clay brick masonry wall.

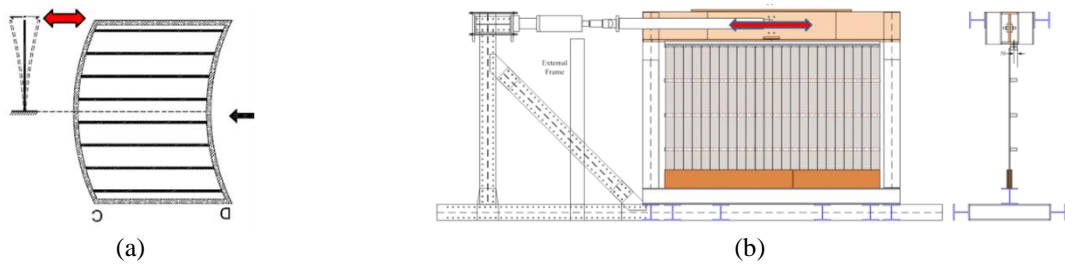
Figure 8. Principle of the mechanical loading of a timber floor based on the displacement in practice (a) and the timber floor in the test set-up (b)

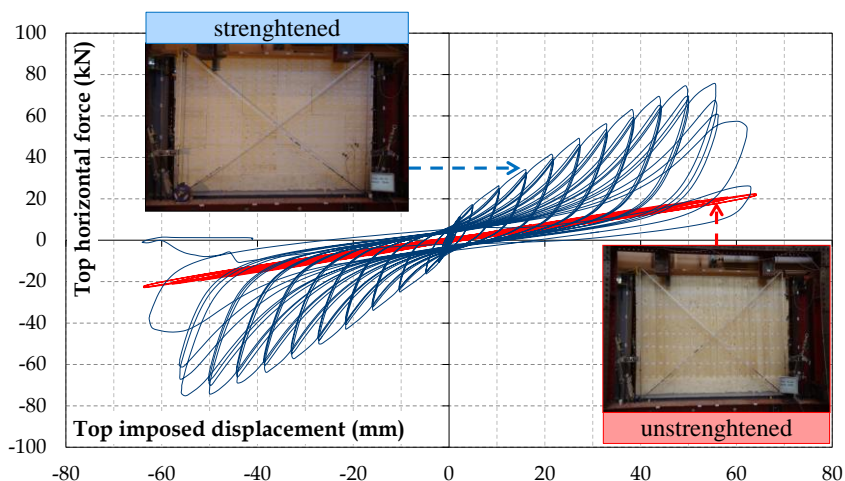
Figure 7. Hysteresis behavior of the unstrengthened and the strengthened timber floor

was made. The floor was not tested up to failure, and it was subsequently strengthened by screwing plywood panels on the planks, and tested up to failure. Figure 8 shows the hysteresis plots of the unstrengthened and strengthened floor. The unstrengthened floor show a limited stiffness and a non-dissipative behavior. The strengthened floor shows a larger capacity, stiffness, and energy dissipation; the pinching effect is clearly visible. The strengthened floor failed at the connection of the plywood panels with the top joist. In most cases in practice the unstrengthened floor will not be stiff enough to take up seismic loads, whereas with a relative simple strengthening technique this is possible.

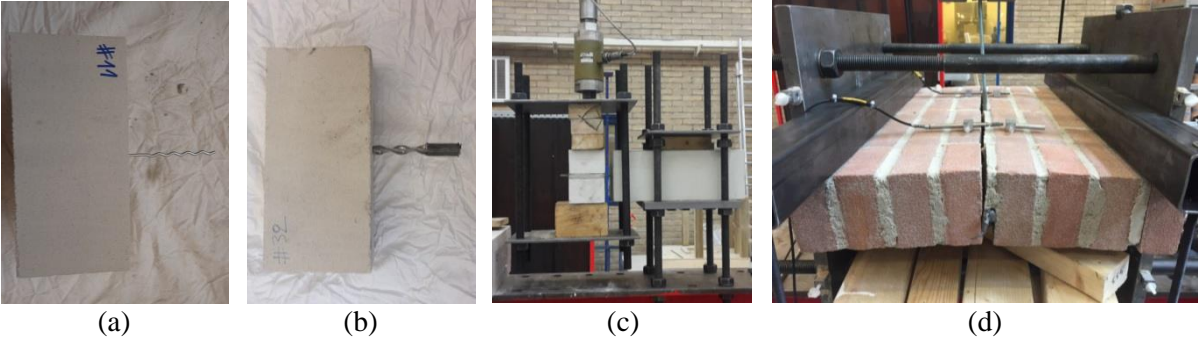
Figure 9. Existing (a) and retrofitting (b) wall-wall anchors. Tests on existing (c) and retrofitting (d) wall-floor connections

Previous experimental campaign investigated the connections in cavity walls throughout tests at component level (Mertens et al 2014) or on full scale structures (Walsh et al 2015), for both existing and retrofitting ties (Giaretton et al, 2016). In the current campaign, both existing replicated and retrofitted wall-wall and wall-floor connections were tested. A detailed description of the tests on existing wall-wall connections is presented in Skroumpelou et al (2018). As for the wall-wall anchors, both axial and shear capacity of the connection was studied. The specimens representing the existing connections consisted of brick couplets including a wall tie embedded in the mortar joint (Figure 9a),

whereas the retrofitted ties (Helifix bars) were drilled directly in the bricks (such as in the common engineering practice, Figure 9b). These tests allowed for a complete mechanical characterization of the connections in static conditions, providing benchmarks to calibrate and validate specific numerical models. As regards the wall-floor anchors, only connections to concrete floors were investigated. For the existing connections, the anchorages consisted of steel threaded rods, and reproduce the connection between the masonry piers and the concrete floors, that typically span directly between the long transversal walls of a terraced house and are hence not supported by the pier. This anchoring typology (an example is shown in Figure 9c) is extremely efficient against the out-of-plane failure of the piers, but negligible shear forces can be transferred for small deformations. As for the retrofitting connections, a tailored system was tested for tensile axial loads only (Figure 9d). The system was composed of a threaded bar connected to two Helifix bars embedded in a mortar bed joint, and in real buildings may be coupled to a dissipative system that is able to withstand the compressive actions. The performed tests allowed to assess whether this type of connections is able to retain efficiently the out-of-plane failure of walls by transferring the reaction forces at the floor level. For every test typology, various levels of axial precompression were considered, in order to assess the component behavior in different locations in the building.

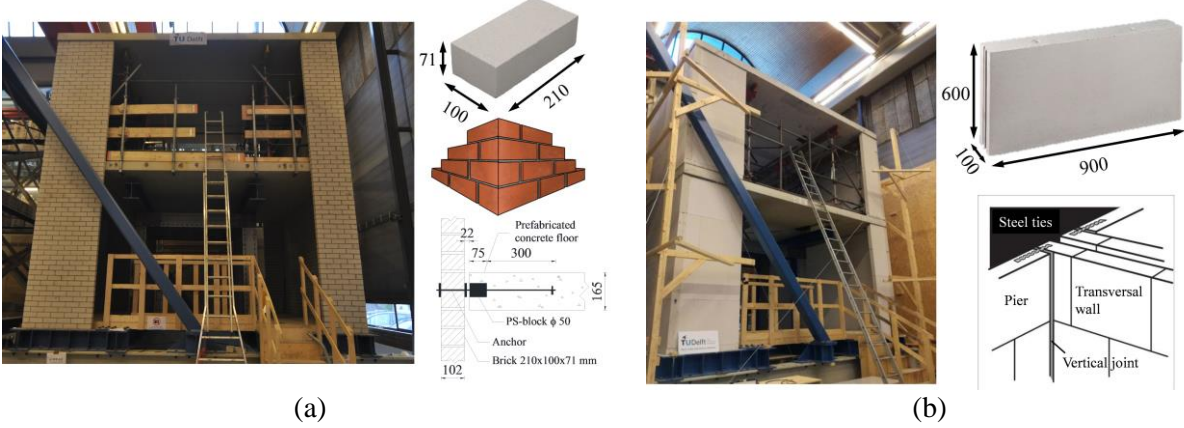
Figure 10. Full-scale assembled structures made of CS brick (a) and element (b) masonry

Quasi-static cyclic pushover tests on full-scale assembled structures resembling typical Dutch terraced houses have been performed. The specimens represent only the loadbearing part of a single terraced house unit (Esposito et al. 2017, Esposito et al. 2018), which is usually a two-story high building composed of rigid concrete floors and cavity walls. To represent both the construction period 1960-80 and the period 1980-2000 (Figure 2), CS brick masonry and CS element masonry were used, respectively (Figure 10a,b). As expected, the structural response was mainly linked to the in-plane damage of the wider piers, which showed extensive damage at the ground floor (Figure 11a,b,c).

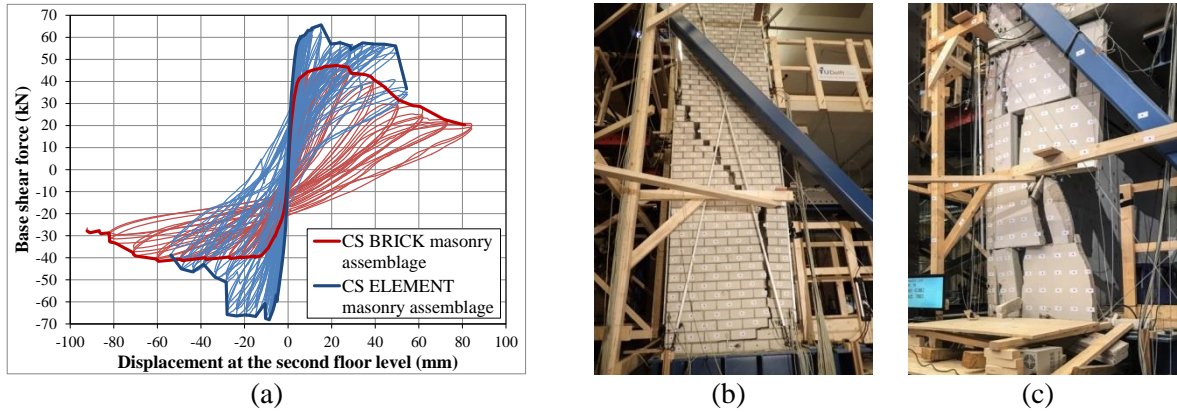
Figure 11. Test on full-scale assemblages: hysteretic behavior (a) and main failure mechanism (b,c)

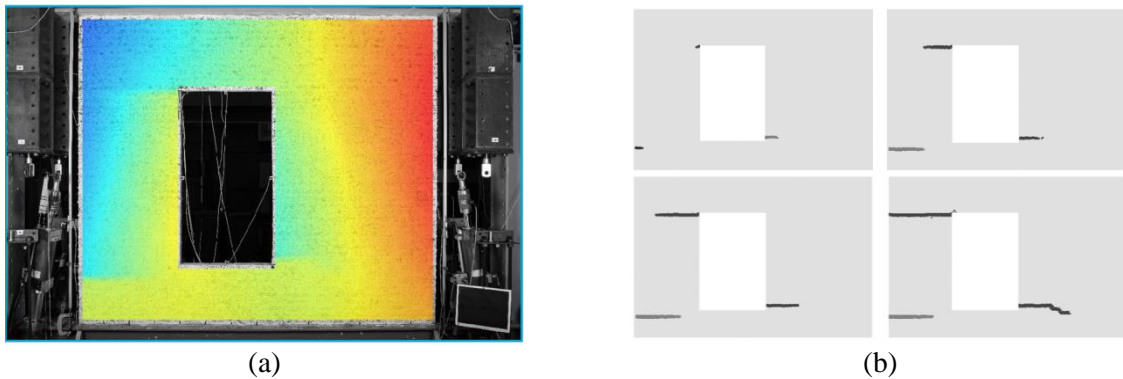
Figure 12. Actual laboratory setup with an overlay of DIC vertical displacement for a lateral top displacement of 2mm (a), and Sequence of crack propagation for different cycles in the test (b)

where  $c_i$  is the maximum crack width of each crack and  $L_i$  is the length of each crack. Equation 1 is tailored such that a value of 1 corresponds to cracks of around 0.1mm, that is considered the threshold at which cracks can be detectable by naked eye. Larger cracks up to 1mm receive a value of 2 and are easy to address, commonly requiring repainting of the walls. Cracks up to 5mm, which will require repointing and repainting, obtain a score around 3. Cracks larger than 5mm typically require additional repair work and were deemed to be outside of the scope of light damage and correspond to more severe and structurally-compromising damage. Not only the width, but also the number and length of the cracks influence the exact damage value computed with equation 1. The use of this strict definition allows for an objective and quantitative comparison between various laboratory samples and numerical models. Moreover, the progression of damage due to repeated or different loading cycles can be assessed directly. In the scope of service-level damage, also exploratory tests have been conducted with the goal of elaborating fragility curves for the initiation of damage for various types of masonry material and building typologies (see section 2). These tests aim to provide a first view into the initiation of (light) damage and its evolution. Five in-plane tests on windowed walls made of single wythe solid clay brick masonry were tested. To detect the initiation and propagation of cracks in the masonry walls, Digital Image Correlation (DIC) was used by painting a random pattern on the wall and capturing high-resolution images with a camera (Didier 2017). The images were later processed to obtain the displacement field of the wall (Jones, 2015) at different test cycles (Figure 12a). The

displacement field was further analyzed to identify and characterize the cracks (Figure 12b), the damage parameter  $\Psi$  was computed automatically and related to the top lateral displacement of the wall expressed as drift. Based on these results, drift values between 0.3‰ and 1.1‰ seem to correspond to aesthetic damage for the tested wall (Figure 13).

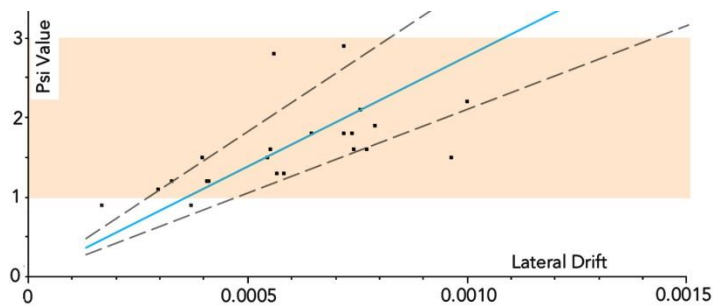
Figure 13. Linear regression of results for the damage parameter ( $\Psi$ ) against lateral drift of masonry test walls, highlighting the zone corresponding to aesthetic damage. Dashed lines indicate one standard deviation
