# Comparing overflow and wave-overtopping induced breach initiation mechanisms in an embankment breach experiment

**Abstract.** As part of the SAFElevee project Delft University of Technology collaborated with Flanders Hydraulics Research, and Infram B.V. in the preparation and execution of a full scale embankment breach experiment in November 2015. This breach experiment was performed on an 3.5m high embankment with a sand core and clay outer layer situated along the tidal river Scheldt in Belgium near Schellebelle. During the experiment a wave overtopping simulator and overflow simulator were used to initiate a breach. Both simulators were placed near the top of the waterside slope. The use of the simulators facilitated comparison between the effects of continuous overflow and the effects of intermittent wave overtopping. This paper presents the data collected during the experiment, describe the development of hypotheses on the failure processes using the latest insights, and comment on the failure initiation process of a grass covered flood embankment with a clay outer layer and a sandy core.

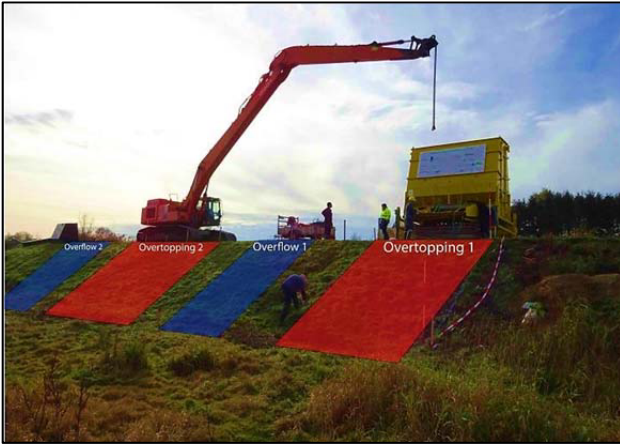
**Figure 1.** Overview test locations on embankment.

Over an approximate 50m long stretch of embankment, two tests were performed on breach initiation due to wave overtopping using the 4m wide wave overtopping simulator developed by Van der Meer [5], [6][7]. Also two breach initiation experiments had been performed using a 2m wide overflow simulator developed specifically for this experiment by Delft University of Technology. An overview of the test sections has been depicted in Figure 1.

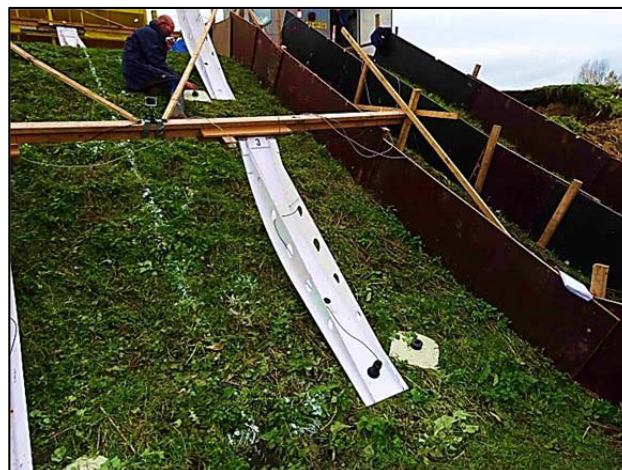
**Figure 2.** Setup for performing hydraulic measurements during wave overtopping tests.

To assess the roughness parameters on the embankment, hydraulic measurements were performed with waves of respectively 500, 1000, 1500, 2000, 2500, 3000, and 3500 l/m. During the hydraulic measurements the flow velocities were continuously measured at the bed and surface of the waves using paddle-wheels. To measure the change in depth profile of a wave over time, a surf-board like construction was used (see Figure 2). The

water depth was derived from measuring the change in angle of the surfboards when a wave passed under it. The paddle-wheels were placed near the downstream tip of the surfboard, both in the embankment surface and on the tip of the surfboard. This way both the flow velocity at the bed and at the surface could be measured. The front velocity of the wave was derived by measuring the time lapse in signal from the surfboards and the known distance between two surfboards.

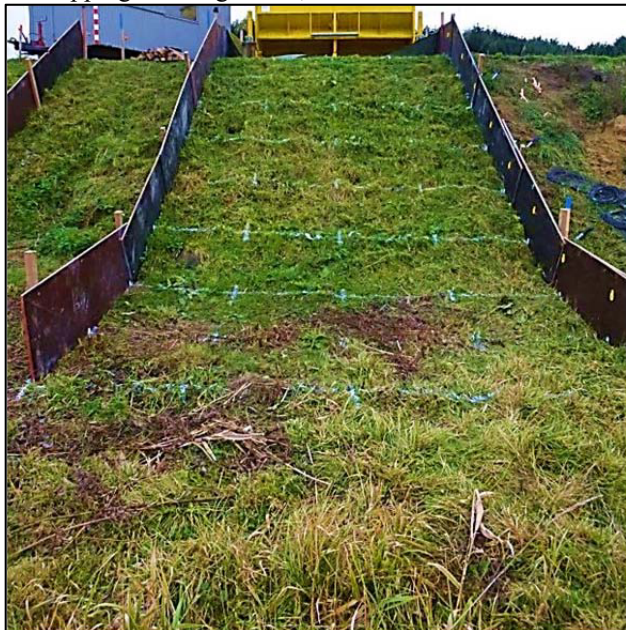
**Figure 3.** Overview picture taken prior to the first wave overtopping experiment

Prior to the tests the embankment was divided into 1x1m quadrants (see Figure 3). The first quadrant (1A) started on the far left hand side of the outflow point of overtopping simulator. The flow channel was 4m wide. Across, it was divided into Sections A through D with A being on the left hand side looking upstream. In total 11 cross sections were created. During the first test cross sections 1, 2, and the first half of cross section 3 were fully covered with a plastic sheet to prevent erosion of the gravel road. Between the end of the plastic sheet and the top of the landside slope some flattened grass cover was present. On the landside slope several stones were present. In Section 4A a small hole was visible. In cross sections 6A and 8C stones were visible from the surface. In section 7 the nettles and moss were visible. In general the grass cover was not nice and smooth but represented a rough surface. Characteristic of the behaviour of grass under the wave loading was that every time the wave had passed the grass bounced back into an upright position. This could therefore have contributed to a higher roughness experienced by the waves and hence higher shear stresses.

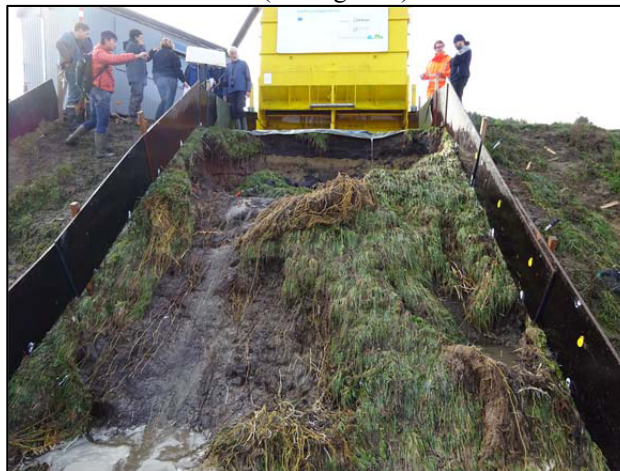
**Figure 4.** Overview picture taken at the end of the 25 l/m/s tests at the first test section

site. At the end of the 10 l/m/s test, the hole had grown to approximately 0.5m deep. During the 25 l/m/s the hole in on the slope increased in size. After 3 minutes, part of the grass cover came loose near the hole. After 12 min the sand layer was reached in the hole. Once the sand layer was reached a trench developed due to erosion downstream of the hole (see Figure 4)

Simultaneously headcut erosion caused for the upstream progression of the hole. The sand under the clay layer acted reasonably cohesive maintaining near vertical slopes. The processes observed during the retreat of the landside slope were similar to the underwater breaching process as observed during dredging at sand pits. Here the dilation of sandy soil due to water infiltration in combination with the reduction of negative pore pressures determine the rate of erosion and prevent large scale slope failures from occurring.

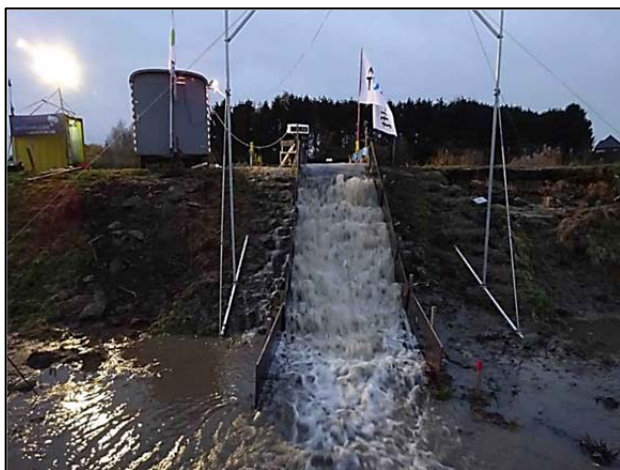
Figure 6. Observed aerated flow during the overflow experiment

Due to limitations in the minimum allowable frequency at which the pump could be operated, tests with the overflow simulator started at 10 l/m/s, followed up by 25, 50 l/m/s and 85 l/m/s. Contrary to expectations, the damage that occurred to the grass cover at overflow discharges of 50 l/m/s and 85 l/m/s was negligible. Instead of the theoretical nice smooth flow of constant density, during all overflow tests the flow became highly aerated down the landside slope (see Figure 6). This could be of influence to the spatial velocity distribution down the slope. Between changes in the discharge the flow was stopped during which became apparent that contrary to the behaviour of grass during wave overtopping the grass cover remained in a flattened position and did not bounce back upwards. Another noticeable, and potentially important observable difference with the wave overtopping tests, was that during overflow the reattachment point of the flow was closer to the crest than during wave overtopping. The normal impact at the reattachment point is therefore also expected to be smaller during overflow than during wave overtopping. These differences with wave overtopping could potentially help in better explaining the difference in timing in failure initiation of the grass cover.
