THE JACOBUSKERK

WINTERSWIJK

Heritage and Design Analyses Jacobuskerk Winterswijk
Heritage & Architecture
November 4th, 2019

Heritage & Architecture

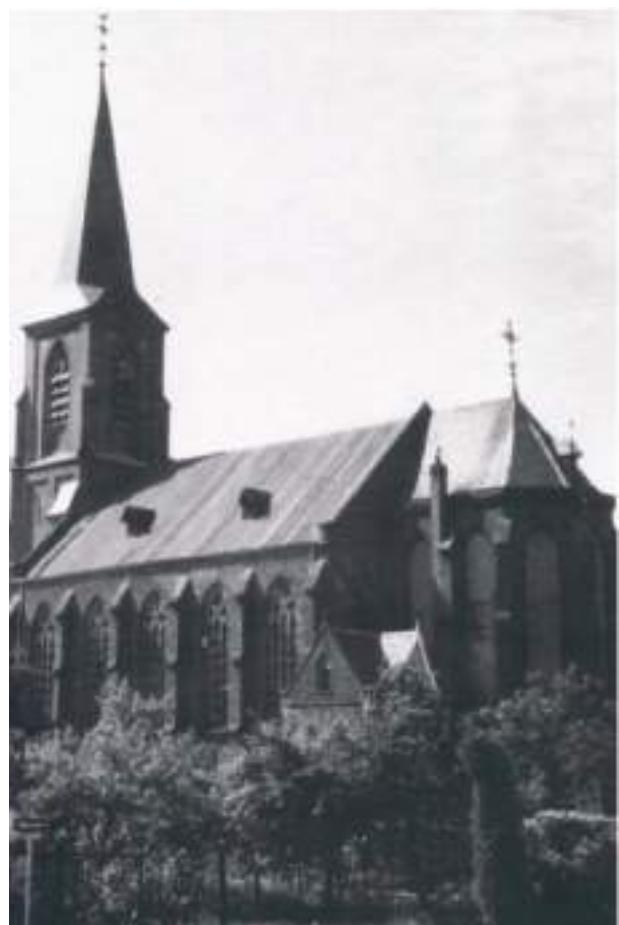
Figure 4 The Jacobuskerk before the extension with the narrow choir and the big pointed archi windows. (Meerdink, 1995, p. 31)

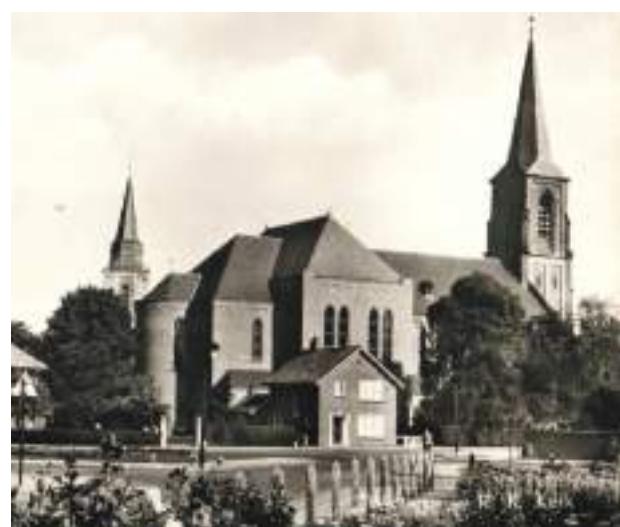
Figure 6 The Jacobuskerk after the extension with the new choir (Meerdink, 1995, p. 39)

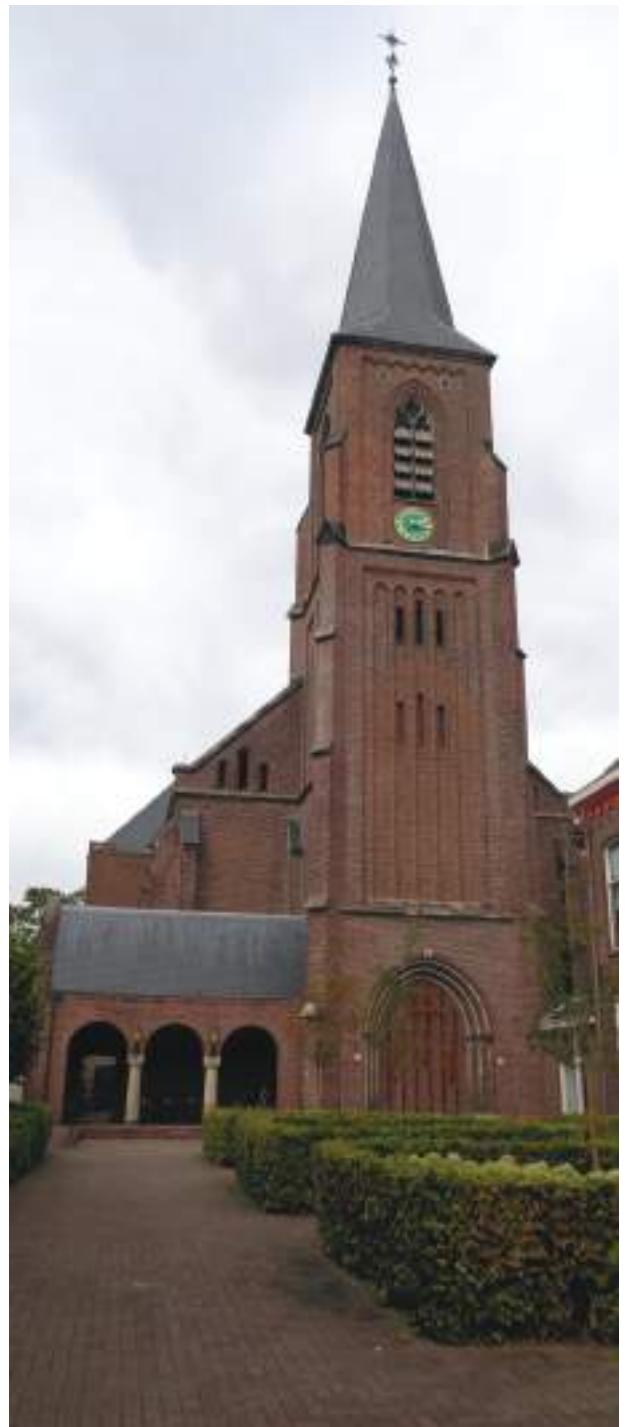
Figure 8 The Jacobuskerk, a front view with the canopy of 1856 visible, and the rectory connected to the church.

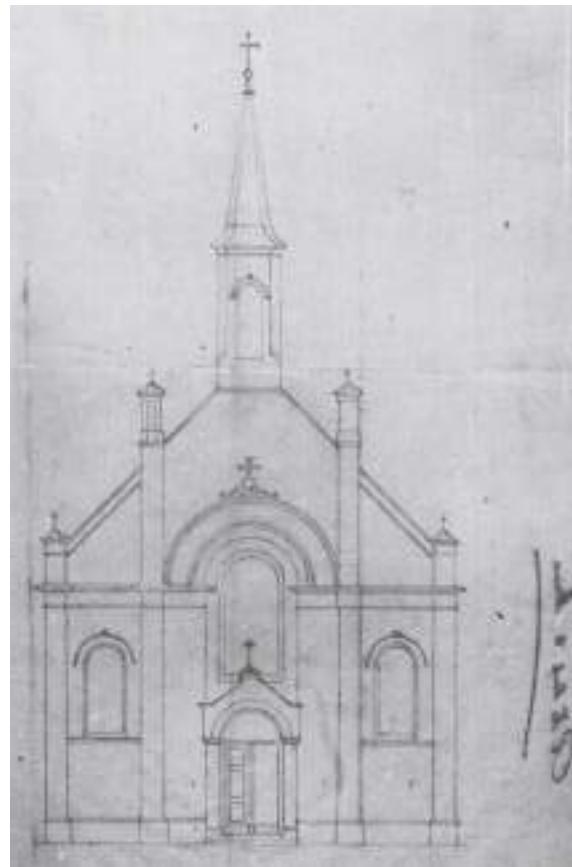
Figure 11 Facade drawing for the church of Heino (Looijenga, 1991, afb 63)

The church of Heino in 1856 was probably his first church design. This church was still more or less in the style of the neoclassicism, which was the main style for churches before neogothic. It had neoclassicist details such as pilasters and a simple barrel vault. The shape of the hall is typical for the influence of the Waterstaat engineers. Something very unusual is the arch resting on the horizontal bands in the upper part of the facade. (Looijenga, 1991, p. 196-198)

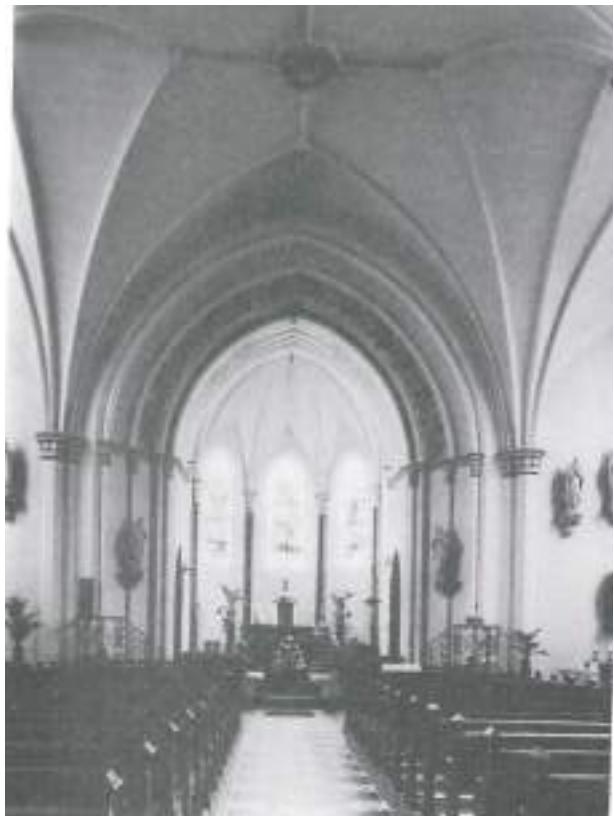
Figure 13 The nave looking at the choir in the church of Olst (Looijenga, 1991, afb. 73)

In this church early neogothical details are seen but it is not that "neogothical" yet. A type of cross rib vaults are used, made of wood and stucco. The windows are pointed arch windows, but they are still quite small. Something very unique is the triumph arch toward the choir. (Looijenga, 1991, p. 202-209)

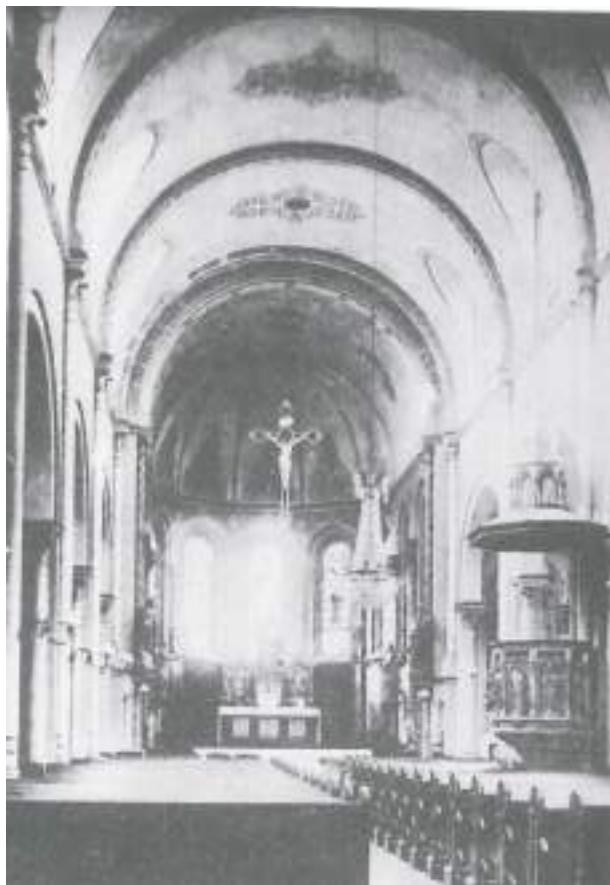
Figure 15 The barrel vault nave of the church of Joure (Looijenga, 1991, afb. 101)

Wennekers didn't work only in neogothic, the church in Joure is an example in neoromanesque style. Striking is the tower with the round arches and ceiling structure with barrel vaults is neoromanesque style. Other neoromanesque designs were for the church of Doetichem and Steenderen. (Looijenga, 1991, p. 243-247)

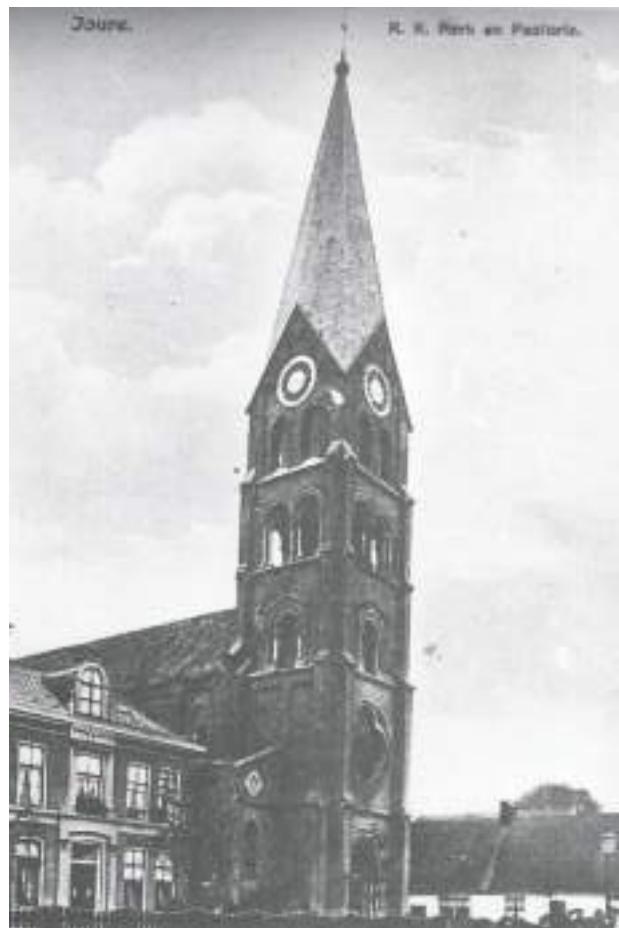
Figure 16 The tower of the church of Joure, with its round arches (Looijenga, 1991, afb. 100)

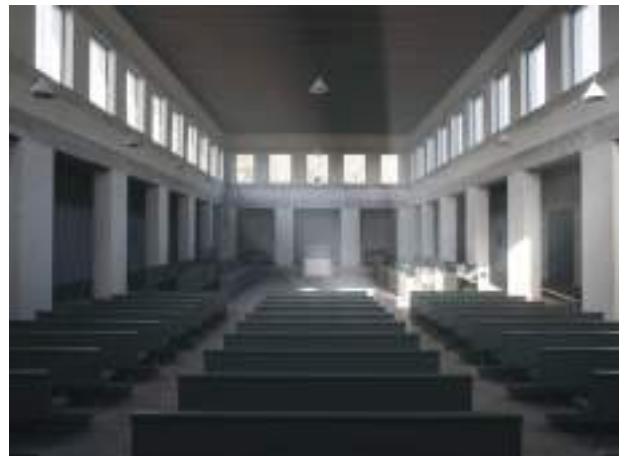
Figure 24 The interior of the abbey of Vaals shows the ortagonality and the rhythms.

This style influenced catholic church construction and originated just after WWII. A main figure in this style was Hans van der Laan. Dom (monk) Hans van der Laan studied architecture in Delft for a few years and realised some buildings. He developed a theory on rhythm and proportion in space and elements called "the plastic number". In the Bossche school they also looked at early Christian architecture like romanesque and Byzantine architecture. Essential for this tradition was a three year study in Den Bosch in religious architecture, where among others Hans van der Laan also taught. Buildings in this style are often orthogonal, quite sober and built of mainly brick, wood and concrete. An example is the abbey in Vaals of 1968 (Melchers, 1965, p. 57-58, 103-106)

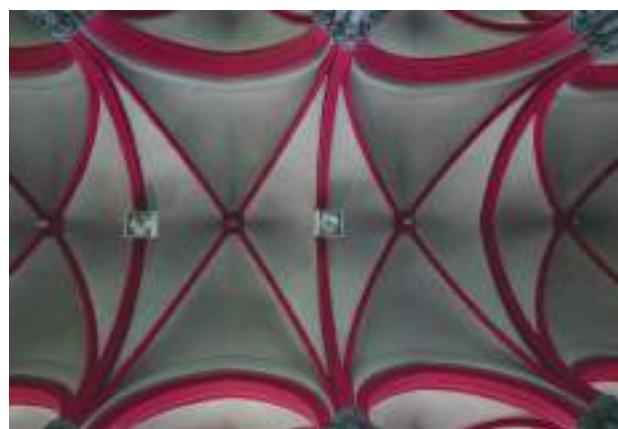
« Image 31 Neogothical elements in the Jacobuskerk, for example the vaults

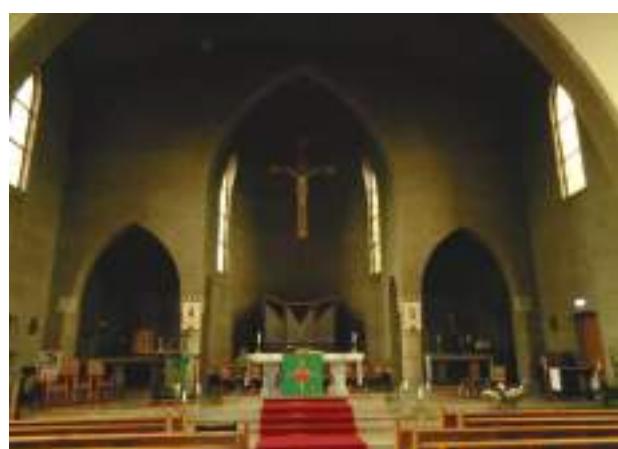
« Image 32 The neoromanesque extension

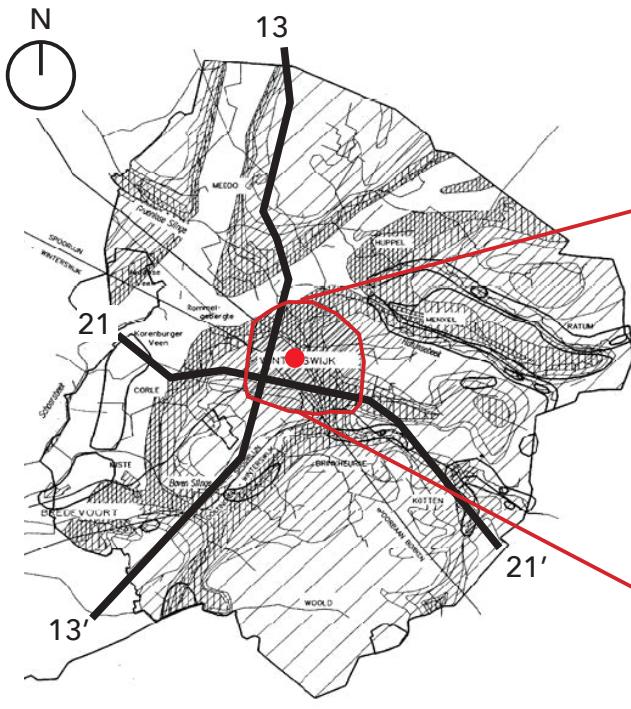
The sandy ground provides a strong layer for buildings. Both the jacobuskerk and the Jacobskerk are built on this strong sand-layer (image x)

Figure 44 Depth of sand layers – municipality Winterswijk (Gemeente Winterswijk, 2009)

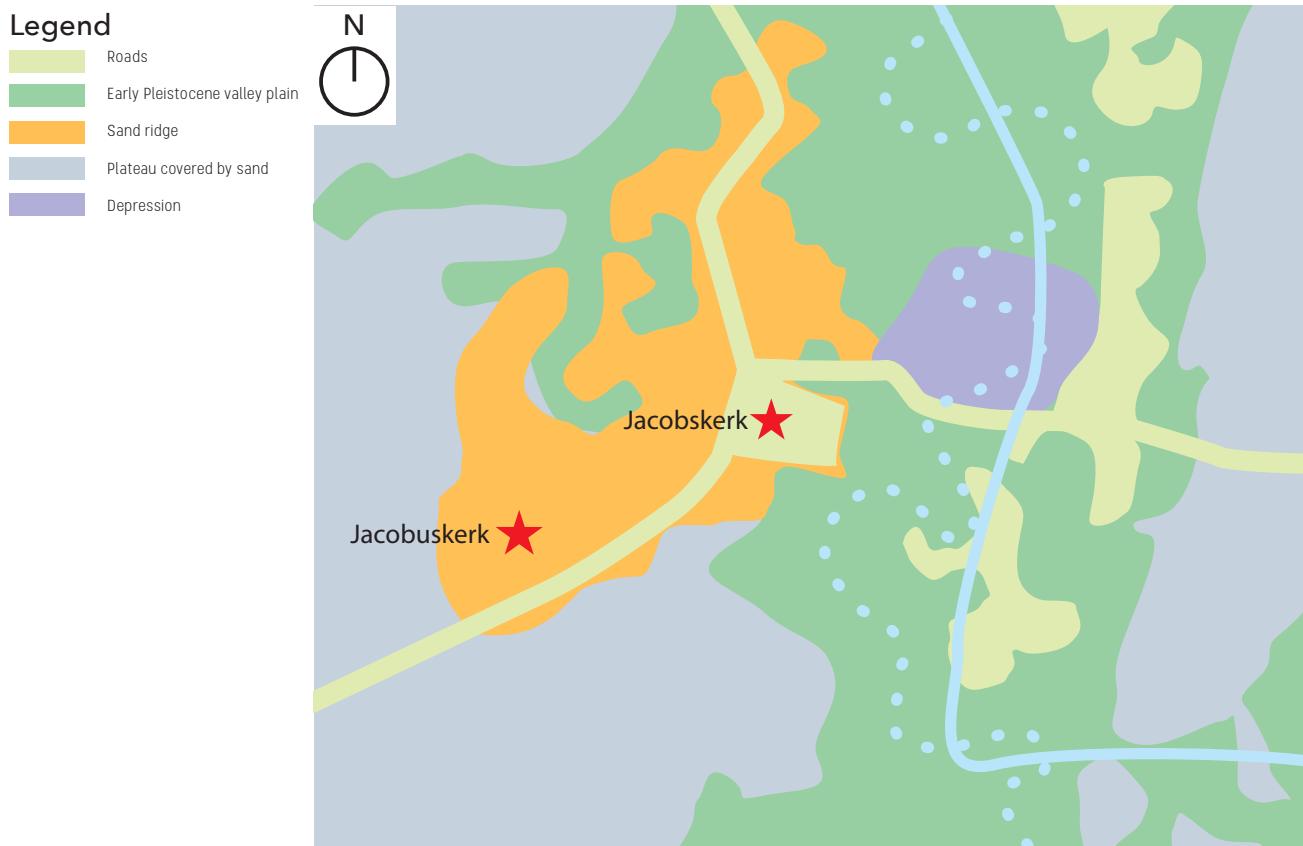
Figure 47 Ground layers center Winterswijk (Cultuurhistorische Atlas Winterswijk, 2009)

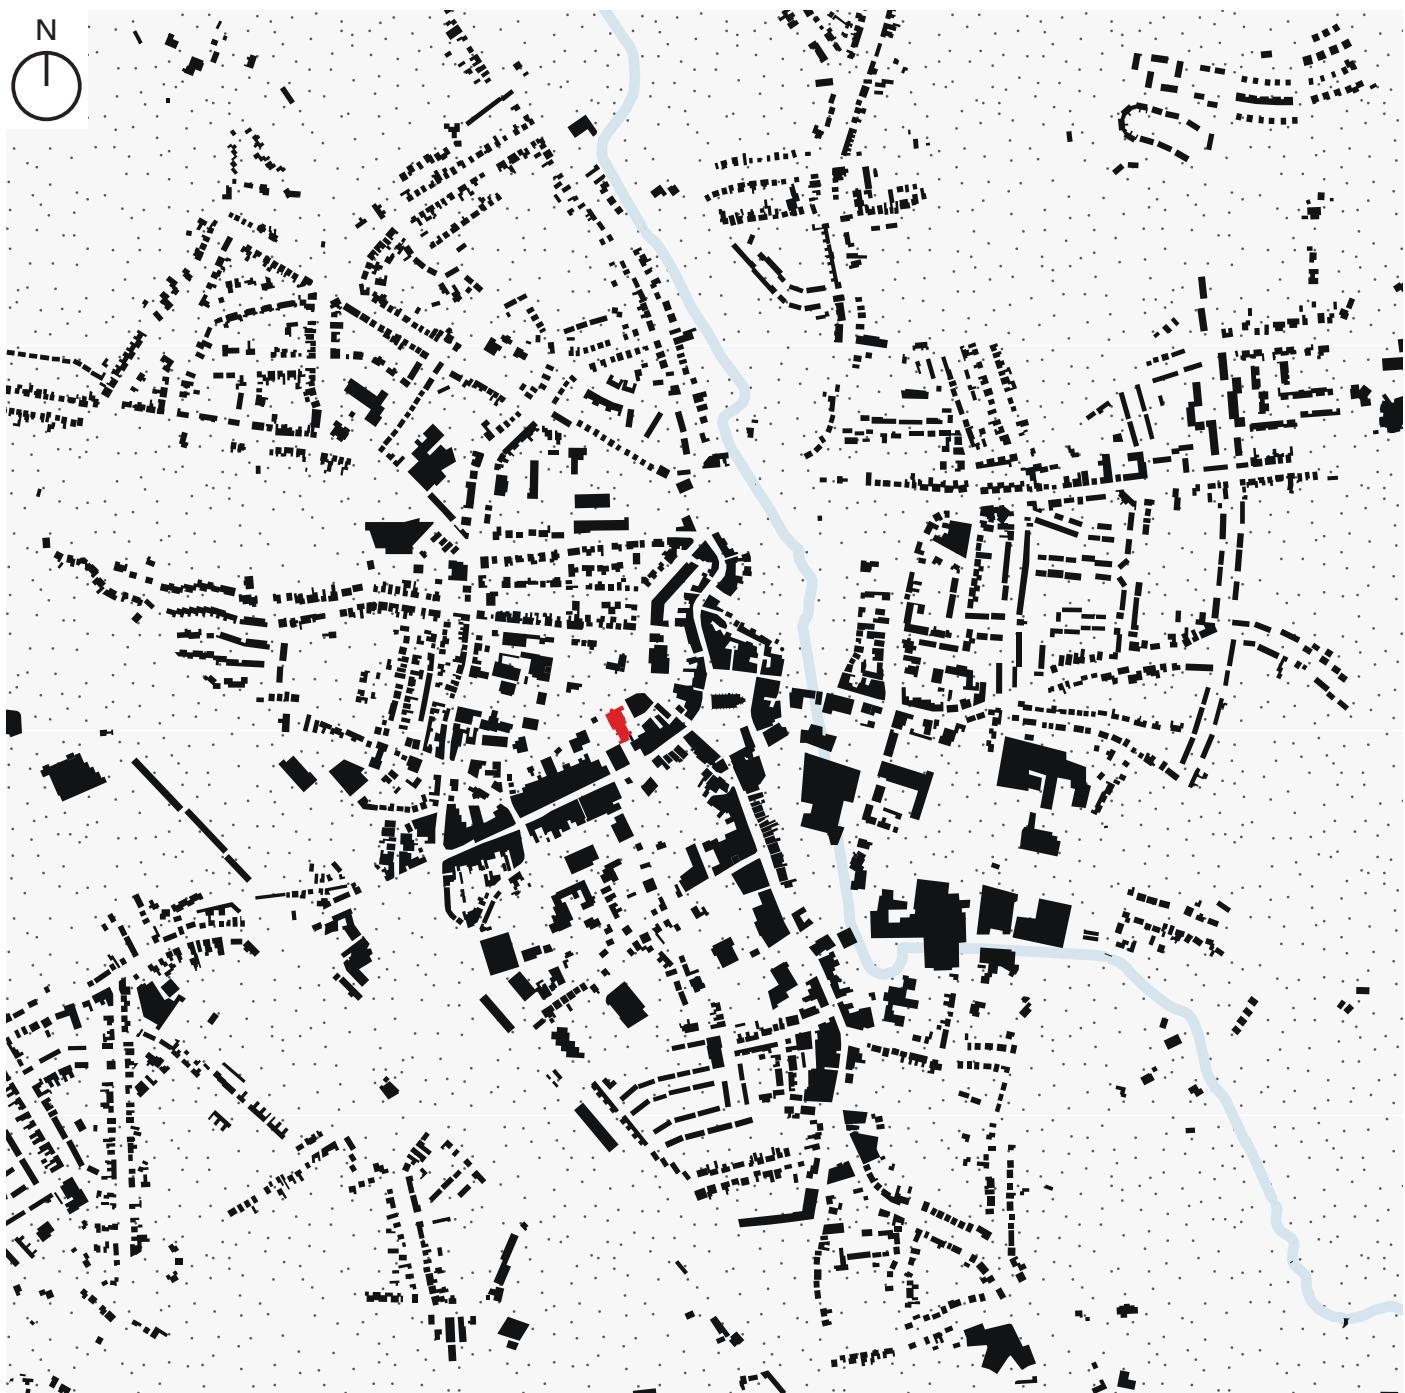
1975 WINTERSWIJK

Figure 56 Plan of 1975. the town has grown more dense as the population kept growing after WWII.

Around this time, German people started to visit Winterswijk, and especially the market. The industry partly left, but the zones where the industry used to be were left unbuilt. Also it is visible that Gaudium on the southeast along the Weeme still has a connection with the hinterland, and that around the factories nothing is built and the city expands in other directions.

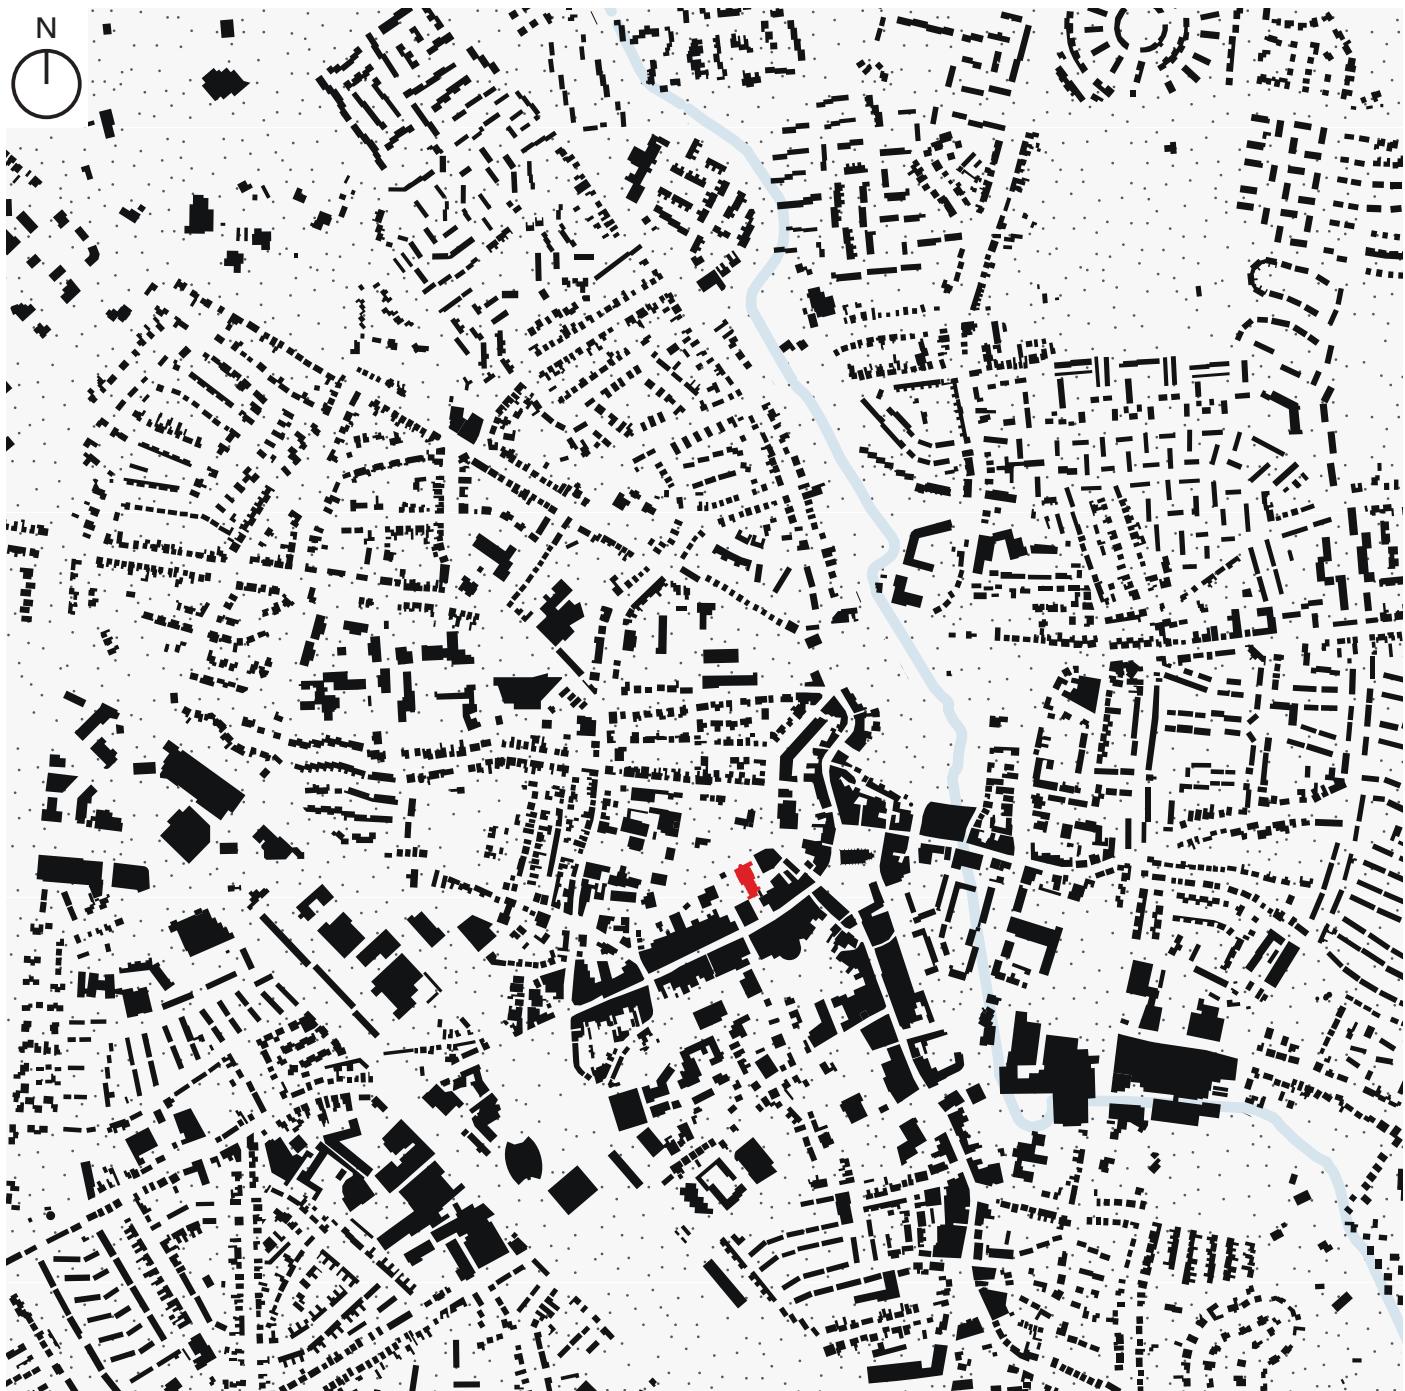
2018 WINTERSWIJK

Figure 57 The current Winterswijk. The industry zones are clearly visible, and the center is recognisable as such because of the dense buildings.

The city expanded to about 29 thousand inhabitants. Nowadays the industry is not that important anymore, only Gaudium is left. The connection of Gaudium with the hinterland is still there, the housing expansion went in all other directions. Also the industry terrain on the south of Winterswijk grew a lot. The most important income for Winterswijk are the (mainly German) tourist that visit the market in big numbers on Wednesday and especially Saturday.

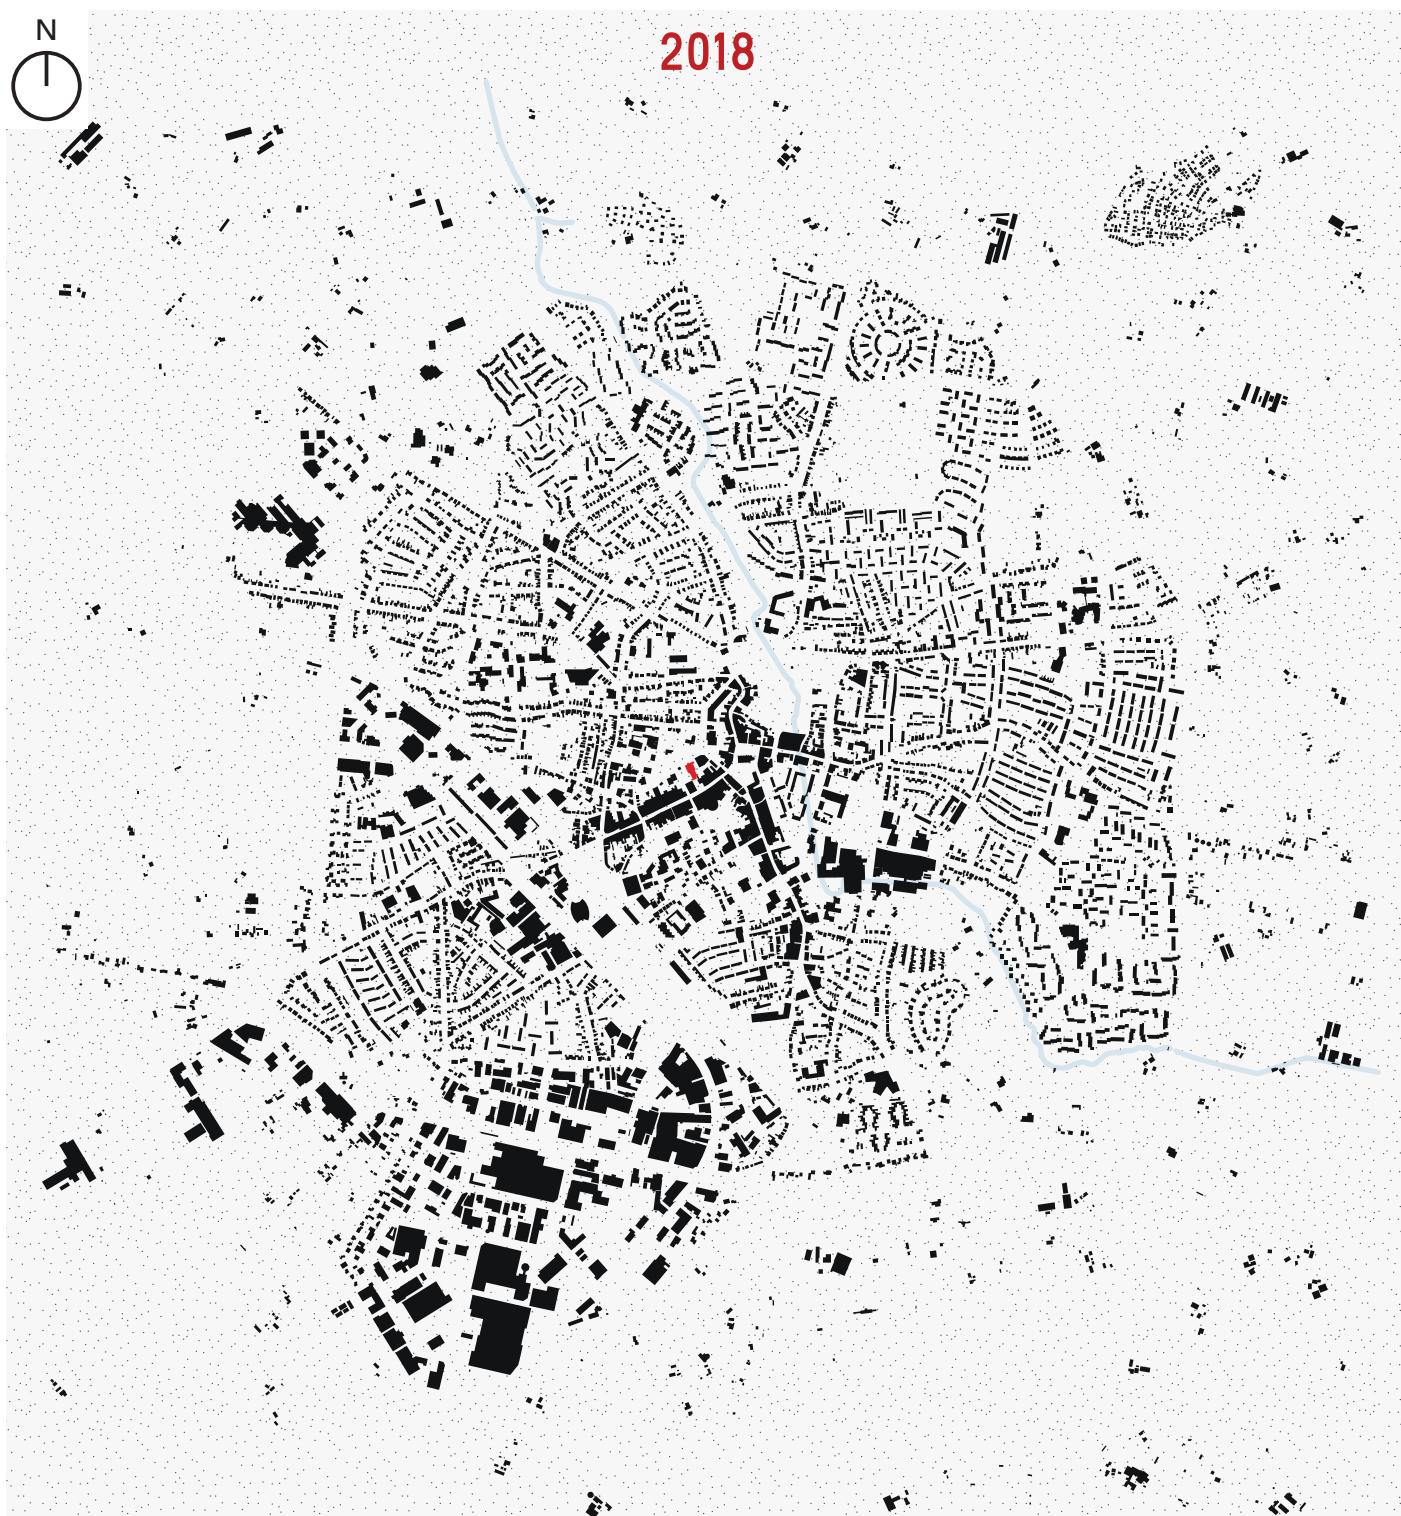
2018 WINTERSWIJK

Figure 58 The whole Winterswijk, the same map as on the previous page but on half the size so that it shows the surroundings

Nowadays Winterswijk is quite a dense village, in an agricultural landscape. In the center are the most shops and other functions, around it are mainly dwelling areas. The biggest industry zones are where the industry originally was and Gaudium for example still is, and on the south side of Winterswijk.

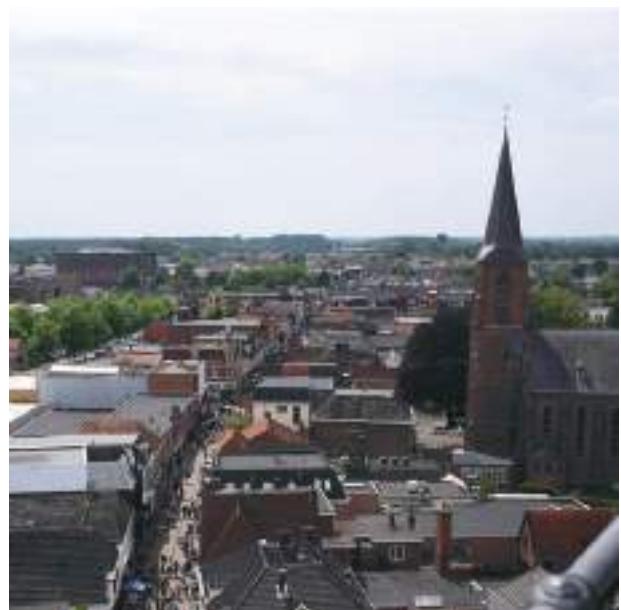
Figure 60 Air view of the current situation of the Misterstraat. (aerophotos, n.d.)

Nowadays the Misterstraat is the main shopping street. Due to the change in street scape the church seems to hide away from the street. (Figure 60)

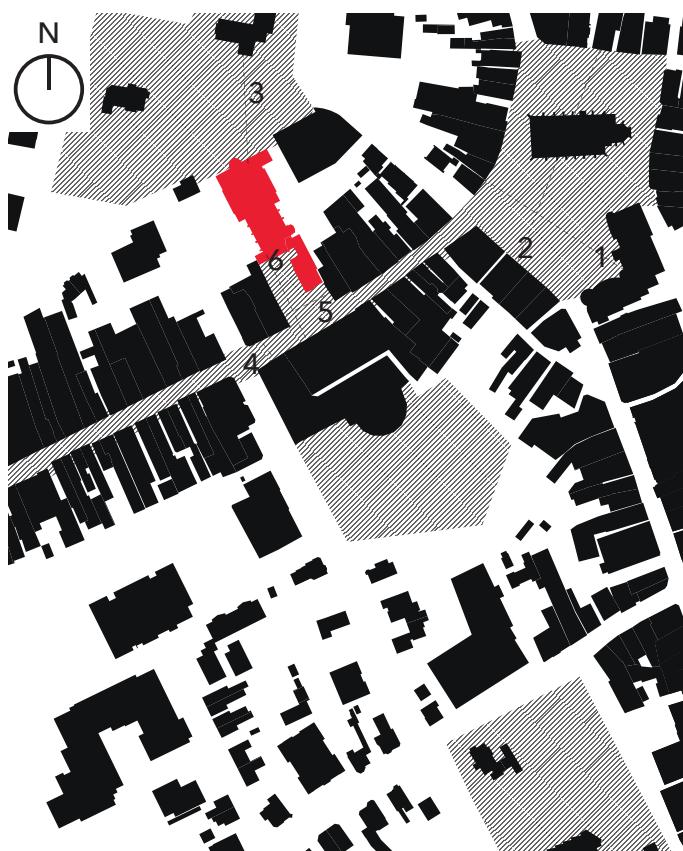
Figure 66 Pedestrian precinct and open spaces Winterswijk center (own illustration)

The street is the place where most people experience the urban environment the most. This so called public realm includes both the street and the buildings facades at eye level. In Winterswijk open spaces such as squares form places where activities are held and people can meet, these places are often very dynamic and are part of how people navigate/travel through the urban fabric. The Jacobuskerk is surrounded by these open spaces: north Eucalyptus park, East the Markt and South the Misterstraat and No-

taristuin. The Jacobuskerk itself has a small square on its site, this square is encapsulated due to the setback of the main church and the flanking of the parish building. The city center is mainly for pedestrians with only access for cars on incidental cases, loading and unloading is only for targeted traffic. This implies that there is no hierarchy in the street pattern within the center. Along the streets within the center, most buildings have a commercial function on the ground floor and dwellings on top. Most buildings are two to three stories high.

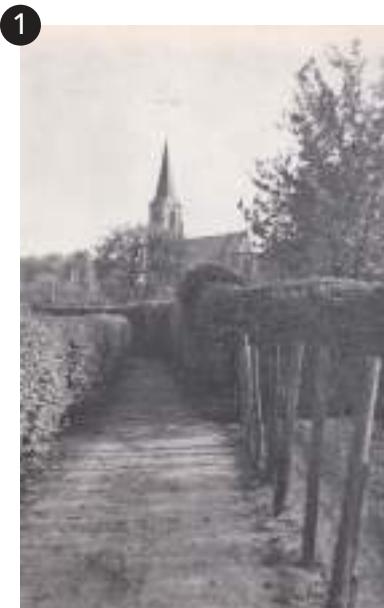
Figure 70 historical photo (beeldbank)

The Jacobuskerk had a tower since its design, initially it was around 35 meters high until it was completed in 1911 when the height of the tower went up to 55 meters. The tower has become a landmark over time and complements the skyline next to the towers of the Jacobskerk and the Raadhuis and the old chimney of the Tricot factory, .

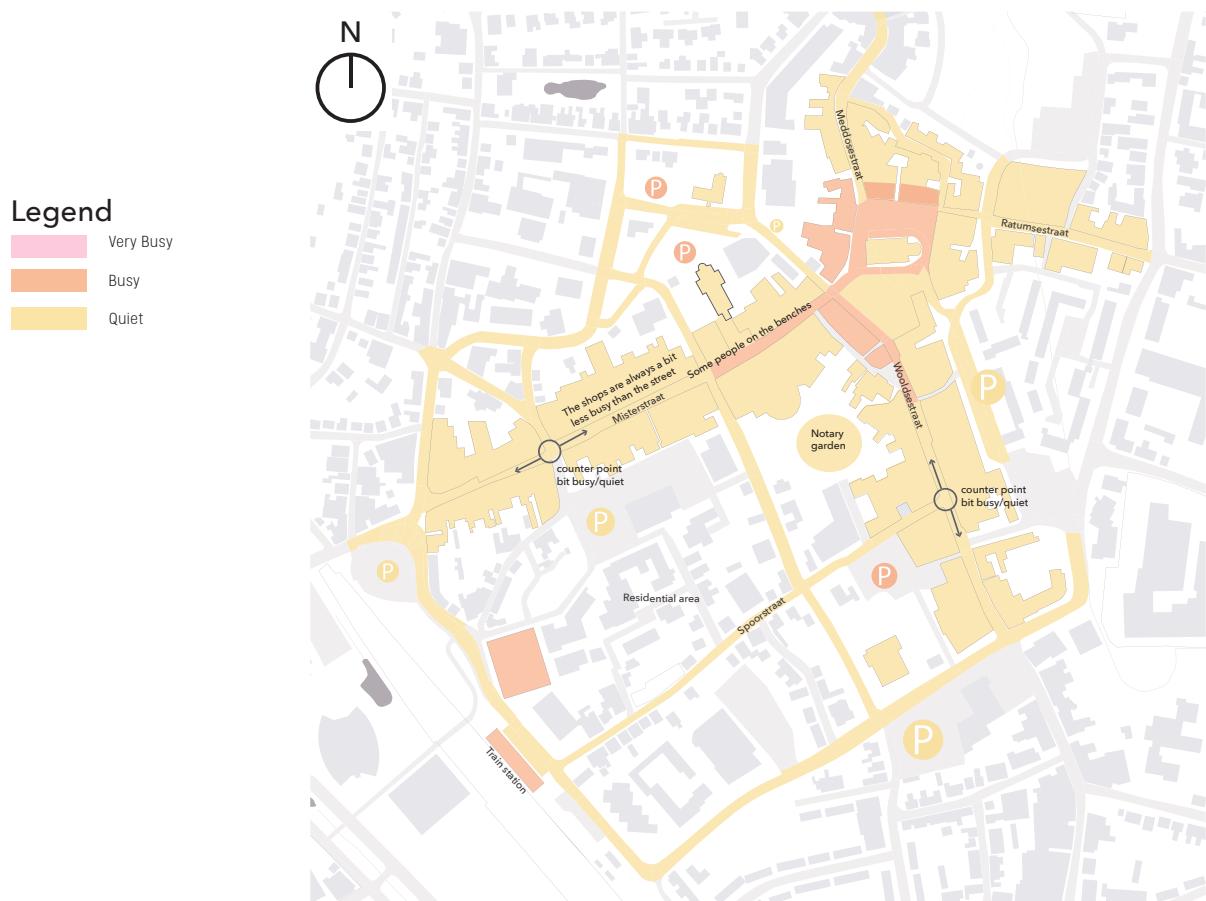
Figure 87 Activity map Winterswijk during the week

The busiest part of the center are the market, the Misterstraat close to the market and the Wooldstraat close to the market.

In front of the Jacobuskerk are several benches that are mostly occupied during days of research. The shops have a low number of visitors and are perceived as quiet. A possible explanation for the quietness can be the high amount of shops compared to inhabitance. The capacity is related to the peak of visitors during the weekend. This observation is similar for the parking spots that are near empty during the weekdays without market. For Wednesdays this amounts to half of the parking spots being used.

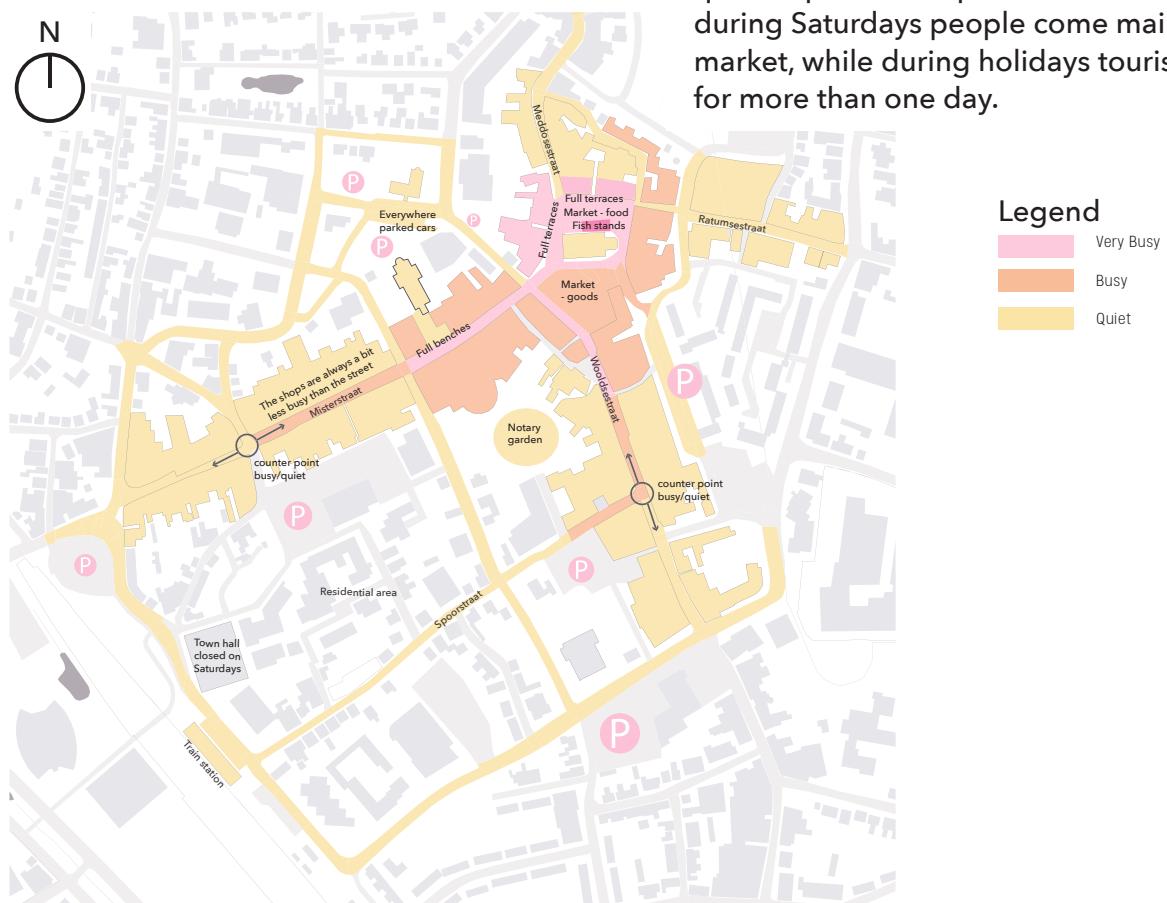
Figure 88 AActivity map Winterswijk during Saturdays

Even tough the streets are rather busy it seems to still be rather quiet in the shops along these streets. We noticed a sharp decline in activity as we went further from the Markt, this decline correlates with the closeness of parking-sport near the end of the streets. The benches in front of the Jacobuskerk are constantly occupied during the day of observation, mainly by elderly people. What we found odd was the quietness of the Meddosestraat. Located close to the Markt and with commercial functions in the plinth, it was still very quiet, this was similar for the Ratumsestraat. All parking spots are filled, with many cars are parked along the streets close to the center of which half were identified with German numberplate's.

The notary garden south of the Jacobuskerk was used by some people but overall rather quiet. Interestingly the former town hall, where the tourism office is based, was very quiet. A possible explanation can be that during Saturdays people come mainly for the market, while during holidays tourists come for more than one day.

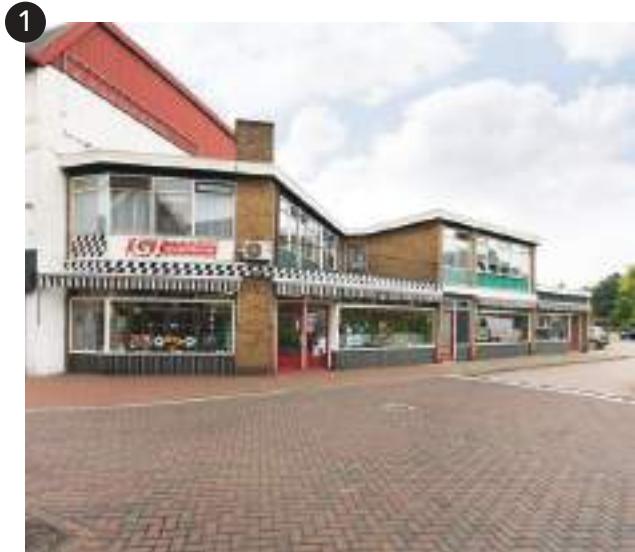
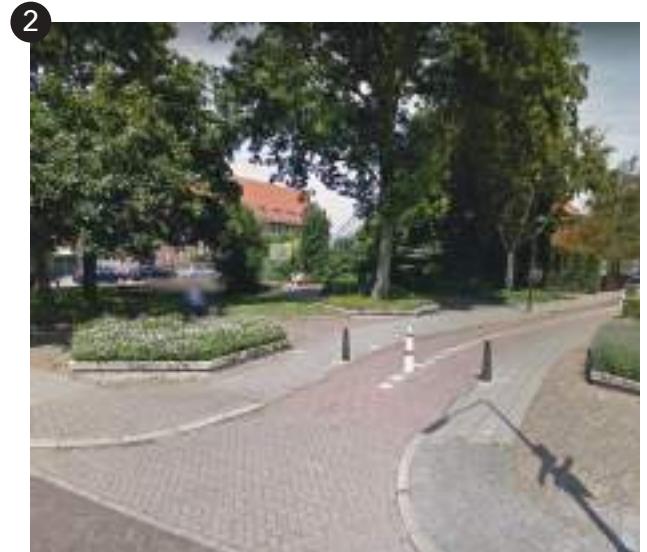
Figure x and x show the difference in pavement and the transitions within the hierarchies.

This attitude is adopted throughout the city center: streets where hierarchy is present a clear difference is found between color and size of the pavement.

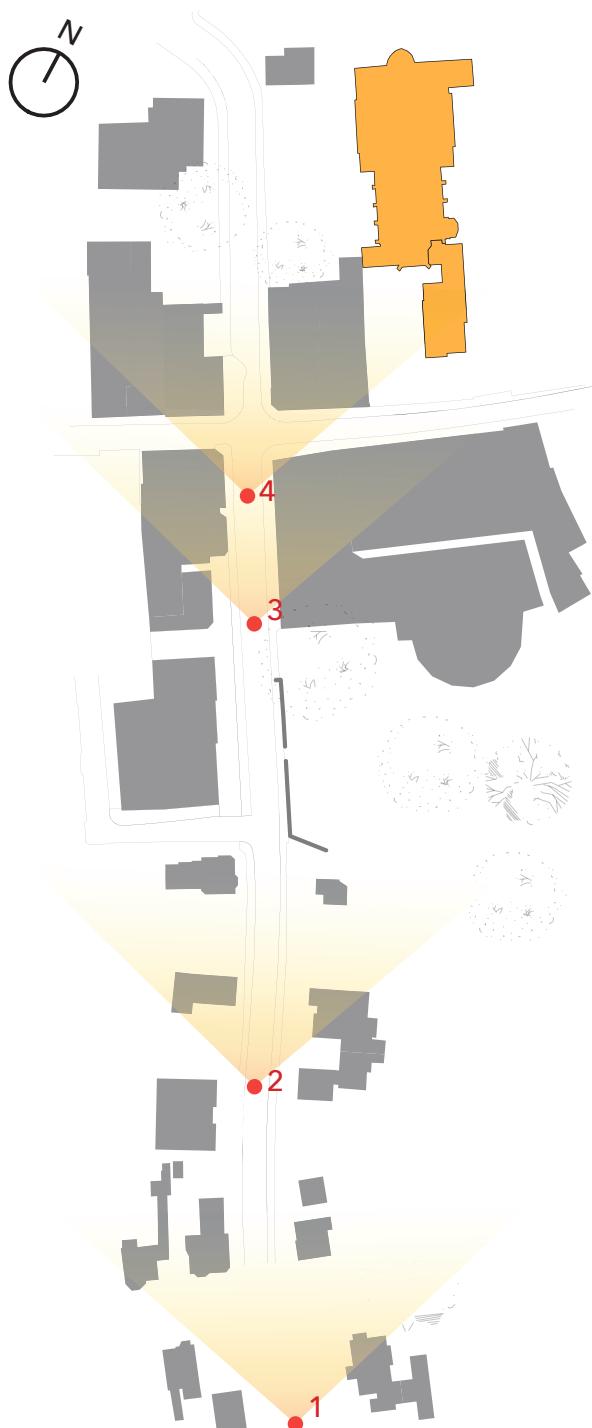
Figure 84 The route in detail, you can see that it is not so densely built and that it gets denser as you get closer to the Misterstraat

1. In the beginning the Roelvinkstraat is quite green and there are not that many houses. In the tower of the Jacobuskerk is already visible.
2. The street gets busier and there are more and bigger houses on the left side. On the right side is the Notary Garden.
3. Close to the Misterstraat there are shops in the Roelvinkstraat. On the right you can just see the tip of the tower of the church.
4. Just before the crossing with the Misterstraat you can see a bit more of the church tower. But to see the rest of it you need to walk to the front or to the side.

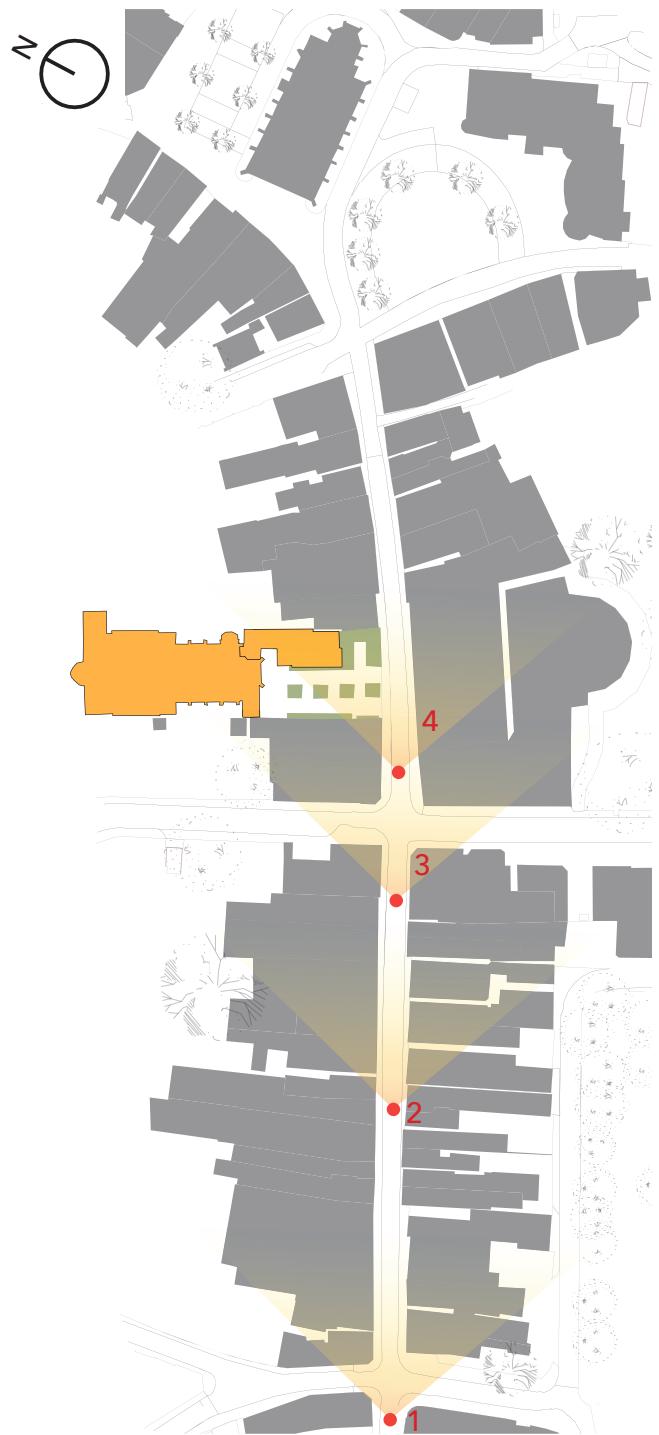
Figure 87 The route more in detail. Clearly visible is the density of the buildings, matching its function as busy shopping street.

1. The street unfolds as a long shopping street.
2. Continuing the shopping street you see different buildings from different construction periods, each with shops on the ground floor.
3. You get closer to the church but still you cannot see it, it is hidden behind the shops.
4. Only when you get close, you get a view of the church but this is only when you stand really in front of it. So even though the Misterstraat is the street on which the entrance of the church is, this doesn't mean that the church is very visible in this street.

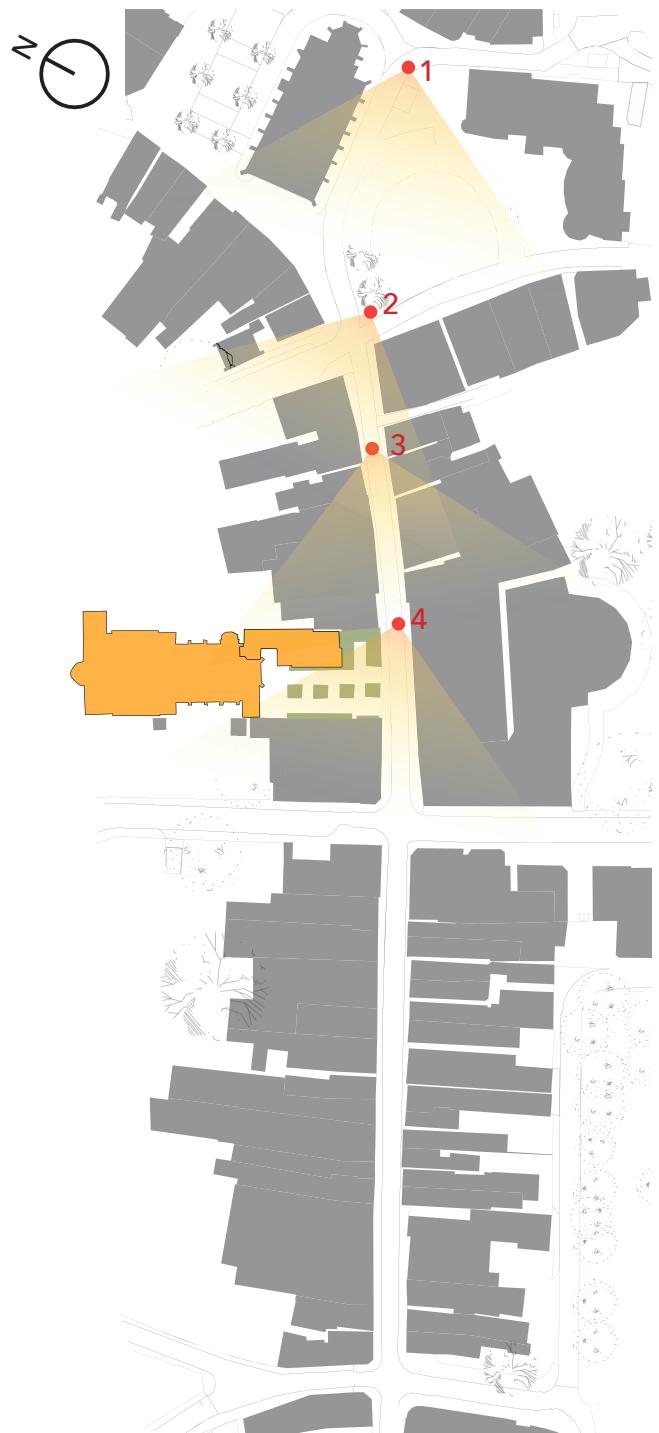
Figure 90 This route goes through the busiest part of Winterswijk, reflected in the density of the buildings

1. From the market you can see the tower of the Jacobuskerk already above the other lower buildings.
2. When you enter the Misterstraat the church disappears out of sight, you can only see the tip of the tower if you pay attention.
3. When you get closer the church completely disappears from view, only the shops are visible.
4. If you get very close you can already see the fence of the church plot, indicating where the church is. But you have to be in front of the church to see it again.

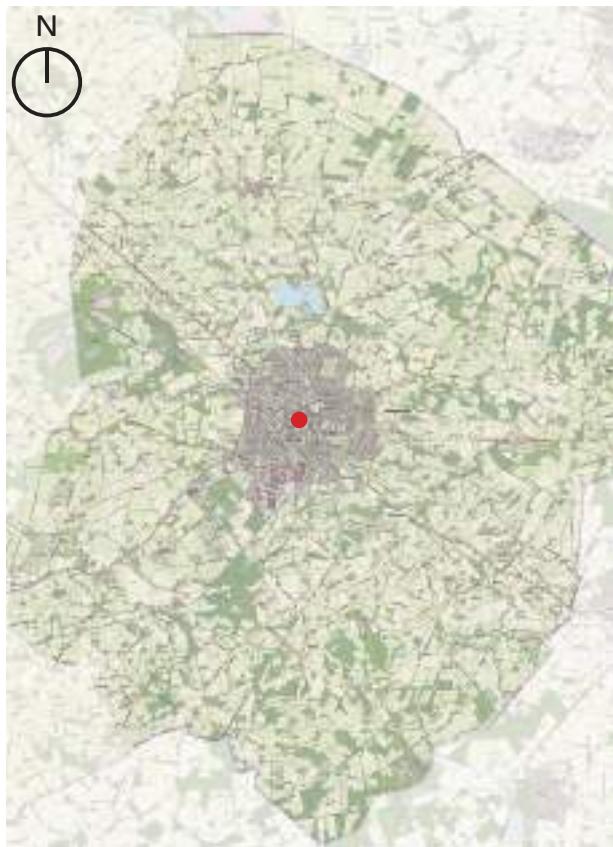
Figure 98 Landscape Winterswijk (Gemeente Winterswijk, n.d.)

The landscape played an important role for Winterswijk, being built on a raised sand back along the creek Whemerbeek. For the largest part of its history Winterswijk was a agraric community and was thus surrounded by a cultivated landscape. Farmers marked their land by planting trees and building wood walls, these are often still visible in the landscape. Nowadays Winterswijk has grown and largely lost its agricultural landscape within the town. Remnants of this landscape can be found along the Whemerbeek where greenery enters the town. The center of the
