THE JACOBUSKERK

WINTERSWIJK

Heritage and Design Analyses Jacobuskerk Winterswijk
Heritage & Architecture
November 4th, 2019

Heritage & Architecture

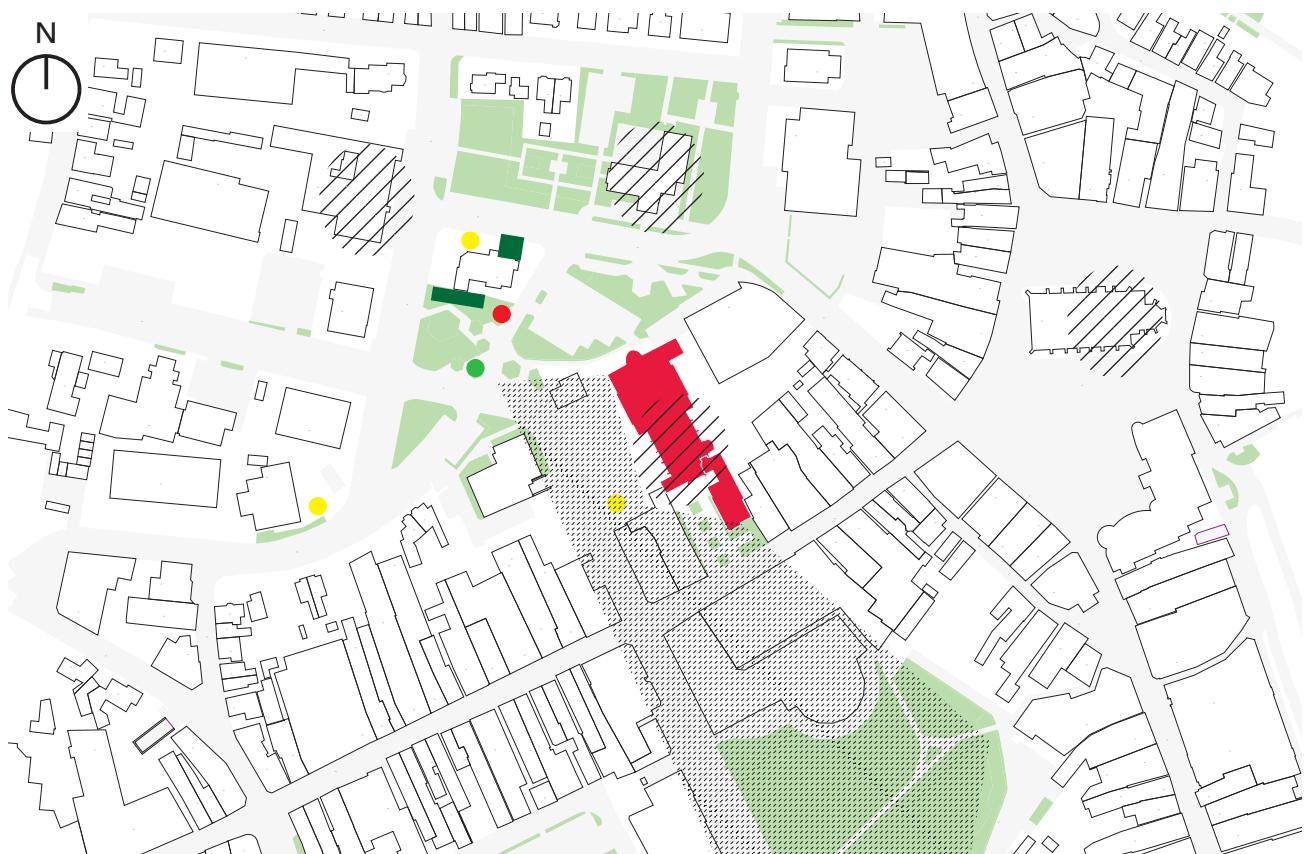
Figure 102 Fauna map surroundings Jacobuskerk Winterswijk

The following figure (X) shows the habitation elements of animals and hunting area.

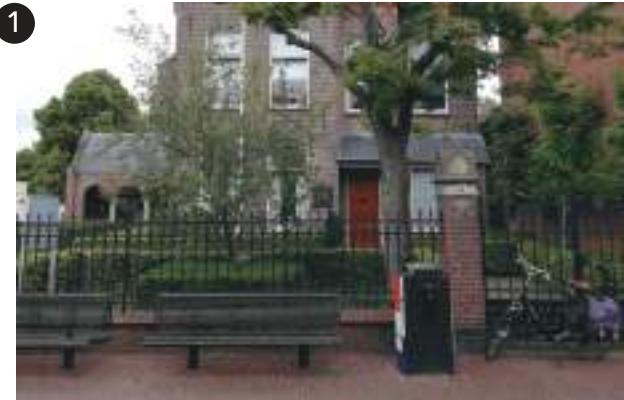
Figure 116 The metal fence with brick supports forms the border of the site. It has authentic details and looks old.

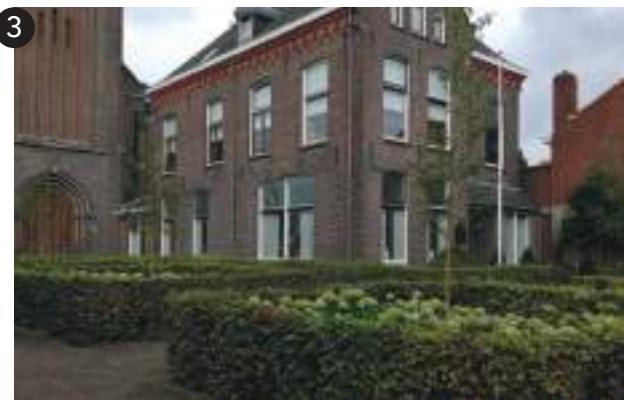
Figure 118 In front and around the rectory are some plant beds. They form an entrance zone to the rectory.

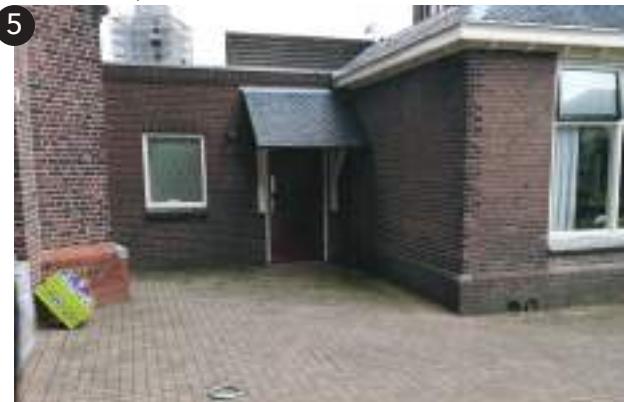
Figure 120 The second entrance of the rectory is a bit put away in the corner. It has a small canopy but it doesn't really do justice to the nice building.

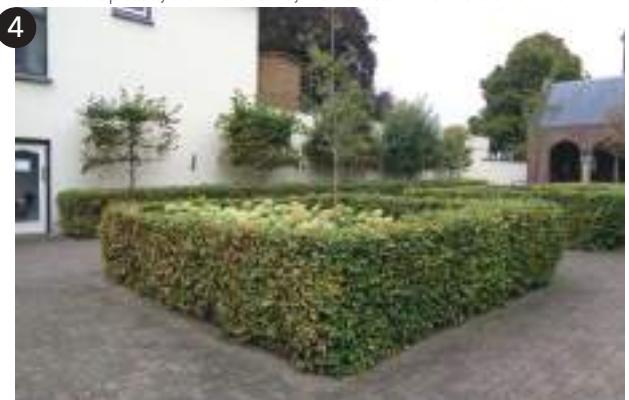
Figure 119 The plant beds in the middle of the terrain structure the entrance zone. There are 4 of them and they all have a small tree in the middle.

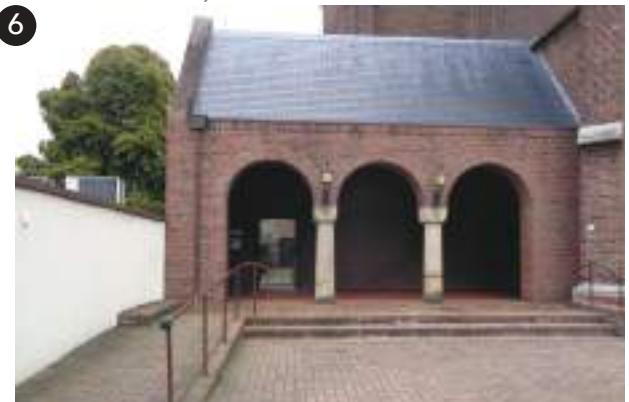
Figure 121 The entrance canopy to the church used to be in one line with the main entrance route, but with the current placement of the plant beds not anymore.

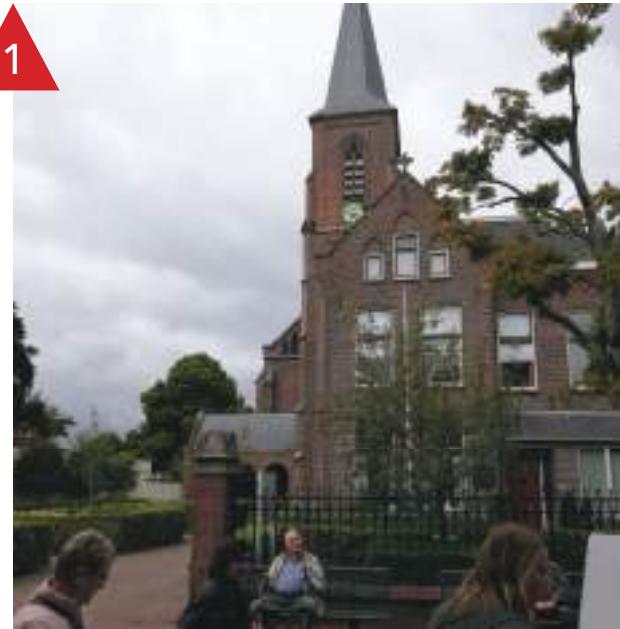
Figure I24 Here the fence that forms the south boundary is visible. You can only see the church when you are right in front of it, otherwise often there are shops in front of it or like here the rectory. Behind the fence the green square forms the transition area to the church entrance.

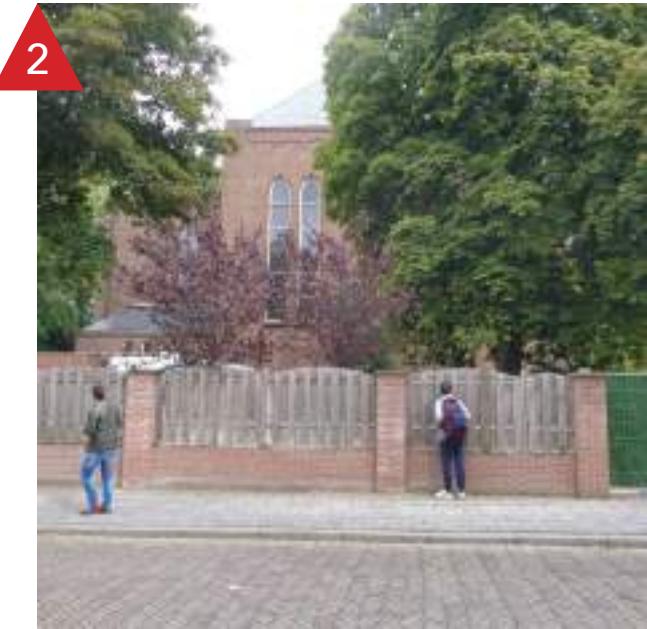
Figure I25 There are two shops on the west of the Jacobskerk, and behind them is a terrain with not a really clear use. There is a street along that terrain and a fence that is partly a wooden fence between brick pillars and partly a metal fence.

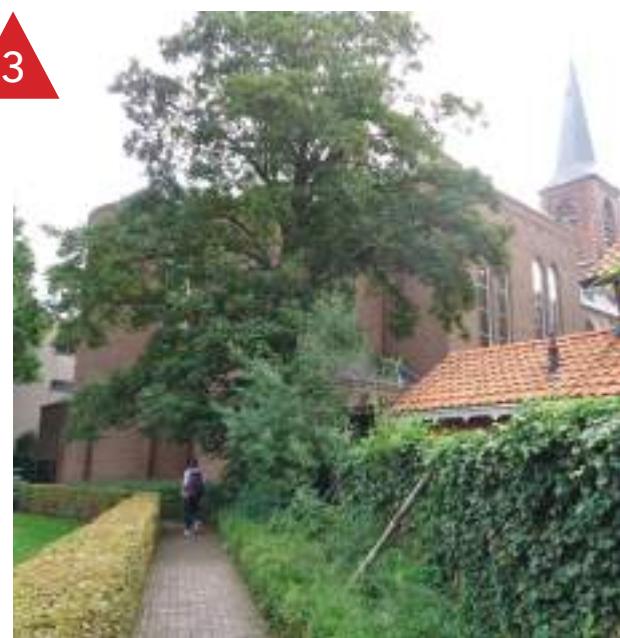
Figure I26 At the side of the parking there is a house next to the church with a hedge around it. Behind that there is a small footpath and along the church some green that forms a buffer in the corner. On the other side of the path there is also some green as a boundary between that path and the parking.

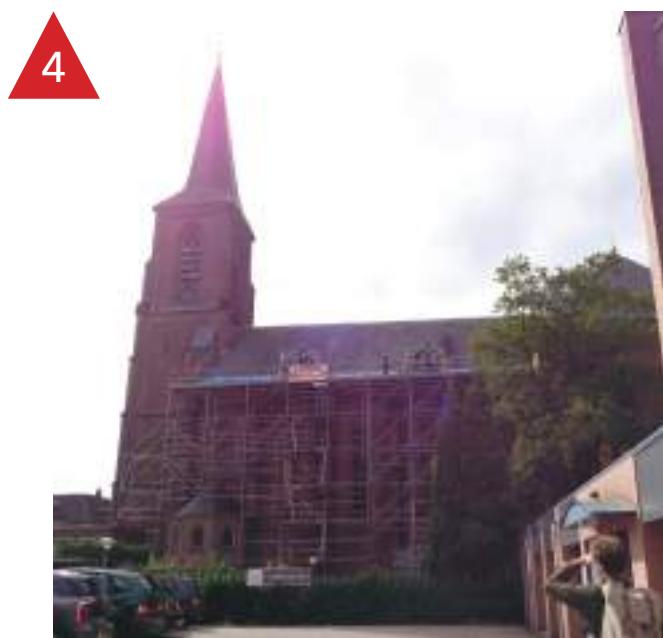
Figure I27 This terrain lies between some shops and is the parking of the owners. It is not really publicly accessible. There is a metal fence with behind it a hedge to mark the terrain of the church, but it is possible to enter through the fence if you have the key.

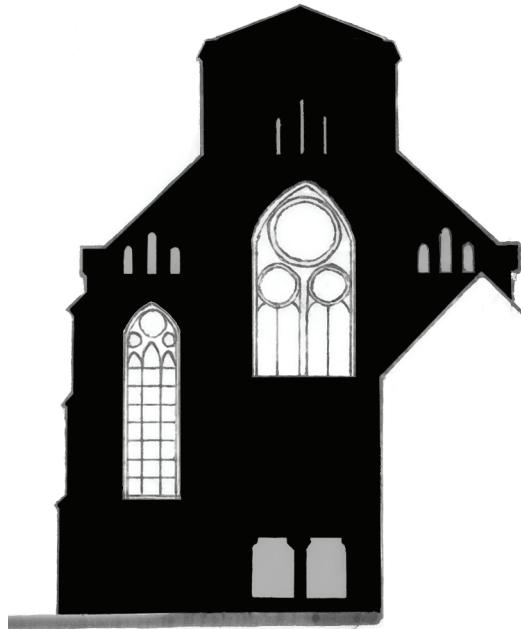
Figure 135 Openings. Front facade, 1868 (1:35)

In the comparison of the openings in both facades the impact of the removal of the rose window in the tower and the neogothic windows becomes clear. The original facade of 1868 expresses the floorplan of the church more clearly compared to the current facade appearance. The current facade appears more closed and rather unwelcoming viewed from the shopping street than the original facade with its big windows and the entrance in the front, clearly visible from the street.

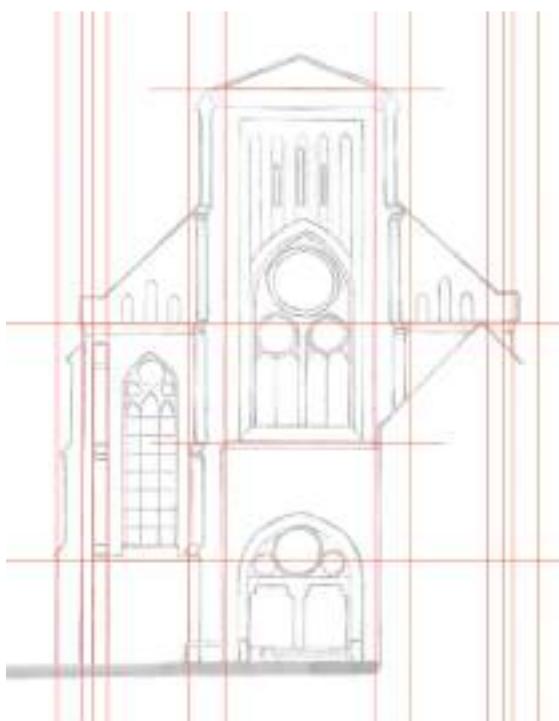
The separation between the tower sections is mostly acknowledged by the elements of natural stone forming horizontal lines. These lines are mostly kept throughout the changes. With the adding of the third tower section and spine the facade gains vertical articulation by height. The verticality is enhanced by the openings in the new entrance and the lines in the second part of the tower which enhances the essence of the tower as tall object. The entrance canopy counters this vertical articulation and replaces it for a horizontal one on eye level by the articulation of the roof line.

Figure 139 Rhythm by elements. Front facade, 1868. (1:35)

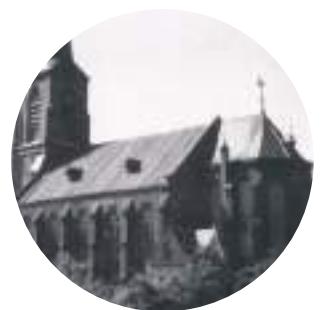
Picture of the demolished choir around 1945
(Meerdink, 1995, p.31).

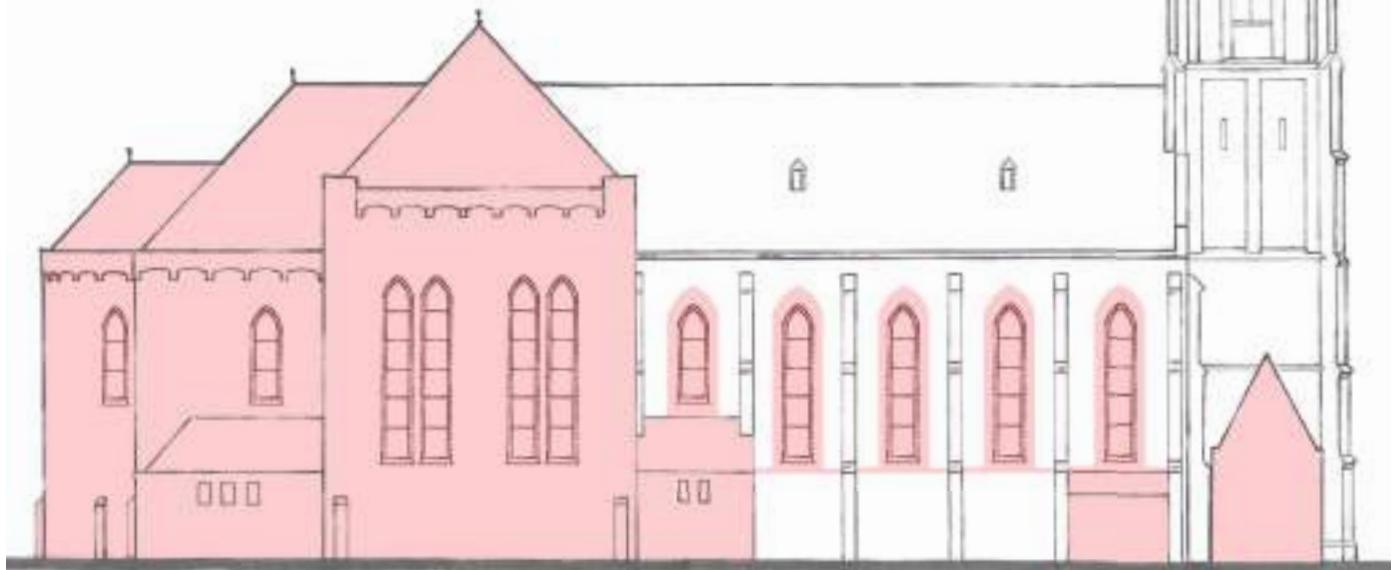
The expansion of the church in 1953 includes the removal of the choir which formed the third section of the original facade. On the exact same line as the previous choir the expansion is built leaving the line of the original rhythm intact. The expansion part breaks loose of the original rhythm as the new facades are flat surfaces without buttresses or other elements dividing the facade. Where the windows were placed according to a vertical rhythm in the design of Wennekers the expansion part of Koldewey seems to place the windows more freely without a clear grid system other than the horizontal rhythm in line with the bottom of the new windows that were replaced for the original neogothical windows in 1949. These windows are smaller in both length and width which is clearly

visible in the current situation as the brick-work has a slightly different color since it is not yet weathered. With these replaced windows the line that was created by the continuous line of the natural stone windowsills has disappeared. The brickwork of the expansion has the same brick bond as used in the Wennekers part but has a different brick, as the stone is lighter of color and smoother of surface. The joint type differs from an extended joint to flush and is locally faded away to a raked joint or has been repaired. The extended joint is similar to the joint type in the part by Wennekers only the joint of 1868 is a bit executed, which shows the difference of construction time.

Figure 145 Side facade, 2019 (1:35)

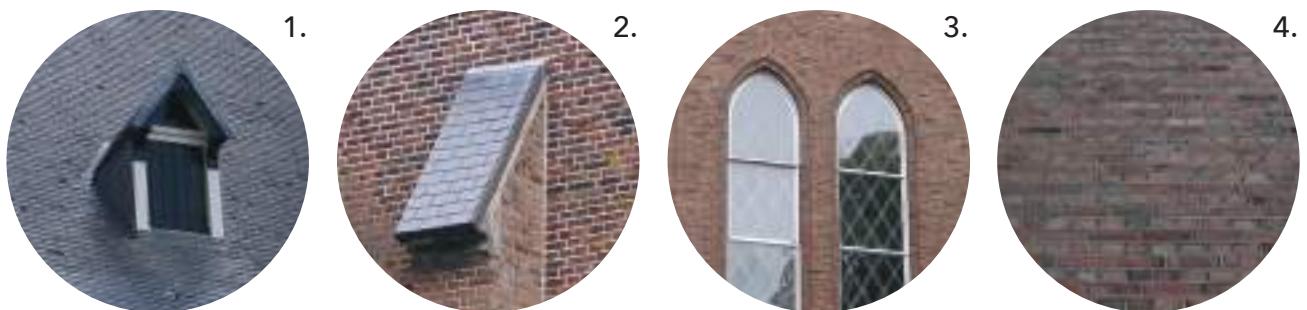
SIDE FACADE 2019

Identical to the front facade, the side facade clearly expresses the historical development of the original facade through material, but brings this to another extend of contrast as the side facades are the only facades where the 1952 expansion meets the original 1868 facade. The 'new' brickwork in the 1868 facade parts is clearly visible and again shows that it has been replaced through time. The same brickwork is used in the facade parts of 1952 making a very clear contrast of time with the old original brick in the 1868 facade. However, throughout the facade the same white painted steel windows and a fully transparent front layer of glass in a white steel frame are placed in the same materials and the same width. This creates a consistent connection

through material between the 1868 and 1952 building parts. This consistence continues by the slated roof that is replaced throughout time and therefore does not acknowledge time differences.

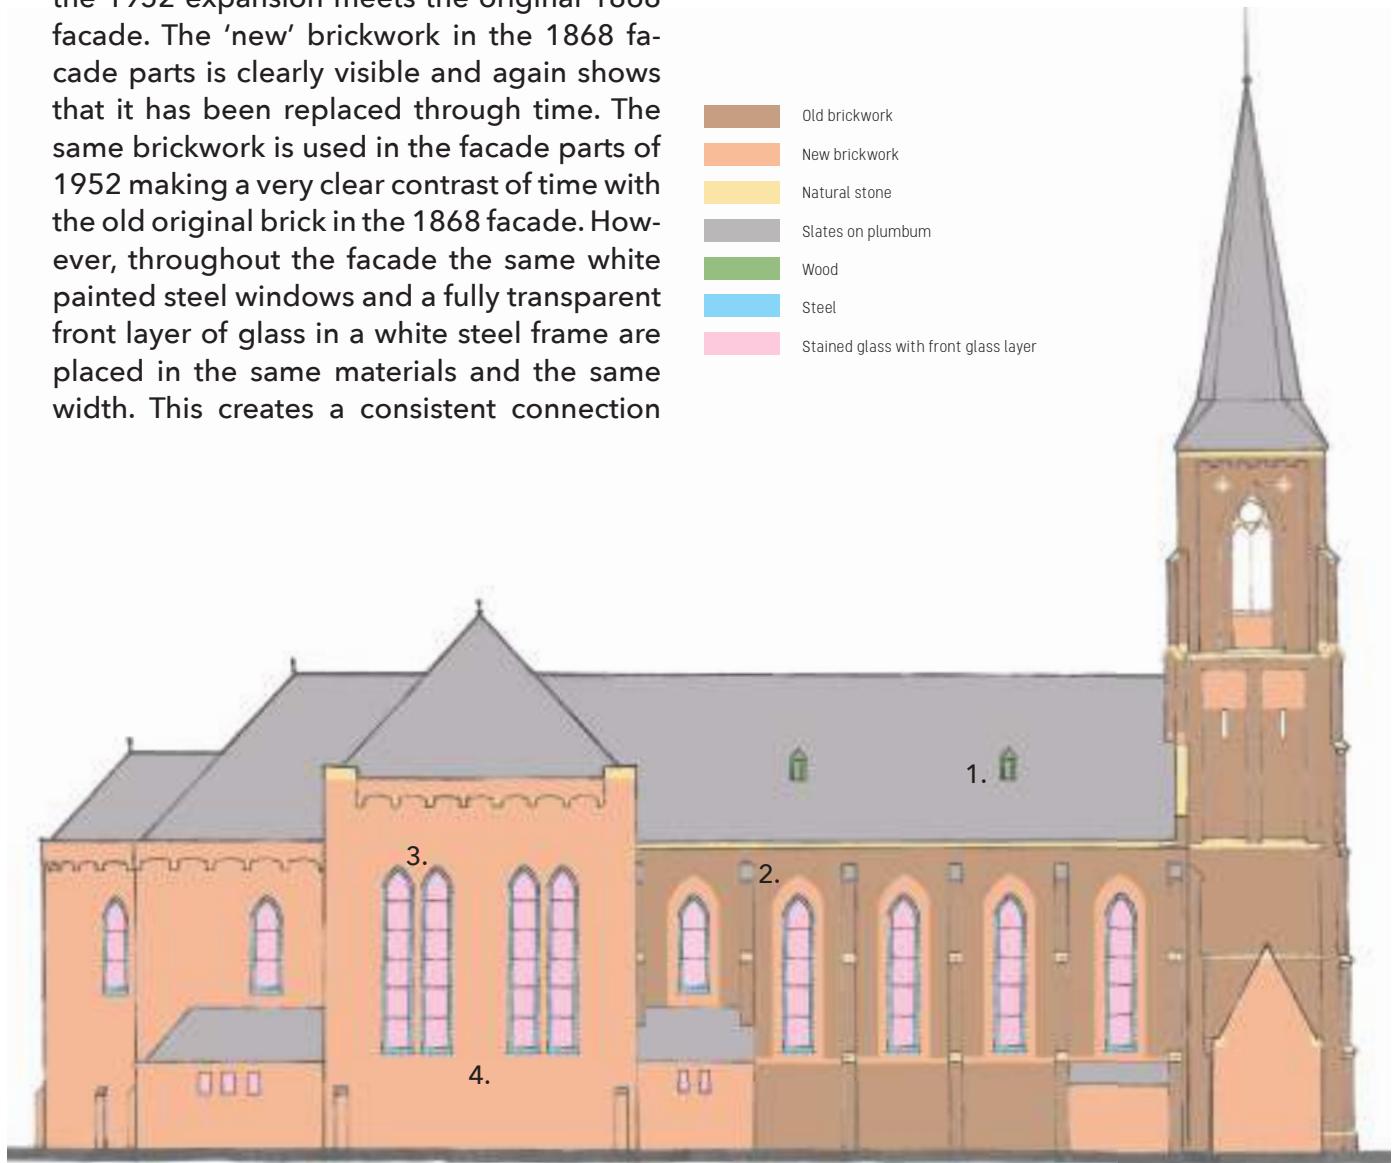
Old brickwork
	New brickwork
	Natural stone
	Slates on plumbum
	Wood
	Steel
	Stained glass with front glass layer

Figure 146 Materials. Side facade, 2019 (1:35)

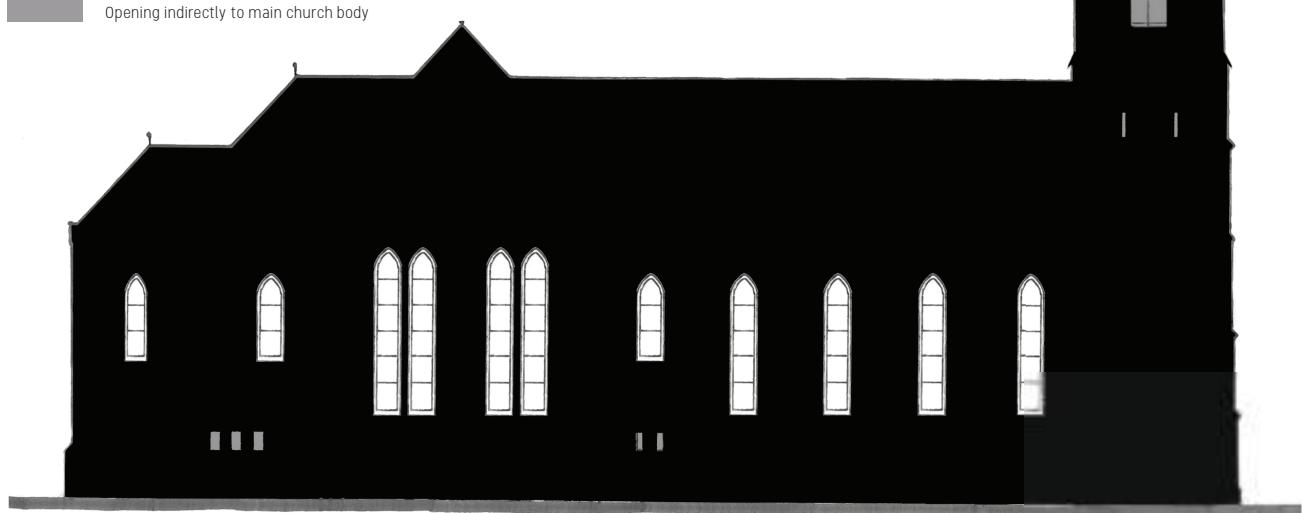
Figure 148 Openings. Front facade, 2019 (1:35, 80%)

In the comparison of the openings in both facades becomes clear how open the back facade of the 1868 church was, made possible because of the dimensions and the close repetition of the windows, in comparison with the 1952 expansion. The total volume as result of the expansion in combination with the repetition of windows indicates more horizontal acknowledgment than the strong vertical articulation originally meant in the 1868 facade. This effect is countered by the windows decreasing significantly in width and therefore becoming more vertical. As a result however, the effect of the decreased width of the windows and the shorter windows, is that more plane voids of brickwork are created accentuating the mass and therefore the horizontality.

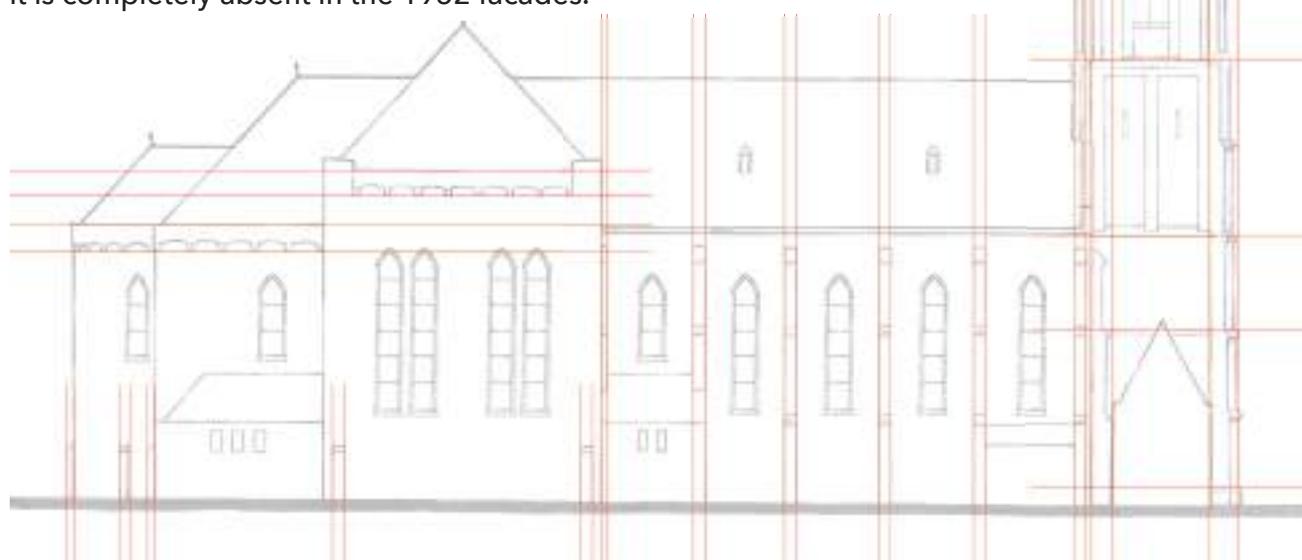
The original 1868 side facade contains a very strict vertical rhythm caused by the structural buttresses spanning over almost the entire height of the facade and is horizontally balanced by the continuous line of the natural stone windowsill in between the buttresses. Both this windowsills and the natural stone strip under the roof line result in horizontal lines clearly splitting the facade planes in 2 horizontal parts. Since the natural stone windowsill has disappeared from the 1868 part, the current facade becomes an horizontally separated facade plane clearly separating the roof from the facade by the remaining natural stone strip and acknowledging the end of height of the facade plane. This effect of the natural stone stroke is similarly created by the top collar of the 1953 facades made of decorative brickwork. Also remaining from 1868 is the strict vertical rhythm caused by the buttresses which clearly separates the original 1868 part from the 1952 expansion since it is completely absent in the 1952 facades.

Figure 152 Rhythm by elements. Front facade, 2019 (1:35, 80%)

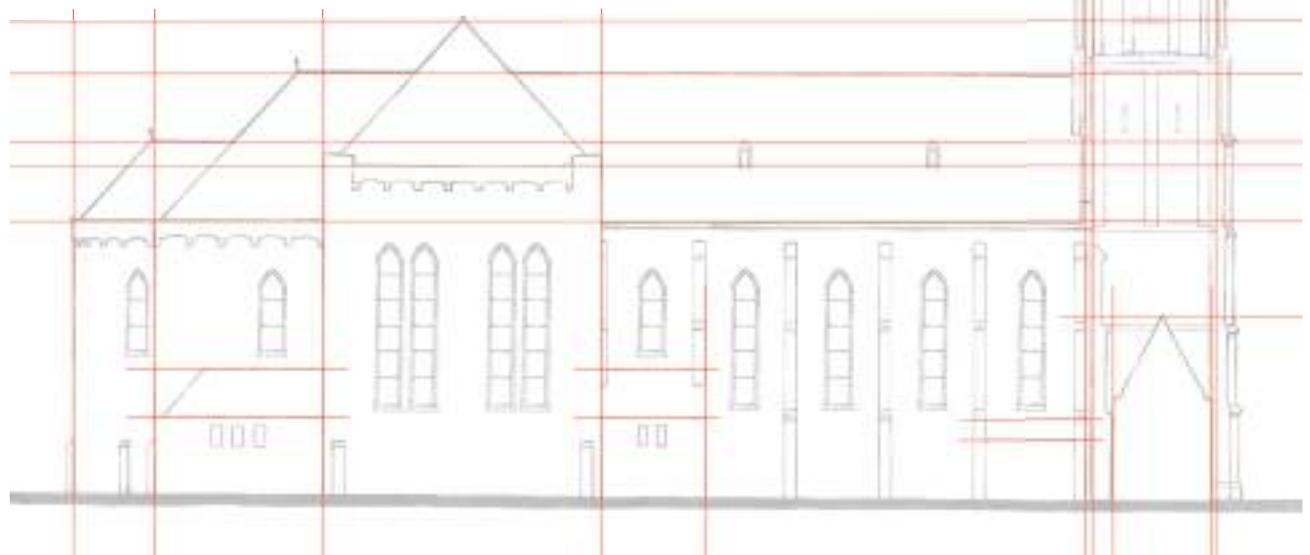
The original side facade consisted of a very clear horizontal separation of 3 parts namely the tower, the nave and the choir. This is replaced by the expansion of 1952 introducing 3 new parts: the transept, choir and the chavrette (small back part of the choir), as addition to the tower and nave, resulting currently in 5 parts. The 3 new parts together are in balanced dimensions of length and width with the original 1868 part of the nave, but they are way bigger than the original choir used to be.

Figure 154 Rhythm by mass. Front facade, 2019 (1:35, 80%)

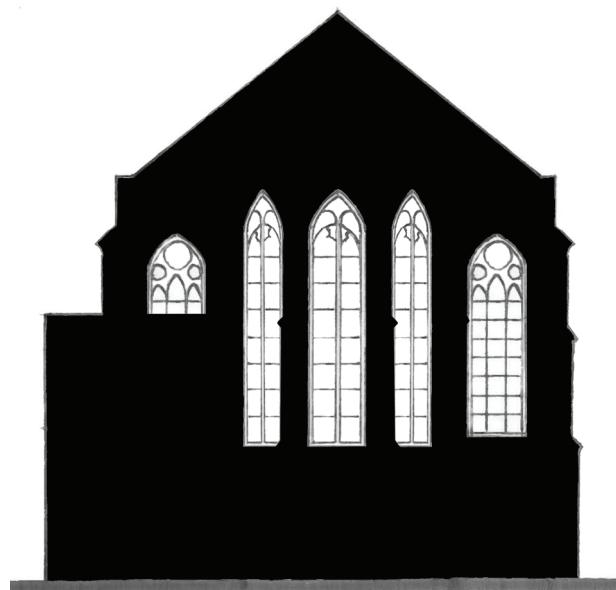
In the comparison of the openings in both facades yet again proves how open the facades of the 1868 church was in comparison with the 1952 expansion of Koldewey. In the 1868 church the windows of the choir were extended in length compared with the windows of the nave and aisles, to maximize the daylight infiltration of the choir. In the 1952 expansion the choir remains to be positioned in the apse in the center of the back facade. However, this apse only facilitates daylight infiltration by two relatively small windows in the corner of the facade and two small round ones. Aside from the windows being hidden behind the volume of the church itself the facade is entirely hidden behind large trees and neighbors a parking area and a house on the corner closing off the West side of the facade completely. There is a narrow uninviting pathway passing by the facade of the church which forms a shortcut for pedestrians. Altogether the back facade of the 1953 expansion has become a completely closed facade resulting in a dark choir in which the vertical articulation by daylight is absent.

Figure 158 Openings. Back facade, 1868 (1:35)

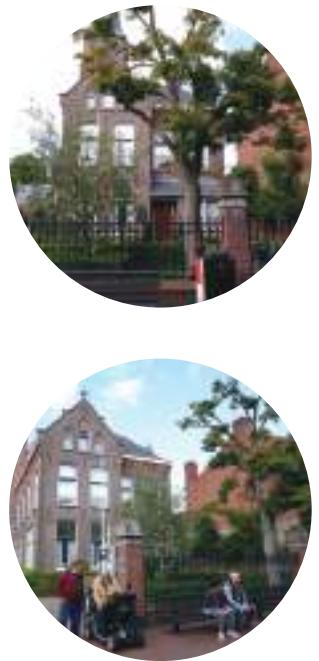
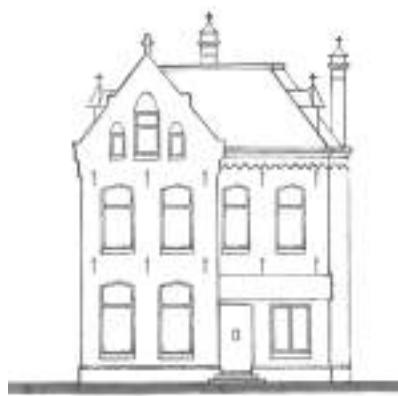
Front facade, 2019 (1:35)

The front facade of the rectory is the first view that a passerby would see from the Misterstraat coming from the market square. Although the front facade is partially hidden by the garden and a large tree standing in front of it, the facade clearly expresses to be different than the shop fronts that dominate the Misterstraat. Together with the high and decorated casted steel gate in separating the garden from the Misterstraat, the facade expresses an old and classical building style through its materials and composition. The windows and floor anchors clearly show the rectory to contain three floor levels.

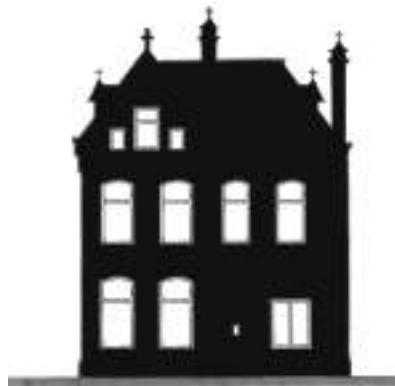
Openings. Front facade, 2019 (1:35)

The front facade of the rectory contains a large number and relatively largely dimensioned openings of the facade. With the rectory being positioned on the foreground of the site, just a few meters from the Misterstraat, which is the street from which visitors would see and approach the church site, it is of high importance that the front facade of the parish has an open and welcoming expression to suffice also for the church since the facade of the church is highly closed. The welcoming effect is enhanced by the windows clearly expressing the building to have three stories which makes the building appear homely.

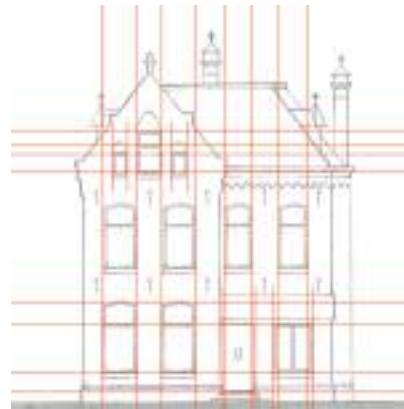
Rhythm by openings: Front facade, 2019 (1:35)

The six large vertical windows divide the rhythm by openings throughout the facade. The 'secondary' openings formed by the three smaller openings on the left top floor, the entrance door in the centre and the window on the right of the door, are placed in line of the rhythm created by these windows.

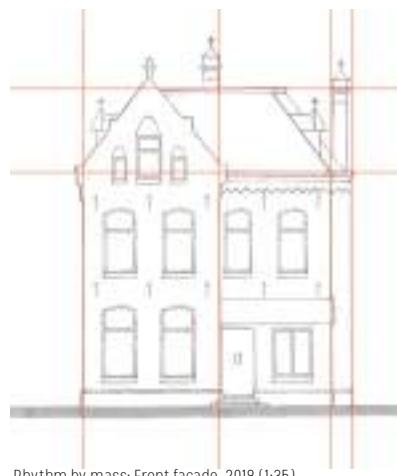
Rhythm by mass: Front facade, 2019 (1:35)

The rhythm of the mass dominantly organizes the front facade of the rectory. It is clearly deriving from the differences in depth by the placement of the facade faces. The composition of depths creates a strong hierarchy of the frontal face and the face placed about a meter to the back. The surface on the right sight is positioned far to the back and is covered by the tree in front of the building and the neighboring building that stands about two meters on the right side of the rectory.

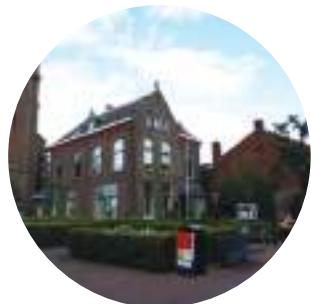
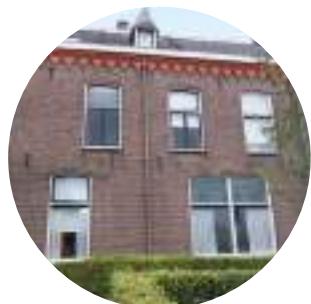
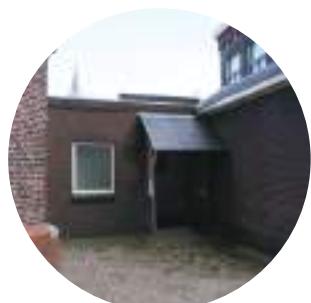
Side facade, 2019 (1:35)

The side facade of the rectory is the facade that becomes visible for a viewer that would walk the Misterstraat towards the market square. While walking the street towards the market square, the facade changes in perspective. As a result of the long horizontal facade surfaces, the facade indicates the viewer to follow this horizontal direction of the surface of the facade. Doing so this would open up the site and the front square before the front facade of the church 'welcoming' the viewer to enter the plot.

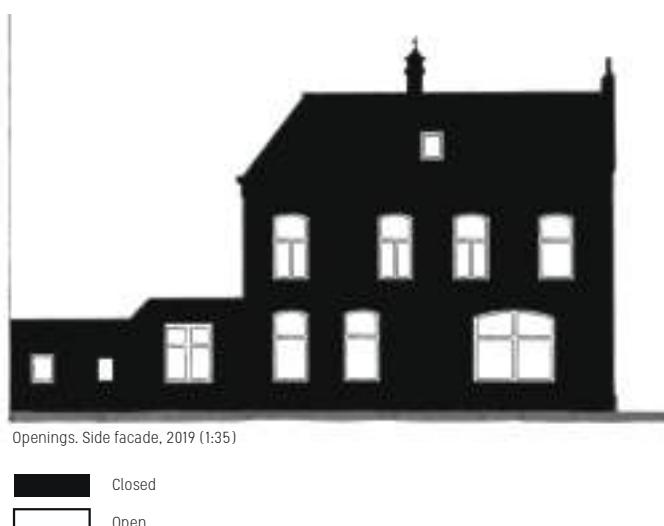
Similar to the front facade the side facade of the three story volume, forming the main rectory building along with the smaller volume on its left side, contains a large number of the largely dimensioned vertical windows resulting in an overall very open facade. The double window in the bottom corner on the right of the facade plane balances the almost becoming monotone vertical direction created by the facade openings as this window is wider. This window is positioned on the corner and large enough to look past the curtains inside from a distance of the Misterstraat. This imitates the corner window of a very typical corner house of a block of Dutch terrace houses. Together with the human proportioning of the facade it therefore reminds of a certain domestic expression.

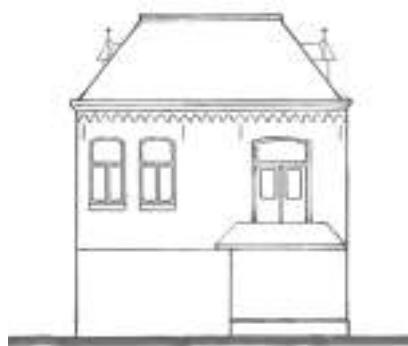
Back facade, 2019 (1:35)

The back facade consists merely of the first and second floor of the rectory and its smaller volume on the right. The left side of the facade is closed by the extention cennnection the rectory to the church. The back facade of the rectory is only visible for the visitor walking back from the church to the Misterstraat, but does not form a dominant presence in the sight of the visitor through the routing. The view of these windows from inside watch over the bitumen roofing onto the brick walls of the church.

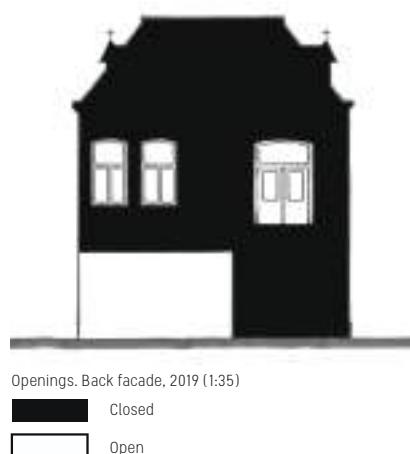
Openings. Back facade, 2019 (1:35)

The back facade only contains openings on the first floor of the rectory through two of the large vertical windows that also appear in the front and side facade, and a door that matches these two windows.

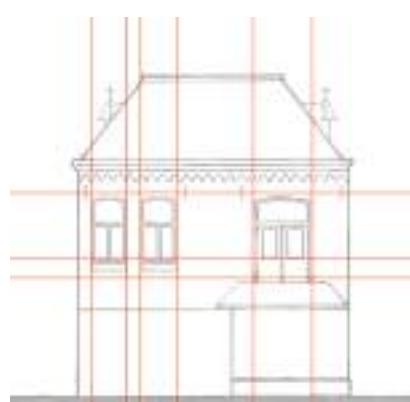
Rhythm by openings: Back facade, 2019 (1:35)

Similar to the side facade the facade openings are positioned on the sides of the facade plane leaving the middle of the facade a blank face of brickwork.

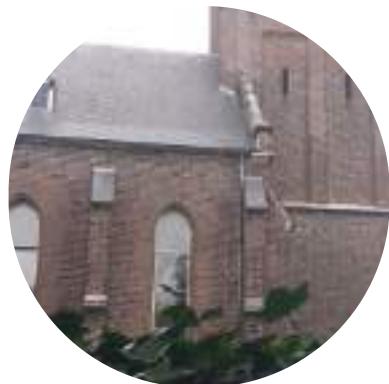
Buttresses (by authors)

Some elements like the buttresses on the exterior, the ornamented columns and the ribs supporting the vaults are elements of the style that also have structural function and are not simply decorative.

The buttresses have a main role in the structure of the building. Together with the walls they carry the wind forces and the roof structure. The buttresses also seem to have been altered in the top part. The same brick type of masonry means it was most probably altered when the windows were altered as well.

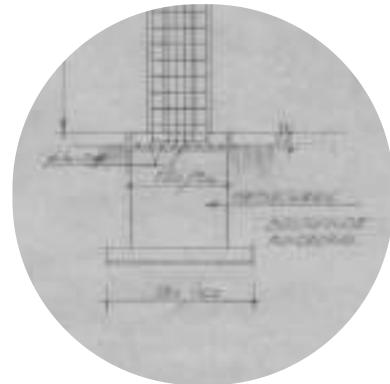
Information about the 19th century foundation only appears in drawings about the new foundations but is not detailed, the old foundation could also possibly be suggested according to the new column detail. The text reads "MASONRY EXISTING FOUNDATION", but doesn't contain any vertical dimensions. The foundation in the old building was made of bricks like the walls of the building. Masonry elements that run along the facade walls, the buttresses and the columns form the foundation. It is a typical type of foundation used in the Netherlands "fundering op staal" or "fundering op zand". The names indicate that the foundation lies on sand pockets in the ground that have load bearing abilities. This corresponds to the sand layers in the substrate of Winterswijk.

Column detail (archive drawing)

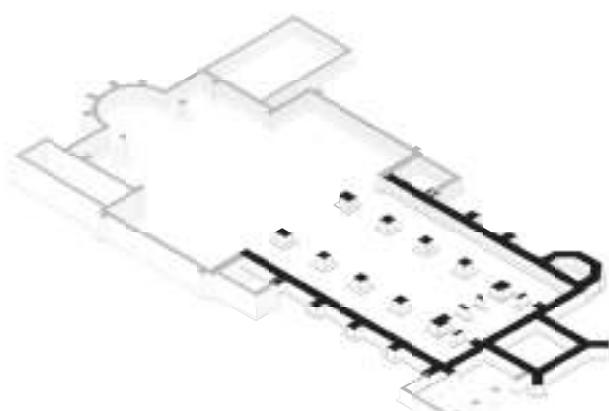
Old foundation in black and new foundation in gray.

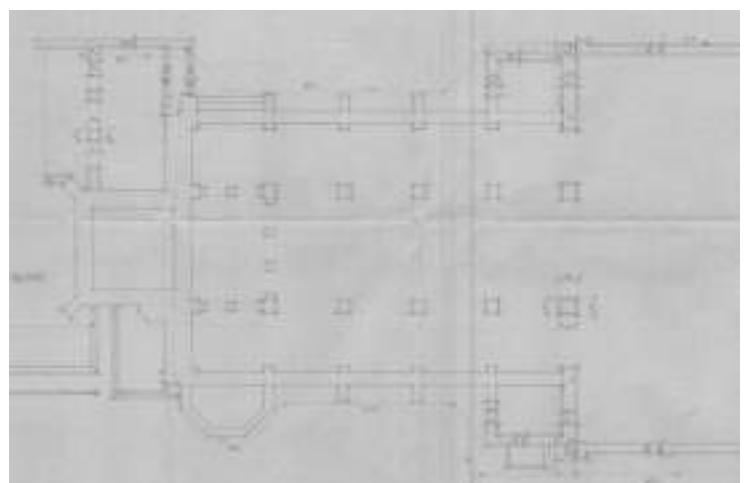
Foundation Plan from the 20th century extension. (archive drawing)

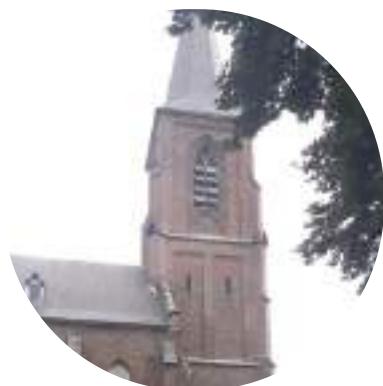
New (by authors)

The tower is the first interior space of the church. Due to its height, it's also the most visible part of the church, while the rest of the building is quite hidden between the neighboring buildings. The tower was constructed in two phases. The first part, visible in old photos of the building, was built in 1868 and it was heightened in the beginning of the 20th century to its current height. On the lower level the thickness of the masonry is 1000mm but it seems to be thinning the higher it gets. The position of the buttresses grants structural stability to the element.

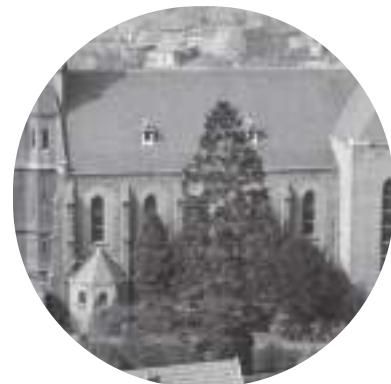
(source: wikipedia.com)

The masonry walls of the 19th century part are partly original but have been altered through the years. These changes are not extensively recorded or archived, but can be very easily observed on the exterior of the building. The interior doesn't offer any information about the condition of the masonry due to the layer of paint on top of it. The areas around the windows are altered to a brick with different color and striking.

These walls are connected to the buttresses and each has five windows

Length : 22.7m
Thickness : 900mm
Height : 13.3m

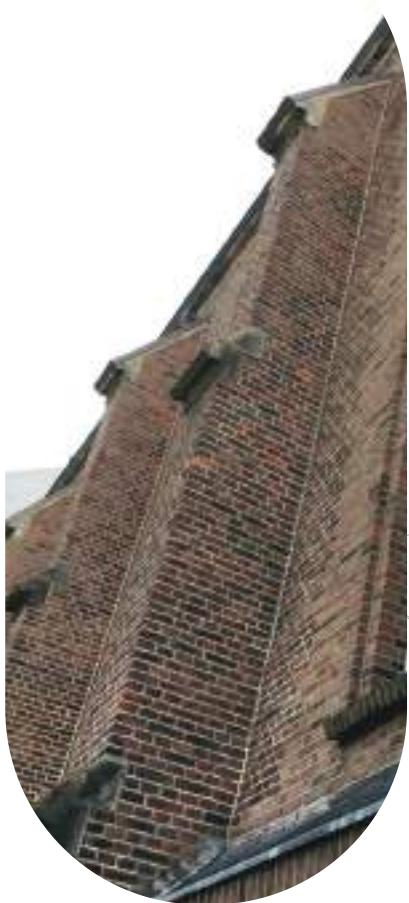
Buttresses (by Ariane)

Height : 12m

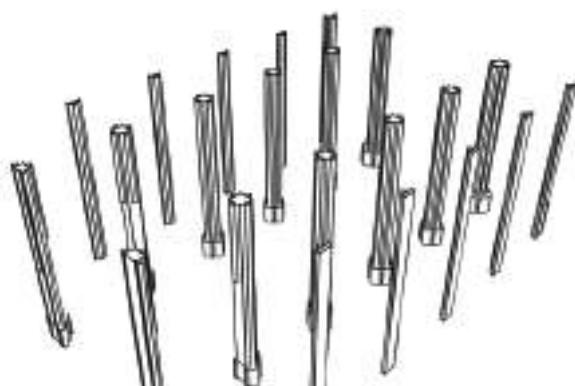
Columns and half columns

The actual composition is unknown and there are no drawings about it, but we can assume they are constructed by massive pieces of stone due to the lack of horizontal joints.

The building spirit of that time would ask for brick or wood, due to the scarcity and the high costs of stone in that time.

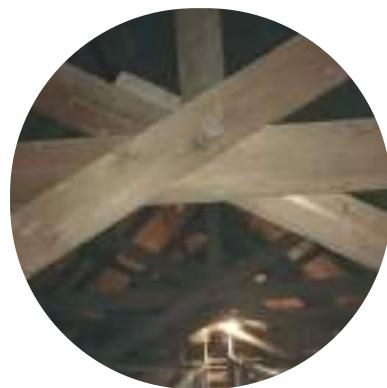
The secondary structure is connected on one end to the exterior wall connecting the church to the tower. The roof is covered in stone tiles. The exterior tiles have been replaced and the rest of the structure functions properly.

Roof trusses (by authors)

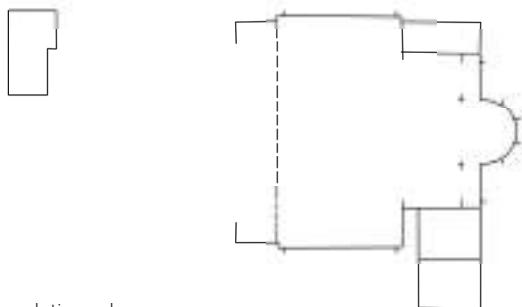
The foundations runs along the walls of the new part of the building.
The foundation is a meter high and rests on a layer of pure sand (bearing sand).
The sand layer is 3,4 meters deep.
The concrete foundations have different thicknesses that correspond to the wall thicknesses above them. The difference is between the main church space and the smaller spaces around it.

Foundation scheme

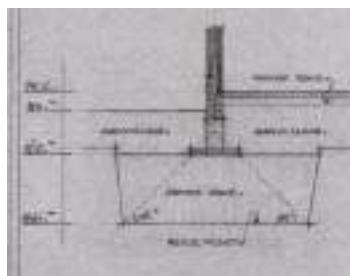
Foundation example 1
(archive drawing)

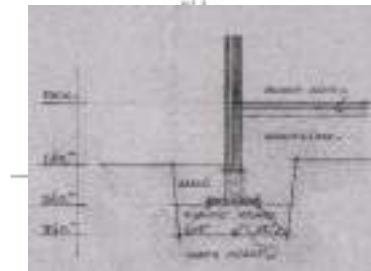
Foundation example 2
(archive drawing)

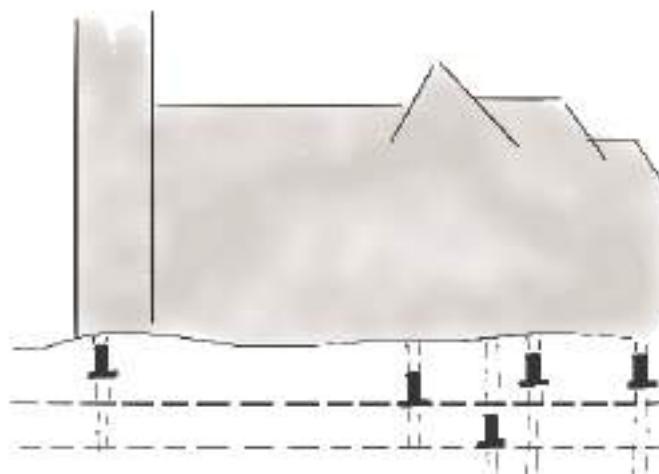
Section with foundations in different heights

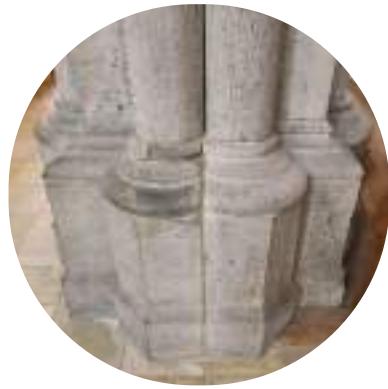
The columns on the new part are constructed from reinforced concrete and are covered with stone elements contrary to old columns that are from massive stone. They carry the vaults and they are part of the new wall between the two parts. These two columns are resting on the remaining foundation of the old building.

New column (by authors)

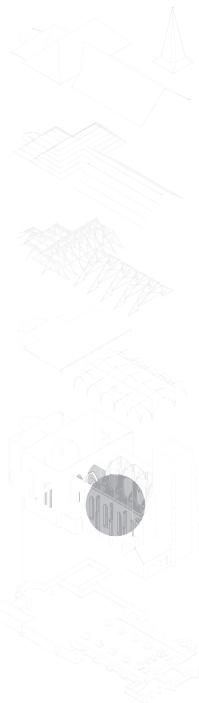
New column structural section

The new columns bridge the two structures of the building and could be easily mistaken as part of the old building. Their material matches that of the original but their size and design are different. These two columns are resting on the remaining foundation of the old building.

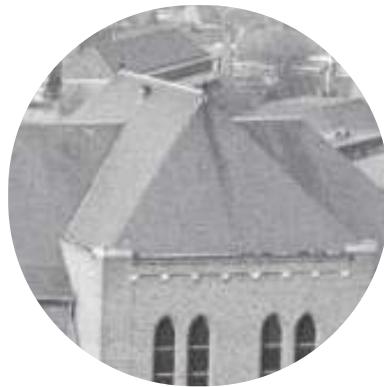
The roof structure of the extension matches the original roof structure in materialization and shape but it spans on a perpendicular direction relative to the old roof span. It is logical, considering the dimensions of the building are changing in the new volume. The new roof is constructed much lighter not only due to the smaller span but also due to different use of the material, with wooden elements getting thinner. The space between the elements is also much smaller. The first volume has two different types.

The roof of the extension
(source: wikipedia.com)

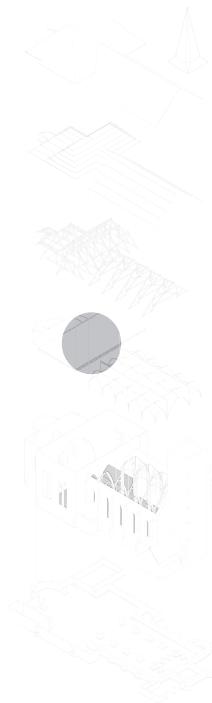
The main roof structure also carries the ceiling above the new nave. The tie beams or ceiling joists, form the main structure for the ceiling of the volume. On the top of the ceiling there is insulation but not in a very good state.

Details of ceiling

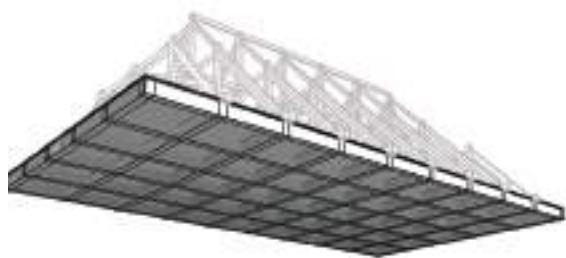
3d view of the ceiling with the roof structure

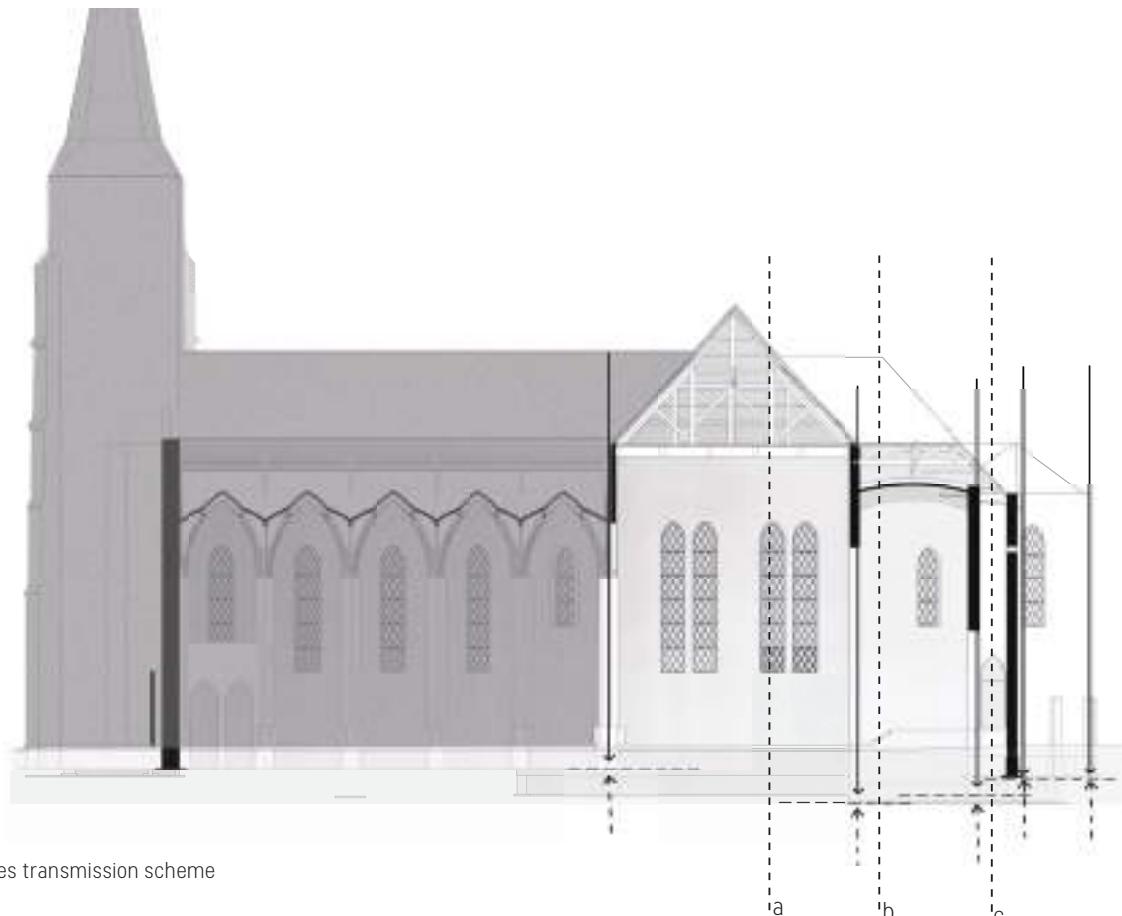
Vertical forces transmission scheme

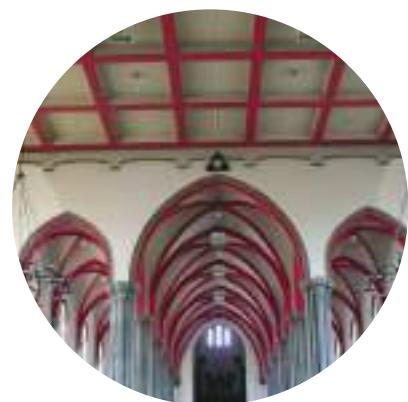
In the interior of the church the wall between the vaults and the new nave has two cracks that are visible. The cracks get thinner towards the arches, indicating that the problem is due to the load it receives from the roof and the thermal contraction and expansion.

Structural damage on the wall of the new nave (by Seong)

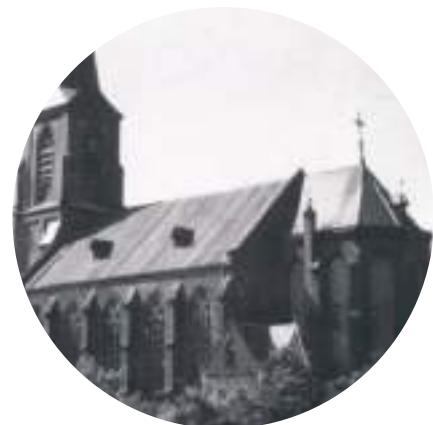
Figure 165 Picture of the demolished choir around 1945.

The first map shows the original design of the church. This second map indicates the existing situation in black and the pre-existing situation in color. During the renovations in the 1950s, the original choir was demolished and the church was extended to the rear and on both sides.

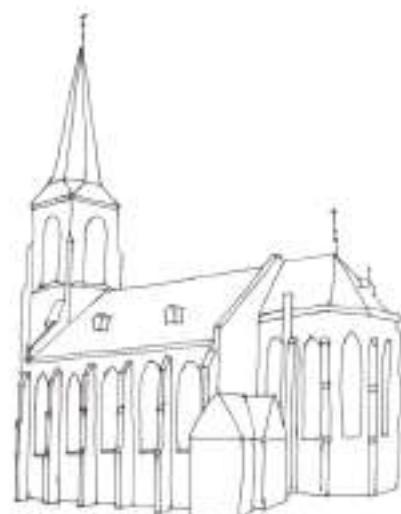
Figure 9 shows the volumetric composition of the interior space of the original church before 1953, which in terms of the sequence of spaces was much simpler than it is now. There was a front portal, the nave and the aisles and at the end the choir. It was a well proportioned church according to Koldeweij (1954), the architect who made the extension in 1953.

Figure 171 Illustration of the church before 1953.
