THE JACOBUSKERK

WINTERSWIJK

Heritage and Design Analyses Jacobuskerk Winterswijk
Heritage & Architecture
November 4th, 2019

Heritage & Architecture

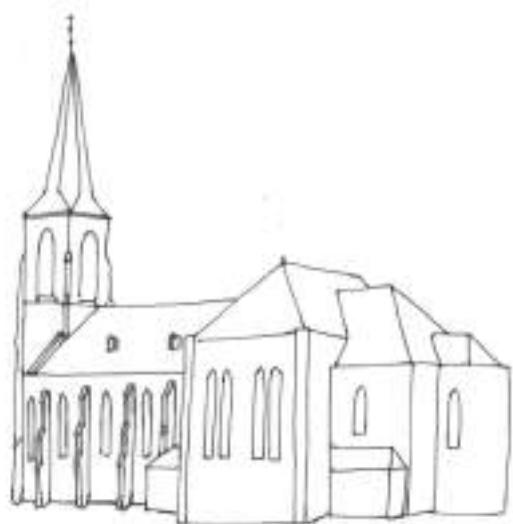
When looking at the volumetric composition of the interior of the church in the current situation, it is noticeable that there is a big difference between the original part and the part built after 1953. Different proportions and shapes have been used. The sequence of space became much more complex. One goes through different spaces with different characteristics and atmospheres. The next chapters will focus on this spatial sequence and the characteristics of these spaces. The comparison will be made with the original design.

Figure 173 Illustration of the church after 1953.

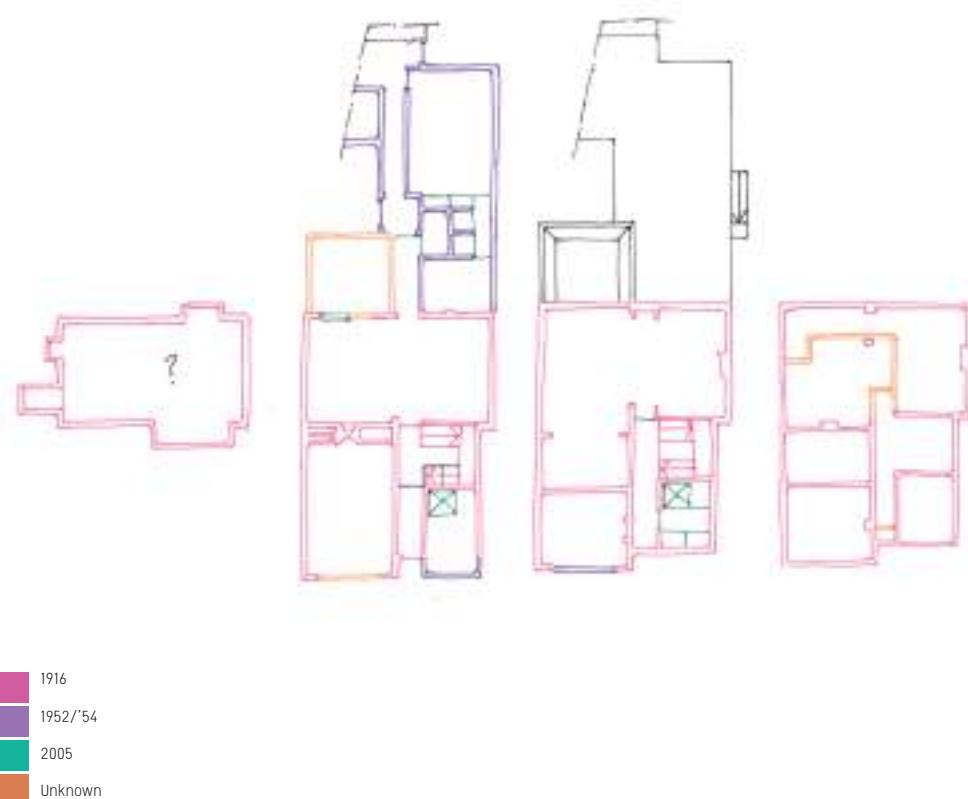
The development of the rectory is summarized in this map. During the 1950s renovation of the church an extension was made to the rectory to make a connection with the church. During this also extra spaces were created. Of some parts it is uncertain when they were adjusted. Nothing is known about the basement since it was not accessible.

Figure 199 Map indicating the different building periods of the rectory 1:400.

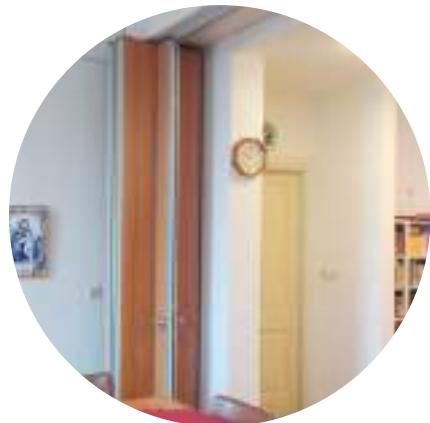
Figure 200 Picture of the partition wall in the communal space on the ground floor.

These maps show the changes that were made to the original floorplan. The most notable change is the extension that was built in the 1950s. Besides that, multiple partition walls have been demolished to create bigger spaces. In some spaces sliding walls are placed, making them flexible. Another visible change is the suspended ceiling that is applied in several rooms. There are still a couple of rooms with the original ceiling height, in which the decorated ceiling is visible.

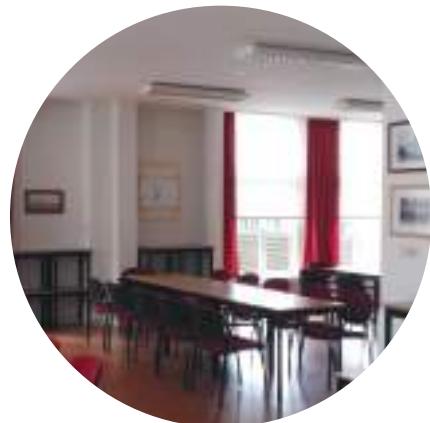
Figure 201 Picture of the communal space on the first floor, in which the walls have been demolished.

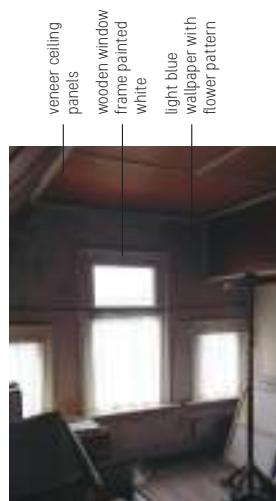
Figure 219 Storage/former bedroom.

Other than the other floors in the rectory, the walls in the attic are painted in a light blue color and there are unfinished wooden floors. It is possible that this is the original color that was used for the walls of the rectory, since the attic has not been used for a long time, but this is just a hypothesis. The rooms show signs of neglect, the surfaces are in a bad condition.

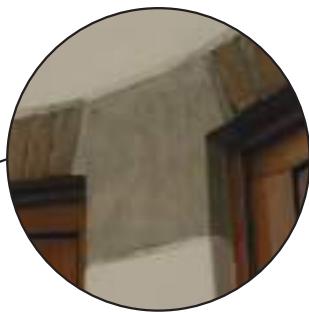
Natural stone elements, columns and vaulting.

The general implementation and expression of materials throughout the church is visualised in this representational model. Although there is a slight diversity of material implementation present throughout the interior of the church, forming an exception on the representational model, the model succeeds to represents the generally coherent atmosphere throughout the whole church created by the most dominantly implemented materials.

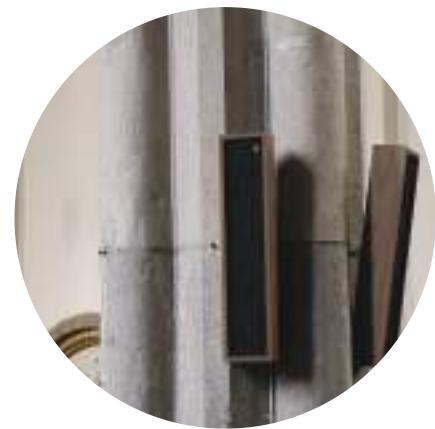
Figure 230 Picture of the sound installation.

This map shows the applied sound system. The red line shows the audio induction loop, which is a system that ensures that hearing impaired can listen to the sound in a church building without disturbing ambient noise. A listener with a hearing aid or cochlear implant can use the loop by setting the device to the T position. The audio signal is connected to an amplifier, which sends the sound signal through a wire that is laid in loops along the plinth. The hearing aid receives the signal from the loop through induction.

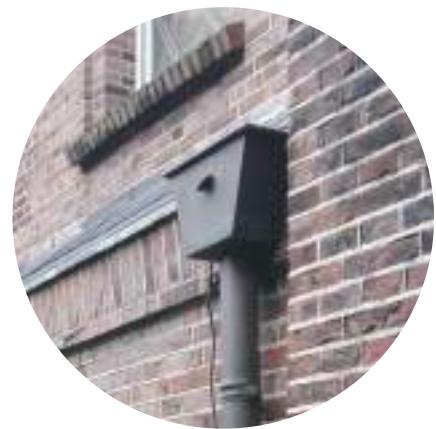
Figure 240 Downspout.

This map shows the rainwater drainage from the roof of the church. In the tower no rainwater drainage is present.

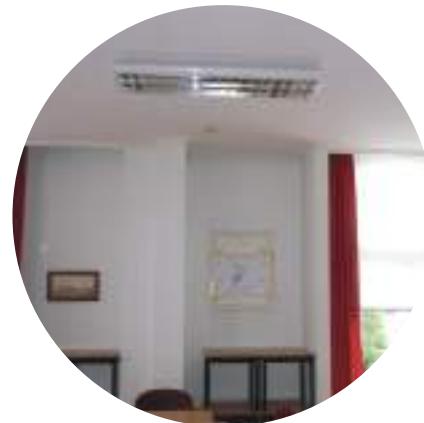
Fluorescent tube lighting.

The spaces where a suspended ceiling is applied are illuminated by fluorescent tube lighting which are placed in this ceiling. In some spaces, no suspended ceiling is applied and the original ceiling is visible. One of these examples can be seen on picture 2.

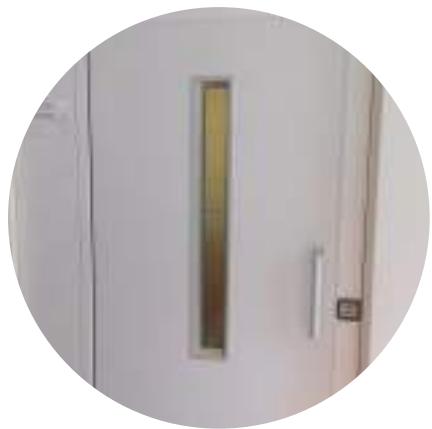
The elevator in the rectory.

During the renovation of the interior in 2004/05 an elevator was placed, also making the first floor of the rectory accessible for everyone. The elevator does not go to the attic.

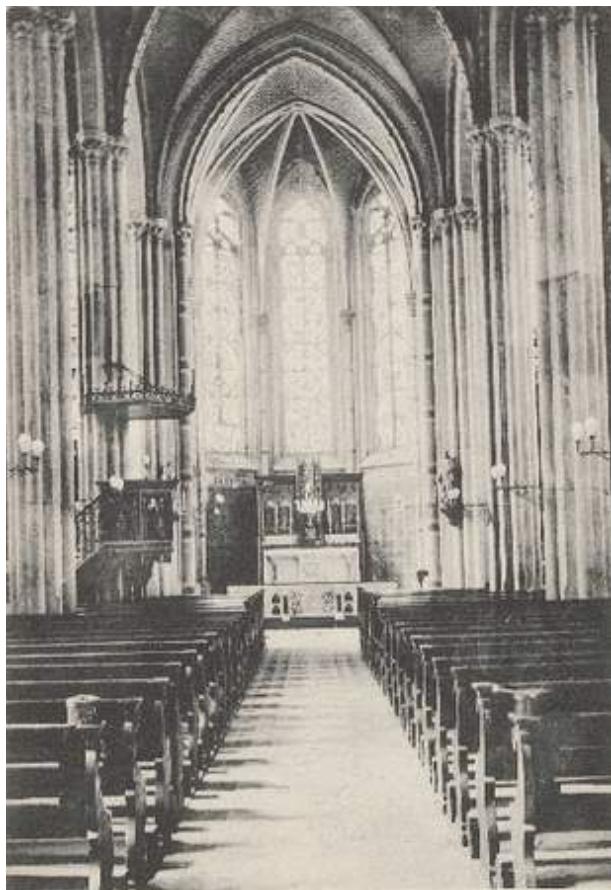
A. Figure 249 The old choir with its neoclassical windows, on the left the pulpit and in the front the communion bench are visible (Meerdink, 1995, p. 48)

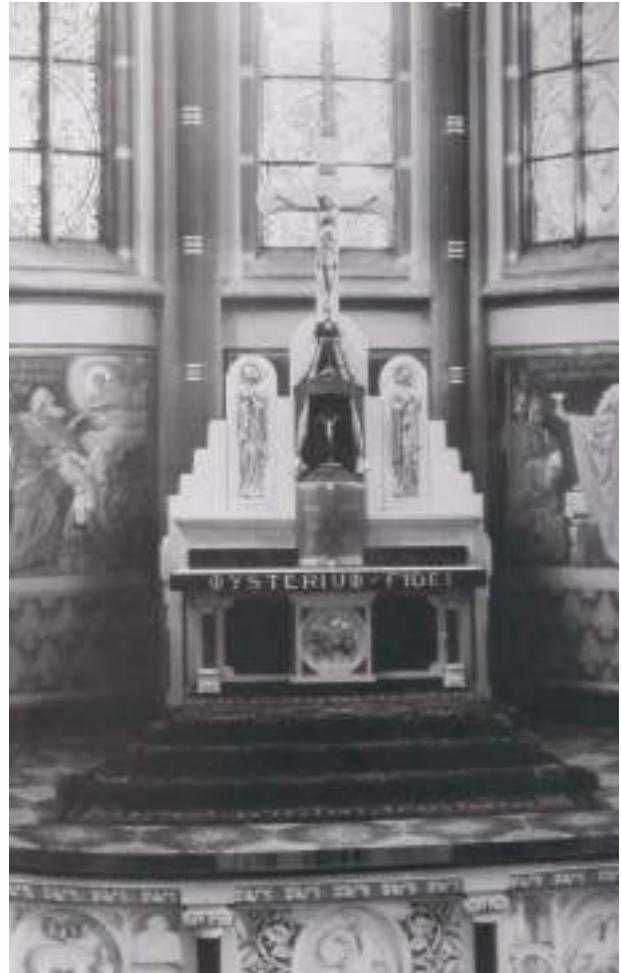
B. Figure 250 The old choir was richly painted and the altar stood on a pedestal (Meerdink, 1995, p. 57)

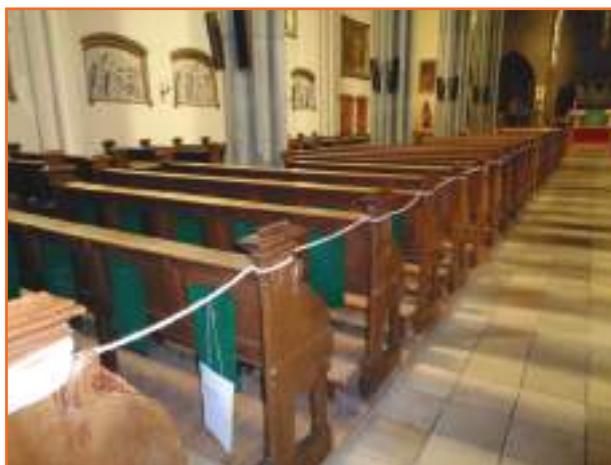
C. Figure 251 The original church pews are still there, they are probably from mid 19th century.

Also some non-religious items in the Jacobuskerk are already very old, for example the church pews from the mid 19th century. In contrast to for example house and office furniture that has a lifespan of years or decades, these pews have been around for about 150 years, and they are still in a good condition. Sometimes they are still used, but only when the church is really full. Usually they are closed off with ropes so that people will sit in the front.

The church pews in the old part of the church look worn and used over the years. Also their decoration recalls previous times. For that these have age value.

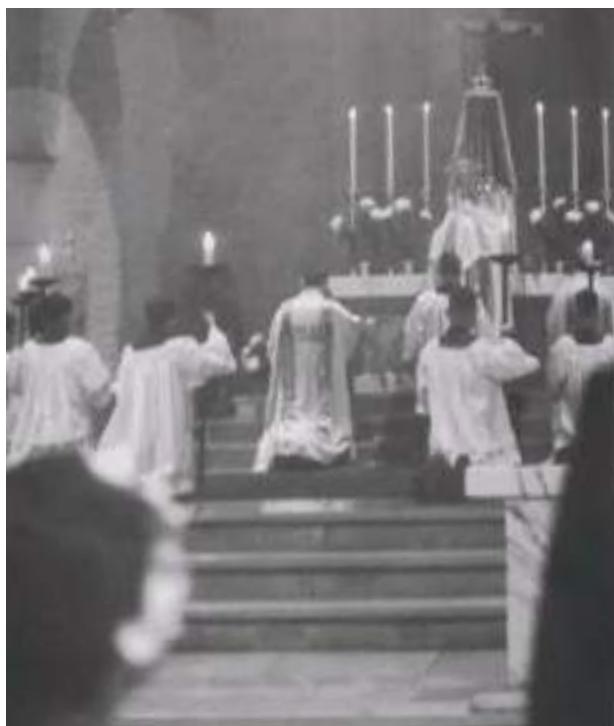
B. Figure 256 The altar was put on a pedestal and stood in the rounded vault at the end of the choir. This altar was made in the 1950's of natural stone. (Meerdink, 1995, p. 158)

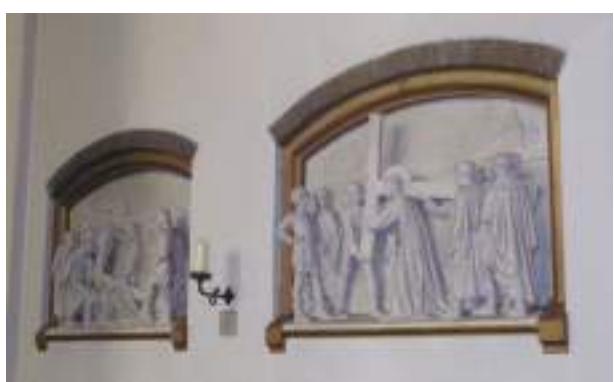
D. Figure 258 The 14 stages of the cross were painted white in the 1950's. They were originally polychromed, and made of gypsum in 1911.

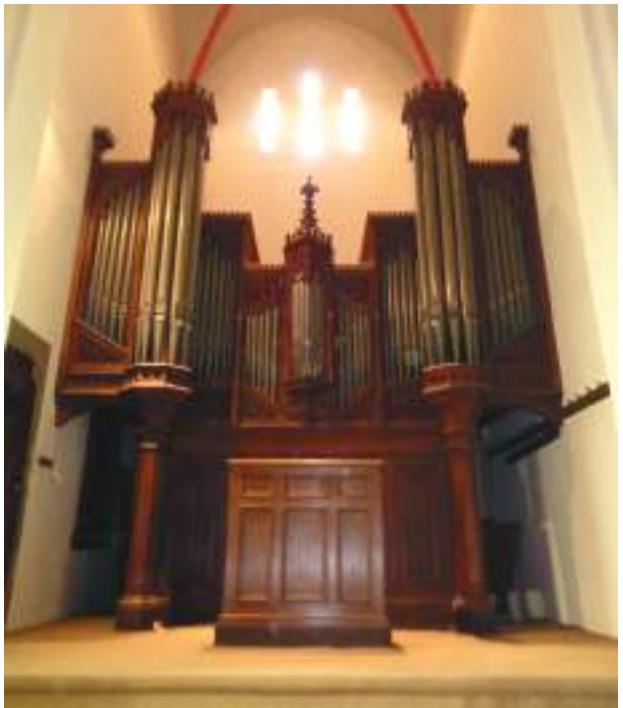
E. Figure 5 The organ was built in 1905 by the firm Maarschalkerweerd and was pneumatic. It is located in the tower on the same height as the choir floor.

E. Figure 5 The organ was built in 1905 and therefore has a high historical value.

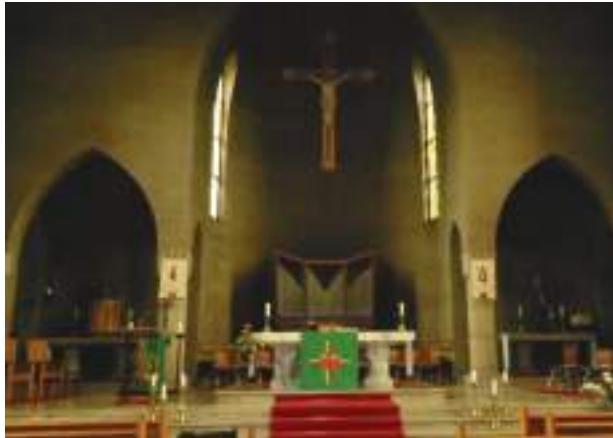
A. Figure 260 Nowadays the altar is more in the front than the original position. It is still on a pedestal. The altar table weights 40 tons. The cross is from 1953.

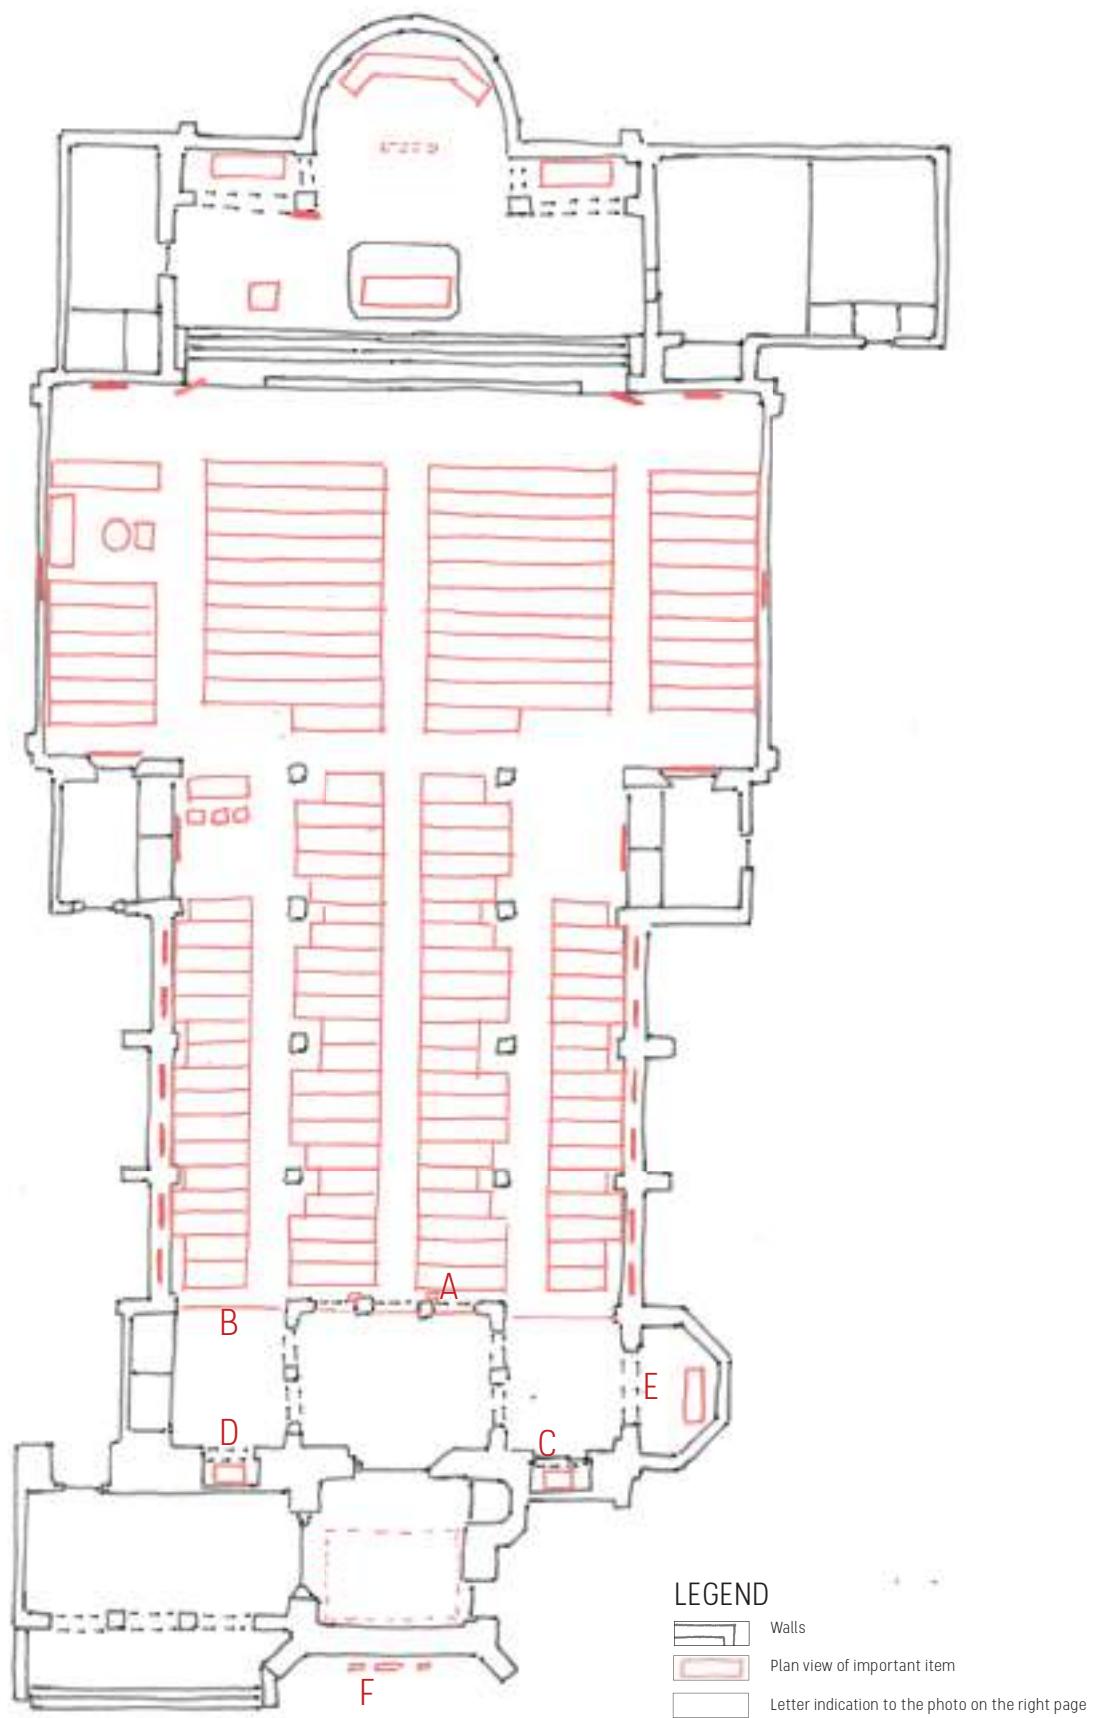
Figure 276 The floor plan of the Jacobuskerk of 2019 with in red drawn all the important items.

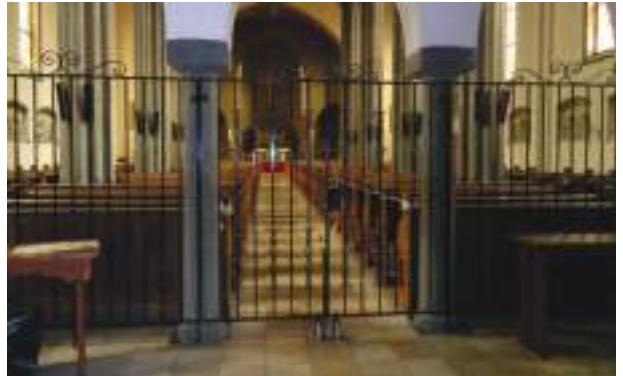
B. Figure 278 The iron fence is added in 1994 to prevent people from entering the nave during the day when there is no one to watch. The church is open every day for personal prayers.

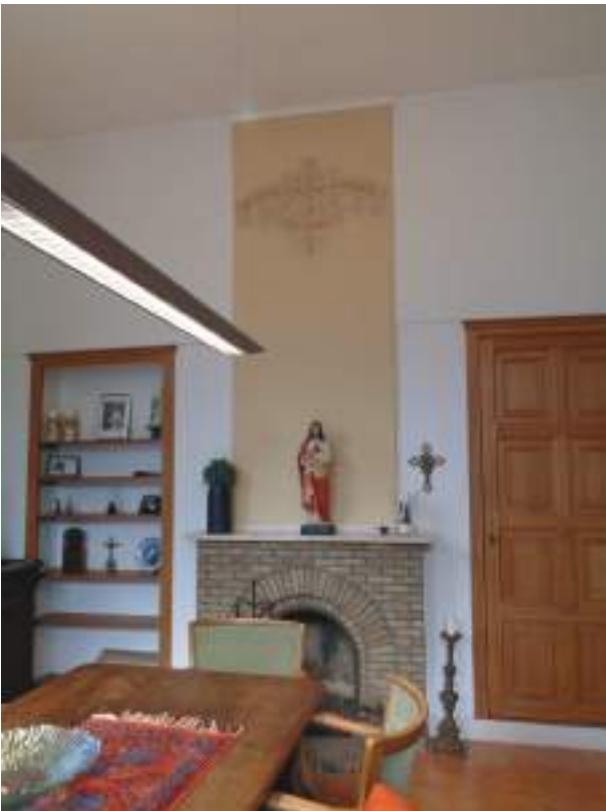
B. Figure 284 The chimney is probably from the construction year 1920. There is a nice wooden table with old chairs, but we don't know the age. The text that hangs on the wall is in latin and probably religious. We don't know the origin of these objects. the original ceiling is preserved here.

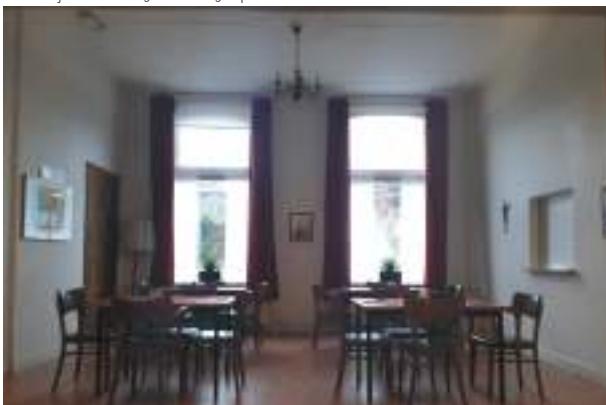
G. Figure 285 The original ceiling is here preserved and a nice chandelier is hanging from it. The wooden furniture looks nice but not very special.

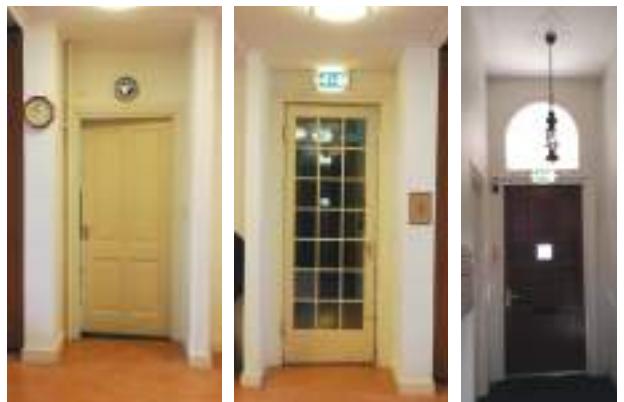
D., E. & F. Figure 287 There are several doors, probably from 1920, of wood, with nice detailing. Maybe the yellow is not the original colour, D is the closed light yellow door, E the glazed door and F the front door.

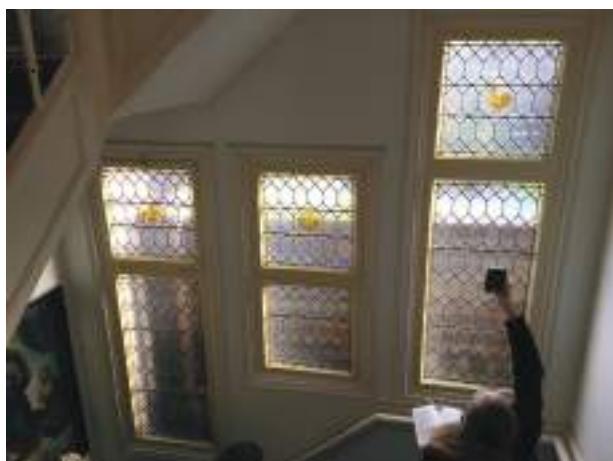
Figure 290 Halfway the stairs, there are very nice stained glass windows that have been there since construction.

Another significant element of the interior is the stained glass, used in the stairwell. Yellow stained glass figures have been incorporated: a rooster, a sun and an eagle. These figures are described in the bible. When the sun rises the rooster starts crowing.

A. Figure 1 On the height of the first floor there are stained glass windows at the side of the stairs, they have a high monumental value.

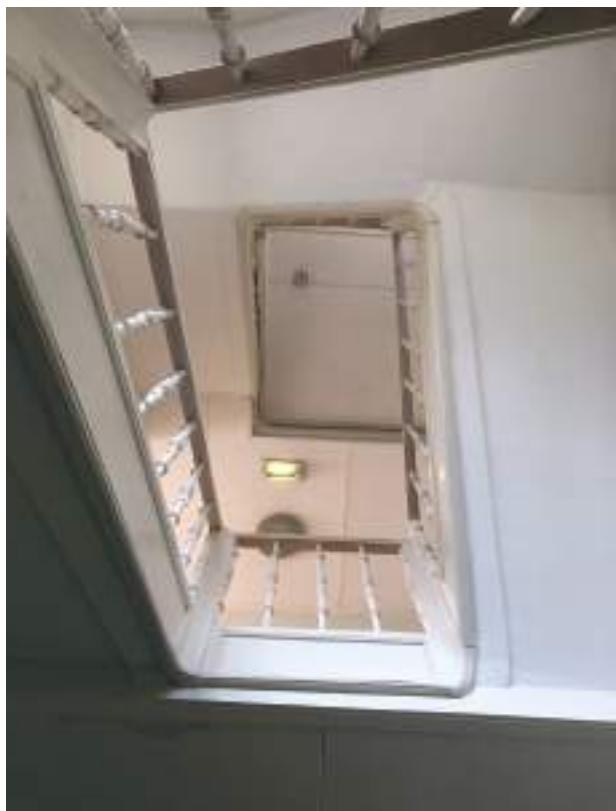
G Figure 294 Here the stairs are seen in total. they are really the central element of the building.

In the rectory the stuff is mostly less important. There are hardly any religious objects and the stuff is mainly furniture. A part of the furniture is nice and old so it is worthwhile to reuse. The stairs are the main eye catcher of the rectory so they should be kept if possible. The more modern furniture like in the coffee room is not that valuable, but it is still in good condition so if it can be reused for the new function that is nice.

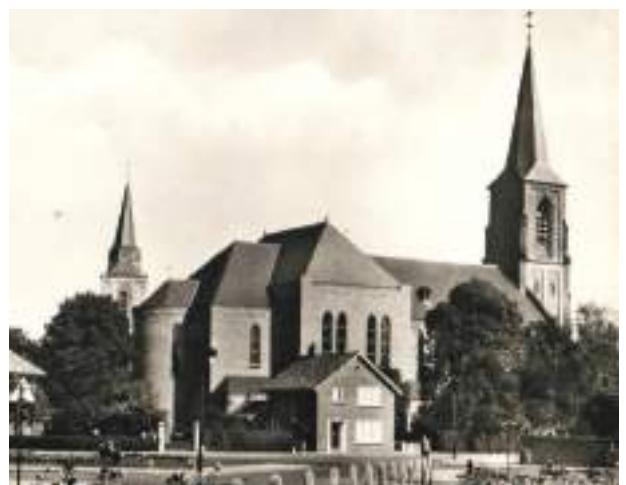
Figure 2 The Jacobuskerk after the extension with the new choir (Meerdink, 1995, p. 39)

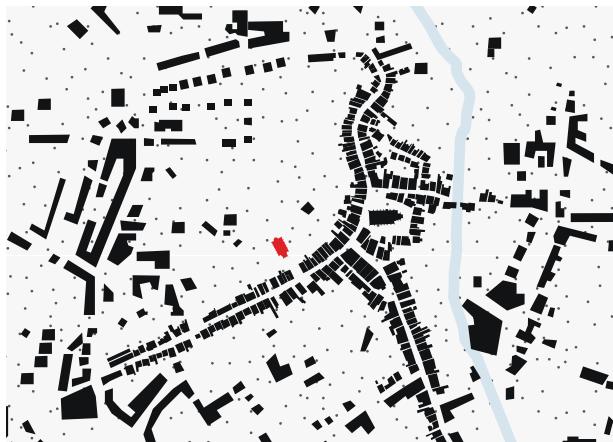
Figure 2 The historical street pattern is visible here, you can still recognise it.

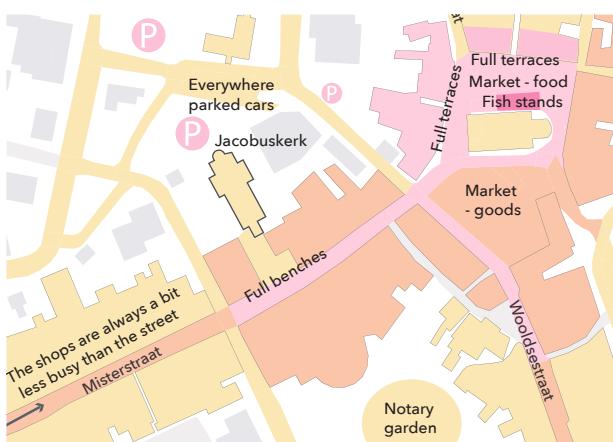
Figure 2 The location close to the market and at the busy Misterstraat is visible here, it has a positive use value.

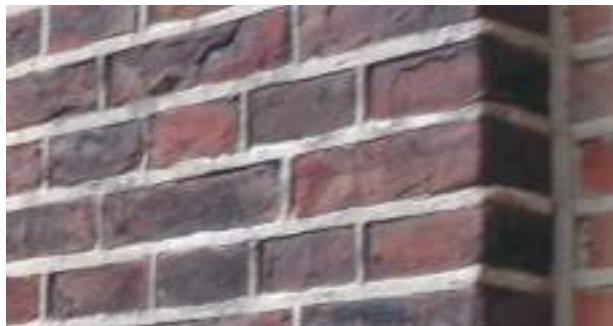
Figure 2 The patina on the old bricks gives the skin age value

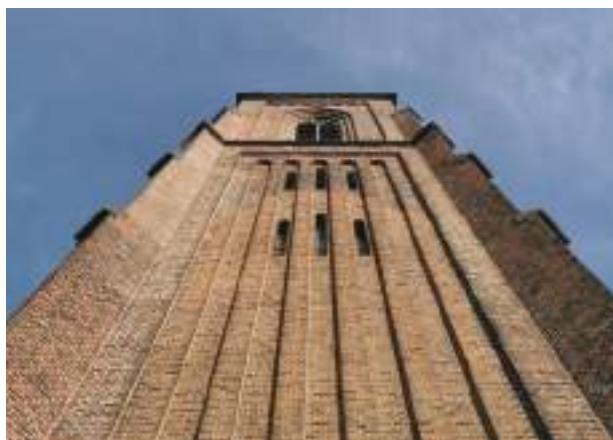
Figure 2 The neogothical elements in the skin have historical value

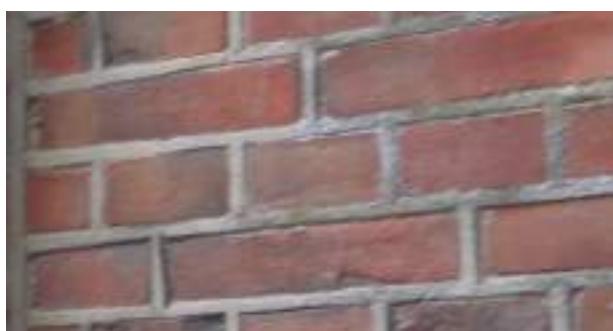
Figure 2 On the contrary, some of the 1950's parts of the facade have brickwork that looks quite new and gives newness value.

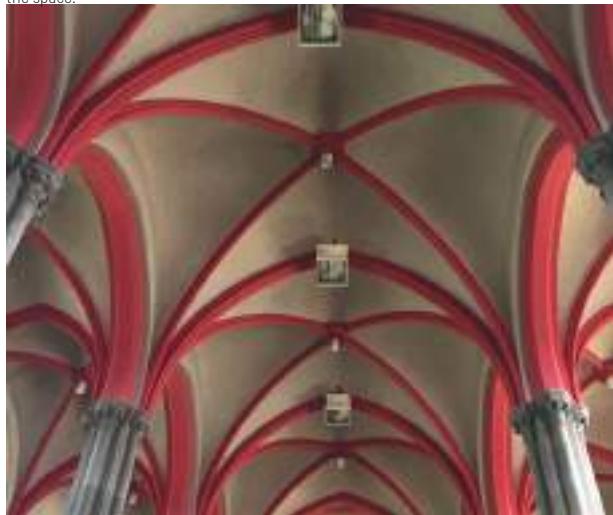
Figure 2 The first stone vault of Wennekers has historical value

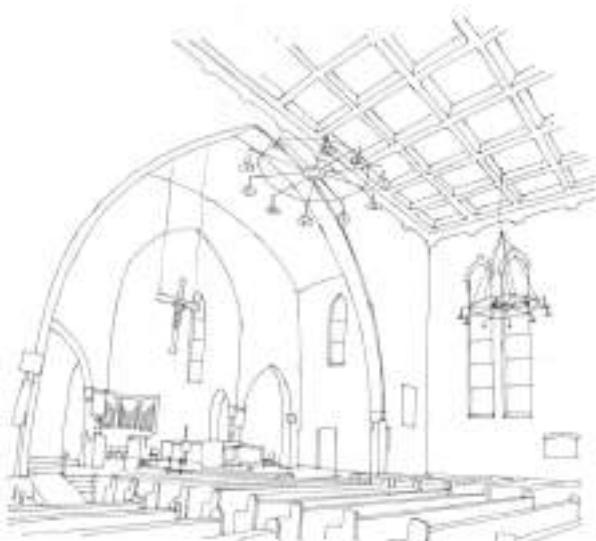
Figure 2 The use value of the big open space can be seen here

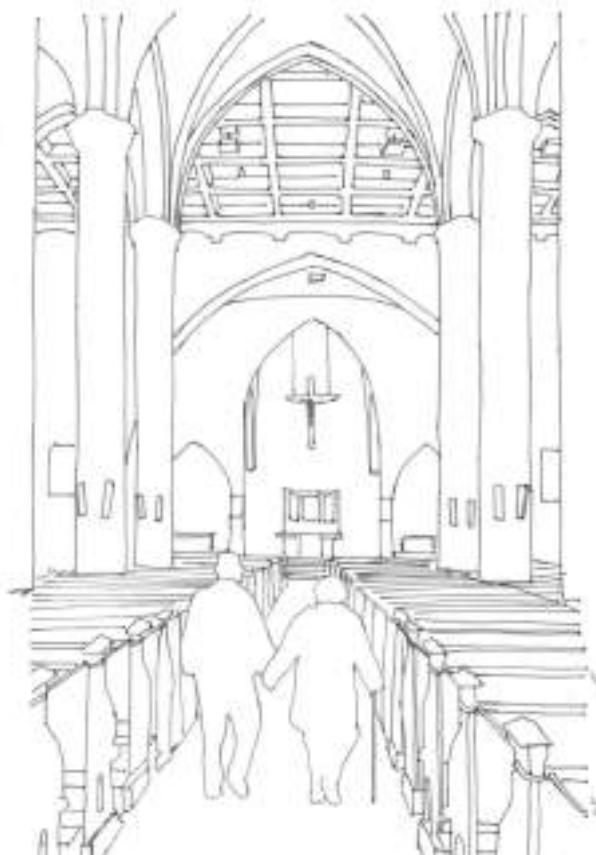
Figure 2 The relationship between the old and the new part brings historical value as it is a time layer added to the church.

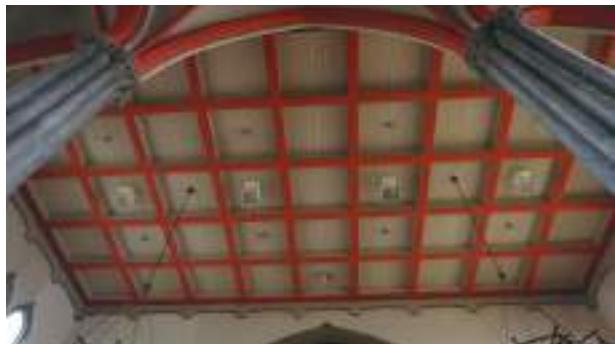
Figure 2 The ceiling of the new part is made of softboard which has good acoustic qualities.

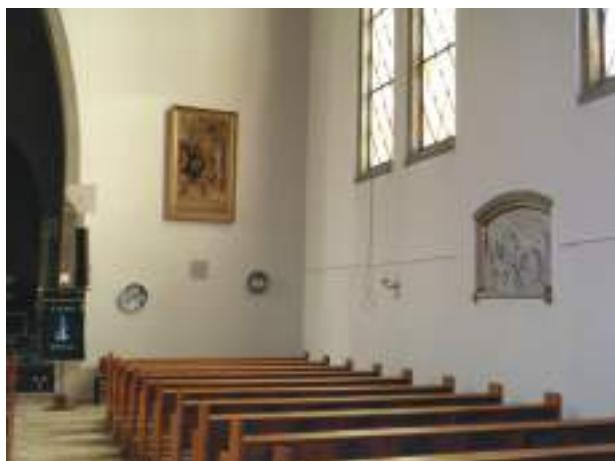
Figure 2 The neatly plastered wall has newness value.

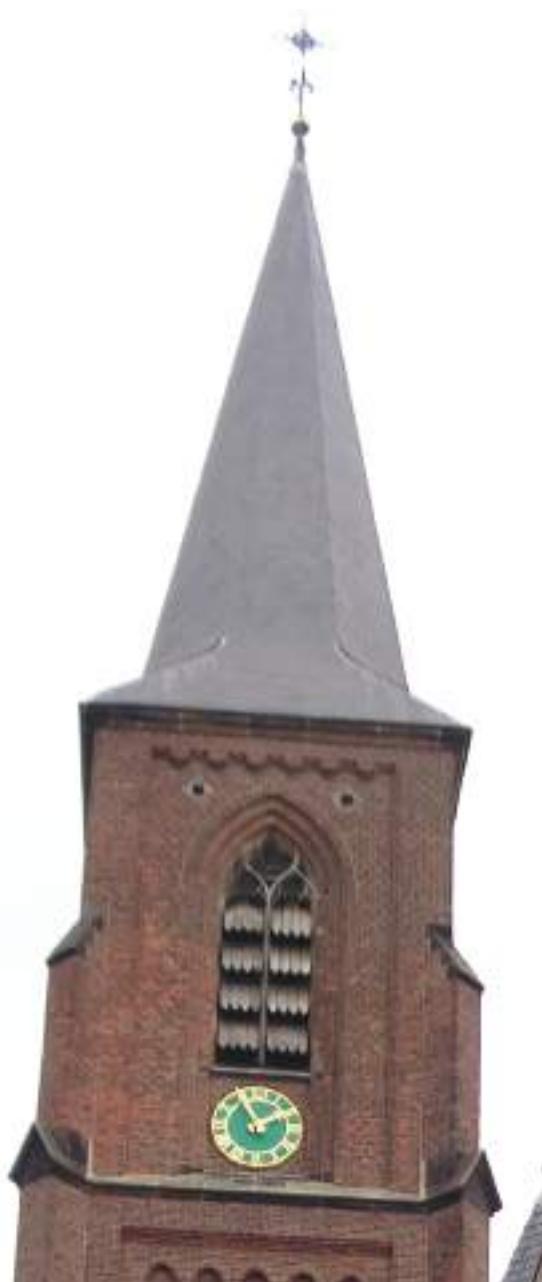
Figure 2 The clock is not valued a lot because of aesthetic reasons but it has historical value.

The clocks on the tower add historical value as historically church towers have had clocks. The fact that this is not an old or original clock gives these clocks quite a low rating on historical value.

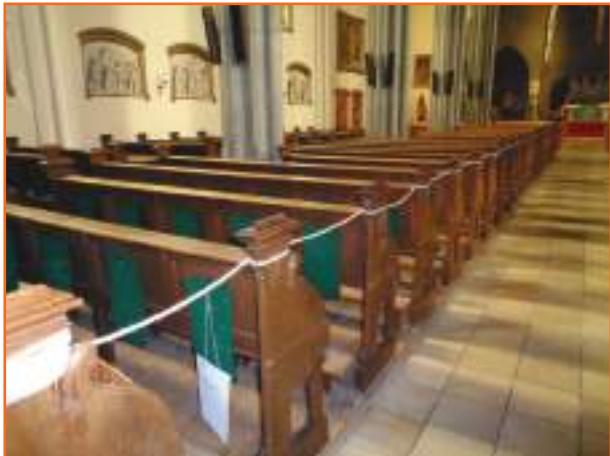
Figure 2 The church pews have patina and for that have age value.

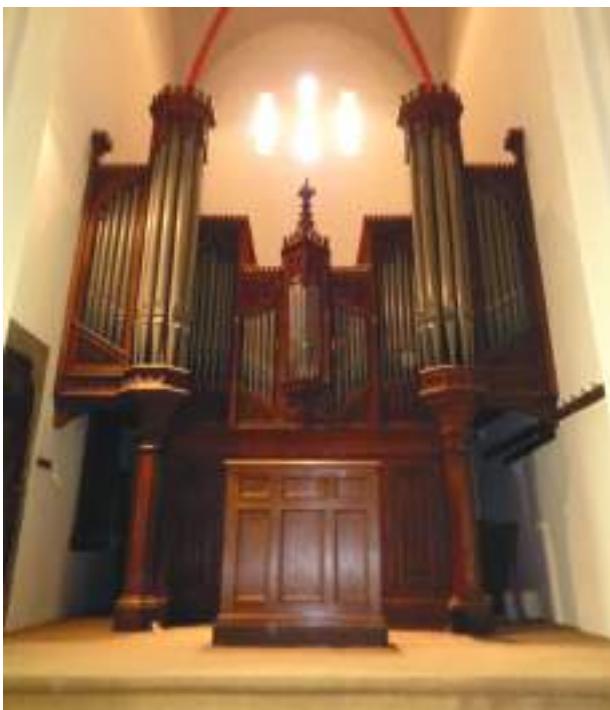
Figure 2 The old organ has historical value. As there is a new organ closer to the choir it has less use value than it used to have, but it is still working.

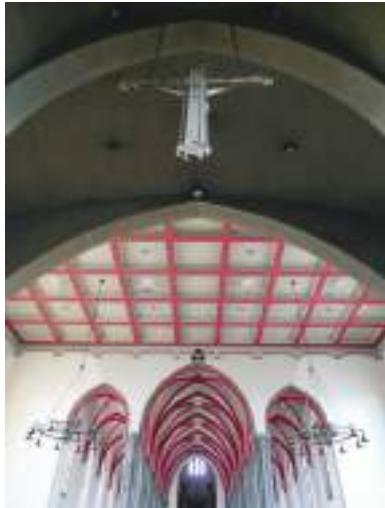
I. Figure 3 Here the relation between the three ceiling types is seen. On the top I, the masonry vault of the choir of the new part, which has a positive monumental value. Under that II, the cassette ceiling of softboard which is in quite a bad state and has a low monumental value. On the back III, the neogothical cross rib vaults. This ceiling is valued the highest for its age and craftsmanship.

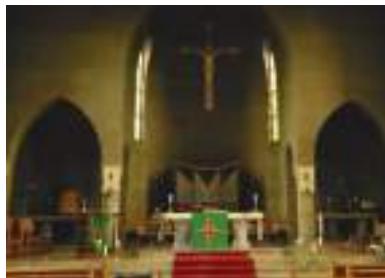
A. Figure 1 A lot of the stuff in the choir of the church has religious value: From left to right the Jacob's altar with tabernacle, the crucifix and altar, and the Maria altar.

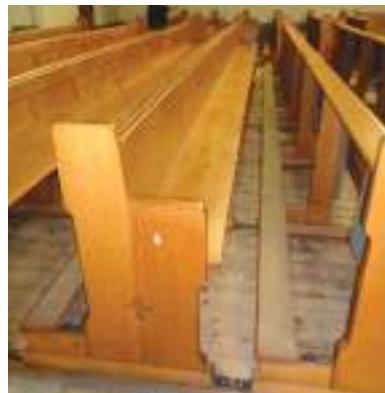
B. Figure 3 The church pews of the 1950's have positive monumental value.

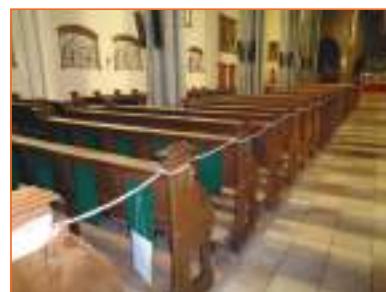
C. Figure 1 The original church pews have a high historical value as they are quite old and have original details.

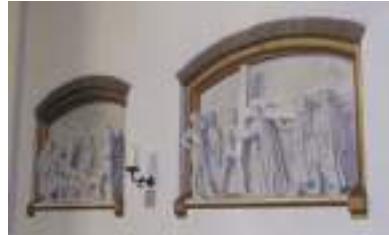
D. Figure 4 The 14 stages of the cross were painted white in the 1950's. However they still have a high religious value.

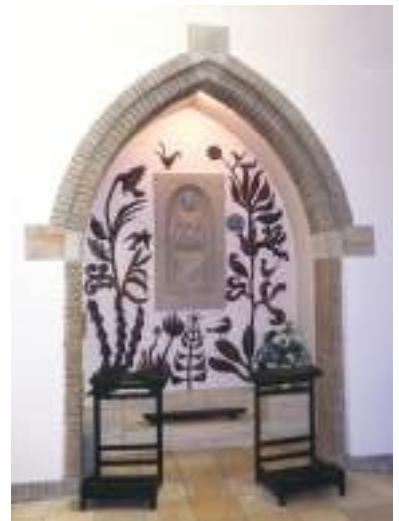
G. Figure 4 This altar for Saint Antony has a high religious value as well and is also daily used for worshiping.

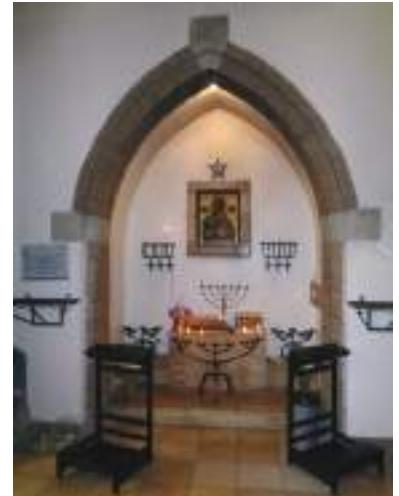
H. Figure 3 The icon of Mary of Perpetual Help is used for daily worshiping and because of this of high religious value.

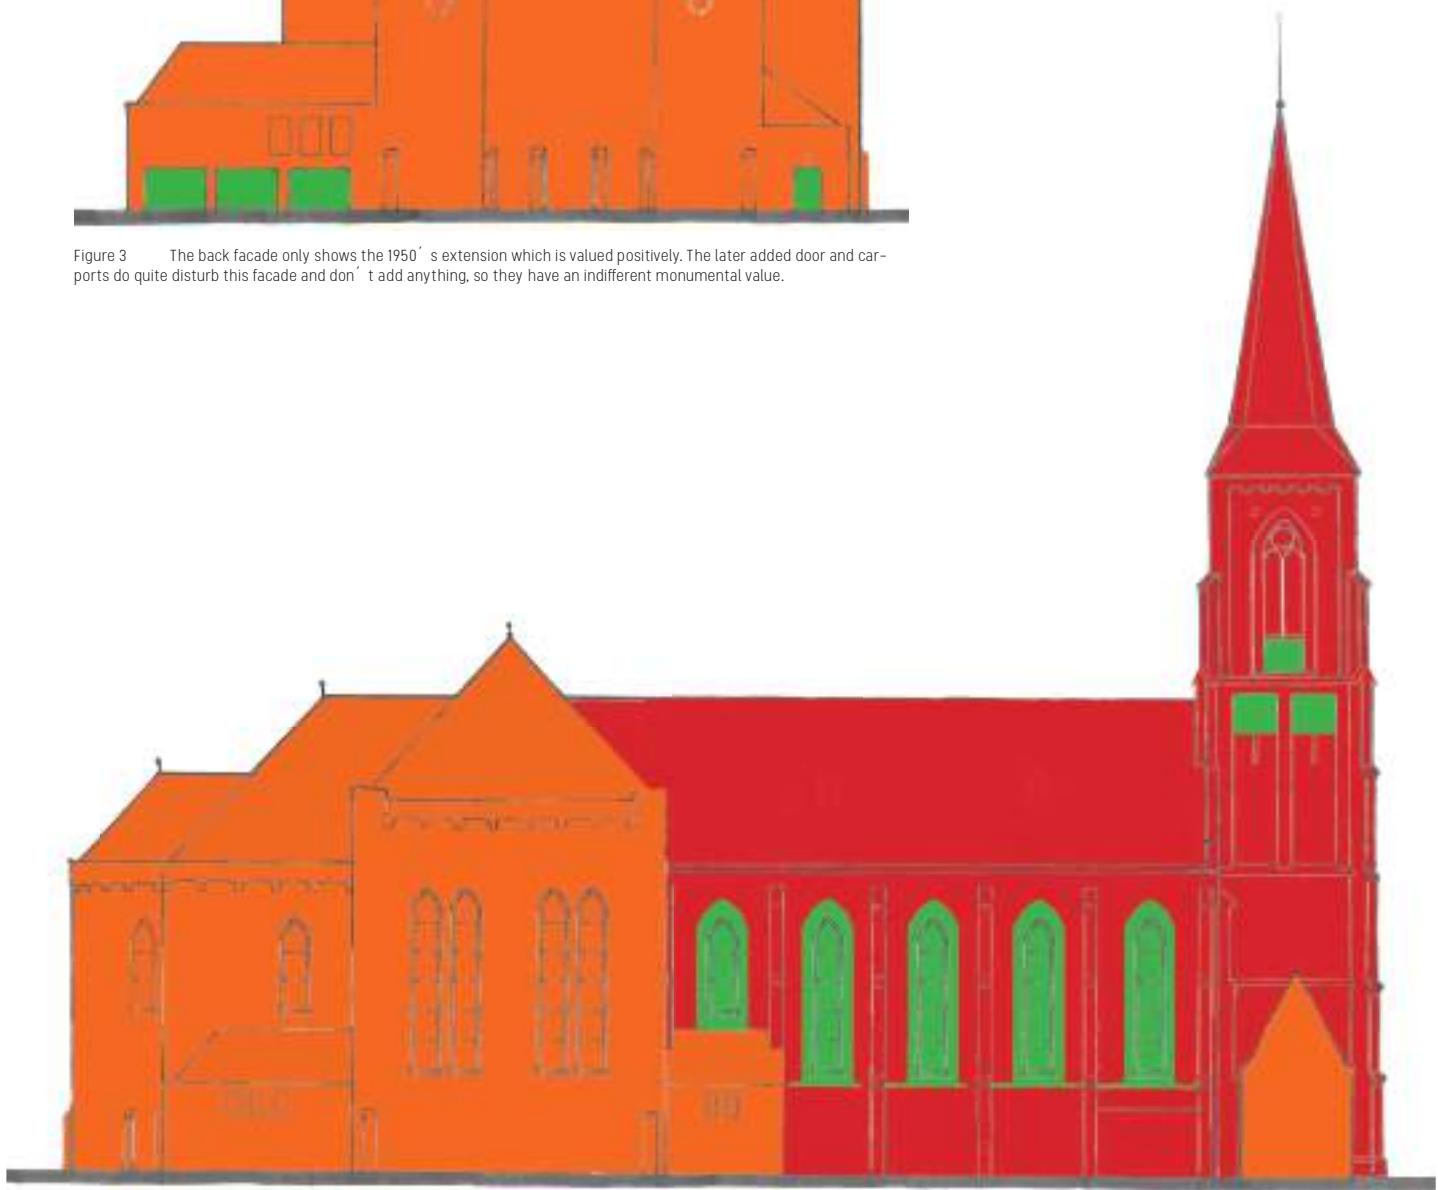
Figure 3 In the side facade the same as in the front facade is seen. All the original neogothical parts have the highest monumental value, then the extension parts and then the smaller windows and new bricks in the existing neogothical facade.

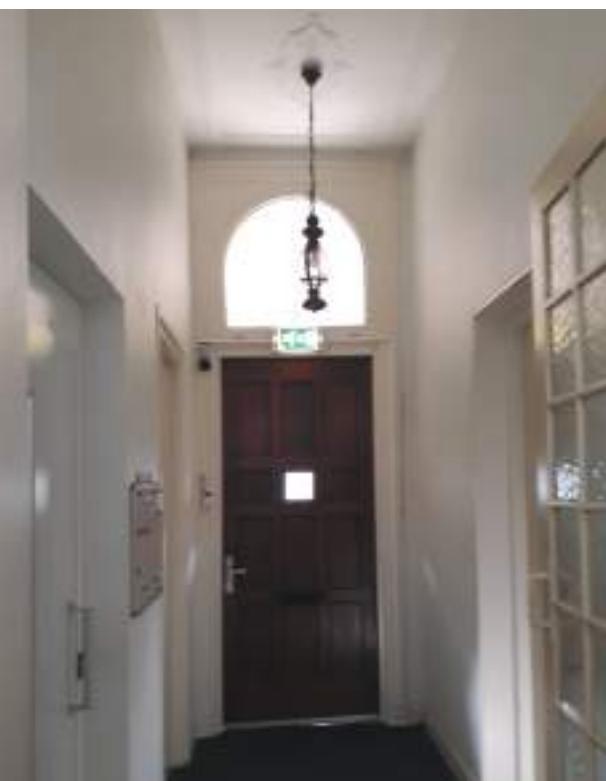
III, E. Figure 1 The front door has a positive monumental value as it is an old wooden door, the ceiling has a high monumental value being original from the construction phase.

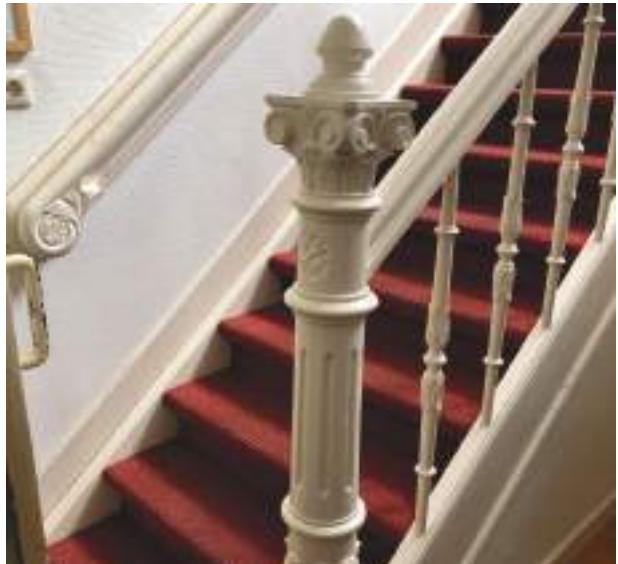
B. Figure 1 The stairs are the most important interior object of the rectory. They are richly decorated, a symbol of craftsmanship with high historical value.

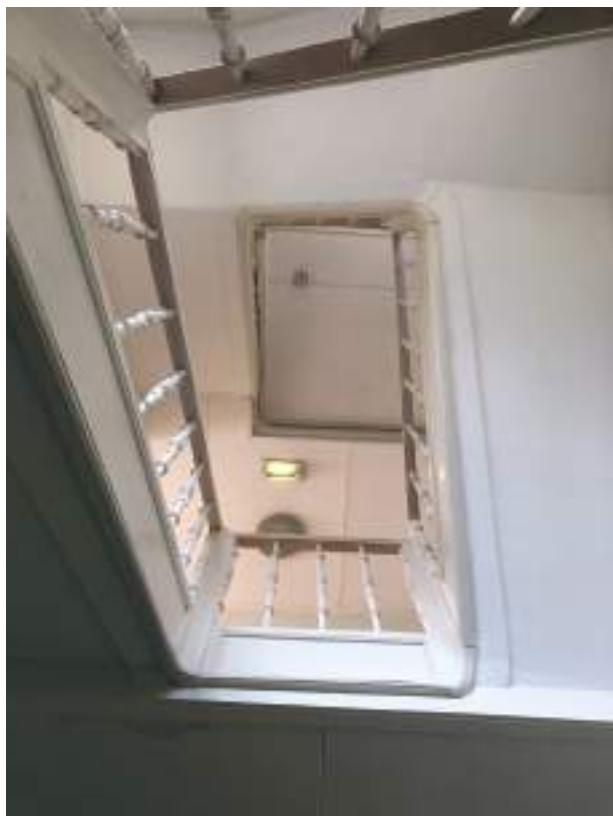
A. Figure 1 The stairs continue all the way from the ground floor to the attic and form the backbone of the rectory.

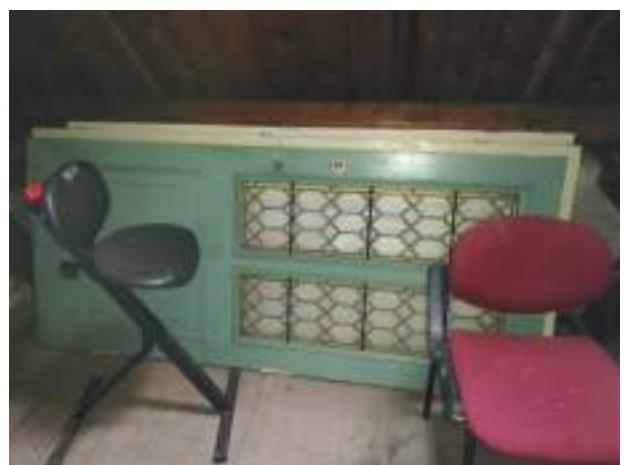
B. Figure 1 These doors are in the same style as the doors on the ground floor. We don't know from which rooms they were but they still have a positive monumental value.

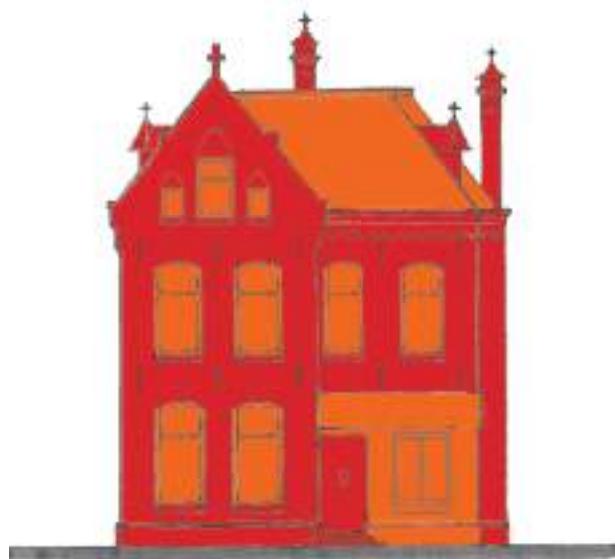
The front facade is valued quite positive. The original brickwork is highly valued, just as the dormer windows. The windows positively just as the roof tiles as not s is valued positively as it's 1950 all of them are original. The addition on the front of the .matches the existing quite well but it is younger

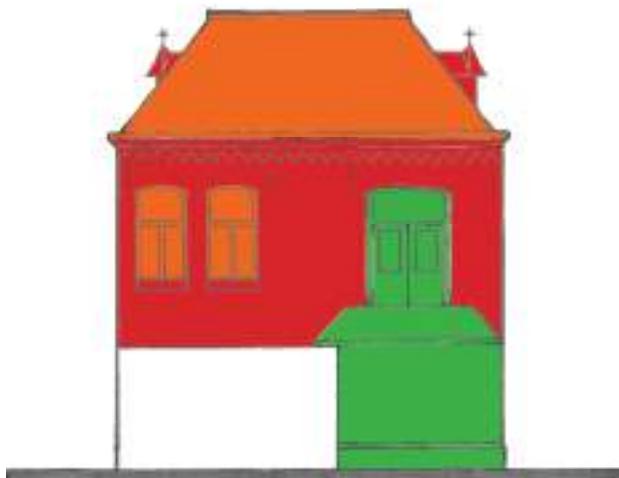
The back facade shows a mixed valuation. The original brickwork is highly valued, just as the dormer windows. The windows positively just as the roof tiles as not all s that connects the rectory to the church is 1950 of them are original. The extension of the .valued indifferently as it is not a special design
