Widening a harbor basin, demolition of a deep sea quay wall in Rotterdam

Erik Broos, Rob Sibbes, Jarit de Gijt

Abstract: The rapid development in containership dimensions creates a huge challenge for ports. But for one port basin in Rotterdam this challenge was too big. The nautical restrictions for the Amazonehaven would start at such moderate conditions that the basin would be closed for Ultra Large Container Ships (ULCS) about a 100 days a year. As this basin contains more than 60 percent of the deep sea quay length at ECT, Europe's largest container terminal, the Port of Rotterdam Authority decided to widen the basin by demolishing the opposite iron ore bulk quay wall. In this way vessels up to 18.000 TEU have access up to 6 Beaufort wind speed.

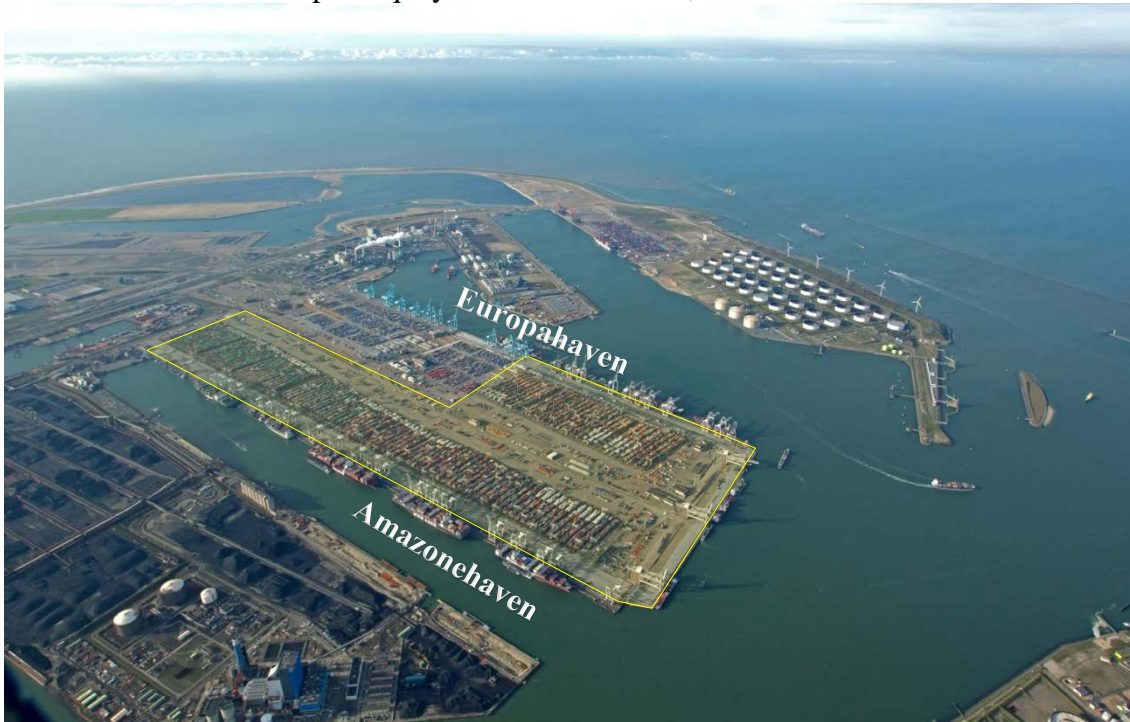
Figure 1: ECT Delta Terminal (yellow area), with Amazonehaven on the front

ECT Delta Terminal at the Maasvlakte in Rotterdam is the largest container terminal in Europe. All major shipping lines at ECT Delta started to use ULCS. The ECT Delta terminal uses two main deep sea quays. The Europahaven and the Amazonehaven (Figure 1). There are no nautical issues at the Europahaven side, smallest sailing path is 355 m wide, but there were major issues at the Amazonehaven side.

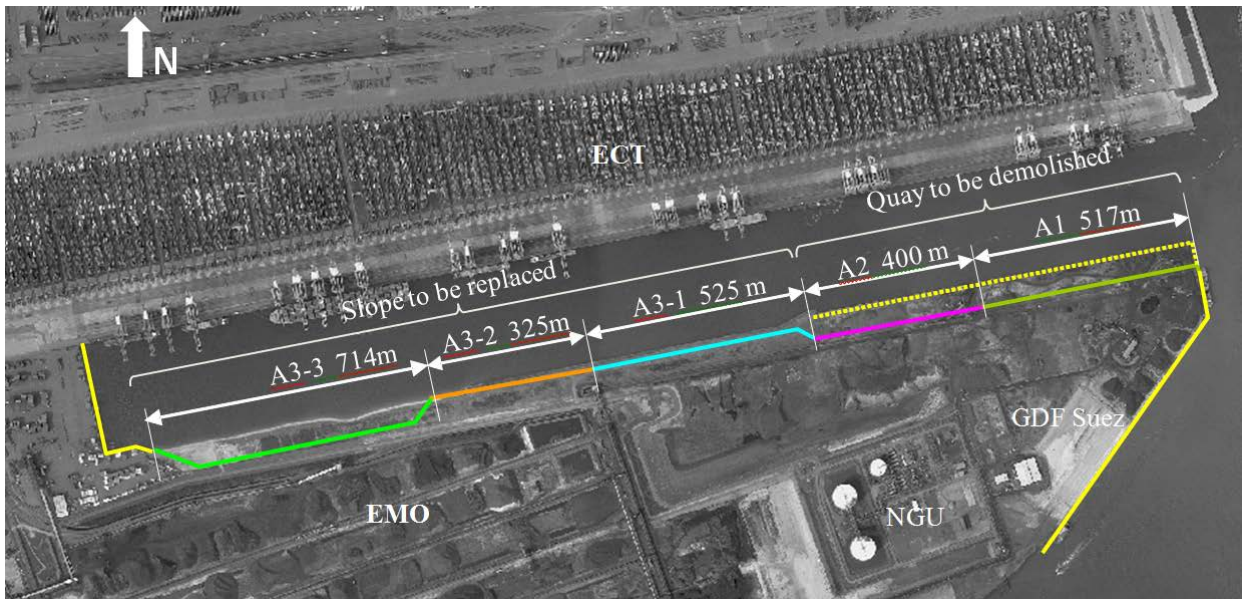
Figure 2: Aerial picture with in color the new basin shape & quay wall

The outcome of this study was that the EMO quay wall (EMO = Europese Massagoed Overslag) on the south of the Amazonehaven had to be removed (Figure 2). However, at the same time a new power plant was constructed at the south side of the basin and this created some extra challenges (Broos, 2014).

The ideal profile was a 275 m wide sailing path for the ULCS with additional 35 m maneuvering space for assisting tugs. This results in a 310 m wide basin. After 2 ship lengths i.e. 800 m, the width of the basin could be reduced down to 240 m plus additional tug maneuvering space. This profile fitted rather well with the coal mixing silos (section A3-1 in Figure 2) that were newly constructed just west of the EMO quay, about 1100 m from the entrance of the basin.

A3-3 in Figure 2). Although the other 1800 m are designed as a quay wall, this is in fact a very heavy earth retaining wall, as mooring is forbidden (sections A1 till A3-2 in Figure 2).

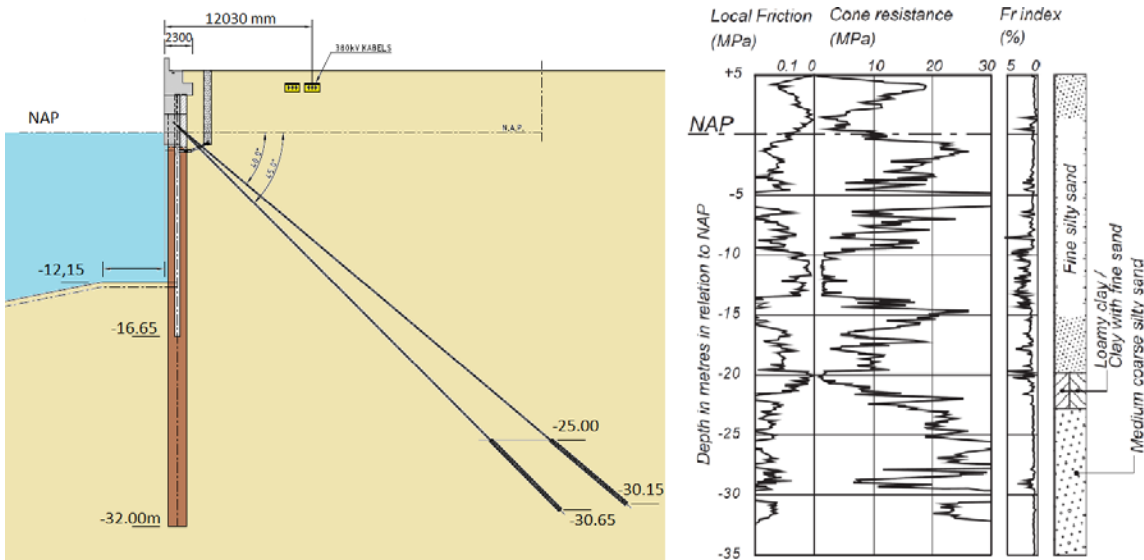
Figure 3: Cross section quay wall and typical CPT for Maasvlakte area

The new quay wall (Figure 3) is a rather simple construction with a retaining height of 20 m. It is a typical Rotterdam solution. There is a firm Pleistocene sand layer below NAP -20 m covered with silty sandy Holocene layers (see Cone Penetration Test (CPT) in Figure 3).

NAP means ‘Normaal Amsterdams Peil’ and is the Dutch reference level, it is roughly Mean Sea Level. Groundwater at the site is at NAP or above. The tubular king piles in the combi-wall bear the vertical loads and resist the bending moments. The intermediate sheet piles provide soil tightness. The drilled anchors provide horizontal stability and the concrete capping beam spreads the loads and provides a mooring surface. More can be found in Rijckaert (2014).

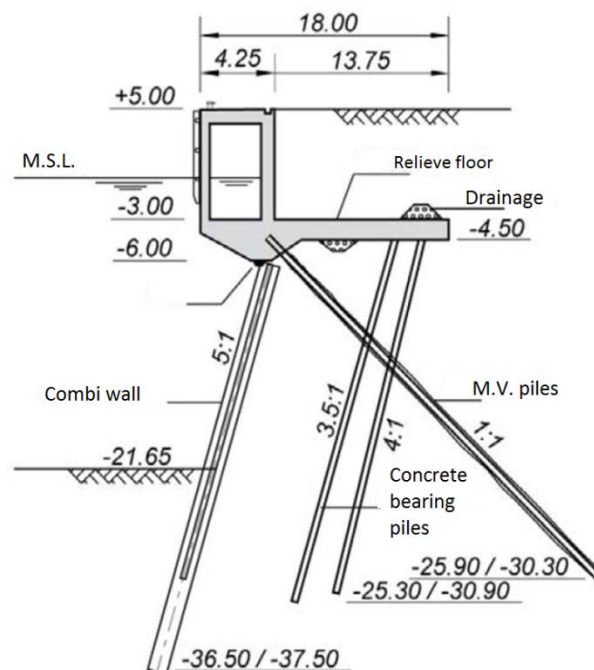
Figure 4: Cross section old quay to be demolished (Gijt, 2013)

The real challenge in the project appeared to be the removal of the old quay wall. The cross section is indicated in Figure 4. This quay wall was designed for the import of iron ore and had a length of 950 m and a retaining height of 32 m. The quay was constructed between 1988 and 1990 with:

- an inclined steel combi-wall (tubes Ø1420-19 mm with triple Larsen IIIs),
- concrete pre stressed bearing piles (450x450 mm),
- MV piles (PSt 370/153 (Peiner profile), design capacity 2,000 kN, and successfully tested up to 5,000 kN)
- and a massive concrete superstructure with a 18 m long relief floor and a tunnel structure on the water side. The entire height of the concrete structure is 11 m, the thinnest (front) wall is 750 mm tick, the thickest part (floor) is 3 m. The concrete is segmented in 40 m long sections each weighting 5000 tons.

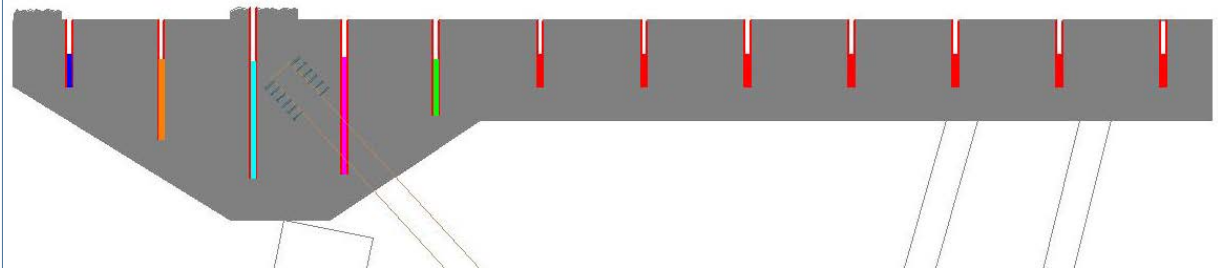
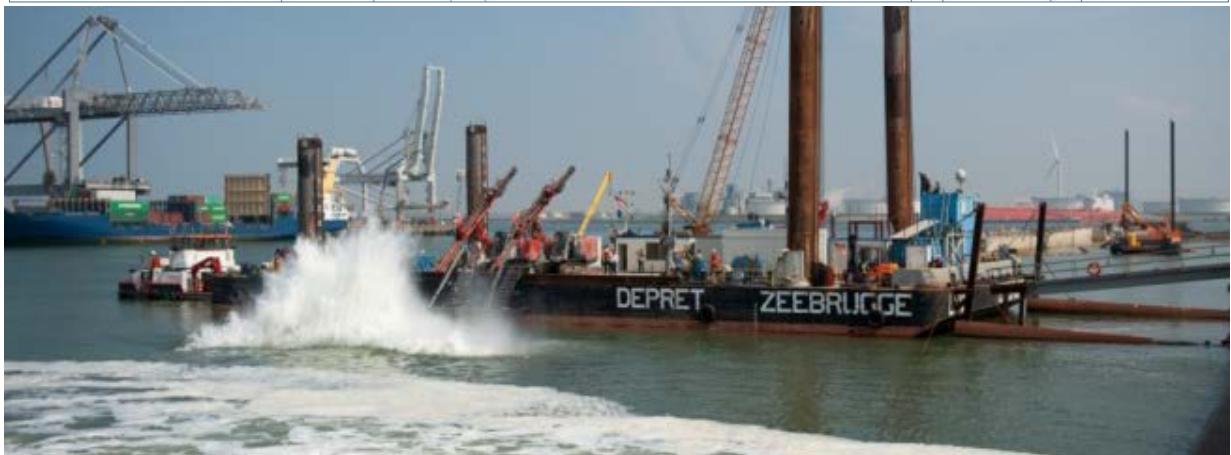
: lading TYPE A	$Q_s = 812 \text{ g/m}^3$, $Q_i = 2500 \text{ g}$, Eurodyn 2000, 1 x (65*500 mm)

: lading TYPE B	$Q_s = 937 \text{ g/m}^3$, $Q_i = 3500 \text{ g}$, Eurodyn 2000, 1 x (65*500 mm) + 1 x (50*350 mm)

: lading TYPE C	$Q_s = 966 \text{ g/m}^3$, $Q_i = 5000 \text{ g}$, Eurodyn 2000, 5 x (50*350)

: lading TYPE D	$Q_s = 918 \text{ g/m}^3$, $Q_i = 5000 \text{ g}$, Eurodyn 2000, 5 x (50*350)
 	: lading TYPE E	$Q_s = 1050 \text{ g/m}^3$, $Q_i = 4500 \text{ g}$, Eurodyn 2000, 1 x (65*500 mm) + 2 x (50*350 mm)

: lading TYPE F	$Q_s = 912 \text{ g/m}^3$, $Q_i = 2500 \text{ g}$, Eurodyn 2000, 1 x (65*500 mm)

Figure 6: Blast pattern and blast

After the removal of the concrete tunnel structure in a classical way using hydraulic demolition excavators, two mining drilling machines placed on a pontoon drilled holes according to an engineered pattern (Figure 6) and loaded the boreholes with dynamite. Every working day over roughly 20 weeks, the day production was blasted. Shipping in the Amazonehaven always continued, except for the first blast were a basin spanning transponder line proved that the blasts were harmless for sailing and moored ships.

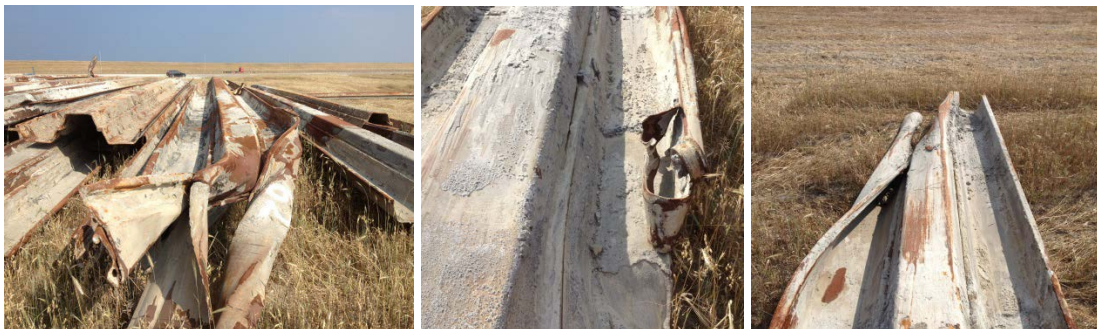
During the dredging works in 1990, 62 interlock openings on 31 intermediate sheet piles were discovered and repaired. When the sheet piles were retrieved, they appeared to be heavily damaged. Almost 50% of the sheet piles were damaged at the last few meters (Figure 7). This damage was never discovered during construction of the wall. The quay wall was never dredged to its final depth and these meters were below the initial construction depth of the quay wall.

Figure 7: Sheet pile damages

Research in old construction documents showed that the last 4 to 5 m were driven with a diesel hammer instead of a low frequency vibrator. Theory describes dense sand to plug inside the interlock under the action of a hammer, pushing the sheet pile out the interlock, creating the damage.

It also appeared that during construction a few centimeters of one sheet piles interlock was removed to ease the positioning of the sheet piles between the tubular piles. This resulted in 'flapping' of this sheet pile edge. This has also been a trigger at other quay walls as described by De Gijt (1996). Today interlocks at the king piles have a 100 mm height difference at the top to ease the placing of the intermediate sheet piles without needing notches. In this way the interlock can save and easily be connected.

This demolition proves that ramming on sheet piles should be avoided under all circumstances. Current practice is to reduce the resistance by using an auger up to 2 m above the planned toe depth. Until 2010 jetting with water and air was the most common used way to reduce the resistance for the sheet piles. Between 2010 and 2014 both methods were used and currently the large auger is the preferred method to reduce the resistance.

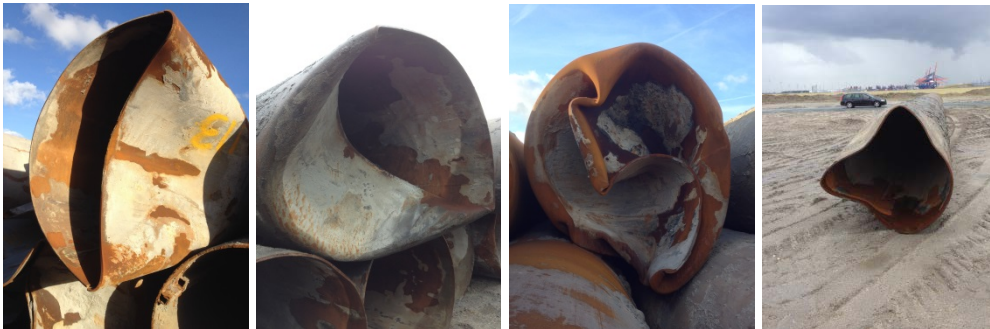
The worst discovery however was the condition of the tubular king piles. Over 20% of the pile toes appeared to be damaged (Figure 8). These piles were supposed to provide horizontal

Figure 8: Pile toe damages

Closer investigation of the piles indicated that soil was ‘burned’ on the pile toe. Apparently the steel has become that hot during installation. Steel strength reduces with temperature; perhaps this effect has played a role in the damage.

American Petroleum Institute (API) rules recommend a minimum D/t ratio of 70 for this kind of piles. This means that a Diameter (D) =1420 mm pile should have at least Wall thickness (t) =20.3 mm. In the past Rotterdam used a minimum D/t of 90 against buckling, with $t=17$ mm these piles had a D/t of 83.5. Today this would be considered to be too conservative, D/t ratios over 100 are seen in D&C projects.

- Drilling and blasting of concrete under water is a good method to demolish. It is safe, silent, fast and environmentally friendly;
- Ramming on intermediate sheet piles must be forbidden;
- Notches and other cutting in sheet pile toes should be forbidden;
- Pile hammering should always be done in one flow to avoid setup;
- D/t ratios should not be too high. The API ratio of 60-70 is recommended for heavy pile driving;
- Heavy combi-walls are almost never removed. Expect damage at the pile toes.

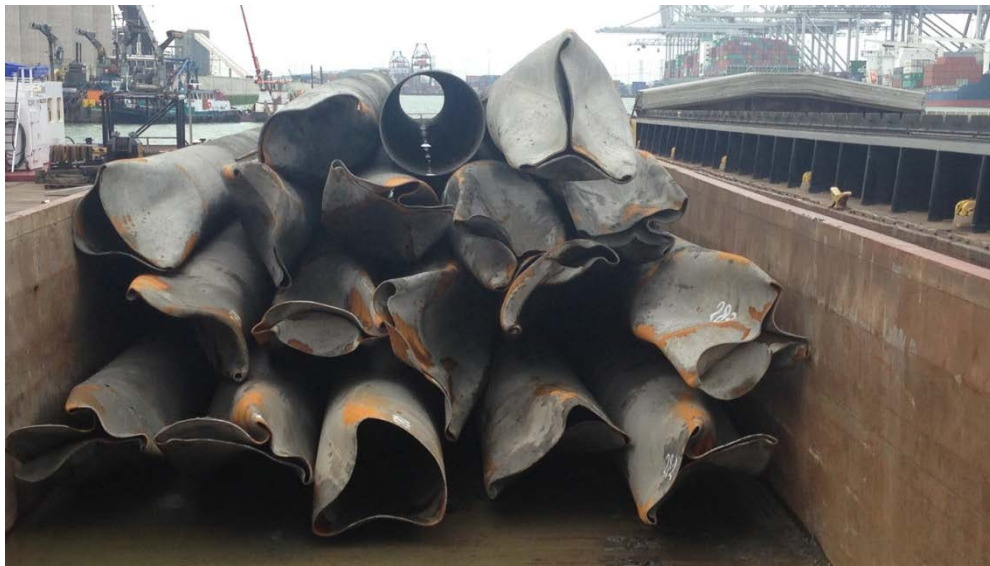
stability. Figure 9 shows piles that were placed next to each other. This cross section did not provide the designed safety. This was further examined by Mourillon (2015), but needs to be studied in more detail.

Figure 9: Heavily damaged pile toes

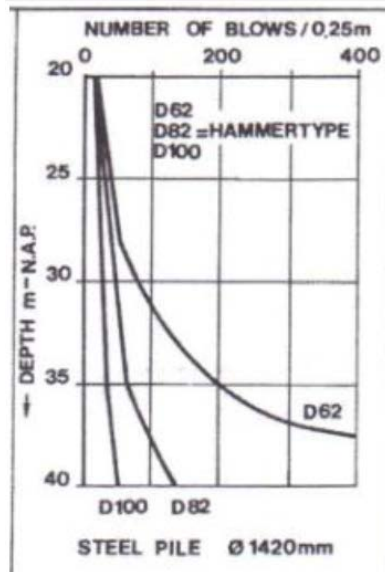
History showed (van Ast, de Gijt 1990) that on this project both a D62 and a D100 diesel hammers were used to drive the piles, probably also often both on the same pile a few days after each other. Figure 10 shows the driving analysis of both hammers under Amazonehaven conditions and indicates that the D62 is too light. This shift in hammer is obviously not done

directly, it is a heavy operation and there have passed a few days between the different hammers. This time gap leads to setup as the water overpressure disappears, making it very difficult to get the pile moving again.

Figure 10: Results drivability of open steel tubular piles (Mourilon, 2015)
