Many buildings lose their function overtime, due to changing needs. This leaves a lot of buildings vacant and unused, in need for a new function. The chair of RMIT does tries to find possibilities for transforming the existing building stock and giving it a new future. This graduation RMIT studio focuses on a selection of these building in The Hague and Delft. The case study building for my graduation studio is the Armamentarium in Delft.

# P1 report Armamentarium Delft

Msc 3 Graduation project | Mixed projects  
04-11-2013

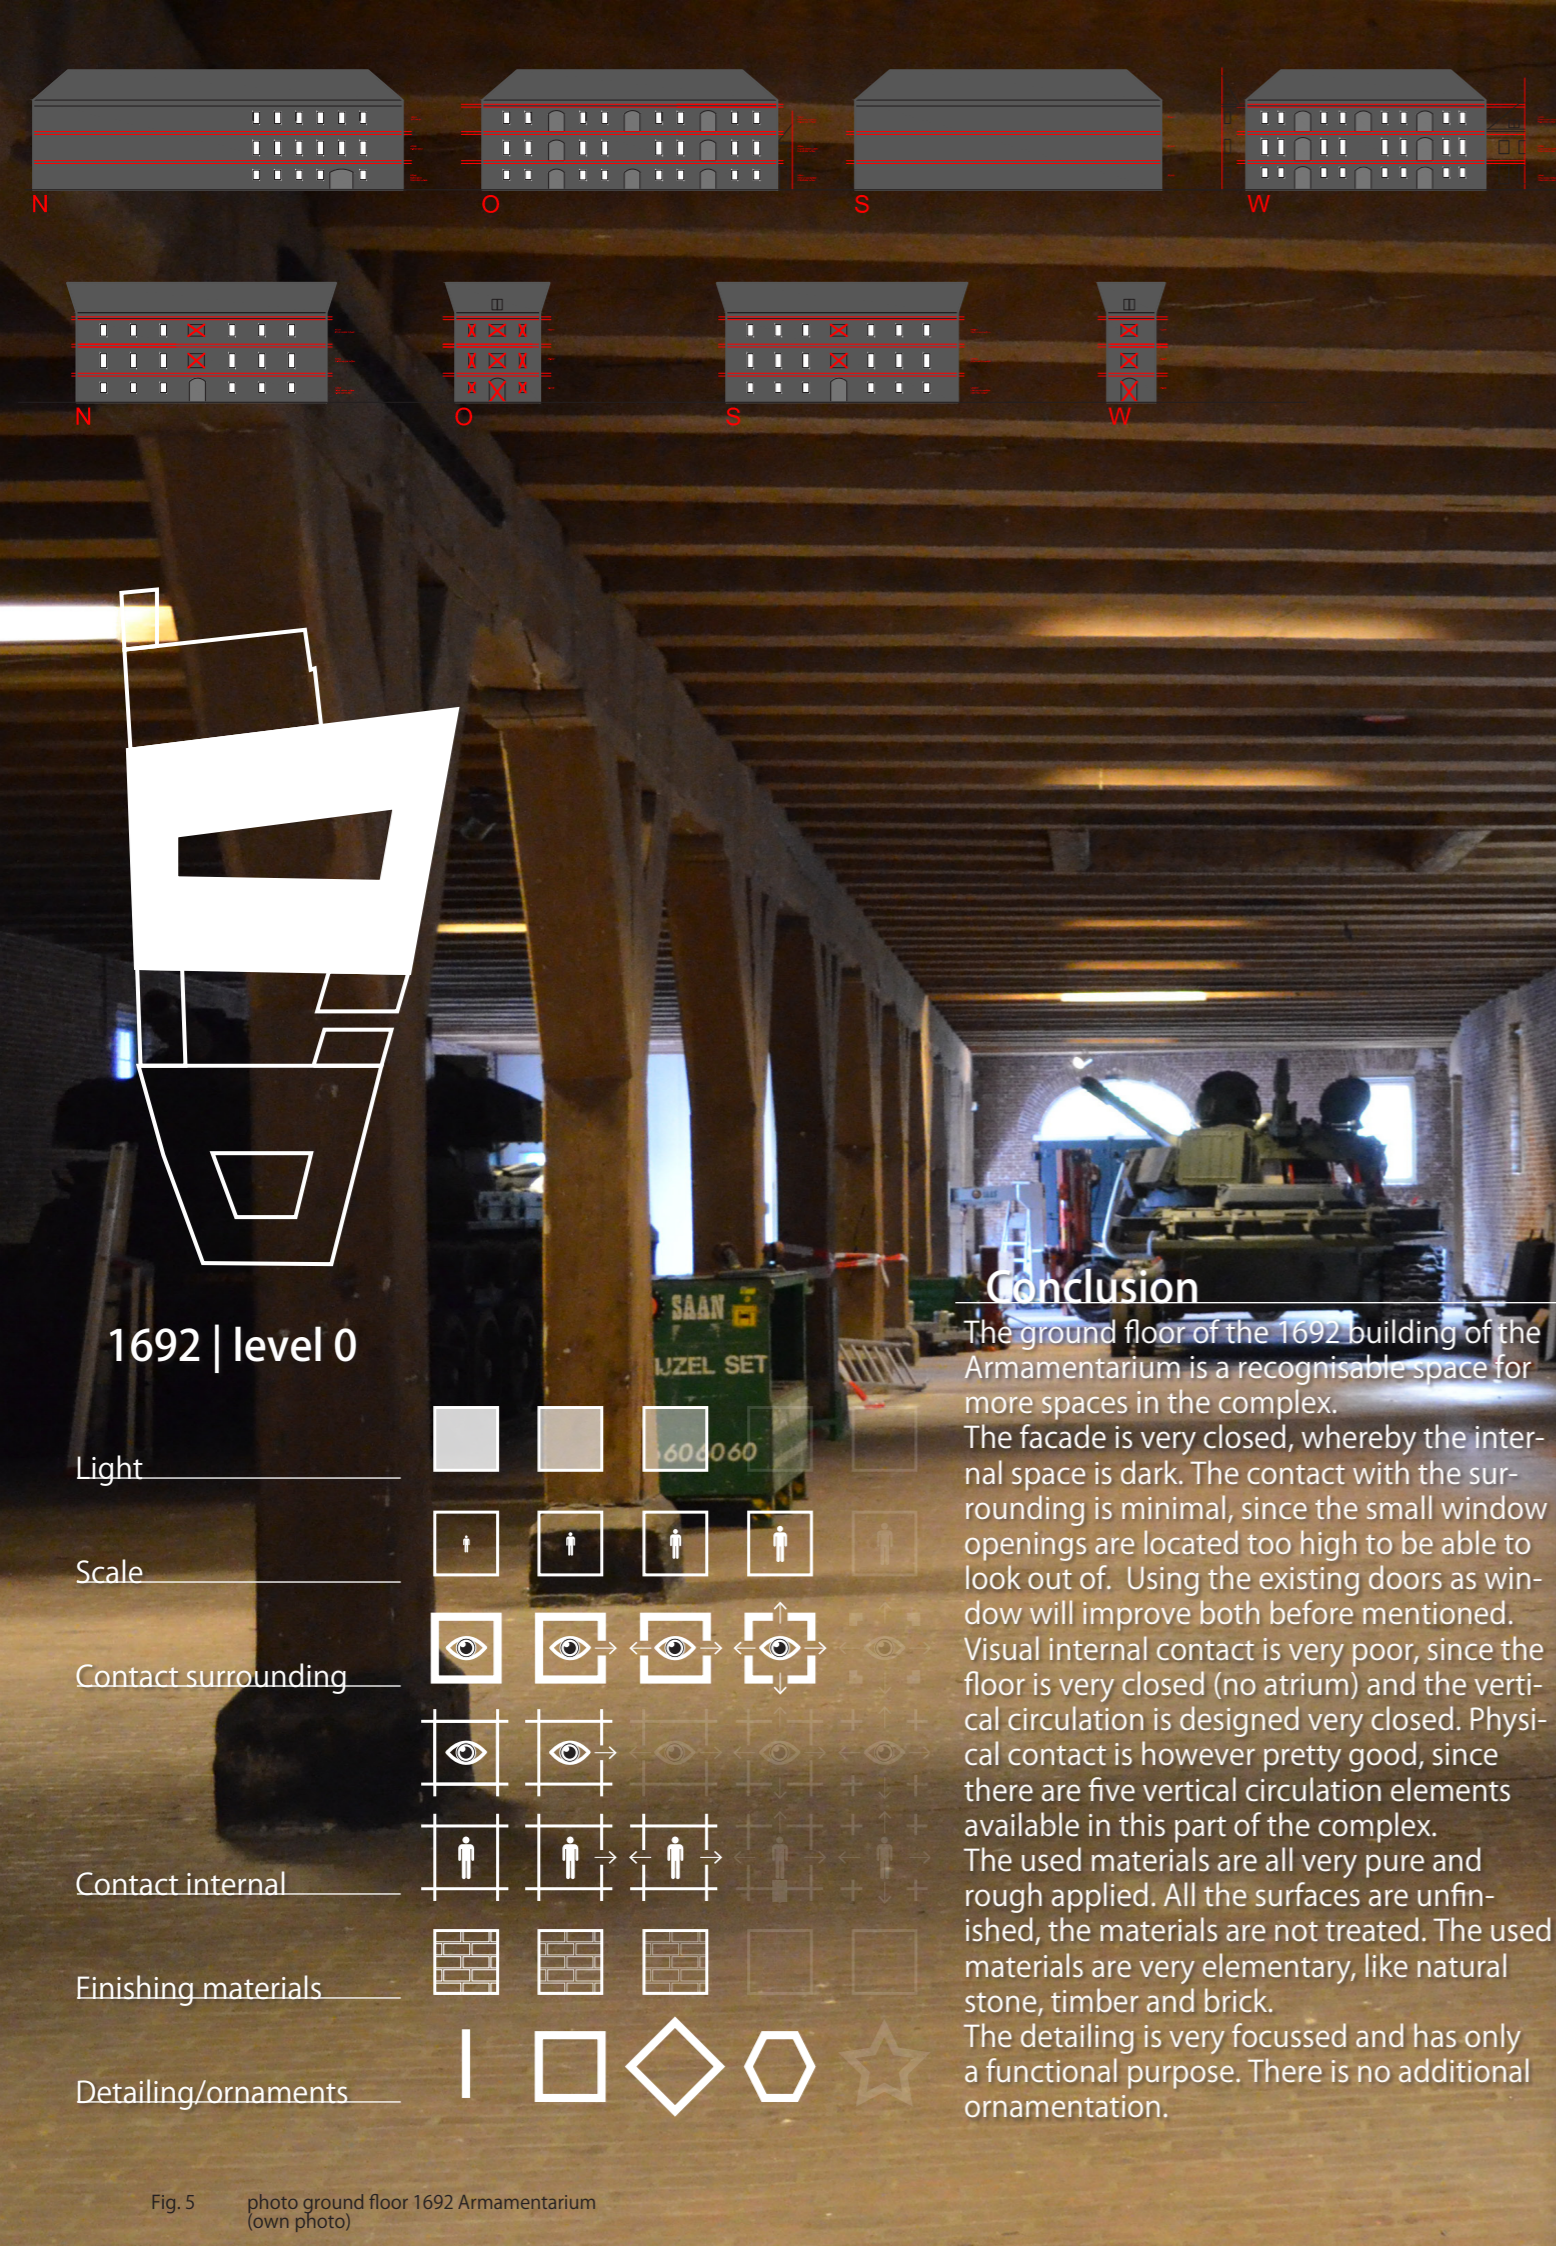
Fig. 4 Matrix character, original size A1 (illustration in collaboration with Merwin de Bruin)

In this matrix is notable that the spaces of the 1692 building, connecting building 1660 and the ground floor of 1602 building have a shared character. They are very isolated spaces (internal as well as to surrounding), are quite dark, have a rough unfinished material use and a focused detailing without ornamentation. The spaces are big and you can not experience the whole space at once. However do the height of spaces and the row of columns reflect to the human scale

The first floor of the 1602 building is a interesting exception. This space is much lighter and has more contact with surrounding, because of the bigger window openings. The space is a lot higher. Furthermore are the surfaces much more finished and detailed with ornamentation.

The entrance building and internal interventions of van Velsen do form a relation with the original character, in its focused appearance and finishing, as well as in the isolation of the spaces. The intervention is however still readable as a new insertion.

The entrance building of Thewessen forms less a relation with the existing building. The material use is more finished. The transparency of the facade is much higher, by which the spaces are lighter and in closer contact with the surrounding.

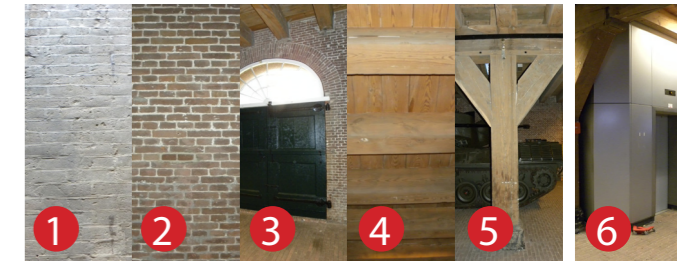
- 1 brick flooring, anthracite
  - 2 bear brick walls, red
  - 3 wooden door, painted green
  - 4 wooden ceiling, no treatment
  - 5 wooden structure, no treatment
  - [6 steel WC/elevator box, grey
- unfinished  
unfinished painted  
unfinished  
unfinished  
powder coated]

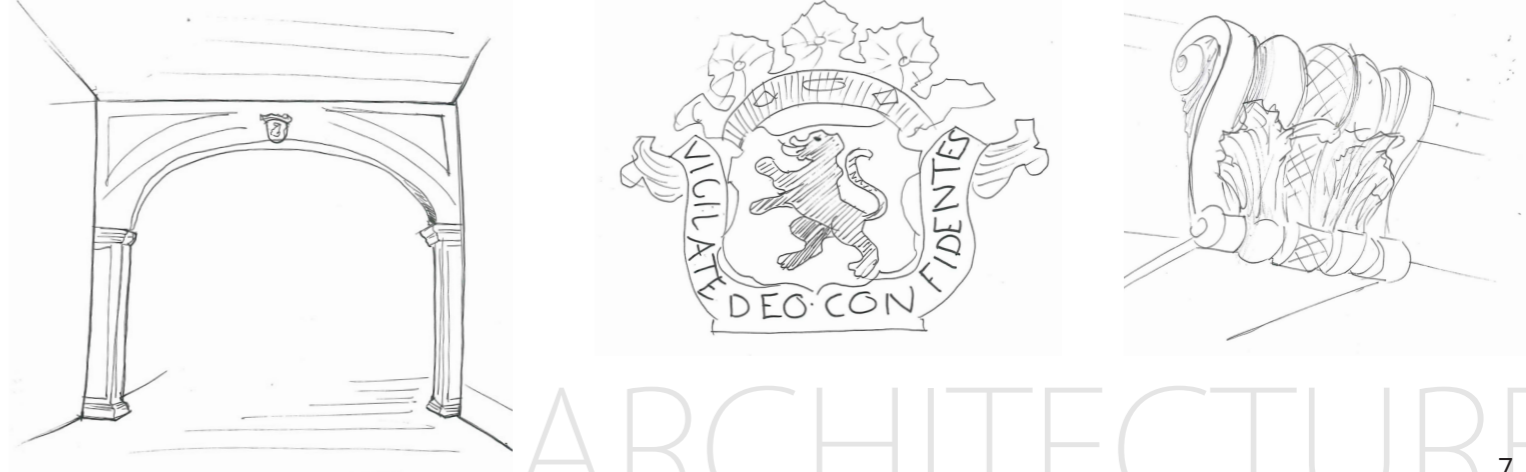
Fig. 6 photo first floor 1602 Amsterdam (own photo)

The first floor of the 1602 building is a major exception in the complex. The facade is much more transparent, by which the interior is very light. The contact with the surrounding is also much bigger, since the larger window openings are located on a height related to the human scale. Visual internal contact is still poor, however one stair is designed quite open. Physical contact is pretty good, with four vertical circulation elements available in this part of the complex. The materials in this space are all finished and treated applied. The walls are plastered, the wood is painted. The detailing in this part of the building is treated with more care and is enriched by some additional ornamentation. The appearance is more representative, instead of focussed.

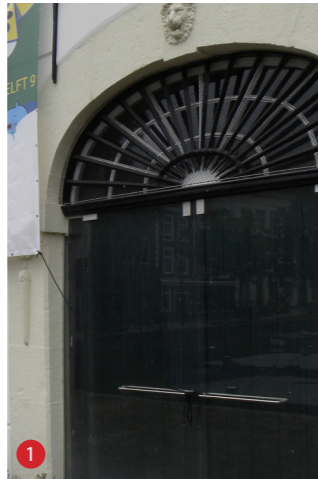
### Door

material: fir wood (26mm), steel plate (3mm), triplex with sawn grooves (6mm)  
 colour: painted dark green  
 other: transom window with radial grill (spinnenkopraam) additional glass door  
 state: very good  
 authenticity: doors replaced in 1981 (Walraad) glass doors added in 1989 (Velzen) transom window added during construction in 1692 or 1754<sup>12</sup>

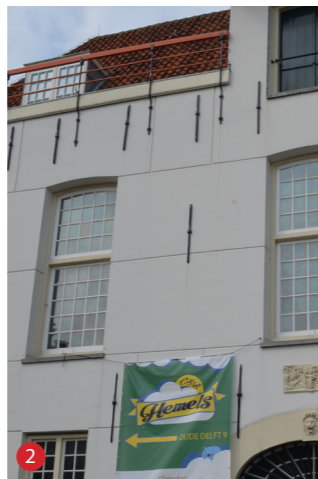
### External walls

material: plastered  
 colour: painted white  
 other: dummy joint in block motif  
 state: very good  
 authenticity: wall originally bear brickwork with natural stone current plaster is from 1981<sup>12</sup>

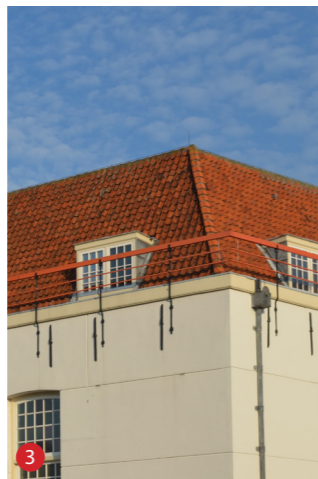
### Roofing

material: ceramic roof tiles  
 colour: red  
 other: old dutch roof tiles  
 state: generally good, valley gutter does create leakages  
 authenticity: 1751?<sup>13</sup>

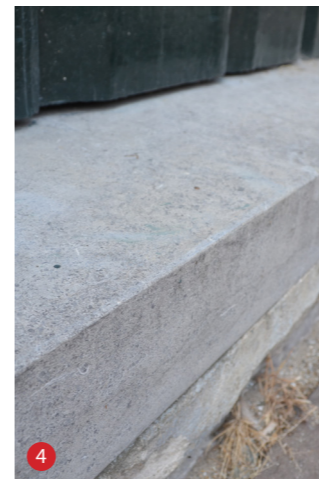
### Sill

material: natural stone  
 colour: anthracite  
 other: -  
 state: very good  
 authenticity: added in 1985 (Walraad)<sup>12</sup>

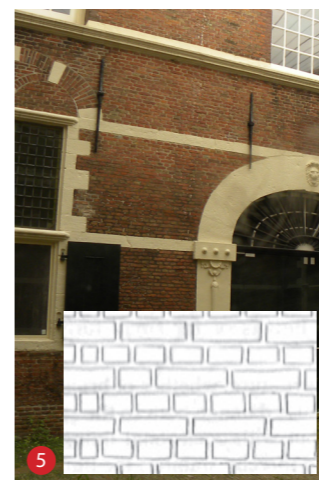
### Pilaster

material: bentheimer natural stone  
 colour: painted off white  
 other: keystone (sluitsteen) with lion head  
 state: very good  
 authenticity: pilaster added during construction in 1692 or 1754 (incl. transom window)<sup>12</sup>

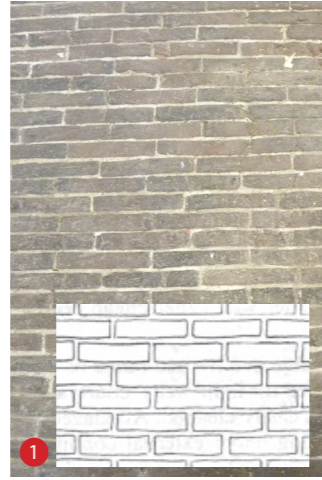
### Flooring

material: brickwork, stretching bond  
 colour: dark anthracite  
 other: size [yet to measure]  
 placed directly on the sand  
 state: very good  
 authenticity: mostly original 1602<sup>13</sup>

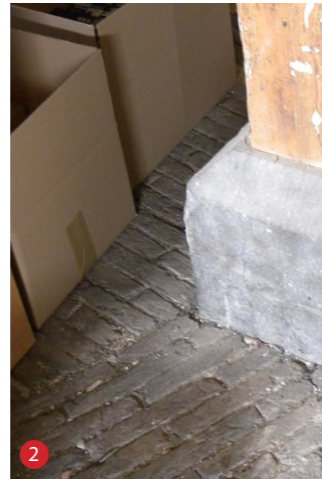
### Footing

material: natural stone; type unknown  
 colour: dark anthracite  
 other: to prevent rising moisture in structure  
 state: very good  
 authenticity: original from 1602<sup>13</sup>

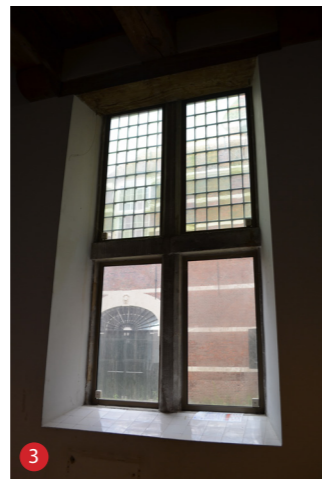
### Windowframe

material: bentheimer natural stone  
 colour: anthracite  
 other: cross frame (kruisraam)  
 state: good, only aesthetic improvement possible  
 authenticity: original cross frame from 1602<sup>12</sup>

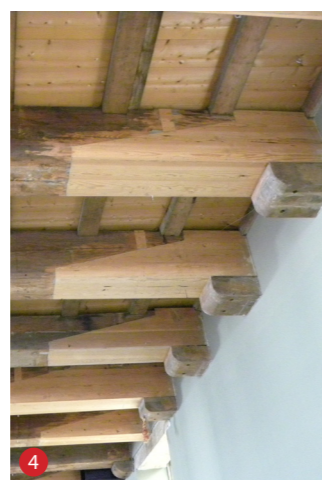
### Ceiling

material: pine  
 colour: untreated  
 other: sleeper (moerbalk) 395\*320 mm<sup>13</sup>  
 secondary beam (kinderbalk)  
 beams laid on timber corbel (sleutelstuk)  
 state: very good;  
 authenticity: beam ends mostly replaced in 1981 (Walraad)  
 others original 1602<sup>13</sup>

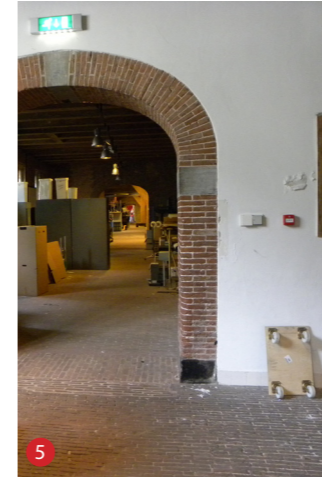
### Walls

material: plastered  
 colour: painted light green and white  
 other: plinth of one layer of white tiles  
 state: very good  
 authenticity: no information

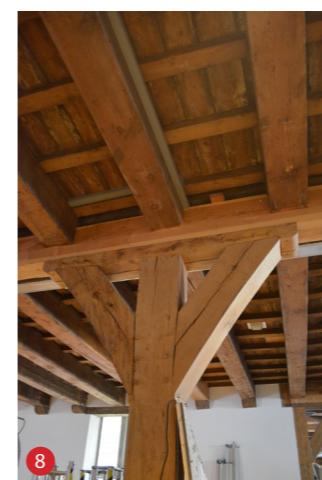
### Structure

material: pine  
 colour: untreated  
 other: size 320\*360mm  
 knee brace structure (standvink)  
 double pen and tenon connection  
 state: very good;  
 authenticity: partly added (1751)  
 partly original (1602)

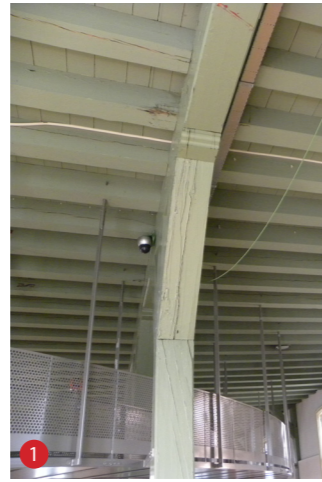
### Ceiling

material: pine (presumed)  
 colour: painted green  
 other: tie beam 295\*240mm  
 state: very good;  
 authenticity: renewed during construction in 1751<sup>13</sup>

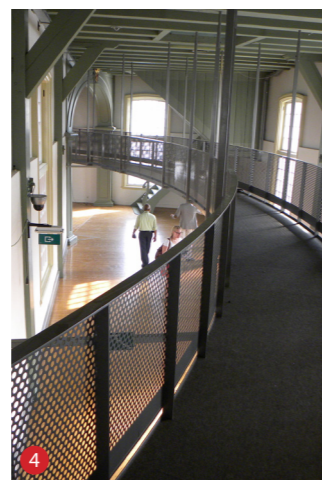
### Suspended walkway

material: steel  
 colour: powder coated gray  
 other: suspended from ceiling  
 state: very good;  
 authenticity: added during construction in 1989 (Velzen)<sup>13</sup>

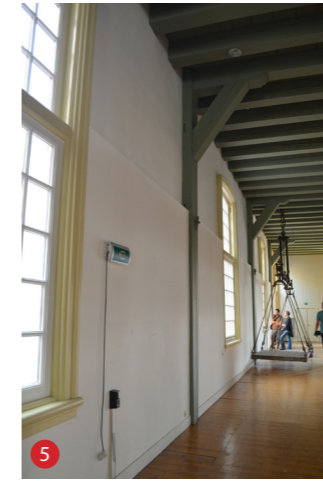
### Walls

material: plastered  
 colour: painted white  
 other: recessed where beforehand the second floor was ( $\pm$  3m above floorlevel)  
 state: very good;  
 authenticity: no information

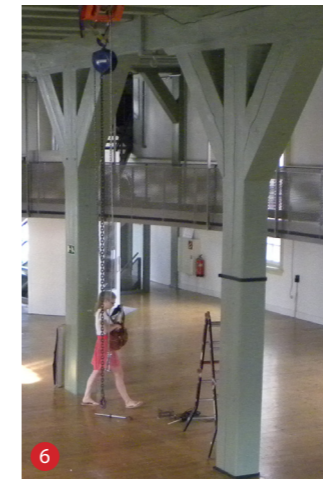
### Structure

material: oak  
 colour: painted green  
 other: knee brace structure (standvink)  
 double pen and tenon connection  
 state: very good;  
 authenticity: renewed during construction in 1751<sup>13</sup>

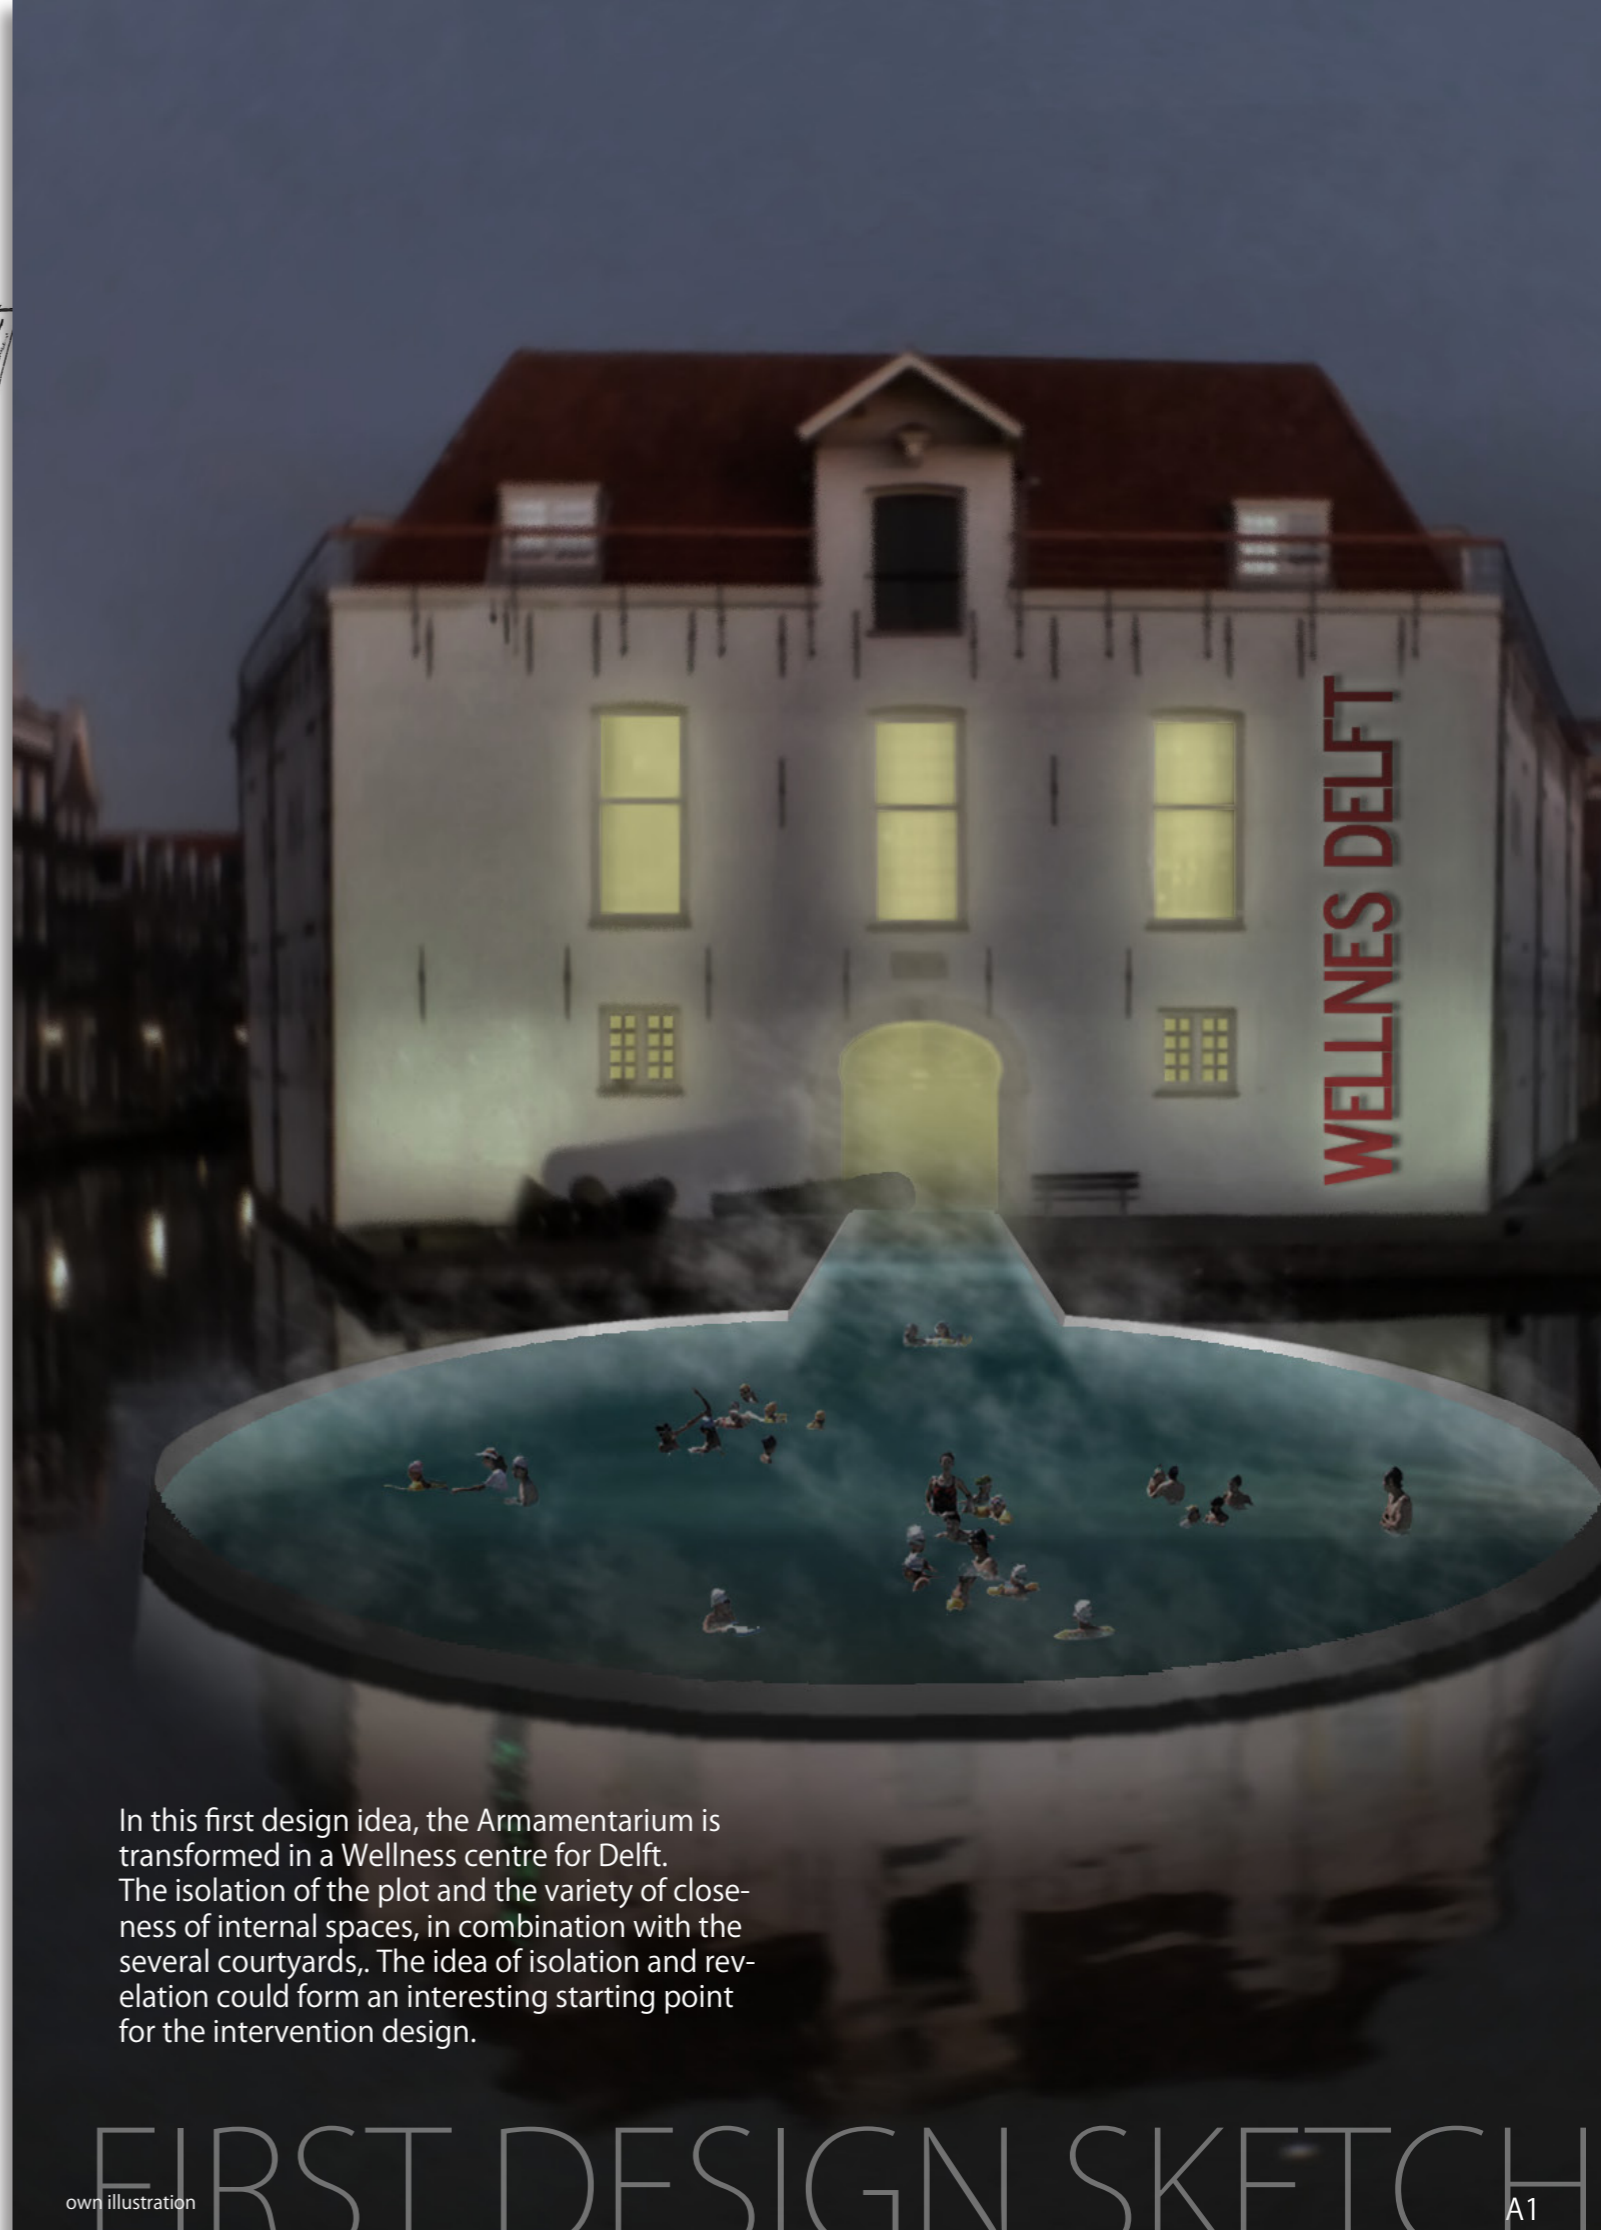
In this first design idea, the Armamentarium is transformed in a Wellness centre for Delft. The isolation of the plot and the variety of closeness of internal spaces, in combination with the several courtyards,. The idea of isolation and revelation could form an interesting starting point for the intervention design.
