## **Subsidence of dredged organic sediments in cultivated peatlands**

E3S Web of Conferences

# Subsidence of dredged organic sediments in cultivated peatlands.

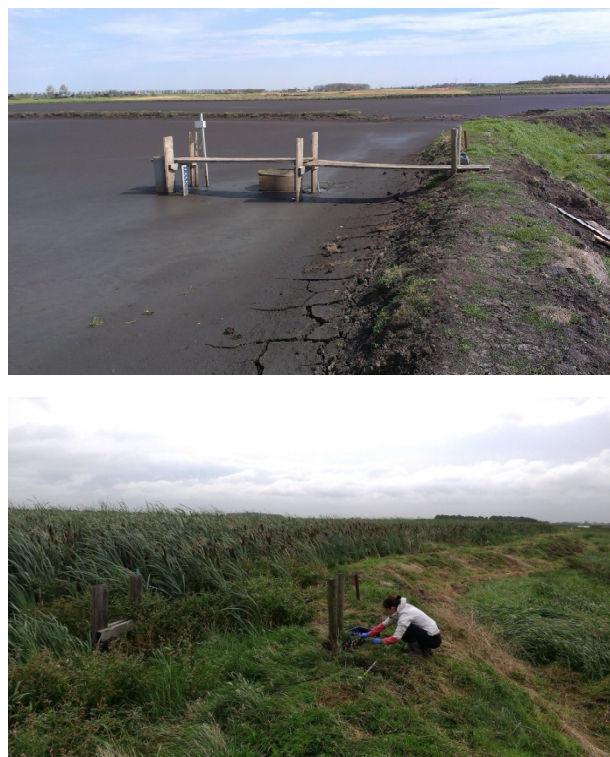
**Fig. 2.** Depot in June 2014 showing the sampling platform and level gauge (top) and in September 2015, illustrating to the rapid growth and potential dewatering effect of reed (bottom).
