## Proceedings of the 4th WTA International PhD Symposium

13-16 September 2017  
Delft, The Netherlands

W.J. Quist, S.J.C. Granneman & R.P.J. van Hees (eds.)

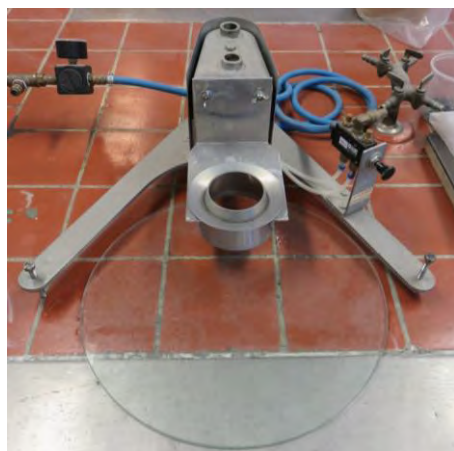
Figure 1: Pneumatic lifting device for determine the slump flow of the pastes

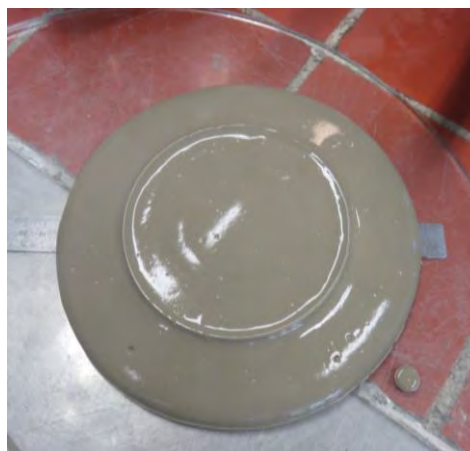
Figure 2: Determination of the slump flow of a cement paste sample

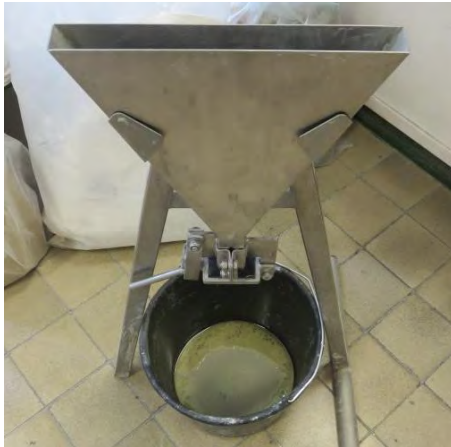
Figure 3: Determination of the V-funnel flow time of the mortars

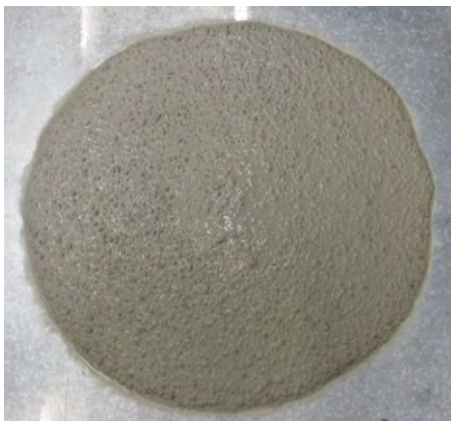
Figure 5: Unmodified reference (SCC) with appearance of separation

In the concrete investigations it was obviously, that the unmodified references showed significant appearances of segregation and separation (figure 5) in part. The stabilizing effect of the polymers is well illustrated in figure 6.

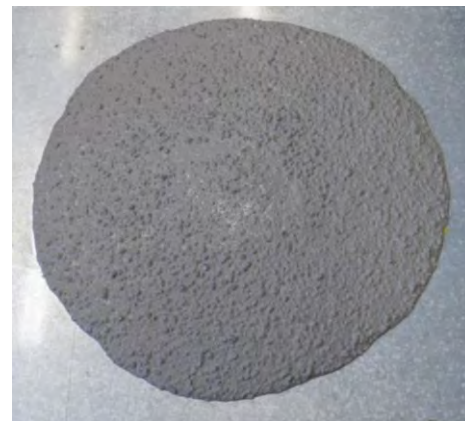
Figure 6: PSSC with no appearance of separation

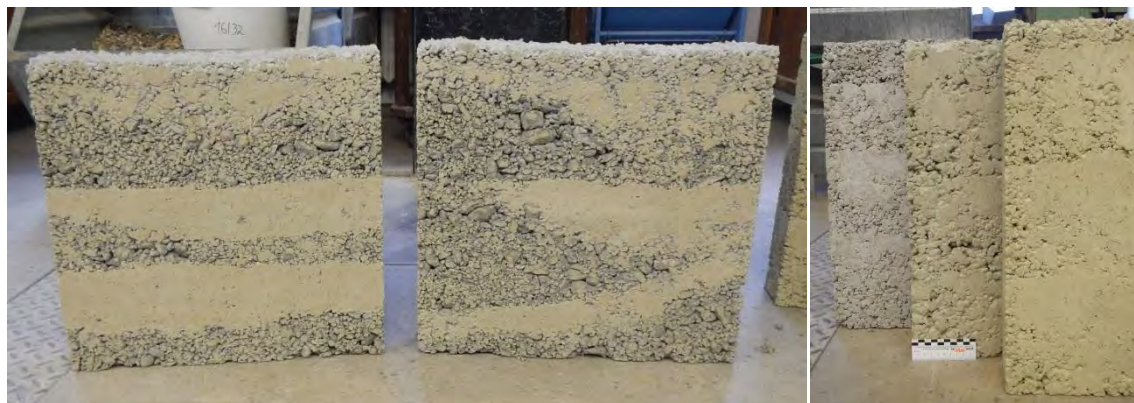
Figure 7: Structural and color design options of tamped concrete

At the moment the investigations are limited to the determination and adjustment of the concrete composition for a purposeful achievement of the required fresh concrete behavior and adaption of certain optical properties of the hardened concrete. Beside the adjustment of the composition to reach the optical properties, different manufacturing techniques were tested. In principle, tamped concretes could be produced which correspond in structure as well as in color

to historical tamped concretes (figure 7). The investigations of the durability and the influence of polymers in the structure of the tamped concrete are still in progress.

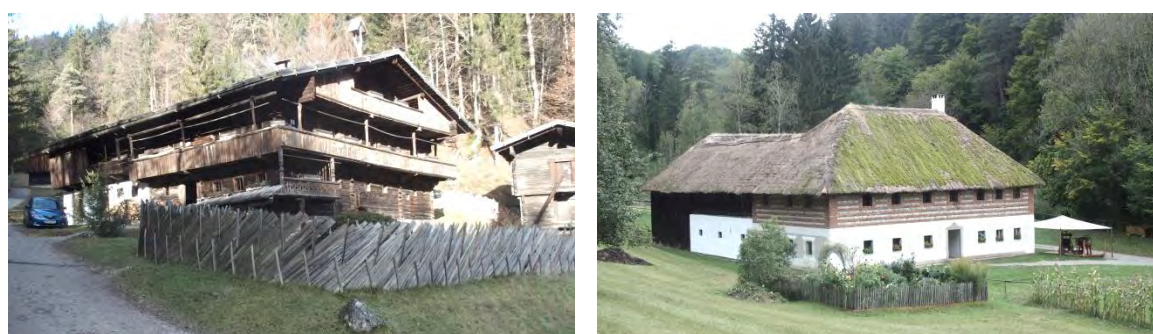
Figure 1: “Alpbach-house” and “Vierkanthof” in the Austrian open-air museum in Stübing.

The typical “Alpbach-house” or house of the Lower Inn Valley is a so called “Einhof”, a two-storey house in which living area, byre and barn are arranged one behind the other and united under a common, flat-sloped roof. Its distribution area ranges from Jenbach to Kufstein and Kitzbühel, and continues to the Salzach- and Ennsvalley to the region of Schladming [7]. The predecessors of this house form are the so called “Gruppenhof” and “Paarhof”, whose elements were brought together in the course of later development steps. An “Alpbach-house” usually shows the principle of a central corridor whereby the house entrance is usually arranged on the gable side. A special form is the so called “Berghaus”. As a result of steep terrain, the entrance is shifted to the eaves. Living room, kitchen and a chamber are located on the gable side. The appearance of the “Alpbach-house” and generally the houses of the Tyrolean lowlands is characterized by outside balconies and open corridors, the so-called “Labn” [8].

A “Vierkanthof” is a two-storey farmhouse, in which living-area, stable, barn and shed are grouped around a courtyard. This creates a closed building complex. The core region of the “Vierkanthof” in Upper Austria is between the cities of Linz, Enns, Steyr and Wels and still characterizes large parts of the landscape. The “Vierkanthof” marks the end of a development of farmsteads, which has gradually extended since the late 16th century from loosely connected buildings to more or less assembled building parts then to the type of a so called “Kleinvierkanter” in the 17th century. The classic “Vierkanter” is in existence since the 19th century. Normally, residential area and barn lie opposite each other at front- and rear side. Stables and sheds form the side wings [9]. The living area consists of an entrance corridor, kitchen with the stove, a representative living room with the stove and usually several chambers. In the first floor there are further chambers and storage rooms. The areas above stable, barn and shed are used as forage. [10]

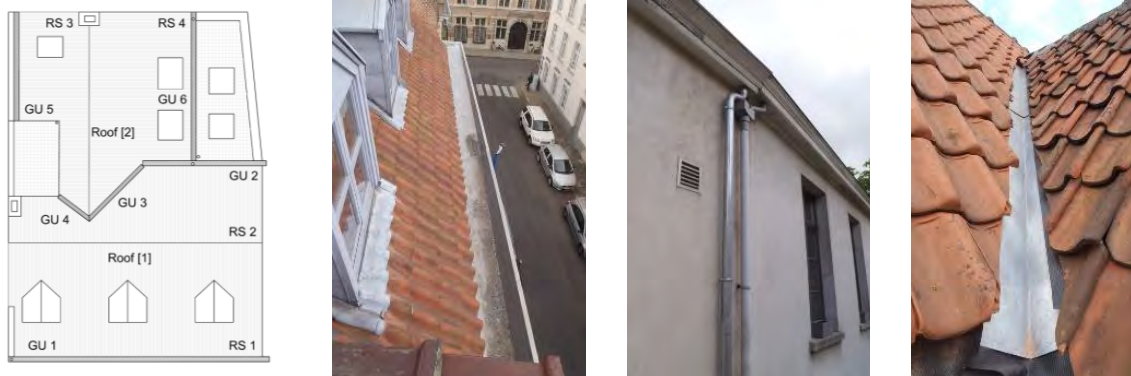
Figure 1: (1) Roof Plan, based on report Monumentenwacht, (2) Eaves gutter GU 1, (3) Eaves gutter GU 6, (4) Valley gutter GU 3, all pictures by Monumentenwacht

The parameters defining the rainwater disposal’s reliability will hereafter be identified based on a case study: a 19<sup>th</sup> century historic urban dwelling with medieval core. The available source data are five inspection reports of Monumentenwacht (inspection reports of 2001, 2004, 2009, 2011 and 2015) and the technical documentation provided by the owner. The building has two saddle roofs, positioned perpendicular to each other. The roof plan in Figure 1 displays the two roofs with respective roof surfaces and gutters. Both roofs have a roof covering in ceramic tiles, roof [1] has a pitch of 50° and roof [2] has a pitch of 60°. Both roofs have eaves gutters (GU 1, GU 2, GU 6) that are lined with zinc. Valley gutters (GU 3, GU 4) are positioned at the connection between the roof surfaces of Roof [1] and Roof [2].

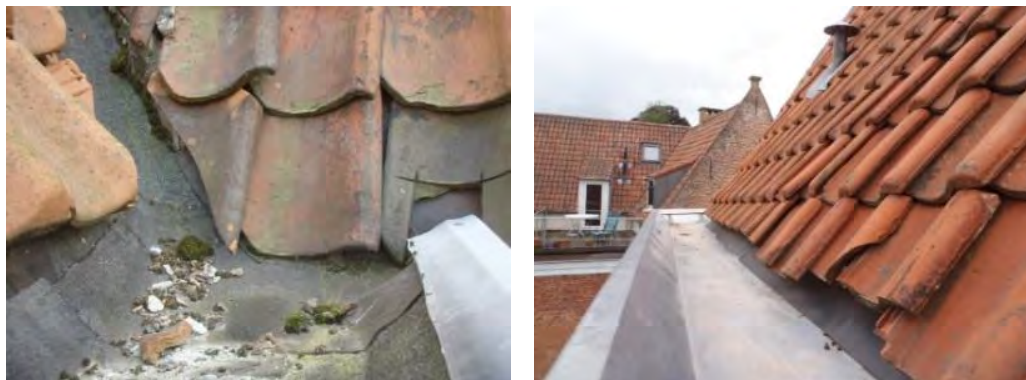
Figure 2: Left: gutters in asphalt, 2011. Right: new gutters in zinc, 2015. Pictures by Monumentenwacht

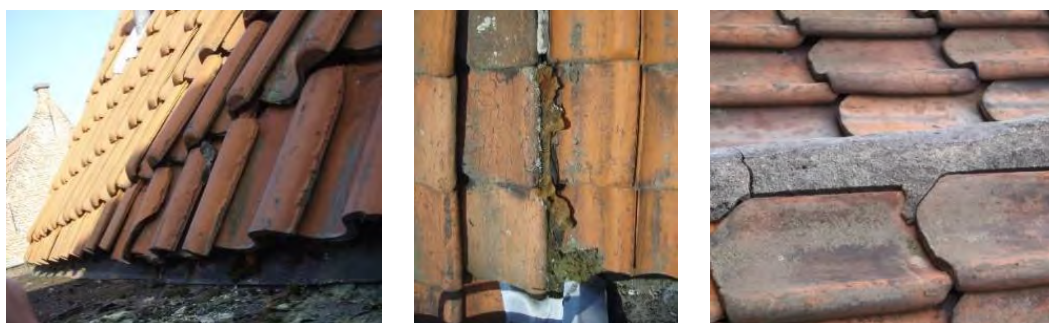
Figure 3: Left: lack of tile lath, resulting in shifted tiles, Centre: repair of connection with building foam, Right: hard mortar at connection between tiles, resulting in cracks and loss of connection. Pictures of case study by Monumentenwacht

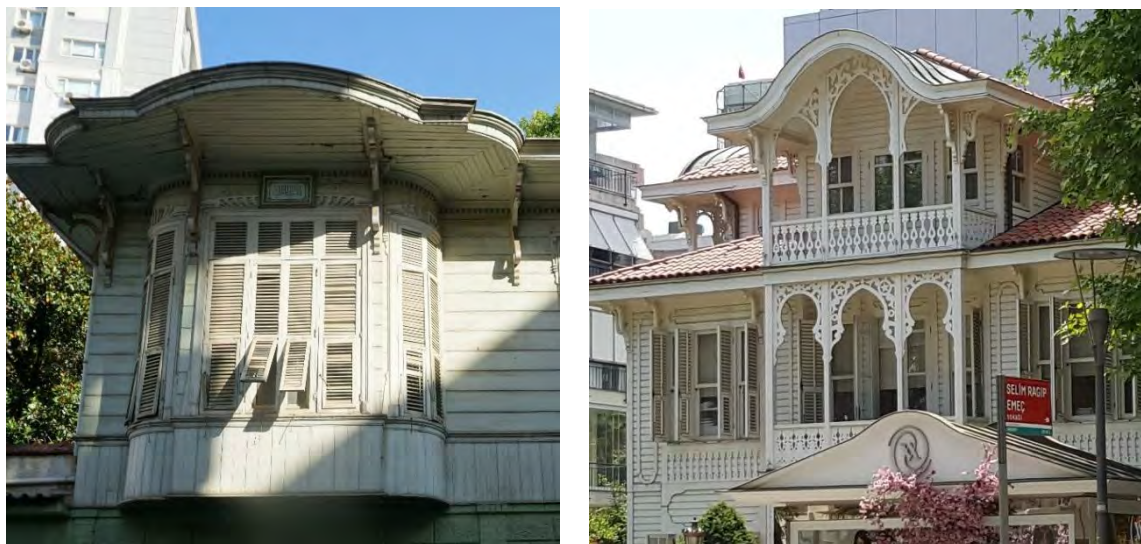
Figure 2: Curvilinearity on the eaves in both horizontal and vertical planes, 2017

The curvilinearity, which was not the characteristic feature of the earlier periods, initiated a new attitude in the last period of Ottoman Empire. S and C figures of the baroque and rococo styles were represented in different combinations in the roofs, especially in the eaves, of timber houses. Such curvilinearity on the roofs can be seen in both horizontal and vertical planes (Figure 2). Another common preference of the same period is the usage of the roof with different levels. Additional space could be generated at the elevated position of the roof in rectangle, T-shaped or cross-similar forms. With the belvederes and differentiated sloods various housing types were obtained. Besides those factors, the roof pitch is an additional issue originating differences. Swiss chalet and Austrian mountain houses inspired the use of steeply pitch roofs in Istanbul's timber housing architecture after the 19th century. [4] While the presence of pitch roofs in Istanbul before the 18th century was the subject of long discussions [5], it can be deduced from the surviving buildings and old photos that the pitch roofed houses built after the westernization period were different from the examples of the 18th century. The increased slope provided the opportunity to create a new living space, which in turn brought along the need for openings such as windows and balcony, resulting in the complete change of the roof structure. It is worth to mention that there are many eclectic houses, which cannot be classified as one defined style because of having traces from more than one approach. In addition to the European influences, an orientalist approach for the roof structures should also be taken into consideration [4].

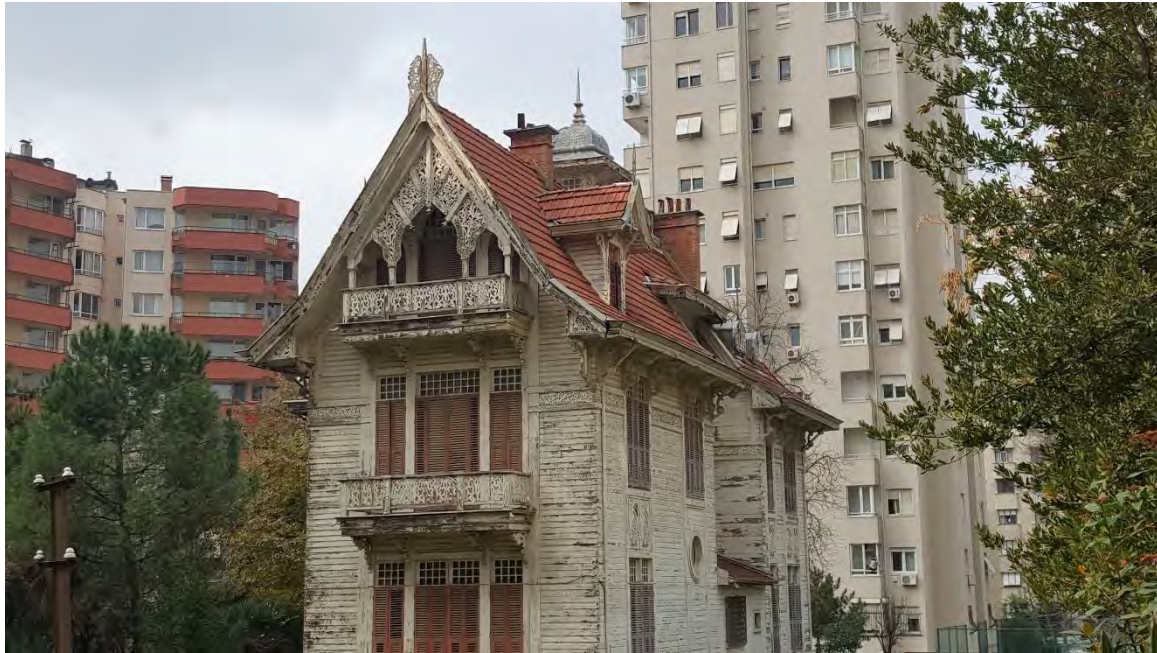
Figure 3: Pitch roofed wooden house with appendant elements on roof, 2016

At last but not least, the appendant elements have also an effect on the view and form of the roof structure. Decorative elements and ornaments on the roofs are reflecting different styles with various compositions. Curvilinear eaves, striking brackets, arrows on the ridge of a steep roof, pointed arches, spires or eaves with scallops and latticework are examples of the popular decorations of the houses from that period. Additionally, balconies, windows and towers on the roof are also part of the design and structure. (Figure 3)

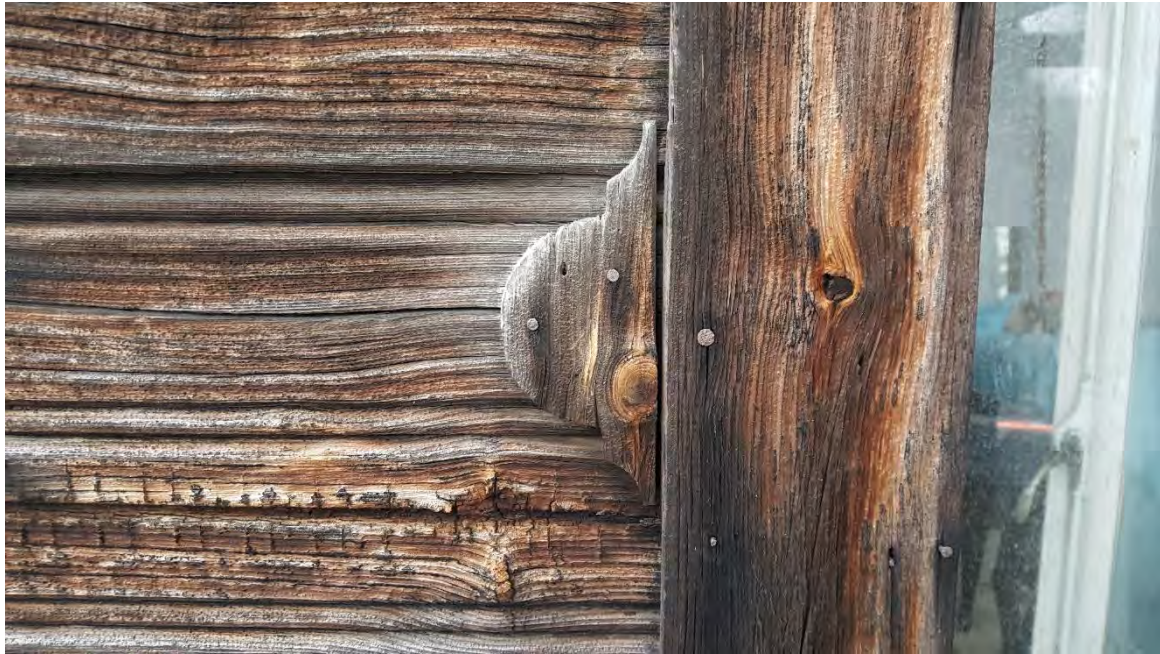
Figure 4: Decorative wooden pieces nailed on the cladding boards, 2017

There are numerous ornaments reflecting various styles. Each style has a different way of representing and most of the houses have unique decoration in a harmony with the features of the building. Façade decorations are nailed above the cladding board with small nails. (Figure 4) Small pieces are brought together to create a variety of figures for back bands or appropriate façade surfaces. Besides the straight-lined and plain decorations, flower motives, neo-Greek elements, curvilinear forms and original figures consisting of several pieces are also encountered.

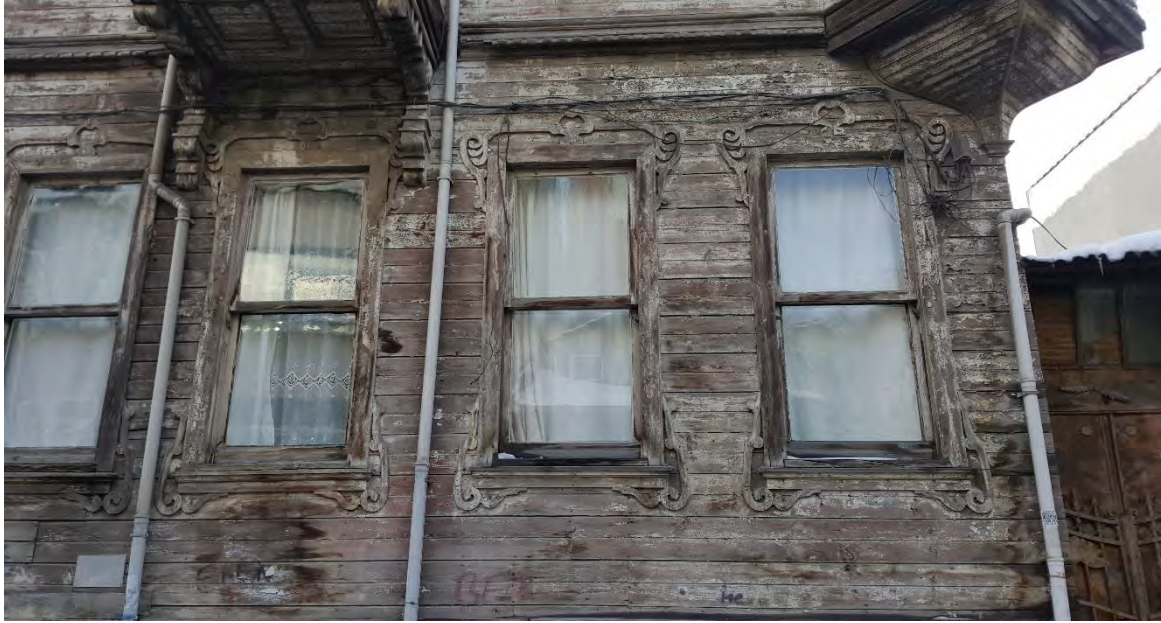
Figure 5: Guillotine windows and European style motives on the wooden cladding, 2016

Uluengin states that the proportion of the windows were changed from 3/5 to 1/2 [7]. Guillotine windows were mainly used on the last Ottoman period houses, which still remain today in Istanbul. (Figure 5) In addition, casement windows or diversified windows with different forms like elliptic, rounded, arched were encountered as well. (Figure 6)

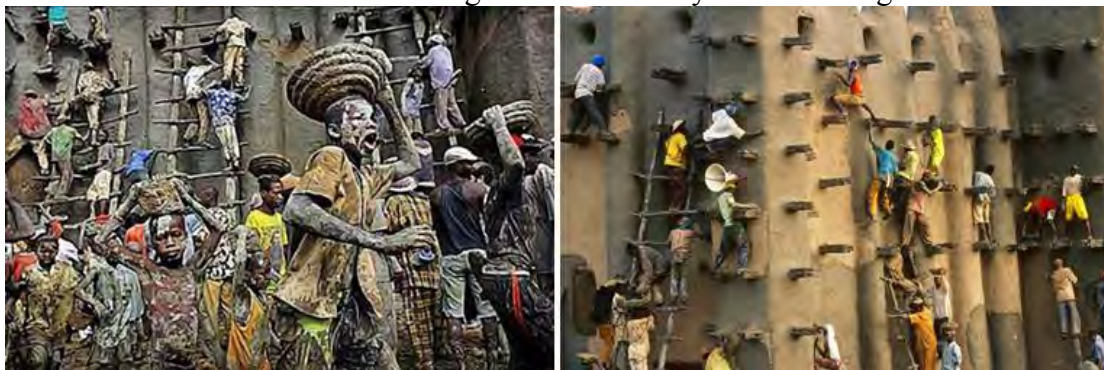
Figure 1-2: Crepissage de la Grande Mosquée (Plastering of the Great Mosque [3].

It is common for earth-block walls to be cracked due to unexpected loads (overloading, seismic vibration), inadequate foundations, and/or differential settlements, shrinkage. Part of the cultural tradition in areas where earth construction is integral to local vernacular architecture, is to repair cracks regularly by renewing the mud-plaster surface finishes [1, 2]. A typical example is the annual festival of the Great Mosque of Djenné in Mali, where the entire community of Djenné takes an active role in the mosque's maintenance by applying new plaster on the walls in order to repair the damage inflicted on the mosque in the past year [3]. However, in many cases, the initial earth structure may have undergone major additions and modifications resulting to a considerably altered configuration.

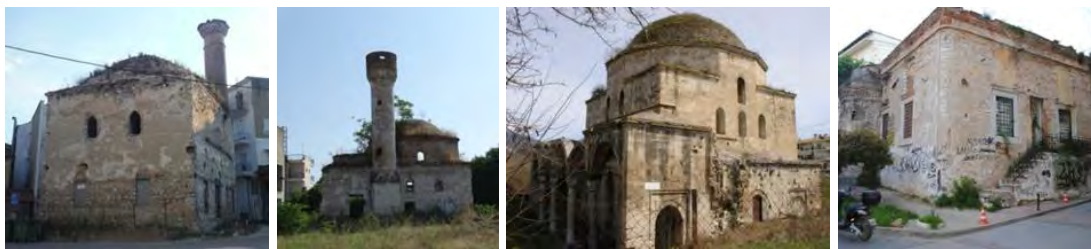
Capture 1: 1<sup>st</sup> and 2<sup>nd</sup> mosques are of the first category, 3<sup>rd</sup> and 4<sup>th</sup> are of the second category.

The combining of typological characteristics resulted in two main categories, based on their individual areas that make up the mosques in today's state of preservation (Capt. 1). The first category includes eight mosques that have an almost square floor plan single prayer space. The second category includes ten mosques, which besides the main quadrangle prayer space have smaller rooms serving social gatherings.

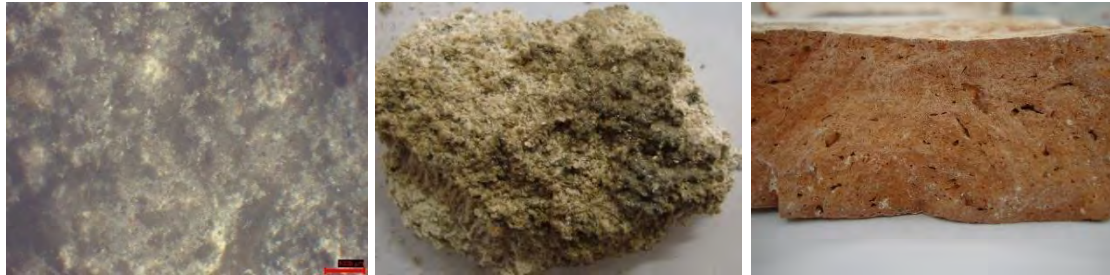
Capture 2: Salts in a sample of mortar (left), black crust (centre) and section of a brick (right).

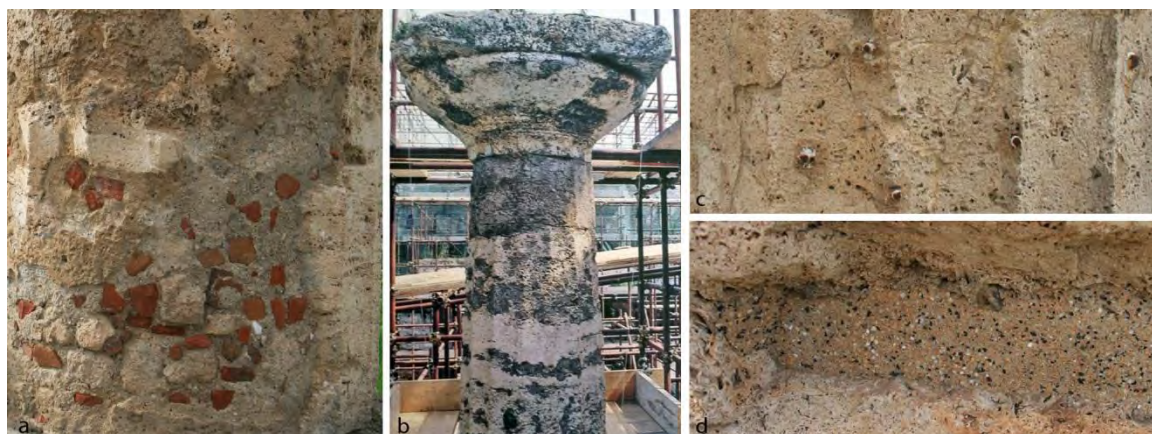
Figure 2: a) temple of Athena, column of the northern side. Addition in fragments of bricks and concrete (1926); b) temple of Neptune, column of the upper order. Integrations in bricks and concrete (Fifties); c) temple of Athena, column of the eastern front. Reinforced perforations (1962); d) temple of Neptune, column of the northern front. Integration made of lime mortars (1997-2002).

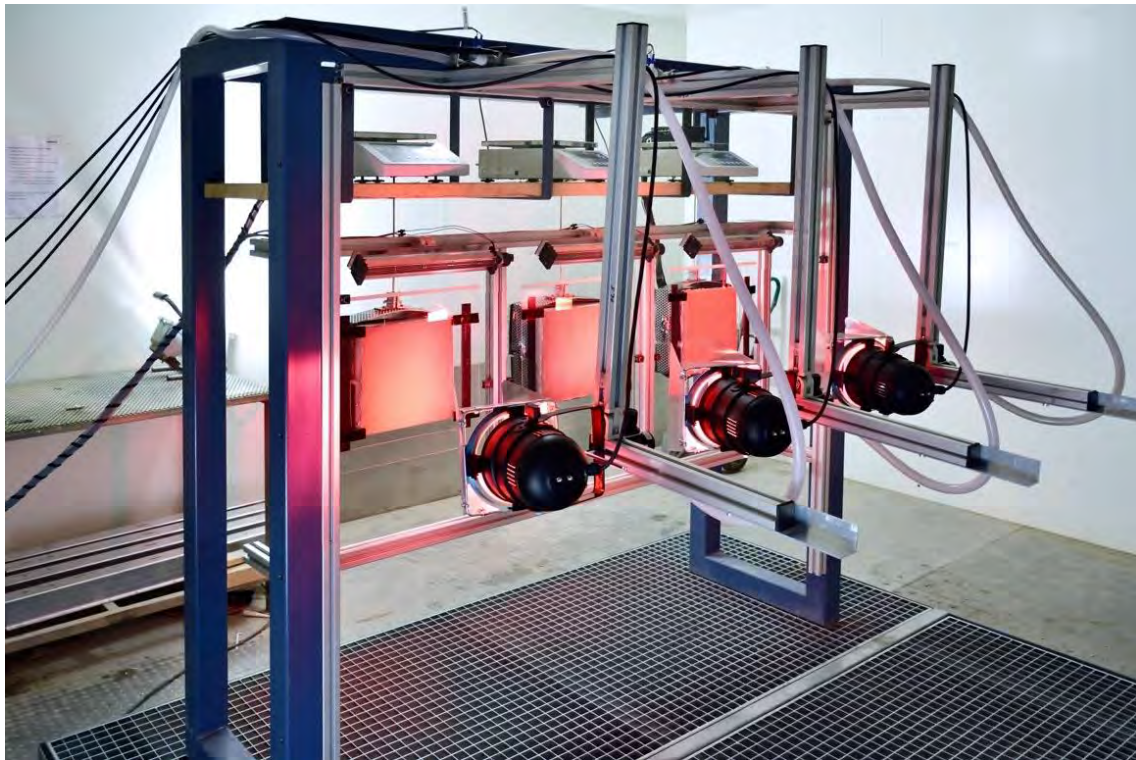
Figure 2: Custom-built machine for the reproduction of weathering conditions on a building facade

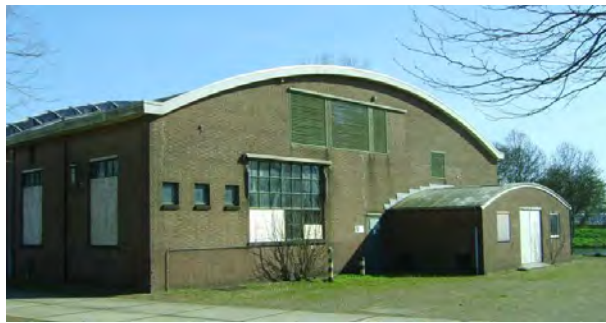
| | Cem. | Limest. | Water | Polym. | Superpla<br>st. | VA | Aggr. |
|---|---|---|---|---|---|---|---|
| VA-SCC | 255 | 170 | 186 | - | 12,4 | 3,0 | 1680 |

Just before WW2 the French architect Jacques Couëlle invented a system to build structures, using ceramic tubes embedded in concrete vaults, known as Fusée Céramique, to reduce the dead weight and save materials. In 1954 this system was introduced in the Netherlands [1] to construct low-rise vaults and domes. During the sixties the costs of labour were rising and this system could not compete with other systems. Fifty years later most of these structures are pulled down. The remaining buildings do not meet the demands of the present concerning comfort, safety, insulation and need of energy. Nevertheless these structures are a fine example of engineering, so at least some of these vaults have to be preserved for the coming generations. Due to temperature variations and time dependent deformations Fusée Céramique structures are subjected to internal forces, which can cause cracks and reduce the stiffness and load bearing capacity substantially [2]. Probably some remaining Fusée Céramique vaults are not safe and have to be strengthened. This paper describes for these vaults a cost-effective method to increase the buckling resistance and load bearing capacity.

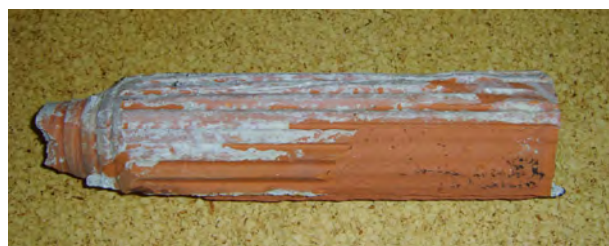
Figure 2: Fusée Céramique element used in Woerden, The Netherlands.

A Fusée Céramique element is a tube with a conical top, which can be shoved into the open rear of the next element. The elements have a length of 350 mm, an outer diameter of 80 mm and a thickness of 10 mm, see figure 2.

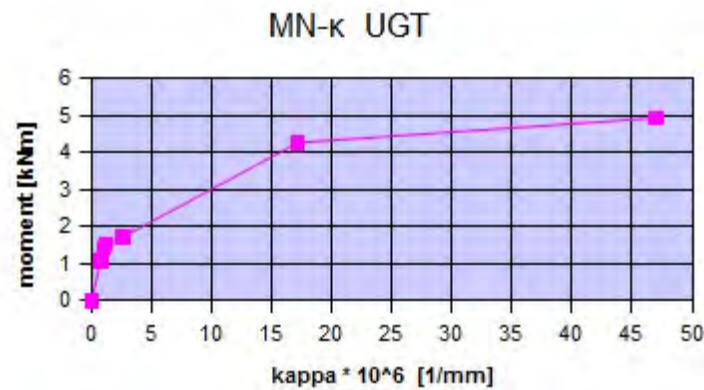
Figure 6: MN- $\kappa$  diagram, ultimate state for a normal force  $N_d = 44,8 \text{ kN}$ .

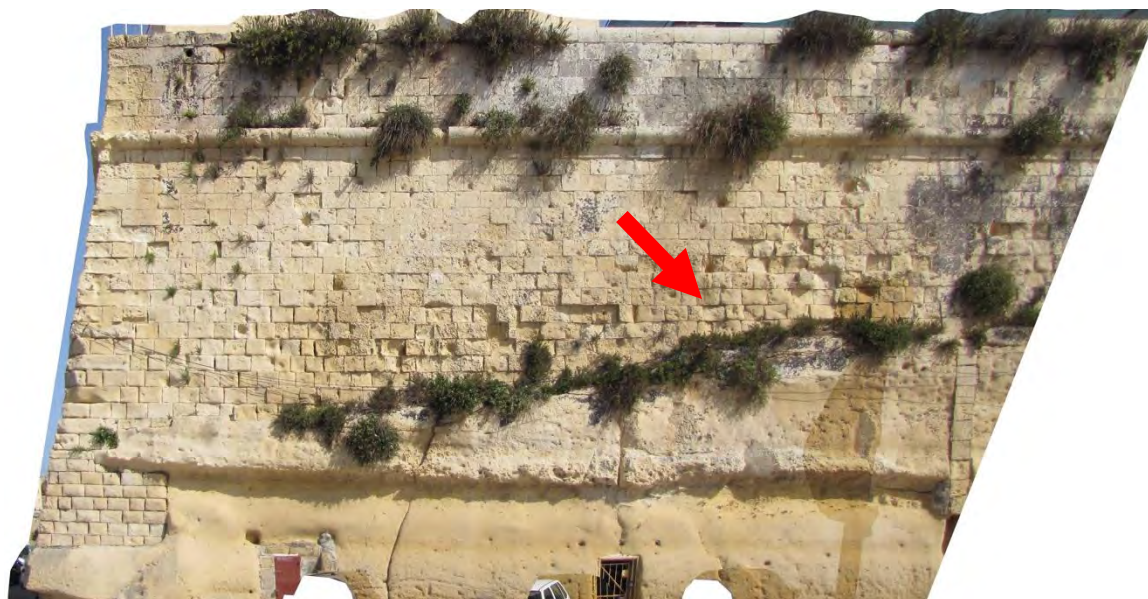
Figure 2: Rectified photography of Saint Sebastian Bastion, Valletta, showing area considered, (Restoration Directorate, Malta).

The first site selected was Saint Sebastian Bastion, part of the fortifications of Marsamxett Harbour, Valletta, Malta and located directly on the coast of the Mediterranean Sea, 35m from the shoreline. In addition to the proximity to the sea, the restoration of this Bastion is envisaged in the near future, making it an ideal study area where the future interventions may benefit from the results obtained in this research.

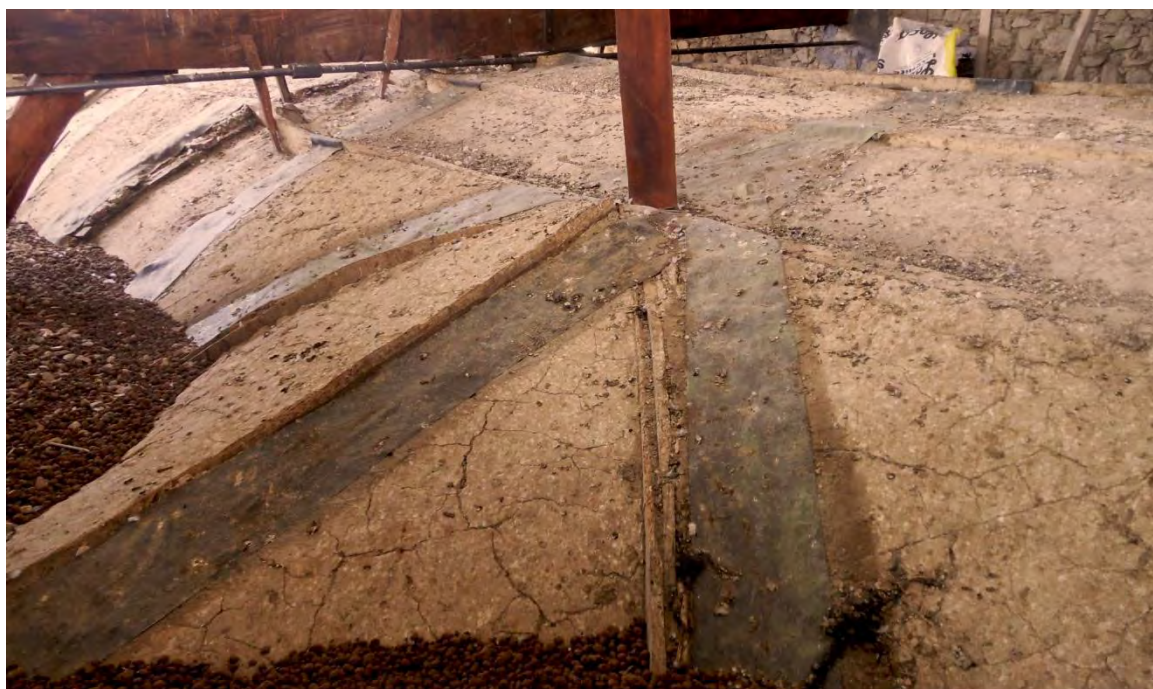
Figure 1: Italy, Baranello (Campobasso). St. Michele Arcangelo church. The extrados of the vault in the central nave: the image shows the wooden structure and the concrete made up of gypsum and lime (L. Romano 2016).

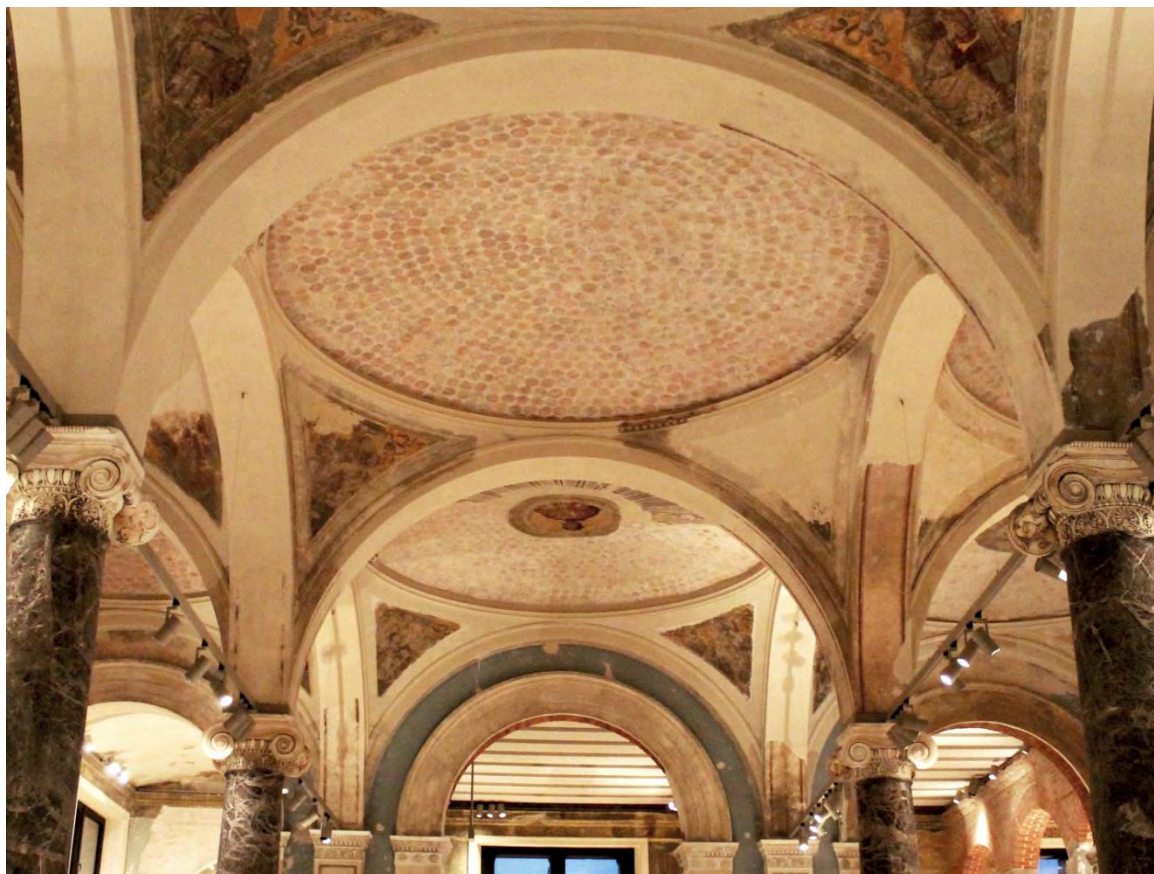
Figure 2: Germany, Berlin: the Neues Museum. Clay pots vaults designed by Friedrich August Stüler in the 19th century (L. Romano 2015).

The Neues Museum, for example, in addition to problems relating to foundations, needed a plan to compartmentalize the building to prevent fire from spreading. Therefore, the lack of clay pot ceilings in Europe is linked to their strong fire-retardant properties as well as to the substantial lightness and to the simplicity of realization. Unlike the Italian contexts – where, in spite of the scientific advancements, the planning was still partially related to an empirical approach – a more scientific methodology can be noticed in France and Germany: a clear example is provided by the project of the vaults in the Neues Museum and by the contemporary studies on their resistance [19].

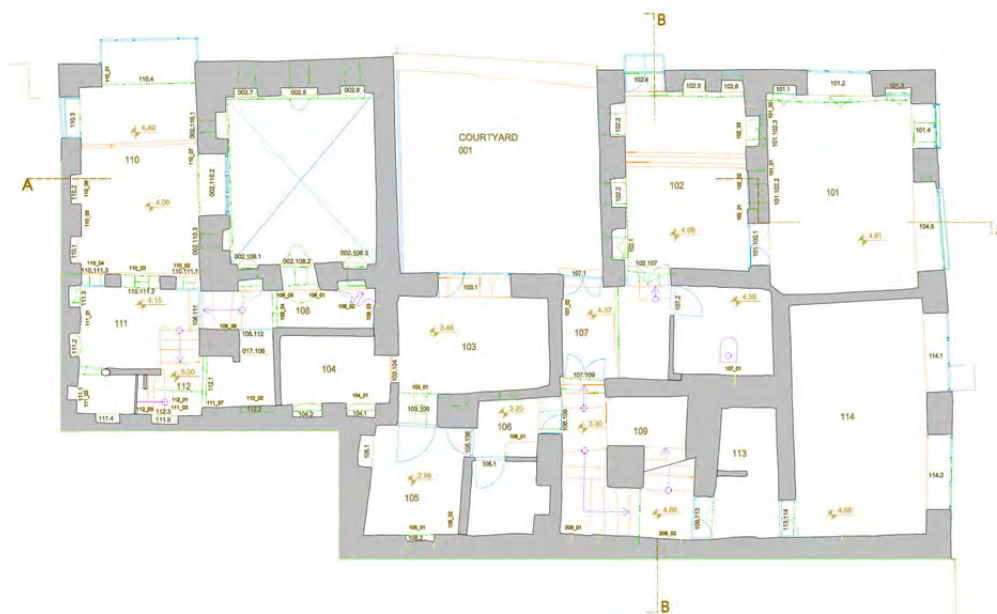
Figure 2: First floor of Al-Nawar House. The surveyed room 101 is located on the upper right corner in north-western direction. The façade openings are just filled with wooden shutters [3].

In the year 2011 a group of scientists from Vienna University of Technology and King Abdul Aziz University of Jeddah performed a contour-accurate building survey of Al-Nawar House using a 3D laser scanner on site for plan mapping in scale 1:50 (see figure 2). Also a damage mapping was drawn up by a photographic documentation of all room surfaces [3]. The information about the way of living in such typical, about 300 year old residential building came directly from Sami Nawar, the former inhabitant and actual owner of Al-Nawar House. Literature study provided the background information such as the connection of Al-Nawar House to the history of Jeddah and its people [4, 5].

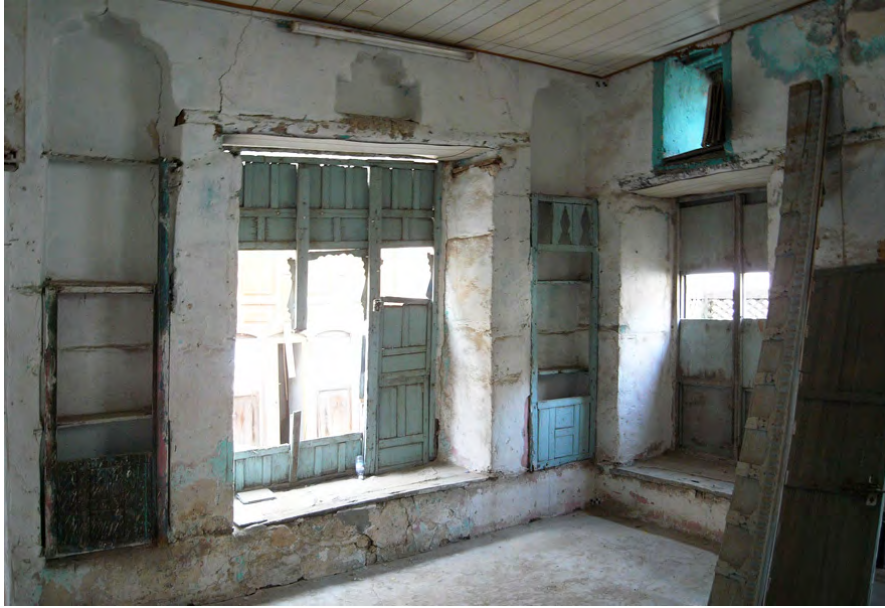
Figure 3: Condition of the Room 101 on the first floor of Al-Nawar House in the year 2011. The openings are facing in western and northern direction. The walls are constructed of load bearing coral stone blocks, covered with whitewashed lime plaster. The openings are filled with wooden shutters, which can regulate the airflow and daylight impact into the room [3].
