Damage characterization of rock slopes

Journal of Marine Science and Engineering

Damage Characterization of Rock Slopes

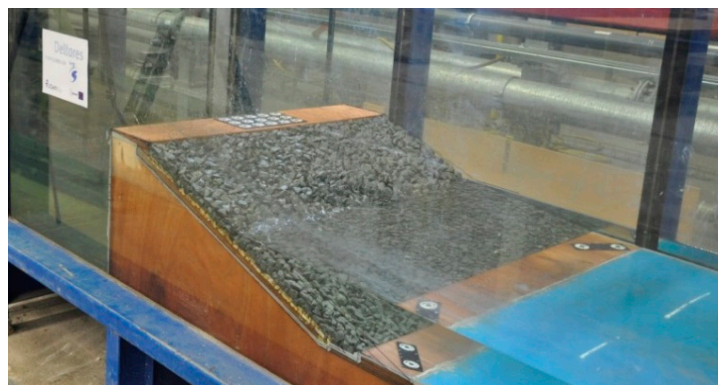
This set-up consisted of a non-overtopped rubble mound structure with an impermeable core, a filter ($D_{n50} = 9.4$ mm), a 1:3 two-layer rock armored slope ($D_{n50} = 16.3$ mm and $D_{n85}/D_{n15} = 1.19$), and a foreshore (see Figure 2). In addition, the main particularity of these tests for shallow coastal areas is that the generated wave was equal for all test runs, and only the change in the water depth at the toe of the structure defined the incident wave height. This way, the effect of the sea level rise in the damage to the structure was clearly represented. Thus, this set-up provided a large amount of data given the number of tests carried out, which allowed the testing of different slope configurations and a number of repetition tests. The testing conditions included the following:

Figure 2. Deltares shallow water tests set-up.

campaign carried out during this research (see tested rock slope in Figure 2). From about 10 pairs of images (Figure 5a) before and after a given test run, the 3D reconstructions of the structure are obtained (Figure 5b). Comparing those 3D models from before and after the given tests, the 3D damage reconstruction is obtained (Figure 5c). This method for measuring damage is used during this research. From those measurements, the erosion areas (in yellow-orange-red in Figure 5c) are assessed and characterized (for more details on the DSP technique, see [6,7,10])

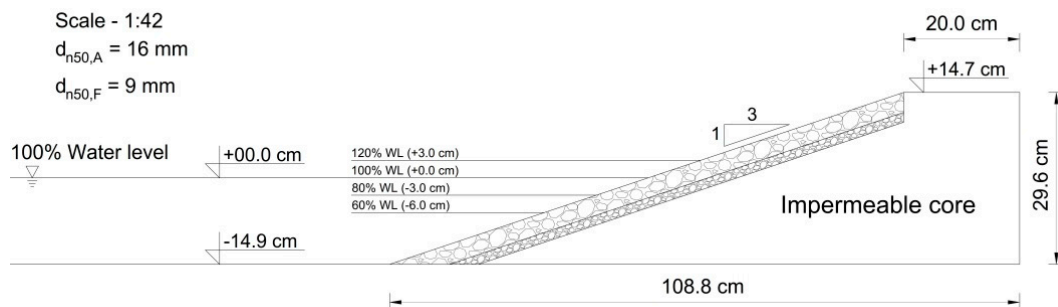
The cross-section of the model set-up used in the Deltares tests is shown in Figure 3. During these tests, only the damage to the front slope was evaluated. In this study, only the straight slope configuration is considered. The test program, including slope configurations with a berm, is described in the works of [8,9]. Incident wave heights were depth-limited given that an 8 m long foreshore was present in this model. The model (considering reference wave climate in the Dutch coast) followed the Froude criterion. Moderate Reynolds ($Re > 1 \times 10^4$) ensured turbulent conditions in the filter and armor (no permeable core) and negligible scale effects. In addition, the wave generation equipment included active compensation for the reflected wave at the wave board.

Figure 3. Deltares tests cross-section.

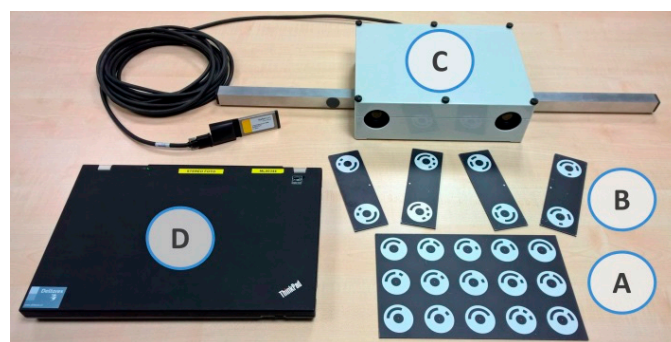
During those tests, the measurement of damage to the armor layer was done using the digital stereo photography (DSP) technique. This method used the following equipment described in Figure 4 and in the list hereafter.

- A—Markers base plate: fixed origin of coordinates for the 3D reconstruction and comparison between test runs, to be kept fixed during the complete testing period.
- B—Additional markers: pairs of reference points used in the 3D reconstruction, to be randomly placed before a measurement and removed after it (if necessary, they can also be fixed).
- C—Cameras: two digital cameras with a fixed distance between each other.
- D—Laptop: used for obtaining the pairs of images and carrying out the post-processing.

Figure 4. Digital stereo photography (DSP) equipment.

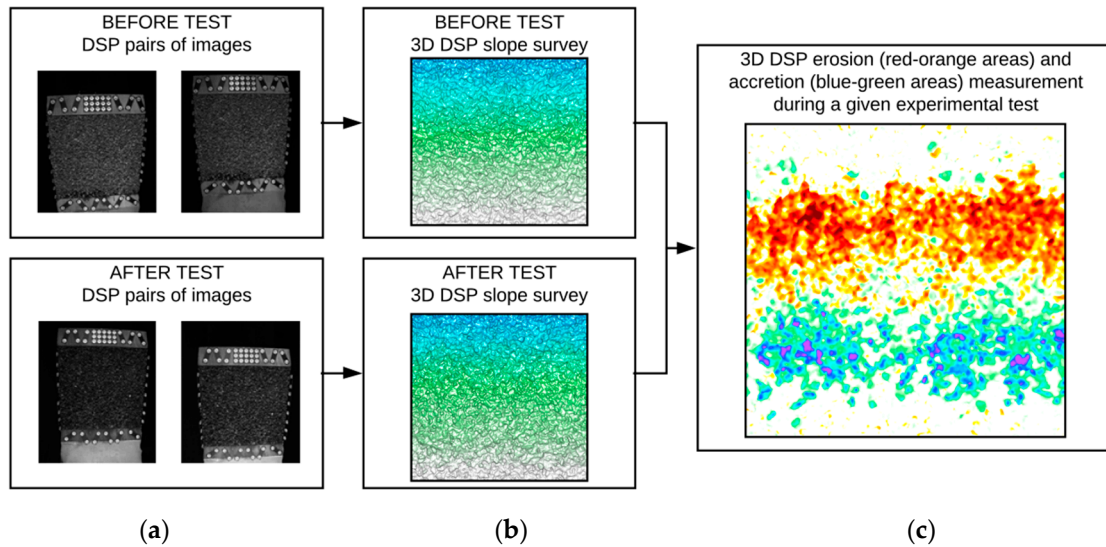
Figure 5 shows the workflow for the characterization of damage to rock slopes using digital stereo photography. The images and measurements shown in Figure 5 are obtained from the measurement

Figure 5. Digital stereo photography (DSP) workflow. (a) Pairs of images from the surveyed slope, before and after a test, (b) 3D slope survey before and after a test (white color being the lower part of the slope, and blue color being the higher part of the slope), (c) erosion and accretion measurement following a given test (red-orange areas being erosion areas, and blue-green areas being accretion areas).

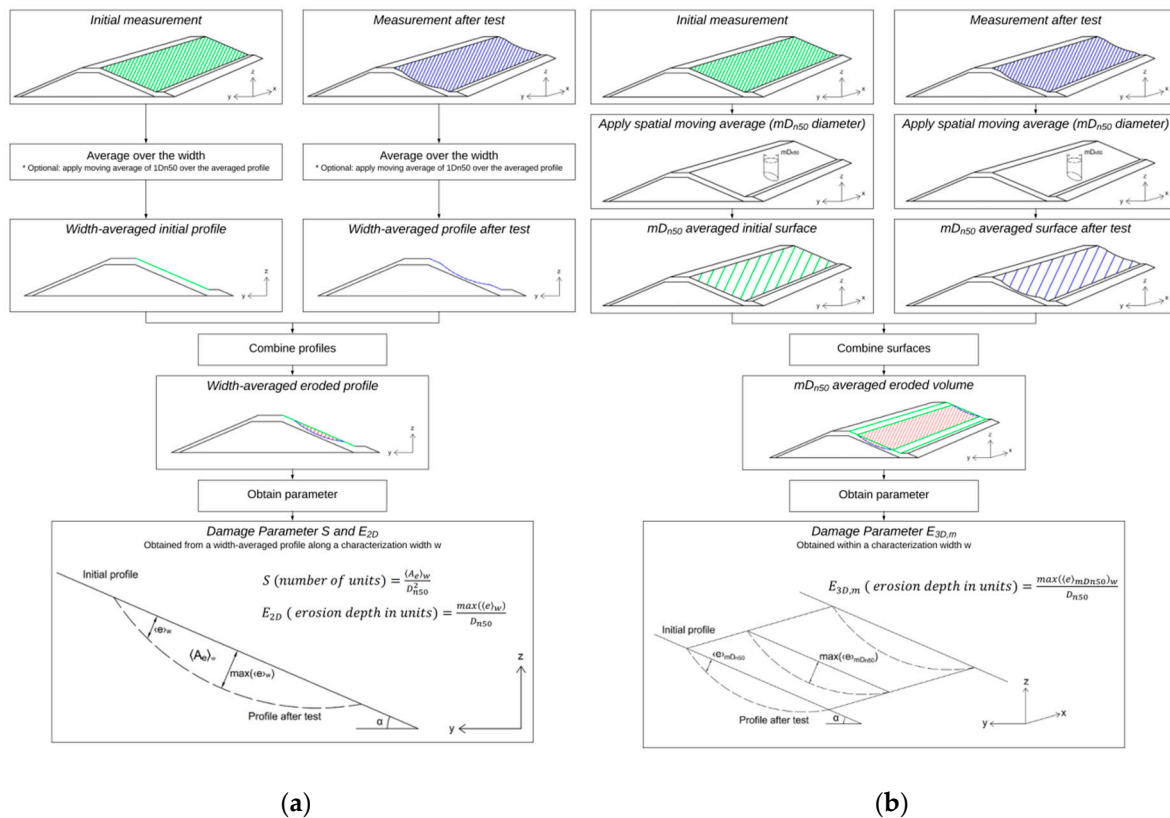
The parameters E_{2D} [5] and $E_{3D,m}$ [6,7] are shown in Equations (2) and (3), respectively. These two parameters estimate the damage to the structure considering the maximum erosion depth perpendicular to the slope. The distinction between them is that for E_{2D} , this erosion depth is measured in the width-averaged profile, while for $E_{3D,m}$, this erosion depth is obtained as the maximum erosion depth recorded at any point of the structure or defined characterization width. In addition, for $E_{3D,m}$,

where $\max(\langle e \rangle_w)$ (m) is the maximum erosion depth from the averaged profile obtained over a given characterization width w , $\max(\langle e \rangle_{mD_{n50}})_w$ (m) is the maximum erosion depth averaged over an area of mD_{n50} diameter obtained over a given characterization width w , and D_{n50} (m) is the nominal median diameter.

Figure 6. Damage parameters methodology. (a) S and E_{2D} parameters obtained from a width-averaged profile, (b) $E_{3D,m}$ parameters obtained from the maximum erosion depth observed within a given characterization width.

This section has the aim of validating the damage characterization methods, which include the damage concepts (Section 3.1), damage parameters (Section 3.2), and measuring techniques (Section 3.3). For that, the physical modelling tests presented in the previous section are used. As a first step, the damage parameters considered in this study are described in more detail, including the procedure for their calculation in Figure 6, for the S and E_{2D} parameters (6a) and for the $E_{3D,m}$ parameters (6b).

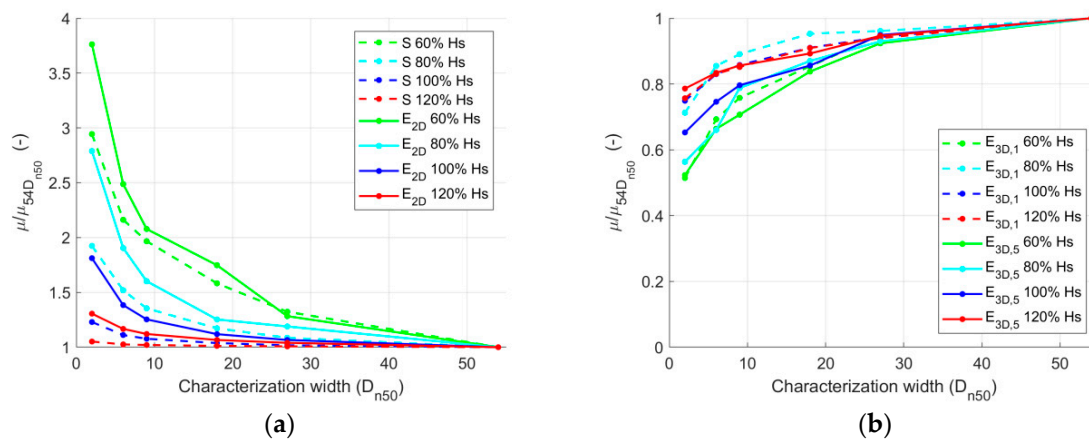
The influence of the characterization width on the mean measured damage can be observed in Figure 7, obtained from the survey of a $54D_{n50}$ wide slope in the Deltares tests Series 1 (see Table 1), carried out five times in five identical repetitions. The values for each characterization width are obtained as the average of all the values for that given width, being between 135 values for the $2D_{n50}$ width and 5 values for the $54D_{n50}$ width. This average damage is then normalized by the damage obtained for the $54D_{n50}$ characterization width.

Regarding the parameters obtained from width-averaged profiles (S and E_{2D} in Figure 7a), it can be observed that the measured mean damage reduces with increased characterization width because the damage to certain areas is hidden by the accretion in other areas. Regarding the parameters obtained as the maximum erosion depth observed within a given characterization width ($E_{3D,1}$ and $E_{3D,5}$ in Figure 7b), it can be observed that the measured damage increases with increased characterization width.

The main observation for the damage parameters $E_{3D,1}$ and $E_{3D,5}$ (also referred in general form as $E_{3D,m}$) is that the measured damage continues to increase with increasing characterization widths. This suggests that there is no upper limit for the damage to the structure and that when considering wider structures, the probability of observing a larger extreme damage will continue to increase. Thus, besides considering the characterization width, this length effect for the design and characterization of coastal structures should then be taken into account (see Section 3.2.2 and [9]).

Figure 7. Characterization width. Mean damage variation (bias), calculated as the mean damage from each characterization width (μ) divided by the mean damage from the $54D_{n50}$ characterization width ($\mu_{54D_{n50}}$). (a) S and E_{2D} parameters, (b) $E_{3D,1}$ and $E_{3D,5}$ parameters.

- Mean evolution: as shown in Figure 7, different characterization widths will affect the measured damage (bias). Thus, ideally, a suitable characterization width will be the one that shows a smaller difference in mean measured damage compared with what is obtained when considering different characterization widths.

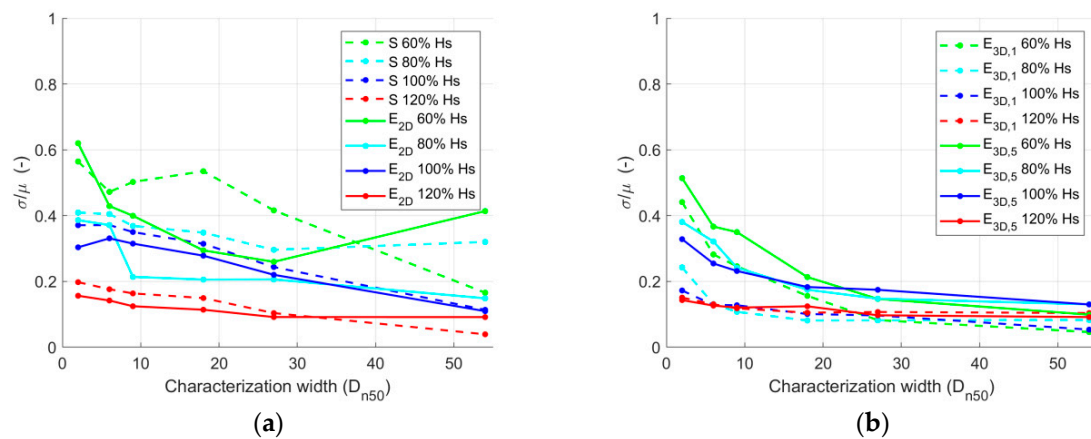
The variability of measured damage is evaluated for different characterization widths. The five identical realizations of Deltares tests Series 1 are considered again, which consists of four test runs each (see Table 1). In Figure 8, the standard deviation normalized by the mean for the four parameters can be observed.

Regarding the parameters obtained from width-averaged profiles (S and E_{2D} in Figure 8a), it can be observed that the increase in the characterization width leads to a general reduction of the variability in the measurements. Regarding the parameters obtained as the maximum erosion depth observed within a given characterization width ($E_{3D,1}$ and $E_{3D,5}$ in Figure 8b), they also show a reduction in the variability (mainly because of an increase in the mean values) with increasing characterization width, with significantly less variability than for parameters S and E_{2D} . For additional details on damage variability, consider the work of [9].

Figure 8. Characterization width. Standard deviation of the damage (σ) divided by the mean of the damage (μ), for each characterization width (random error). (a) S and E_{2D} parameters, (b) $E_{3D,1}$ and $E_{3D,5}$ parameters.

- Variability evolution: as shown in Figure 8, it should be considered that different characterization widths will present different variability in the results when the same condition is tested several times (random error). Thus, ideally, a suitable characterization width will be the one that shows a smaller variability in the results.

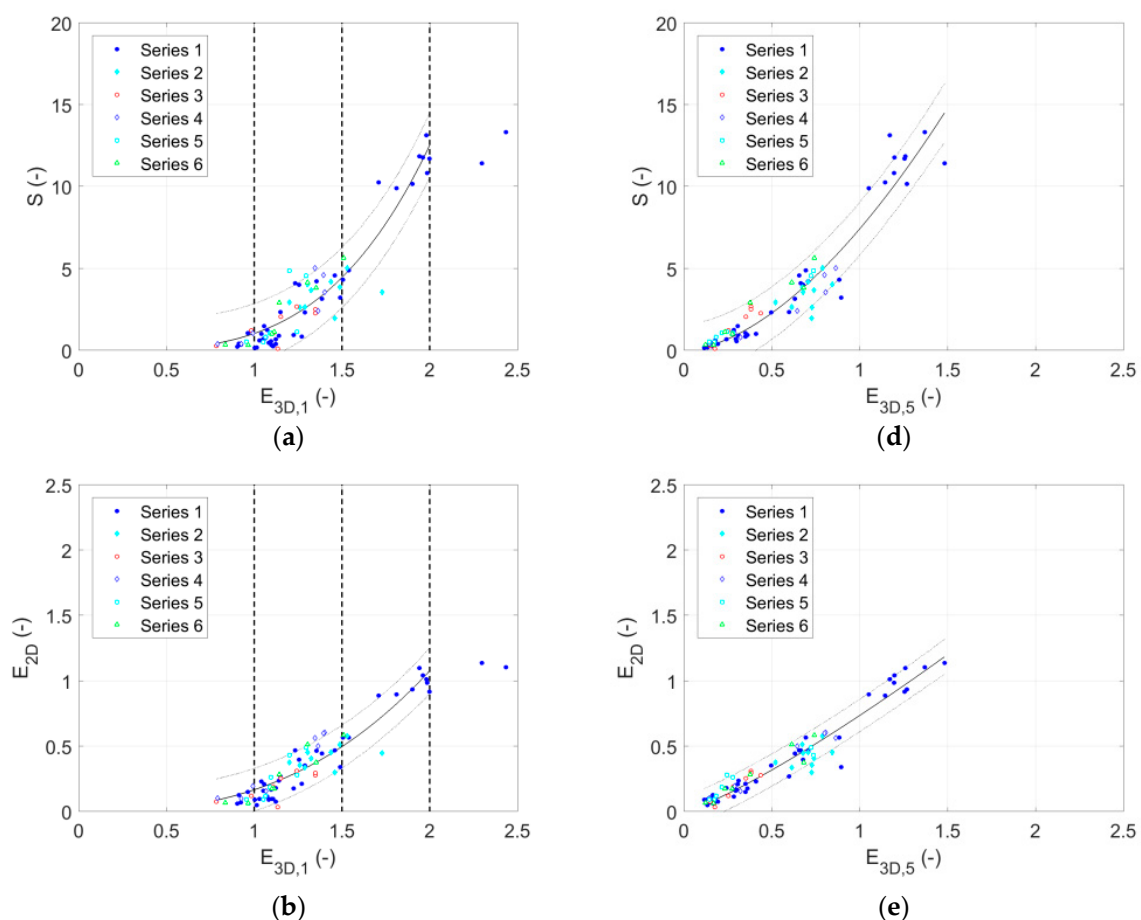
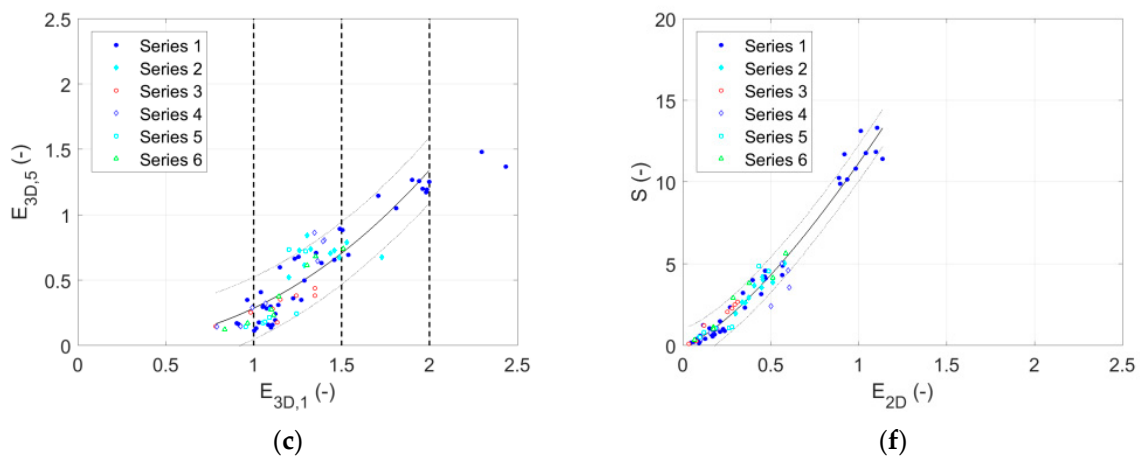
Thus, considering all the measurements carried out with a high resolution technique (DSP) and the damage parameter $E_{3D,1}$, the damage limits can be calibrated based on the Deltares tests (characterization width of $27D_{n50}$), see Figure 9 and Table 2.

Figure 9. Comparison of all damage parameters (for $27D_{n50}$ characterization width). (a) $E_{3D,1}$ vs. S parameters, (b) $E_{3D,1}$ vs. E_{2D} parameters, (c) $E_{3D,1}$ vs. $E_{3D,5}$ parameters, (d) $E_{3D,5}$ vs. S parameters, (e) $E_{3D,5}$ vs. E_{2D} parameters, (f) E_{2D} vs. S parameters.

An important remark from the previously defined calibrated damage limits is the fact that, according to the available data, they are constant for the slopes applied (1:3 in Deltares tests). Nevertheless, this should be further investigated considering a larger number of tests and different slope configurations in order to validate these conclusions.

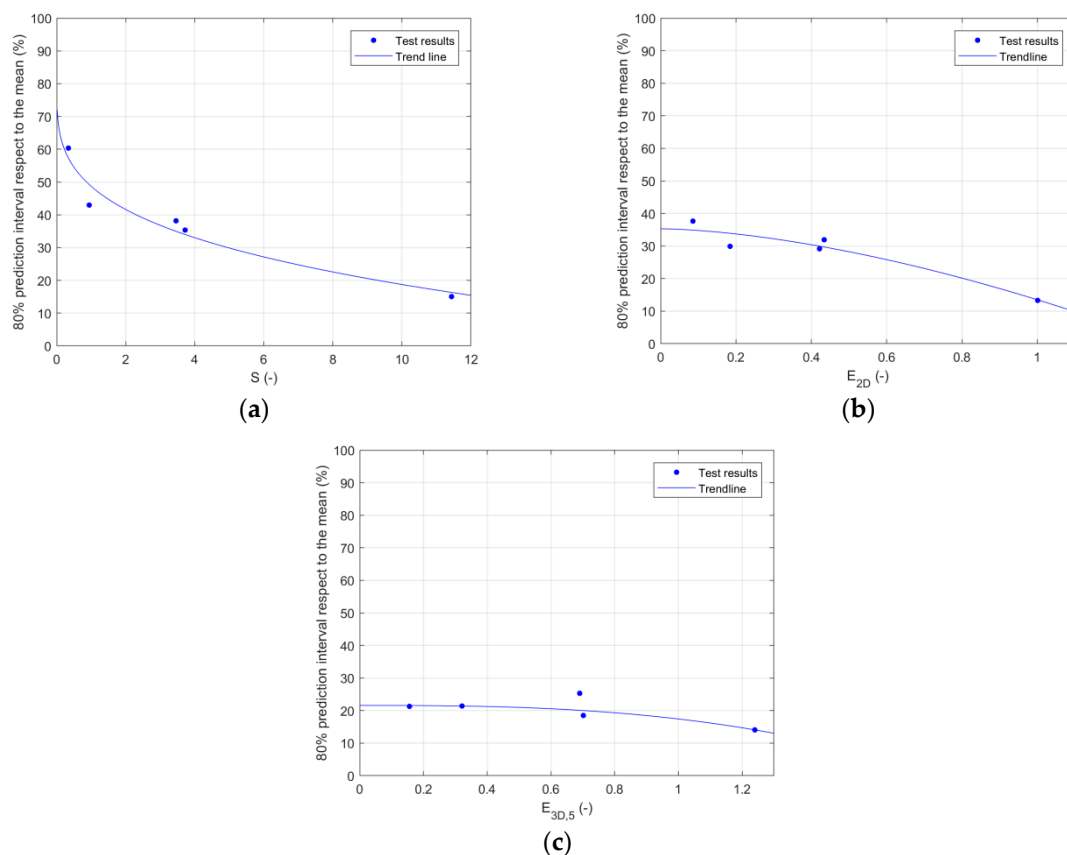
The damage data for Series 1 (composed of four test runs of 60%, 80%, 100%, and 120%) and Series 2 (composed of one test run of 100%) is described in the table below. For each test run, 10 observations are considered, obtained from five realizations in a model with a width of $54D_{n50}$ (twice the considered characterization width of $27D_{n50}$). For these 10 observations and the 3 damage parameters, Table 3 and Figure 10 show the 80% confidence prediction interval, applying a Student's t -distribution with a critical t -value of 1.383 ($\delta = \pm 1.383 \cdot \sigma \cdot \sqrt{1 + 1/10}$) expressed as a percentage of the mean.

According to these results, it can be observed that damage parameters $E_{3D,5}$ present a lower variability (random error), especially for the lower conditions associated with a lower amount of damage (60% and 80%). Damage parameters S and E_{2D} present low variability in higher damage levels (120% in Series 1 run 4), but much higher variability (random error) in the other damage levels.

Figure 10. Eighty percent prediction interval with respect to the mean (for $27D_{n50}$ characterization width). (a) S parameter, (b) E_{2D} parameter, $E_{3D,5}$ parameter.

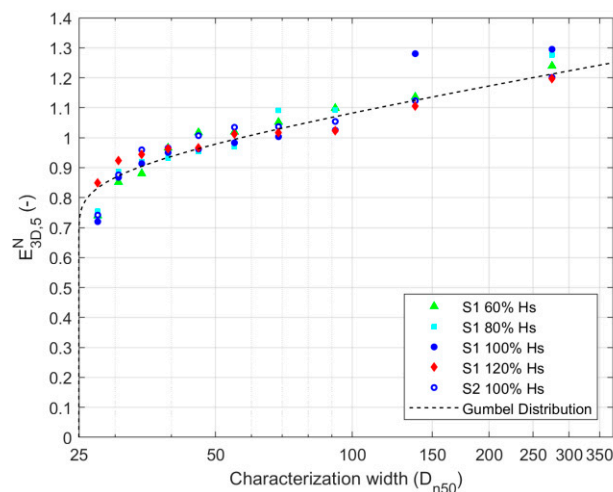
The exceedance probability for the damage is translated to a return width in a similar form to that used for the study of extreme wave climate (see Equation (4)). The combined extreme distribution for the normalized damage parameter $E^N_{3D,5}$ is shown in Figure 11.

**Figure 11.** Gumbel extreme distribution for $E_{3D,5}^N$ parameter (for $27D_{n50}$ characterization width).

Figure 11 shows that a single realization of a test run for a characterization width of $27D_{n50}$ is expected to present damage of approximately 0.8 as the mean damage (calculated from 10 realizations), while for a structure 10 times wider (approximately $270D_{n50}$ wide), damage of 1.2 as the mean damage is expected. Thus, according to this study, the damage to a structure $270D_{n50}$ wide is expected to present damage up to 50% ($1.2/0.8 = 1.5$) larger than that obtained in a single realization in a $27D_{n50}$ characterization width. Detailed guides on how to account for the length effect on rock armored structures are presented in the work of [9].
