Open-File Report 91-502

GEOMORPHIC AND VEGETATIVE RECOVERY PROCESSES ALONG MODIFIED STREAM CHANNELS OF WEST TENNESSEE

By Andrew Simon and Cliff R. Hupp

U.S. GEOLOGICAL SURVEY

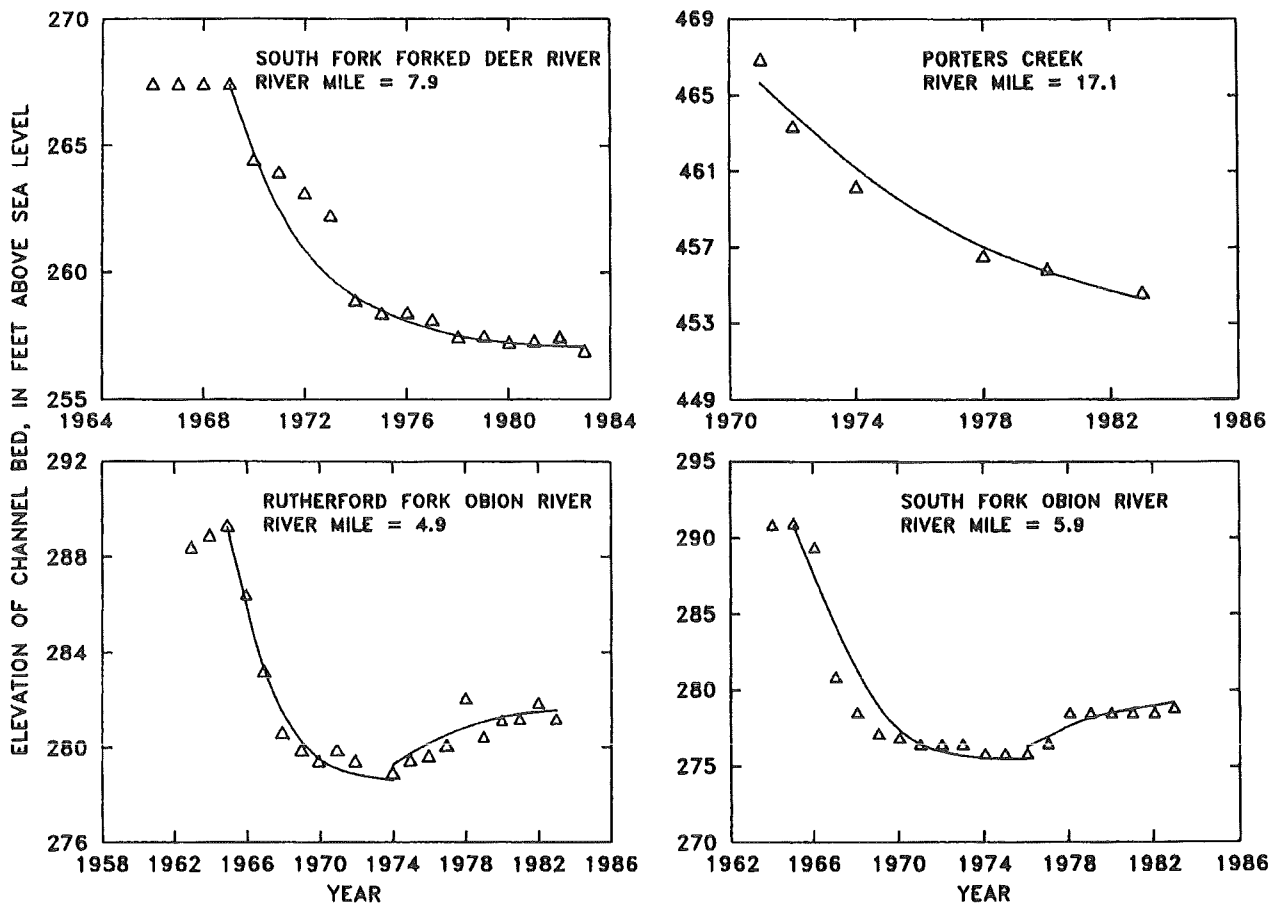
Figure 3.--Relation of channel-bed elevation and time since channel modification for selected stream sites in West Tennessee (curves are visually fitted). (Modified from Simon, 1989.)

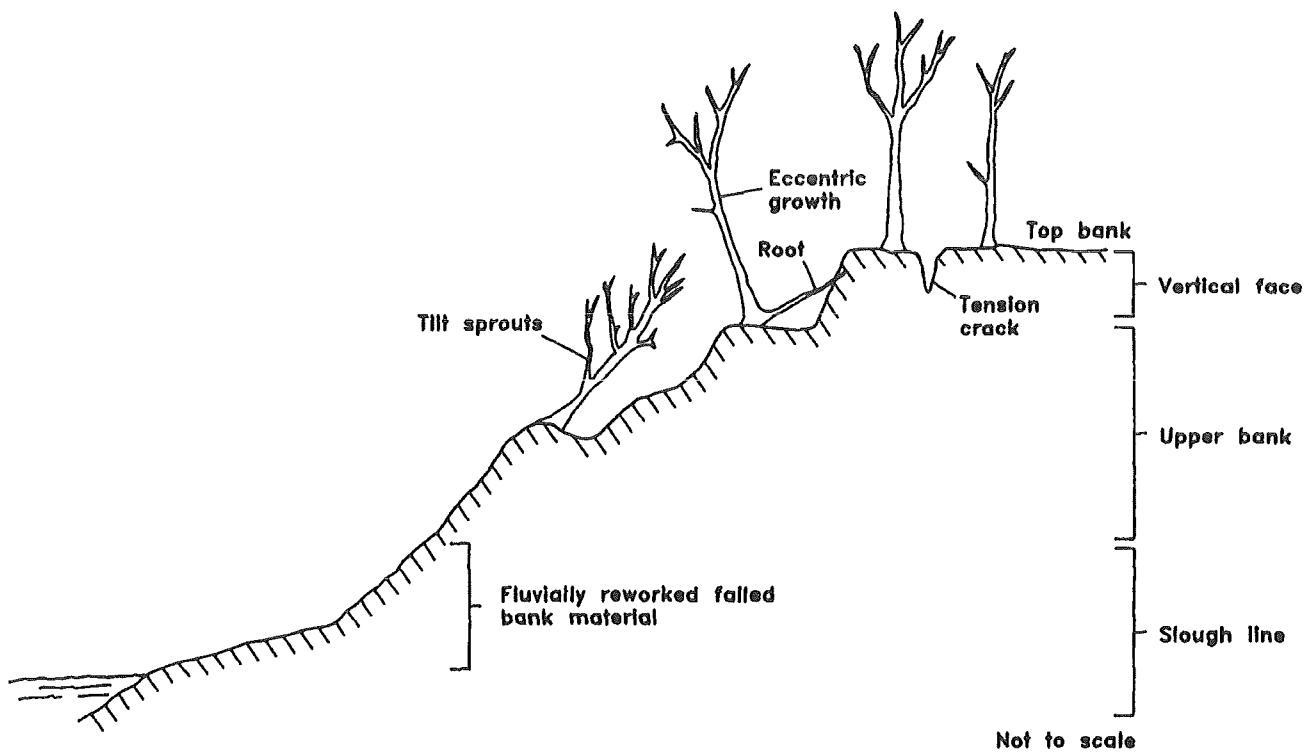
Figure 16.--Generalized bank cross section of modified channel after extensive channel-bed degradation and channel widening. Failure blocks and botanical evidence are shown. Note location of typical streambank forms, indicated on right.

Dates of bank failure were combined with measurements of failure-block width or the horizontal distance between affected specimen and the present edge of top bank (fig. 16). Average width of failure (horizontal distance into bank), was divided by the time since failure (years) to obtain the amount and rate of channel widening by site.

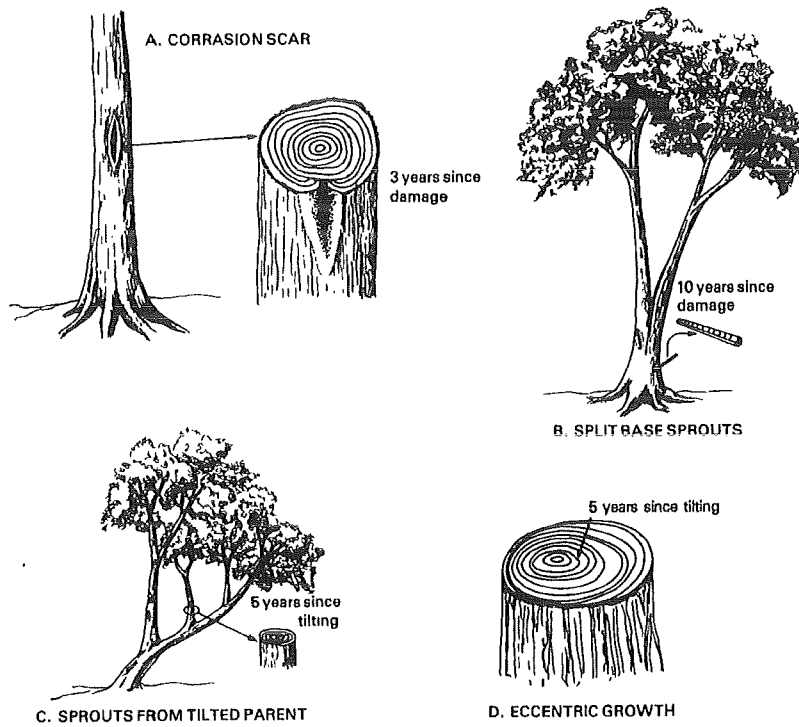
Figure 17.--Types of botanical evidence associated with typical geomorphic disturbances. (Modified from Hupp, 1988.)

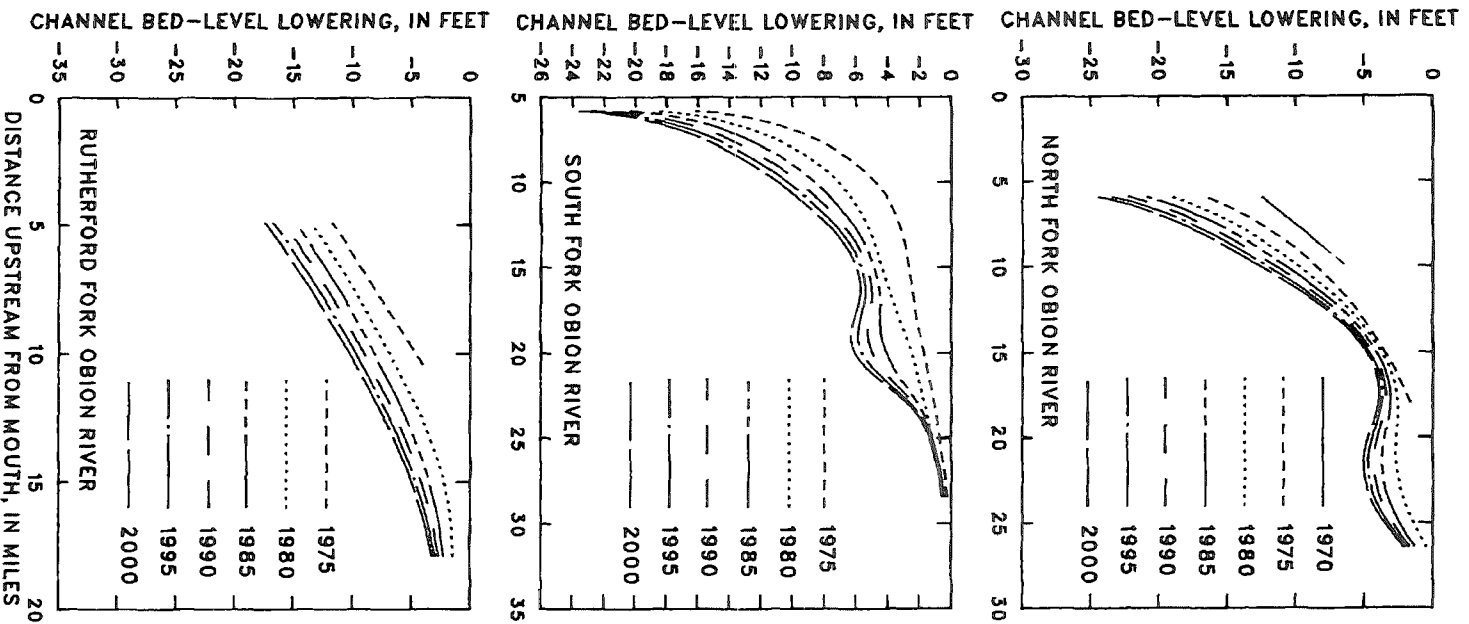
Figure 20. --Projected channel bed-level lowering for North Fork, South Fork, and Rutherford Fork of the Obion River.

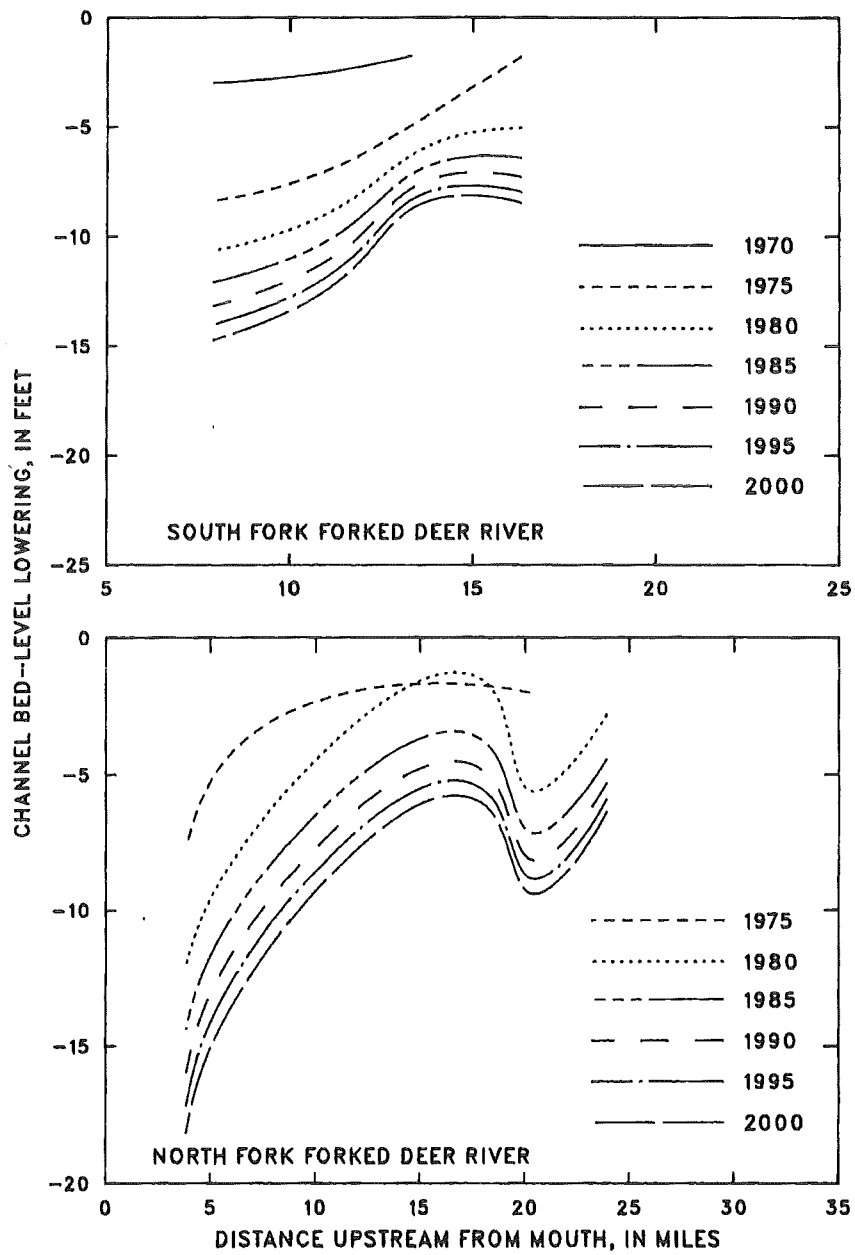
Figure 21.--Projected channed bed-level lowering for South Fork and North Fork of the Forked Deer River.

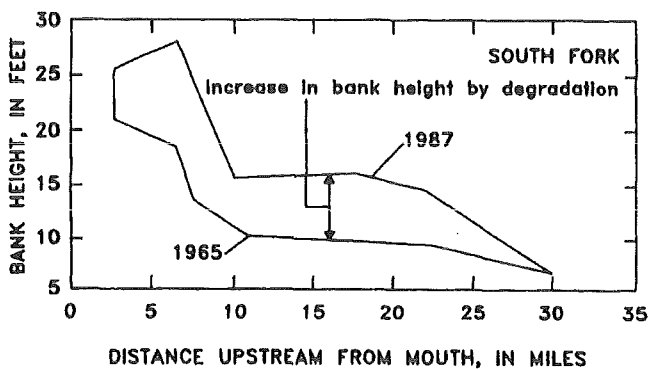
Figure 23.--Changes in bank heights by degradation along the North Fork, South Fork, and Rutherford Fork Obion River, 1964, 1965, and 1987.

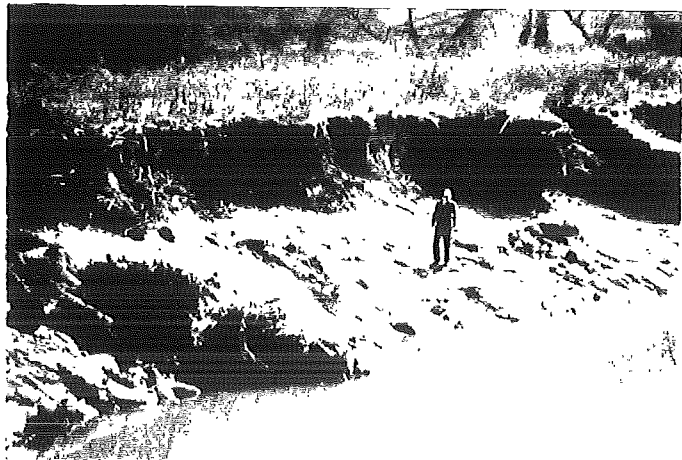
Figure 34.--Typical planar failure, South Fork Obion River (station number 07024550, river mile 11.4, 1984).

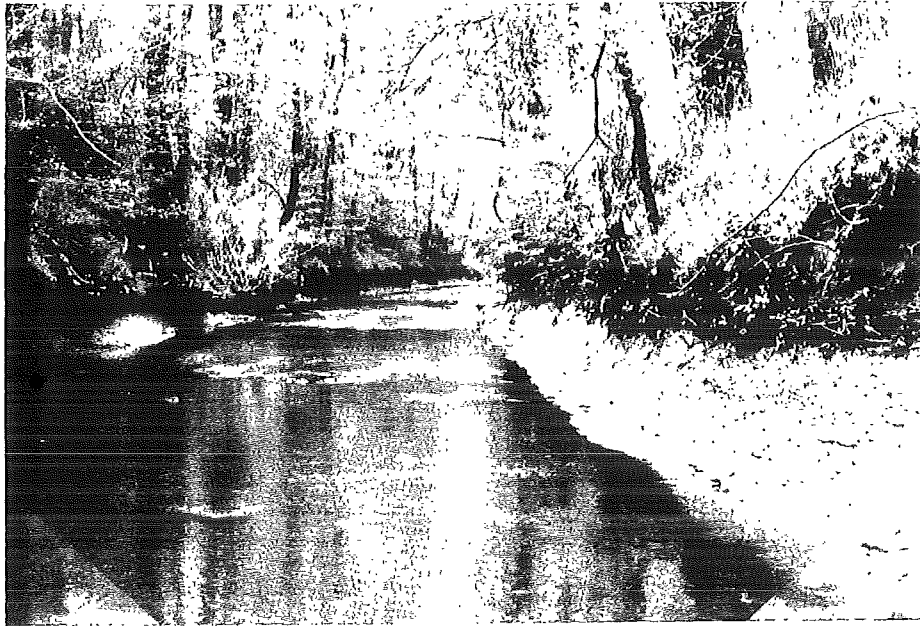
Figure 56.--Upstream view of Davidson Creek near U.S. Highway 51; site is a typical reach during degradation stage (stage III).
