RESEARCH PAPER

# Reuse potential of architectural glass: experimental study on the strength of used window glazing

Jagoda Cupac<sup>1</sup> · Kyriaki Corinna Datsiou<sup>2</sup> · Christian Louter<sup>3</sup>

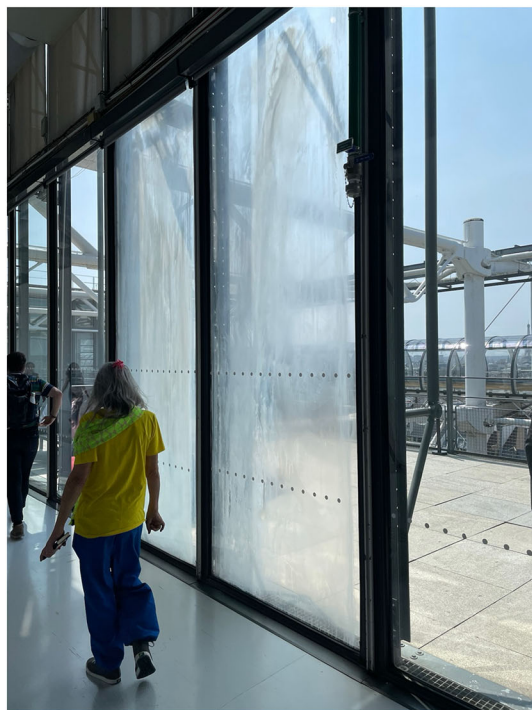
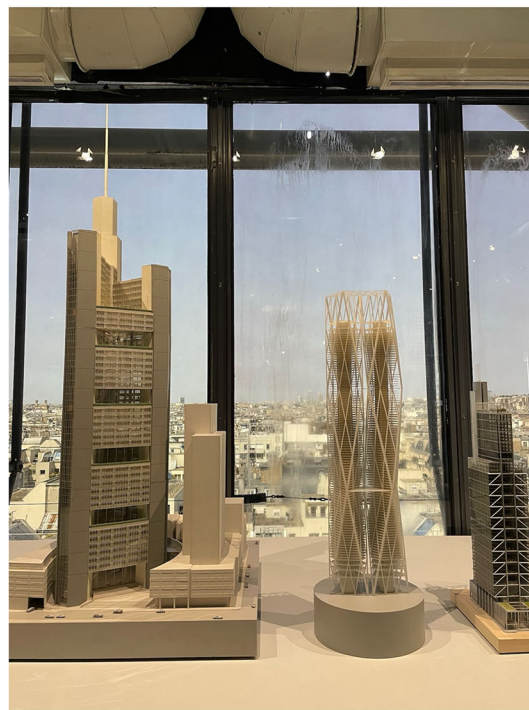
**Fig. 1** Effect of condensation in the IGU cavity on the transparency of the glazing; Centre Pompidou, Paris

IGUs are mainly being replaced due to degradation of the primary seal which results in significant reduction of thermal performance and may lead to condensation in the air cavity, with a negative impact on the transparency of the glazing (Fig. 1). The expected service life of an IGU assembly is only 25 years, due to the limited durability of the seal, while the expected service life of a single glass pane is 60 + years (CWCT 2021).

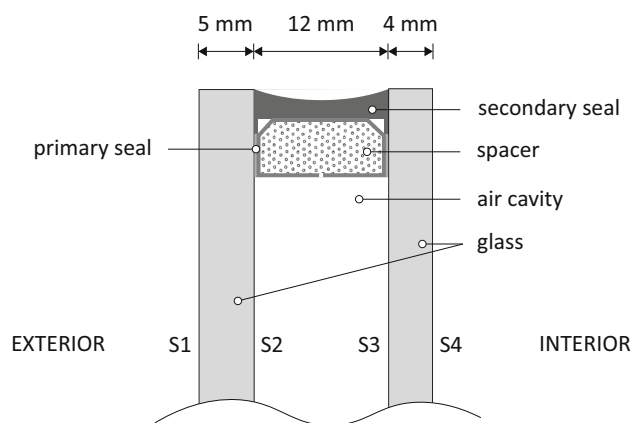
**Fig. 2** IGU composition

Seven IGUs were initially analysed with Bohle GlassBuddy®, to determine the glass thickness, configuration of panes, any coatings, interlayers (i.e. laminated glass), and their exact position in the IGU. The configuration of the IGUs, schematically shown in Fig. 2, includes two annealed float glass panes, with a nominal thickness of 4 mm and 5 mm. According to the refurbishment contractor, the IGUs were installed with the thicker 5 mm pane facing the exterior. No coatings were detected on any of the glass surfaces. The two panes were separated with a spacer and bonded with a sealant, enclosing a 12 mm wide air cavity. Furthermore, the measuring device Bohle TinCheck® was used to identify the tin bath side of the glass. No consistency was found in the placement of the tin/air side relative to the position of the glass surface within the IGU. Glass surfaces are numbered from the exterior to the interior, as shown in Fig. 2 (surfaces S1–S4).

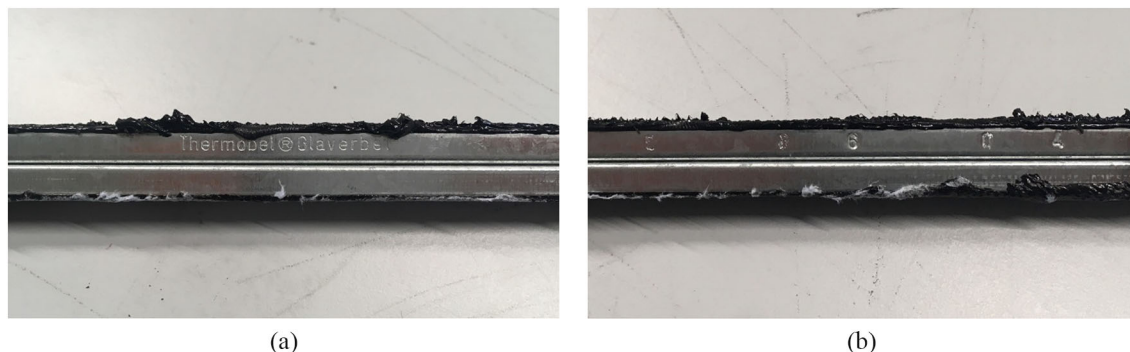
**Fig. 3** IGU spacer indicating: **a** the product name (Thermobel®Glaverbel); **b** the production code (5 86 04)

According to the product name, Thermobel®Glaverbel, and the five-digit code imprinted on the spacer (Fig. 3), the IGUs had been produced by AGC Kempenglas in Belgium between January and May 1986. The IGUs had, therefore, been in use for about 30 years. An example of the spacer code is shown in Fig. 3b. The first digit (5) indicates the

factory, the second and third (86)—the year, and the fourth and fifth digits (04)—the month of production. The interpretation of the code was obtained through personal communication with the manufacturer.

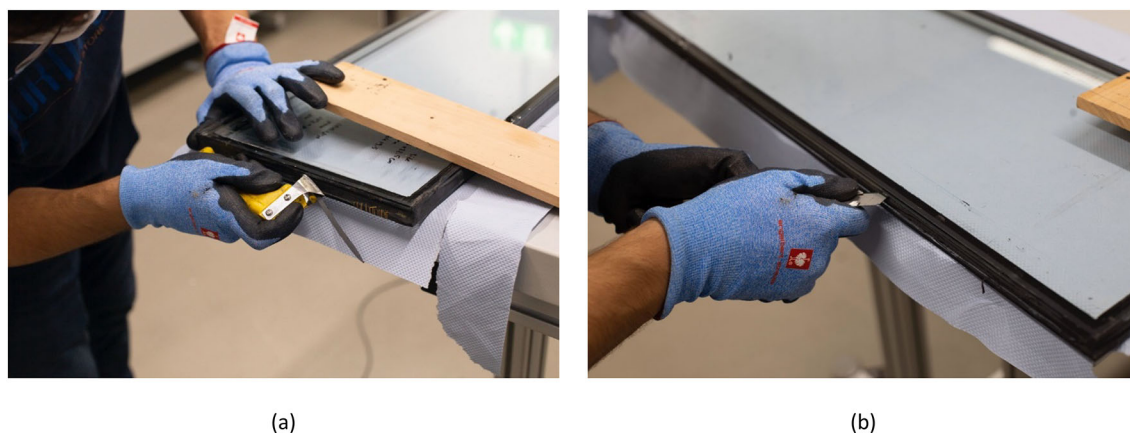
**Fig. 4** IGU disassembly: **a** removal of the secondary seal; **b** cutting through primary seal

To perform the experimental investigation on different surfaces of the IGUs, the units were disassembled, and the glass panes cut into test specimens for subsequent microscopy evaluation and coaxial double ring tests. The units were disassembled by, firstly, removing the secondary seal with a joint knife to provide access to the primary seal (Fig. 4a). With a box cutter, the glass panes and the spacer were then separated by cutting through the primary seal (Fig. 4b). The glass panes were cleaned with a cleaning agent (REINEX GLAS Reiniger) and a dry cloth and handled carefully to prevent additional damage.

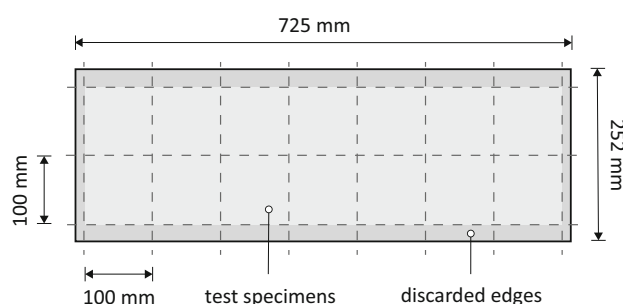
**Fig. 5** Cutting scheme for obtaining the test specimens from the disassembled glass pane

After the disassembly, the glass panes were cut into specimens of 100 mm × 100 mm, according to the EN 1288-5 standard for coaxial double ring tests on flat specimens with small test surface areas (CEN 2000). The standard specifies a method for determining the comparative bending strength of glass, as intended in this study, using relatively small specimens, which maximises the number of specimens obtained from a single pane and results in a larger data set for the statistical analysis. The surface of the glass pane was marked for cutting, discarding the edges of the pane, which were likely damaged while cutting through the primary seal (Fig. 5). The glass was manually scored along the cutting lines with a diamond cutter and cut by applying tensile stress along the scored lines. Series

of maximum 14 specimens were obtained from each glass pane, reduced in some cases to 12–13, due to the damage which occurred in the disassembly and/or cutting process. The thickness of each specimen was measured at 4 points on the edges, and the average thickness was determined per specimen. The number of obtained specimens tested in each series, and their average thickness, is listed in Table 2.

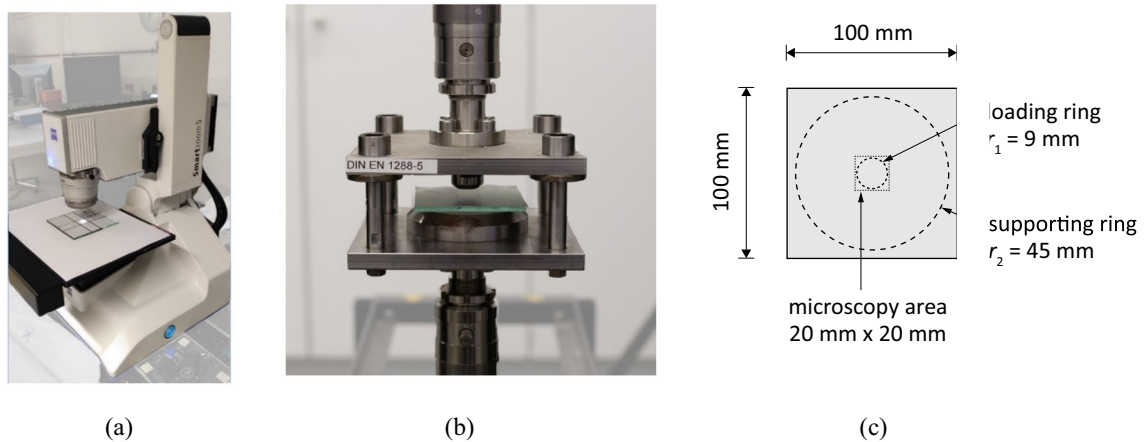
**Fig. 6** Test specimen in **a** the microscopy and **b** the coaxial double ring test setup; **c** loading and supporting ring and microscopy area marked on the test specimen

Micrographs of each glass surface were recorded for all the specimens to obtain qualitative images of the surface, determine the comparative level of surface damage and detect potential critical flaws (Fig. 6a). Only the central area of 20 mm × 20 mm (enclosing the test area under the loading ring) was examined (Fig. 6c) with an automated digital microscope Zeiss Smart Zoom 5 at a magnification level of 100x. It should be noted that the micrographs provide only a two-dimensional image of

The specimens were subjected to coaxial double ring tests (Fig. 6b), following the procedure set in EN 1288-5 (CEN 2000). The tested IGU surface (Fig. 2) for each series/glass pane (S1/S2 for the external pane, S3/S4 for the internal pane) varied according to the test matrix shown in Table 1. The test series are detailed in Table 2, listing the tested surface, detected tin or air side, average thickness, number of tested specimens and valid tests, and applied nominal stress rate.

For the specimen size of 100 mm × 100 mm, a corresponding loading device R45 was applied, with the radius of the loading ring  $r_1 = 9$  mm, and the radius of the supporting ring  $r_2 = 45$  mm (Fig. 6c). The tests were performed under ambient conditions ( $22 \pm 2$  °C, 36–58% RH), and were force controlled, loading the

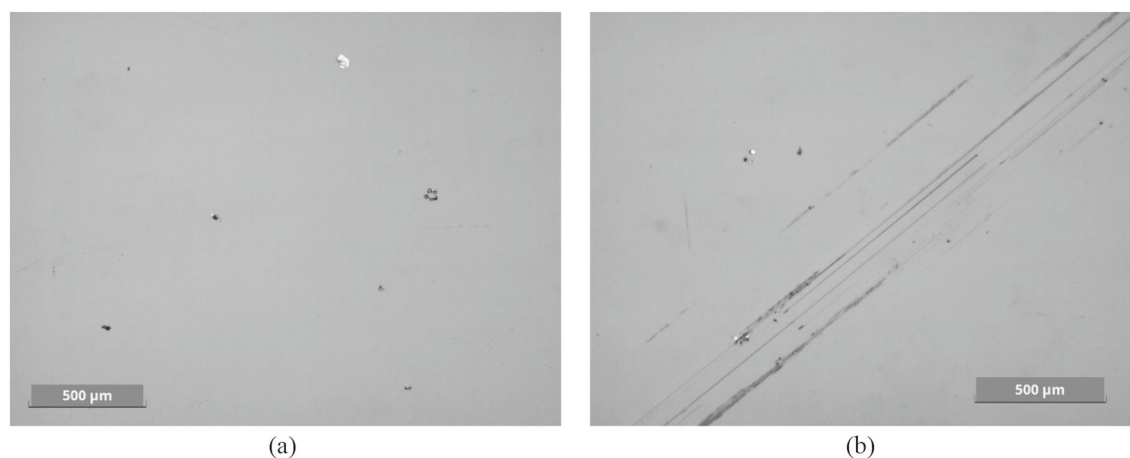
**Fig. 7** Micrographs of externally facing glass surface (S1); **a** predominant pitting damage; **b** pits and scratches

Microscopy of the externally facing glass surface (S1 in Fig. 2) revealed extensive damage, predominantly pits and some scratches (Fig. 7). The damage can be attributed to the long-term exposure of the surface to the external environment. Pits were likely caused by the impact of airborne projectiles, as well as transport, installation and cleaning processes that were likely also responsible for the observed scratches. This is consistent with previous observations in Datsiou and Overend (2017a), and more recently in Stuurstraat (2023).

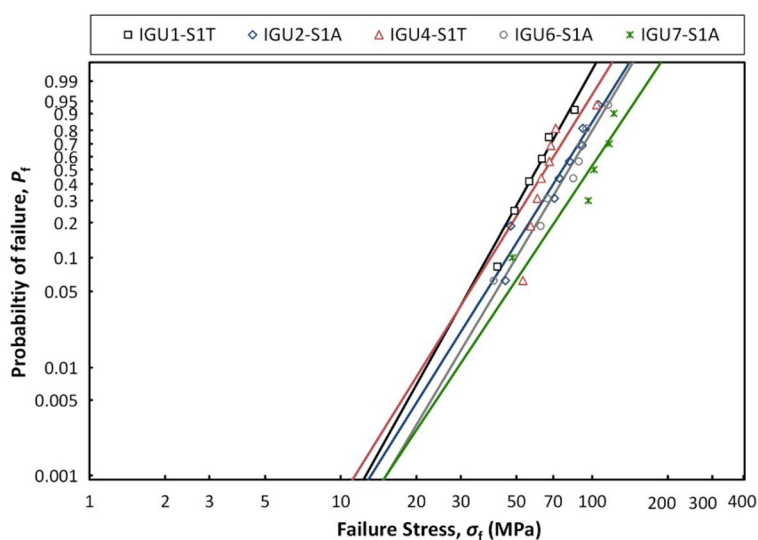
**Fig. 8** Cumulative distribution functions for externally facing glazing (surface S1)

The cumulative distribution functions (CDFs) for all series exhibited a consistent trend, with each curve being nearly parallel to one another (Fig. 8). Indeed, it was found that the shape factor,  $\beta$ , which governs the gradient of the CDF of the Weibull distribution, was low and very similar across all series, within the range of  $3.51 \leq \beta \leq 4.1$ . This indicates the wide spectrum of the obtained fracture strength data and closely matches previous findings on the shape factor of naturally aged glass in Datsiou and Overend (2017a). Low shape factors are expected for naturally aged glazing as it is subject to uncontrolled and random flaw inducing mechanisms during its service life.

Close agreement was observed in CDFs for series IGU1-S1T and IGU4-S1T, both of which featured fracture strength data on the tin side of glass. Similarly for

the air side data, series IGU2-S1A and IGU6-S1A were closely aligned. A small deviation was observed for series IGU7-S1A which, however, converged with the other two for strengths at low probabilities of failure. It is evident that the tin side series consistently resulted in lower strength compared to the air side. Overall, the strength of glass varied between  $19.9 \leq \sigma_{f,0.008} \leq 27.4$  MPa at low probabilities of failure ( $P_f = 0.008$ ) with a coefficient of variation of 13.8% while the mean fracture strength ranged between  $60 \leq \sigma_{f,0.5} \leq 76.1$  MPa with a coefficient of variation of 19%.

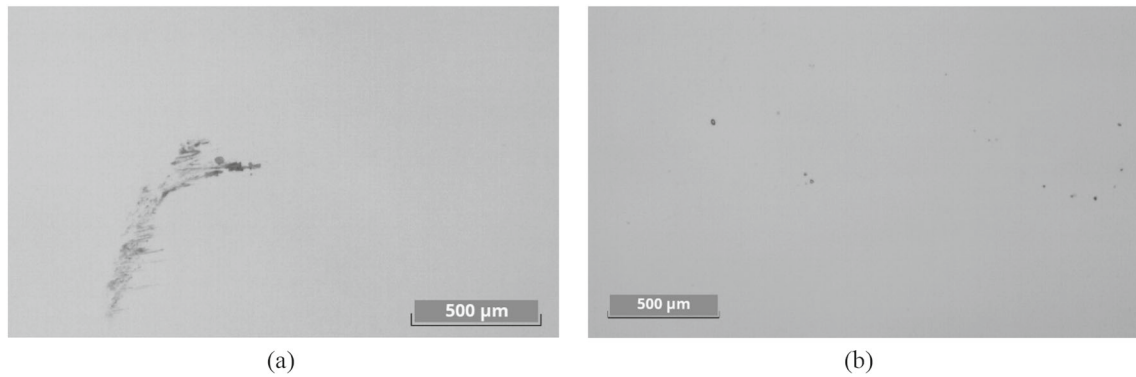
**Fig. 9** Micrographs of cavity facing glass surface, with rare damage found on: **a** surface S2; **b** surface S3

Micrographs recorded on the cavity facing glass surfaces (S2 and S3 in Fig. 2), exhibited nearly defect free conditions. Figure 9 shows two micrographs of the cavity facing surface, where a rare instance of damage was detected: a widely spread scratch on surface S2 (Fig. 9a, specimen IGU5-S2T-4) and pits on surface S3 (Fig. 9b, specimen IGU4-S3A-13). Given that the cavity facing surfaces were protected during the lifetime of the IGU, the damage might have been caused during assembly or disassembly of the units. In subsequent destructive tests, the observed flaws did not initiate the fracture of the specimens, indicating that a more severe flaw was present on the surface, but was not detected through surface microscopy.

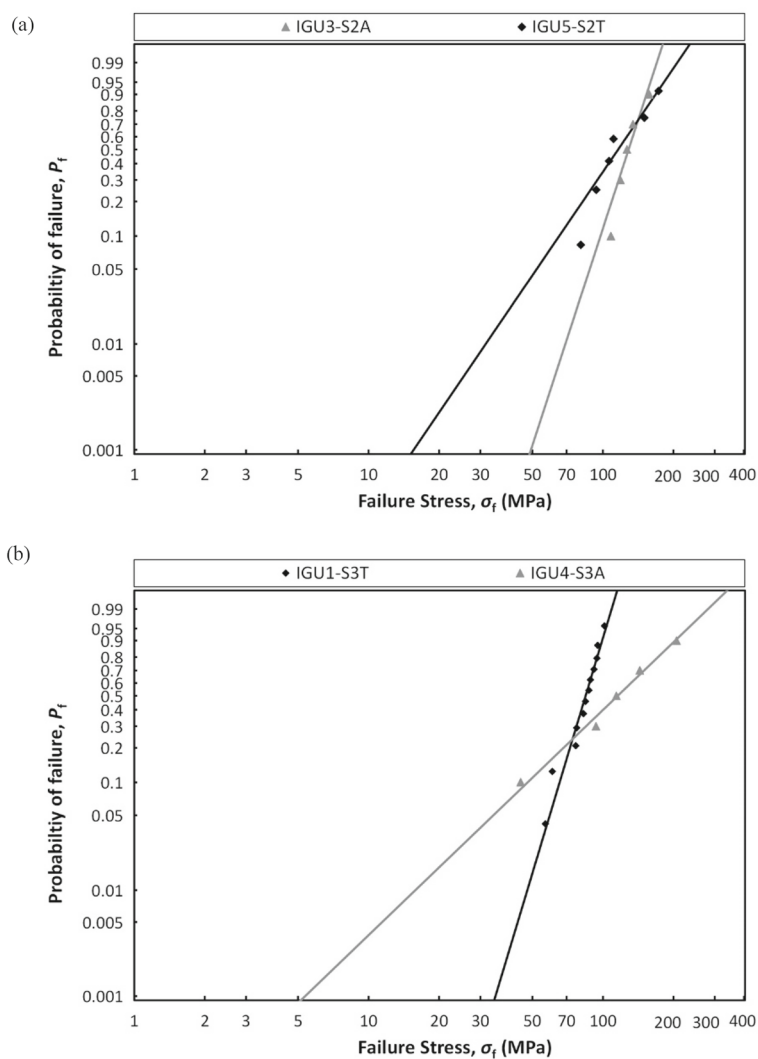
**Fig. 10** Cumulative distribution functions for cavity facing glass surfaces: **a** S2 and **b** S3

Overall, the strength of glass at low probabilities of failure ( $P_f = 0.008$ ) varied between  $30 \leq \sigma_{f,0.008} \leq 67$  MPa for S2 and  $14 \leq \sigma_{f,0.008} \leq 46$  MPa for S3 (Fig. 10). The upper limit of these series matches

the bending strengths of glass reported in Datsiou and Overend (2017b) and Overend and Louter (2015), however, the lower end indicates that more severe damage was evident in the glass specimens of this study. Meanwhile, the mean fracture strength ranged between  $116 \leq \sigma_{f,0.5} \leq 129$  MPa for S2 and  $84 \leq \sigma_{f,0.5} \leq 116$  MPa for S3.

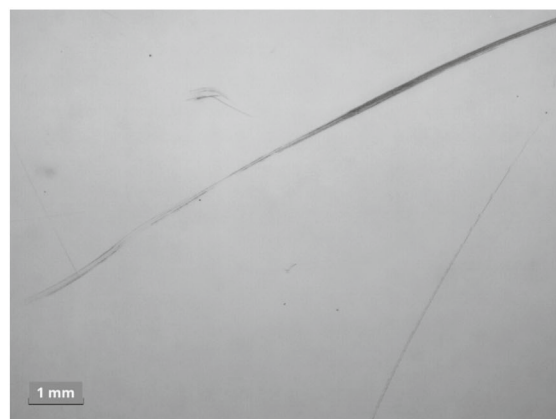
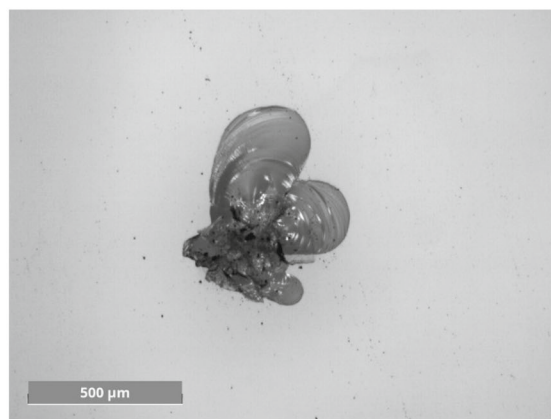
**Fig. 11** Micrographs of the internally facing glass surface S4: **a** scratches and **b** pits

On the internally facing glass surface (S4 in Fig. 2), significant damage was observed, predominantly scratches (Fig. 11a), likely caused by cleaning, and some severe local pits (Fig. 11b), which might have been caused by an impact with a hard object during installation, use or dismantling and disassembly.

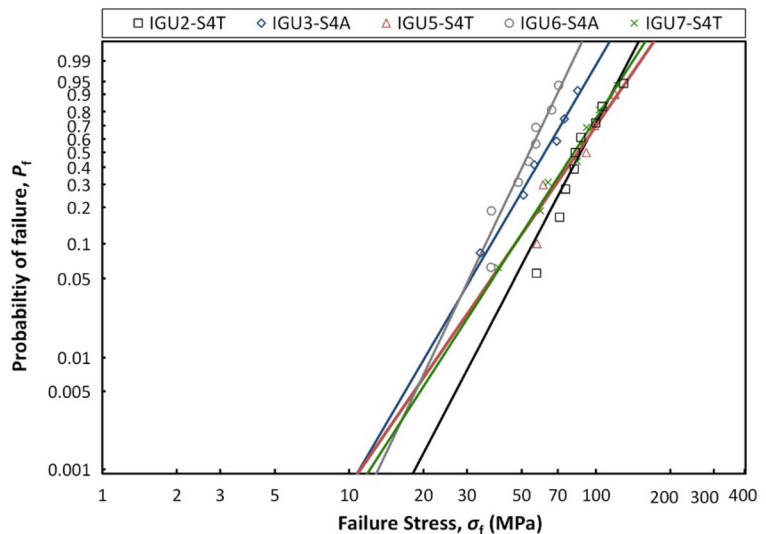
**Fig. 12** Cumulative distribution functions for internally facing glass surface S4

CDFs for series IGU5-S4T and IGU7-S4T featuring tin side data, were almost identical (Fig. 12). However, the CDF for IGU2-S4T intersected the other two at approximately  $P_f = 0.55$  and diverged considerably at low probabilities of failure. A fairly good agreement was found for the air series IGU3-S4A and IGU6-S4A although some discrepancy was observed at high probabilities of failure. It is worth noting that all series, irrespective of the side of glass used for acquiring the data, met at low probabilities of failure except for IGU2-S4T. Overall, the strength of glass varied between  $19.1 \leq \sigma_{f,0.008} \leq 30.3$  MPa at low probabilities of failure ( $P_f = 0.008$ ) with a coefficient of variation of 19.3% while the mean fracture strength ranged between  $53.6 \leq \sigma_{f,0.5} \leq 86.7$  MPa with a coefficient of variation of 20.2%.

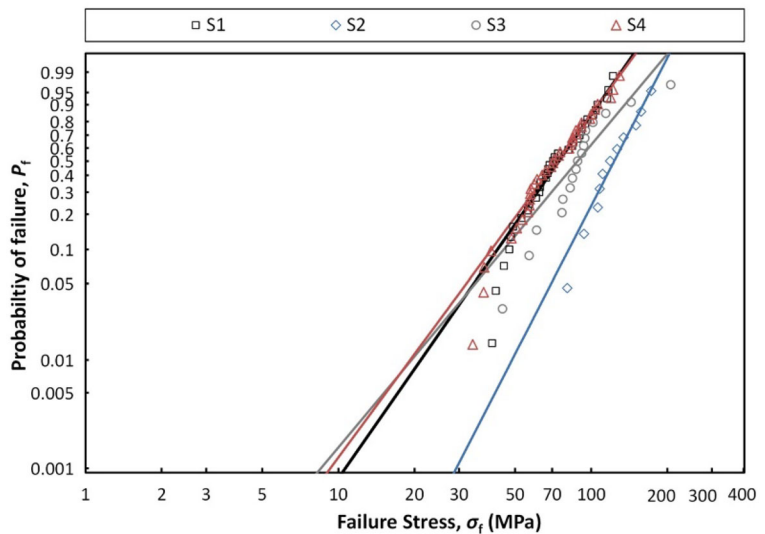
**Fig. 13** Cumulative distribution functions for externally facing glazing (S1), cavity facing glazing (S2 and S3) and internally facing glazing (S4)

Interestingly, very close agreement was found for CDFs of series S1 and S4 (Fig. 13) indicating that the externally and internally facing surfaces experienced

similar levels of ageing during their service life. However, further post fracture microscopy is required to determine and compare the type and morphology of critical flaws found on both surfaces. As anticipated, the CDF of the protected, cavity facing surface, S2, was shifted along the horizontal axis towards higher strength values compared to surfaces S1 and S4. The coefficient of variation for surfaces S1 and S4 was very similar (32.8% and 34.5% respectively) whilst a lower coefficient of variation of 25% was found for S2.

Strengths at low probabilities of failure ( $P_f = 0.008$ ) were found to be 19.8 MPa and 17.9 MPa for externally and internally exposed surfaces S1 and S4 respectively, indicating a 11% higher strength for externally facing glazing. In turn, the cavity facing surface exhibited a strength of 46.3 MPa at  $P_f = 0.008$ , denoting a 234% and 259% increase compared to exposed surfaces S1
