# KATOENVEEM

MERWE-VIERHAVEN, ROTTERDAM

MSc III Heritage & Architecture

Architectural, Building Technology & Cultural Value Analysis

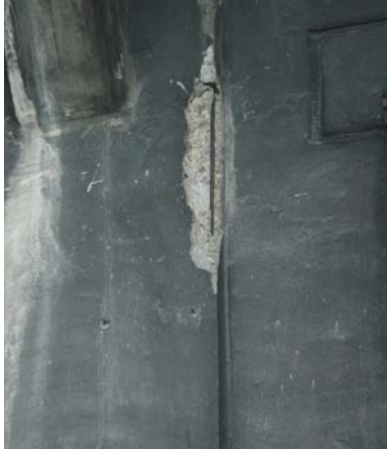
1 Spalling of concrete

Spalling of concrete [1] is a result of carbonation induced corrosion of the reinforcement. Due to contact with water the reinforcement starts to rust [2]. This not only negatively effects the loadbearing capacity of the construction as the diameter of rebar is reduced, but also the stresses that are caused by the rust can cause the surface to crack [3]. Cracks first appear parallel to the corroding reinforcement. This later leads to spalling of concrete and further exposure of the already damaged reinforcements.<sup>1</sup> Since the damage is caused by a presence of water, it is important to have a flawless drainage system. There

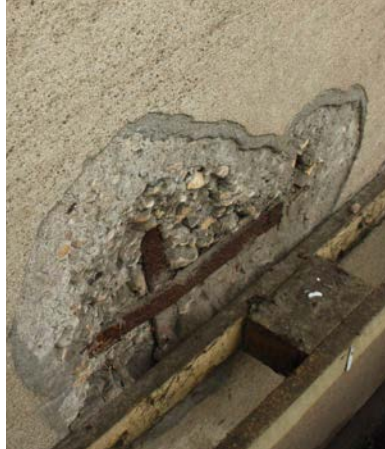
2 Corrosion of the reinforcement

is a lot of leakage from rainwater pipes, which further accelerates the deterioration of the material. The proximity of the site to river however also affects the building due to (salt) water spray. Water carried in small particles through the air enables salts to easily reach the building. Since the prevailing wind direction in the Netherlands is southwestern (see annex 2), wind often blows over the water towards Katoenveem and thus causes the damage to spread. The type of damage caused by salts [4] can be different from carbonation induced corrosion, as the reinforcements shows rather 'pitted' type of damage and

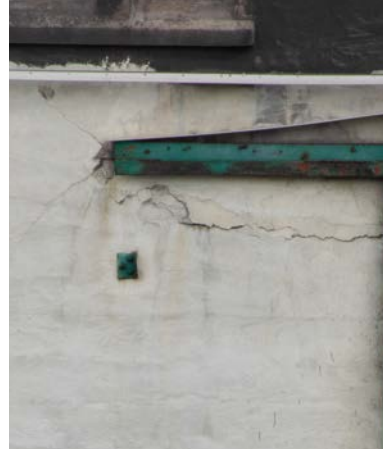
3 Cracks

a rust layer is not always formed.<sup>2</sup> The reaction with salts does not increase the volume of reinforcement, and therefore cracks and spalling are not always present. However, the structural strength of the concrete can be severely affected.
