## Carriage interior noise-based inspection for rail corrugation on high-speed railway track

Applied Acoustics

# Carriage interior noise-based inspection for rail corrugation on high-speed railway track

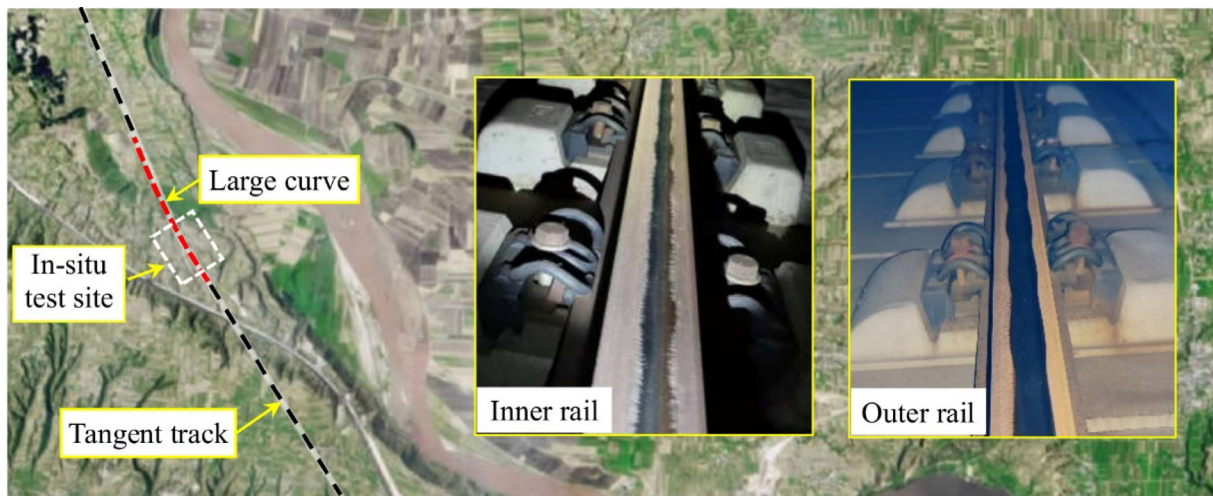
Fig. 7 gives another example of rail corrugation on a large curve of the HSR track B. The degraded track section is within a tunnel of HSR track B, the curve radius is 10000 m, and the measurement speed is around 300 km/h.

**Fig. 7.** Rail corrugation on the large curve of the HSR track B.
