Climate Risks Vulnerability Assessment for Built Heritage: Investigation in Gorinchem, the Netherlands

Research Paper | MSc Architecture, Urbanism and Building Sciences
Faculty of Architecture and the Built Environment, Delft University of Technology, the Netherlands

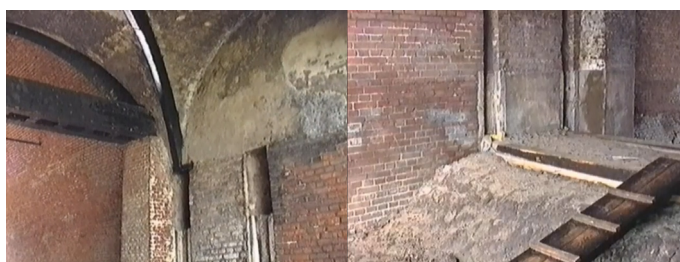
Fig.1.2. Screenshots of a Video Taken in 1995, Showing the Degradation of Building Due to Excessive Water. ©Jan Boshoven.

In the year 1995, Gorinchem, one of the riverine cities in this region, barely escaped a disaster caused by constantly high water levels, lots of precipitation, strong winds and insufficiently reinforced dikes. (De Stad Gorinchem, 2015) (Fig. 1.1) (Fig. 1.2)

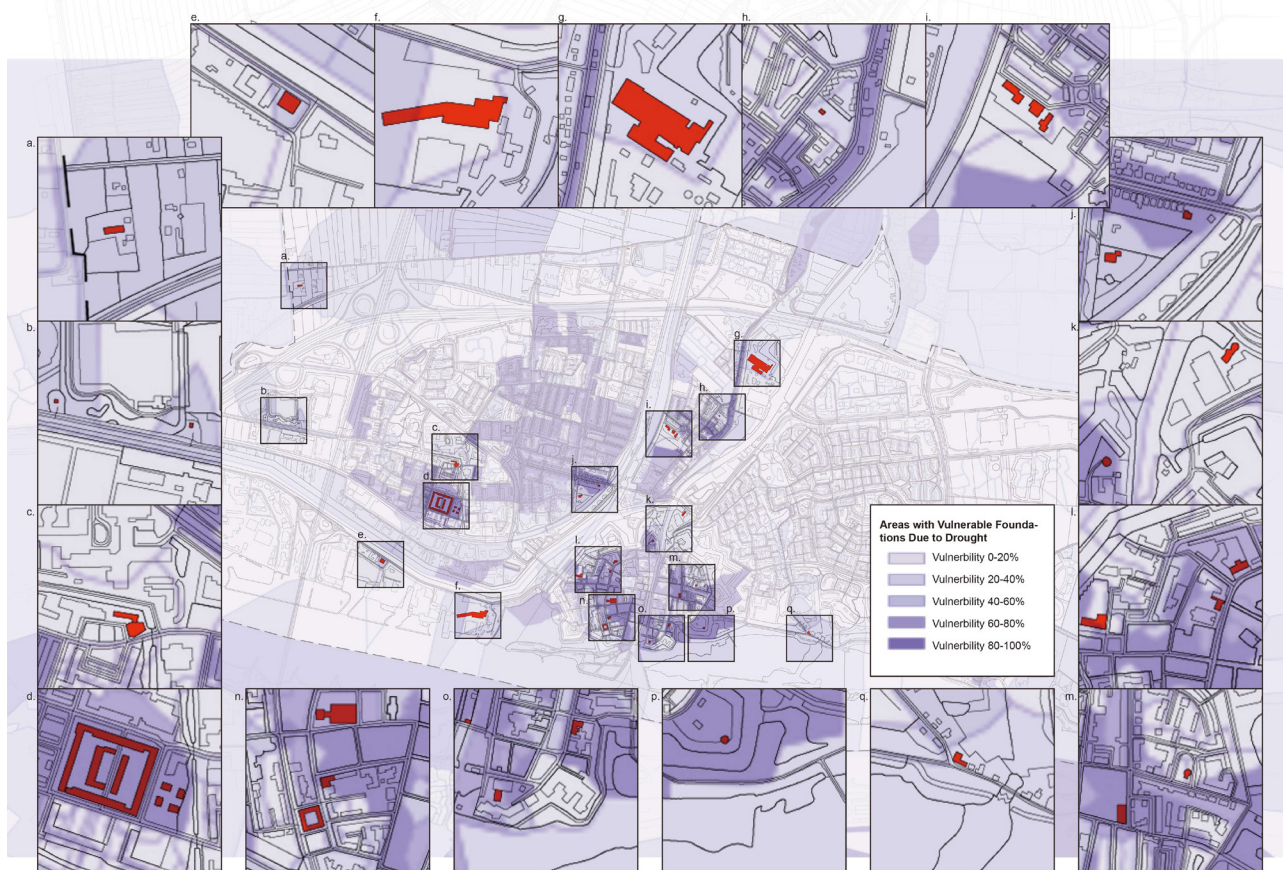
Fig. 4.3.3. Areas with Vulnerable Foundations Due to Drought.

4.3.3. Areas with Vulnerable Foundations Due to Drought (Fig. 4.3.3)

To the other extreme, too little water can also be risky to the structural integrity of buildings, particularly affecting their foundations. When there is a prolonged period of drought, the soil around a building's foundation can dry out and shrink, leading to gaps and potential instability.

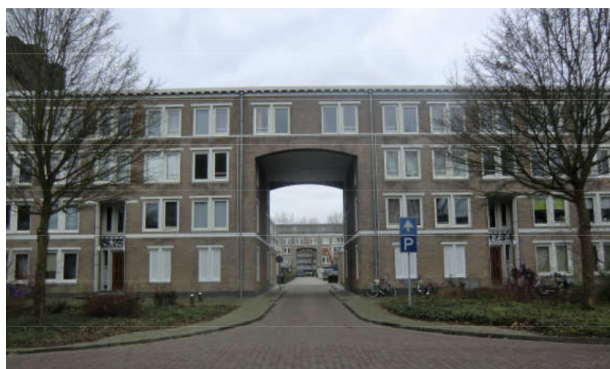
4. Housing Complex “Het Kremlin-2”, St. Jorisplein 1, 4205 JA

The low-rise building of the complex consists of 20 single-family homes, shops and studios. Its social, functional, and historic value are identical to the above-mentioned complex.

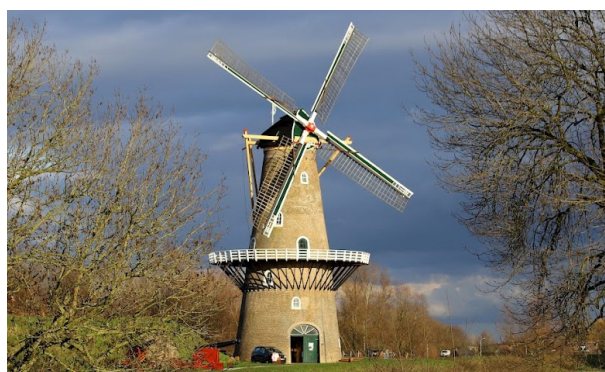
10. Windmill “Nooit volmaakt”, Bagijnenwal 38, 4201 JJ

The windmill “Nooit Volmaakt” is a round stone tower mill on one of the bastions in the fortress. This corn mill was built in 1718 on the site where a mill had been destroyed by a storm. Later, the mill was raised and provided with a tower. The mill was restored in 1996-1997 and opened in 1997. Since then, the mill has been in operation again for grinding grains. Now the mill also functions as a tourist point where people can visit and buy grain and flour products and mill bread.

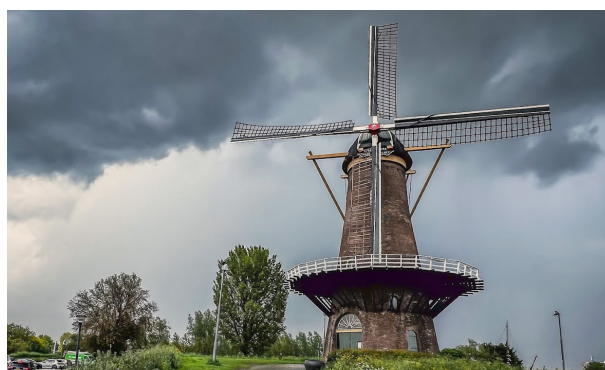
11. Polder Mill “Oostmolen”, Grote Schelluinsekade 2, 4204 TX

The Oostmolen, built in 1817, served as a polder mill, just like the Westmolen. Their predecessors were set on fire by French troops and it was hoped that one mill would be enough later. This turned out not to be the case, which is why the Oostmolen was also rebuilt in 1817. In 1973, the municipality of Gorinchem became the owner, until transferred to a foundation SIMAV in 2017.

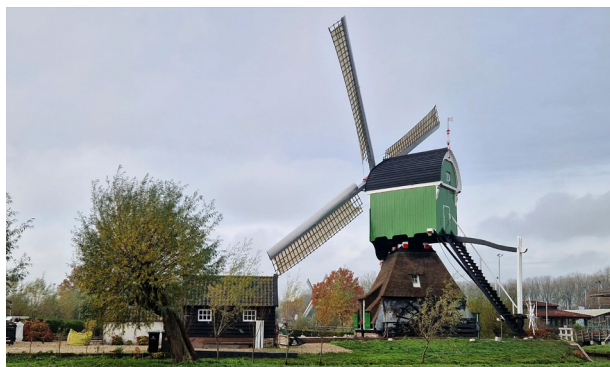
12. Polder Mill “Westmolen”, Grote Schelluinsekade 18, 4204 TX

The mill Westmolen was built in 1814. Like the Oostmolen, the mill was owned by a foundation called Binnen Molenstichting SIMAV since 2017 and is not open to tourists. The hollow post mill was completely restored in 2021 and has also been given new sails.
