Wave overtopping resistance of grassed slopes in Viet Nam

Abstract

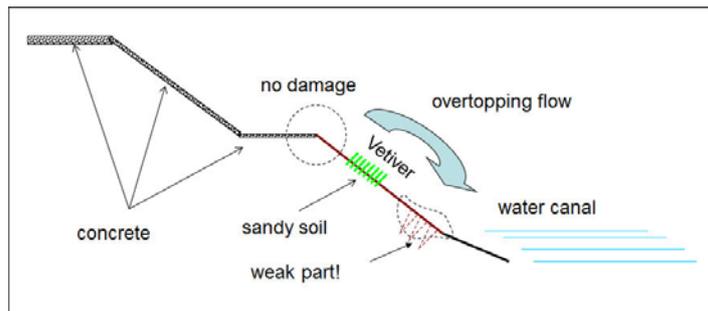
Figure 1: Do Son sea dike in Hai Phong, 2-year-old Vetiver grass on the low landward slope.

Destructive tests were performed on slope sections that were selected according to a set of criteria of operation and testing (Le et al., 2010). The pilot test was conducted in Do Son, Hai Phong where dike was reinforced with concrete on three sides: seaward slope, dike crest, upper part of landward slope and berm. The lower part of the landward slope was sandy soil covered with Vetiver grass (*Vetiveria Zizanioides*). Slope section DS_01 with inclination of 1:2 was tested and the Vetiver covered part was 5 m long, next to the dike toe was a water canal, Fig 1.

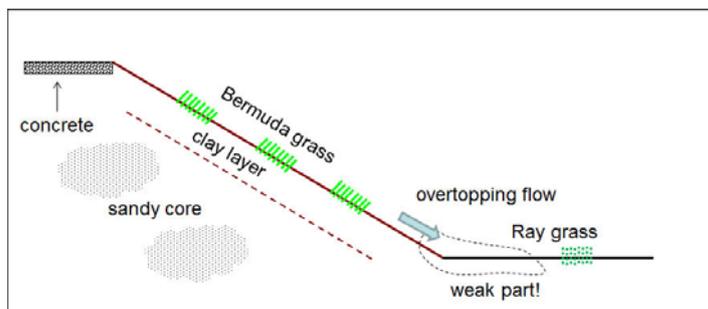
Figure 2: Thinh Long sea dike in Nam Dinh, 4-year-old Bermuda grass slope.

In Nam Dinh, Thinh Long sea dike with an inclination of 1:3 was tested and the slope was covered with Bermuda grass (*Cynodon Dactylon*) and sometimes Casuarina trees as well. The dike body was constructed by a sand core and a layer of clay with moderate quality, see Fig 2. The thickness of the clay layer was found to vary from 80 to 100 cm at 3 sections. On horizontal dike toe, it was Ray grass (*Hemarthria compressa*) that covered evenly toward a brackish water canal. Section TL_01: grass covered slope of 10 m long, relatively regular slope, no hole was found. TL_02: irregular slope, poorly covered with three different grass species (mainly Bermuda), 5 eroded holes and 7 Casuarina trees (amongst those, one with a trunk of 7 cm) were recognised. TL_03: relatively regular, covered with Bermuda grass and Crabgrass (*Eleusine indica*), 5 small Casuarina trees with diameter of 1 cm.

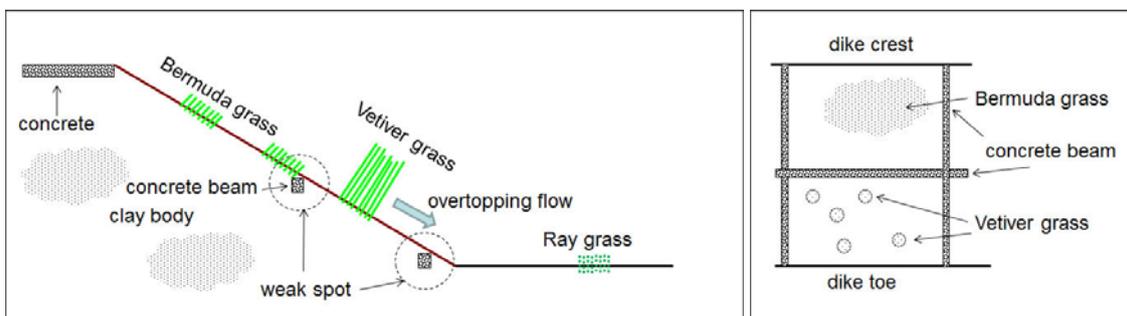
Figure 3: Thai Thuy sea dike in Thai Binh, a mixture of Bermuda and Vetiver grass on clay slope.

Within 50 m of the Thai Thuy dike stretch, 3 sections were tested. The slope inclination was 1:3. The dike body was constructed by good clay, a mixture of Vetiver and Bermuda grass was planted within concrete frames, see Fig 3. The horizontal berm was protected with a dense sward of Ray grass. Vetiver and Bermuda grass covered evenly section TT_01 and horizontal concrete beam was at the middle of the slope. TT_02: number of Vetiver clumps was few while Bermuda grass was dominant however with low density, concrete beams divided the slope section into 4 parts. TT_03: concrete beams divided the section into 4 parts, in which one was mainly covered with Vetiver while at the others both Vetiver and Bermuda grass could be found.

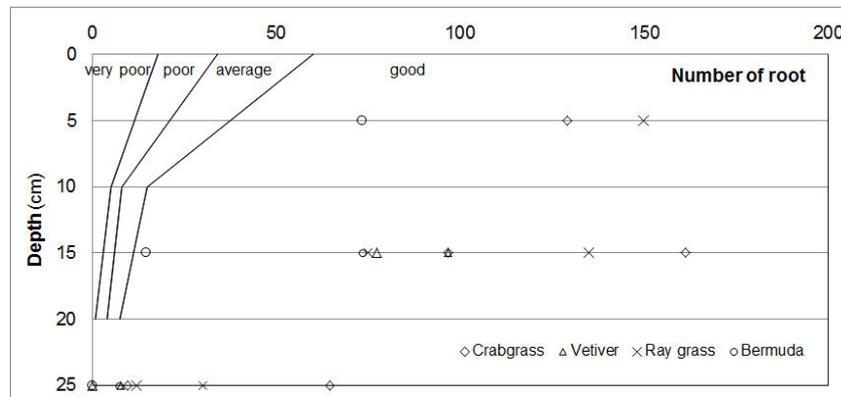
Figure 4: Classification of grass according to the Dutch guidelines VTV 2006.

The resistance against erosion induced by wave overtopping of a grass covered slope is solely determined by the quality of grass turf. According to the Dutch guidelines for safety assessments of dikes (VTV 2006), quality of a grass cover can be estimated by the amount of roots in depth. 8 samples of 4 different grass species taken on Thai Thuy dike were analysed to derive the number of roots. In general, the quality of the tested grass slopes were far beyond “good” criterion of VTV, Fig 4. It should be noted that the growing condition of grass in Viet Nam and the Netherlands are obviously different and grass species are themselves different.

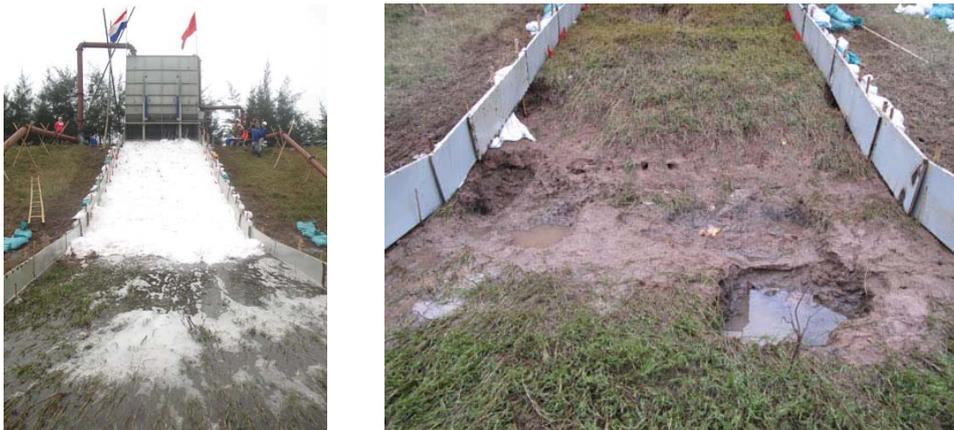
Figure 5: Rough guidance of overtopping flow (left) and damages (right) at dike toe, TL_01.

Section TL_01, slope surface was regular and covered with Bermuda grass, horizontal toe was covered with Ray grass. Around the transition between these two parts, grass cover was rather poor that clay was exposed directly to overtopping flow. Besides, at the transition acting force seemed larger than on the slope due to the rough guidance of overtopping flow, see left panel of Fig 5. Damages were therefore caused to take place at the dike toe, a geometry transition, right panel of Fig 5.

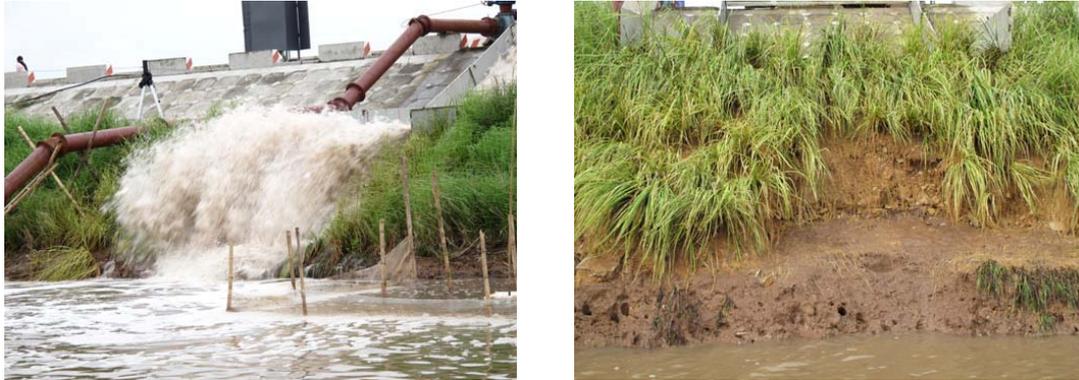
Figure 6: Overtopping flow flying from the berm attacks the dike toe.

Section DS_01, bare soil was first eroded and subsequently Vetiver clumps were swept away at the transition between the low part of the slope and the canal bank as can be seen in Fig 6 right panel. It could be explained by the water flow with high energy flying into the air from the end of the concrete berm to attack the dike toe more or less vertically, Fig 6 left panel. Interestingly, the first row of Vetiver clumps next to the concrete berm was first hit by overtopping flow however these clumps remained intact till the end of the test, they were only forced to lie down.

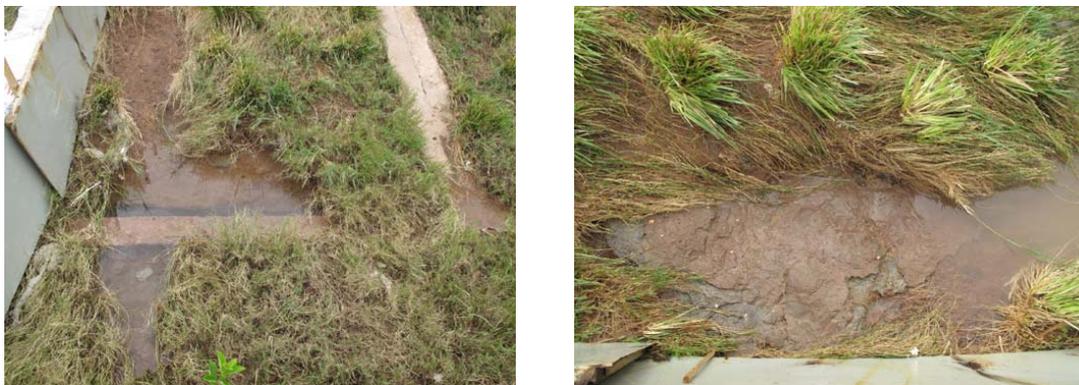
Figure 7: Left: concrete beam was exposed. Right: mortar layer under a top grass sod.

Fig 7 left panel gives an impression of a damage at dike toe that expose the horizontal concrete beam, section TT_03. When the top layer of grass sod (about 10 cm) was eroded, a thin layer of mortar was found, Fig 7 right panel. The mortar layer prevented grass roots from penetrating deeply dike body underneath. As a result, the connection either between the top soil layer and the mortar layer or between the mortar layer and the soil body were weak. Therefore, either the top grass sod or the mortar layer were easily eroded to expose the underneath body of soil. The damage at geometry transition was facilitated by the transition of material.

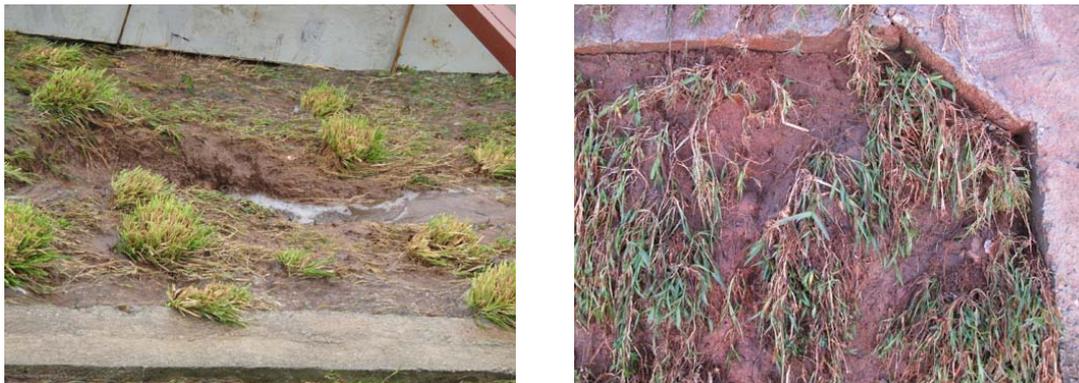
Figure 8: Left: damages amongst Vetiver clumps. Right: poor cover of Bermuda grass and settlement of soil around concrete beams,

sparse. Bermuda grass predominantly protected the dike slope. More Vetiver clumps were planted on the riverside slope in May 2010, beginning of the rainy season and about 6 months before testing. In November, when destructive tests were carried out, Vetiver clumps were growing well and about 1 m high. As can be seen in Fig 8, left panel, Vetiver sward was cut off to expose the thin cover of Bermuda grass. It was Vetiver grass that overwhelmed the mat grass. Due to the high shape of Vetiver clumps, flow tended to concentrate amongst close clumps, as a result, trenches were formed. The more soil was eroded the deeper the trenches became. Sufficiently deep trenches split Vetiver clumps from the slope, the slope was therefore damaged. As described above, at section DS_01 damages were also first initiated amongst separate Vetiver clumps where soil directly exposed to overtopping flow. The existence of more than one species of grass caused discontinuity of the dike slope, weak spots were often found at these transitions of different grass species.

Transition between grassed soil and concrete beam could be potential vulnerable spot where grass cover was often poor and soil surface was settled down, Fig 8 right panel. Poor cover of grass might be due to a low root density in top soil layer and uneven surface around the beam would introduce flow concentration. Combination of these two features caused higher chance of erosion around the concrete frames as illustrated in Fig 9 left panel.

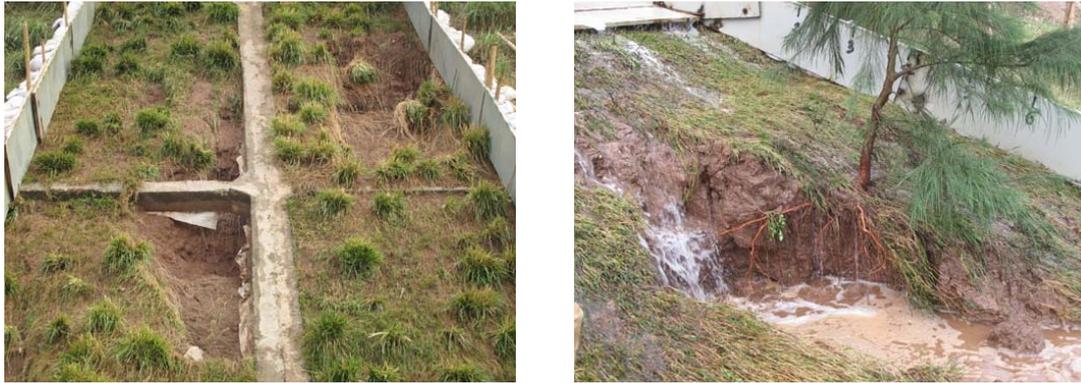
Figure 9: Left: damage around concrete frames. Right: damage extension to the Casuarina tree.

At section TL_02, damage was first started from an existing hole. Later on, it was rapidly extended to reach the Casuarina tree. Overtopping flow eroded and carried away soil aggregates hold by the root system that the connection between the Casuarina tree and the dike slope became increasingly weak. The anchoring forces were reduced smaller and no longer sufficient to retain the tree anymore, the Casuarina fell down. Due to the large trunk of about 7 cm wide, the Casuarina tree also caused flow blockage, force intensity was hence increased. Situation of the Casuarina tree before its collapse is shown in Fig 9, right panel.

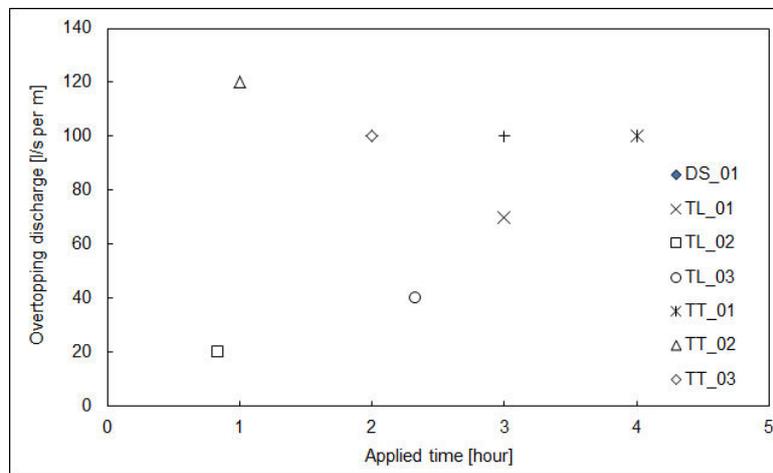
Figure 9: Maximum overtopping rate vs. applied time at 7 tested sections in Viet Nam.

If the effect of smaller discharges that were applied before the maximum rate is not taken into account, the maximum rate and its applied time (time to failure) at each tested section are plotted in Fig 10. It can be seen that overtopping resistance of grass slope varies enormously from 20 to even more than 100 l/s per m. This high variability is due to the difference in geometry and soil/ grass characteristics of the tested sections and the length effect.
