# HISTORIC CONCRETE

FROM CONCRETE REPAIR TO  
CONCRETE CONSERVATION

PROEFSCHRIFT

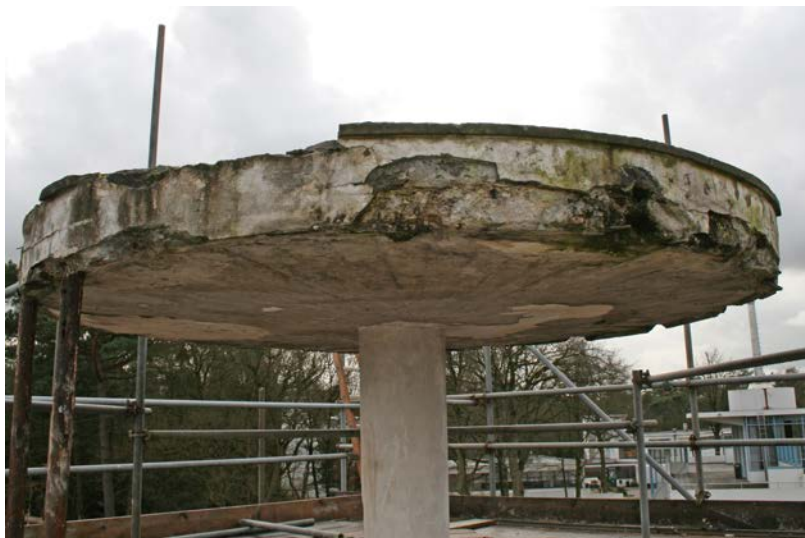
(a)

**Figure 1.1** Example of a deteriorated architectural icon, the Dresselhuys pavilion, part of the former Sanatorium Zonnestraal (Hilversum, J. Duiker, B. Bijvoet and J. G. Wiebenga, 1928, situation 2008). Details of the concrete staircase after years of neglect just before repair, showing typical degradation symptoms such as detachment of render, biological growth, spalling and corrosion. a) Roof of the staircase. b) Stringer of the staircase.

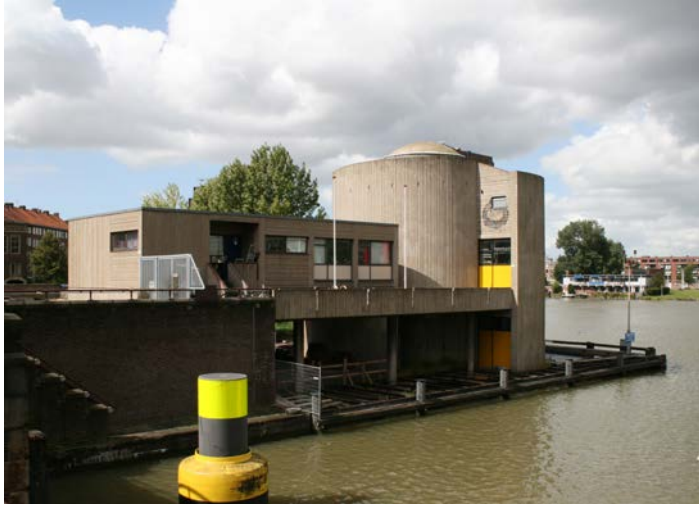
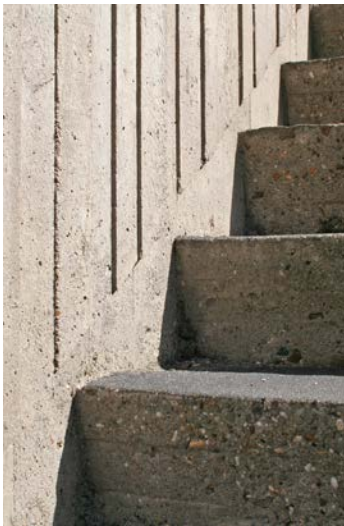
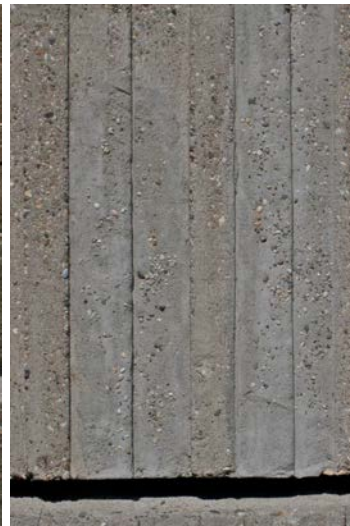
**Figure 1.9** Pictures of the second case study, Parksluizen Pumping Station Rotterdam ( J. G. van der Grinten, H. J. Heijdenrijk, 1968, repair 1996, situation 2006). a) Overview. b) Detail of exposed concrete stairs, showing the geometrical variations of the exposed concrete wall. c) Detail of a patch repair; gravel was added to adapt the texture to the surrounding eroded concrete; the repair mortar is greyer than the original concrete.

The second case study was the pumping station Parksluizen in Rotterdam (1968, see Figure 1.9) by J. G. van der Grinten (born 1927) and H. J. Heijdenrijk (1932-1999). One main criterion for selecting this building was that it represented a different period of concrete use, i.e. late Post-war years, and the aesthetical and architectural use of exposed concrete. The use of reinforced concrete for structural elements had become common by then, and the aesthetical possibilities of concrete were widely explored.

This case reflects a common dilemma for buildings dating from this period, where corrosion has to be treated while fulfilling high aesthetical demands. The history of damage and repair of the pumping station is representative for many buildings. Several small scale standard repairs had been carried out during the years, not solving the problem and rather creating a patchwork look. The underlying cause of damage was an insufficient thickness of the cover concrete, aggravated by textural variations of the surface (see Figures 1.9b and 1.9c). Insufficient thickness of the concrete cover is commonly encountered at buildings from the period, facilitating corrosion induced by carbonation, and resulting in cracking and spalling of the exposed concrete.

The results of the interventions were considered aesthetically acceptable, although one can notice the coating and the patch repairs (Figure 1.9c). The cause of the degradation has not been eliminated - insufficient concrete cover due to the geometrical design of the façade - and corrosion and spalling continue. In this case, a technical solution which would treat the cause of damage would have been possible. Instead, it was decided to put the emphasis on the appearance of the repair, and the technical performance and durability of the intervention were considered secondary. Measures to compensate the reduced durability of the intervention were not taken, such as retreatment of the coating in regular intervals.

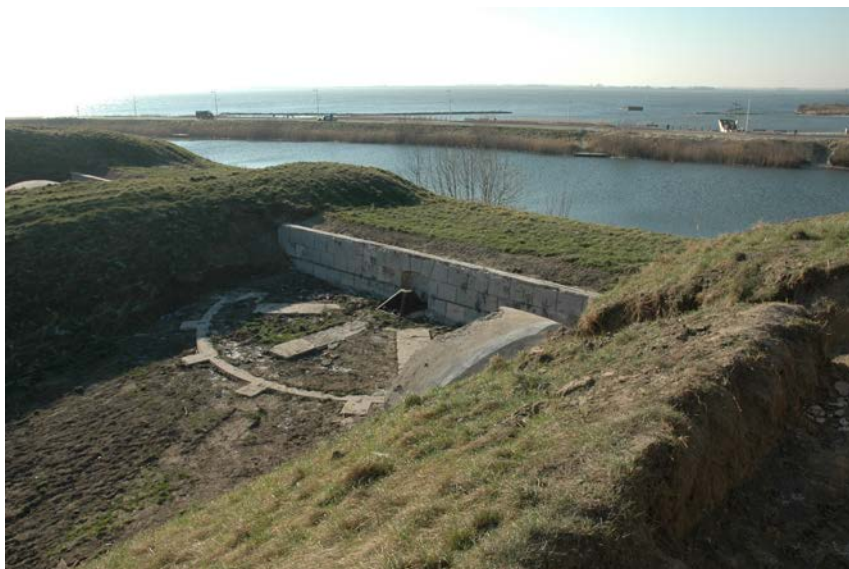
**Figure 2.1** Example of the use of plain concrete made with broken bricks in a 19<sup>th</sup> century military structure. The wall is rendered and with imitated joints (Fortification Hellevoetsluis, built from 1880 onwards; situation 2012, picture Wido Quist).

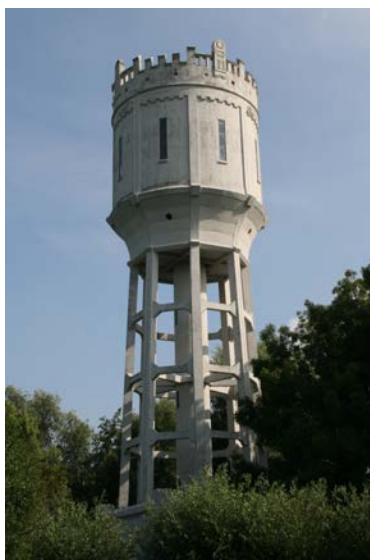
**Figure 2.5** Early example of a reinforced concrete water tower built by *Koninklijke Rotterdamsche Betonijzermaatschappij voorheen van Waning & Co.* (Rijswijk, N. Biezeveld, 1911, situation 2009).

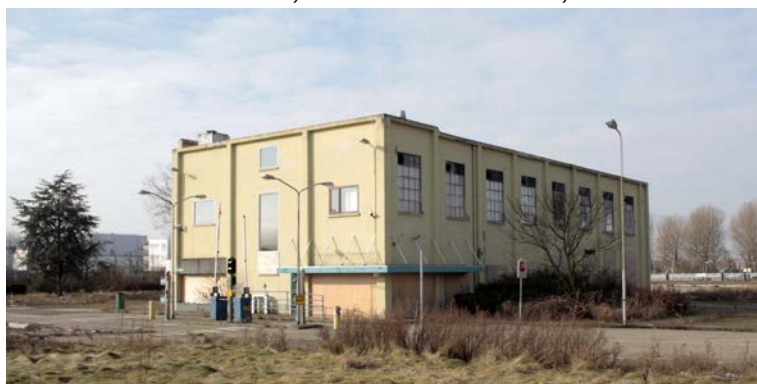
**Figure 2.6** Earliest known still remaining factory building in the Netherlands designed according to the Monier system and built by *Amsterdamsche Fabriek van Cement-IJzerwerken Wittenburg* (Calvé factory, Delft, 1905, situation 2010).

The now demolished warehouse *Graanpakhuis* in Leeuwarden (1902) was considered the first building with a reinforced concrete frame (Sanders, 1907). A similar but smaller building dating from 1905 still exists in Delft for the Calvé factory (Figure 2.6), and is considered to be the earliest known still remaining reinforced concrete factory building in the Netherlands (see Stenvert & Dekker, 2009). The first reinforced concrete arched bridge was supposed to have been built by *Rijkswaterstaat* in 1900 (Scharroo, 1946). The Cenacle church in Heilig Landstichting (1913-1915, Figure 2.7) was considered to be the first large Dutch concrete dome without ribs with radius of 14,5 m (Scharroo, 1946).<sup>3</sup>

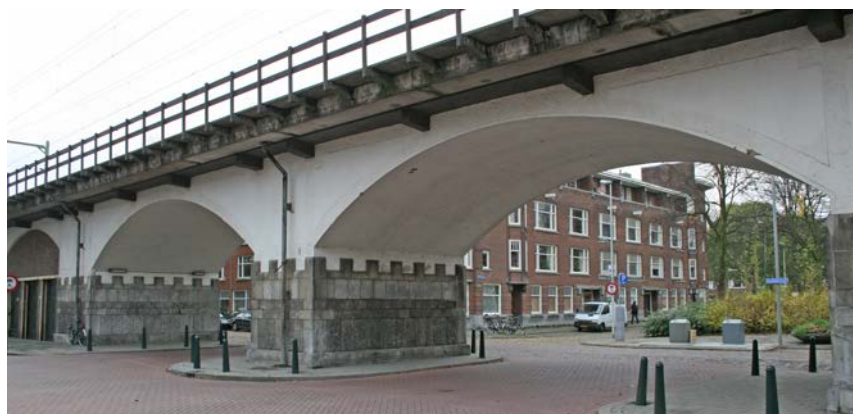
**Figure 2.8** The once largest reinforced concrete structure in the Netherlands, the Hofplein railway viaduct in Rotterdam (van Hemert, 1900-1908, situation 2009).

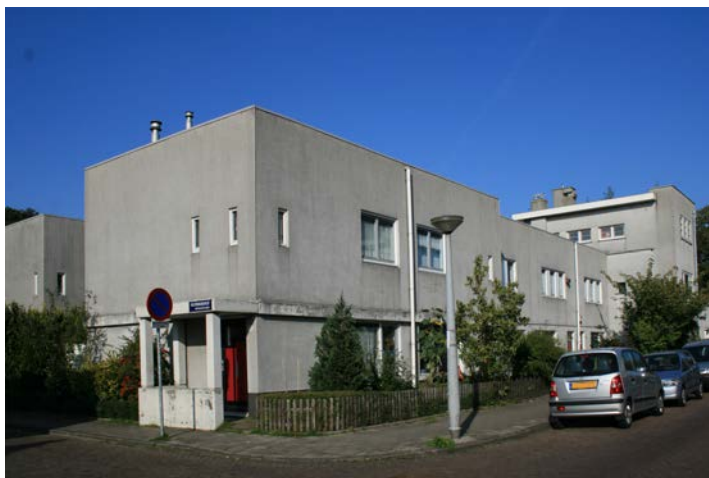
**Figure 2.9** Housing made with one of the many building systems used in Betondorp, the Bron system; a three leaf prefabricated reinforced concrete wall made with different concrete types: the outer leaf with gravel as aggregate, the interior and insulating layer with breeze (*sintels*) and in between a breeze filling. The concrete surface was originally brushed but is now plastered (see Kuipers, 1987, p. 191) (Amsterdam, D. Greiner, 1923-1925. Situation 2008).

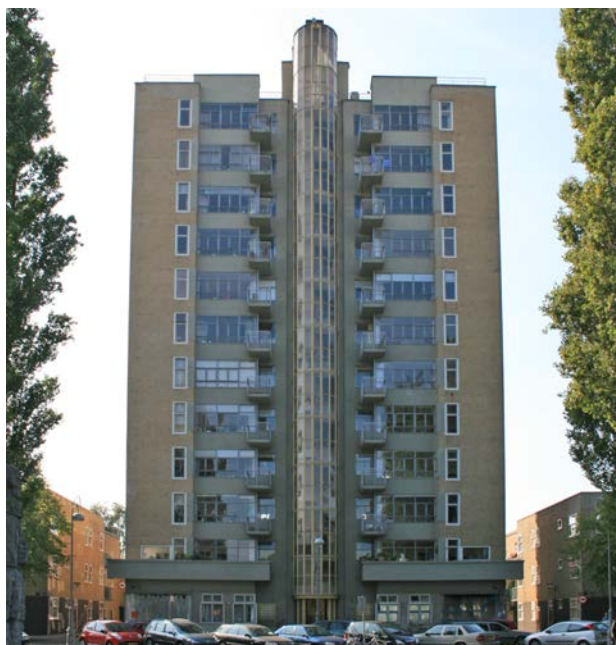
**Figure 2.10** The first high-rise housing project in the Netherlands, the “Wolkenkrabber”, was made with a reinforced concrete structure (Amsterdam, J. F. Staal, 1932, situation 2009).

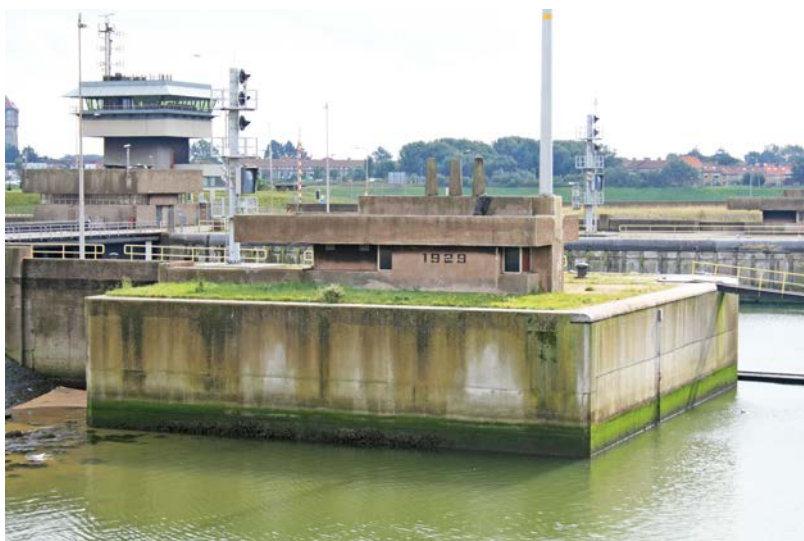
**Figure 3.4** The Noorderlsuis in IJmuiden; experiments were carried out to identify a suitable binder for the brackish water (Rijkswaterstaat with J. A. Ringers, lock houses by J. Emmen, 1921-1929, situation 2012).

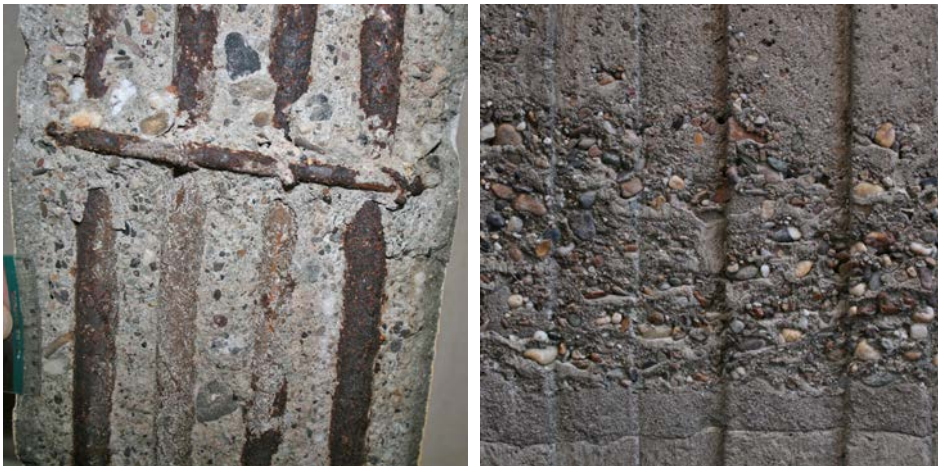
**Figure 4.5** Early example of reinforced concrete made with gravel; notice that between the reinforcement bars only smaller sized aggregates are present (circumambulation passageway, Pilgrimage church, Brielle, 1912, situation 2010).

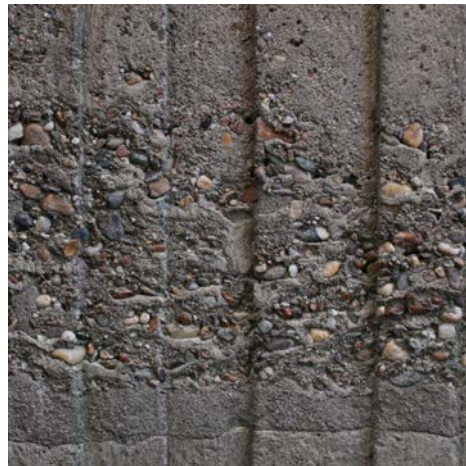
**Figure 4.6** Example of use of gravel for exposed concrete; the gravels are locally visible due to segregation of the concrete during construction (Pumping station Parksluizen, Rotterdam, G. J. van der Grinten, 1967, situation 2008).

Already at the beginning of the 20<sup>th</sup> century, gravel was the most commonly coarse aggregate used in the Netherlands (Boon, 1908). It was locally available, and thus (its use) economical. Its use for reinforced concrete was never excluded (see for example Figure 4.5 and Figure 4.6), and together with crushed stone mentioned in the first G.B.V. from 1912. For military structures the use of river and pit gravel was allowed as well (Minister van Oorlog, 1906, §89).

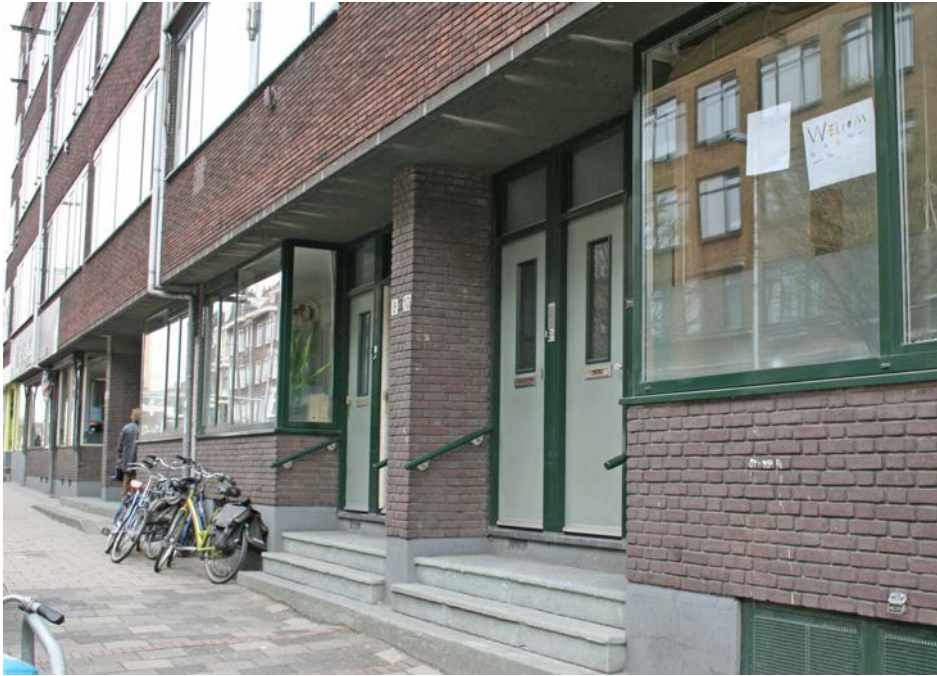
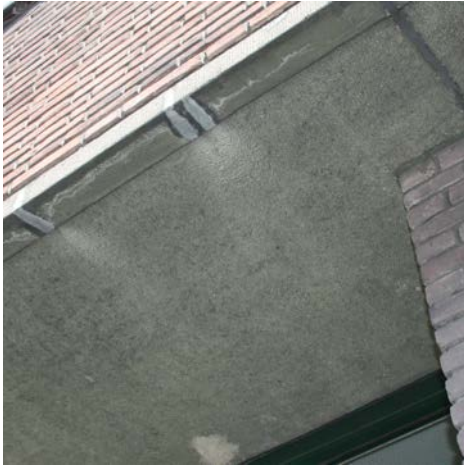
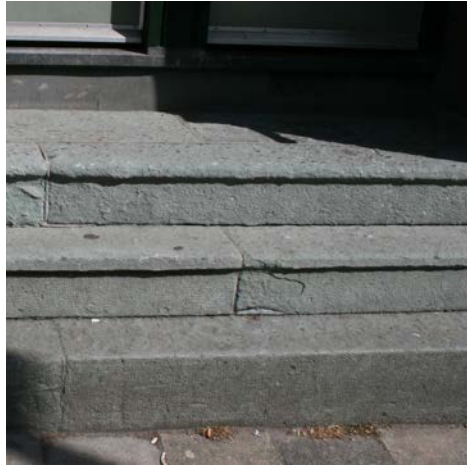
**Figure 4.8** Combined use of natural stone and concrete with crushed stone; both surfaces have been bush hammered to increase a similar appearance (housing Rotterdam, Walenburgerweg, architect and exact date unknown ca. 1933, situation 2011). a) Overview. b) For the concrete soffit a green stone as aggregate was used, possibly the same as for stairs. c) For the stairs natural stone, Anröchter Grünstein, a German limestone, was used.

as these were important buildings which required a strong concrete (Figure 4.7). Some natural stones were explicitly not advised such as sandstone, trachyte and lava (Bergsma & Homan van der Heide, 1910b; Boon, 1908; Probst, 1917). For exposed concrete, a wider variety of natural stones can be found (see Chapter 7 *The surface finish of historic concrete*) and commonly encountered in the Interwar period (Figure 4.8).

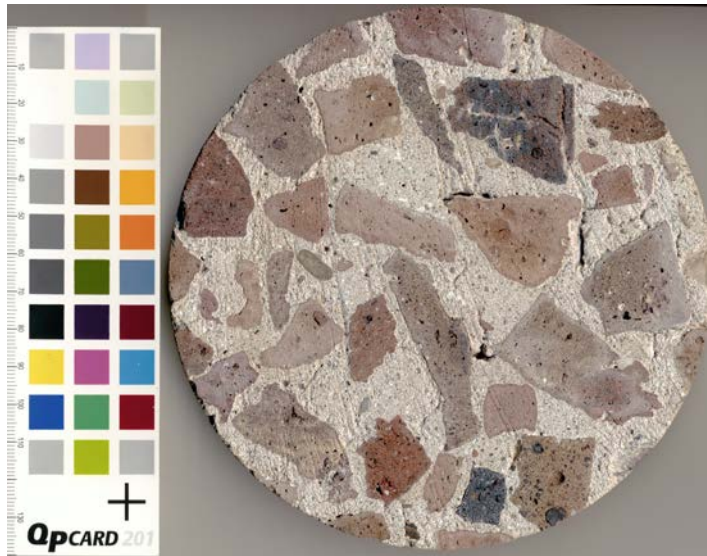
**Figure 4.9** Example of plain concrete from the Nieuwe Hollands Waterlinie, ca. 1850 made with broken bricks and a trass-lime binder. The angular shape of the aggregates in combination with manual compaction explains the presence of voids near the aggregates. No contaminations were found along the edges of the aggregate, indicating the use of new bricks and not debris (see also Heinemann et al., 2012) .

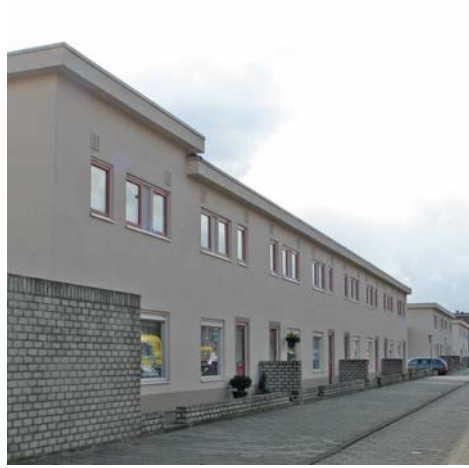
**Figure 4.13** Housing made with poured *korrelbeton* using the Greve system (see also Kuipers, 1987). The present appearance (windows, roof, colours) differs from the original (Scheveningen, W. Greve, 1920-1922, situation 2006).

*Slak* could also refer to the heavier slags from blast furnaces, which were considered of better quality. The building system Kossel used a mix of granulated blast furnace slags and breeze (Sweys, 1924). A Dutch patent for slag bearing concrete is *korrelbeton* (see Figure 4.12 and Figure 4.13), which contained blast furnace slag as aggregate, sometimes pumice (Scharroo, 1946; Van der Kloes et al., 1924). Scharroo (1942b, 1944) mentioned the use of blast furnace slag and bottom ash for *sintelbeton*.

A wide variety of different lightweight concrete can be found in many housing projects dating from the 1920s, with the *Betondorp* (Figures 4.11 and 4.14) in Amsterdam as the most known (Kuipers, 1987). Similar housing projects were carried out in Scheveningen (Figure 4.13) and Rotterdam. The buildings were either constructed with cast concrete, concrete bricks, or prefabricated concrete elements; the concrete used was usually not reinforced. Many of the concretes were sold under proprietary names such as Isola, Kossel or Greve (Sweys, 1924).

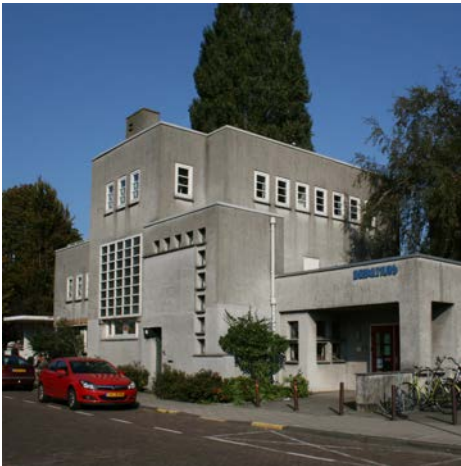
**Figure 4.14** Public library building built with *korrelbeton* (Betondorp, Amsterdam, D. Greiner, 1926-1928, situation 2008).

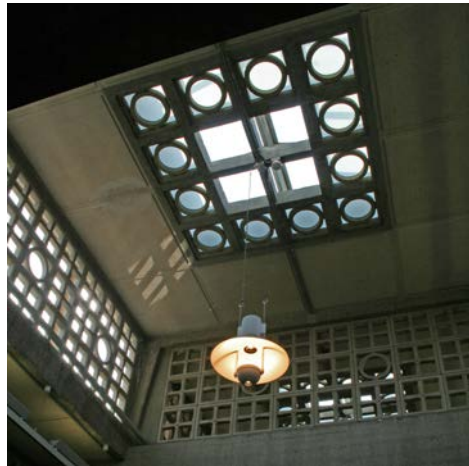
**Figure 4.15** Soffit panels made with vermiculite concrete, darker claustra are made with gravel (Railway station Enschede, H.G.J. Schelling, 1950, situation 2009).

Experiments with new aggregate types to improve the building physical properties continued after the Second World War. A new concrete type was vermiculite concrete; vermiculite is a mineral and was an interesting building material as it is heat and sound insulating, and lightweight (Hamer, 1951a,b). An early example is found in the railway station in Enschede (Figure 4.15), where Schelling used vermiculite concrete for the soffit panels to improve acoustics (Schelling, 1950b).

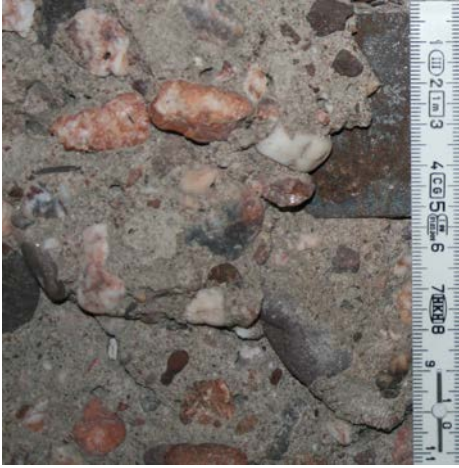
**Figure 4.16** Gravel used for columns at the Hofplein railway viaduct; originally intended were 5 and 25 mm large aggregates, yet local deviations can be encountered. The pink discolouration of the aggregates was caused by a fire during the bombardment of Rotterdam in May, 1940. (Rotterdam, A. C. C. G. van Hemert, 1900-1908, situation 2009).

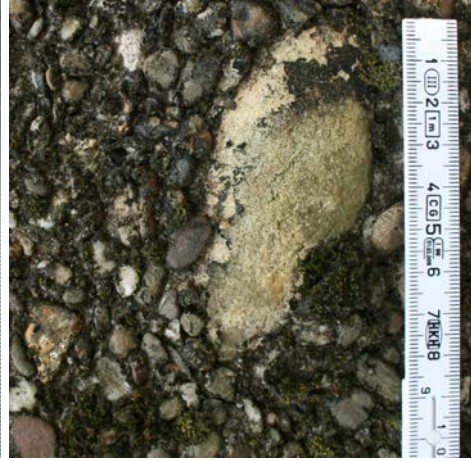
**Figure 4.17** Local deviation of maximum aggregate size, the maximum size should have been 60 mm (earth retaining walls of the unfinished Groot Museum Kröller - Müller, national park Hoge Veluwe, H. van de Velde, 1921-1922, situation 2008).

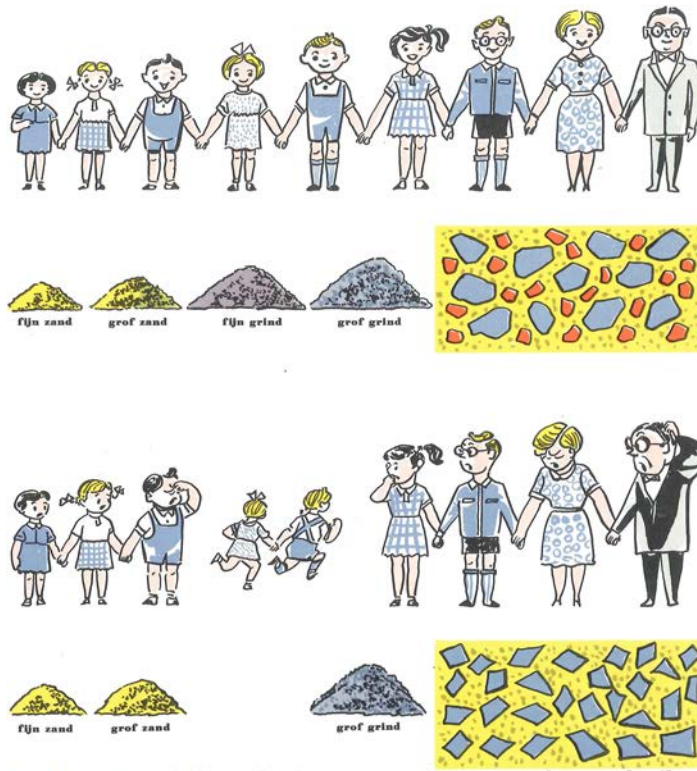
**Figure 4.18** Popular illustration of the concept of continuous grading with all fractions present (top) and gap grading where some fractions are missing (bottom) (Anon., 1968, p. 13).

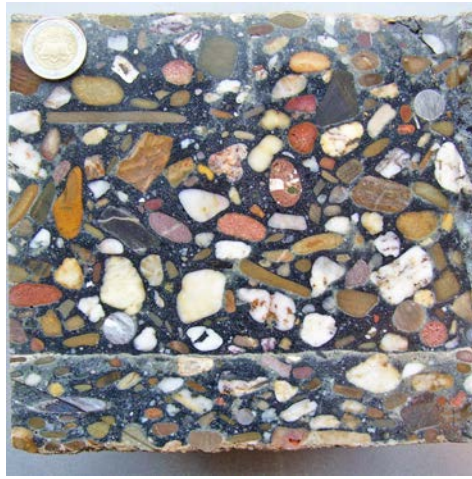
**Figure 4.22** An early Dutch example dating from 1936 of gap-graded concrete made with blastfurnace slag cement (Sewage water reservoir, below the Jonas Daniel Meijer square, Amsterdam, picture 2008 by Timo G. Nijland).

In the 1930s, a deviation of the ideal curve which was based on a continuous grading was discussed again. Examples in France and Belgium and research had shown that a strong concrete was possible with “irregular” grading (Bergsma, 1934) and Dutch examples soon followed (Figure 4.22). Although in theory known for decades, a practical application was only then possible due to new and improved compaction methods and better control of the mix design. Manual compaction with poking rods or by hitting against the formwork was slowly replaced with mechanical internal vibrators from the 1930s onwards and became common in the 1950s. In this period the term gap-graded was introduced (CUR report 1, 1955; Visser, 1950). For exposed concrete, the use a gap-graded concrete was considered to be slightly better than a continuous graded as it could help to prevent blowholes (CUR report 36, 1955).

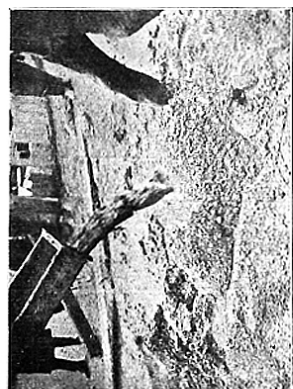
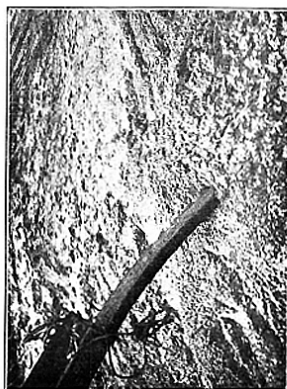
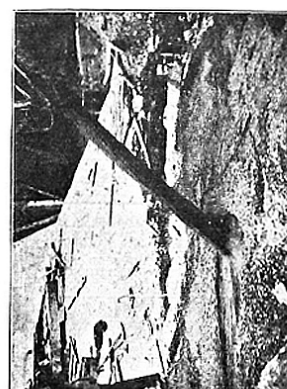
**Figure 5.5** Different consistencies of fresh concrete (Scharroo, 1927b, p. 305): (top left to right): too dry tamped concrete, good tamped concrete, plastic concrete; (bottom left to right): good fluid concrete; borderline between fluid and too wet concrete; too wet concrete.

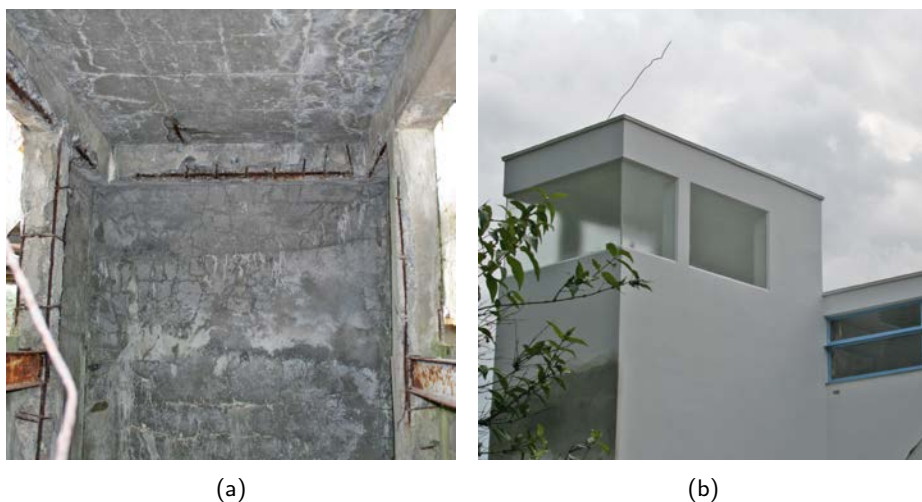
**Figure 5.6** Example of corrosion induced by chlorides which were cast in to allow works during low temperatures. The historic concrete structure was demolished and reconstructed (*Dresselhuys pavilion*, part of *Sanatorium Zonnestraal*, Hilversum, J. Duiker, B. Bijvoet and J. G. Wiebenga, 1928). a) Interior view of lift shaft before demolition, showing exposed reinforcement, cracking and efflorescence (January 2008). b) Exterior view of the reconstructed lift shaft (September 2008).

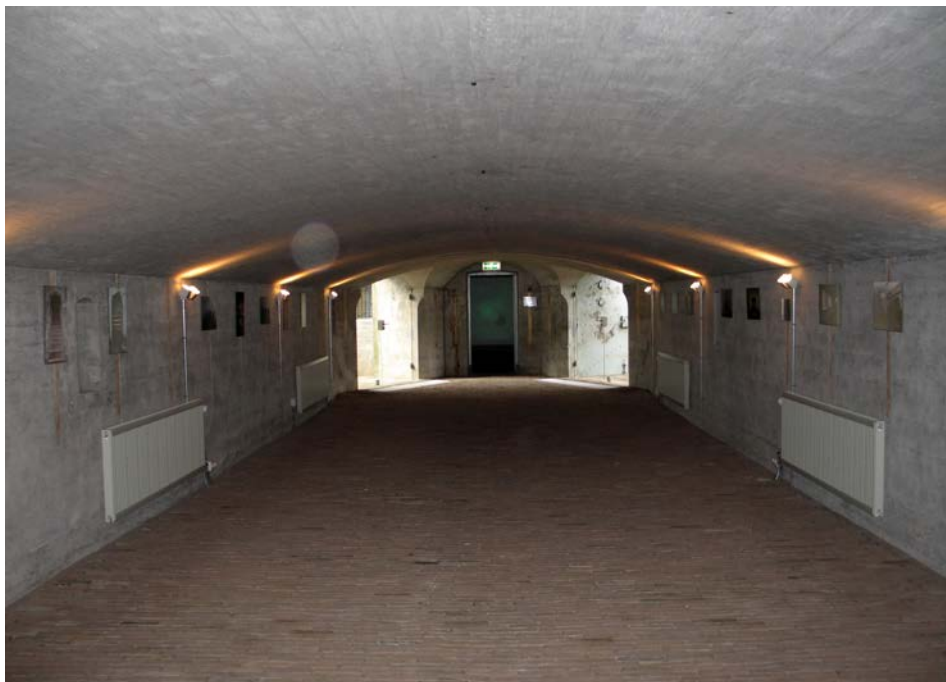
**Figure 6.1** Example of a plain concrete vault (Fort near Vijfhuizen, 1899, situation 2006).

As concrete can only carry little tensile stresses, a concrete structure has to be designed either to carry only compressive loads, for example by using a vault structure (Figure 6.1), sometimes in combination with external iron profiles (Figure 6.2), or a reinforcement has to be embedded in the concrete to carry the tensile stresses (see Figures 6.3 and 6.4). The concept of embedding iron in masonry to carry tensile strengths was known and applied before the invention of reinforced concrete (Addis, 2007).

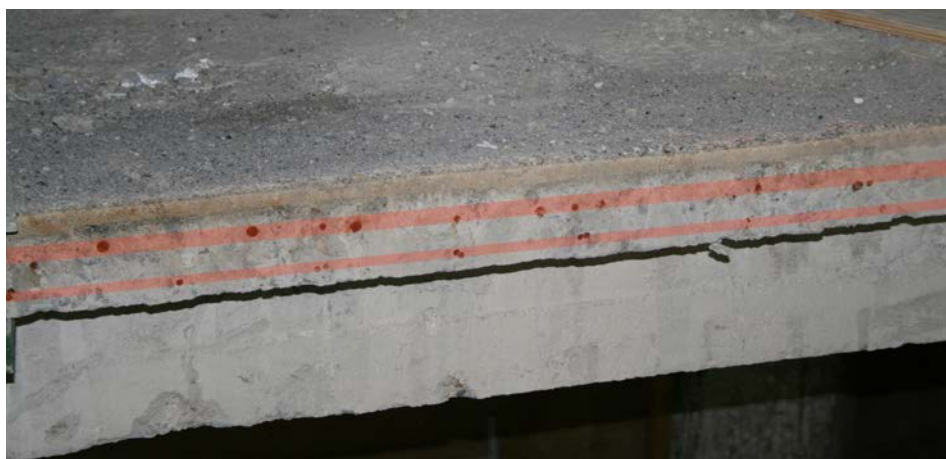
**Figure 6.4** Section through floor slab at a negative bending moment above a beam, showing two reinforcement layers: (red lines) at the top with larger cross sections and at the bottom with smaller cross sections, reflecting the bending moment (Philips Lichttoren, building EC, Eindhoven, A. Beltman, 1909-11, situation 2007).

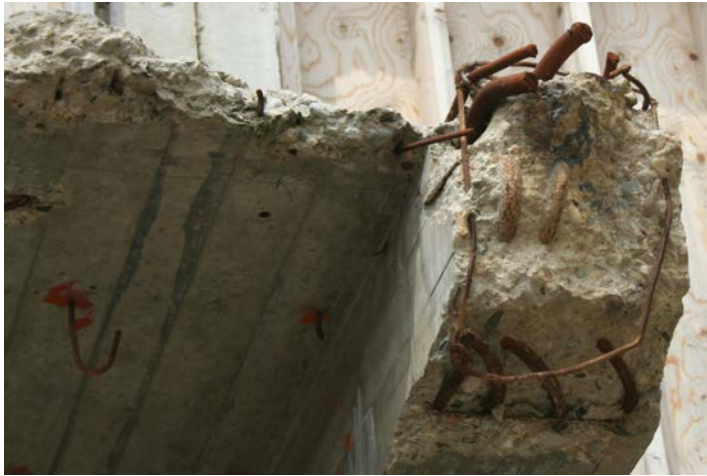
**Figure 6.13** Plain circular reinforcement for main reinforcement and stirrups of a beam (Central Station Rotterdam, 1950-1957, S. van Ravesteyn, picture taken during the demolition of the station in 2008).

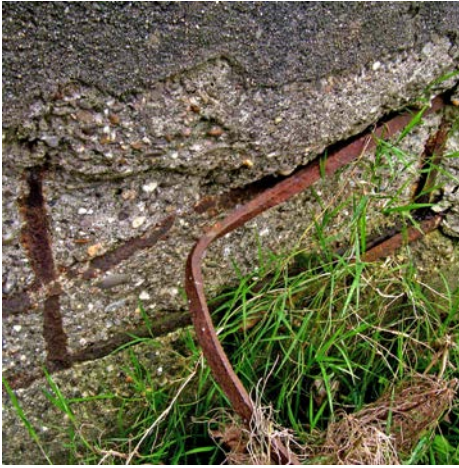
**Figure 6.17** Example of an unusual use of only rectangular reinforcement (bomb shelter near Fort Benoorden Spaarndam, 1916 - 1919, situation 2006, picture by T. G. Nijland).

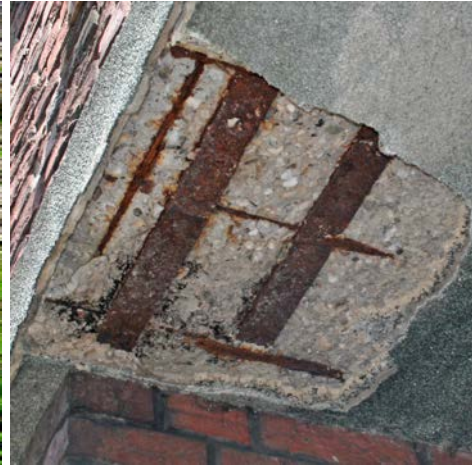
**Figure 6.18** Floor construction made with a combination of flat strips and round bars for reinforcement (Housing, The Hague, 1930s, exact year and architect unknown, situation 2009).

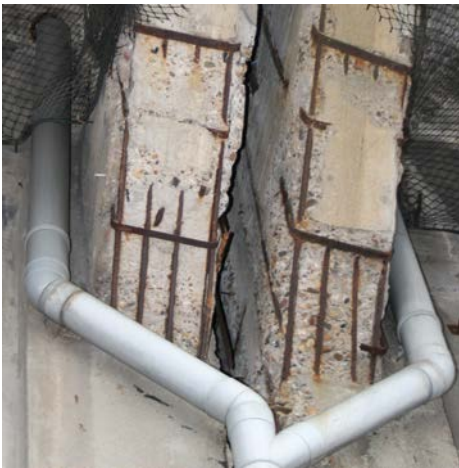
**Figure 6.19** Example of the typical stirrups of the Hennebique system made with strips (former cotton warehouse Katoenveem Rotterdam, J. J. Kanter, 1920, situation 2009).

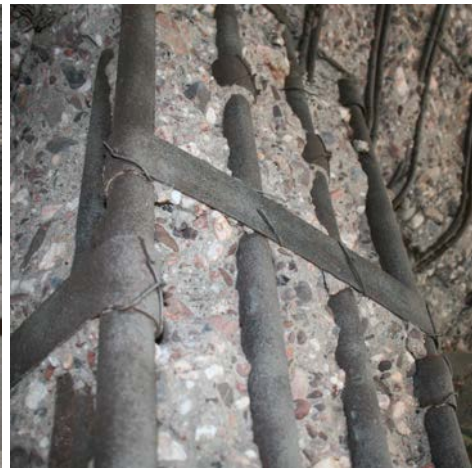
**Figure 6.20** Stirrups made from strips in combination with plain reinforcing bars; notice the coupling of the bars above the strips and the annealed wires to connect the elements (emplacement of the Hofplein railway viaduct, Rotterdam, Van Hemert, 1904, situation 2009).

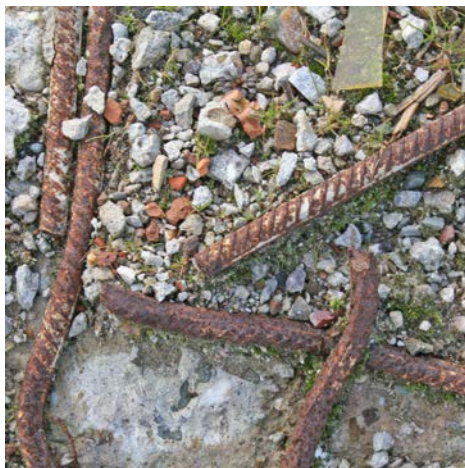
**Figure 6.31** Ribbed reinforcement bars visible after demolition of a building on the Calve factory grounds probably dating back from the early 1960s (see Stenvert & Dekker, 2009)

Ribbed reinforcing steel is defined as having “*at least two rows of transverse ribs, which are uniformly distributed over the entire length*” (NEN-EN 10080:2005). This is the most common reinforcement type now used for reinforced concrete (Figures 6.31 and 6.32). They combine the advantages of easy placing and calculation of plain reinforcement bars with the increased mechanical bond between the previously used special patented reinforcement bars. Using ribbed bars had also the advantage of spreading possible cracks more evenly (Dicke, 1966). Two groups of ribbed reinforcement bars existed: bars with ribs and bars with ribs which were twisted (see Section 6.3.4).

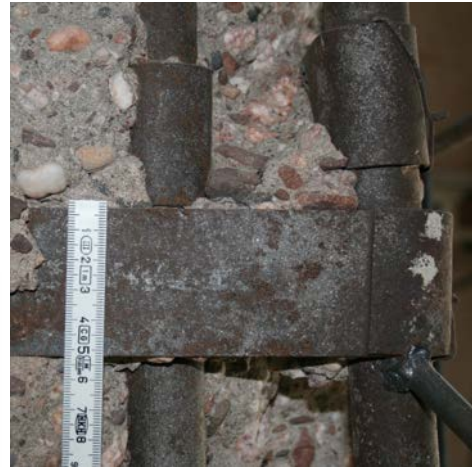
Fig. 143.

**Figure 6.40** Connection to extend bars with wires (left) and with coupling (right), (Boon, 1908, p. 78).

As reinforcement bars could not always be delivered in the required length, it was necessary to connect the bars, either by coupling, using annealed wires or welding (Figures 6.40 and 6.41). The choice of connection type depended on whether tensile or compressive loads had to be transferred. The connection with wires was advised for secondary reinforcement bars and for bars with a relatively small diameter (Christophe, 1905). An overlap of the bars of 10-20 cm (Boon, 1908), or, depending on the bar diameter, for example a length of 20 – 30 times the diameter, was advised (Memmler et al., 1907; Scharroo, 1929). This technique was also applied to vertical bars in columns of multi-storey buildings (Boon, 1908). Other authors advised not to connect the bars with wires, even considering it wrong; instead, the bars should overlap and be placed with sufficient distance, for example 2 cm, to embed both bars well in the concrete to ensure sufficient adhesion to transfer the stresses (Bergsma, 1934; Betonvereniging, 1929; Memmler et al., 1907; Van der Schrier, 1960). For bars with a large diameter and for bars exposed to compressive loads, the use of couplings was advised. In case tensile length had to be transferred, the coupling was threaded (Boon, 1908; Christophe, 1905).

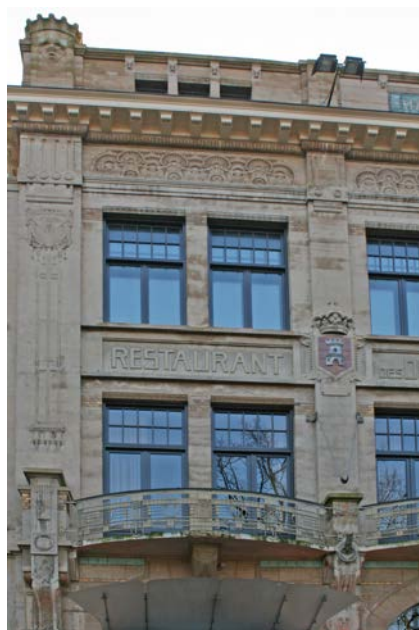
**Figure 7.2** Façade of a reinforced concrete building, combined use of artificial stone and *kunstzandsteenpleister* (artificial sandstone render, former hotel-restaurant “De Twee Steden”, The Hague, Joh. Mutters Jr, 1904-1906, situation 2010).

concrete; its use prior to the Second World War is often not considered or even recognised. Instead, reinforced concrete with a jointless *kunstzandsteen* render (artificial sandstone render) and artificial stone are mistaken for natural stone (Figure 7.2), coloured concrete for a rendered concrete (Figure 7.3); opposite mistakes happen as well and natural stone, in this case a tuff stone, is identified as *kunststeen* (artificial stone, Figure 7.4, for example RCE 1993; 2002b; 2008).

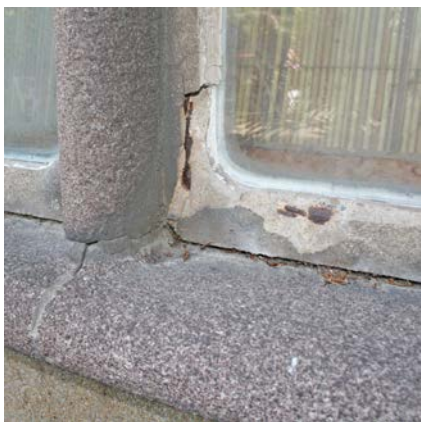
**Figure 7.3** Prefabricated coloured concrete elements; due to local damage it can be seen that the material is concrete and not a render (Riveràhal of the Zoo Blijdorp, Rotterdam, van Ravesteyn, 1939-1941, situation 2011).

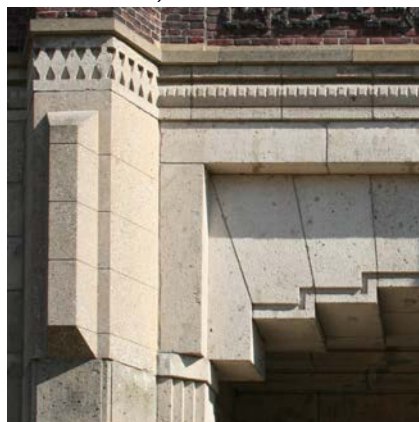
**Figure 7.4** The original material of the column and arch is tuff stone, only local replacements were carried out in well-made natural stone imitations (top of the column) (Faculty of Architecture, former Faculty of Chemistry, TU Delft, G. van Drecht, 1918-1923, situation 2011).

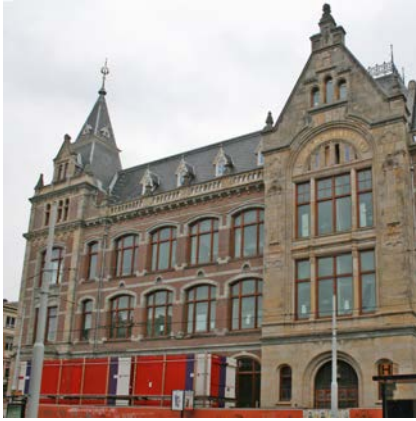
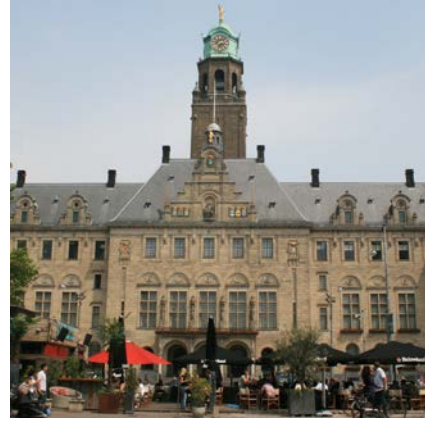
**Figure 7.5** Two early reinforced concrete buildings with façades made from traditional materials. a) One of the earliest Dutch examples using reinforced concrete slabs (Sanders, 1907) which is not noticeable from the façade made from brick and sandstone (Former bank building Rijkspostspaarbank, Amsterdam, D. E. C. Knuttel, 1899–1901, situation 2011). b) Reinforced concrete frame clad with natural stone (Rakovice sandstone for the main building, Ettringer tuff for the tower, Town hall Rotterdam, H.J. Evers and A.J.Th. Kok, 1914–1920, situation 2009).

In the late 19<sup>th</sup> century, the use of concrete was mainly limited to structural elements such as columns, vaults, and floors, later also to walls. Concrete was commonly disguised either by plastering or by cladding with other, traditional materials (e.g. bricks, natural stone, see Figure 7.5). Therefore, an aesthetical treatment of concrete surfaces was not relevant. An exception was the use of concrete as natural stone imitations, known in Dutch as *cementsteen* or *kunststeen*. The colour and texture of the concrete was modified to match the appearance of the stone to be imitated (Stokroos, 1985). This was done by using special coloured constituents and by tooling the surface. Good examples are the products of the company *Rotterdamsche Cementsteenfabriek Van Waning & Co* (Figure 7.6). In Germany, for example, an entire *Kunststein* (artificial stone) industry existed, with several recipes for imitating different natural stones from initially sand stones to later a wider variety of natural stone such as grey wacke, porphyry, tuff, sandstone, limestone and granite (Probst, 1919).

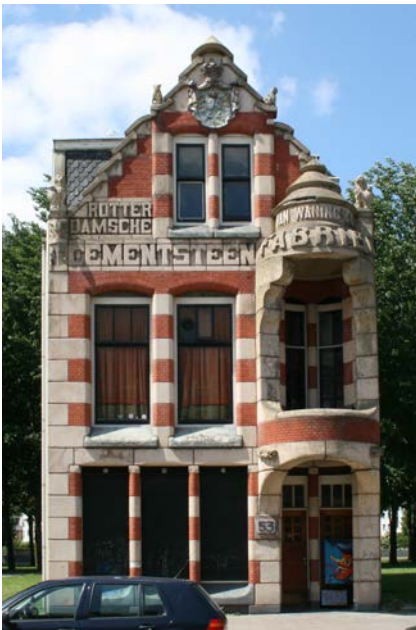
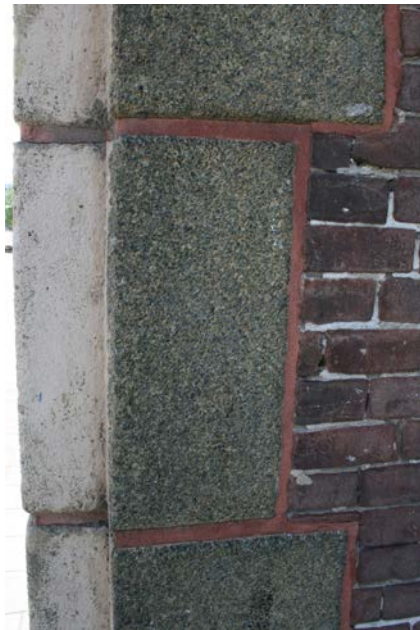
**Figure 7.6** Natural stone imitation used in the former headquarters of the *Rotterdamsche Cementsteenfabriek Van Waning & Co* ( Rotterdam, J. I. van Waning 1898, situation 2010). a) Façade with advertisement made in artificial stone; the artificial stone has been painted. b) On the side the original texture and colour of the artificial stone is locally still visible.

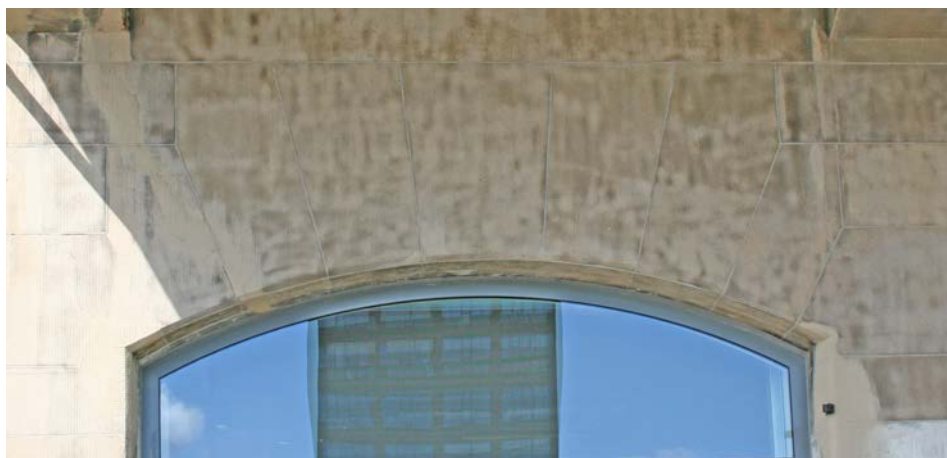
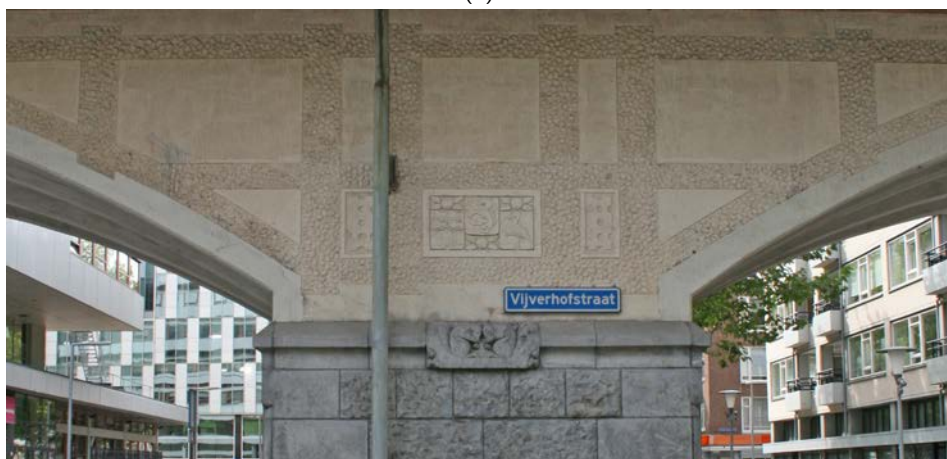
**Figure 7.7** Two examples of reinforced concrete structures rendered with *kunstzandsteenplaster*, imitating the appearance of a tooled sandstone façade. a) With the imitation of joints (St. Jobsveen Rotterdam, J.J. Kanter, 1912, situation 2010, showing local repairs). b) Without imitating joints (Hofplein railway viaduct, Rotterdam, A. C. G. van Hemert, 1900-1908, situation 2009, original surface painted).

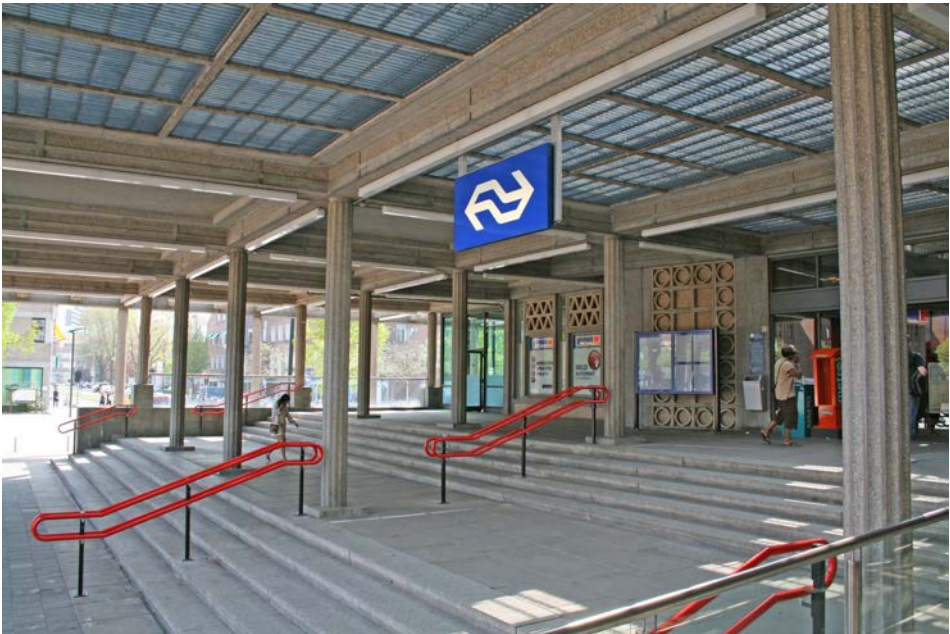
**Figure 7.12** Overview of the Railway station Enschede; the beams were made with permanent formwork (Schokbeton) due to timber scarcity after the Second World War (H.G.J. Schelling, 1950, situation 2009, see also Figure 6.45).

Concrete had become a more reliable material; the experimental years of this new technique had passed, and knowledge about concrete was well disseminated. A reliable construction of exposed concrete was possible due to the existing infrastructure for the production and construction of concrete buildings. This made a good quality of the concrete surface possible, which strongly depends on the level of workmanship and material. Especially the development of better compaction methods, including *schokken* of prefabricated elements, improved the quality of the concrete surface (Schelling, 1950b). The economic benefits when using exposed concrete compared to rendered walls increased its use (Scharroo, 1951). The lack of timber for formwork supported the use of prefabricated elements as a permanent formwork (Figure 7.12, see also Schelling, 1950a,b, 1952b).

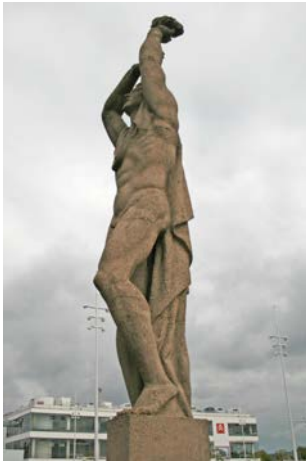
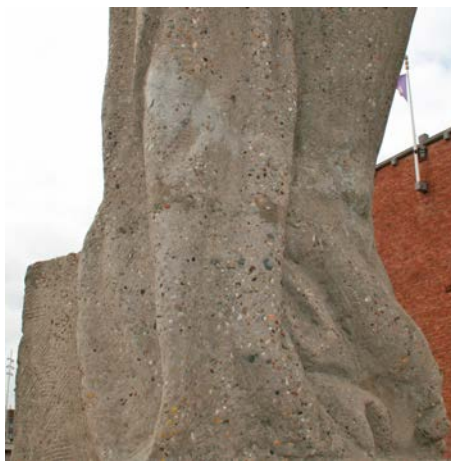
**Figure 7.14** Reinforced concrete sculpture in front of the Olympic stadium in Amsterdam by F. Carasso (1947, situation 2007). a) Overview. b) Closeup showing eroded surface texture.

buildings, several pieces of art made from or with concrete can be encountered, either as sculptures or integrated in walls as mosaics (see Figures 7.14 to 7.19).

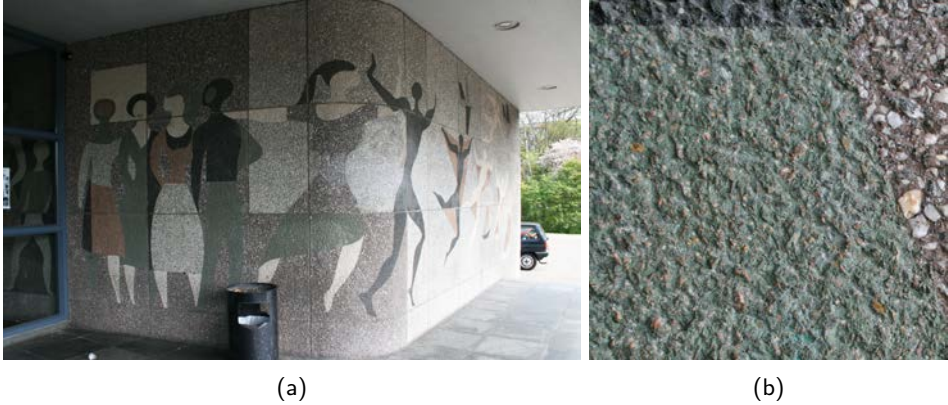
**Figure 7.15** “Drawings” made in decorative concrete elements, produced by the Dutch company De Metoor (Grotius high school, The Hague, Sj. Schamhart, “drawings” by W.J. Rozendaal, 1949-1955, situation 2006). a) Overview entrance. b) Detail showing the use of different coloured concrete in one element and tooled surface.

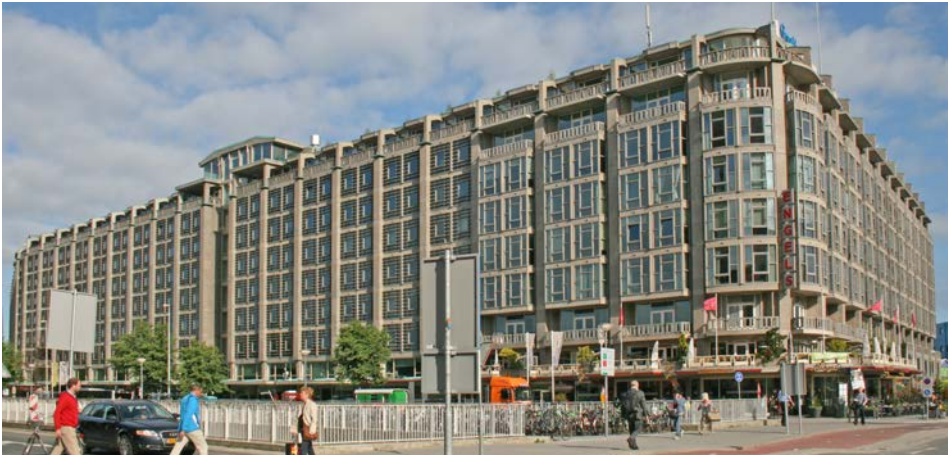
**Figure 7.20** The office building *Groothandelsgebouw* is an example of combining pre-fabrication with different surfaces finishes. The building was painted white to cover up repairs in the 1960s. During large scale restoration works in 2001-2005 the paint was removed; degradation problems are still present (Rotterdam, H. Maaskant & W. van Tijen, 1950).

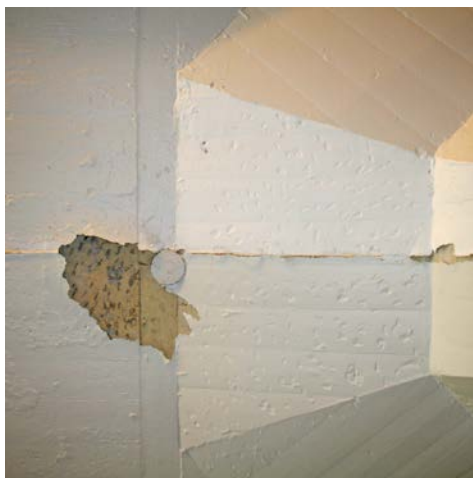
**Figure 7.22** Soffit and head of a mushroom column, currently painted, with local detachment of paint. Several, irregularly spread holes in the concrete surface, applied to increase the roughness, indicate that the soffit and column were previously plastered (Van Nelle factory, J.A. Brinkman and L.C. van der Vlugt, 1926-1931, situation 2008).

Before rendering, the concrete surface either had to be cleaned with wire brushes (Minister van Oorlog, 1906), or in case the surface was too smooth, it had to be roughened up first (Figure 7.22, see also Van der Kloes, 1893; Van der Schrier, 1938). The thickness of the render was advised to be between 10-12 mm (Van der Kloes, 1893), or 3-10 mm (Minister van Oorlog, 1906), limiting thereby the aggregate size; latter could be applied with a brush.
