# HISTORIC CONCRETE

FROM CONCRETE REPAIR TO  
CONCRETE CONSERVATION

PROEFSCHRIFT

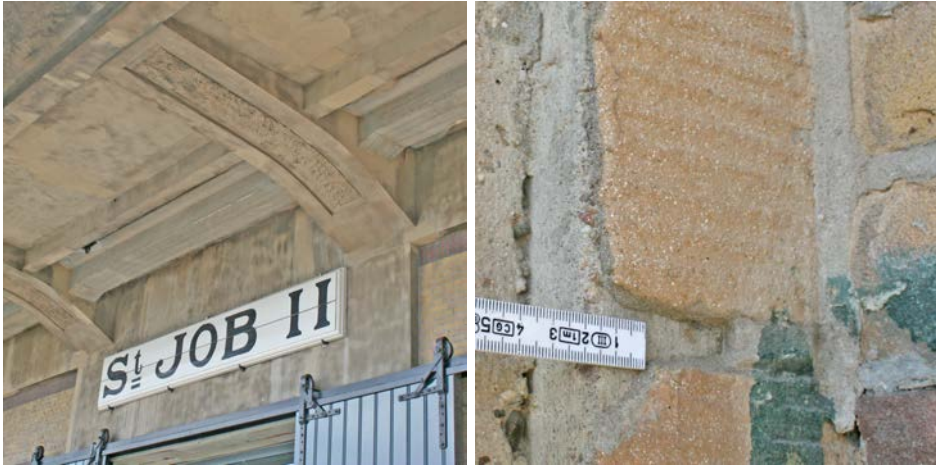
**Figure 7.23** Reinforced concrete rendered with a tooled *kunstzandsteen* (former warehouse St. Jobsveem, Rotterdam, J.J. Kanters, 1912, situation 2010). a) Overview plastered wall and cantilevered balcony slabs; local colour differences are visible between original plaster and a repair from 2006. b) At a damaged area two layers of render can be seen, a bottom grey render, probably made with Portland cement and a top coloured and tooled layer.

viewed as a cheap surrogate for natural stone to illude the observer to see a large piece natural stone; in combination with imitation joints, the illusion increased (Rutgers, 1909). In other cases, it was considered as a good solution to improve the appearance of concrete buildings and an alternative for facing concrete (see Section 7.6). Two early examples for the application of a decorative and tooled plaster can be found in Rotterdam: the plinth of the warehouse St. Jobs (see Figures 7.7 and 7.23) and the Hofplein railway viaduct (Figures 7.25 and 7.26).

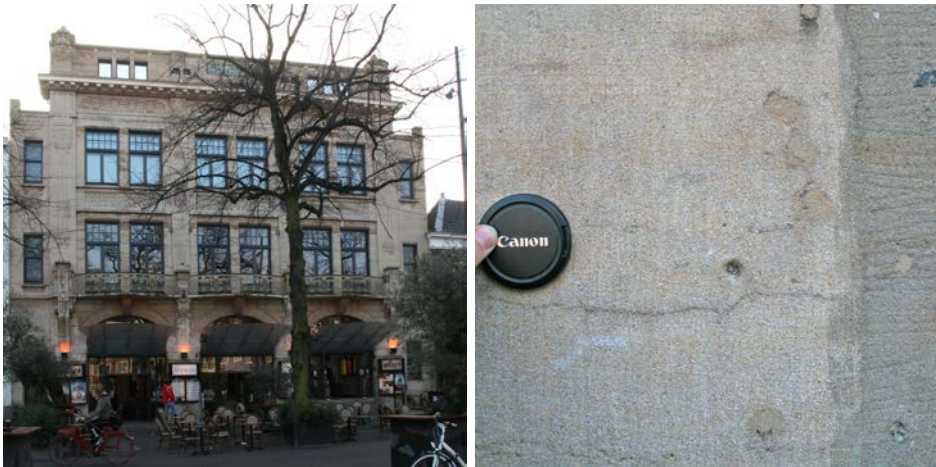
**Figure 7.24** Façade of a reinforced concrete building, combined use of artificial stone and *kunstzandsteenpleister* (artificial sandstone render, former hotel-restaurant "De Twee Steden", The Hague, Joh. Mutters Jr, 1904-1906, situation 2010). a) Overview. b) Detail of the surface with local repairs which neither match in colour nor texture.

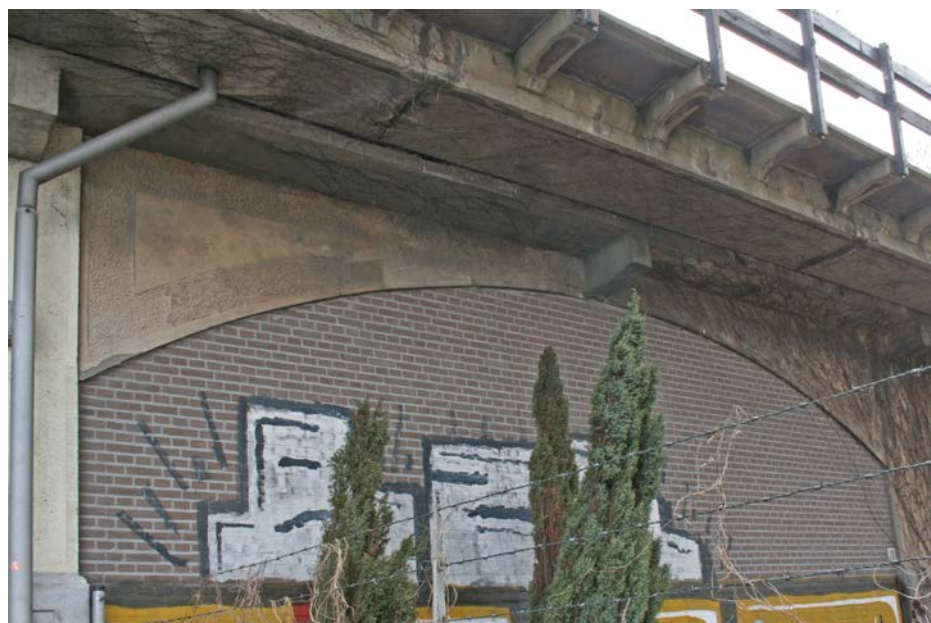
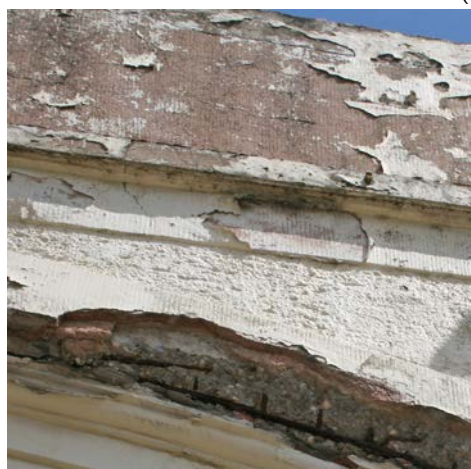
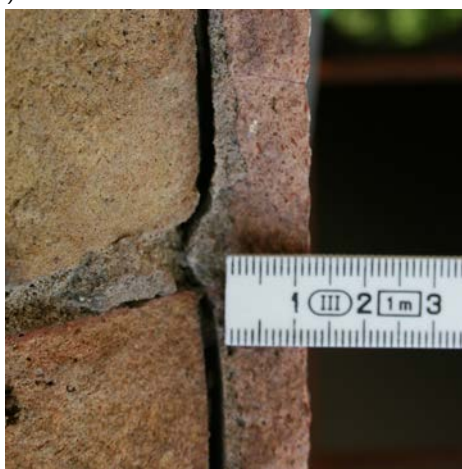
**Figure 7.25** Example of an early reinforced concrete building with a tooled *kunstzandsteen* render: the colour changes between the two renders can be explained by a severe fire during the Second World War in the yard (Van Zutphen, 1958), turning the plaster reddish (Hofplein railway viaduct, Rotterdam, A. C. C. G. van Hemert, 1900-1908, situation 2010). a) One of the last remaining unpainted segments, showing the original yellow sandstone like colour. b) Picture of the yard with a reddish plaster under layers of peeling paint. c) Picture of the yard with the same reddish plaster applied on brick works.

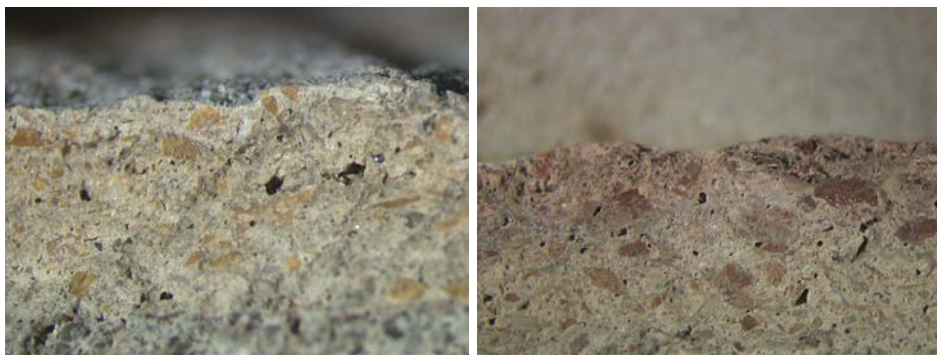
**Figure 7.26** Stereo micrographic pictures from two differently coloured render samples of the emplacement of the Hofplein railway viaduct, both made with a greyish bottom layer (Portland cement based) and a coloured finishing layer with broken sandstone as aggregate (Pictures Laura Bolondi). a) Finishing layer is yellow-beige, the original colour (9 times magnification). b) The finishing layer is reddish due to colour changes of the sandstone aggregate caused during the fire in 1940.

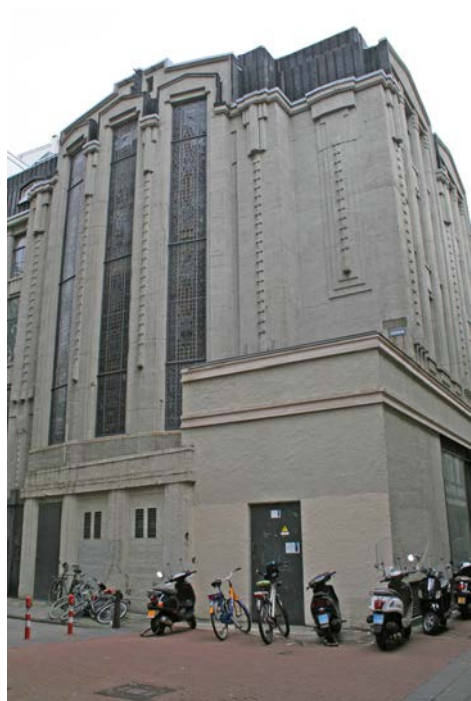
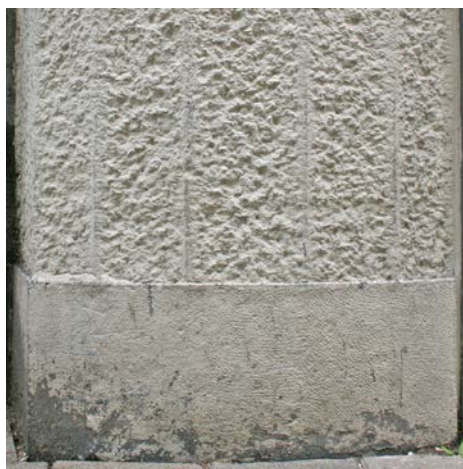
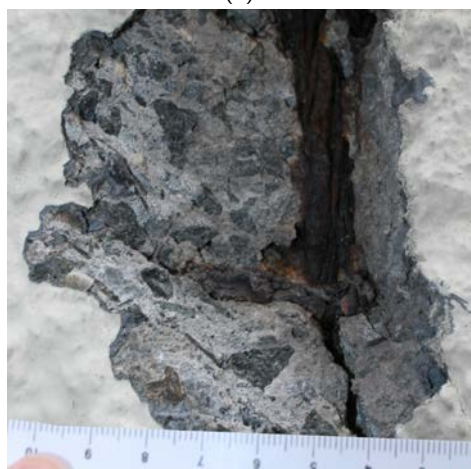
**Figure 7.28** Rear façade of the former fashion store Gerzon (A. Moen, Amsterdam, 1915, situation 2011), the surface has been painted white. a) Overview of the painted rear façade. b) Detail of a pilaster of the rear façade, showing the combination of bush hammering at the column foot and point tooling above (c) Due to local damage the original colour combination of dark crushed rocks as aggregates and the grey cement can be seen; the colour of the entire façade would have varied depending on the degree of exposure of the aggregate. As the building is now painted, these effects are not visible anymore.

In the first decades of the 20<sup>th</sup> century, several large scale buildings were indeed bush-hammered. The former fashion store Gerzon (Figure 7.28) is considered to be the first large scale application of exposed tooled concrete in the Netherlands (Gratama, 1915; Oosterhoff et al., 1988); other examples are the radio station Kootwijk (Figure 7.29, see also Emmen, 1923), and the industrial building HAKA (Figure 7.30). However, the original surfaces of these buildings can no longer be experienced, as they were covered during time, disguising the original colour and texture of a tooled concrete surface.

The patterns created by tooling varied during time, and was influenced by the geometry of the concrete element (Figures 7.28 to 7.35). Large areas were often either bush hammered or point tooled (Figure 7.8, Figures 7.28 to 7.30), whereas smaller areas were chiselled. A traditional pattern was to combine bush hammering with chiselled margins (Figure 7.31, see also Von Mecenseffy, 1922); a more recent pattern, dating from the late 19<sup>th</sup> century, of polygonal forms with changing directions, is the so-called *kathedraalslag* (see Figures 7.32 to 7.33).

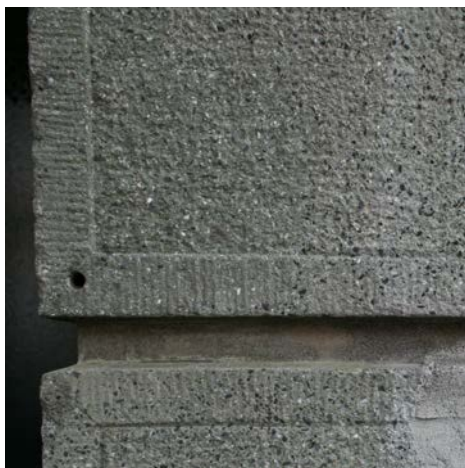
**Figure 7.31** Example of a bush hammered surface with chiselled margins; the concrete is made with diabase as aggregate (housing, 1930s, exact date and architect unknown, Rotterdam).

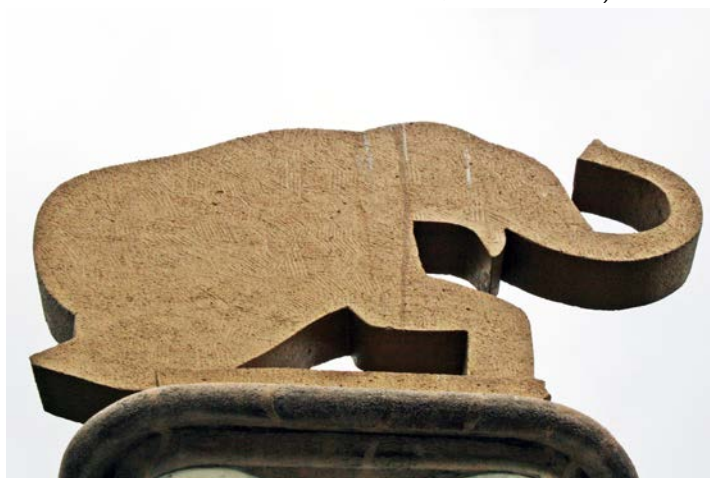
**Figure 7.33** Concrete sculpture at the entrance of the Zoo Blijdorp, surface chiselled with *kathedraalslag* (Rotterdam, L. Boole; 1939-1941, situation 2011).

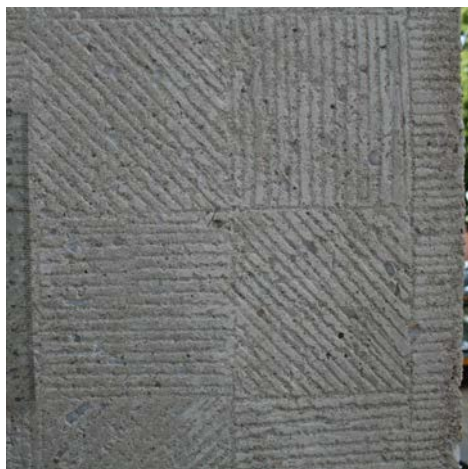
**Figure 7.34** Example of horizontal, vertical and diagonal tooling with chiselled margins of prefabricated concrete elements (*Paleis van Justitie*, Arnhem, F. Sevenhuysen Jr., 1953-1963, situation 2010).

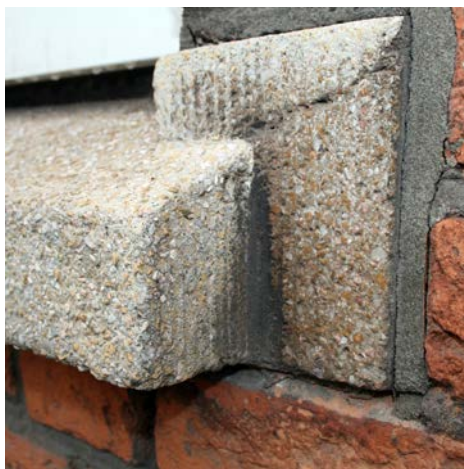
**Figure 7.35** Prefabricated coloured concrete window sill; the texture has already partially eroded (housing, Rotterdam, exacts date and architect unknown, 1930s, situation 2010).

In the 1920s and 1930s, prefabricated concrete elements such as window sills were commonly tooled, imitating natural stone (Figure 7.35). In the course of time, the tooling of concrete freed itself from the reputation of being a technique used to surrogate natural stone, and tooling was seen as an honest and logical method to show that concrete is a composite material (see for example Gray & Childe, 1943). In the reconstruction period after the Second World War, tooling was often used in combination with decorative concrete (see Section 7.7). Another area of application was tooling of decorative renders applied on concrete surfaces (see Section 7.3.1). Tooling of surfaces became out of fashion as it was too laborious, too costly and associated with health risks (Redactie Cement, 1983).

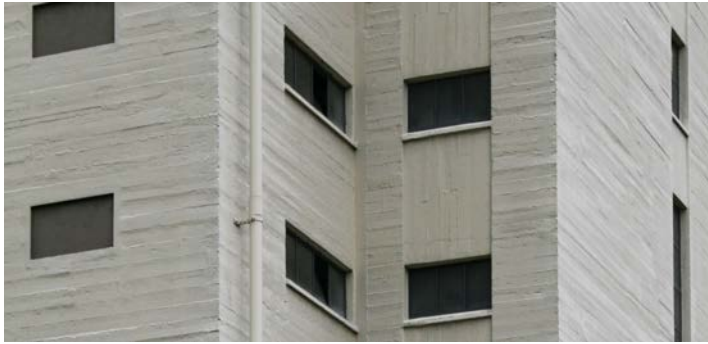
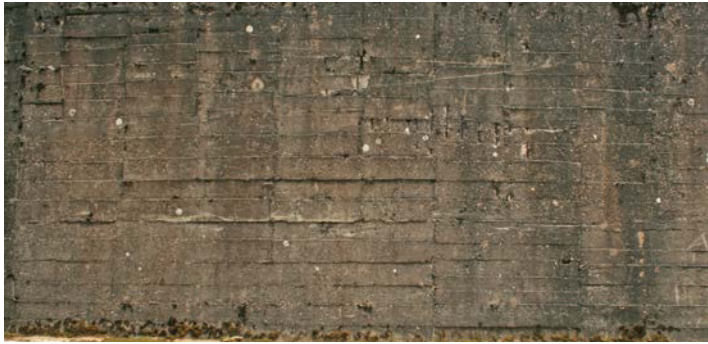
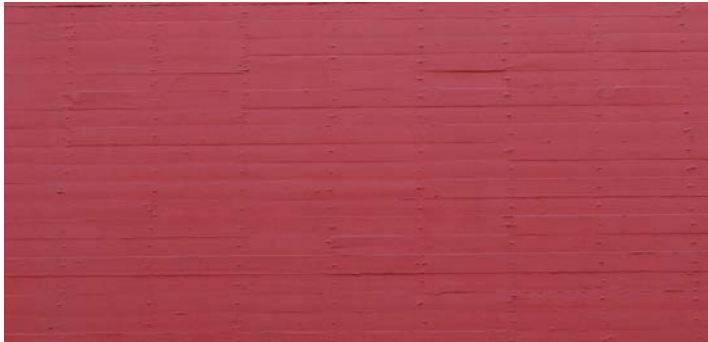
**Figure 7.48** Three examples of similar timber formwork finish yet with different underlying design intentions and technical possibilities. a) Façade of an industrial building, which was originally not painted (Klokgebouw, Strijp S, Eindhoven, A. de Broekert, 1928-1929, situation 2007 with a white painted surface). b) Surface of an earth retaining wall; the original intention was to clad it with natural stone, notice also the width of the formworks which is less than the other examples (unfinished Groot Museum, Natural park Hoge Veluwe. H. van de Velde, 1922, situation 2008). c) Surface of a public building showing imprints of individual boards and nails and painted red (Faculty Building for *Elektrotechniek, Wiskunde en Informatica*, TU Delft, J.P. van Bruggen, G. Drexhage, J.J. Sterkenburg & A. Bodon, 1959-1972, situation 2006).

Understanding the historical context can give first indications if an encountered formwork finish was common approach for a façade with low aesthetical requirements or a specially chosen surface finish. Comparing the surfaces in Figure 7.48, all show the irregular imprints caused by timber formwork made from individual boards. The individual boards were not levelled, causing even more surface disturbances. Although these three examples are similar in technique and resulting texture, the underlying intentions vary strongly. Figure 7.48a shows the façade of an industrial building from the late 1920s located on a site restricted from the general public. The surface texture is the result of a standard use of timber formwork boards. Figure 7.48b dates from the early 1920s; also in this case, the use of timber boards was normal; as the intention was to clad the wall with natural stone, no special attention had been given to the effects of the formwork on the surface appearance. Figure 7.48c, however, tells a different story. It is the façade of a 1960s' public building, a period where several types of formwork material existed to create either very smooth or specially textured finishes; however, in this case, an out-dated, traditional and less commonly used formwork technique was consciously chosen.

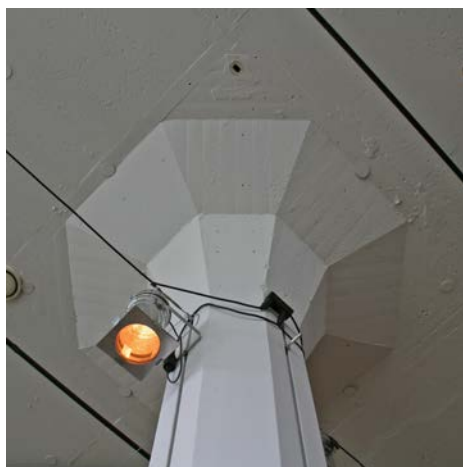
**Figure 7.53** Geometric pattern based on the technical solution for a timber formwork of a mushroom floor (Van Nelle factory, J.A. Brinkman and L.C. van der Vlugt, 1926-1931, situation 2008, surface originally plastered, now painted).

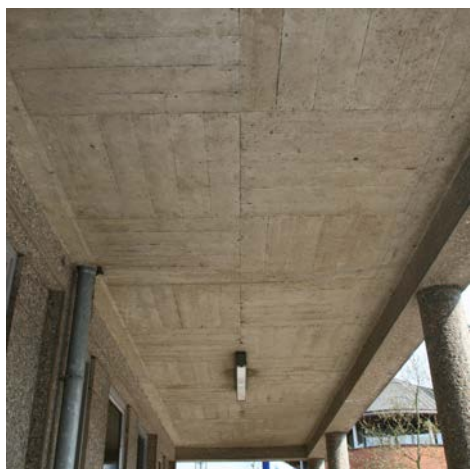
**Figure 7.54** Soffit with pattern consciously chosen by arranging individual timber boards perpendicular in squares (Train station Zutphen, H.G.J. Schelling, 1952, situation 2009).

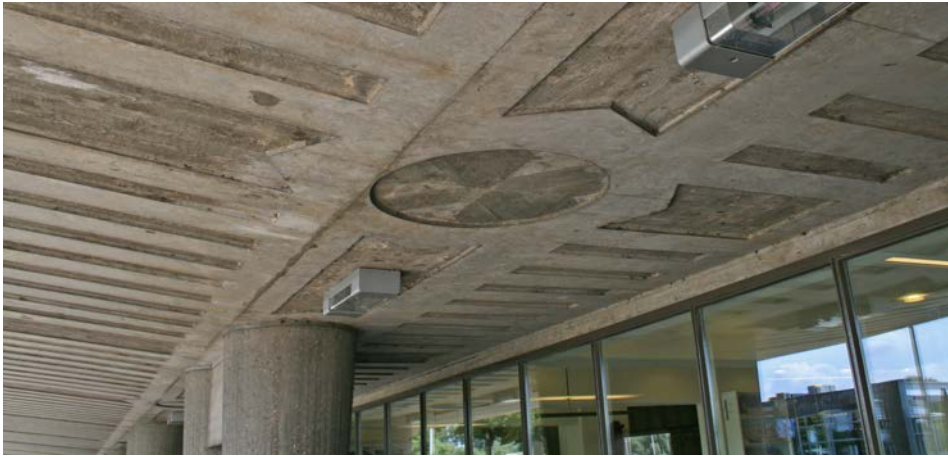
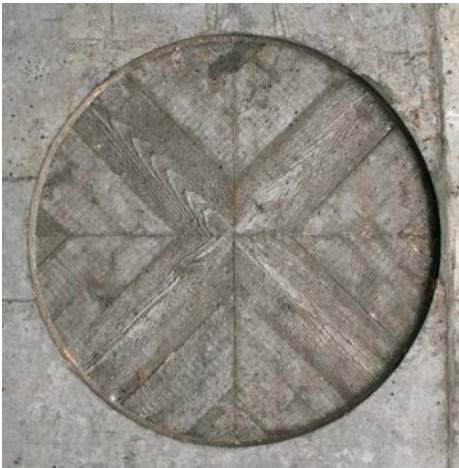
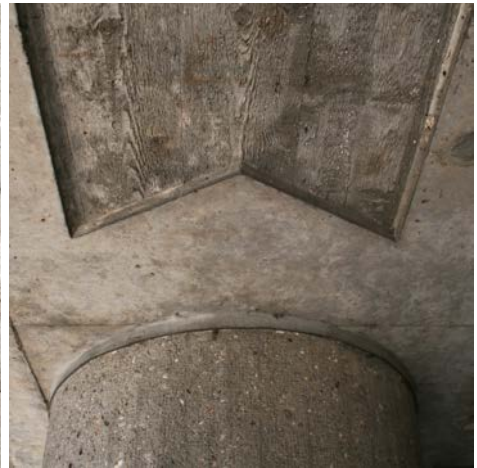
**Figure 7.56** Example of the combination of different textures, sizes and orientation of formwork imprints to create an aesthetical effect on the exposed concrete surface (Provincial house Gelderland, Arnhem, 1950-1955, J.J.M. Vegter and H. Brouwer, situation 2010). a) Overview soffit showing the combination of different textures and orientation. b) Detail of a circular indentation made with diagonal and symmetrical orientated rough timber boards, the surrounding surface was made with a smooth formwork. c) Combination of indented surface with timber formwork imprint, smooth surface and bush hammered column.

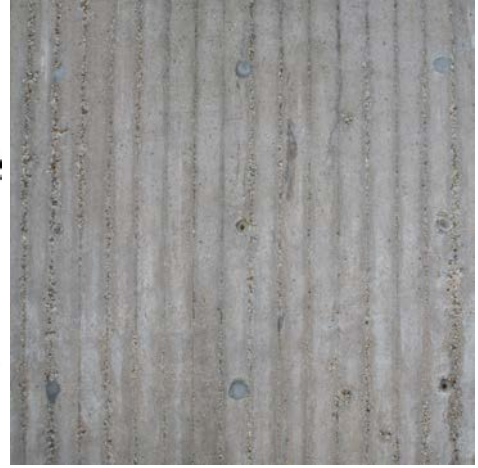
**Figure 7.59** Regularly placed openings for tie wires, later closed with a mortar, in an exposed concrete wall made with a vertical timber formwork with visible blemishes (waterways) at the joints (Faculty of Architecture, Delft University of Technology, architectural firm van den Broek & Bakema, the building burnt down, May 13 2008).

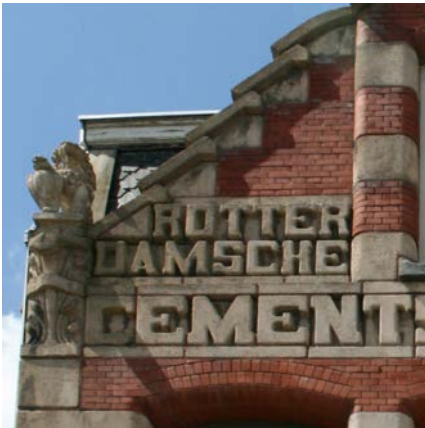
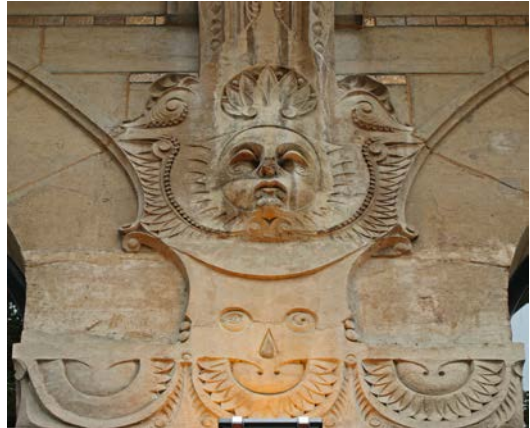
**Figure 7.60** Two examples of detail rich artificial stones. a) Figures and letters cast in concrete, for the original colour see Figure 7.74 (former office building for Rotterdamsche Cementsteenfabriek van Waning & Co, Rotterdam, J. I. van Waning 1898, situation 2010). b) Sculptured artificial stone with local repairs at the bottom, where only the outlines but not the details of the texture were reconstructed (former hotel-restaurant "De Twee Steden", The Hague, Joh. Mutters Jr, 1904-1906, situation 2010).

Besides modifying the formwork to alter the surface of exposed concrete, special formworks were used to cast sculptures in concrete. Already with the introduction of artificial stone at the end of the 19<sup>th</sup> century, special formworks were applied, which allowed transferring detail-rich designs as seen in Figure 7.60. A known early formwork technique for such purposes was gypsum formwork, which could be produced according the design of the artist (Petry, 1913). For concrete structures cast on-site, gypsum formwork could be used in combination with normal formwork to accentuate areas on the concrete. An example of the use of gypsum formwork for on-site casted concrete can be seen in Figure 7.61 for the sculptures above the entrance of *Radio Kootwijk* (Emmen, 1923). An early example of the use of specially sculptured wooden formwork are the concrete façade elements of a shop refurbishment (Figure 7.62) by Gerrit Rietveld (1888-1964), who was originally trained as a carpenter (Kuipers, 2011).

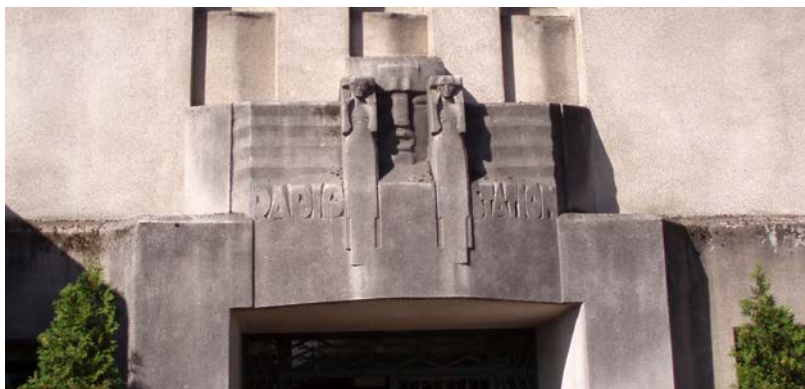
**Figure 7.61** Entrance Radio Kootwijk, relief made in-situ by using gypsum formwork. The colour difference between the entrance and the walls behind is not original, but caused by the application of sprayed concrete in the 1960s on the walls (J. M. Luthmann, J. Emmen, artist H. van den Eijnde, 1921-22, situation 2006).

of crushed stone led to the choice of normal gravel. For Radio Kootwijk crushed stone was first considered, yet try-outs showed that the difference to concrete made with gravel when bush-hammered was not significant enough to justify the higher costs of crushed stone (Emmen, 1923) (Figure 7.29 and Figure 7.61). In the 1930s, an increase use of coloured, prefabricated concrete can be observed, using crushed natural stone to alter the colour of the concrete. An architectural ensemble of such concrete can be found the Rotterdam Zoo Blijdorp built by Sybold van Ravesteyn (1889-1983) between 1938 and 1940 (Figures 7.66, 7.3, and 7.11).

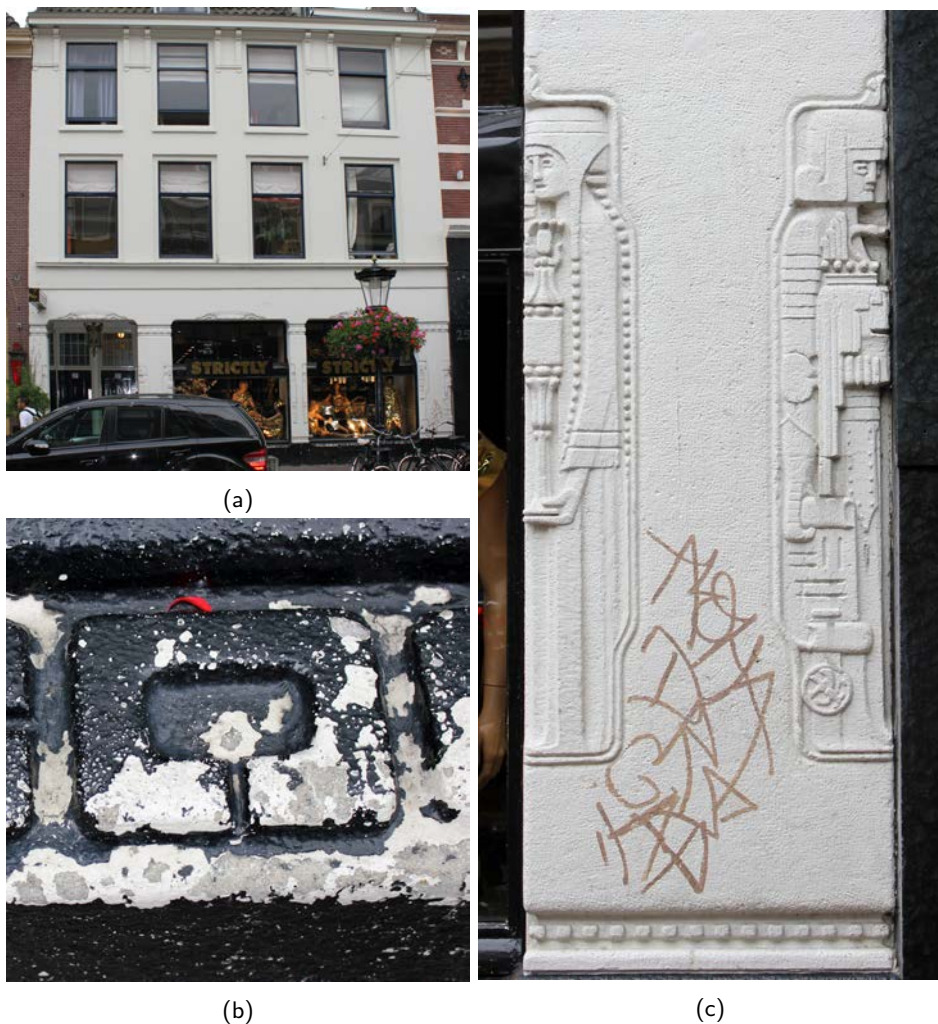
**Figure 7.62** Example of the use of a specially carved timber formwork for reliefs in concrete for the refurbishment of a shop façade (G. Rietveld, Utrecht, Oudkerkhof, 1919, situation 2011). a) Overview with the refurbished ground floor. b) Where the paint has chipped off the use of concrete can be identified. c) Detail of a column with reliefs. The surface has been tooled, and in the meanwhile painted white, easily leading to the assumption that natural stone had been used.

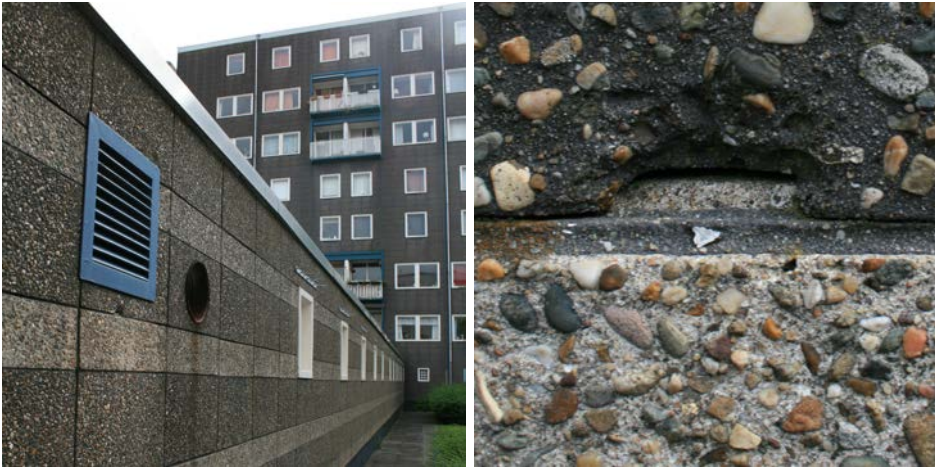
**Figure 7.63** Example of black and light coloured concrete elements (apartment buildings and garage, Slotterhof, Amsterdam, J.F. Berghoef 1958-1960, situation 2009). a) Overview rear side garage with a stripe pattern achieved by using differently coloured elements, and the dark coloured apartment building in the back. b) Detail of the joint between dark and light coloured elements, at a damaged area in the black elements it can be seen that the concrete is coloured through and through.

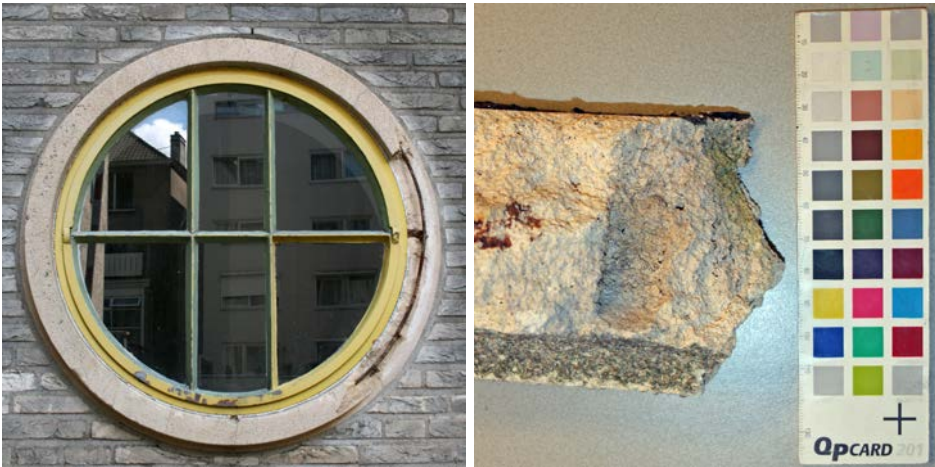
**Figure 7.64** Example of the use of white cement for a prefabricated window casing. Beside white cement, hydraulic lime, chert as fine aggregate and yellow ochre (limonite) as pigment were used (Van Rhijn, 2010) (Stationspostkantoor Arnhem, H. L. Engberts 1955-1961, situation 2010). a) Overview with local spalling. b) Spalled concrete, notice the lack of coarse aggregates and the darker colour at the surface due to soiling.

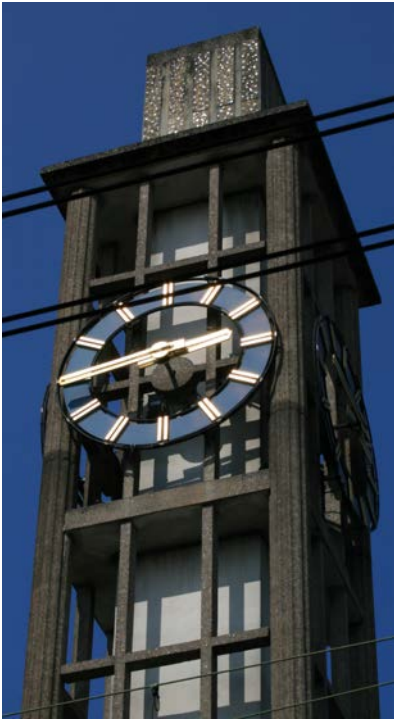
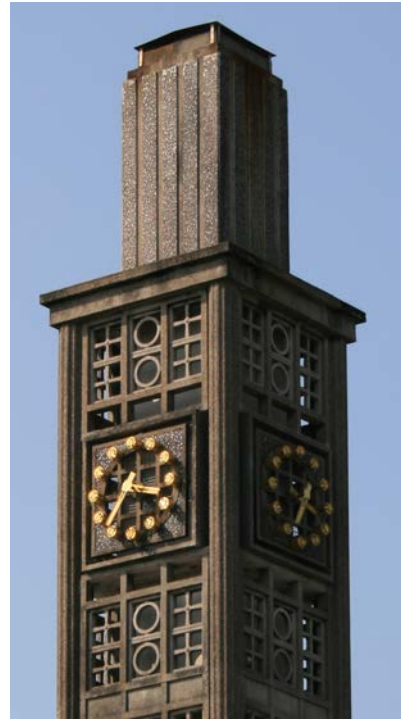
**Figure 7.67** Chimney towers of two railway stations by H. G. J. Schelling. The concrete was made with broken mirror glass and broken glass (around the clocks, and top part), reflecting the sun light. a) Railway station Enschede, 1950, situation 2009. b) Railway station Hengelo, 1952, situation 2009.

Again, the Post-War railway stations by Schelling are salient examples of exploration of the effects of special aggregates (Figures 7.67 to 7.70). Schelling carried out trials to find suitable aggregates for coloured concrete, including broken ceramic materials, glass and mirror glass (Schelling, 1950b, 1952b). Blue and yellow broken glass and mirror glass were used to create glimmering effects at the top of chimney towers (Figure 7.67); crushed bricks in yellow and red, broken blue roof tiles in combination with white cement, and an exposure of the colour by rubbing down the surface (Figure 7.44); broken stoneware was used in combination with sand blasting (Figure 7.38, Schelling, 1950b). The choice of aggregate depended on the type and the location of the element. For exterior elements in the train station Enschede, Schelling appreciated quartz and quartzite, for interior elements granite (Schelling, 1950b). Crushed flint stone with its shape and colour differences were valued as they gave the surface a vivid character (Figure 7.68, see also Schelling, 1952a, 1953). For claustra elements in the train stations Hengelo and Enschede (Figures 7.69 and 7.70), Schelling chose crushed white gravel from the Dutch town of Brunssum, which was known for its rather expensive white gravel and sand, in combination with white cement (Schelling, 1950b, 1952b, 1953).

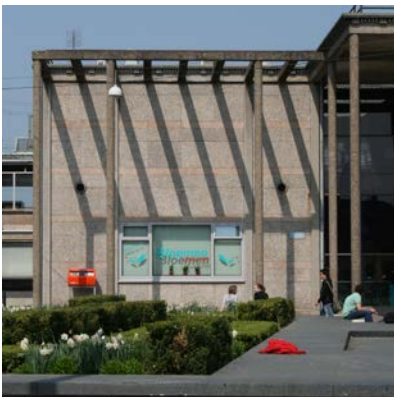
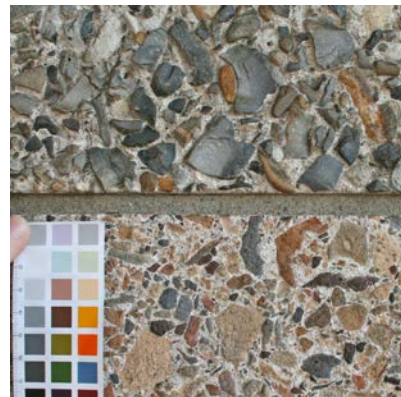
**Figure 7.68** Façade of the railway station in Zutphen made from prefabricated, sand-blasted panels with different aggregates to achieve the horizontal colour pattern (H.G.J. Schelling, 1952, situation 2009). a) Partial overview with visible reddish and grey horizontal bands. b) Detail of the façade showing the use of crushed flint stone for the darker panels (top) and broken bricks for the red panels (bottom).

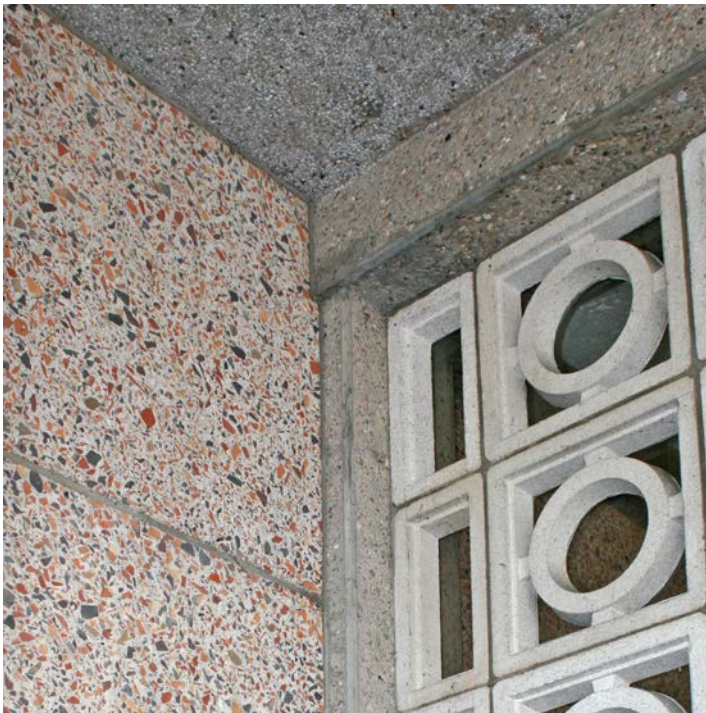
**Figure 7.70** Combination of different coloured concrete, both in-situ and prefabricated (Schelling, 1952b): columns and beams of “grey” on-site concrete made with river gravel and Portland cement; prefabricated claustra with white small (5-10 mm) gravel and white cement; panels with broken ceramic and white Portland cement; ceiling with white small (5-10 mm) gravel and Portland cement; all surfaces, except for the rubbed down panels, were sand blasted (Railway station Hengelo, H.G.J. Schelling, 1952, situation 2009).

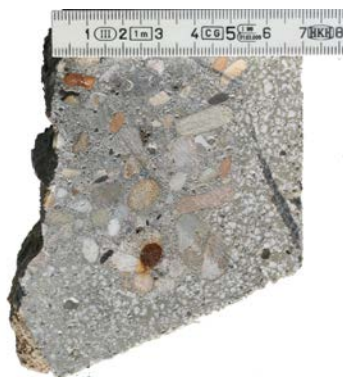
**Figure 7.72** Section through a prefabricated window sill with clearly visible ca. 2 cm thick facing layer and a reinforced backing concrete (1930s housing, The Hague).

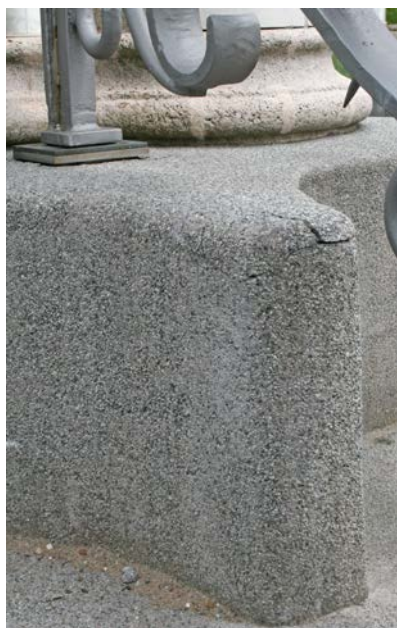
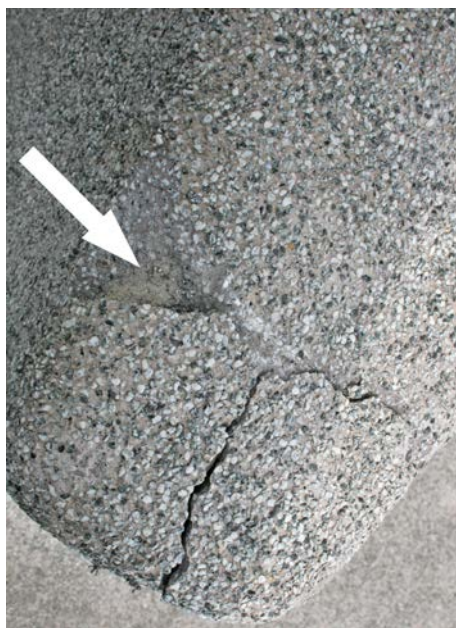
**Figure 7.73** Detail of a column base made from decorative concrete (Main entrance Blijdorp Zoo, Rotterdam, S. van Ravesteyn, 1939-1941, situation 2011). a) Overview of the column base, cracked at the top right corner. b) Detail spalled and cracked concrete, exposing the interface between facing and backing concrete (arrow).

Unambiguous is the use of facing concrete for prefabricated decorative concrete elements, especially from the 1930s on. Several examples, from fine architecture to mass housing from this period exist. The use of a facing layer can often be seen in damaged areas (Figure 7.73 to 7.76). As the use of a facing layer saves costs, it is still advised nowadays (Neville, 2008).

Common decorative concrete elements were balustrades (Figure 7.78), column bases (Figure 7.73), flower pots, claustra (Figure 7.70), façade decoration (Figure 7.79), window sills (Figure 7.35), capitals, columns, cornices, monuments, pergola, plinths, and tiles (Anon., 1934; Bond van Fabrikanten van Betonwaren in Nederland, 1957). Besides mass produced decorative concrete elements, customised decorative concrete elements were produced (Figure 7.80). Many large scale post-war buildings made with prefabricated coloured concrete elements were made by Artistone (Figure 7.81 and 7.82). Differences can be seen in the way the decorative concrete was artistically approached; one option was to combine individual concrete elements, and textural and colour differences were per element, as the works of Schelling show. A different approach was to use an entire façade as a canvas on which an artist would “paint in concrete”; the prefabricated panel sizes would not necessarily correspond with the drawing and multiple colours would be used on one panel. Examples are the former *stationspostkantoor* in Rotterdam (Figure 7.82) and the former Grotius lyceum in The Hague (Figure 7.15).

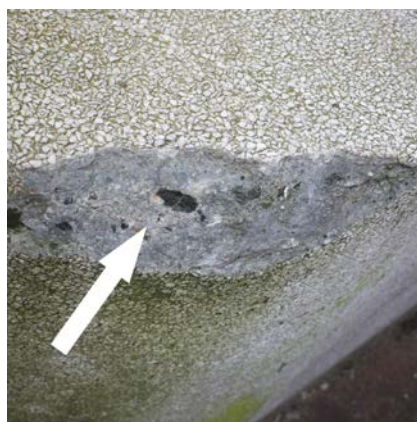
**Figure 7.75** Decorative concrete element, due to damage of the facing layer and backing layer are visible; the facing layer was made with one type of small crushed stone; notice their greyer colour at the fractured surface (social housing, Rotterdam, M. J. Granpré Molière P. Verhagen, 1935, situation 2010).

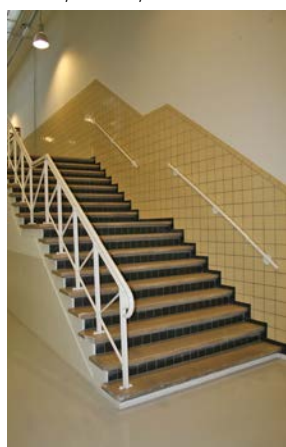
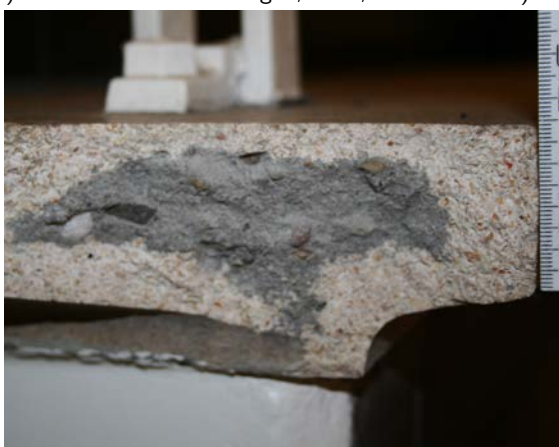
**Figure 7.76** Stair case made with prefabricated steps (Caballero factory, The Hague, 1953, F.A.W. van der Togt, situation 2009). a) Overview. b) The use of a facing concrete is visible at a damaged corner.

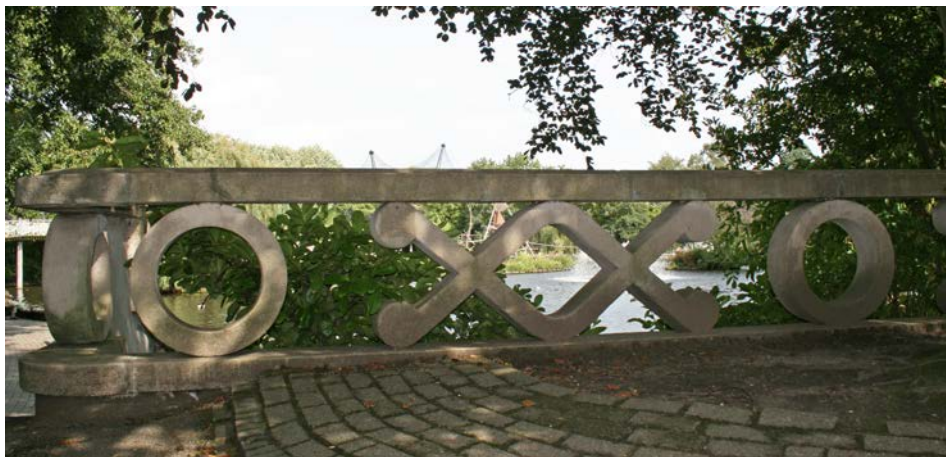
**Figure 7.78** Decorative concrete balustrades (Zoo Blijdorp, Rotterdam 1939-1941, situation 2010).

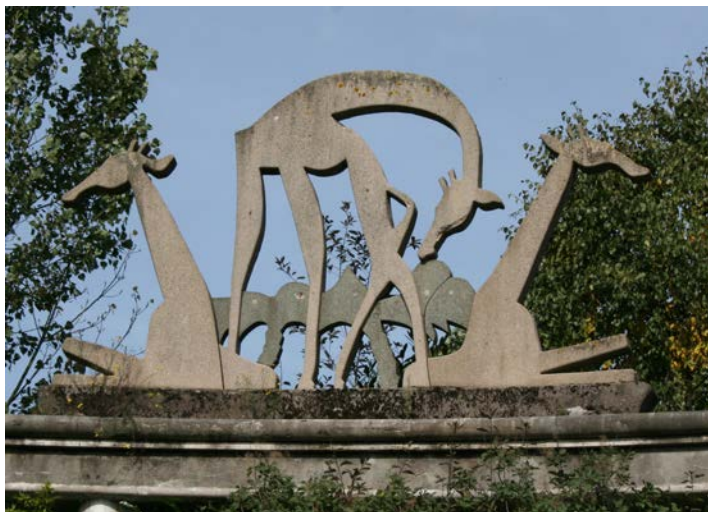
**Figure 7.80** Example of a sculpture in decorative concrete, combining red and green concrete (former Giraffe compound, Zoo Blijdorp, Rotterdam, S. van Ravesteyn, 1939-1941, situation 2010).

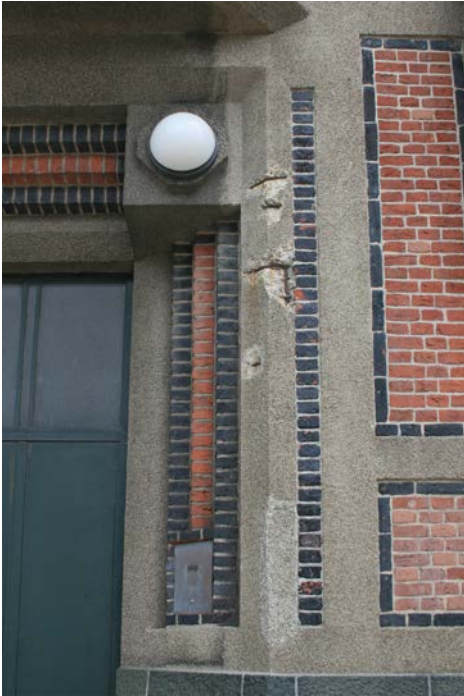
**Figure 8.3** Example of a modified surface: the original surface was sand blasted, but has been covered with a render with pebbles, and with local later repairs and spalling (office building *De Nederlanden van 1845*, The Hague, H.P. Berlage; 1921 -27, situation 2009).

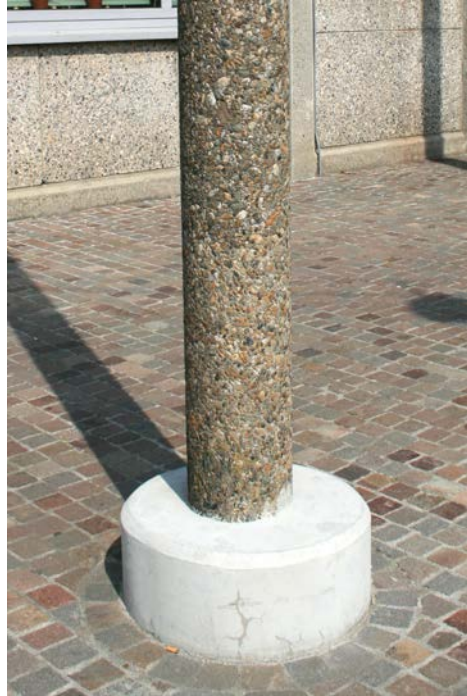
**Figure 8.4** Example of an intervention: the column was made with consciously chosen constituents; the aggregates are exposed to modify the texture and colour, resulting in a brownish multi-coloured appearance, whereas the intervention (footing) is light grey and smooth (railway station Zutphen, 1952, H.G.J. Schelling, situation 2009).

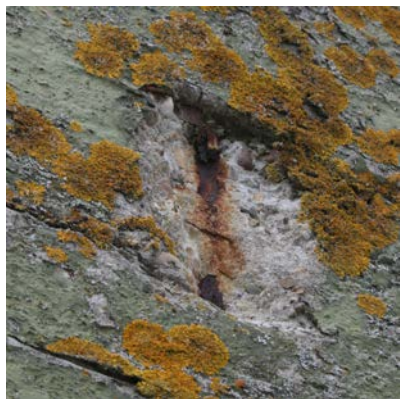
**Figure 8.8** Biological growth on concrete surface, spalled concrete and corrosion (casement V, Defence line Kornwerderzand, 1933, situation 2009).

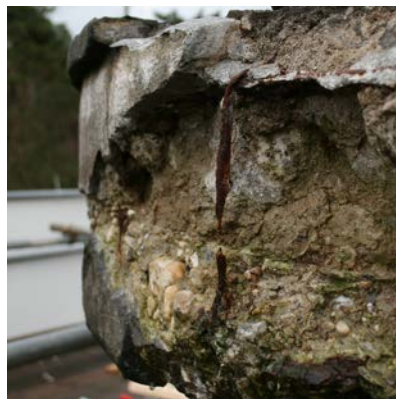
**Figure 8.9** Loss of entire cross section of a reinforcement bar and parts of the concrete bulk (Dresselhuys pavilion, Hilversum, J. Duiker, B. Bijvoet and J. G. Wiebenga, 1928, situation 2008).

When the mutual relationship between heritage values and the historic concrete is known (see Section 8.3), it can then be reviewed whether the encountered damage and damage symptoms are related to the heritage values. In Table 8.3, an overview is given of different degradation symptoms/alterations which either affect the surface, the bulk or the reinforcement of the concrete. For example, most degradation symptoms affect the surface of the concrete, due to cracking, spalling, staining or leaching (see Figures 8.7 to 8.11). Therefore, any damage mechanism leading to these symptoms is a potential threat to heritage values related to the surface. Yet not only can the surface be affected but also the concrete bulk (e.g. aggregates, binder, original mix design) or the reinforcement (Figure 8.9).

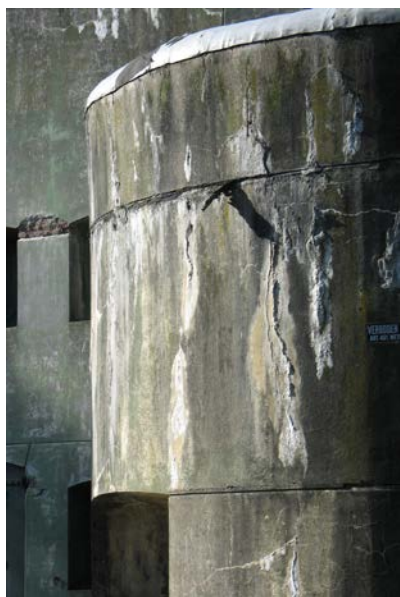
**Figure 8.10** Deposits caused by leaching and cracking (Fort near Hoofddorp, 1904, situation 2006).

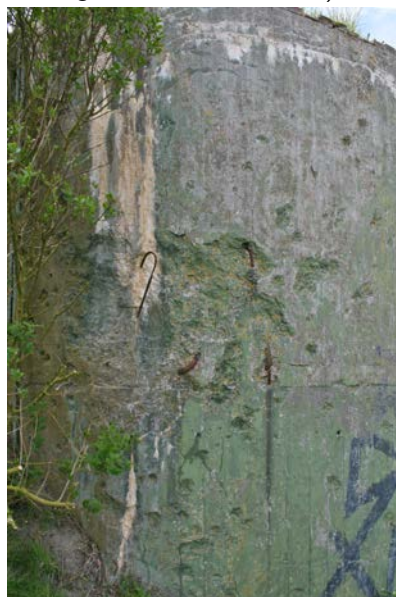
**Figure 8.11** Damage caused by impact of shells during the Second World War (kanonkazemat VI, 1932, Defence line Kornwerderzand, situation 2009).

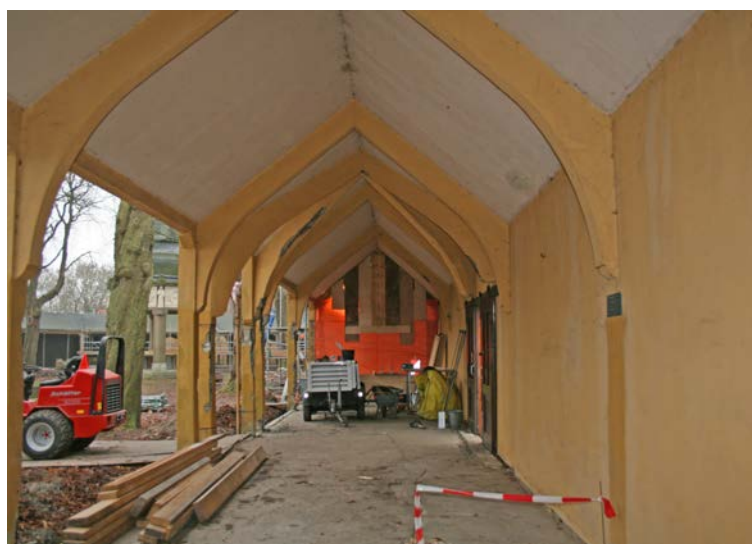
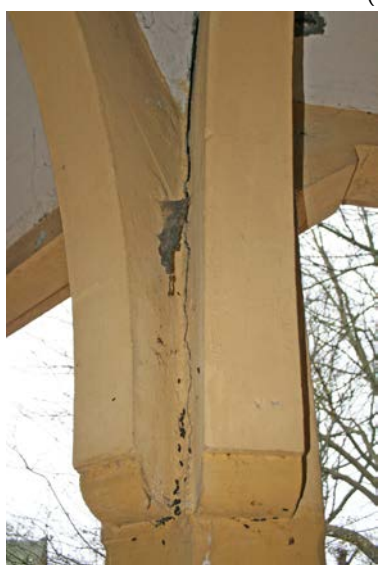
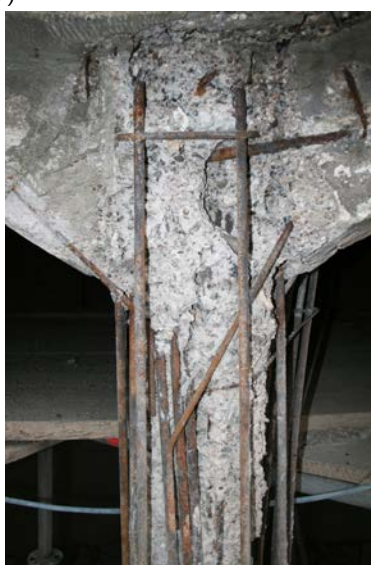
**Figure 8.12** Example of an early reinforced concrete structure based on a timber design and relating degradation due to the geometry of the design and quantity of reinforcement (circumambulation passageway of the Pilgrimage church in Brielle, H. Goossens (reconstruction), E.J. Margy, 1912 situation 2010). a) Overview of passage way. b) Detail of a corner at the intersection between two rafters and column. c) Exposed reinforcement after hydrodemolition, showing a high concentration of reinforcement bars.

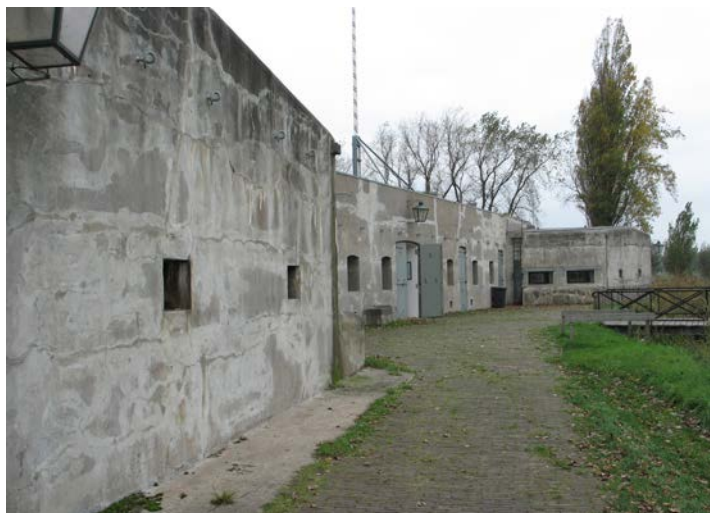
**Figure 8.14** Overview gorge façade Fort Bezuiden Spaarndam (1897-1901, situation 2006).

Fort Bezuiden Spaarndam (1897-1901, Figure 8.13 and Figure 8.14, see also Section 1.3.2), a plain concrete structure, is one of the earlier concrete forts of the Stelling van Amsterdam (Heinemann et al., 2008, 2011). The Stelling van Amsterdam was inscribed in 1996 as a UNESCO World Heritage Site, amongst other aspects, for its significance in the development of concrete technology. It is evaluated as “*an outstanding example of a type of building, architectural or technological ensemble [...] which illustrates (a) significant stage(s) in human history*”. The justification was that “*in the Europe of the 19<sup>th</sup> century, the Stelling van Amsterdam was considered a leading example of a ring of forts. [...] The forts illustrate the transition in building and architecture from brick construction in the 19<sup>th</sup> century to applying reinforced concrete in the 20<sup>th</sup> century. This transition especially, with its experiments in concrete and emphasis on applying unreinforced concrete, is an episode in the European history of architecture which in the material sense has only rarely been preserved*” (UNESCO, sa). It is considered authentic in material and substance as “*the works were built with exceptional care. They have been preserved as they were designed and specified. The materials and building constructions used have also remained unchanged. Repair in arrears applies in some cases. No parts of the Stelling have been reconstructed.*”(i); Each individual and combined part of the structure of the Stelling van Amsterdam is a significant social, cultural-historical and scientific source of historic material [...] Its outstanding universal value is expressed in the authenticity of the design (the typology of forts, sluices, batteries, line ramparts), of the specific use of building materials (brick, unreinforced concrete, reinforced concrete), of the workmanship (meticulous construction apparent in its constructional condition and flawlessness), and of the structure in its setting [...]” (UNESCO, sa).

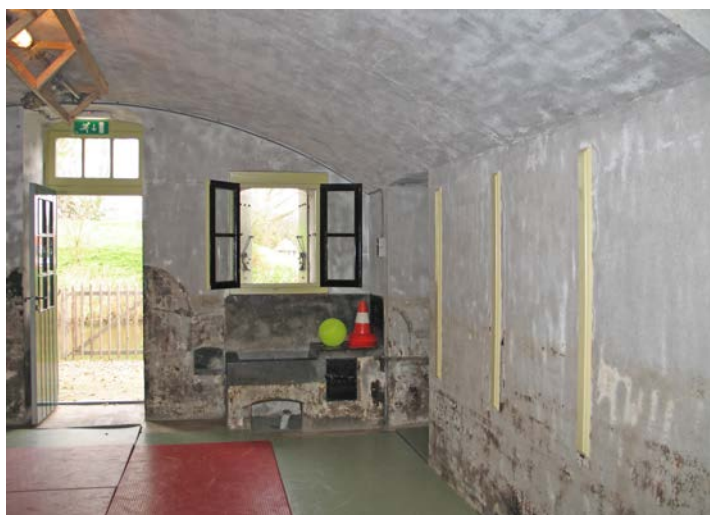
**Figure 8.15** Interior of Fort Bezuiden Spaarndam with visible wooden boards cast into the concrete wall for the later attachment of interior elements (situation 2006).
