# HISTORIC CONCRETE

FROM CONCRETE REPAIR TO  
CONCRETE CONSERVATION

PROEFSCHRIFT

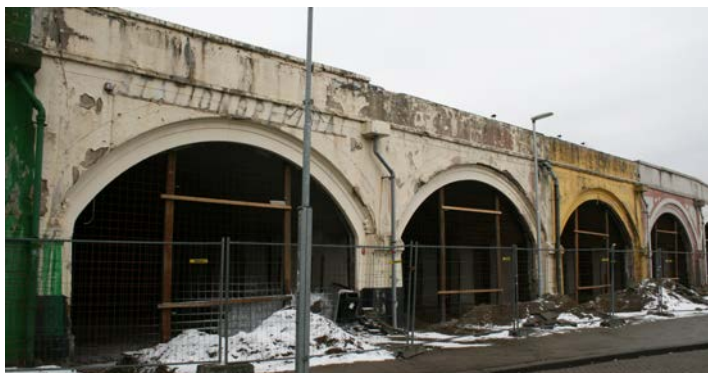
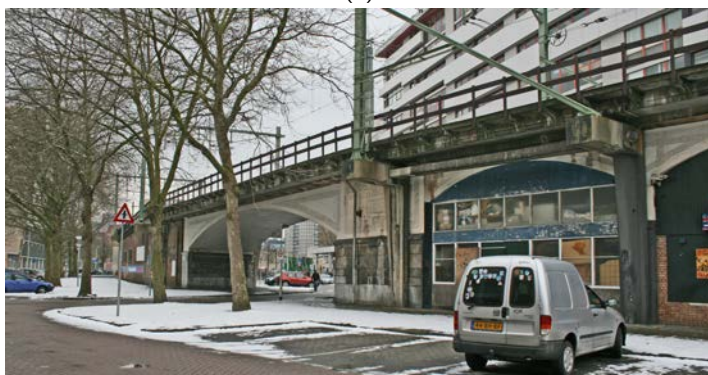
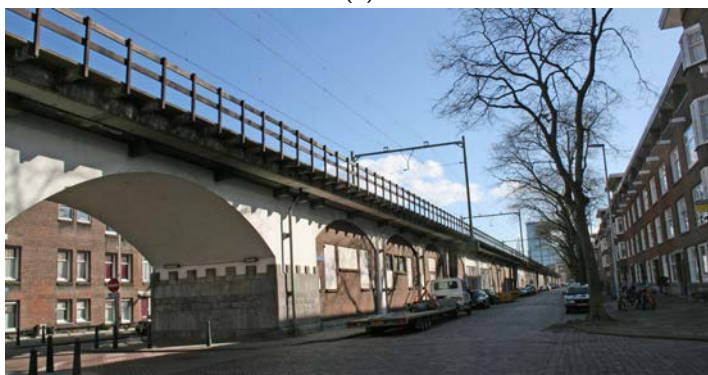
**Figure 8.16** Three different construction phases of the Hofplein railway viaduct (situation 2010) a) Emplacement with vault structure and use of round reinforcement bar (1904). b) Use of a rigid reinforcement system made from profiles (1904); clearly visible are the additions from the 1950s with columns and extension of the width. c) Last phase finished in 1908 and made with round, plain reinforcement bars.

The historic concrete of the Hofplein railway viaduct in Rotterdam (1900-1908, Figure 8.16) reflects many heritage values related to scientific significance and early reinforced concrete technology in the Netherlands. In Part I *Understanding and Characterisation of Historic Concrete*, the viaduct has been mentioned several times for its role in the development of reinforced concrete theories and concrete industry in the Netherlands. Especially, the diversity and evolution of the reinforcement are noticeable and the reaching of independency of proprietary reinforcement systems (see Section 6.2 *Application and history of reinforced concrete*). The surface finish of the concrete with a *kunstzandsteenpleister* (“artificial sandstone render”) and tooling represents the construction period and typology very well (Figures 7.25 and 7.26).

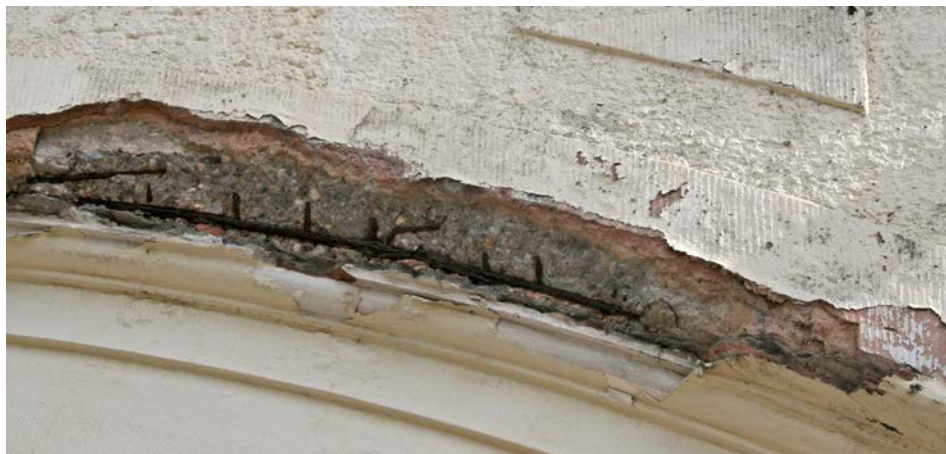
**Figure 8.17** Example of local damage of render and concrete, exposing the reinforcement, in this case round bars and round stirrups (Hofplein railway viaduct, situation 2009).

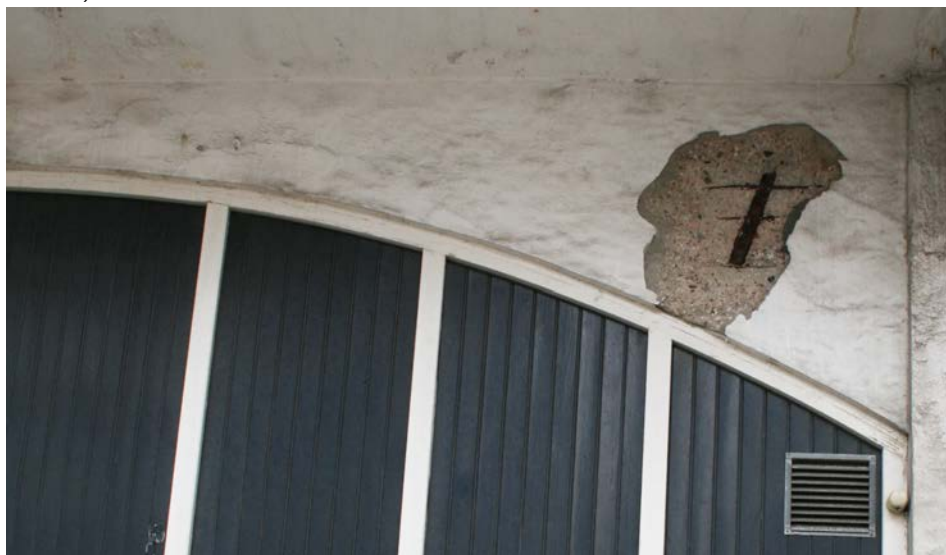
**Figure 8.18** Example of an arch without the original surface. Instead a smooth, grey render was applied and painted white. The original reinforcement is visible due to local damage, notice the rectangular strips and horizontal plain round bars (Hofplein railway viaduct 1900-1908, situation 2012, compare also Figure 6.22).

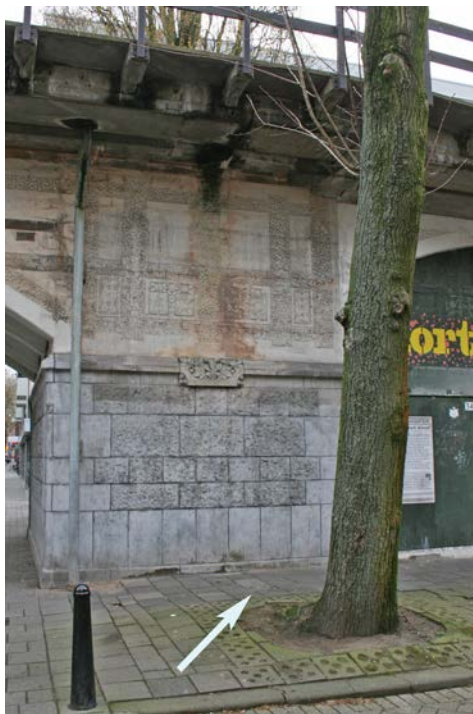
**Figure 8.19** Location of the *brandgrens* (fire border) of the fire May, 1940 during the Second World War (Hofplein railway viaduct 1900-1908, situation 2012). The arrow indicates a lamp in the ground, which is part of a memorial, outlining the *brandgrens*. The render is discoloured in this area due to the fire, locally visible under the paint. Notice the biological growth caused by seepage through the roof.

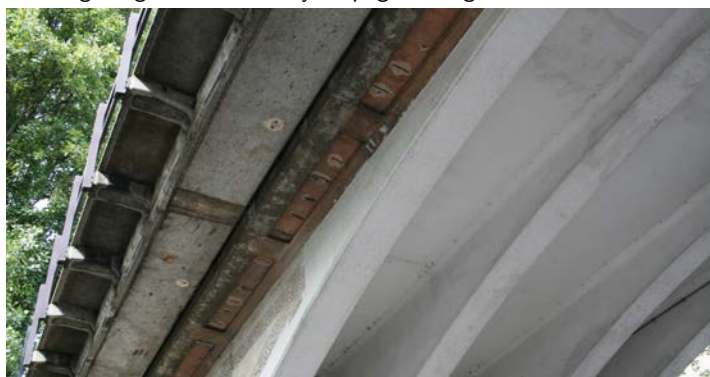
**Figure 8.20** Example of different interventions and resulting surface finish: the soffit shows a grey concrete from 1950s extension, next to it an original reddish stripe of render with locally exposed reinforcement and the white painted intrados with local repairs without texture (Hofplein railway viaduct 1900-1908, situation 2012).

The surface finish of the concrete is representative for the construction period for infrastructure in an urban environment. The use of ground sandstone to modify the colour of the render corresponds with the period (see Section 7.5.2 *Coloured aggregates*), as does the imitation of natural stone tooling in the render. Historic events such as the fire during the bombardment of Rotterdam in the Second World War in May 1940 can be seen in the discoloration of the aggregates in both concrete (see Figure 4.16) and render (see Figure 7.26) of the vaults of the emplacement. The border of the fire can be traced back in the monument and corresponds with a light installation in memory of the fire (Figure 8.19). During the last century, the viaduct underwent several changes, either to adapt the function, improve the design or alter the appearance. Especially the appearance has been altered by painting the surface white (and other colours) and by local repairs without adapting to the texture or colour to the original surface (Figures 8.20 and 8.21).

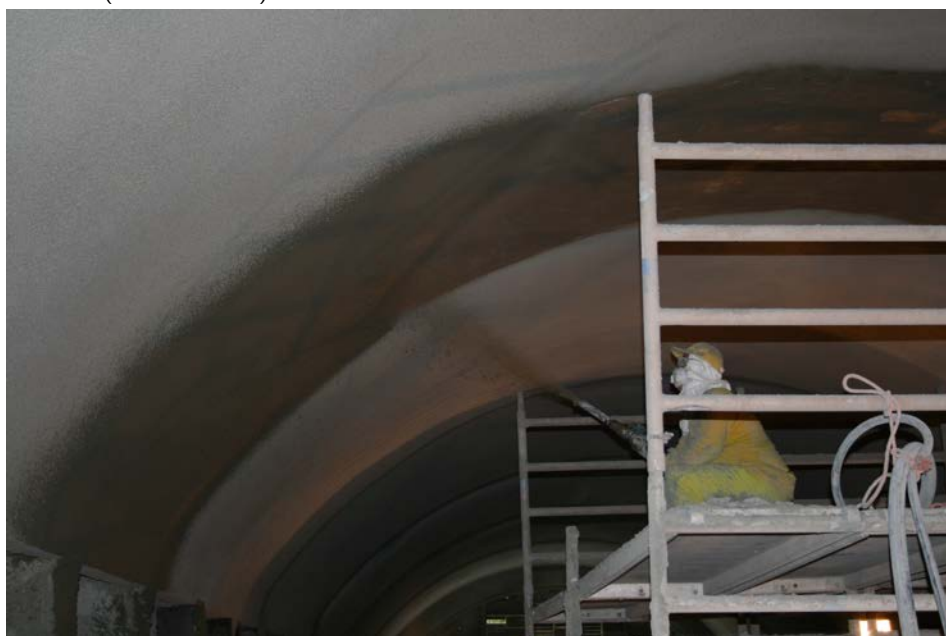
**Figure 8.22** Application of sprayed concrete in the vaults of the emplacement, this technique was chosen due to the size of the intervention and the costs (Hofplein railway viaduct 1900-1908, situation 2009).

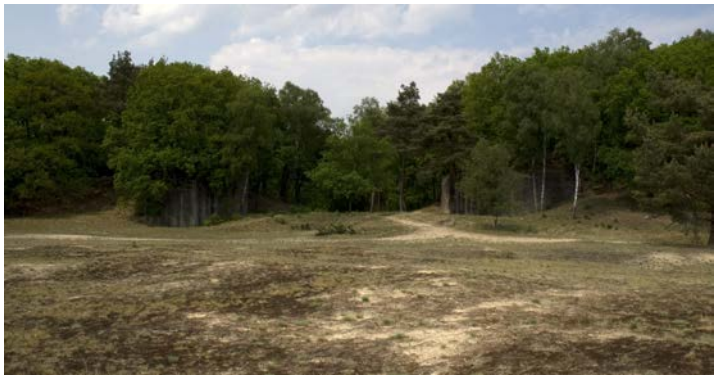
**Figure 8.23** Overview of the earth retaining walls of the sculpture yard (Groot Museum, Natural park Hoge Veluwe. H. van de Velde, 1922, situation 2008).

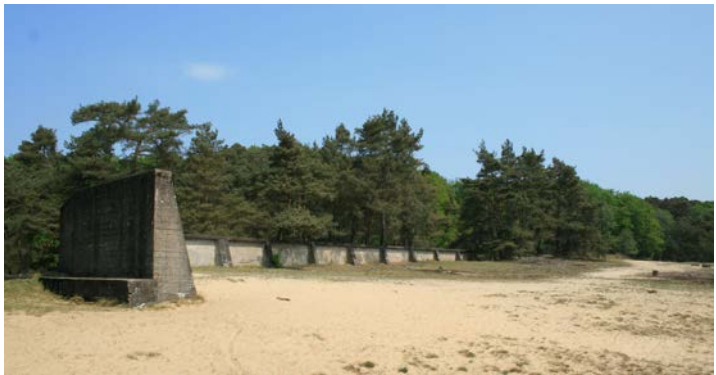
**Figure 8.24** Overview of the walls of the terrace, which were initially intend to be earth retaining (Groot Museum, Natural park Hoge Veluwe. H. van de Velde, 1922, situation 2008).

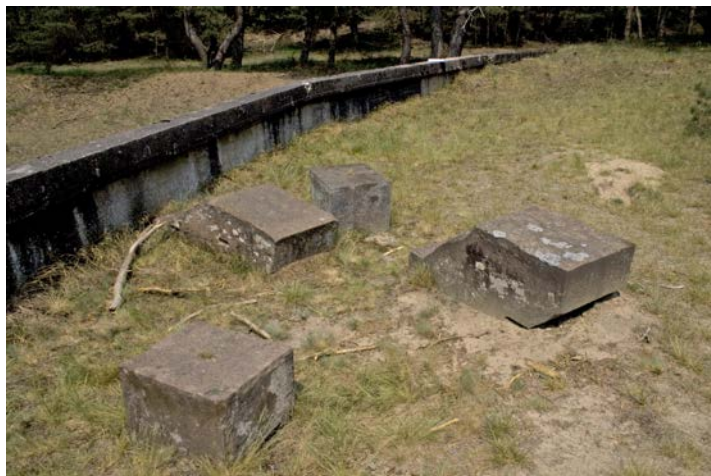
**Figure 8.26** Examples of dispersed blocks of Maulbronn sandstone spread near the walls of the terrace (Groot Museum, Natural park Hoge Veluwe. H. van de Velde, 1922, situation 2008).

The earth retaining walls, made from reinforced concrete, and some dispersed blocks of Maulbronn sandstone, once intended to clad the walls, are the only existing remains on-site of the Groot Museum for the art collectors Kröller - Müller in the national park Hoge Veluwe, designed by H. van de Velde (1863 - 1957, see Figures 8.23 to 8.27). The construction of the museum started June 20, 1921; works ceased May 7, 1922 due to price inflation. Van de Velde continued designing the museum until 1929, but the museum was never finished. Instead, a smaller museum was built nearby in the national park (Sembach, Schulte & Breuer, 1992). The earth retaining walls were left unfinished and traces of the workmanship can still be encountered unaltered on-site (Figures 8.26 to 8.28).

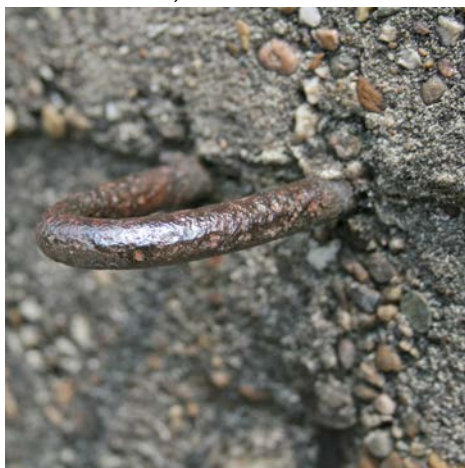
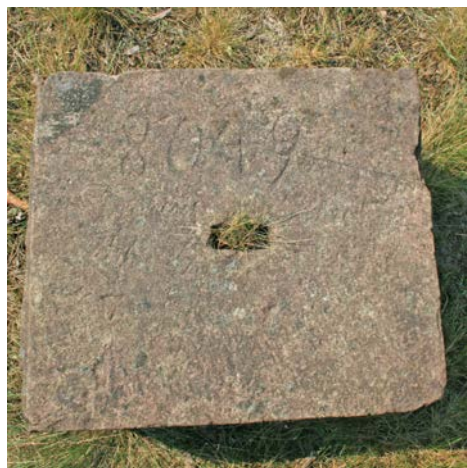
**Figure 8.27** Details of the construction to place the natural stone blocks (Groot Museum, Natural park Hoge Veluwe. H. van de Velde, 1922, situation 2008). a) Hook cast in the concrete to place a block. b) Rear side of a block showing the opening to insert the hook.

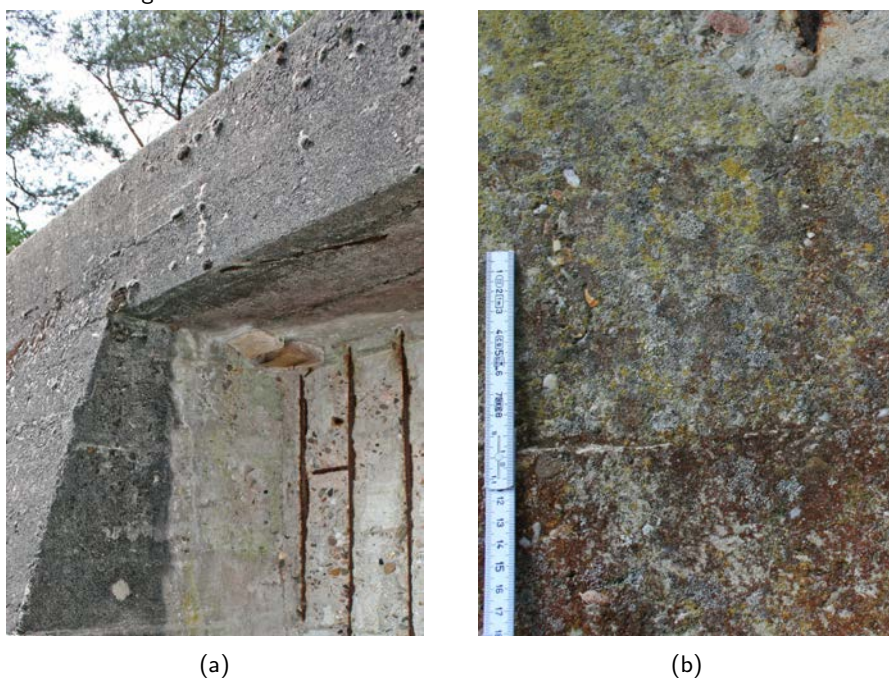
**Figure 8.29** Signs of merging with the landscape and local degradation (Groot Museum, Natural park Hoge Veluwe. H. van de Velde, 1922, situation 2008). a) Colour variation of the concrete caused by biological growth, and local spalling of the concrete; notice the remains of the original formwork in the corner. b) Colour variation of the concrete caused by biological growth.

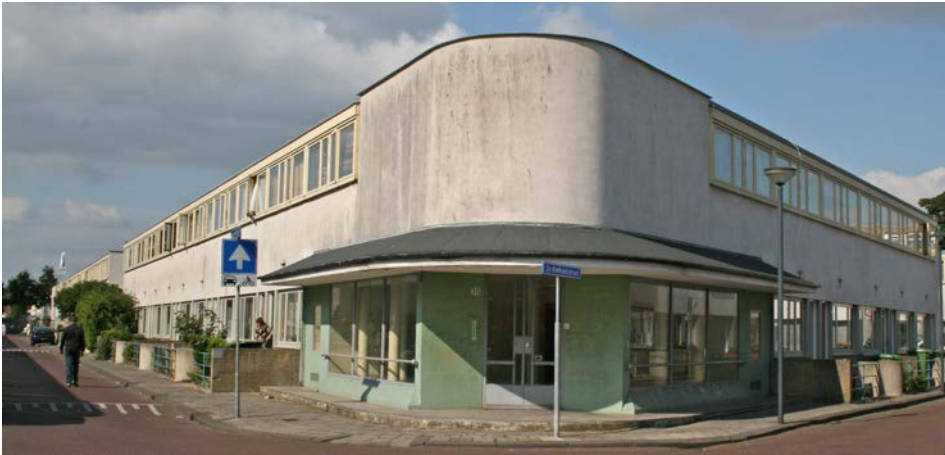
**Figure 9.1** Example of the reconstruction of an entire housing project, (Kiefhoek, Rotterdam, J.P.P. Oud, 1928-1930, demolition and reconstruction 1990-1995, situation 2009).

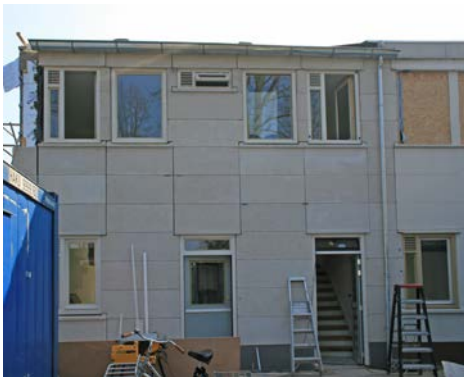
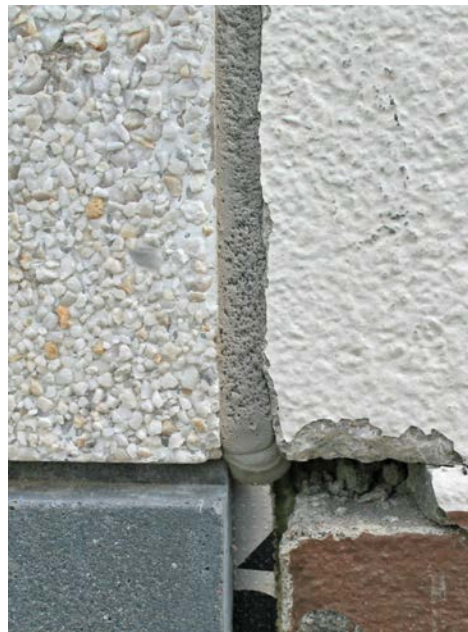
**Figure 9.2** Reconstruction of façade panels, the house adjacent to the right still has the original panels, although painted white (Housing *Jeruzalam Frankendaal*, Amsterdam, B. Merkelbach, Ch. J. F. Karsten, P. J. Elling 1947-1949, situation 2011). a) Overview. b) Close-up of new (left) and original (right) façade panels. As the original panels are painted, the colour cannot be compared, however differences in aggregate size can be noticed.

In general, preservation is often considered to be the ideal option and reconstruction the least desired. In practice, differences in acceptance can be noticed, depending whether an entire building is reconstructed (Figure 9.1), which is often widely discussed, and replacement of building elements (Figure 9.2), which is less noticed in public and academia.

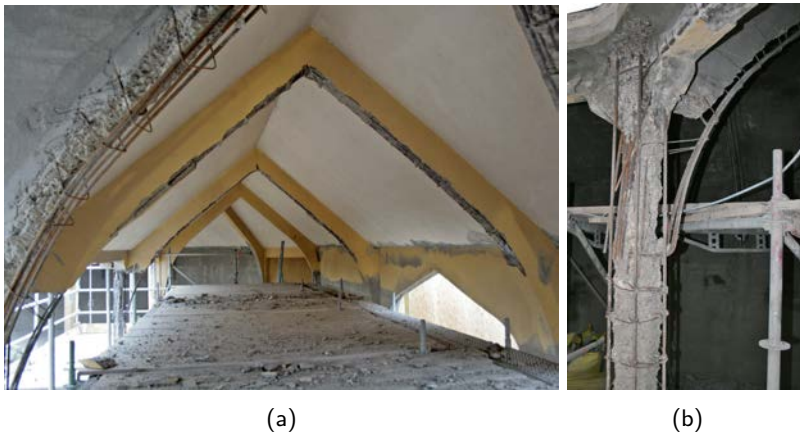
**Figure 9.6** Large scale concrete removal with hydrodemolition (circumambulation passageway of the Pilgrimage church in Brielle, H. Goossens (reconstruction), E.J. Margy, 1912, situation 2010). a) Overview of concrete rafters, partial concrete removal. b) Column after removal of the entire original surface and most of the original concrete, exposing the reinforcement.

Large-scale removal of cracked and carbonated historic concrete is not uncommon for conservation (Figure 9.5 and Figure 9.6), especially when decisions are mainly based on technical aspects and the possible heritage values of the historic concretes not understood. In case of patch repair of exposed concrete, the edges of damaged areas might have to be modified, either to disguise the joint between

loss when applying conventional repair techniques, whilst considering the conservation aim and the ascribed heritage values to the materials. However, advantage can be taken of situations where the reinforcement is once exposed during large-scale interventions (see for example Figure 9.6). It might be considered whether installing preventively conductivity of the reinforcement might be beneficial, depending on the value of the historic reinforcement and the remaining corrosion risk after repair, and thereby facilitate the future application of electrochemical repair techniques.

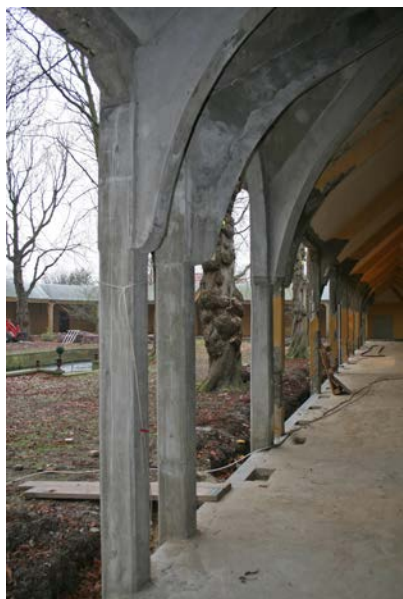
**Figure 9.7** Trial repair of three columns to test the workability (sprayed and poured polymer modified repair mortar) and quality of the surface finish (circumambulation passageway of the Pilgrimage church in Brielle, H. Goossens (reconstruction), E.J. Margy, 1912, situation 2010).

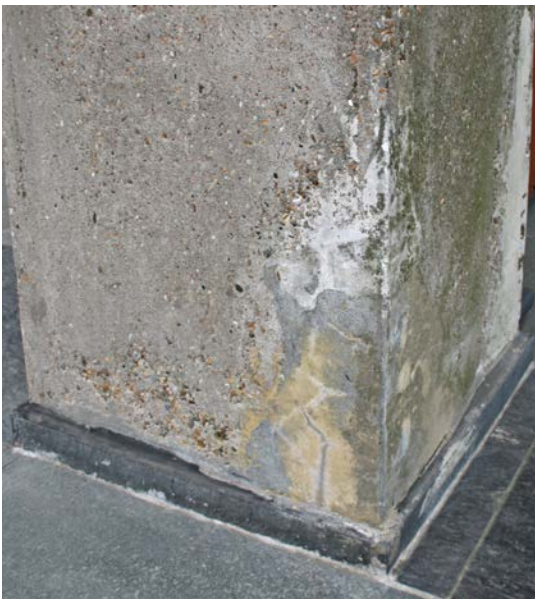
**Figure 9.8** Column of an exposed concrete repaired with a polymer-based patch repair, showing discoloration due to ageing (Faculty of Architecture, TU Delft, architectural firm van de Broek & Bakema, 1960-1970, building burnt 13.05.2008, situation 2007).

**Polymer-modified repair mortars** are based on a cementitious binder such as Portland cement to which 10 – 20% by mass of polymers are added. The permeability can be reduced, the corrosion protection and bond strength increased, yet these mortars are considered to be harder to place and to finish. When as polymer epoxies are used, the colour can change when exposed to UV-light as shown in Figure 9.8 (ACI Committee 546, 2006, CUR recommendation 55, 1997c).

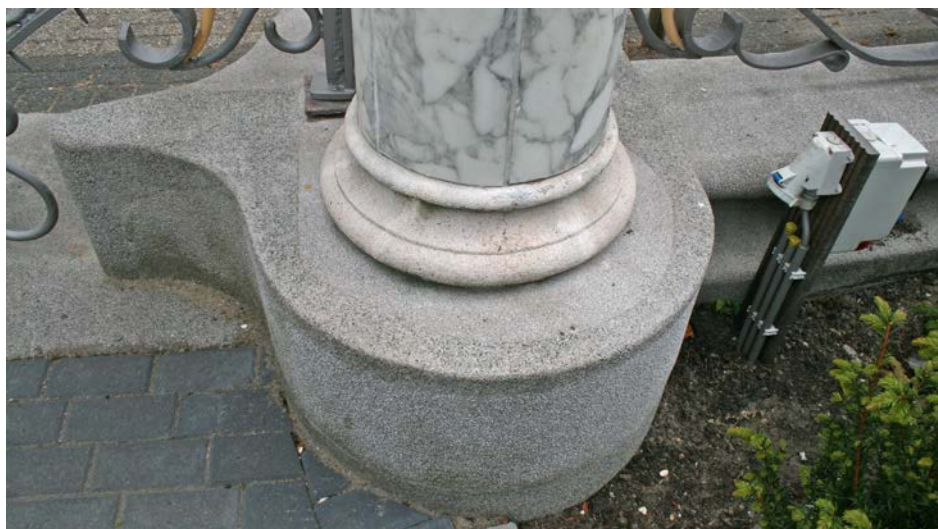
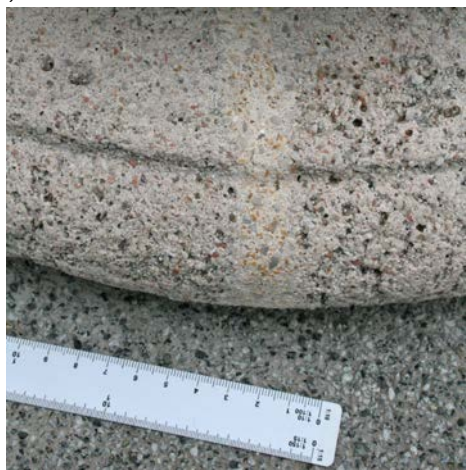
**Figure 9.9** Column foot made from decorative concrete with local repairs (Main entrance Zoo Blijddorp, Rotterdam, S. van Ravesteyn, 1939-1941). a) Overview column foot, the lighter coloured repair areas stands out from a distance. b) Close-up of column foot showing the use of a more reddish mortar with slightly larger aggregates for the repair than the original, more beige coloured mortar. c) Detail of the base of the column with a too beige repair.

Repair mortars can be adapted in colour and texture to the parent concrete. The adaptation of mortars to the original concrete and a reconstruction of the original surface is one of the few aspects more commonly discussed for the conservation, and for the repair of architectural, exposed concrete surfaces. Yet in practice, a close match to the parent concrete is not always achieved (Figures 9.9 to 9.11), and mismatching repairs are still frequently encountered (Figures 9.12 and 9.13).

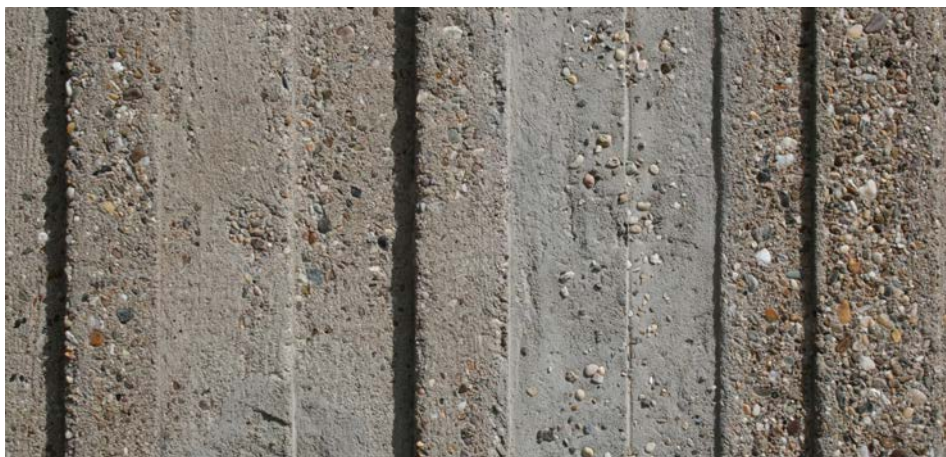
**Figure 9.11** Repair of an exposed concrete surface made with blast furnace slag cement and gravel, originally with a wood grain structure. Although several try-outs were made, locally the patch repair can still be distinguished due to the lighter colour and irregularly pressed-in aggregates. The wood grain texture was not reconstructed (Pumping station Parksluizen, Rotterdam; G. J. van der Grinten, 1967, situation 2010).

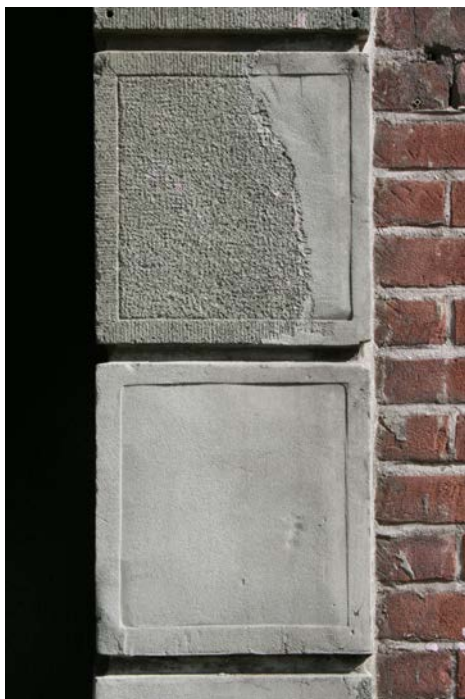
**Figure 9.12** Concrete made with diabase as aggregate and bush hammered surface with chiselled margins which was repaired with a grey, smooth repair mortar (housing, 1930s, exact date and architect unknown, Rotterdam, situation 2011).

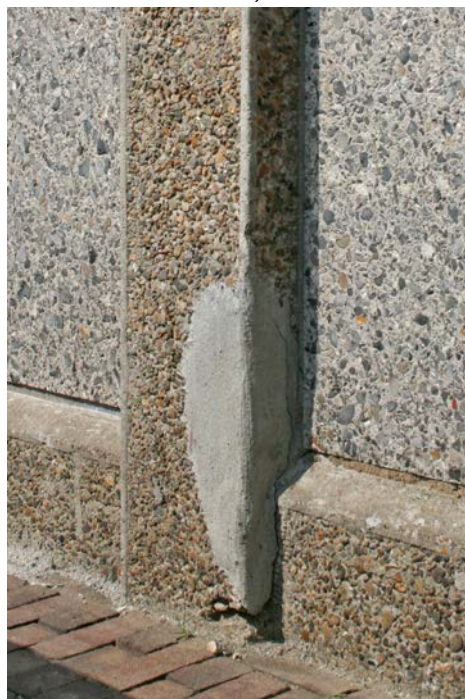
**Figure 9.13** Column with exposed aggregate surface finish and standard grey patch repair (Train station Zutphen, H.G.J. Schelling, 1952, situation 2009).

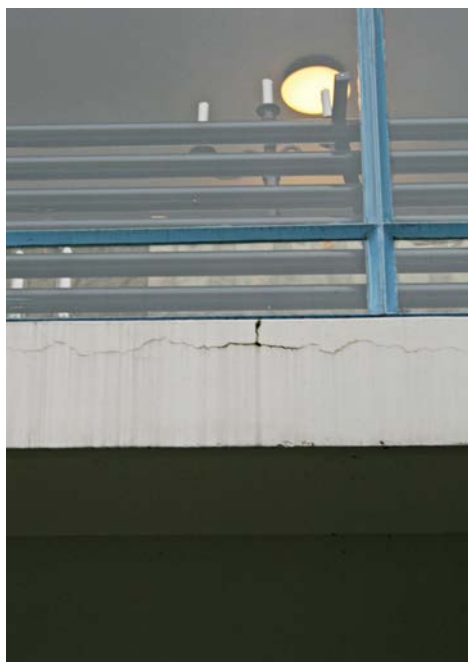
**Figure 9.16** Detail of a corner of a concrete slab, the repair mortar has cracked in less than 6 years after repair and is visible due to soiling (Sanatorium Zonnestraal, Hilversum, J. Duiker, B. Bijvoet and J. G. Wiebenga, 1928, restoration began in 2001, situation 2007).

**The durability** of repairs is strongly influenced by the understanding and elimination of the cause of damage, the workmanship and the composition of the repair mortar in relation with the parent concrete. Poorly designed or executed repair mortars might only last a few years (Figures 9.16 and 9.17), whereas during the CONREPNET project repairs lasting 20 to 50 years were observed as well (Tilly & Jacobs, 2007, 2011). The failure of a repair can lead to delamination and cracking of the mortar, corrosion of the reinforcing steel, loss of load carrying capacity and a poor appearance.

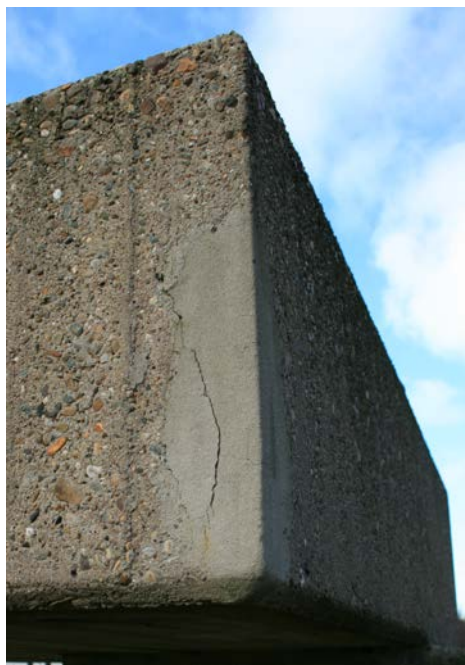
**Figure 9.17** Corner of an exposed concrete sculpture showing a cracked repair mortar with rust stains, indicating ongoing corrosion (sculpture by C. Visser, TU Delft, 1966, situation 2006).

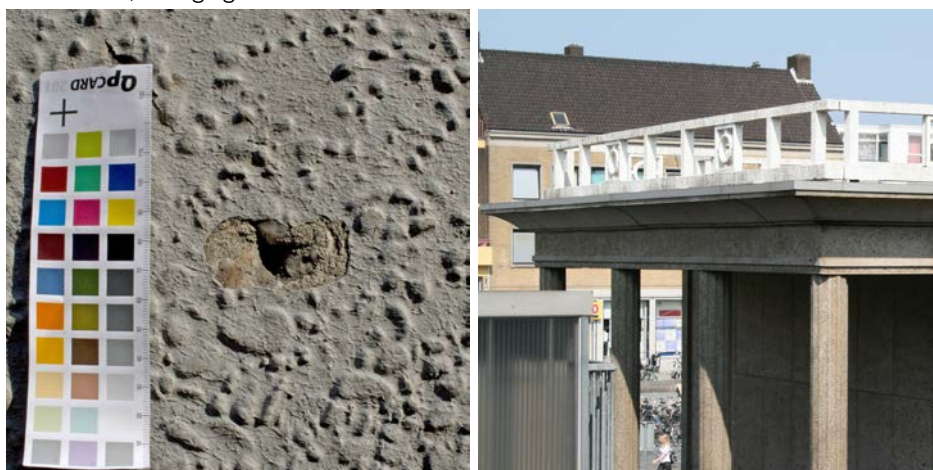
**Figure 9.20** Example of a grey painted, previously exposed, concrete surface; the original more brownish colour and colour variations due to visible aggregates cannot be experienced anymore (Olympic stadium, Amsterdam, J. Wils, 1928, situation 2008).

The direct impact of surface treatments mainly affects the appearance of the concrete, especially colour, texture and gloss of the surface as well as the visibility of concrete constituents (see Figures 9.19 to 9.22). The appearance of coatings can be modified, pigments can be added, and different shades of “concrete grey” are available. However, the appearance of the treated concrete becomes more uniform than the original concrete and small colour nuances due to visible aggregates or weathering will disappear.

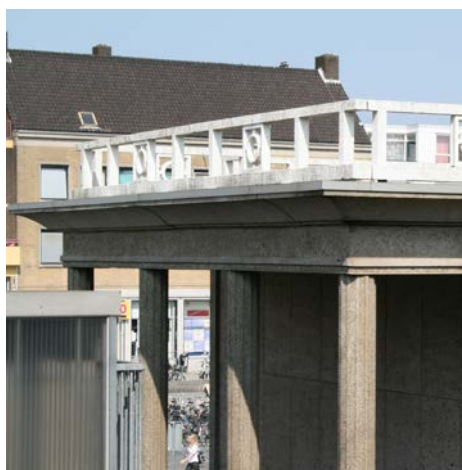
**Figure 9.21** Example of the colour change caused by surface treatments: the original composition of the prefabricated balustrades is white Portland cement with Rhine gravel, claustra in the middle of the balustrade made with white gravel and sand blasted (Schelling, 1952b); the architect explicitly rejected painting of concrete (Train station Hengelo, H.G.J. Schelling, 1952, situation 2009).

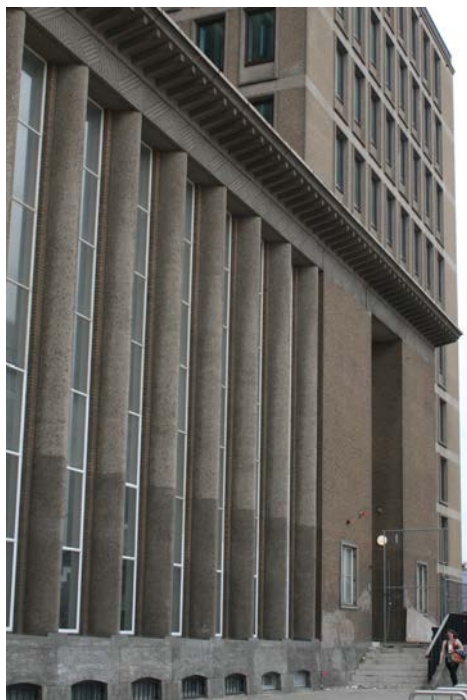
**Figure 9.22** Example of the visual impact of anti-graffiti coatings: the lower zone of the façade was treated and is clearly distinguishable from the untreated upper zone (Former tax office, Amsterdam, G. Friedhoff and M. Bolten, 1954–1958, situation 2011).

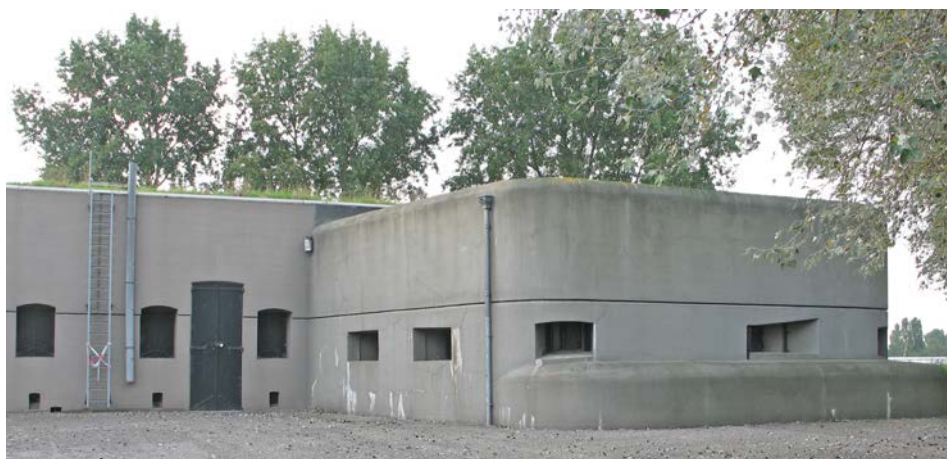
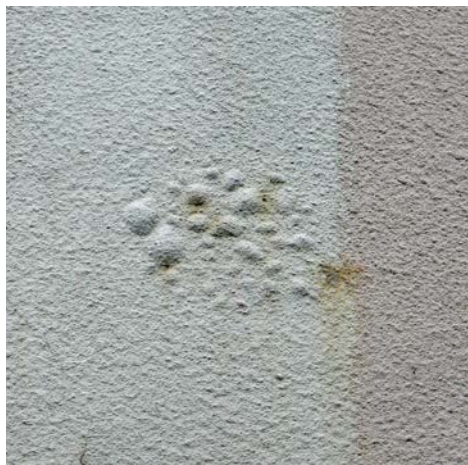
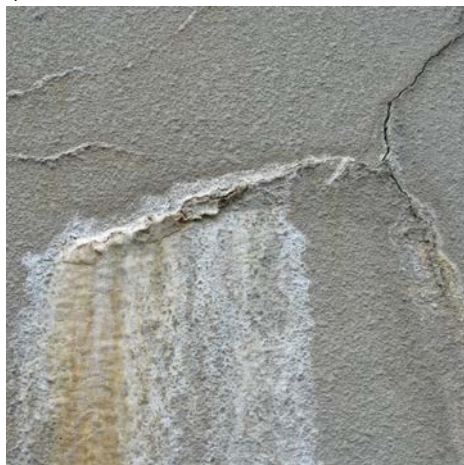
**Figure 9.24** Example of a failure of a coating due to the presence of moisture on a plain concrete fort (Fort near Aalsmeer, 1904, repair 1996, situation 2006). a) Overview b) Blistering of coating. c) Cracked coating with deposits indicating seepage.

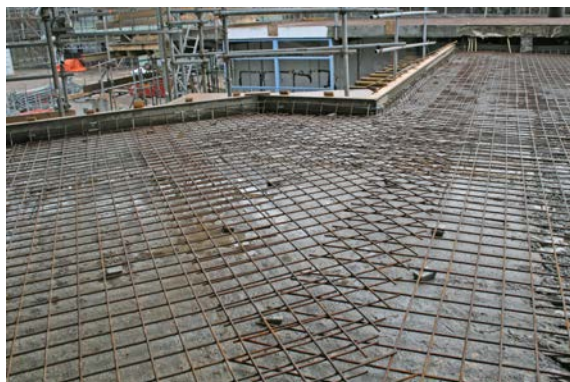
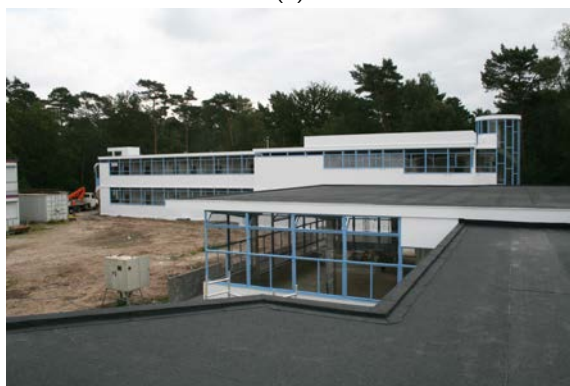
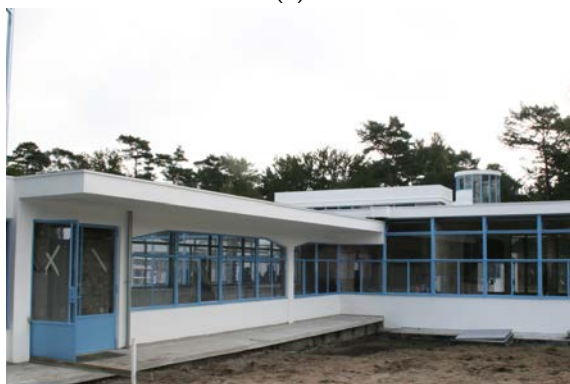
**Figure 9.26** Example of external strengthening with an additional reinforced concrete layer on an existing roof slab (Dresselhuys pavilion, Hilversum, J. Duiker, B. Bijvoet and J. G. Wiebenga, 1928, situation 2008). a) Picture of the reinforcement on top of the existing slab; b,c) after completion of works.

For all methods, the material is attached to the surface; it thereby changes its appearance, either totally or locally if only strips are used. Modifying the resulting surface colour and texture is partially possible. For concrete overlays, the same options exist as for sprayed concrete (see Section 9.4.2). FRP can be covered with a thin mortar layer, which can be adapted, to a certain limit, in colour and texture. The main advantage of external strengthening methods is that the original historic material, although covered, can stay in-situ, limited damage occurs in the original material and the functionality of a monument is restored. Whereas the attachment of steel plates and additional concrete overlays significantly modify the proportions of the concrete member (Figure 9.26), FRP is characterised by minor geometrical changes, which are only a few mm thick (Figure 9.27).

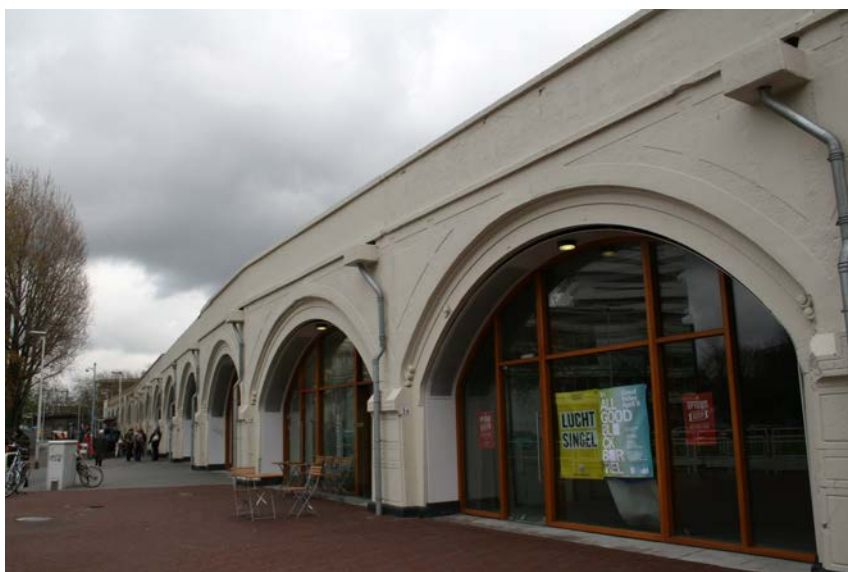
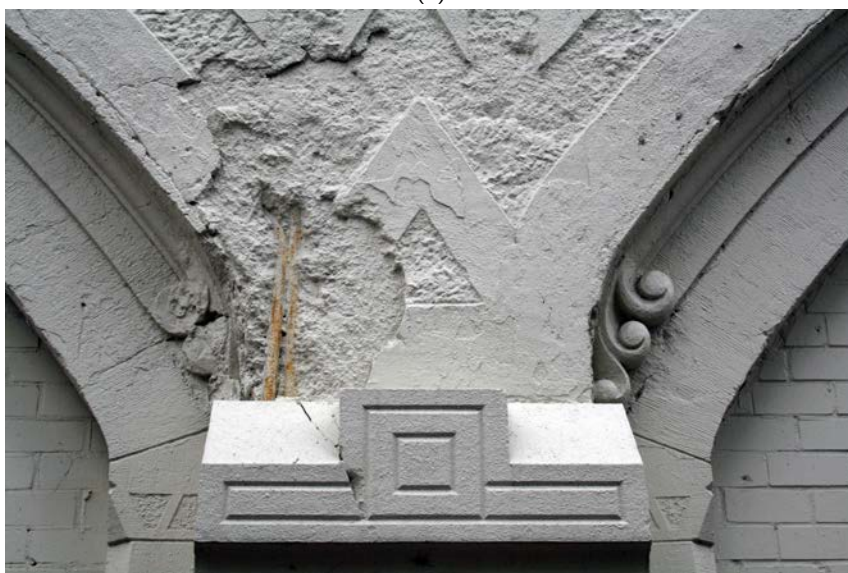
**Figure 10.2** Façade of the emplacement after being painted entirely white (Hofplein railway viaduct, situation 2012, compare also with Figure 8.16a). a) Overview. b) After painting, the different materials (Blue Belgian limestone, artificial sandstone render) cannot be distinguished anymore from a distance. Damages have not been treated, material loss is expected to increase, and the corroding reinforcement might gradually stain the white paint.

During repairs in 2011, the façade of the emplacement was painted homogeneously white (Figure 10.2). The intervention was carried out to improve the appearance of the façade of the newly opened shopping centre. The painting is intended to be temporary although the reversibility of the intervention has not been discussed. Therefore, present damage and damage symptoms were not treated. In the meantime, research on suitable repairs options for the façade is being considered. This intervention allows a real size mock-up of the effects of painting the

In the actual state of conservation, the state of the historic material related to the heritage values has come below the acceptable state. The original appearance is impeded as both concrete and natural stone plinth have been painted, but also due to mismatching repairs and to local soiling and spalling (Figures 8.16 to 8.21). The reinforcement is endangered as corrosion is locally already in the propagation phase and should be stopped to prevent further loss of reinforcement and surface. An intervention is therefore required, and the original surface appearance should be restored. As the railway function has ceased, functional thresholds are more flexible as they can be adapted to the requirements resulting from preservation of the heritage values and technical performance.

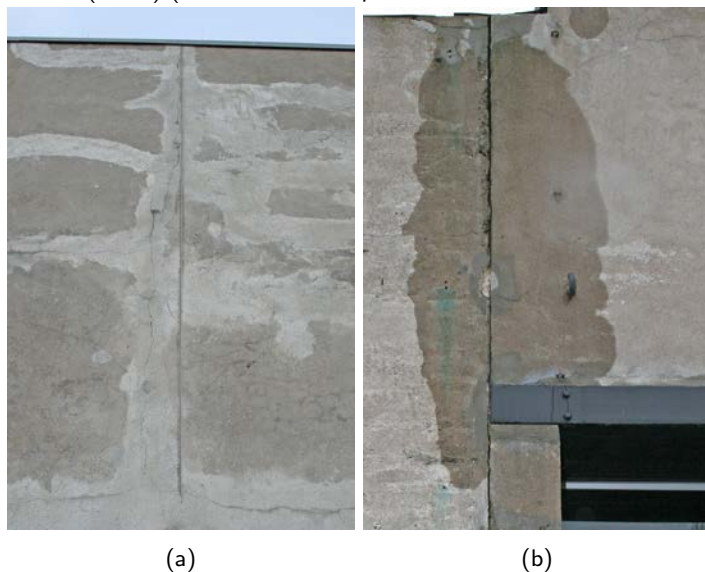
**Figure 11.3** Two different interventions of the active cracks caused by thermal movement. a) Example of a failed repair of an active crack: the concrete was injected and new expansion joint created and filled with an elastic sealant; yet, the cracks reappeared (Fort Bezuiden Spaarndam, 1897-1901, situation 2006). b) Example of an untreated crack showing the risk of moisture ingress (dark zone is moisture, visible after a rain shower); the parapet has not been covered, allowing additional moisture ingress from the top (Fort near Vijfhuizen, 1899, situation 2008).

The presence of cracks in the wall is not an immediate but a potential future threat, as leaving the cracks untreated may increase the risk of freeze-thaw damage. To prevent premature failure of crack repairs, it is necessary to know whether the cracks are still active. Active cracks require a different approach, and the elastic properties of the repair material have to be chosen in accordance with the expected movement of the cracks. Such active cracks appeared at Fort Bezuiden Spaarndam as no expansion joints were present (see Figures 11.2 to 11.3). Moisture ingress through these cracks is common, and in combination with voids, moisture can easily penetrate into the depth of the concrete (Figures 11.3 to 11.5). The presence of voids in the concrete is more likely due to the use of crushed rock as aggregate and the manual compaction applied. For the choice of a repair material that could fill the cracks and compensate the thermal stresses, parameters are currently missing to define its properties. As this damage symptom is common for the plain concrete forts of the Stelling van Amsterdam, different previous interventions can be studied/evaluated for their impact and effectiveness (Figures 11.2 and 11.3).

Injection of the cracks is problematic due to voids, and the presence of moisture in the concrete. Injections have been tried out during the conservation campaign in 1996 and new expansion joints using elastic sealants to compensate the stresses had been created (Figure 11.2a). The execution of the repair was difficult, voids and interstices complicated the injection. The new expansion joints were empirically dimensioned, not taking into consideration the depth of the walls (ca. 1.50 m) and the movement of plain concrete walls. The intervention failed due to problems with injecting the concrete and the lack of reference data of the thermal movement of such plain concrete structures.

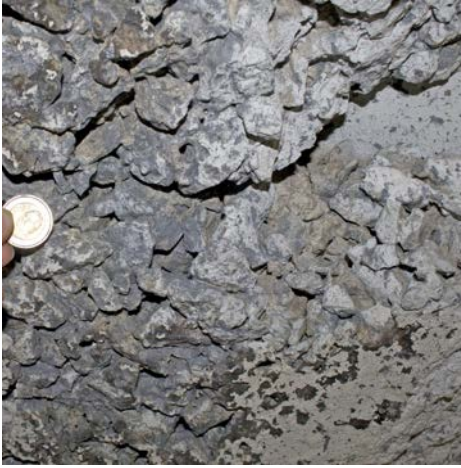
**Figure 11.4** Example of honeycombs; plain concrete wall with crushed rock, cut through during a previous intervention (Fort near Hoofddorp, 1904, situation 2006).

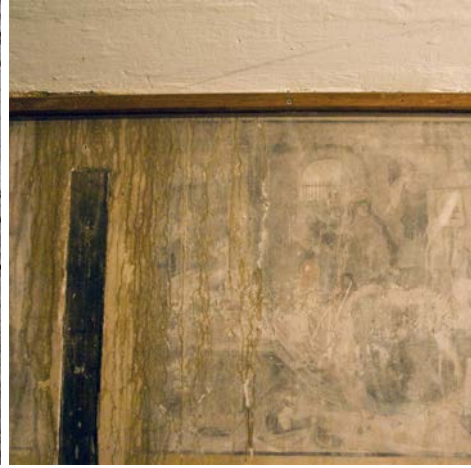
**Figure 11.5** Example of seepage through former construction joints and cracks caused by thermal stresses in the interior of the fort (Fort Bezuiden Spaarndam, 1897-1901, situation 2006).

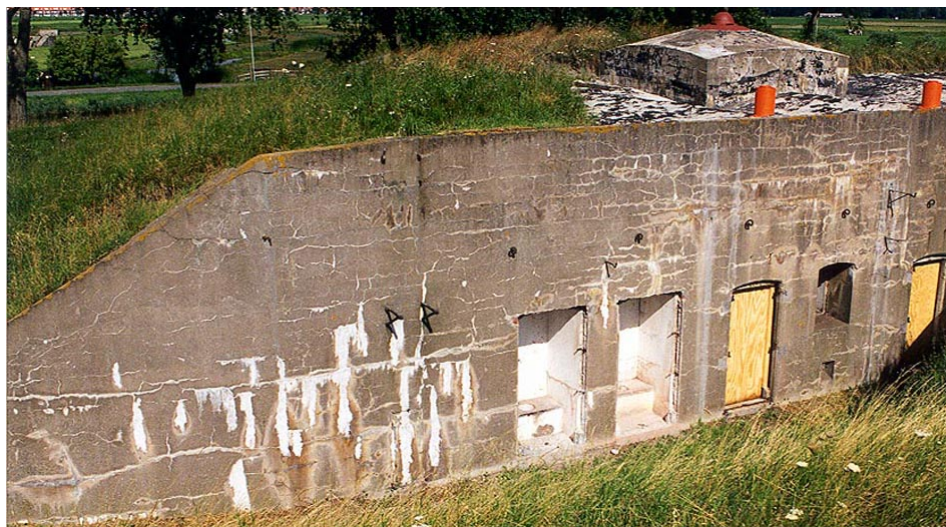
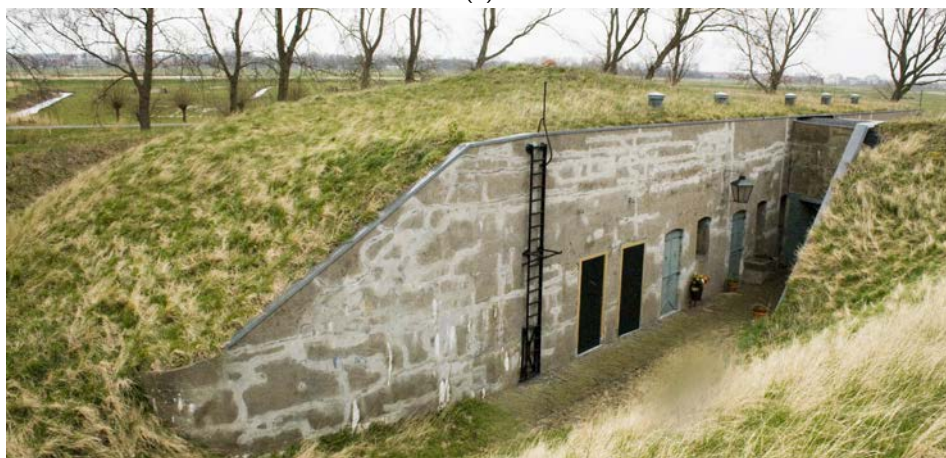
**Figure 11.6** Example of the visual impact of repaired cracks (Fort Bezuiden Spaarndam, 1897-1901, repair 1996). a) Situation before intervention (1995) with visible cracks and deposits from leaching (picture R. P. J. van Hees). b) Situation after intervention (2006); the repair mortar was not adapted in colour, emphasising the pattern caused by the cracks (NB Painting of the façade was intended but not performed, therefore the repair mortars were not adapted in colour).

In case the cracks are inactive, investigations can be made for a compatible repair mortar to fill or inject the cracks (Sections 9.4.1 and 9.4.3). As no reinforcement is present, considerations of future compatibility with electrochemical repair methods are not necessary. Although the appearance of Fort Bezuiden Spaarndam is not the main criterion of the conservation aim, the aesthetical impact of the repaired cracks should be considered (Figure 11.6). To underline the monolithic appearance of the fort, repairs should not be visible from distance. It is technically possible to adapt the colour of a repair mortar to the surrounding concrete, yet it should be considered that the colour can deviate overtime due to moisture and ageing. As the historic concrete is covered with a thin layer of render and no aggregates are visible, covering repaired areas with a similar render or using a repair mortar with a similar appearance could be considered.
