MONITORING FOUNDATIONS

Master's thesis

Master of Science
in Civil Engineering

at the Delft University of Technology

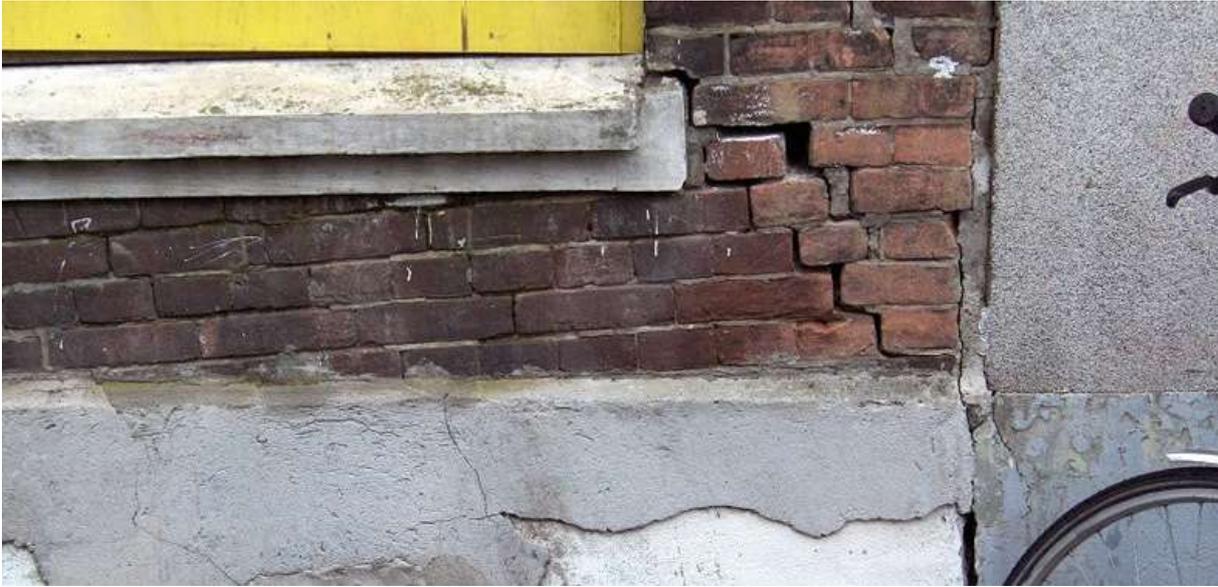
Figure 1 Cracks in the façade caused by settlement. (source: kcaf.nl)

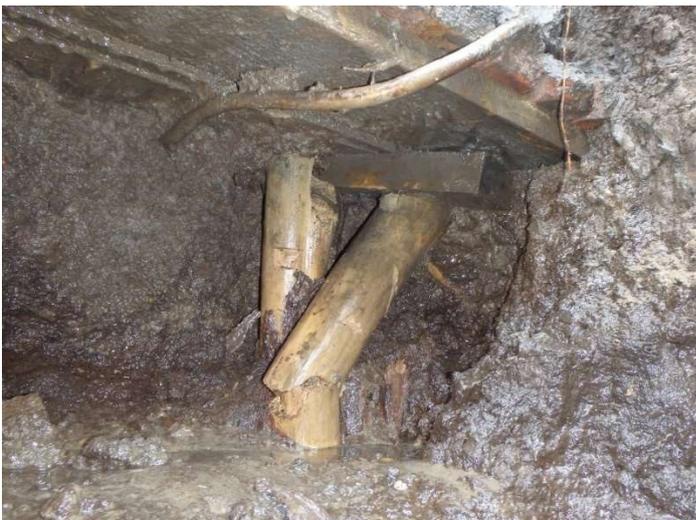
Figure 2 Broken wooden foundation piles (source: Fugro)

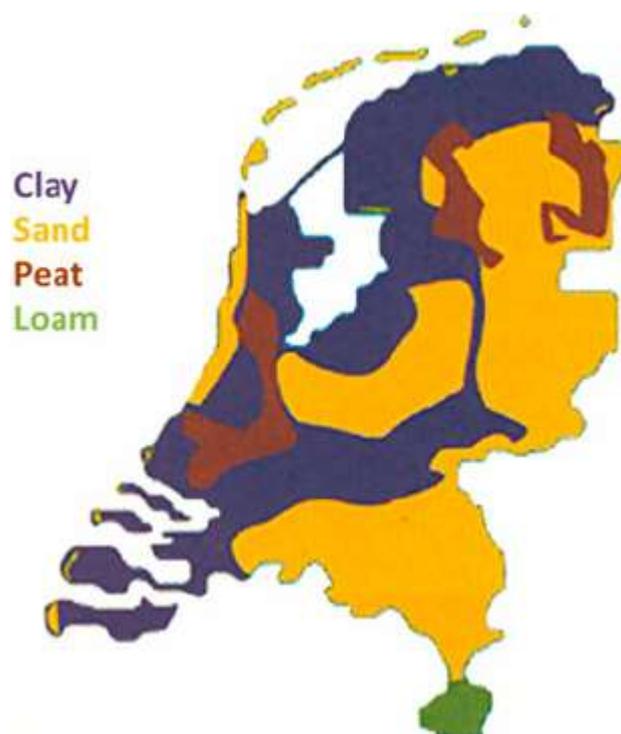
Figure 3 Overview soil types in the Netherlands. Source: (Ritzema)

A lot of areas in the Netherlands have a weak top layer especially in the western parts. Figure 3 shows an abstract overview of the upper soil types in the Netherlands.

As the figure shows, a big part of the Netherlands is covered with weak soils like clay, peat and loam. In those areas the load-bearing layers like dense sand layers are located below the surface.

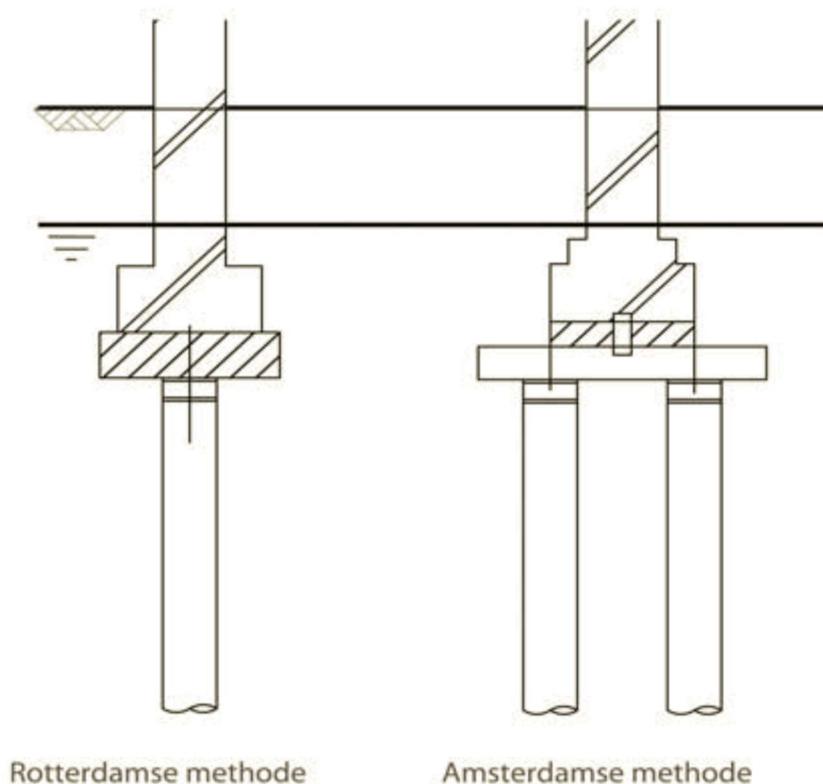
In the Netherlands, mainly two types of pile foundations for houses are present. The first method is the Rotterdam foundation. A single row of piles was placed below the load bearing walls of a house. This method was mainly used in Rotterdam and its surroundings. The second method is the Amsterdam foundation. In this method two rows of piles with a wooden beam (in Dutch: 'kesp') on top were placed below the load bearing walls. The additional row of piles was used to increase the capacity of the foundation. This method is mainly used in Amsterdam but occurs in different cities as well, for instance Zaandam and Haarlem. The picture below shows the two pile foundations schematically.

Figure 5 Pile foundations occurring in the Netherlands

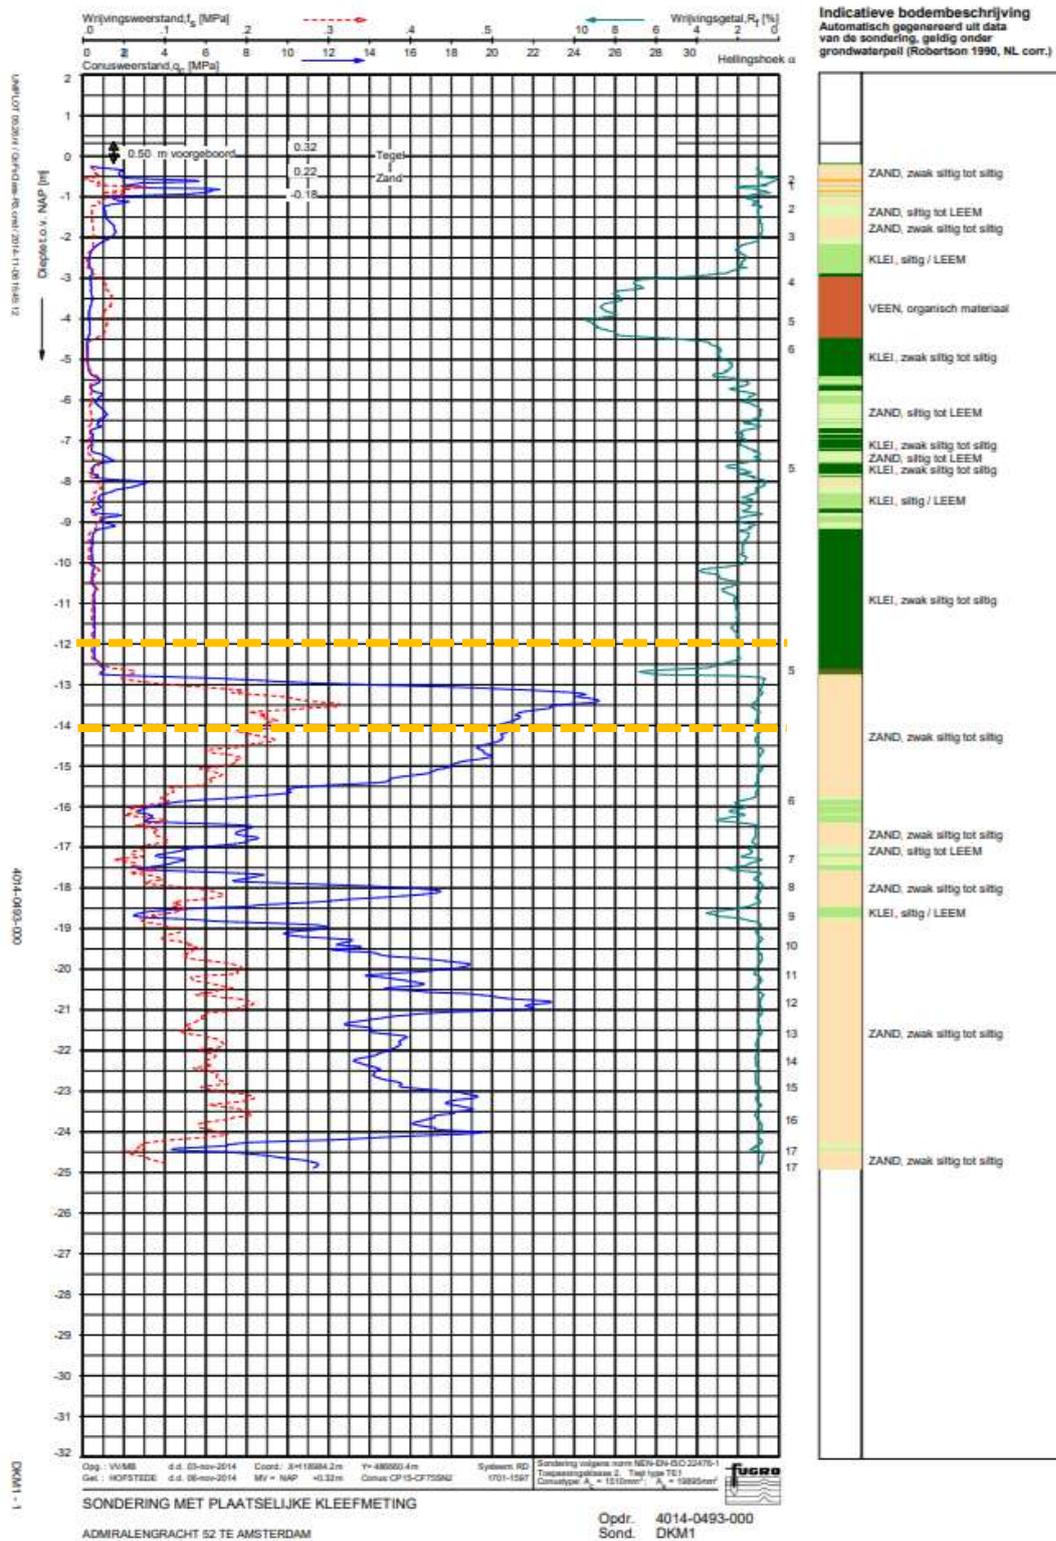
The top layer consists of sand raisings (0 to -1,5 m NAP) followed by a mixed layer of peat and clay (-1,5 to -7,5 m NAP). In the region of Amsterdam the dense sand layers start at a depth of 12-14 meters below NAP, see CPT 2 below.

Figure 7 CPT 2 Admiralegracht, Amsterdam (source: Fugro)

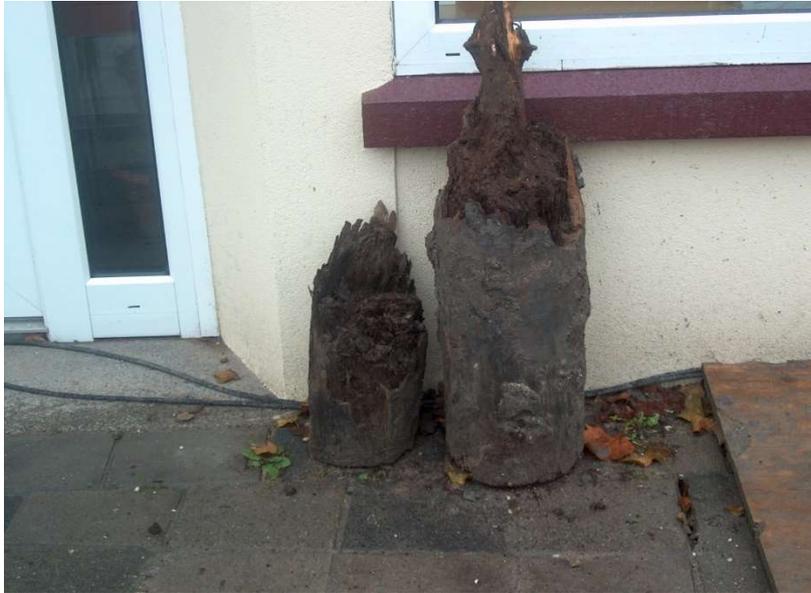
Figure 8 Fungus attack on wooden pile (source: Platform Fundering)

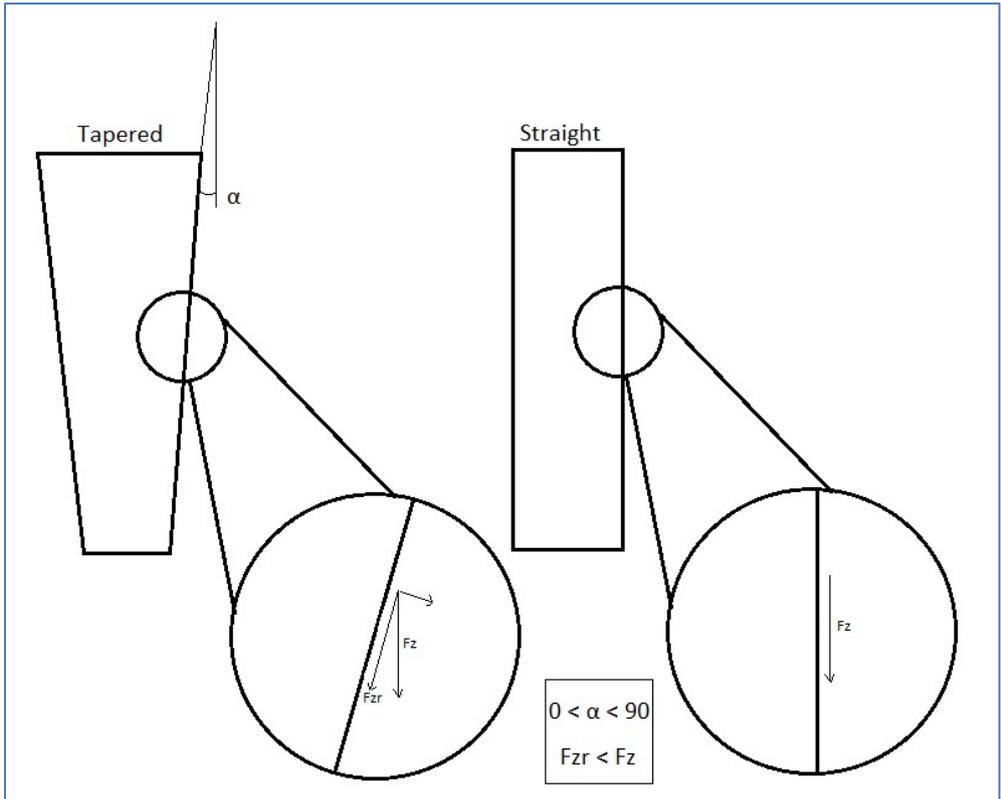
Wooden piles are tapered, lengths of 15 to 18 meters are common in the region of Rotterdam. The diameter on the head of the pile is 260 to 280 mm and the 130 to 150 mm on the tip of the pile. Although these measurements are easy to use, in practice the perimeter of the pile is used: For instance, 0,85/0,45 m. The tapered shape has a positive effect on the skin friction, the friction component is reduced by the angle of the pile, see Figure 9 below. Unfortunately in practice α is smaller than 1° which is not sufficiently significant to reduce the *negative skin friction*. This phenomenon will be elaborated in 2.3.3. (Tol, 2006)

Figure 9 Less negative skin friction due to tapered shape

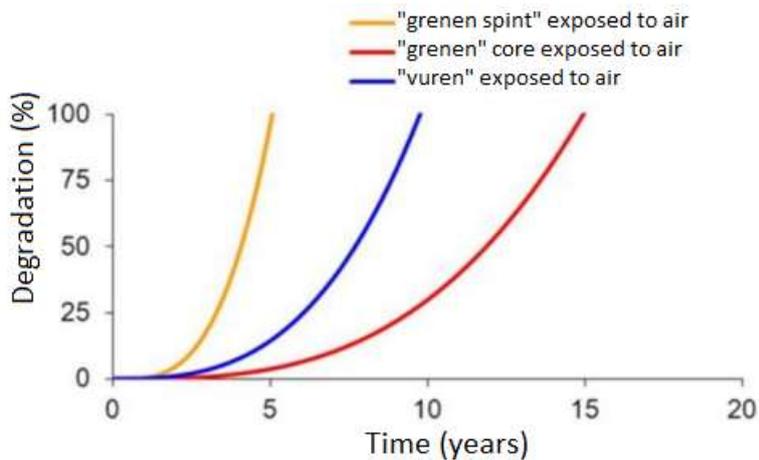
It is estimated that the maximum degradation velocity of soft-rot fungi that attack water-saturated wood from outer part towards the inside of the pile is approximately 10 mm/year, whereas brown- and white-rot fungi which attack drier wood act much faster by penetrating with a maximum of 100 mm/year radially into the pile. See the graph below. This graph shows the progress once the soft rot is active. If the cumulative time of exposure to air is more than 2 years, there is a possibility that wood degrading fungi is active in “grenen spint” and 4 years for “vuren”.

Figure 10 Wood decay by soft rot (Source: SHR)

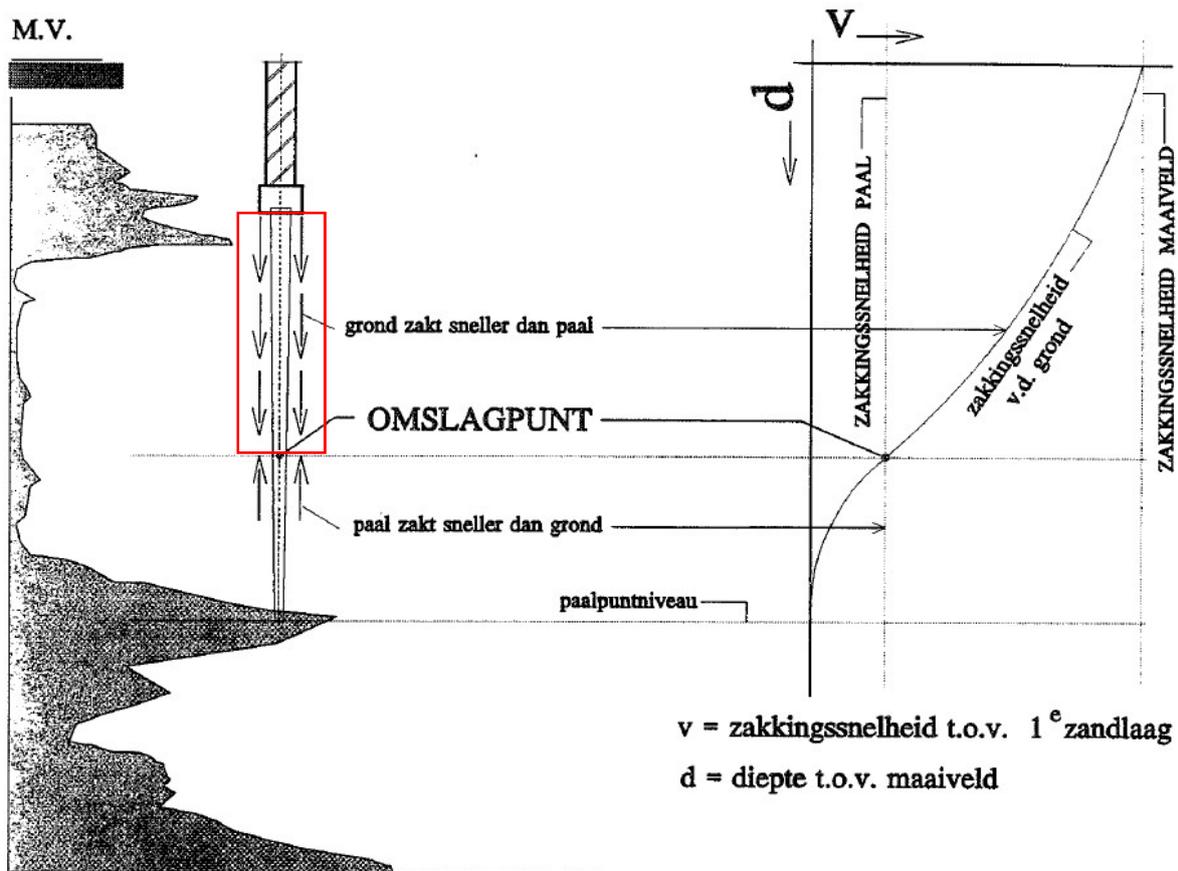
Usually piles are driven through soft top layers where the head of the piles are placed in a load-bearing layer which can carry the pile loads almost without settlement. The soft top layers exert a negatively directed frictional force on the pile shaft if they are subjected to sagging, when they are loaded by sand raisings (Figure 11).

Figure 11 Negative skin friction (Bruine de Bruin, 1997)

This additional load can rise to very high values, even to the same order of magnitude as the load on the pile head. It is therefore necessary to consider the possible load caused by negative skin friction.

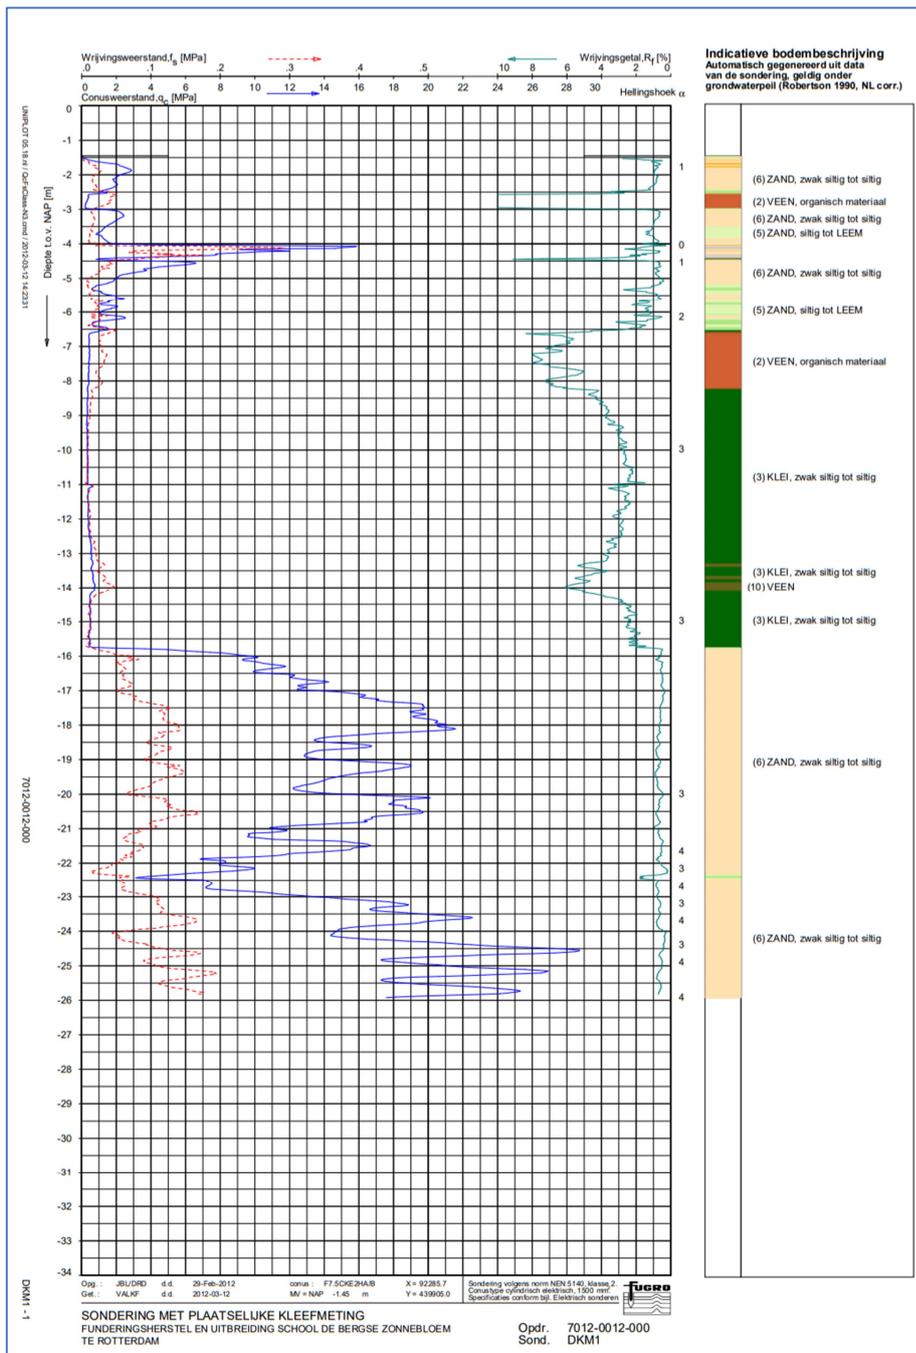
In Rotterdam, the soil in areas with buildings has been raised with 4 meter thick sand layer. Surface level is around -2 m NAP and a thick layer of clay and peat starts at -7 m NAP until a depth of -16 m NAP followed by a dense Pleistocene sand layer with cones resistances between 10 to 30 MPa. See Figure 12 below for a representative CPT (Cone penetration test) in the Elektroweg in Rotterdam (29-02-2012).

Figure 12 CPT in Elektroweg, Rotterdam (source: Fugro)

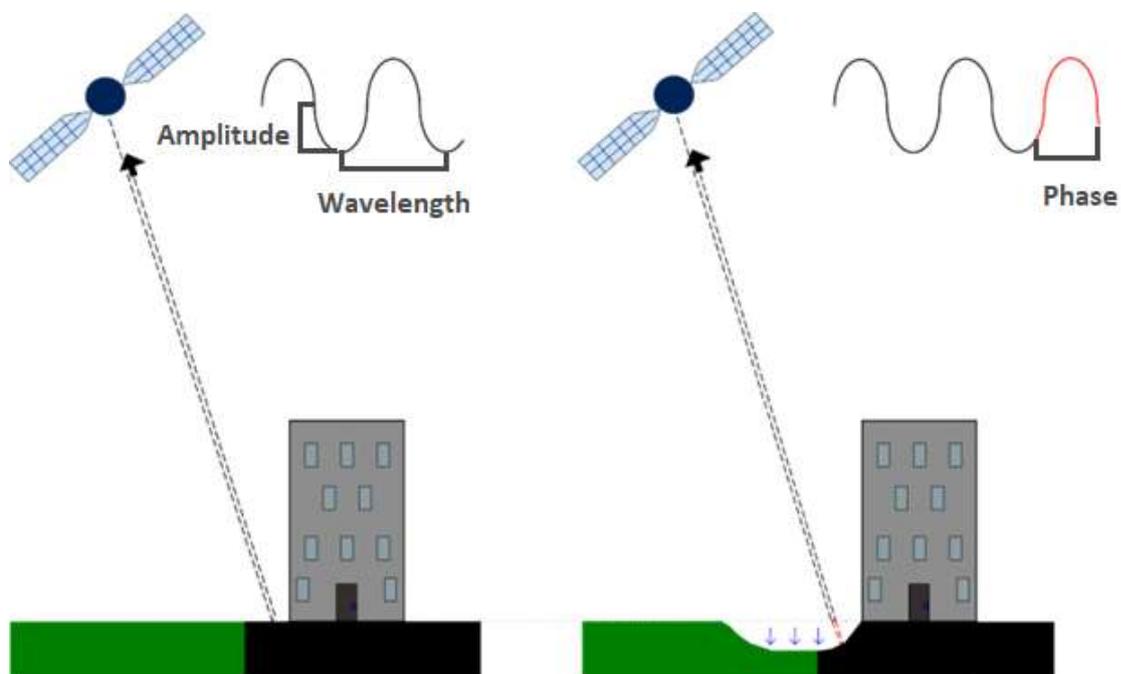
Active satellites mounted with a radar system are able to send out a radar signal to the surface of the earth which is reflected and captured by a sensor as an image containing the phase and the amplitude. The phase is the fraction of a complete wavelength reaching the sensor on a scale from 0 to 2π and can be coded by a colour. The amplitude is the strength of the signal. See Figure below.

Figure 13 Radar signal before and after subsidence.

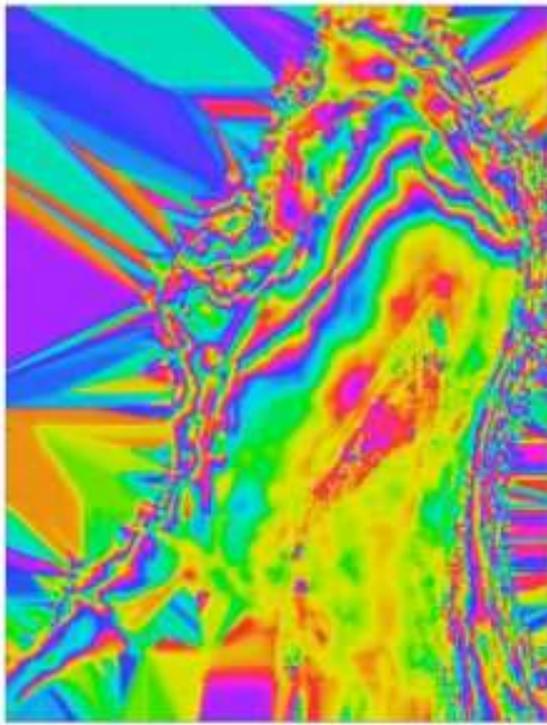
To measure deformation with this radar signal, two images containing the phase can be subtracted. The resulting image is called interferogram (see the Figure below).

Figure 14 Example interferogram

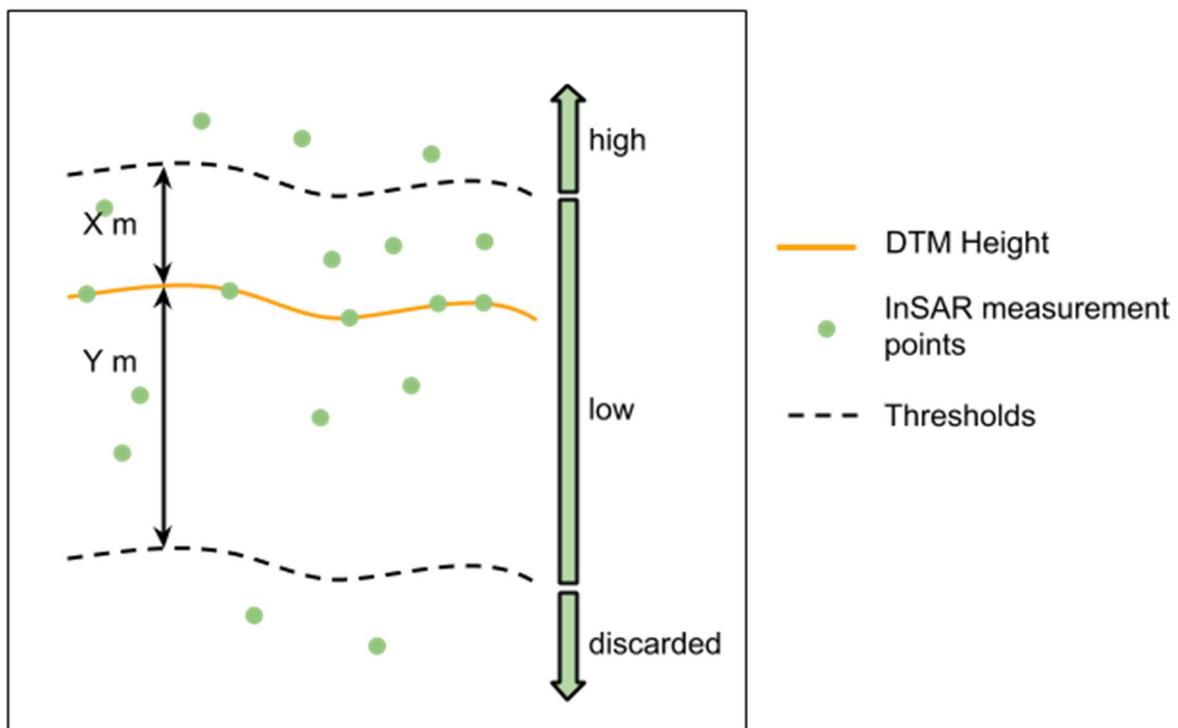
In order to separate measurement points on buildings and ground level, the algorithm compares the data with a Digital Terrain Model (DTM). Classification is done according to the following distribution: High points are bigger than (DTM height + X), X = 2 m for high resolution satellites and X = 3 m for standard resolution. Low points are between (DTM height - Y) and (DTM height + X). Points below (DTM height - Y) are discarded. Y = 10 m for all satellites. The picture below shows the distribution.

Figure 15 High-low point distribution

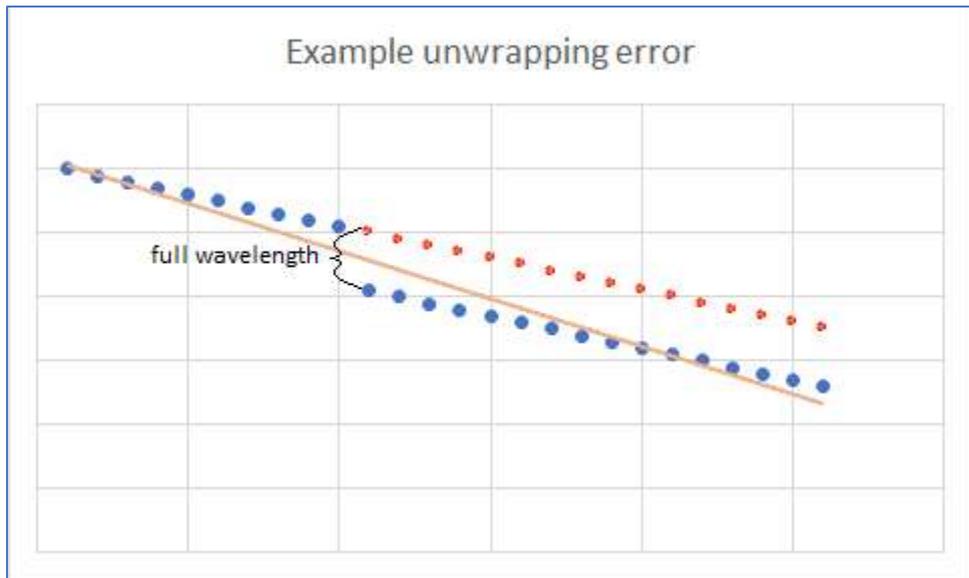
Figure 16 Example Unwrapping error

The deformation is derived by means of the phase difference. It is important to note that a finite number of phase measurements can be recorded (from 0 to 2π). If a point has changed by one complete wavelength, the phase difference can be interpreted as no change at all, since only the last wavelength of the signal is recorded. In other words, the interpretation can be off by $(\pm x * 2\pi)$ with $x \in \mathbb{N}$. This phenomena is called a “unwrapping error”. This can give a deviation in the trendline. See the example below.

The data shows a clear trend but because of the unwrapping error the trendline may deviate. These errors have an order of magnitude of the wavelength of the radar signal. For instance the TerraSAR-X satellite can detect deformations up until ± 15 mm per 11 days.

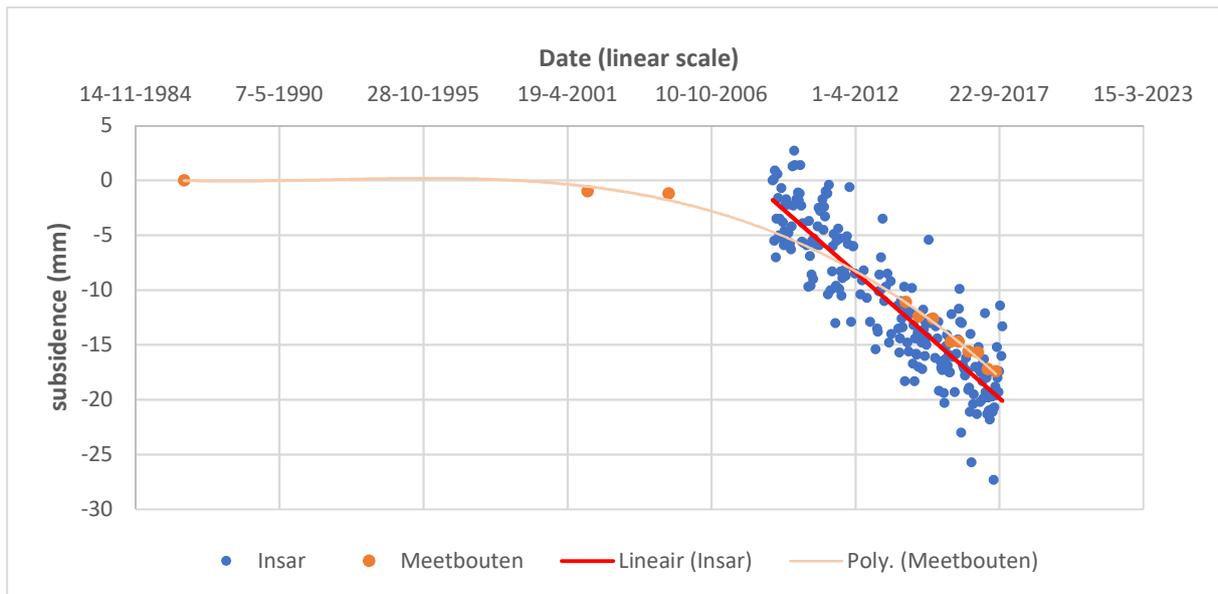
Once a comparison is found, the data is collected in an Excel sheet. Both InSAR and measurement bolts data are drawn in a graph where trendlines are plotted. Below the graph of measurement bolt number 93 is given. An example of a comparison is explained.

Figure 18 Measurement bolt 93 with added trendlines.

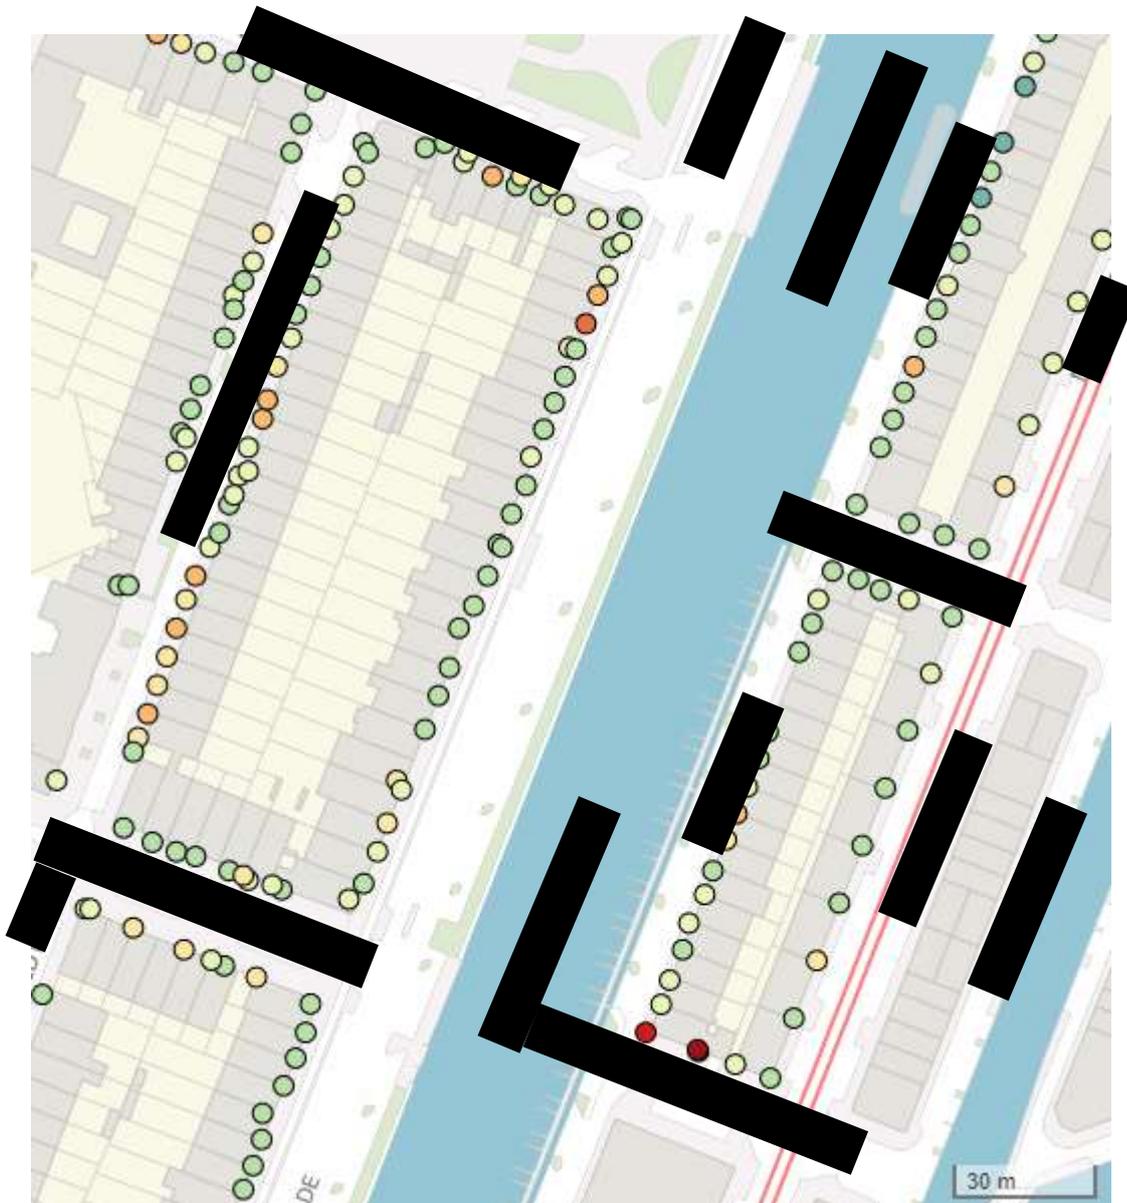
Figure 19 Measurement bolts Case Study Block B Source: Gemeente Amsterdam

Also, a second project has been analyzed. This is Case Study Block B in Amsterdam because plenty of measurement bolt data is available. See the figure of the location below.

Gemeente Amsterdam provides a lot of data for these two building blocks. It is open-source (Amsterdam, 2018). The measuring period of the measurement bolts ranges from around 2000 to 2018 but for some of the measurement bolts only from 2014 to 2018 the data should cover at least more than 3 years.

The InSAR data is filtered and edited by SkyGeo. In this period the satellite was able to make a point-set of 219 observations per point. Details of the InSAR data set can be found in Appendix A.1. Together with the locations of the measurement bolts (Figure 19) a comparison can be done with the

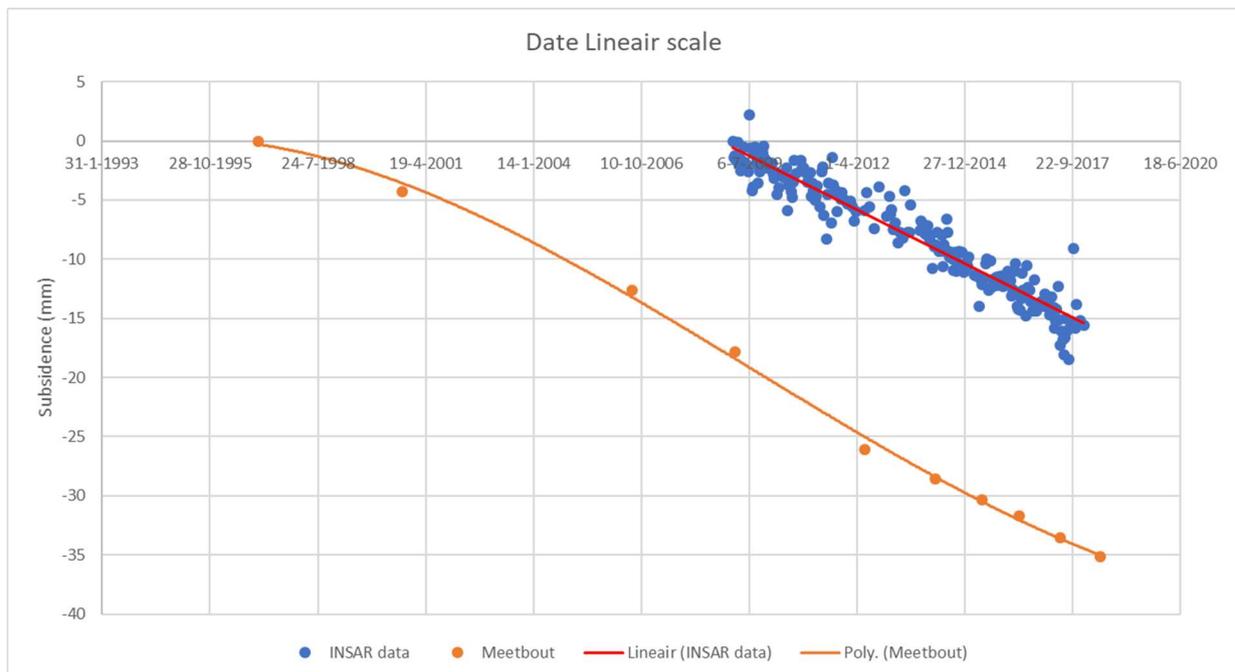
Once a comparison is found, the data is collected in an Excel sheet. Both InSAR and measurement bolts data are drawn in a graph where trendlines are plotted. Below the graph of measurement bolt number 10381285 with the closest InSAR data point is given. An example of a comparison is explained.

Figure 20 Measurement bolt 10381285 with added trendlines

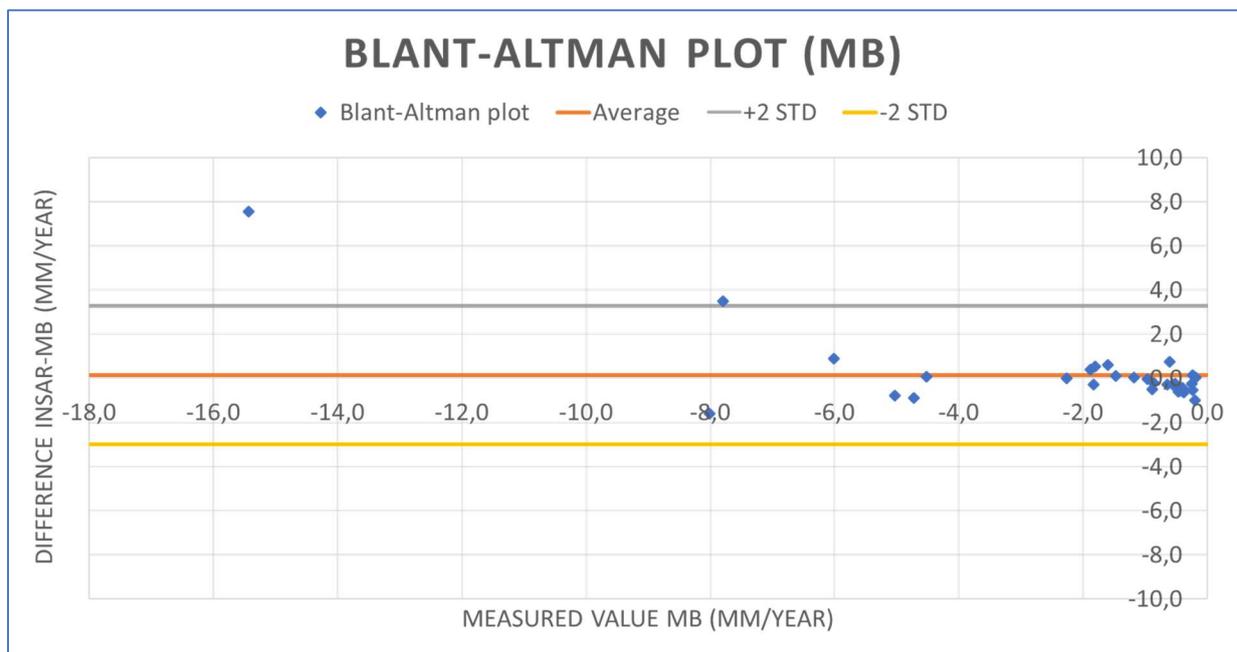
First, all measurement bolts are plotted in graphs to derive subsidence speeds see Appendix A.1. The Blant-Altman plot for all 32 comparisons is given in the following graph.

The x-axis is the value measured by measurement bolts in mm/year and the y-axis shows the value measured by InSAR minus the value measured by measurement bolts in mm/year. The orange line is the average of the difference in both methods and the yellow and grey line are showing the

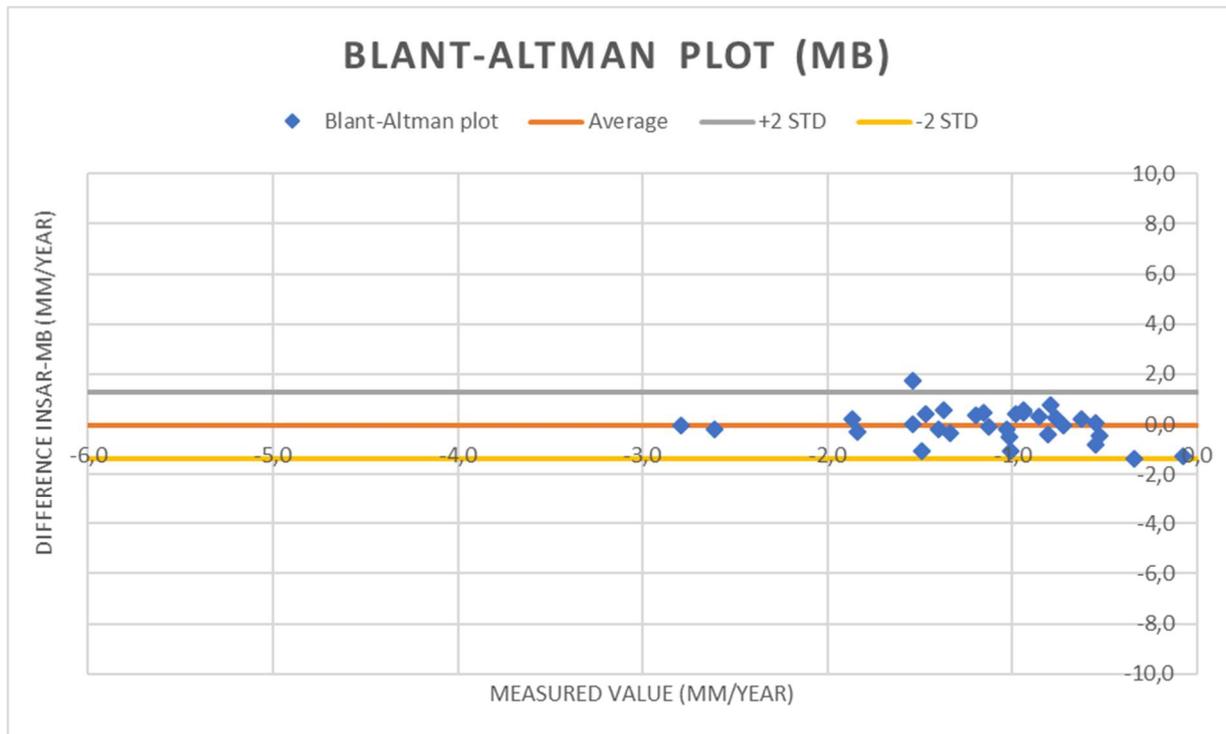
First, all measurement bolts are plotted in graphs to derive subsidence speeds see Appendix A.1. The Blant-Altman plot for all 31 comparisons is given in the following graph.

The x-axis is the value measured by measurement bolts in mm/year and the y-axis shows the value measured by InSAR minus the value measured by measurement bolts in mm/year. The orange line is the average of the difference in both methods and the yellow and grey line are showing the 95% - confidence interval.

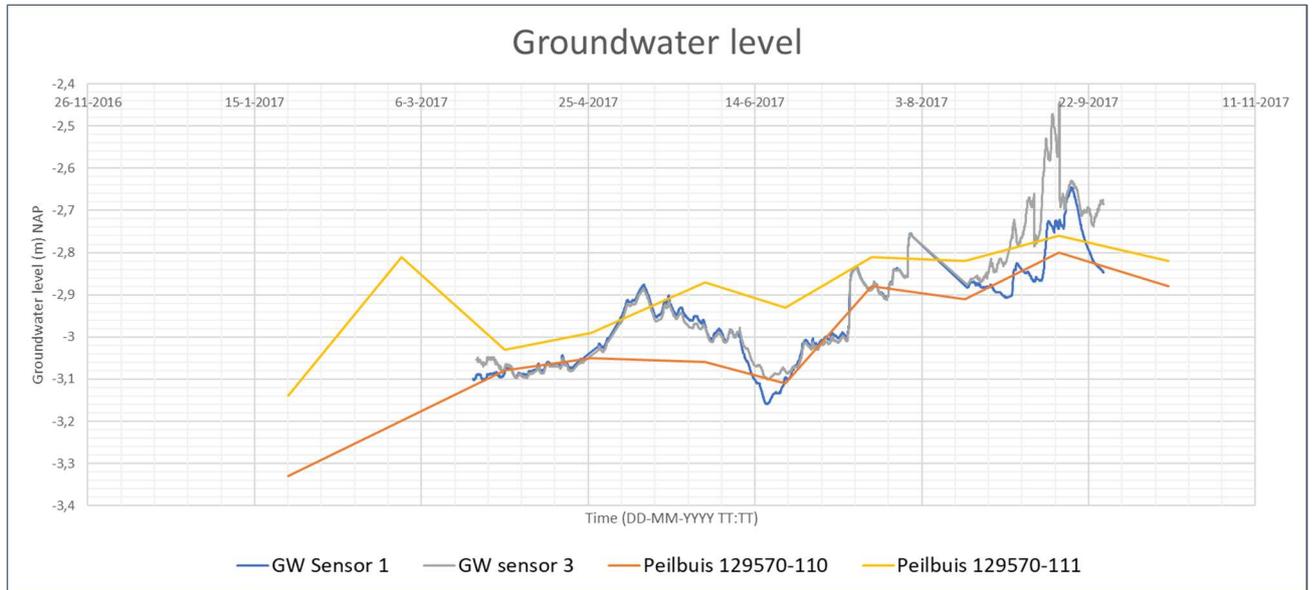
A comparison of the groundwater sensors to the local monitoring wells has been performed. If the groundwater level sensors are compared to the level measured by the monitoring wells, it can be concluded that they all show a similar slightly raising trend. See the graph below.

Figure 21 Groundwater level measurements

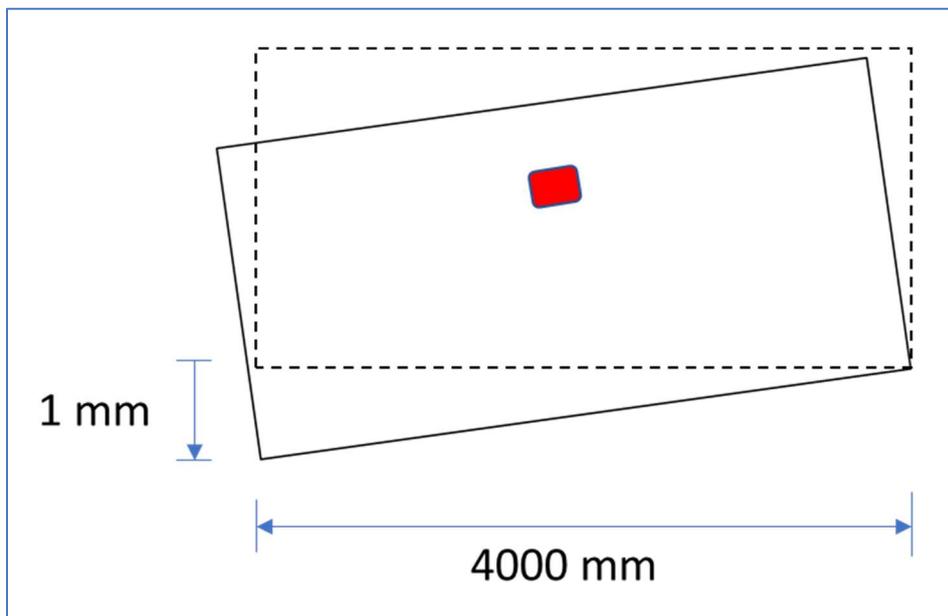
- The reference point of a tilt sensor is the initial measurement starting at 0° .
- The precision of the “Kelag KAS901-xxX inclination sensor” is $\pm 0,014^\circ$. The error can be almost 1 mm assuming the wall behaves like a rigid wall. If this error margin is not adequate, a sensor with higher precision should be used.

Figure 22 Error margin tilt sensor

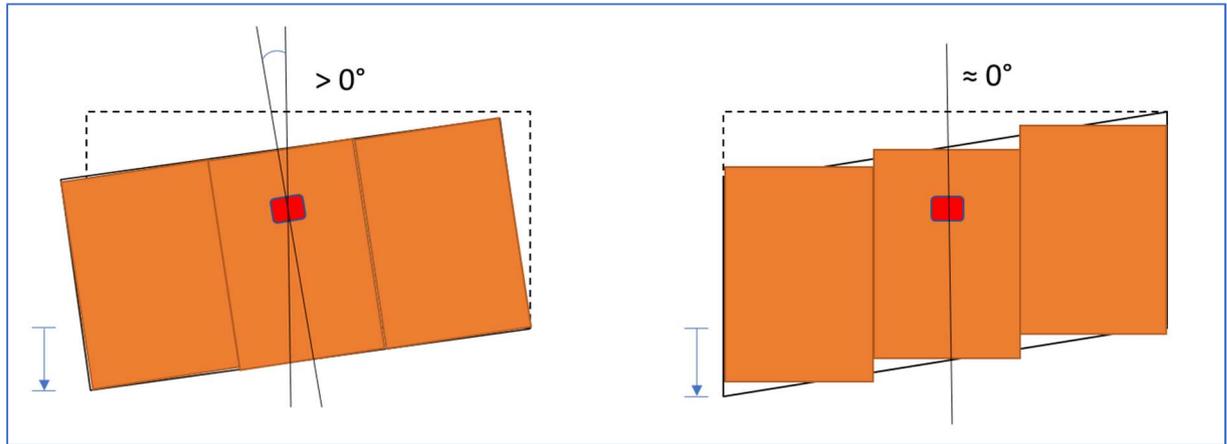
- The tilt sensor should be installed on a load bearing wall in order to relate the deformations to the foundation because the loads are distributed to the foundation through the load bearing walls.
- The figure below shows a wall with a tilt sensor. The stiffness of a wall has consequences for the rotation measured by the tilt sensor. The wall on the left is sufficiently stiff to rotate as a result of sagging differences. The wall on the right behaves as a flexible wall and shows shear deformation. The sensor will not observe rotation.

Figure 23 Observed rotation in relation to stiffness.

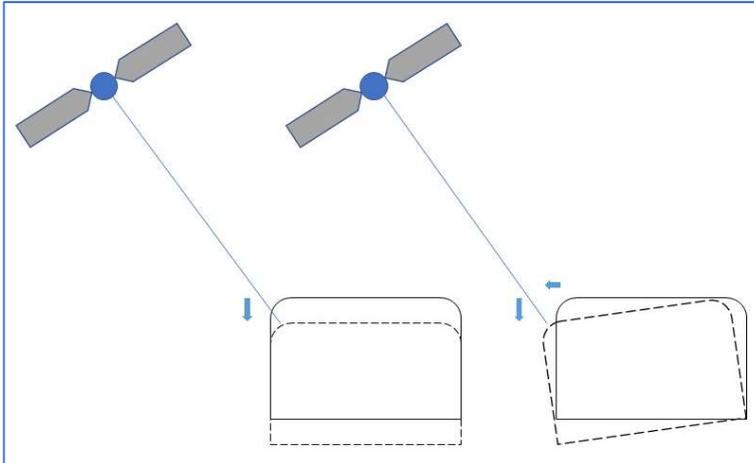
the satellite can reduce the observed subsidence. The length of the signal will be shorter than a subsidence with only a vertical component. See the picture below.

Figure 24 Horizontal movement of a building changes the length of a signal.

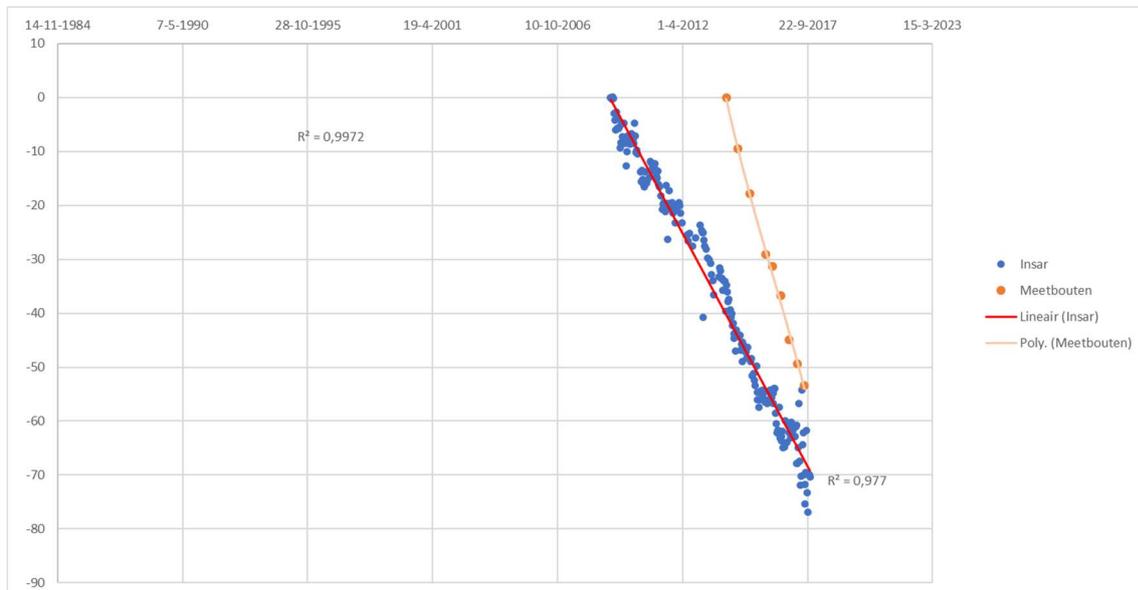
A few graphs from the comparison will be discussed and shown below. First the comparison of measurement bolt 120 in Case Study Block A test case.

InSAR	-7,9	mm/year
Measurement bolts	-15,4	mm/year

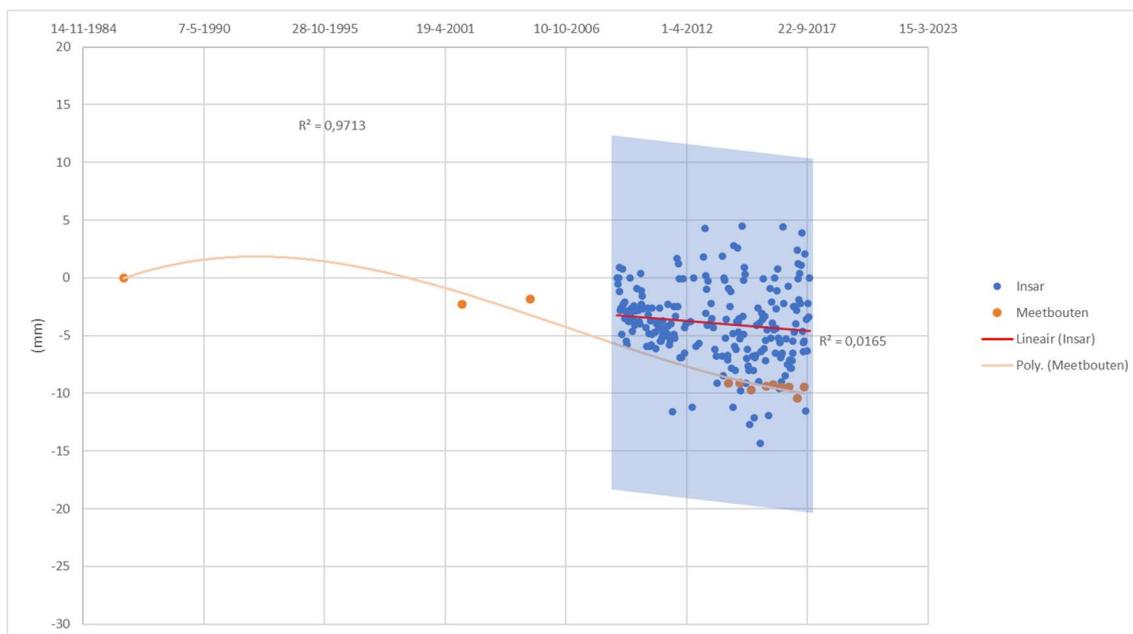
The next graph of measurement bolt 114 in Case Study Block A shows a perfect similarity. Still the InSAR data looks scattered. The points differ about ± 10 mm of the plotted trendline. This is well within the wavelength of one phase (30 mm) which comes down to a ± 15 mm bandwidth (marked in blue). Settlement changes bigger than 15 mm within 11 days (time of one full orbit) cannot be detected and will be “corrected” to a value within the bandwidth marked below.

InSAR	-0,2	mm/year
Measurement bolts	-0,2	mm/year

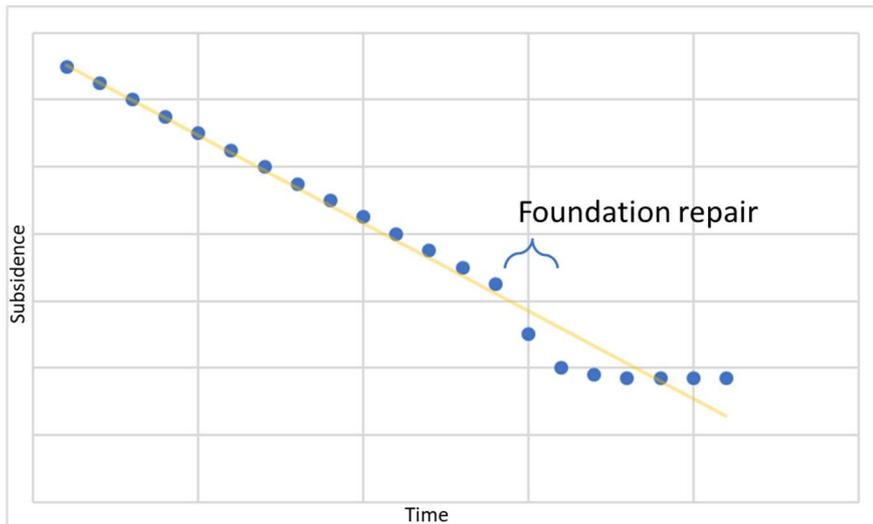
Foundation repairs can also influence the trend observed by the InSAR data. Usually after such a repair, stabilisation takes place and a certain equilibrium is found. The InSAR data can interpret this as an error in the measurement and thereafter discard the point or just use it as continuation in the trend. See the example below. Further research is needed to know to what extent this can lead to errors in relation to the measured subsidence speed.

Figure 25 Foundation repairs can influence InSAR data trends
