MONITORING FOUNDATIONS

Master's thesis

Master of Science
in Civil Engineering

at the Delft University of Technology

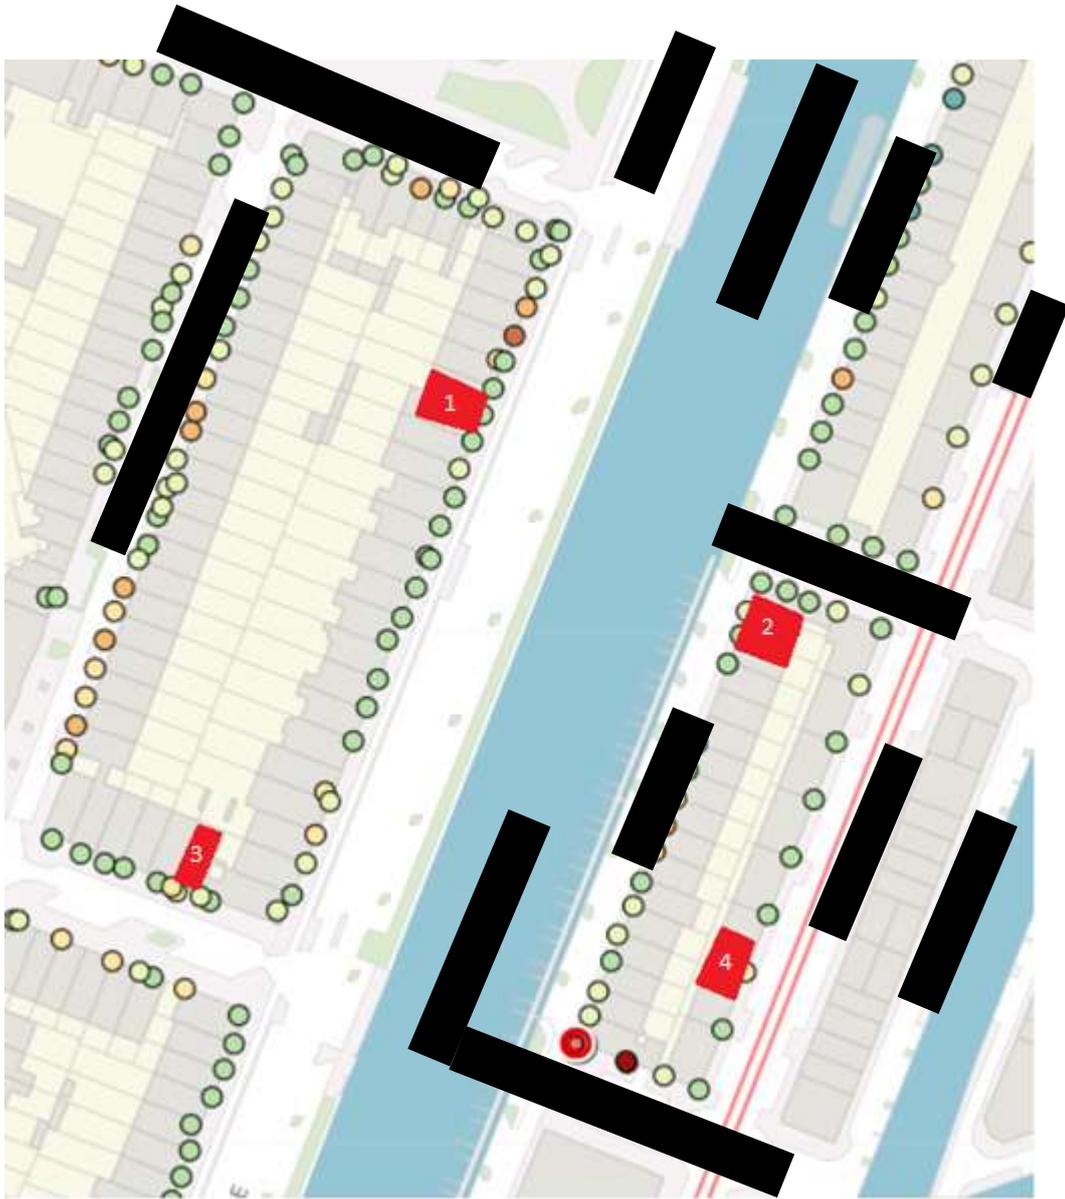
Since the results for the error margin are better in Case Study Block A, possible explanations have to be discussed. Large differences between the measurement bolts and InSAR are marked in red on the map below.

Figure 28 Marked houses with large differences between measurement bolt and InSAR data on Case Study Block B.

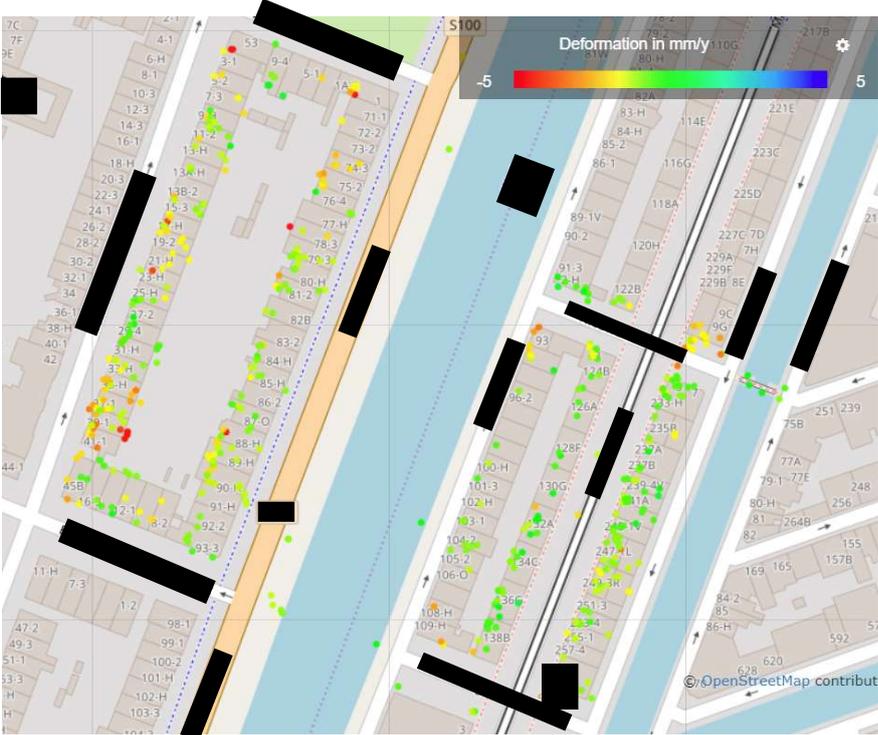
Interface of © SkyGeo InSAR data Case Study Block B:

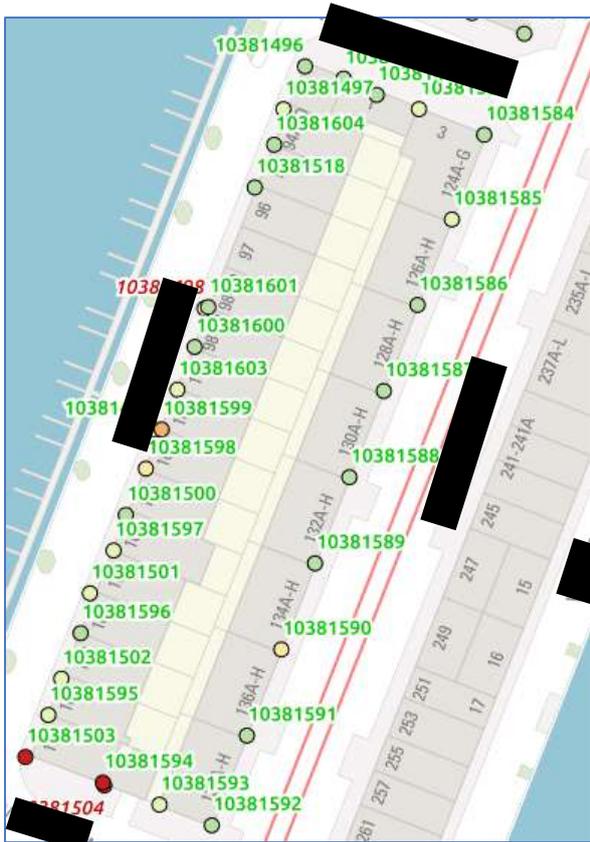
Figure 33 Map of Case Study Block B. The location of the measurement bolts are marked with a number. (source: City Data Amsterdam)

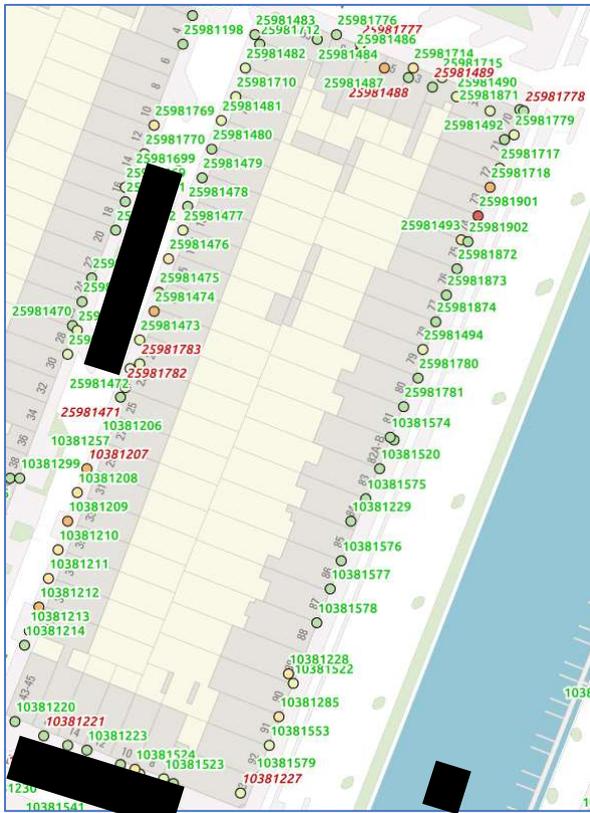
Figure 34 Map of Case Study Block B. The location of the measurement bolts are marked with a number. (source: City Data Amsterdam)

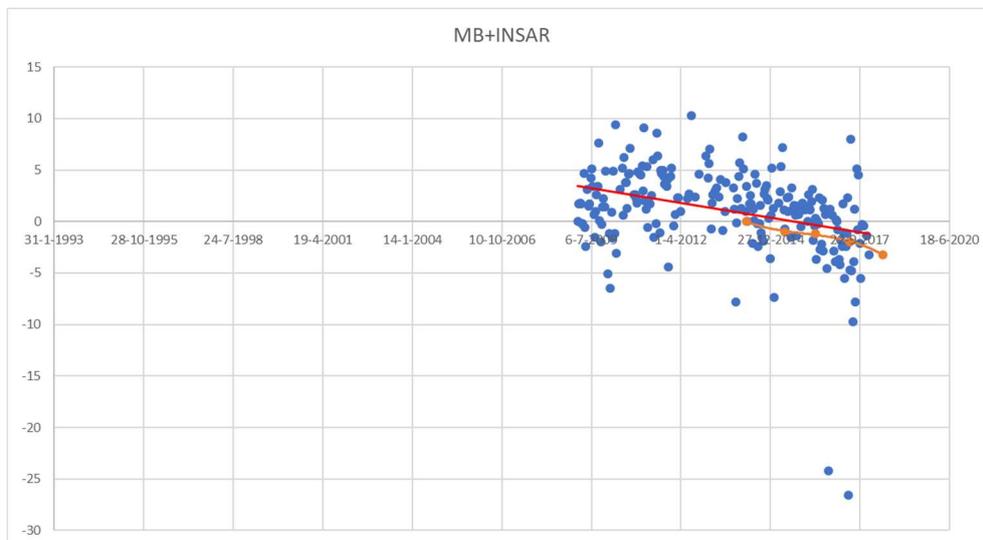
MB 10381589

Zakking InSAR	-0,529	mm/year
Zakking mb	-0,767	mm/year

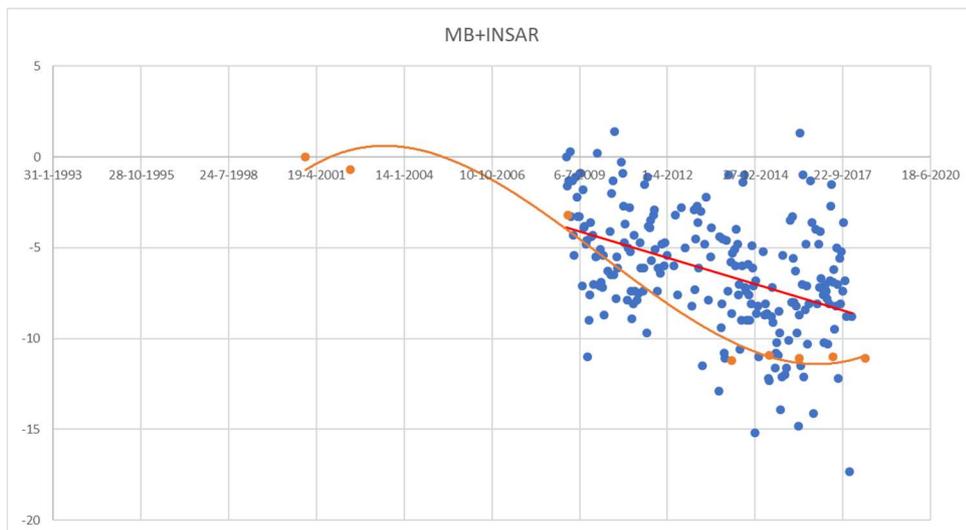
MB 25981776

Zakking InSAR	-0,528	mm/year
Zakking mb	-0,852	mm/year

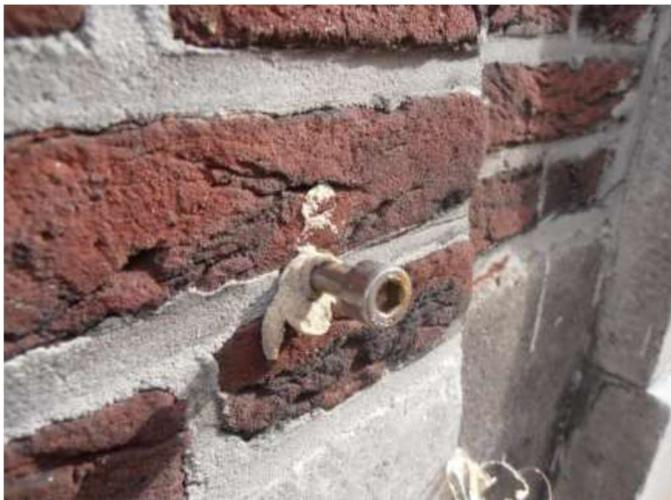
Figure 35 Stainless steel pins

The measurement bolts method uses stainless steel pins in the façade to measure the vertical translation in time relative to local NAP-calibrated points see the Figure below. Although these points are considered as fixed, they are always subjected to (very small) subsidence.

In addition to the fixed measurement bolts, one or more reference points are placed in the vicinity in constructions that are (almost) not subjected to subsidence. Otherwise, local NAP-calibrated points are used.

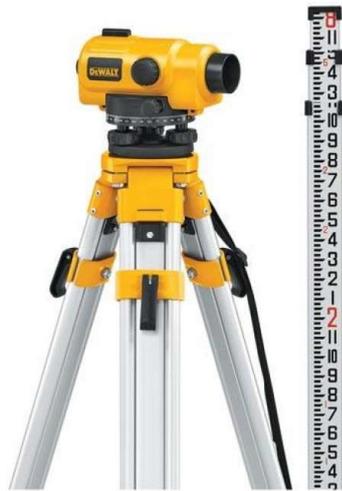
Figure 36 Level, an optical instrument to measure height differences (source:www.gereedschappelijk.nl)

of the results of repetitive measurements to be carried out later. When performing a repetition measurement, the heights of the measurement bolts are measured again. The height of the reference point is also tested if this was chosen correctly. This procedure is quite labour-intensive. The instrument used for this conventional method is the level (Figure 36), which is an optical instrument that measures the height of two different points. Thereafter, the height difference can be calculated. This device can be digital as well as analogue.

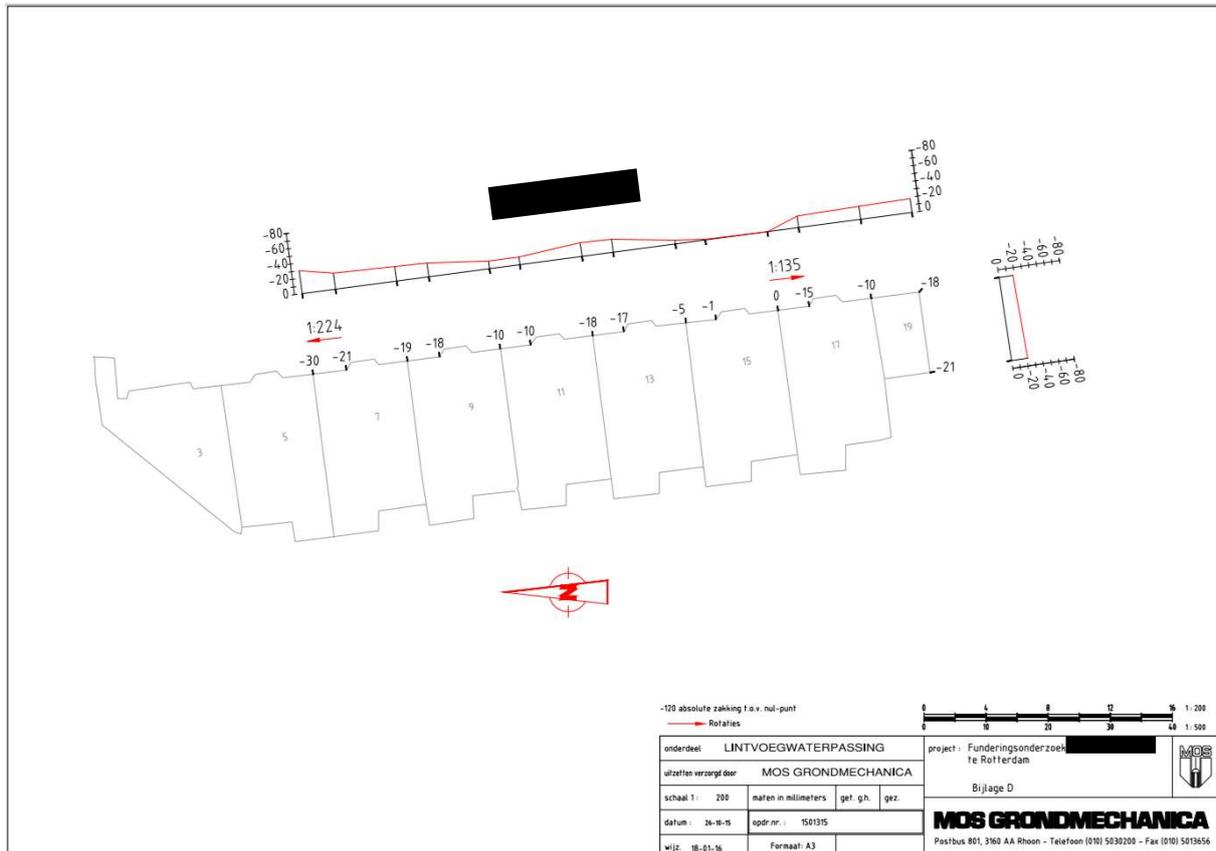
Figure 38 Level measurement for masonry Case Study Block C

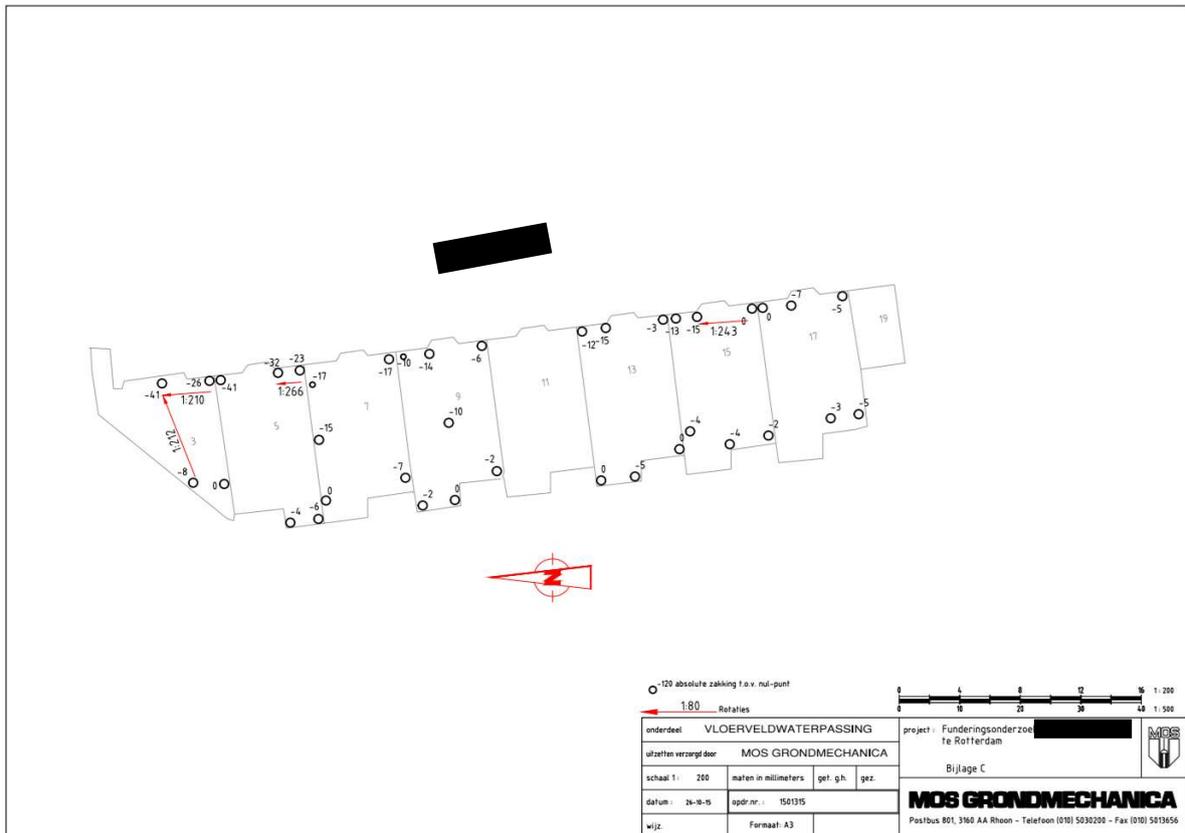
Figure 39 Level measurement for floor Case Study Block C

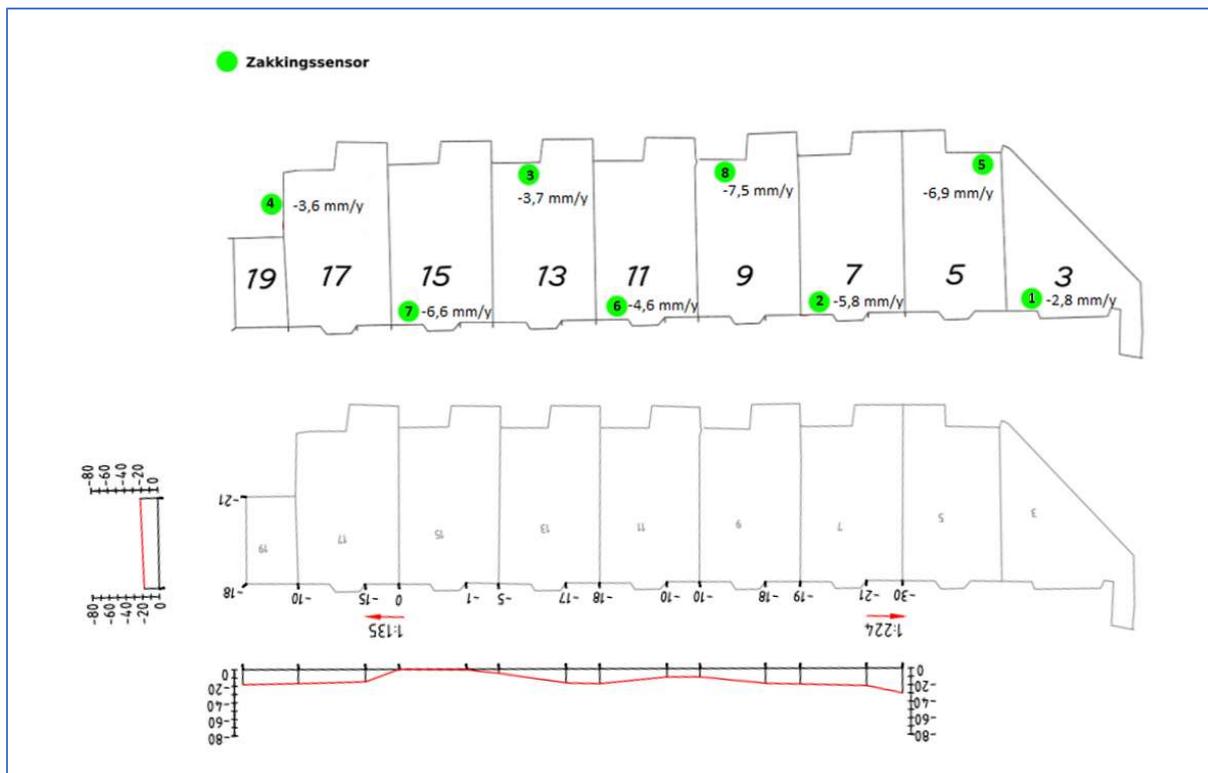
Figure 40 Comparison level measurement for masonry and sensors

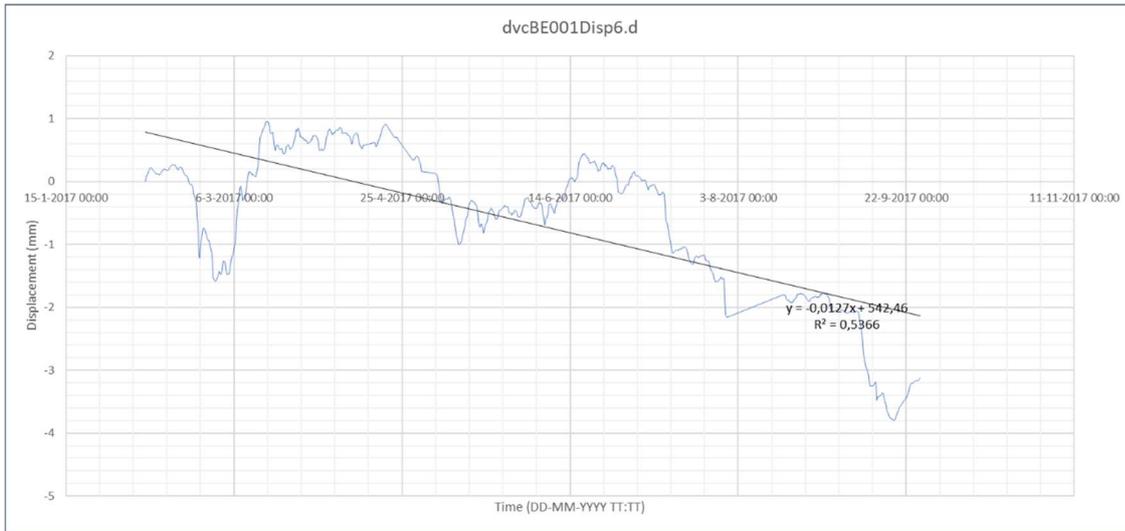
Sensor 7: -3,28 mm/½year ≈ -6,56 mm/year

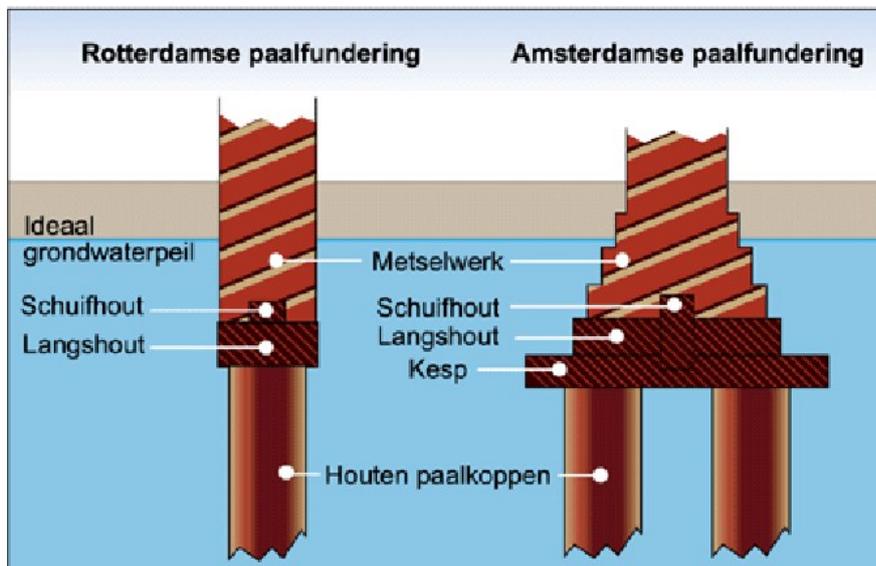
Figure 41 Schematic wooden pile foundation (Source: Platformfundering.nl)

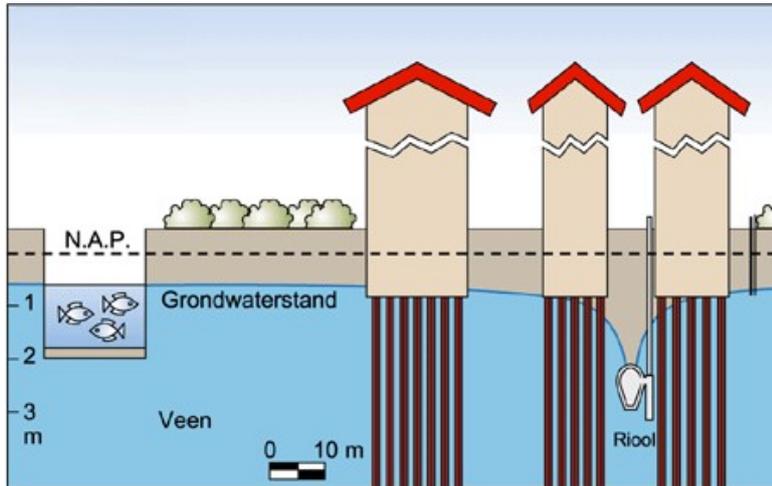
Figure 42 Leaking sewerage lowering groundwater table locally (Source: Platformfundering.nl)

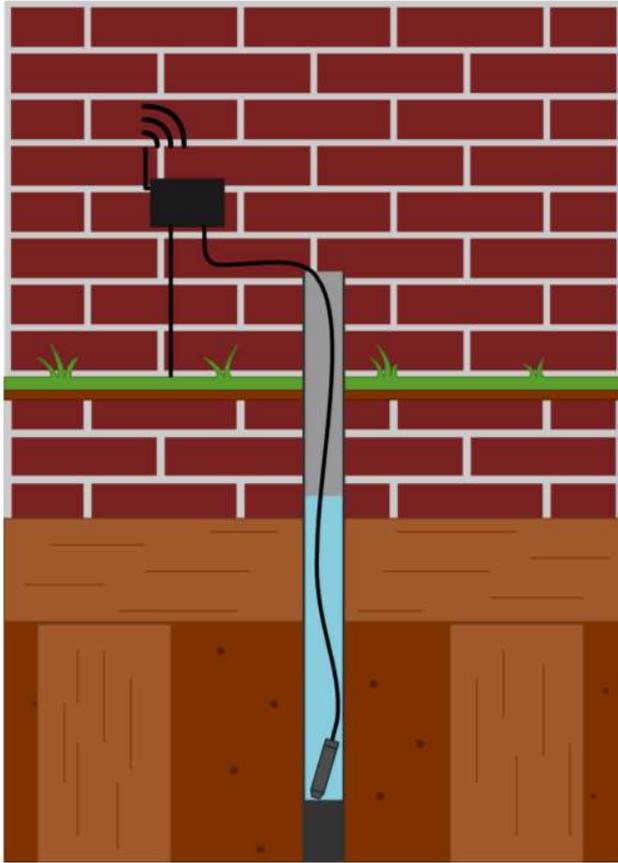
Figure 43 Schematic view of the hydrostatic pressure sensor (Source: Omnifor)

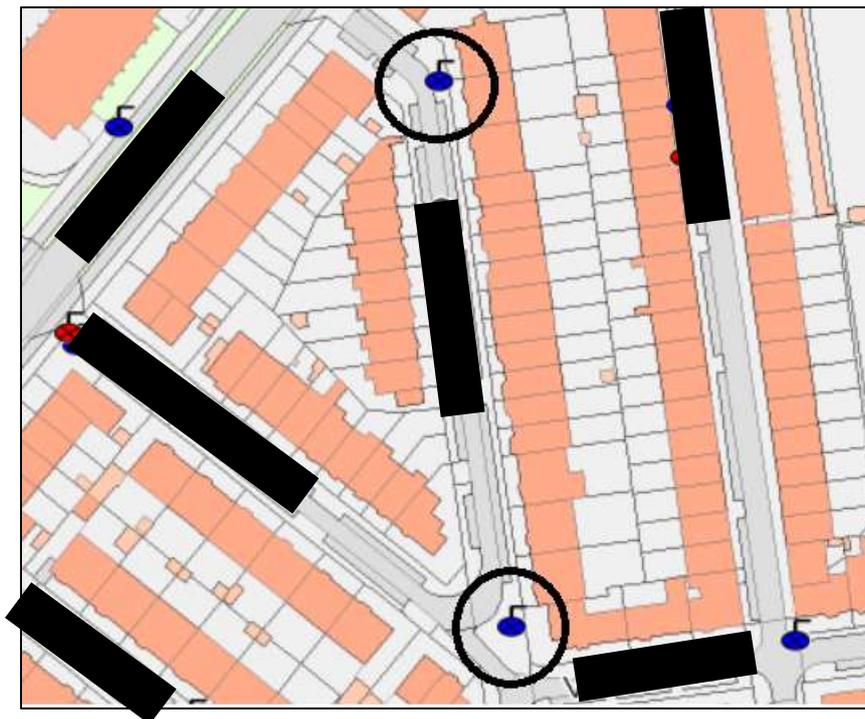
Figure 46 Location of the monitoring wells

Important to note is the location of these sensors. In order to get a complete picture of the groundwater level around the building block, at least one sensor needs to be located in front of the block. Factors like raisings and sewerage systems can have great influence on the groundwater table. The location of the monitoring wells is given in the next map.

There are a few things to consider when the groundwater level is measured. In Rotterdam, there can be a high fluctuation in groundwater level in very small areas, since clay prevents the flow of the groundwater (Hebing B. , 2018). Since the measuring period is not covering an entire year, seasonal influences cannot be derived. As noted earlier, the sewerage system has been renewed in 2015.

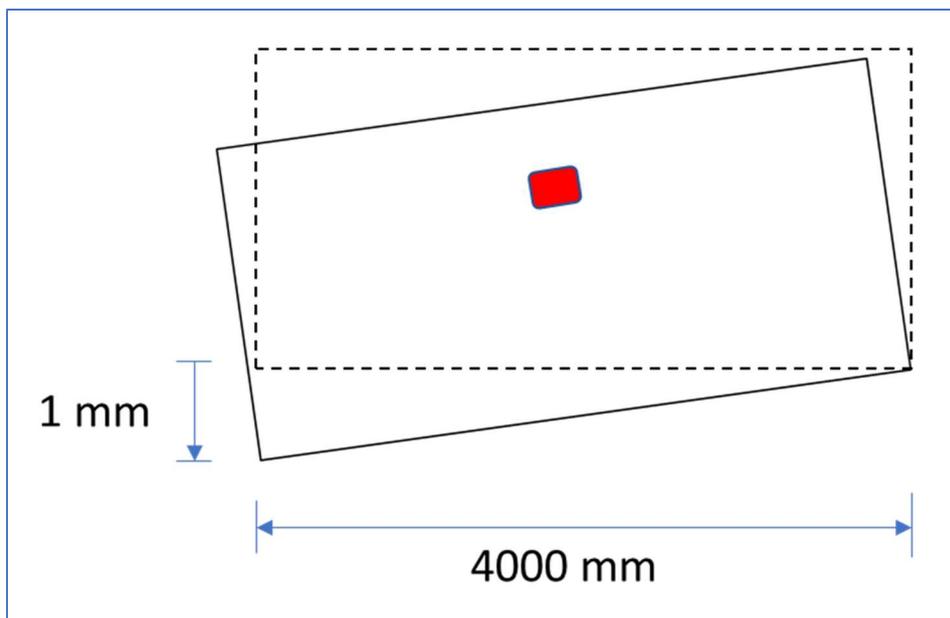
Figure 47 Error margin tilt sensor

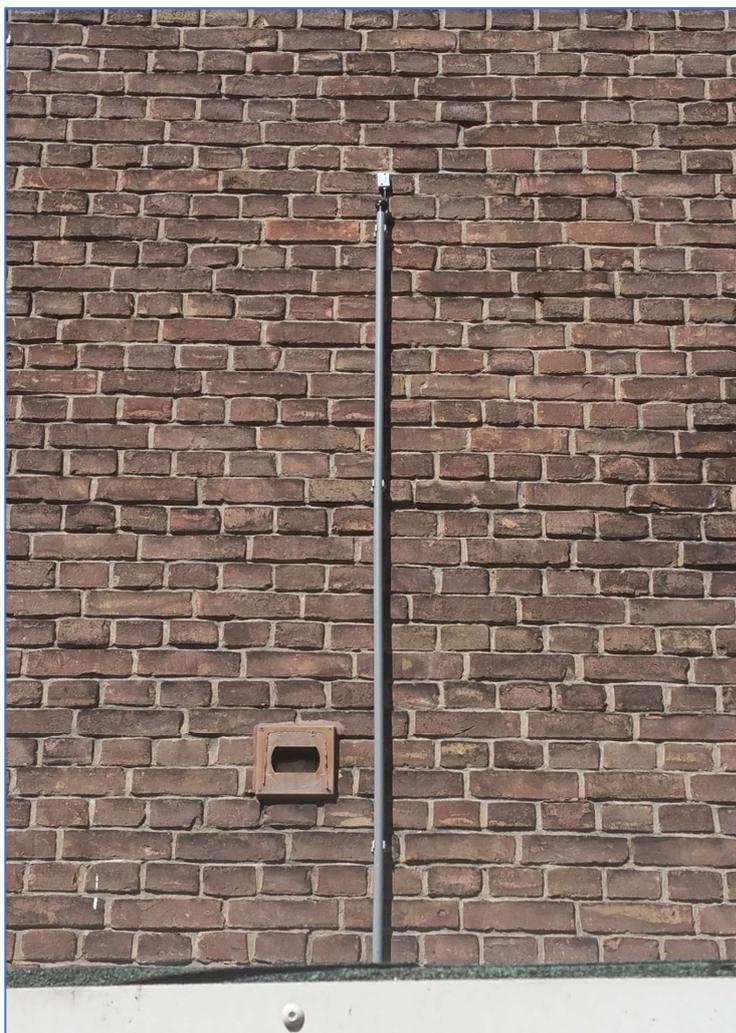
Figure 48 Placement of tilt sensor Case Study Block C, Rotterdam

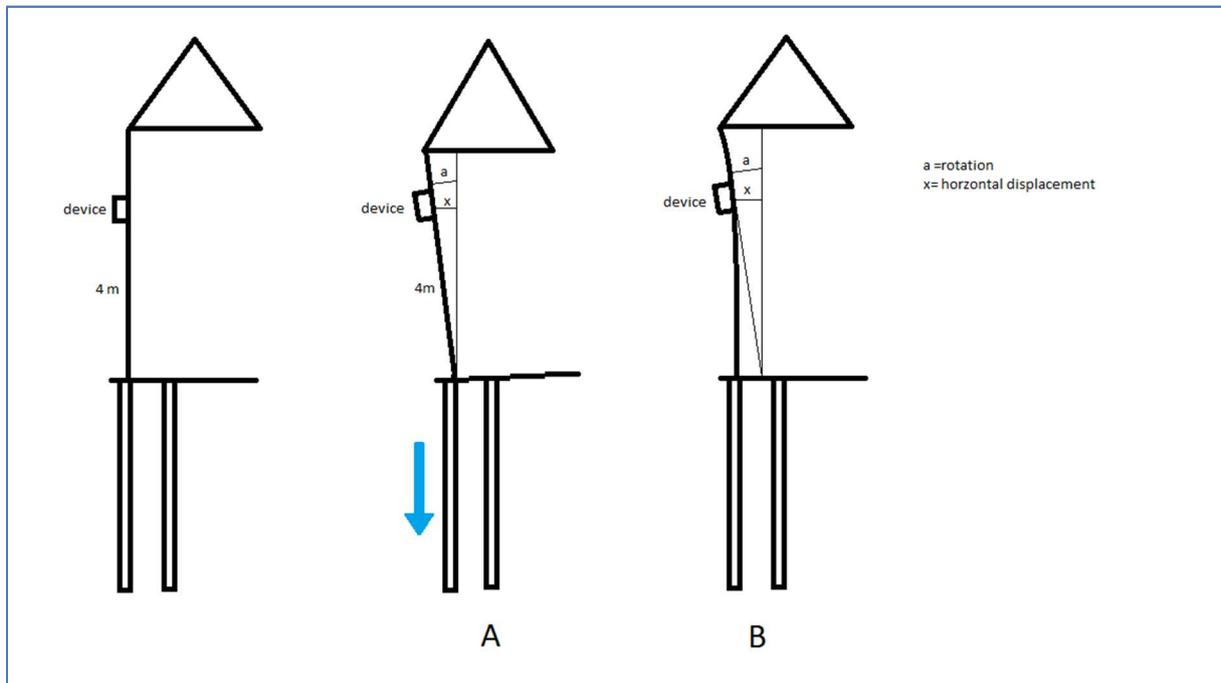
Figure 49 Sketch of possible rotation measurements

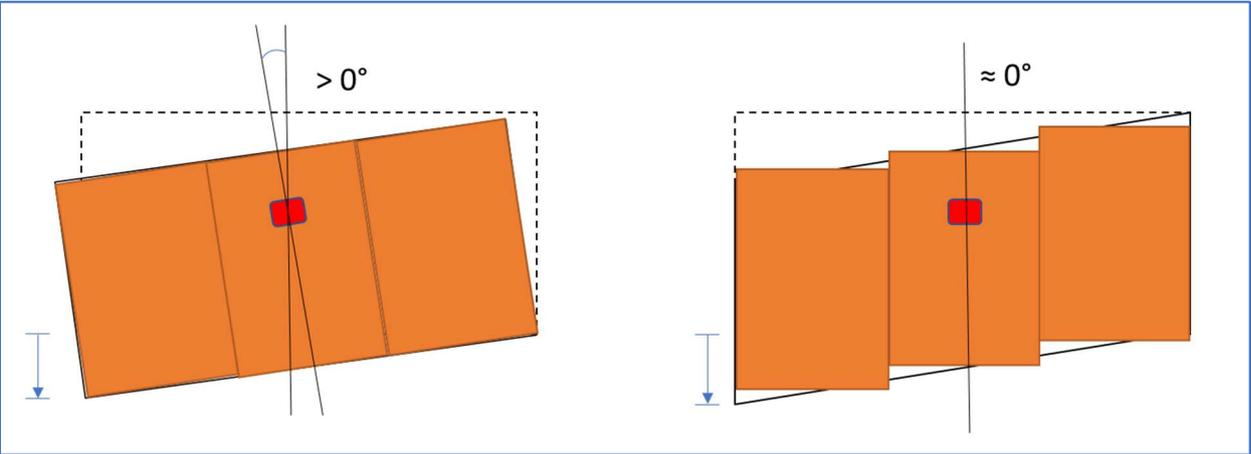
Figure 51 Observed rotation in relation to stiffness
