Exploring the possibilities of structural cast glass in the consolidation of historic buildings

Master of Science
in Building Engineering, Structural Design,
Faculty of Civil Engineering

The search for a transparent, reusable, innovative, architecturally aesthetical, structural material that could be used as consolidation system for decayed historic buildings led to the ambition to test a topological interlocking (osteomorphic) design by using numerical calculations. In the last decennia glass has evolved to be a structural material that could be implemented in diverse structural elements. The mechanical properties of glass, in particular the high compressive strength, offer today a competitive solution that can be used for the purpose of restoration, allied to its transparency and aesthetics. The use of glass as a material is also aligned with the recommendations laid down by the international agreements for restoration. Due to its transparency it allows the ruin (Schaesberg Castle) to be perceived in its damaged state keeping the identity and at the same time being distinguishable from the original material in a subtle and immaterial way.

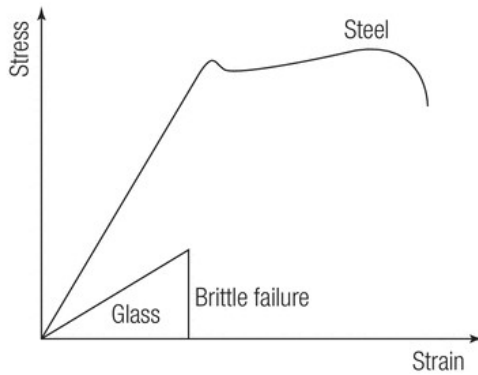
Figure 3- Stress/Strain behaviour for steel and float glass
Retrieved from (O'Reagan, 2015)

When comparing glass with other structural materials like steel, the latter is ductile, it can yield and deforms plastically. Glass behaves almost perfectly elastic until it breaks unpredictably (Fig. 3), cannot plastically deform which means it gives no warning before collapse, giving no chance for replacement before it completely loses its coherence and falls apart. That's not a good feature to have in a structural material (Nijse, 2003). Fortunately, due to the great interest in glass as a structural material, there has been a huge advance in the last twenty years and there are many ways to give glass the strength and protection it needs to be a structural material and compete with the ones on the market today. More on that in chapter 2.1.3. (Safety).

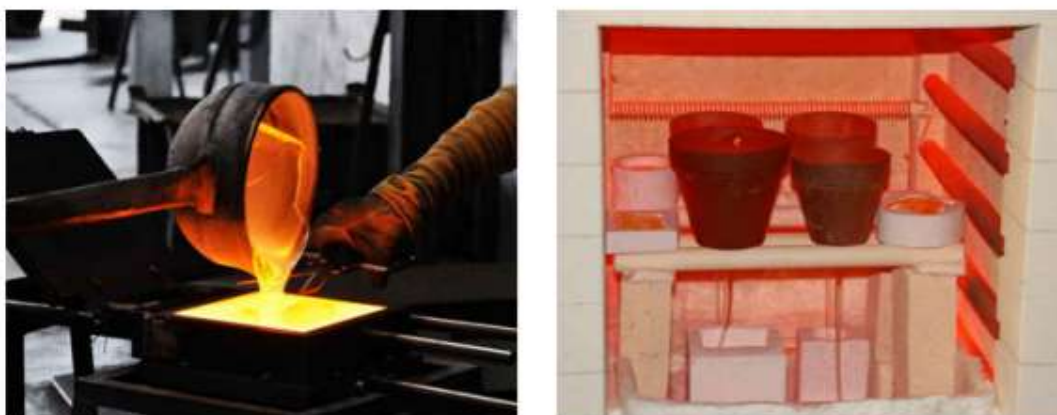
Figure 5- Hot pour (left), kiln-cast (right) (Oikonomopoulou, 2019)

may be used for the most affordable outcome, as the employment of disposable moulds is possible, also custom made objects are easier and more affordable to make with this method. The hot pour is generally used for quality, standardized, repeatable elements with metal moulds, press metal moulds or adjustable metal moulds (see Fig. 6). 3d print is also an option, although the quality of the end product is not as good. The research made in cast glass also put in evidence that there is more investigation needed in order to become more affordable and sustainable. Affordable by improving the production process and time of manufacturing (less time spent in annealing). Sustainable by using disposable glass from used utensils in the daily life (glasses, windows and so on) which are not really being used in its full capacity. Most of the trashed glass is in fact, never re-used and just a small percentage is recycled with the most ending up in landfills. Glass can be endlessly remelted without the loss of strength, transparency, quality, and hence it is a pity it's not being used for more things, like structural materials. Telesilla Bristogianni has been studying that since some years (Bristogianni *et al.*, 2018) The kiln casting has been used in research for more custom made elements, like the interlocked cast elements. More on that in the following chapters.

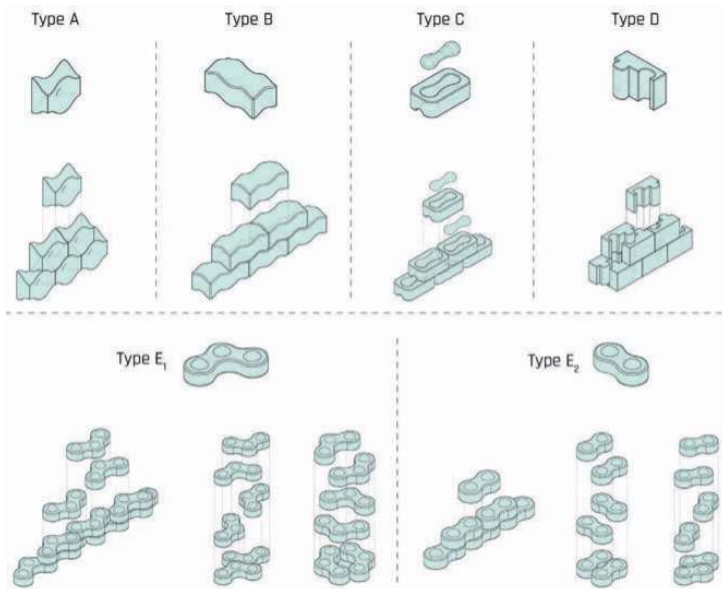
Figure 12- Comparison of different types of interlocking blocks retrieved from (Oikonomopoulou, 2019)

Other conclusions can be drawn from studies like the lower bending rigidity than a monolithic system because of the blocks acting independently and not being bonded to each other and can rotate under bending which continuously diminishes the contact area in the course of loading (Dyskin, Estrin and Pasternak, 2019). In this case the shear locks also help to keep the units in place and act against delamination, at blocks interfaces, or a constraining structure, can also help in that sense. The soft interlayer between units gives extra compliance and ductility which for brittle materials such as glass is very important. This system if topological interlocked has furthermore, a high tolerance to local failure (Oikonomopoulou, 2019). In research it is proved that the percolation of 25% of the blocks is allowed until it reaches collapse (Dyskin, Estrin and Pasternak, 2019). Blocks follow a concave convex geometry which allows them to establish a self-lock whilst remaining free of stress concentrations. In plane and out of plane movement is in this way, prevented by its neighbours without the need of connectors or glue (binders) (Oikonomopoulou, 2019). Another feature of this system is, the enabling of some restricted movements of the units relative to each other. This is very important and useful in earthquake prone areas, in which the vibration energy is dissipated due to the friction between the moving surfaces avoiding cracking. The most promising form type of Lego like elements are the Osteomorphic units type A and B used in studies (see Fig. 13). By comparing them (on Table 5), these shapes offer the highest shear capacity by restraining movement in two perpendicular directions, the self-alignment capacity is very high too, by its concave, convex shapes, the equal mass distribution is effective allowing a homogeneous annealing and less probability of inhomogeneous shrinkage. The limited number of units which facilitates in the logistics, manufacturing and assembling is also another good feature. Together with the symmetry of the blocks, for type B in both directions eases the possibilities and flexibility in construction. For instance the units can be used in corners, columns or double layers. That symmetry promotes, furthermore the centric load bearing capacity avoiding excessive bending moment stresses.

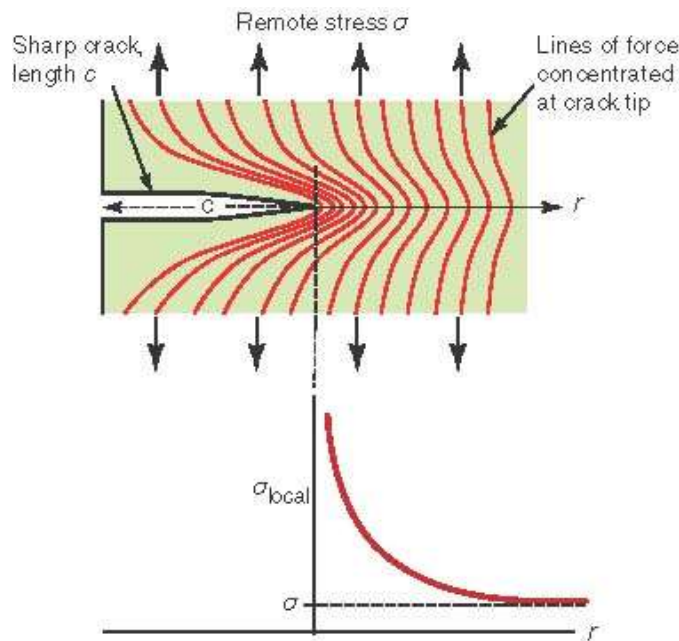
Figure 13- Local peak stresses caused by a crack (Veer, *Structural glass classes 2019*)

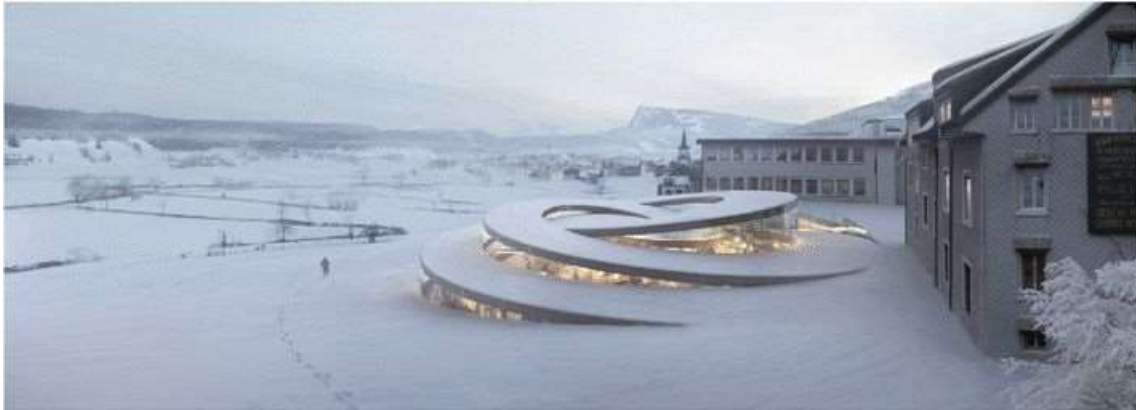
Figure 16- All glass load bearing spiral glass wall of “La maison des fondateurs” (the founders house), BIG architects and Lüchinger + Meyer structural engineers, 2018, Brassus Switzerland retrieved from (VILLIGER ET AL., 2019)

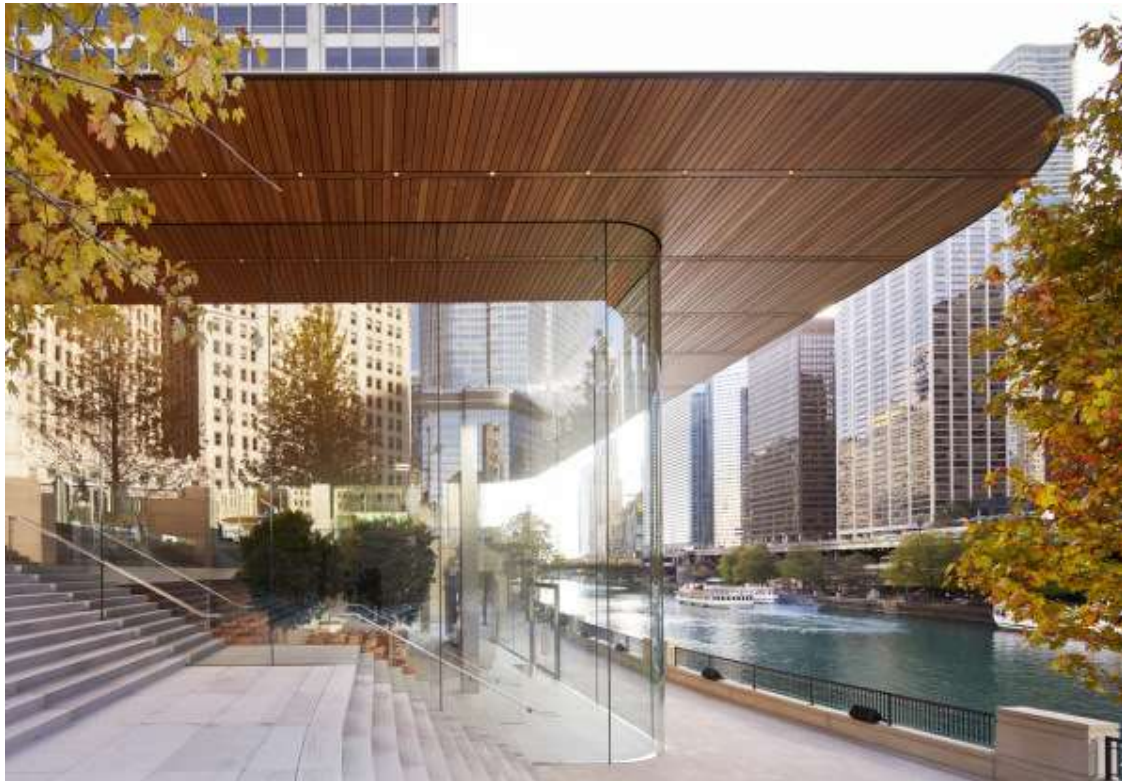
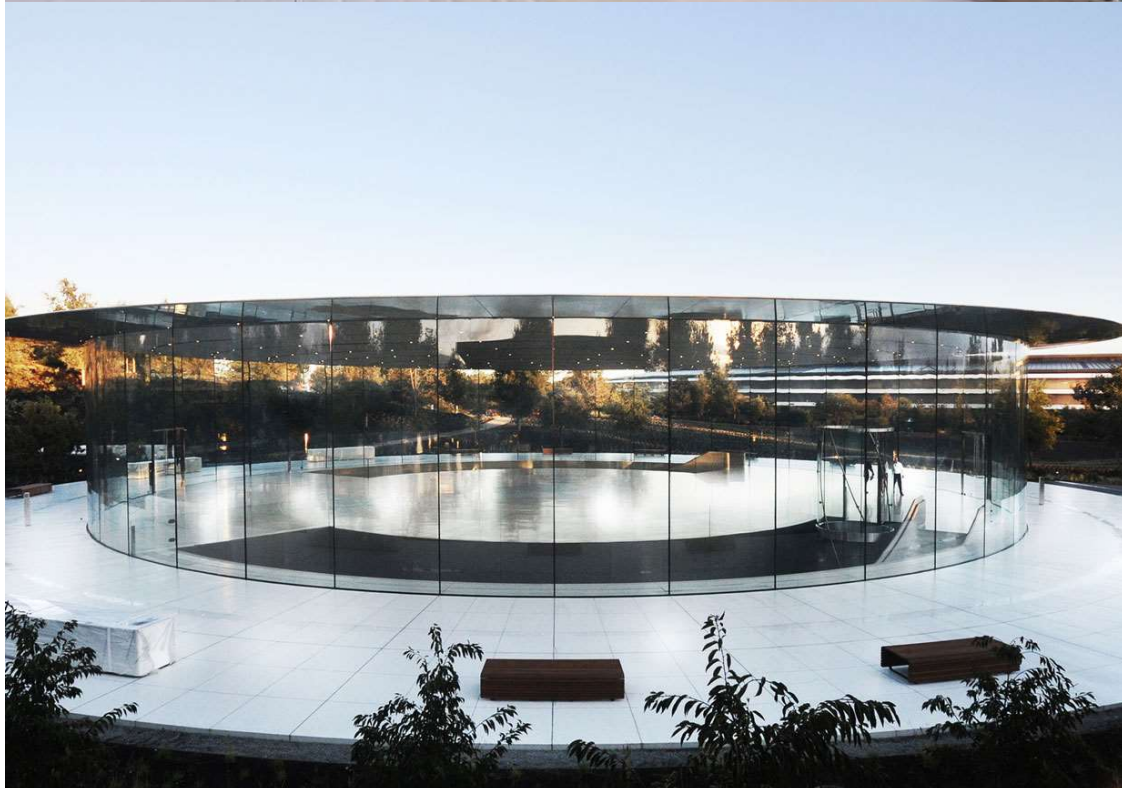
Figure 17- Above: Apple store, Foster+partners and eocengineers, 2017, Chicago, USA, below: All self-supporting glass wall, Steve Jobs pavilion Apple park, Foster+partners and eocengineers 2018, Cupertino California, USA retrieved from dezeen.com

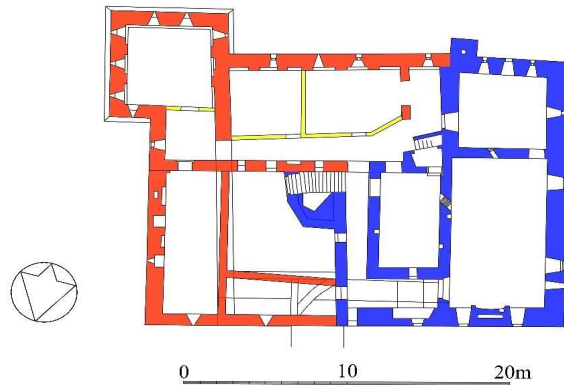
Figure 38- Representation of the two phases of the castle, the blue from 1571 and the red from 1616 (Viersen, 2014)

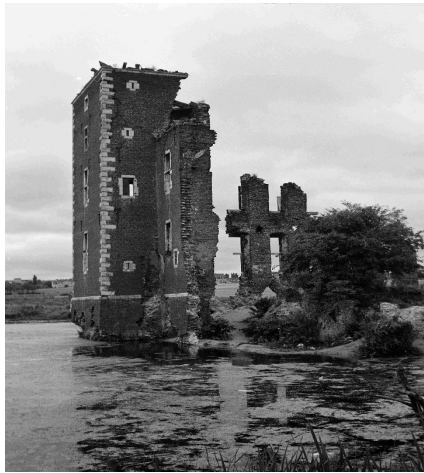
Figure 41- Overview of the Castle in 1974 retrieved from (Viersen, 2014)

Fig. 41 shows the overview of the castle in the late summer of 1974, just before the southeast corner of the tower collapsed on December 26. At the northeast corner it is visible that the brickwork at the height of the waterline and above had already been restored once. This photo clearly shows why so little brickwork remained at the start of the work. By cleaning the canals and omitting a protective slope on the facades, the remaining existing façade at the level of the water line was calved down, eventually resulting in collapse as it can be seen on the picture above.

Two main consolidations were done recently. The first in 1975 by the former Tu Delft (TH Delft). Unfortunately they never issued a report and therefore much of the information is unsure. There was also a previous restoration done but there is however not much information available than a picture from 1974 (see Fig. 41). The second consolidation started in 2014. For this there was an archaeological research made before (Viersen, 2014) which gave information of the present state of the Castle and also of the consolidation made in 1975. The institution “Bureau voor bouwhistorie en architectuurgeschiedenis” (BBA-office for construction history and architecture history) made the assessment of all the information and produced a report where I based my research for the 1st consolidation. The pictures are also part of the report.

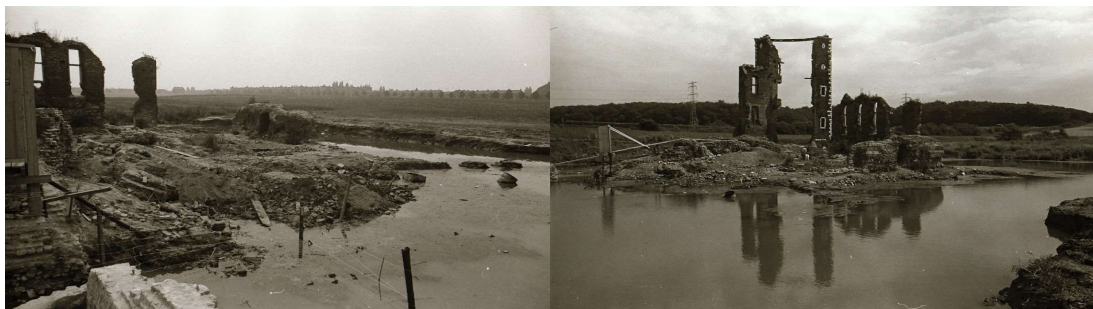
Figure 42- Overview of the castle at the start of the works in 1975. It can be seen that almost nothing remained above the canal level. The fragment of the west facade is the only part of the castle, of which something has been preserved above the water level. This means that

almost all of the currently visible brickwork in this part of the castle is part of the consolidation work (Photo: Hukkelhoven, Heemkundevereniging, (Viersen, 2014))

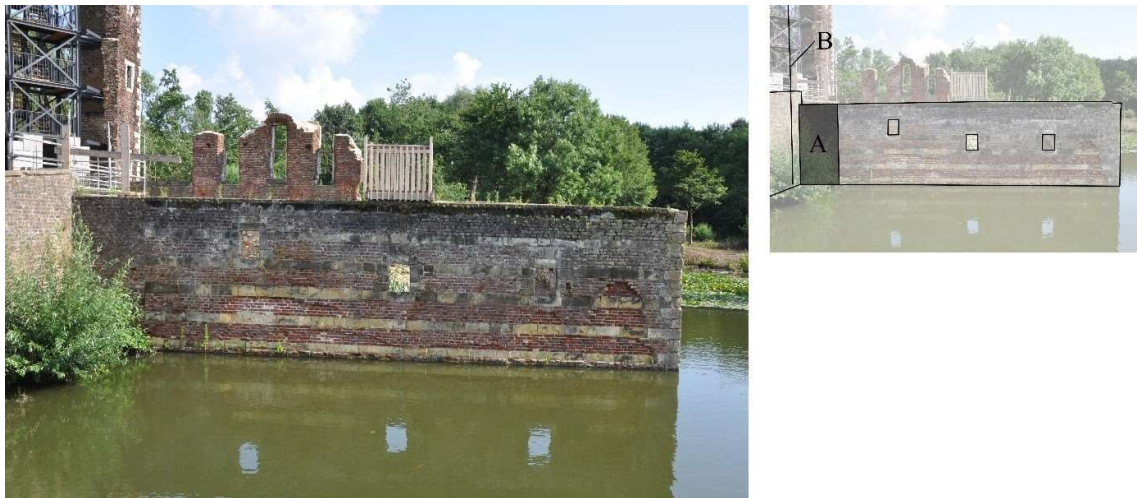
Figure 43- Actual overview of the castle, north façade retrieved from (Viersen, 2014)

As it is depicted in the picture above, one can see that all the brickwork visible here from the north façade was created during the consolidation. In the picture in the right corner a comparison of colours shows the difference between the consolidation and the remaining existing part (original elements). A vertical seam located at (B) suggests the location of the east façade of the west wing. By raising the foundations to the basement level, the main shape of the castle has become recognizable again. It is clear, however, that little of the original brickwork on the west and north side of the ruins has been preserved.

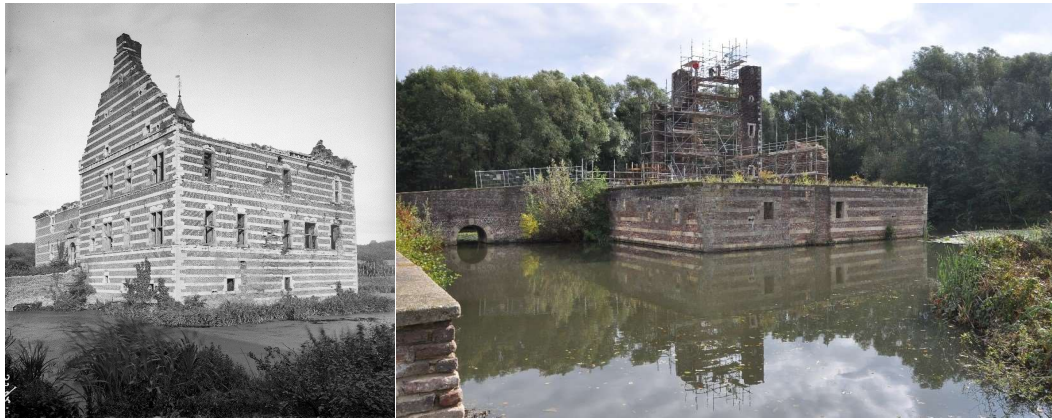
Figure 44- The castle in 1919, in comparison with the situation in 2014. Although the roofs and parts of the façades had been lost in the meantime, the castle was at that time in a considerably better condition than at the start of the recovery in 1975. (Photo: RCE) (Viersen, 2014)

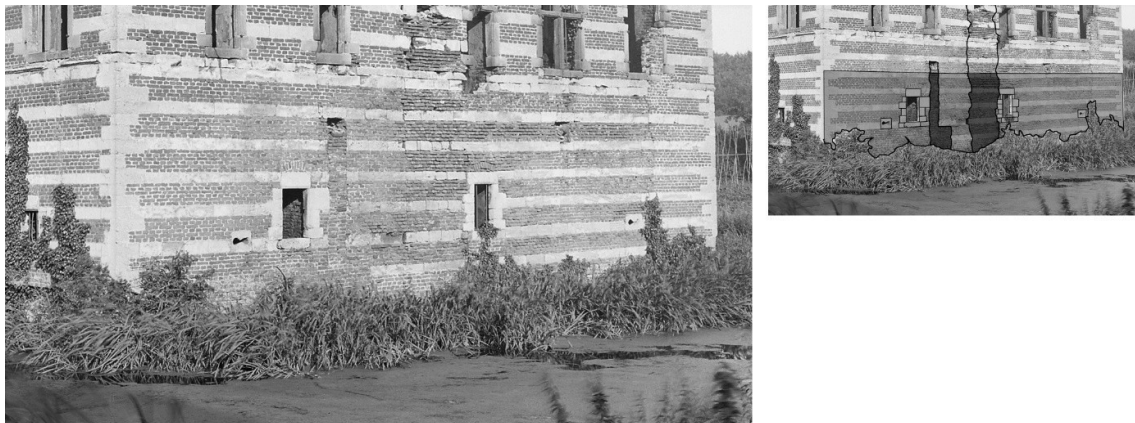
Figure 45- Overview of the castle, west façade on 1919, (Viersen, 2014)

This picture depicts the detail of a photo taken in 1919 of the castle west facade. Light grey shows the part of the facade that was restored in 1975, dark grey shows the original brickwork. The contour of the façade was quite irregular which contrasts with the current situation, where the irregularity was made tight and straight. The size and location also deviate slightly from the original.

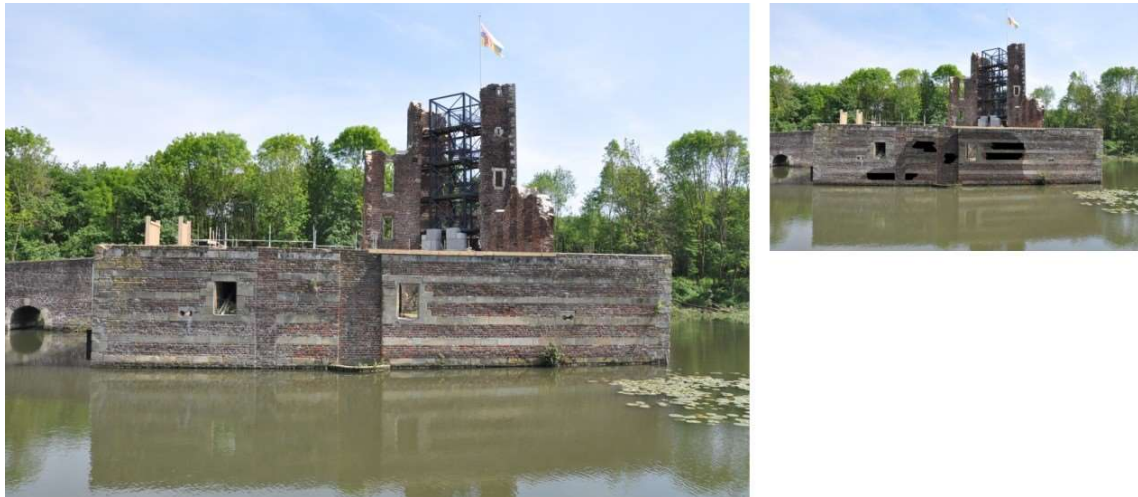
Figure 46- Actual overview of the castle, west façade, (Viersen, 2014)

When the façades were repaired, the brickwork was raised to the basement level. The existing remnants of the west façade have been incorporated into the new brickwork here. The part where the original façade surface is still present is shown in dark grey. Given the poor accessibility of the facade, this could not be determined at the moment of the archaeological research. Internally, a big part of the brickwork is still authentic. When reconstructing the facade, use was made of part of the original window frames that were found during the excavation of the canals. The masonry of the new facades consists of a rough stack of concrete blocks, with on both sides a covering of field fire bricks with alternating layers of marl.

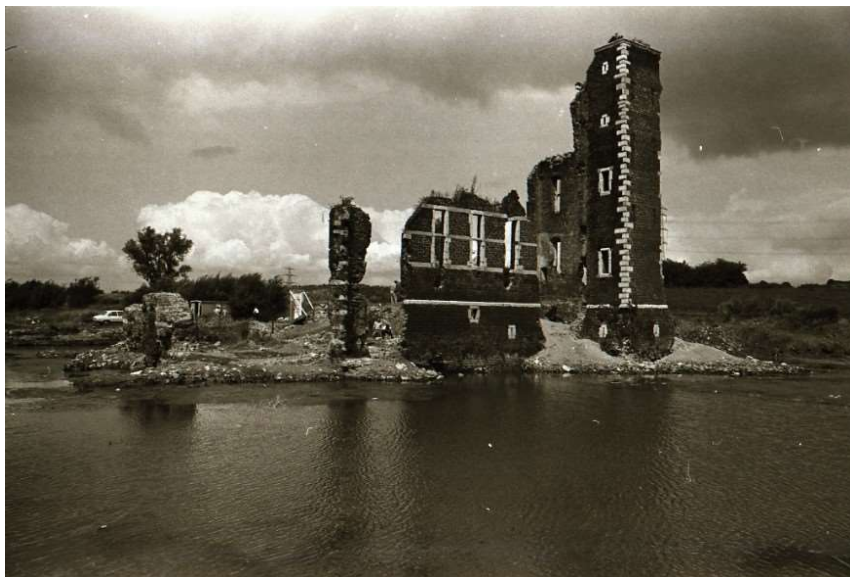
Figure 47- Overview of the ruin, seen from the south at the time of the excavation. The upper part of the narrow and high fragment on the left side of the still preserved part of the south façade is no longer present. (Photo: Hukkelhoven, Heemkundevereniging, (Viersen, 2014)

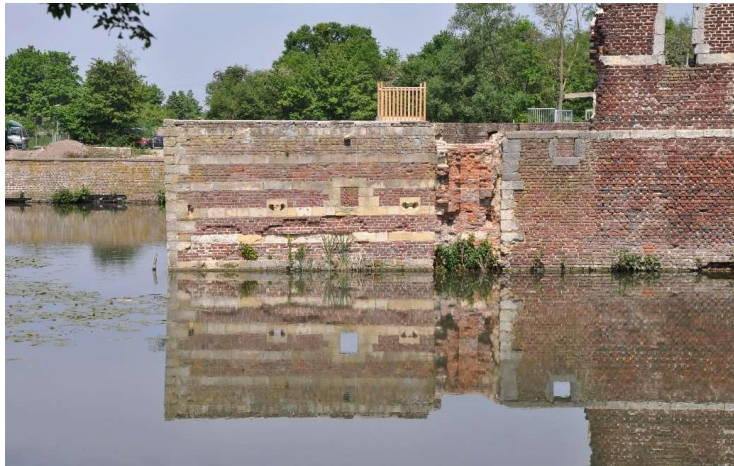
Figure 48- Overview of the castle south façade, western part, (Viersen, 2014)

The picture above (Fig. 48) shows the western part of the south facade. In 1975 this part collapsed to the level of the water by then. All the brickwork visible here was created therefore during the consolidation of 1975 and afterwards. The brickwork used for erecting the walls consists of a core of concrete blocks with on both sides a half-brick heavy clamp of field fire bricks with alternating layers of marl. Due to presumably moisture and frost action on this brickwork, parts of the brick jumped off, that can be seen on the picture above. The alternating layers of marl have completely disappeared locally, making the mortar and concrete blocks of the core visible. This damage is also present on the north façade.

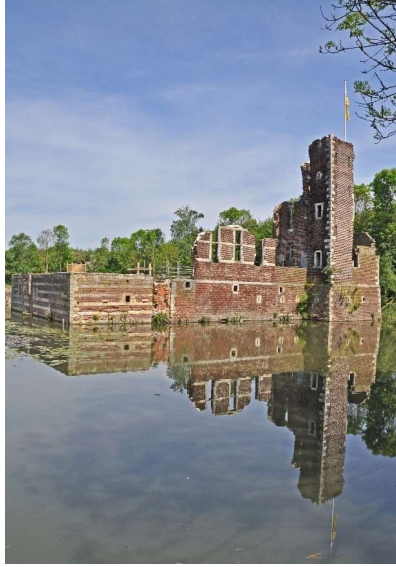
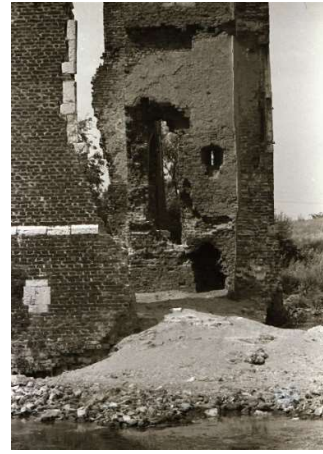
Figure 50- Left: the castle, seen from the southwest. The west facade of the tower is almost entirely original. Right: the south facade of the tower before it was consolidated. Shortly before taking this photo, the southeast corner of the tower collapsed. The basement is still partly filled with debris. On the outside, the masonry was heavily damaged by watering. The masonry of the outer wall has probably been lost below the water level. On the inside, the brickwork has been preserved up to about a meter above the level of the basement. If the canal had not been dug out in the 1950s, the corner of the tower would probably not have collapsed. (Photo: Hukkelhoven, Heemkundevereniging, (Viersen, 2014))

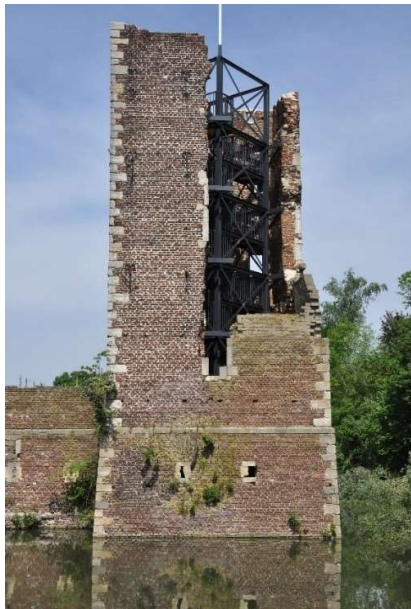
Figure 51- Overview of the castle tower, south façade, (Viersen, 2014)

The picture above (Fig. 51) shows the south facade of the tower. (A) depicts the original brickwork. (B) shows the masonry added by the consolidation works of 1975. Attending the fact that during the restoration of 1975 the field fire bricks were used up earlier than the concrete blocks, the brickwork of the concrete blocks protrudes above the rest of the

brickwork. Traces of older repairs can be recognized on the underside of the original part of the facade.

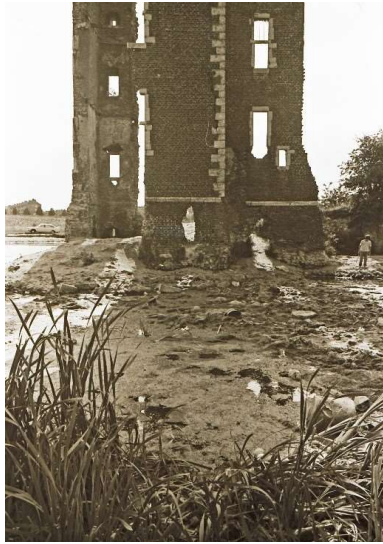
Figure 52- The lower part of the tower, viewed from the east, shortly after the southeast corner collapsed. The adjacent part of the east facade is also visible here (Photo: Hukkelhoven, Heemkundevereniging, (Viersen, 2014)

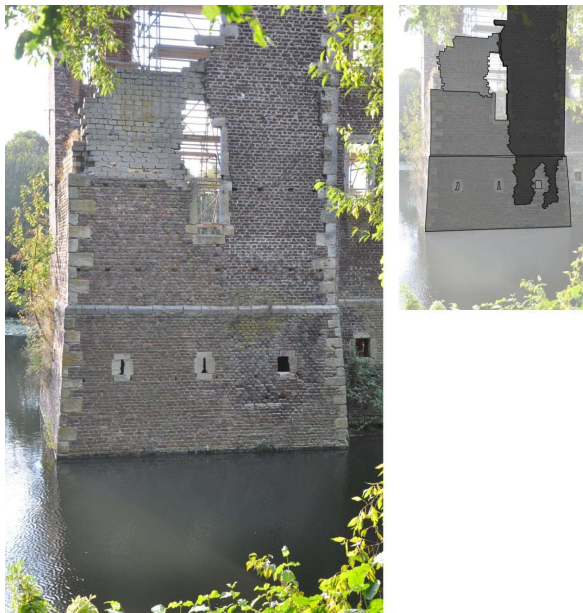
Figure 53- Overview of the castle tower, east façade, (Viersen, 2014)

The picture above shows the east facade of the tower in 2014. With dark grey, are those parts of the tower, which were assumed by BBA as part of the original design. The light grey colour indicates those parts that were created during the repair work of 1975 and thereafter. After the research carried out by TH Delft, in 1975, a recovery plan was drawn up under the leadership of the TH with Ingenieursbureau Oranjewoud. Part of it was the partial reconstruction of the recently collapsed corner of the tower, by erecting a core of concrete bricks with a half-brick cleat of field fires on both sides. Brick laying continued until the

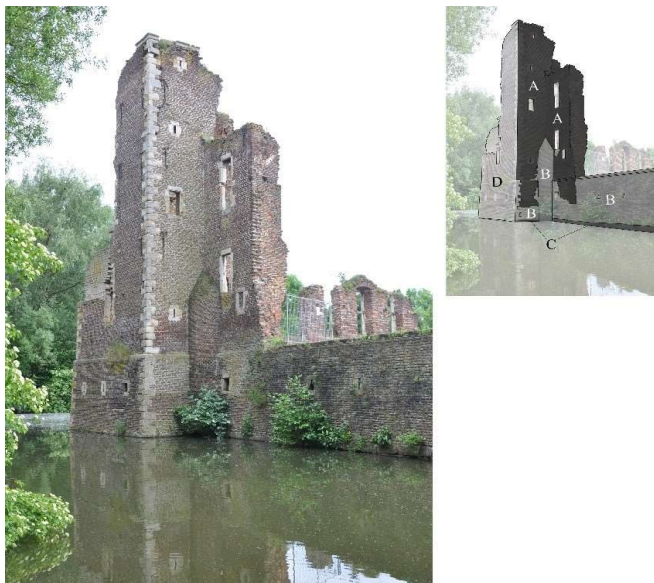
Figure 55- Overview of the castle tower ruins, north façade, (Viersen, 2014)

The picture above show the north façade of the tower remnants with the adjacent part of the east façade. As depicted on the picture, the original brickwork can be found at (A). The restoration work is indicated by (B). On the underside of the wall at the waterline, a strip of natural stone is included at the facade brickwork (C). It is not known whether this brickwork is still original or it was realized during the consolidation work. Facade (D) (east facade) has already been described previously.

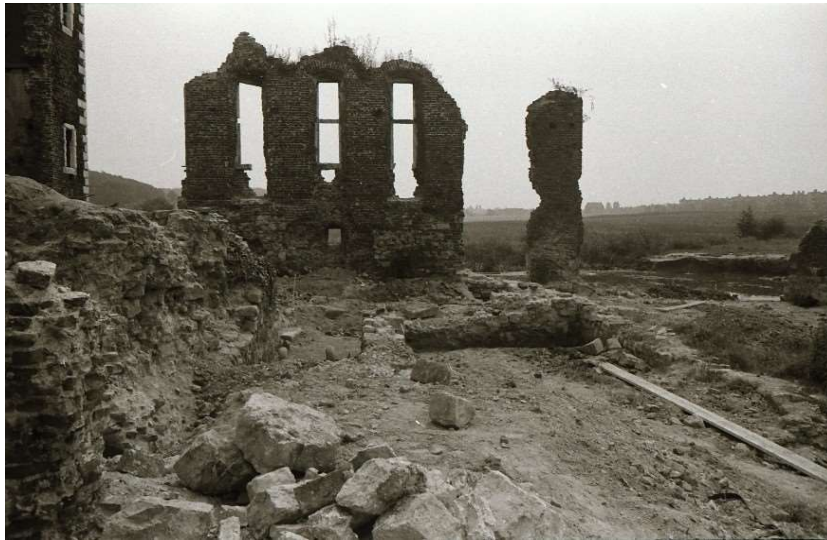
Figure 56- Overview of the interior of the castle, facing south. The remaining part of the south facade is visible at the background. The formless brickwork on the far left is from the wall, which now borders the part covered with a concrete slab on the west side. The photo would have been taken in 1975. (Photo: Hukkelhoven, Heemkundevereniging, (Viersen, 2014)

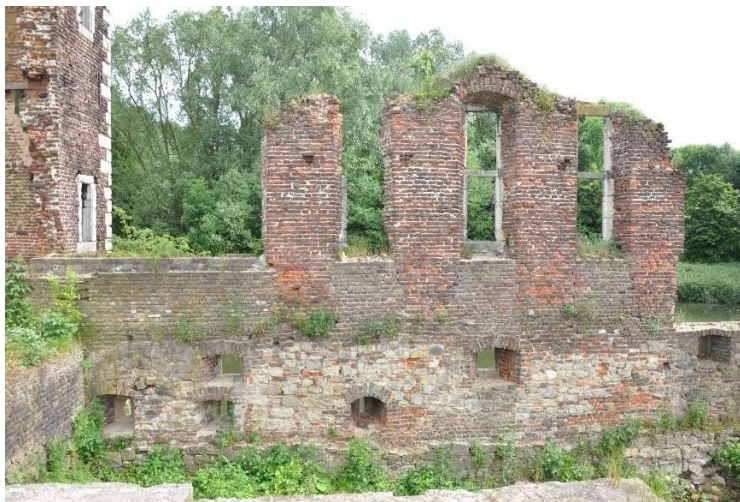
Figure 57- Overview of the south façade of the castle, eastern part seen from the north, (Viersen, 2014)

The picture above shows the overview of the eastern part of the south facade, seen from the north side. The dark grey part (A) indicates which parts of the façade's surface still belongs to the original design. The light grey part (B) concerns the brickwork, which was added during the 1st consolidation (1975). A standing tooth (C) is just visible on the right-hand side which probably gives indication that an intermediate wall was there. Also at (D) the concrete blocks can be seen, which protrude above the level of the reconstructed brickwork. At (E) a standing tooth in the south façade has been kept to indicate also the location of the intermediate wall.

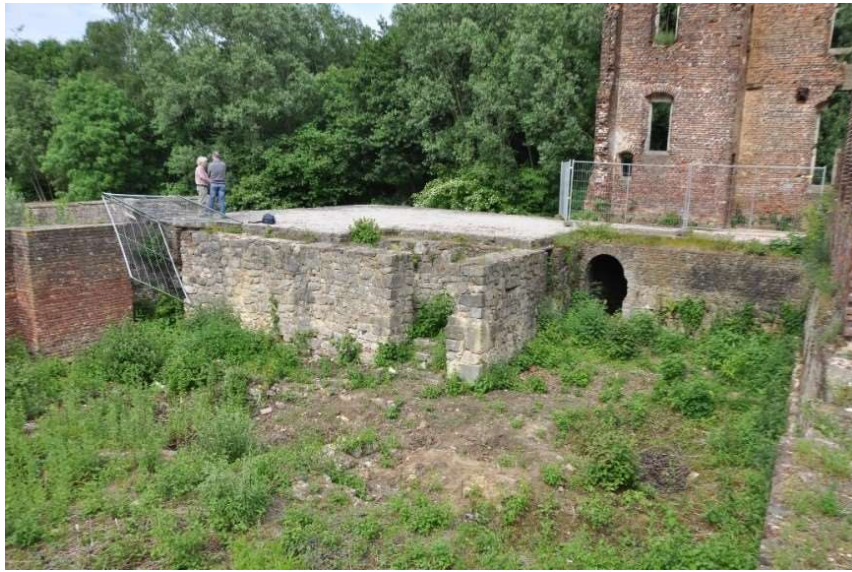
Figure 58- Overview of the largely reconstructed (rebuilt) brickwork that forms the walls of the former courtyard. Only on the underside of the walls there are some layers of the original masonry. The lower steps of the stairs are also original. (Viersen, 2014). See also the following image (Fig. 60).

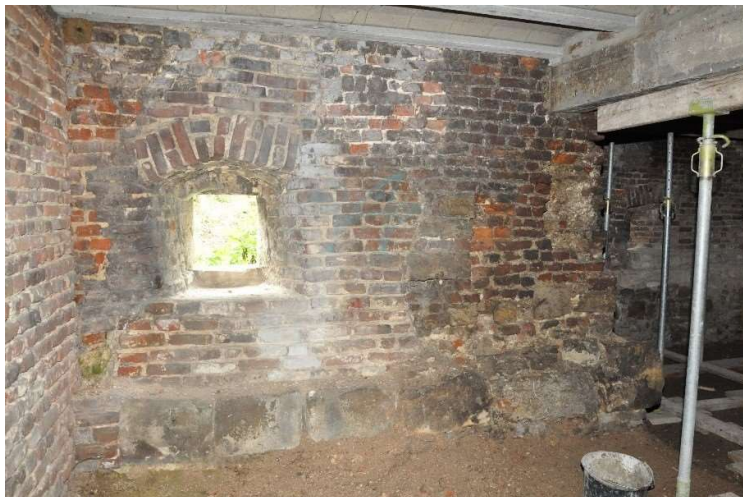
Figure 59- Overview of the tower cellar room, east wall, (Viersen, 2014)

The picture above shows the overview of the east wall of the tower cellar. At (A) the original cover of the brickwork can be seen. The brickwork at (B) is new, but partly still contains original work behind.

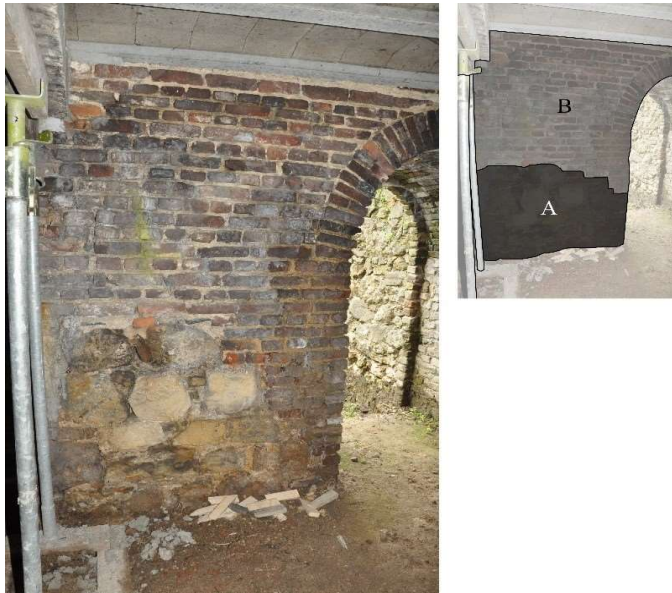
Figure 60- Overview of the tower cellar room, west wall, (Viersen, 2014)

The figure above shows the west wall of the cellar room with the original masonry at (A) and the masonry at (B), which was created during the consolidation.

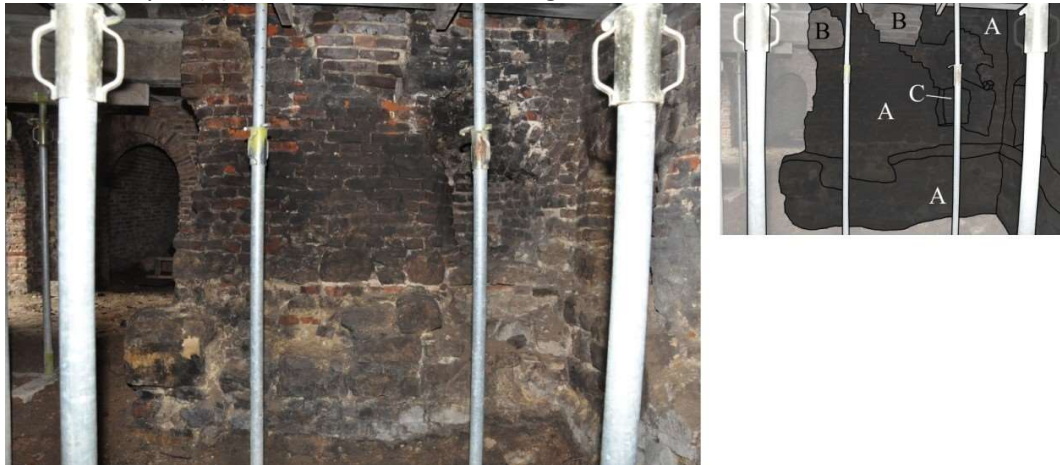
Figure 61- Overview of the tower cellar room, north wall, (Viersen, 2014)

The figure above is the overview of the north wall of the room within the tower. This wall is mostly original. The original brickwork at (A) is depicted with dark grey. The masonry created during the consolidation is indicated by (B) light grey. The opening at the wall (C) has already been closed once in the past. This happened before the 1st consolidation (of 1975).

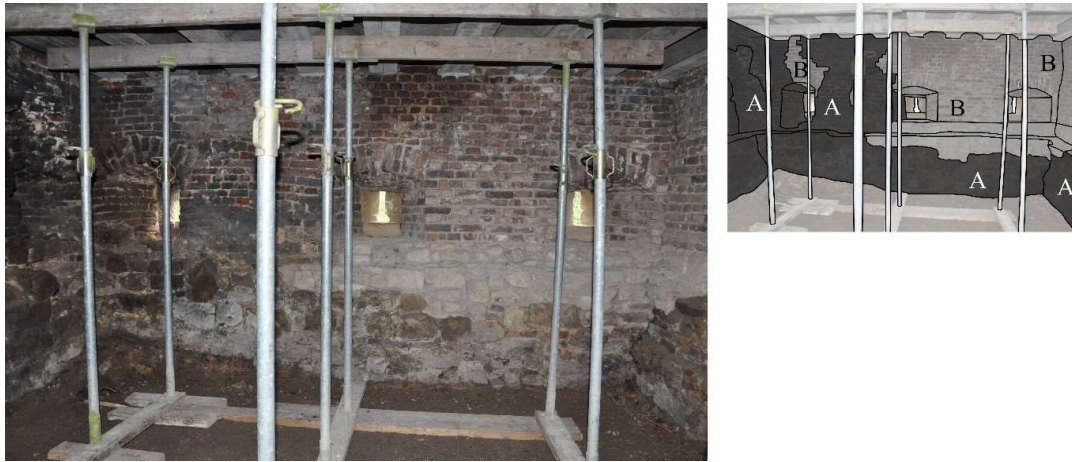
Figure 62- Overview of the tower cellar room, east wall, (Viersen, 2014)

The figure above shows the overview of the east wall of the tower cellar room. At (A) the brickwork that is still original is shown and (B) depicts the brickwork that was created during the consolidation work and shortly after 1975.

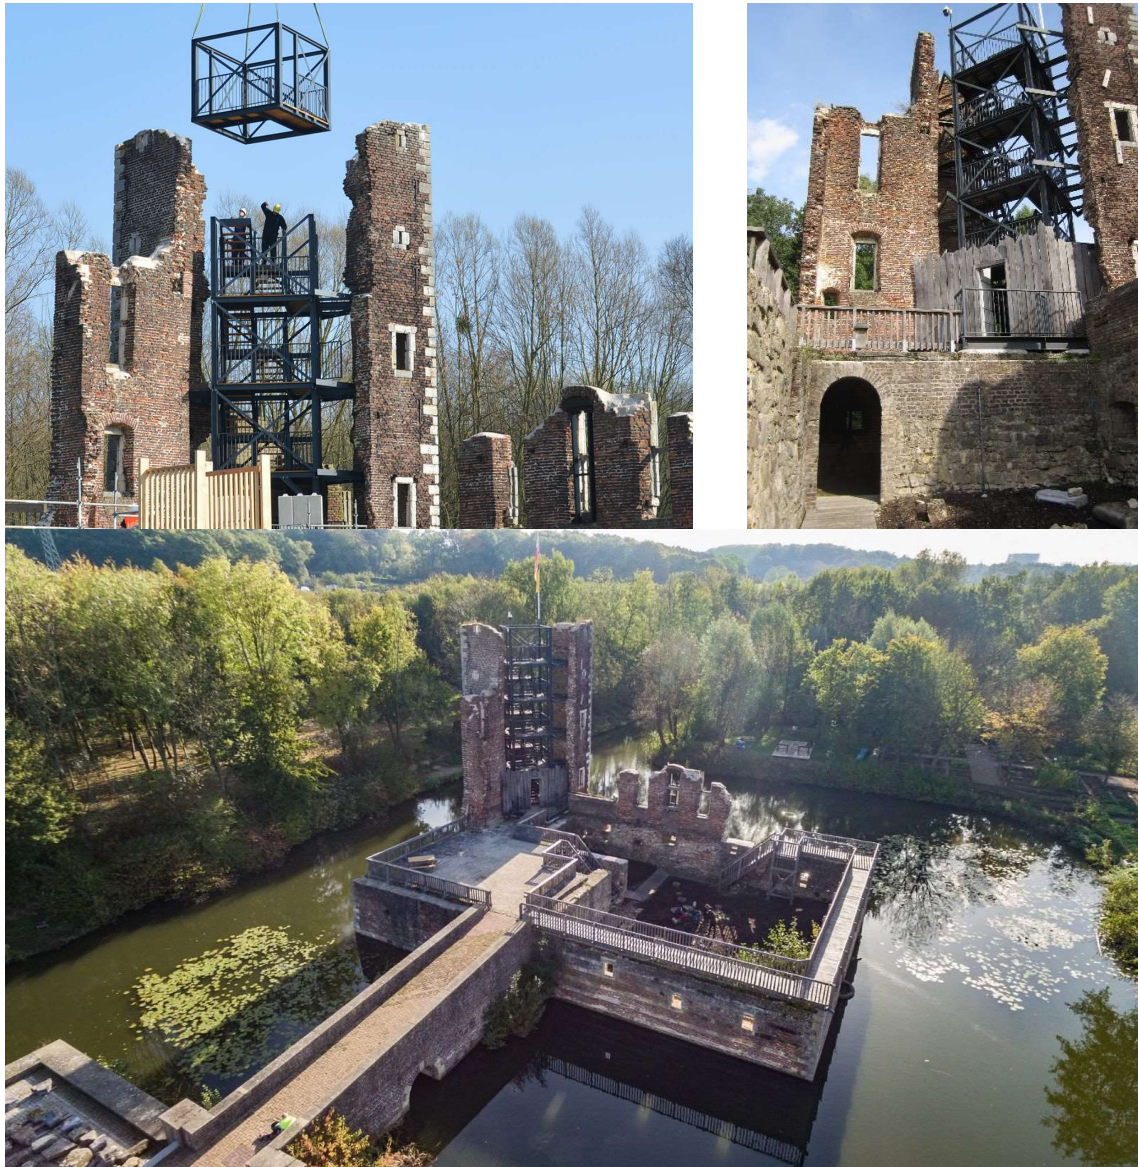
Figure 63- Overview of the construction of the steel staircase (on top left) and the ready done stage (at the other pictures)(Viersen, 2014)

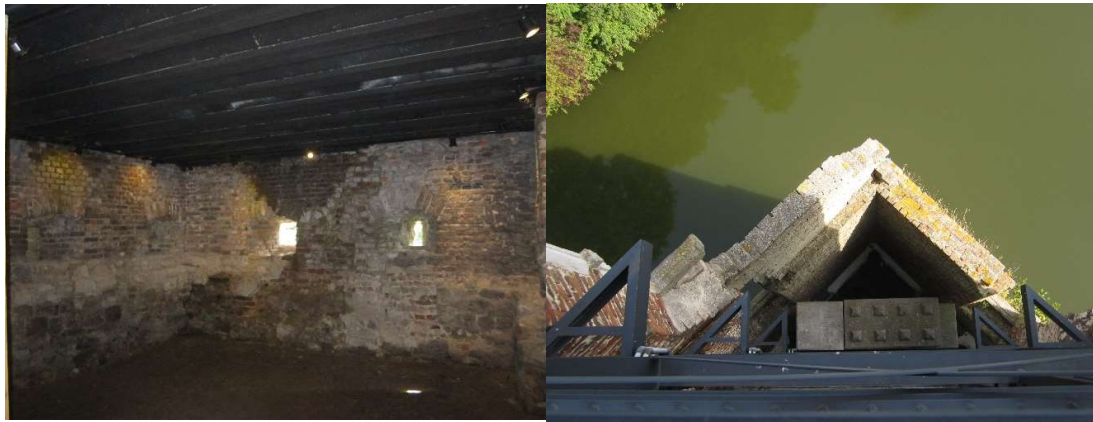
Figure 64- Overview at the left side of the prefab concrete floor at the cellar which substitutes the vaults and floors from the original construction. This consolidation was made at the 1st consolidation works of 1975. At the right side it's the overview of the concrete ballast where the steel staircase is standing on (own pictures)

The steel stair-case was built on top of the cellar which had in the previous consolidation (1975) a concrete floor at the top which supports the staircase. The staircase stands on top of a concrete ballast which serves as a kind of stabilizing support for the structure. The function of the staircase structurally is to substitute the former iron anchors which didn't exist anymore or were not doing any structural function anymore because the floors were not there. These iron anchors function was by fixing the floors to the walls to transmit, on this way, the horizontal force of the wind action to the floors. The iron anchors provided that the walls didn't fall in or out and therefore not only working in tension but also in compression. The floors performed the diaphragm action which was directing the load to the vertical supports (columns and outside wall). The stair-case it's in this way substituting, temporarily several load-bearing elements.

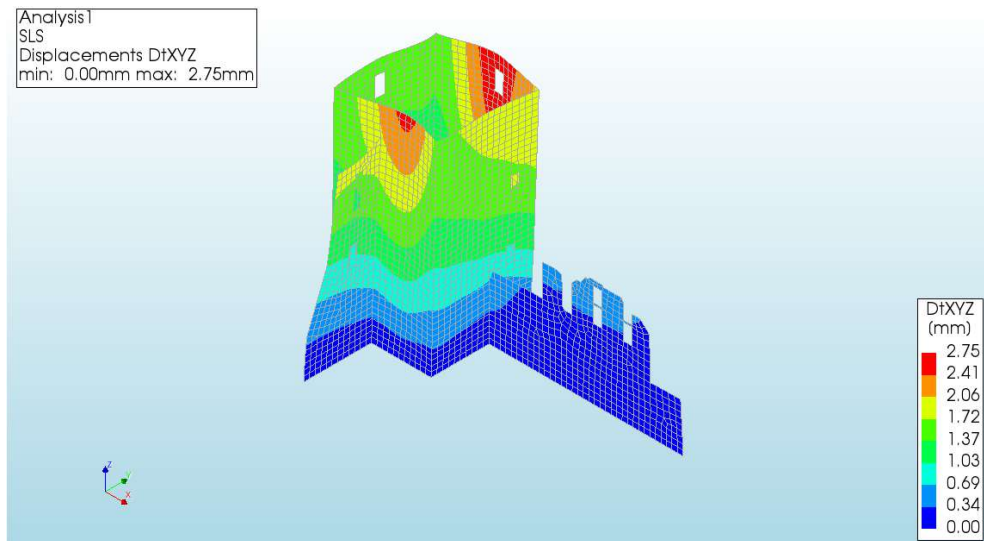
Figure 88- Diana results for the highest displacement according to SLS

In following figures an overview of the Diana Fea results is given:

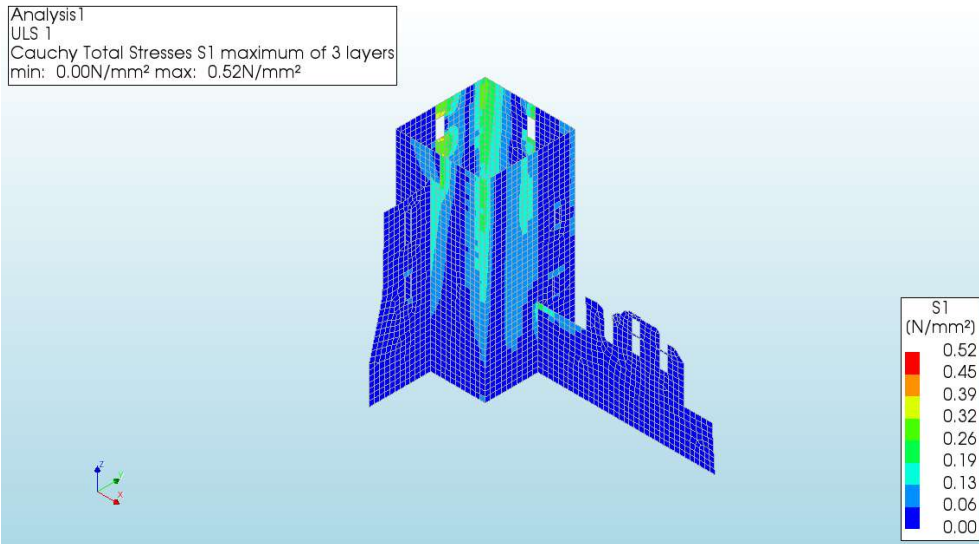
Figure 89- Diana results for the highest tension in glass S1 according to the principal direction
